# Quality Control Report

**Consultant** **Wahib Medanat** Consultant Engineers  
**Site Name** **Jumana Bint Abi Taleb Basic Mixed - Marka**  
**Package** **Package 2**  
**Contractor** **Dijlah Est. Construction Co.**  
**Tender No.** **10/2019/USAID/SKEP/3/2**

**Rep No.** **QC-23 20**  
**Date** **23 / 07 / 2022**

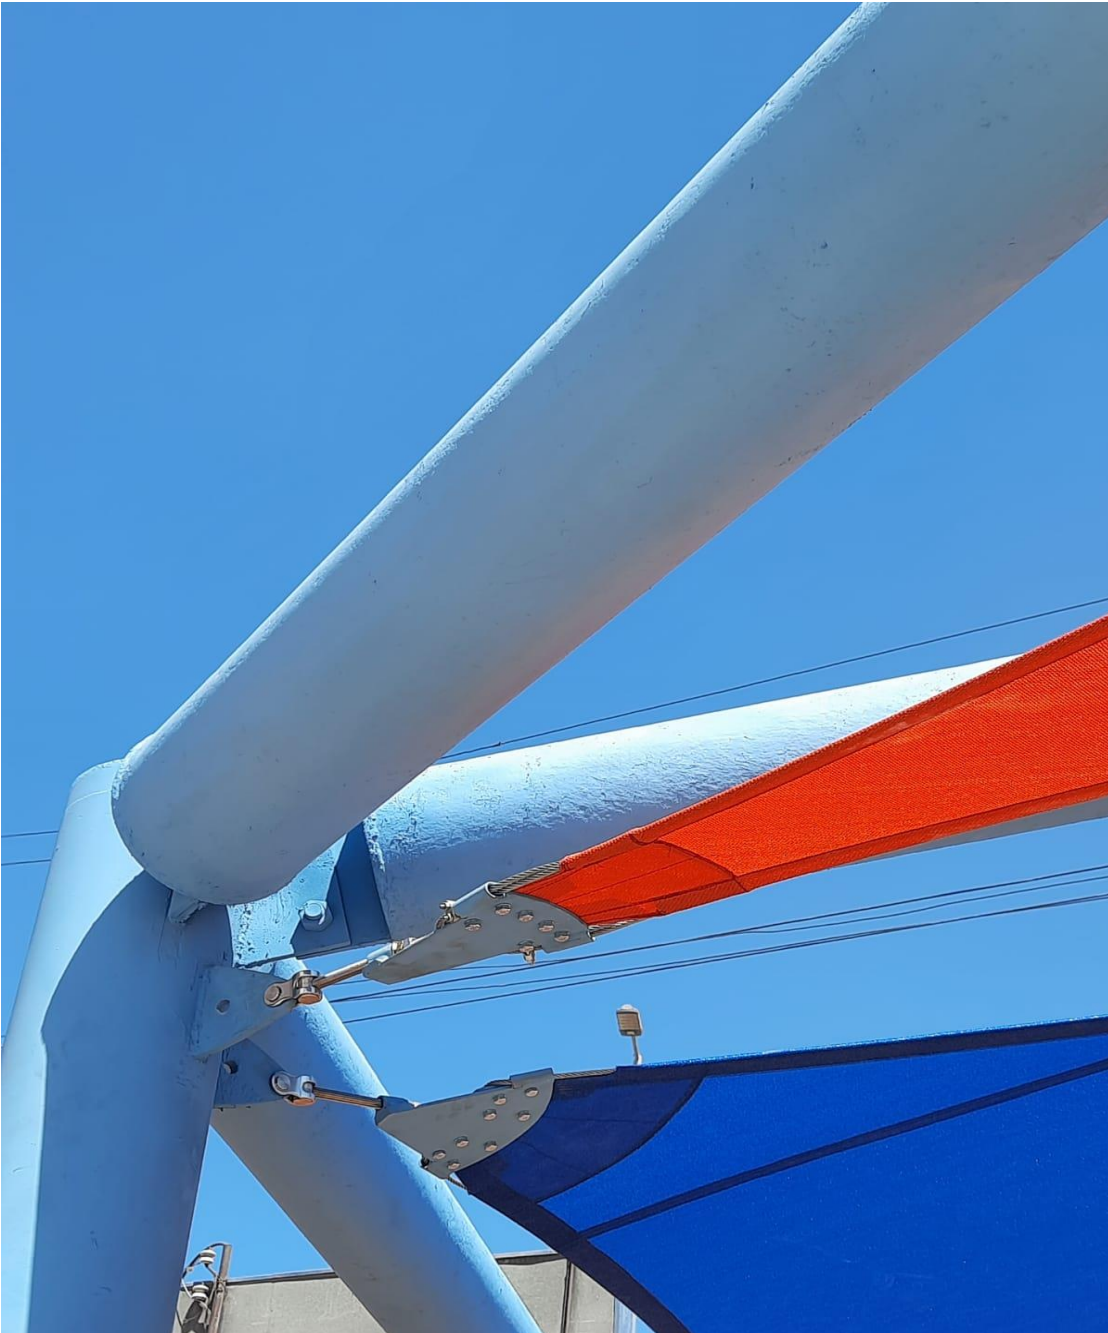
**Defects in the painting of the horizontal pipes of the shading. Untight fabric**

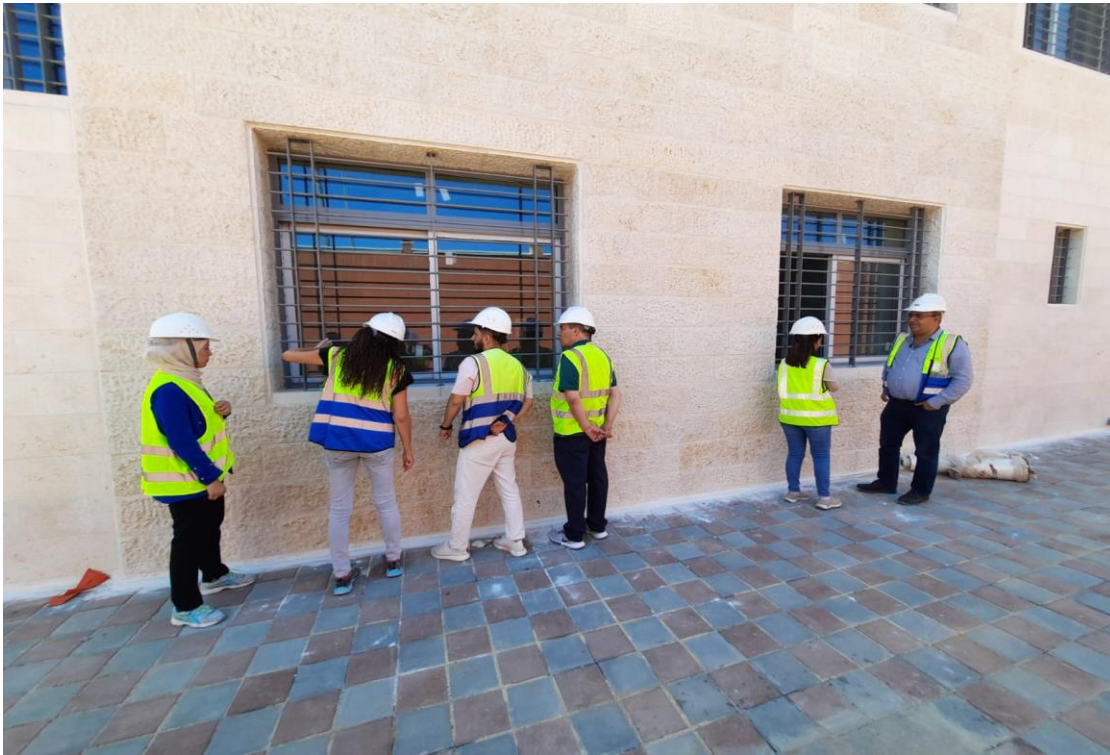
Parts of the steel protection screens are painted with different color

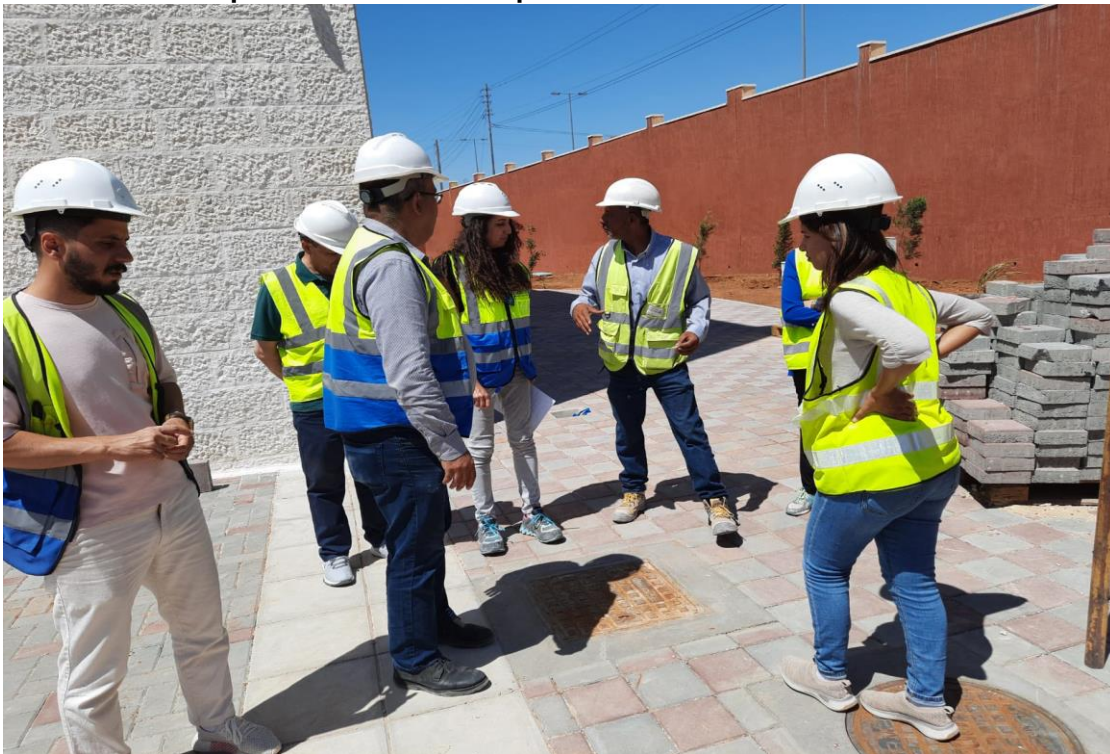
Manholes covers need cleaning from corrosion, and paint

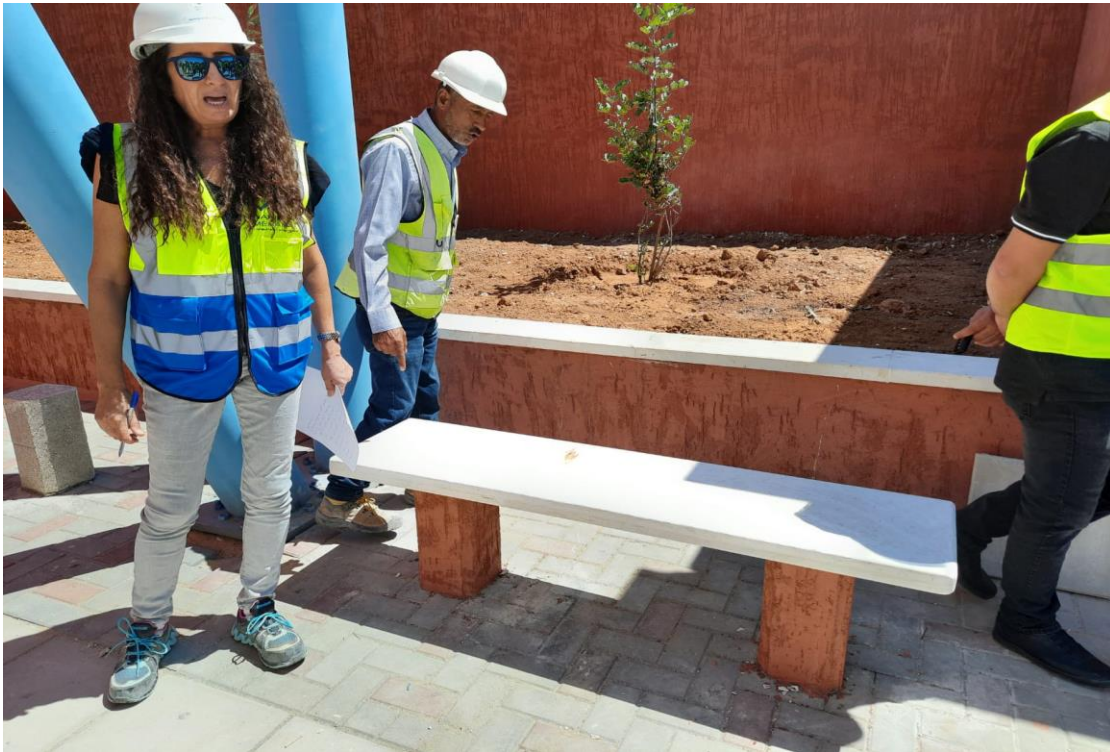
**External benches supports not colored and the stone is one piece not two**

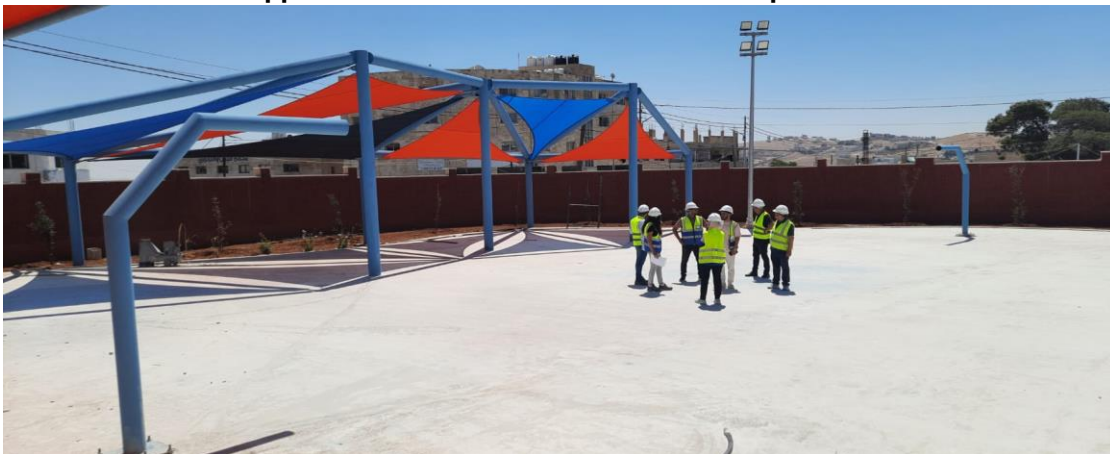
**The fabric of the shading does not cover the whole area**

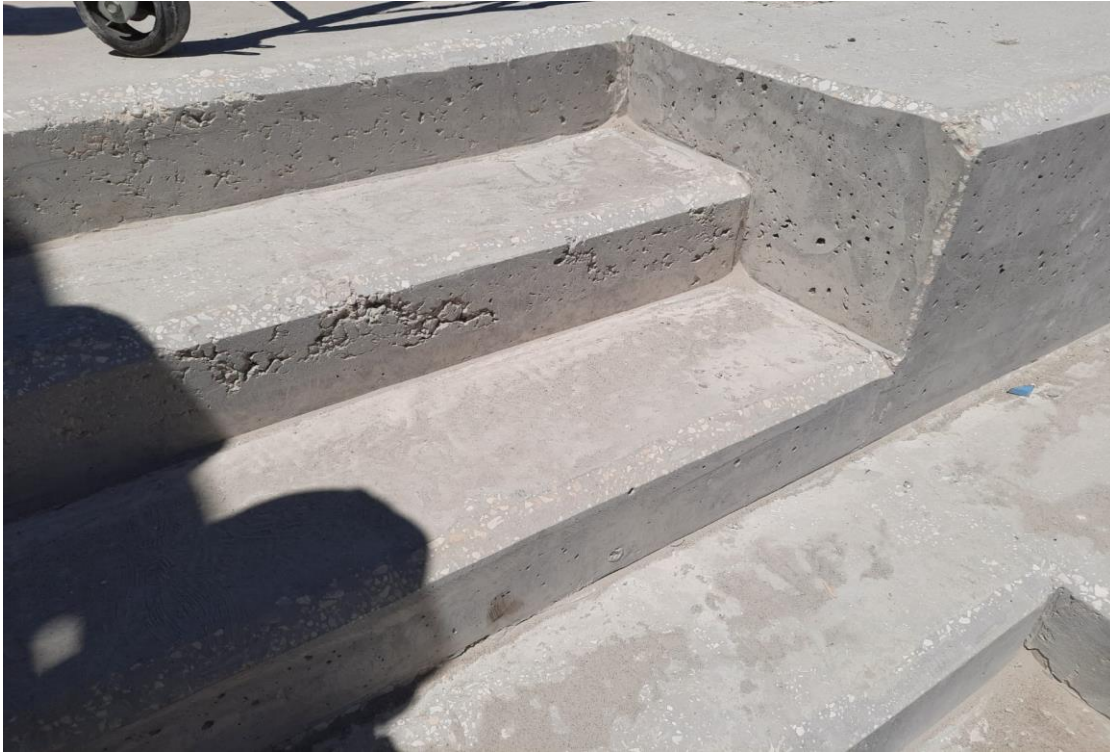
**Voids in the casted concrete of the amphitheater**

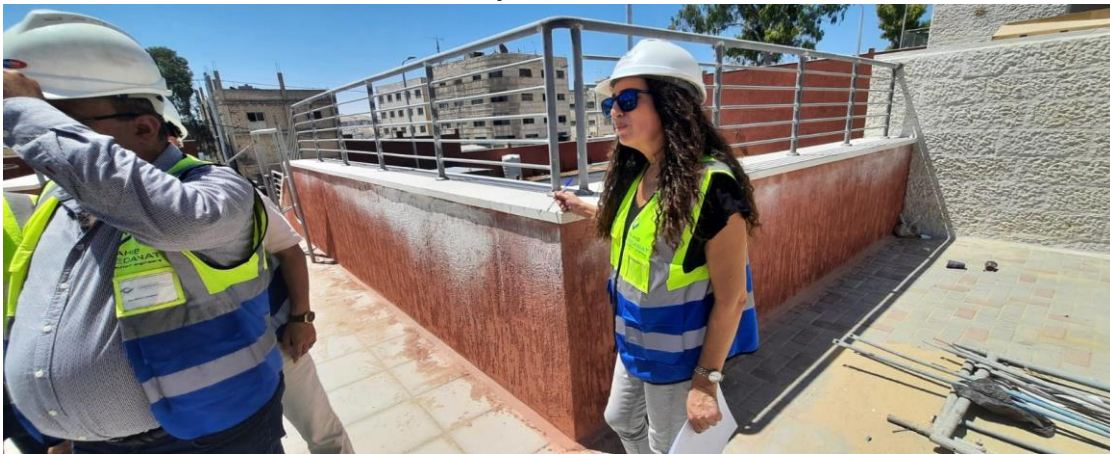
**Dirt at the colored plastering**

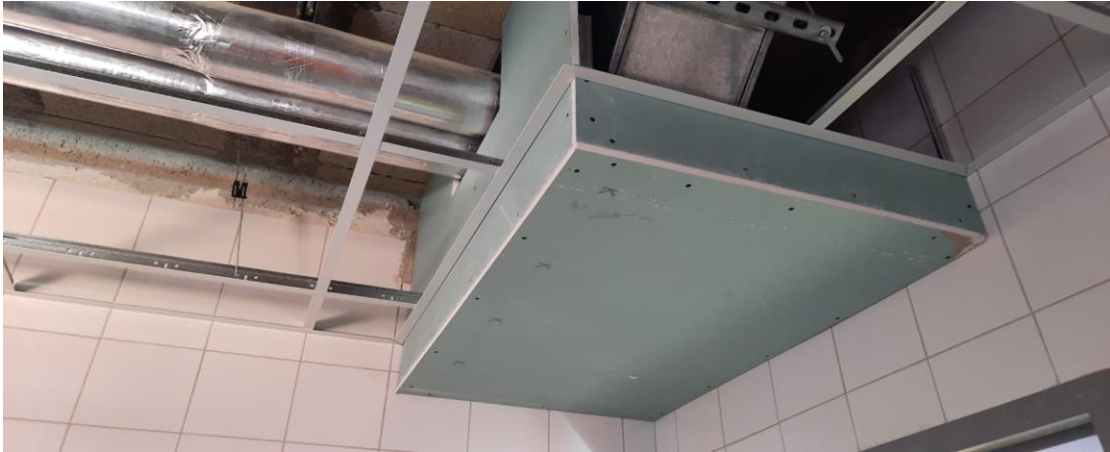
**Suspended ceiling at the women toilet has wrong level**

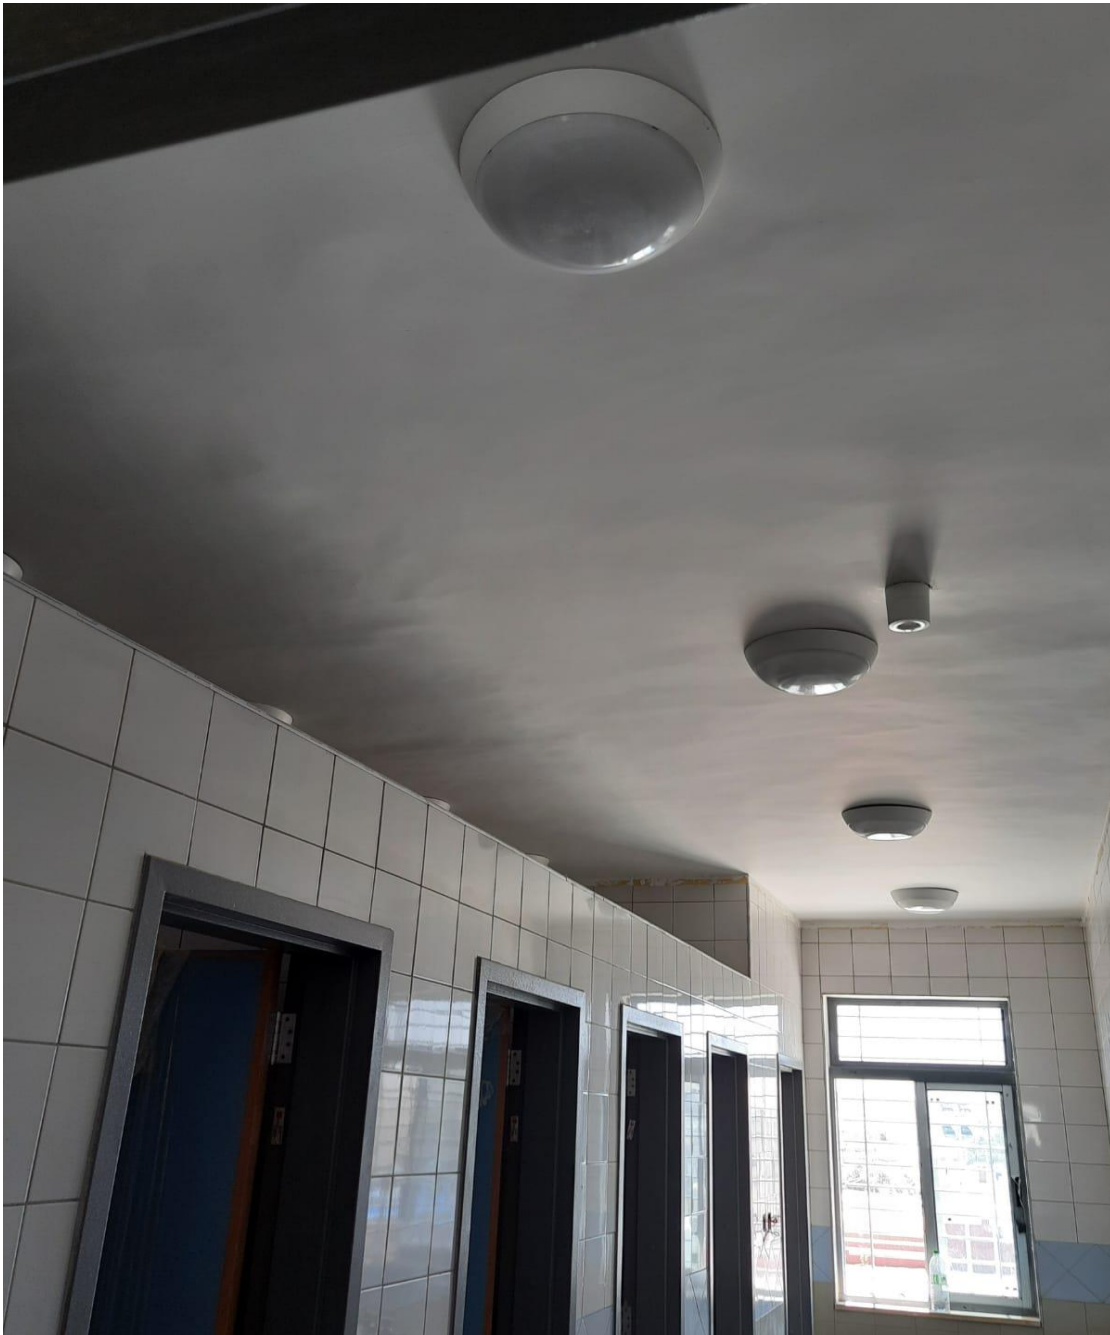
**Waving in the plastering/painting of the ceilings of toilets**

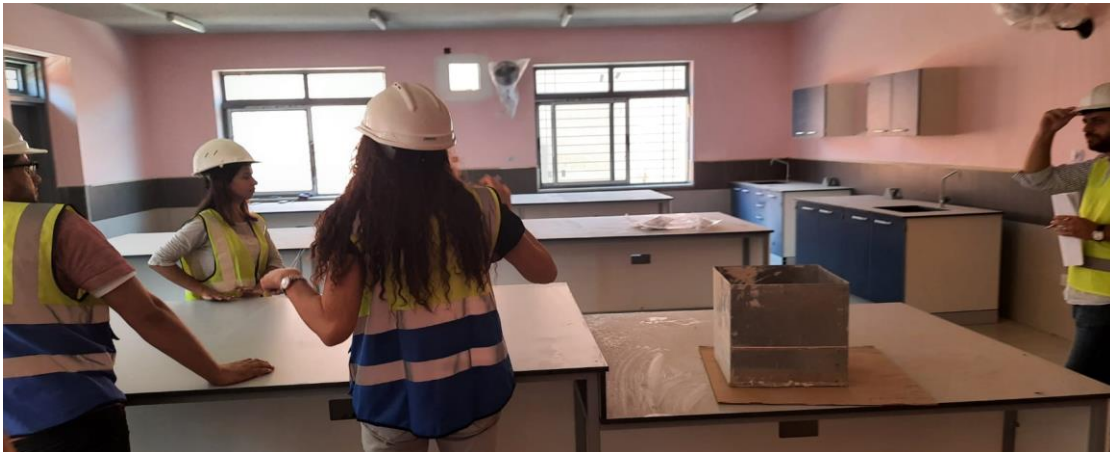
**Parts of the laboratory furniture do not comply with color scheme**

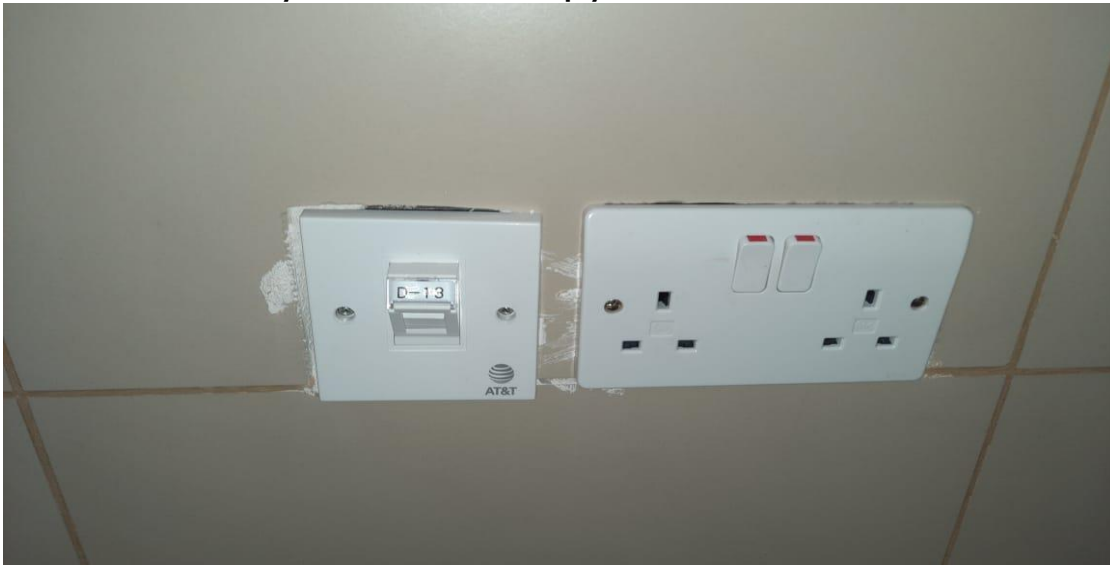
**Defects in the finishing around the electrical sockets**

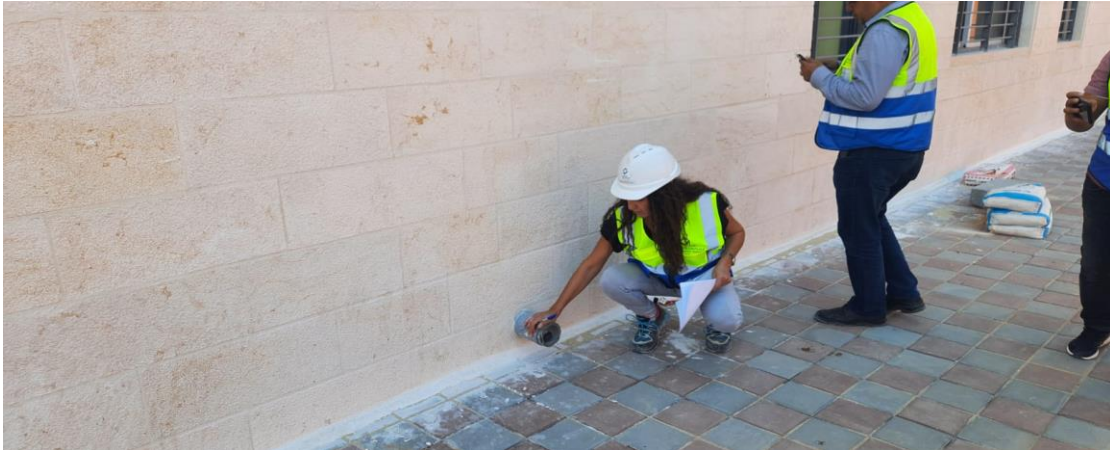
**Protrusion of rainwater drainage pipe is more than required**

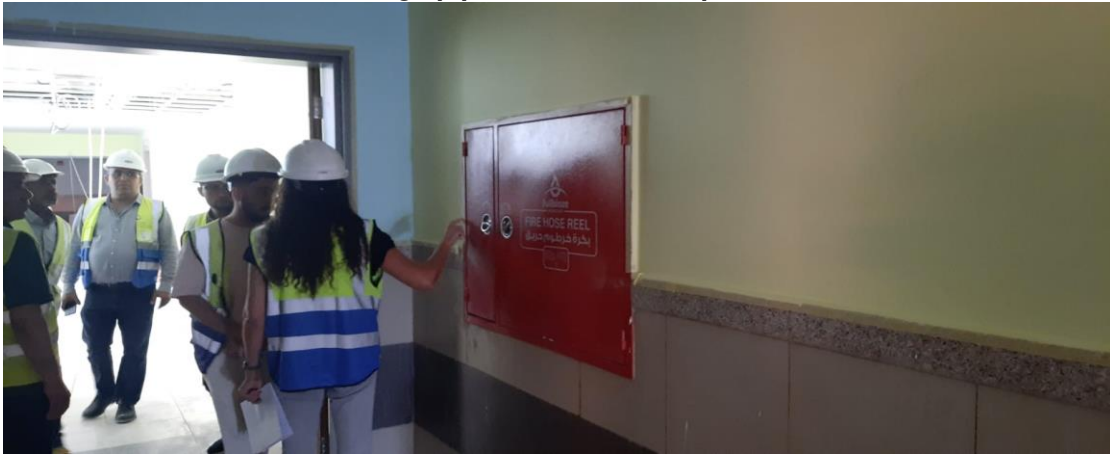
**Finishing around fire hose cabinets is not finished as agreed upon previously**
