# Quality Control Report

**Consultant** **Wahib Medanat** Consultant Engineers  
**Site Name** **Khadija Bint Khwailed Basic Mixed - Balqa**  
**Package** **Package 1**  
**Contractor** **Derar Saraireh & Sons for Engineering & Contracting**  
**Tender No.** **1/2020/USAID/SKEP/3/1**

**Rep No.** **QC-13 14**  
**Date** **16 / 02 / 2022**

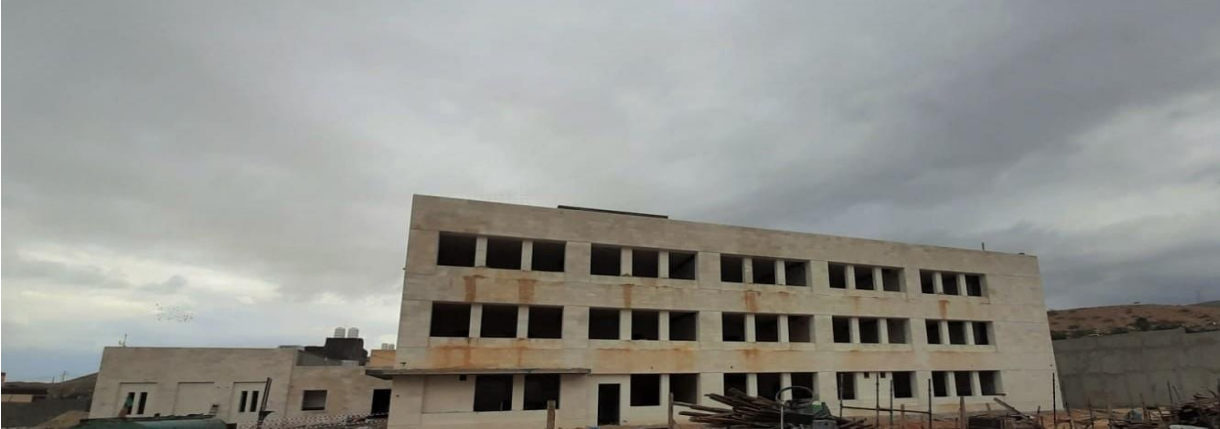
**Dirts on the built stones**

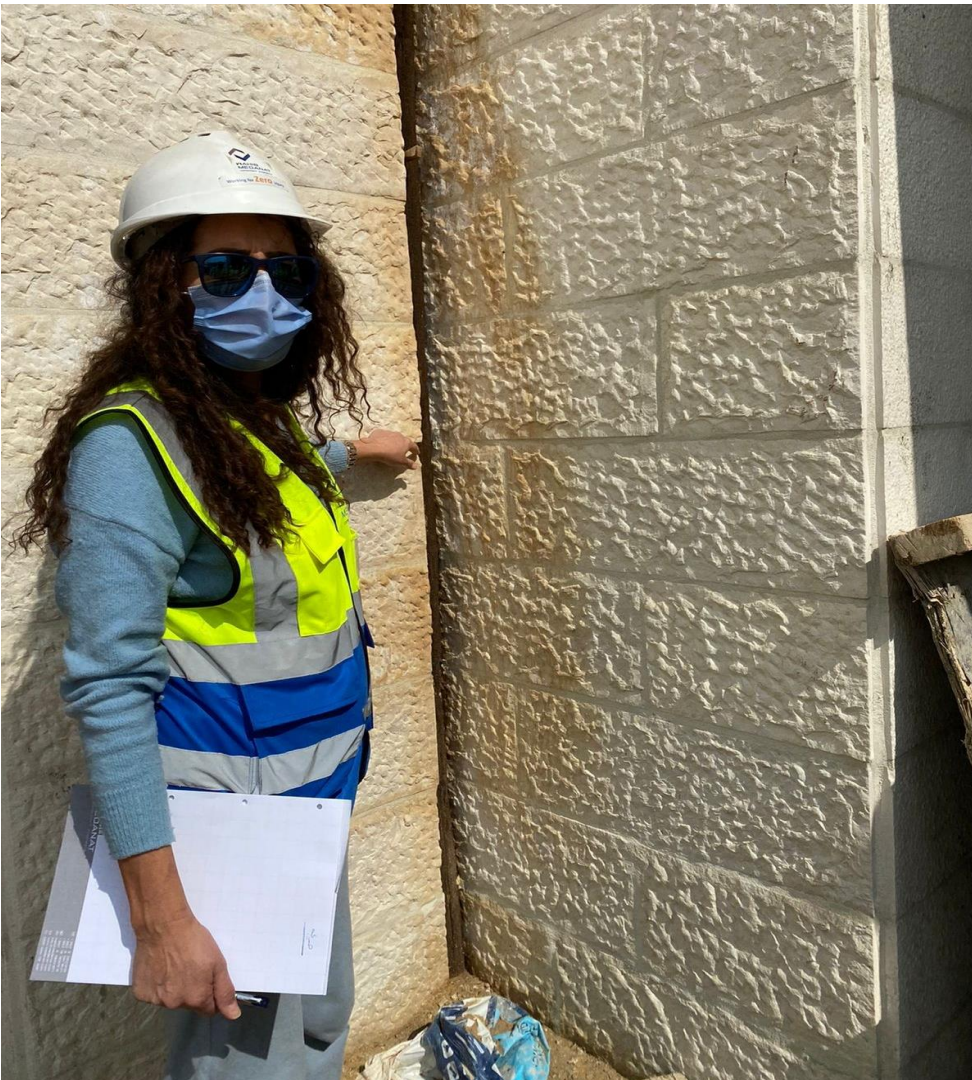
**Dirts on the built stones**

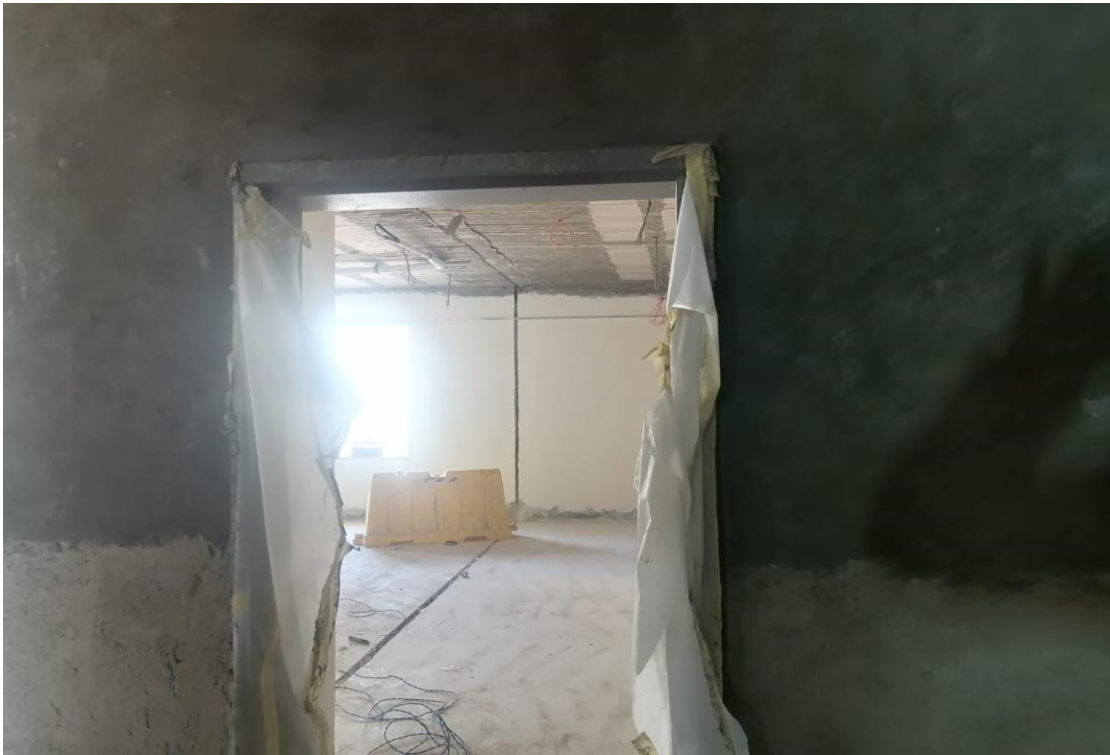
**Door frame with wrong dimensions**

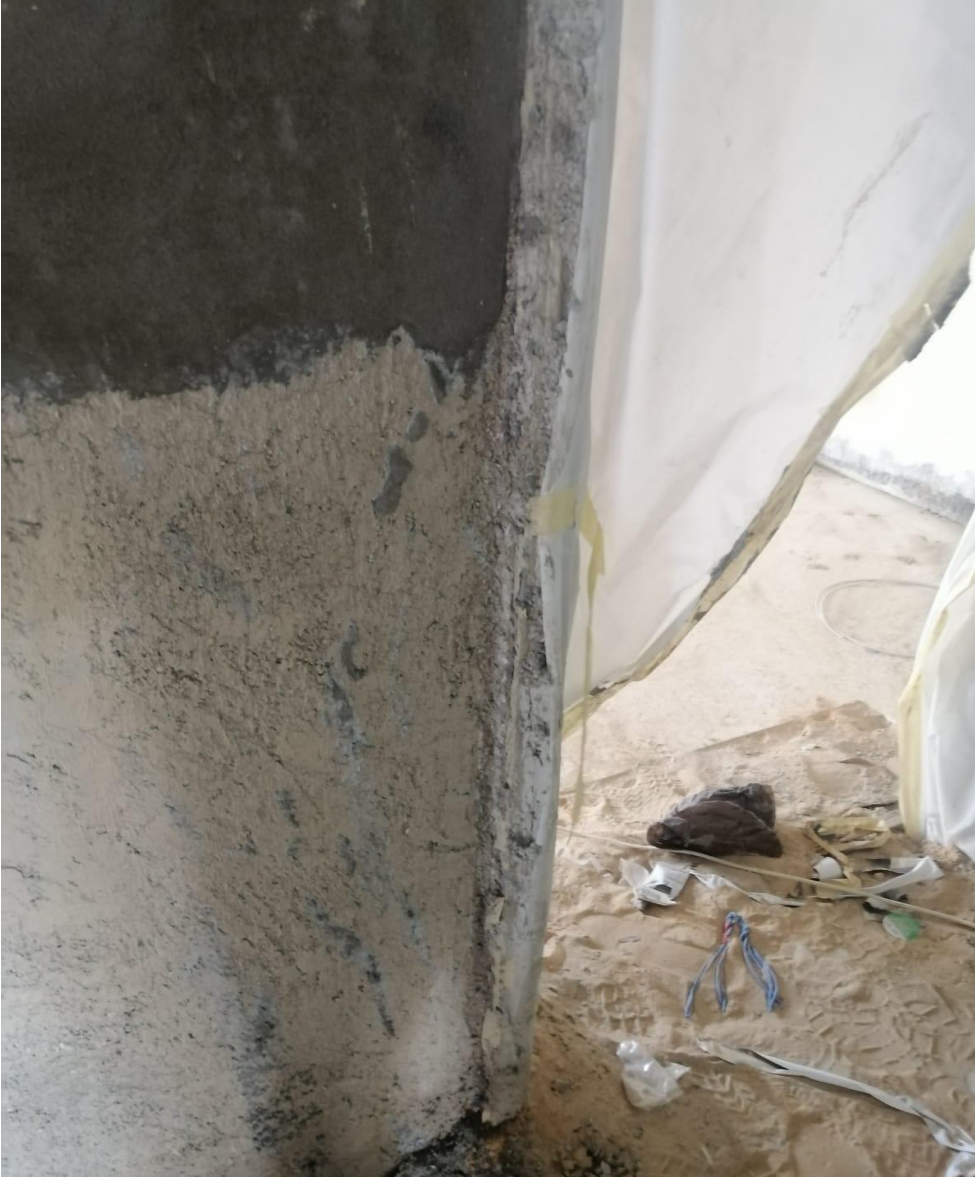
**Removal of door frame with wrong dimension**
