Quality Control Report

Consultant **Wahib Medanat** Consultant Engineers
Site Name **Thahr Al Sarow Basic Boys - Jerash**
Package **Package 2**
Contractor **Dijlah Est. Construction Co.**
Tender No. **10/2019/USAID/SKEP/3/2**

Rep No. **QC-22 17**
Date **15 / 06 / 2022**

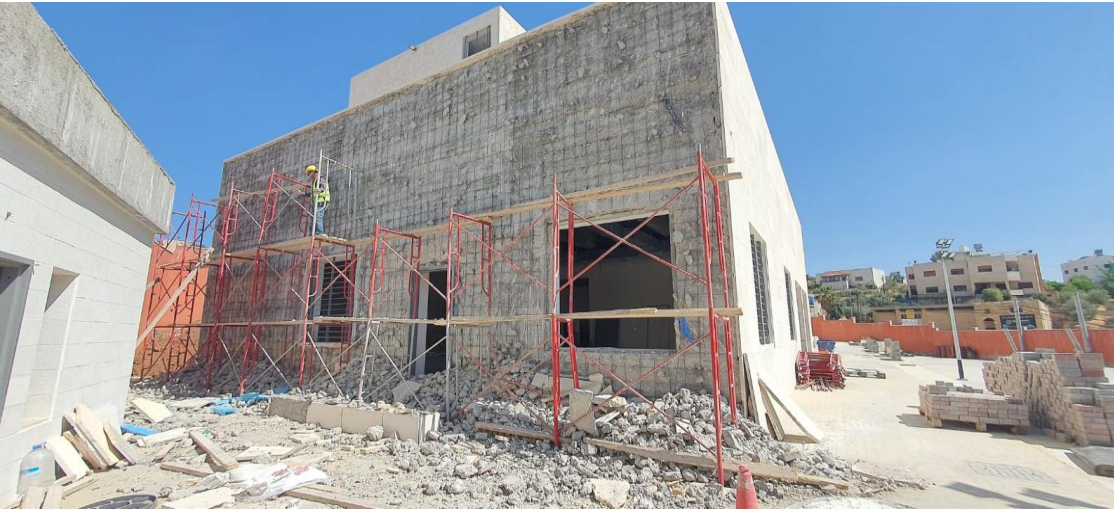
Removal of defected stones

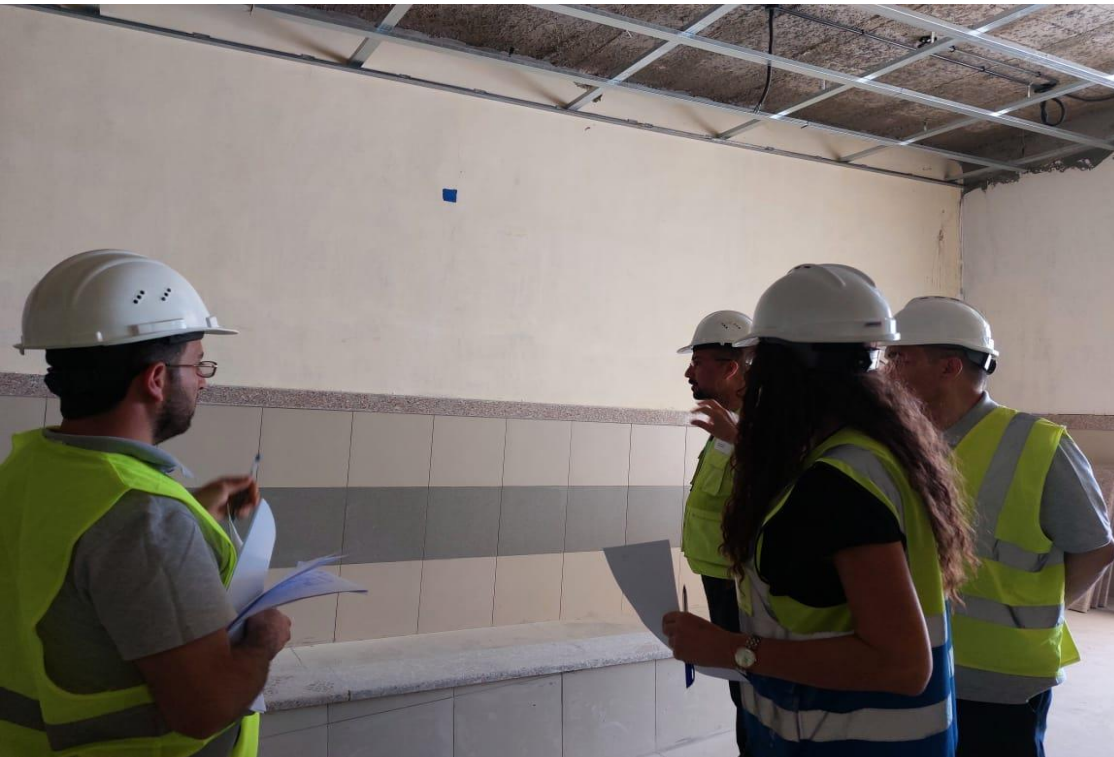
Walls at entrance/tiling not in accordance to drawing

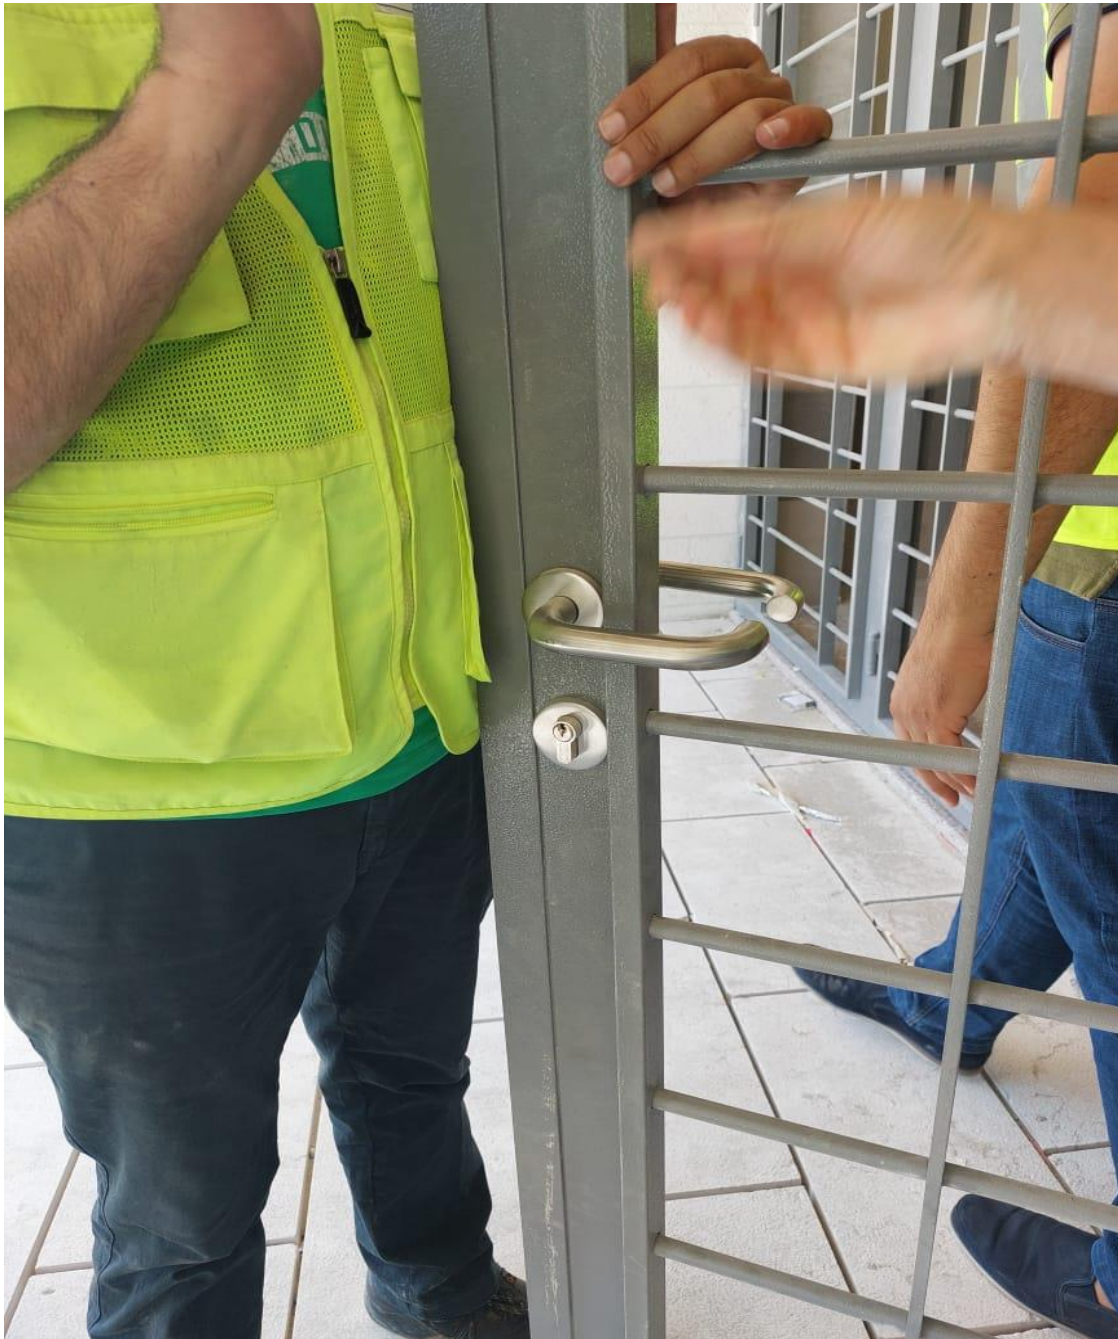
Door part does not comply with architectural details

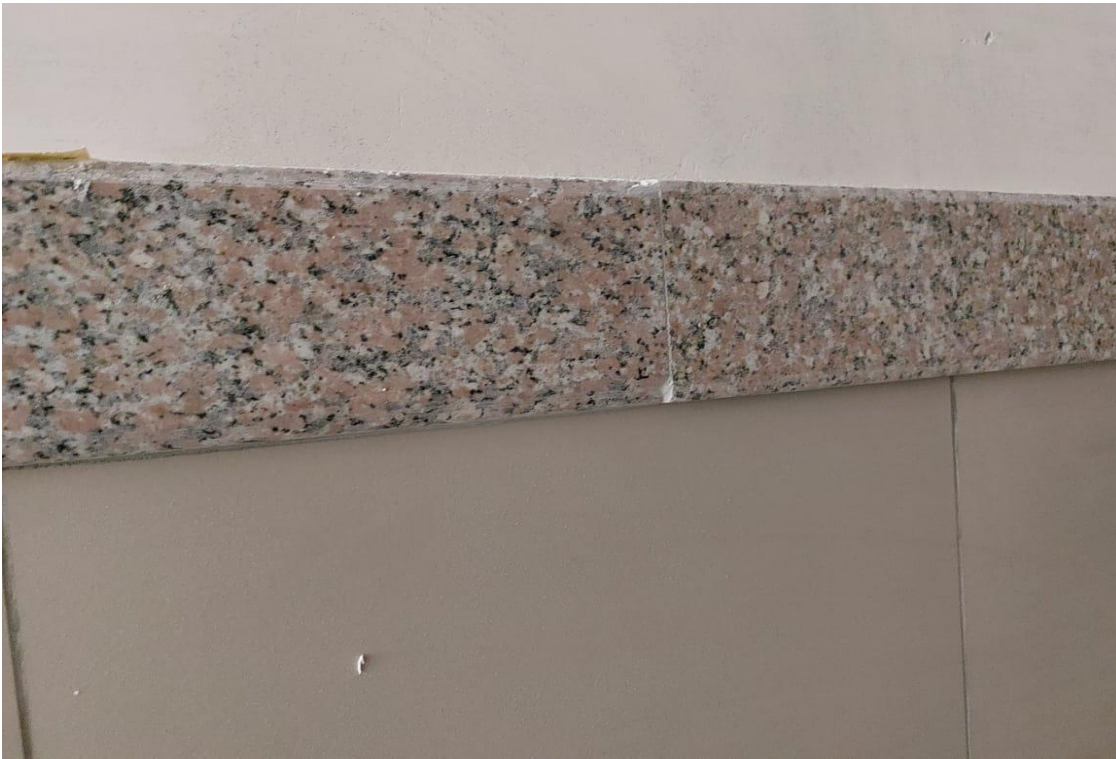
Broken edges of granite coping and defects in installation

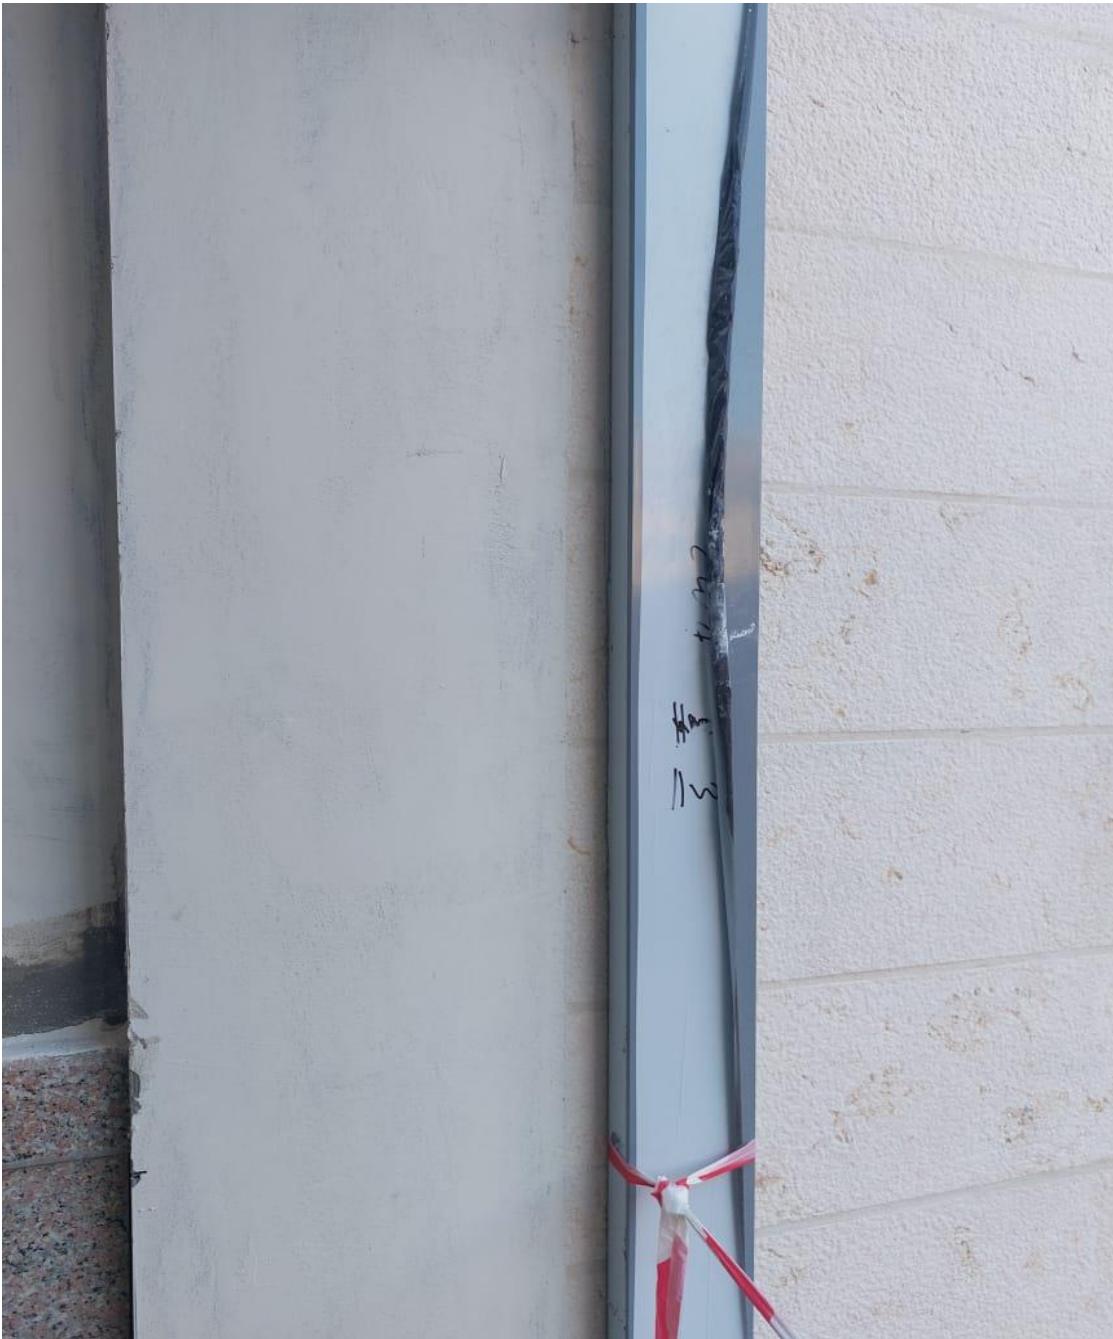
Defects in installation of curtain wall

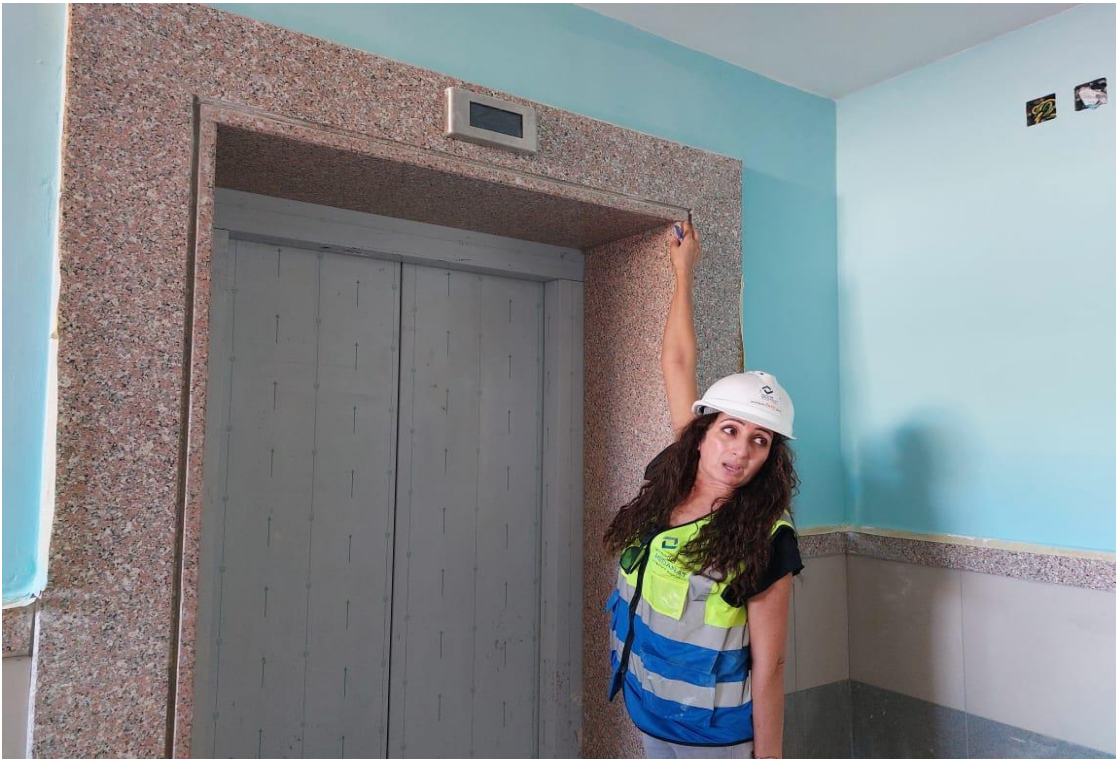
Protrusion of granite/elevator frame

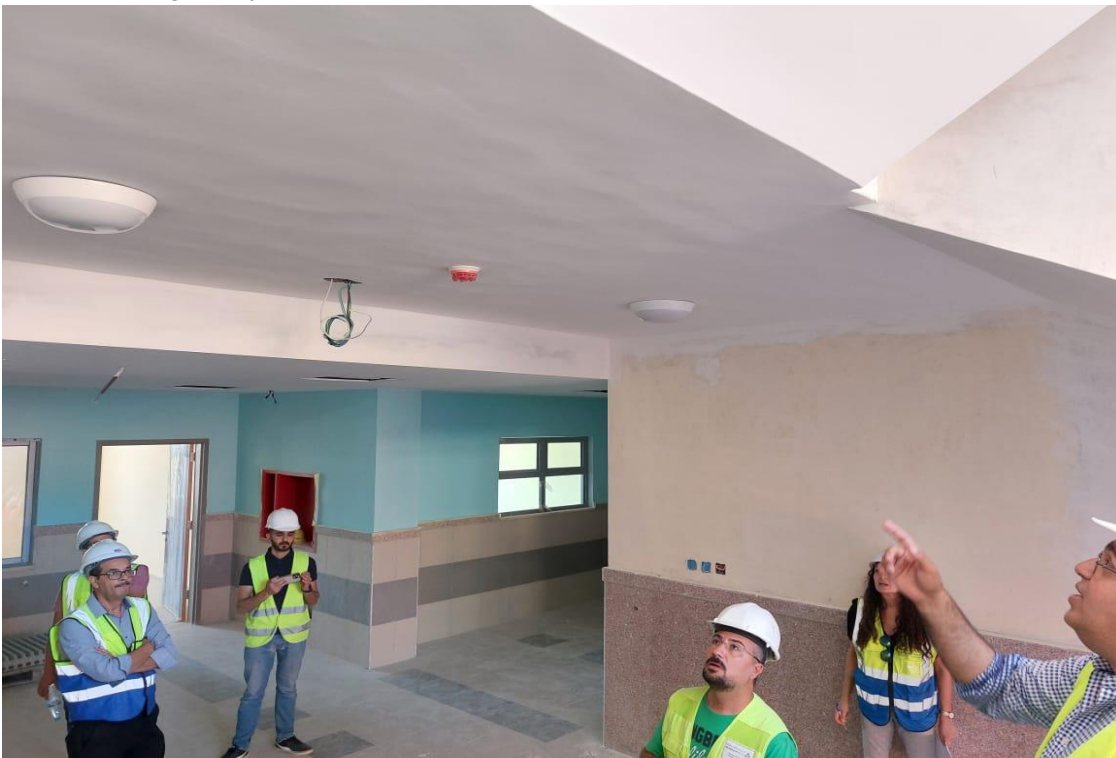
Waving in ceiling

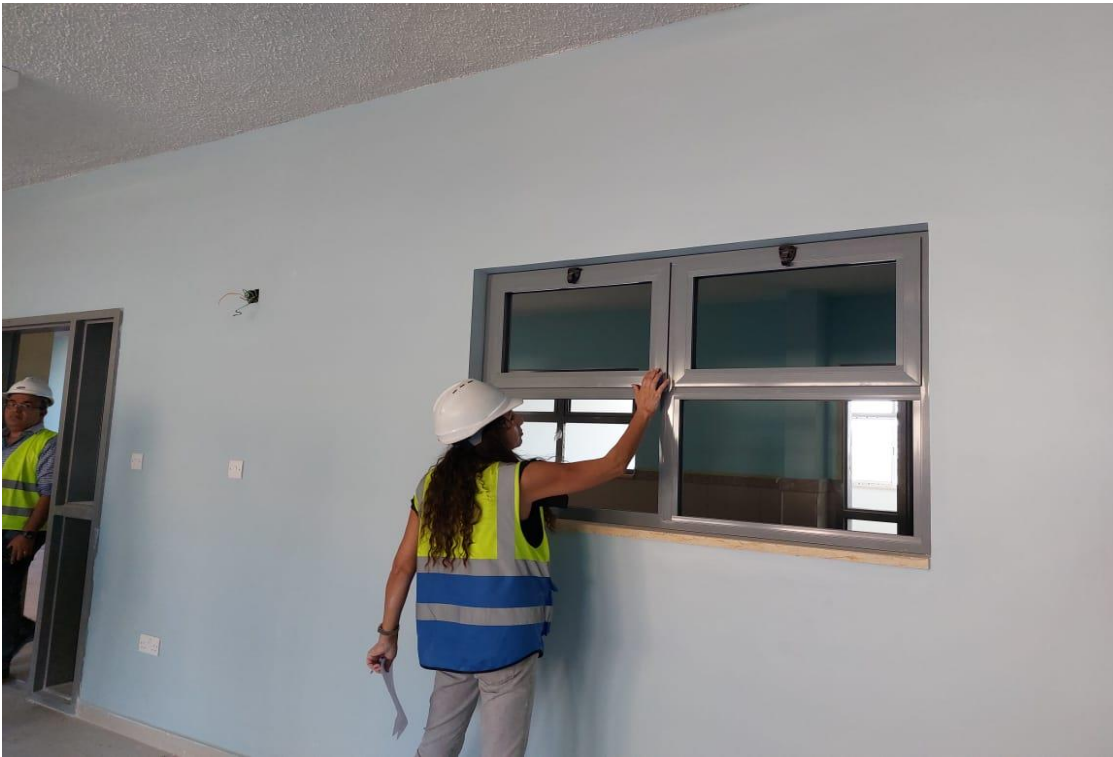
Sharp edges in aluminum window
