Quality Control Report

Consultant **Wahib Medanat** Consultant Engineers
Site Name **Thahr Al Sarow Basic Boys - Jerash**
Package **Package 2**
Contractor **Dijlah Est. Construction Co.**
Tender No. **10/2019/USAID/SKEP/3/2**

Rep No. **QC-22 12**
Date **2 / 01 / 2022**

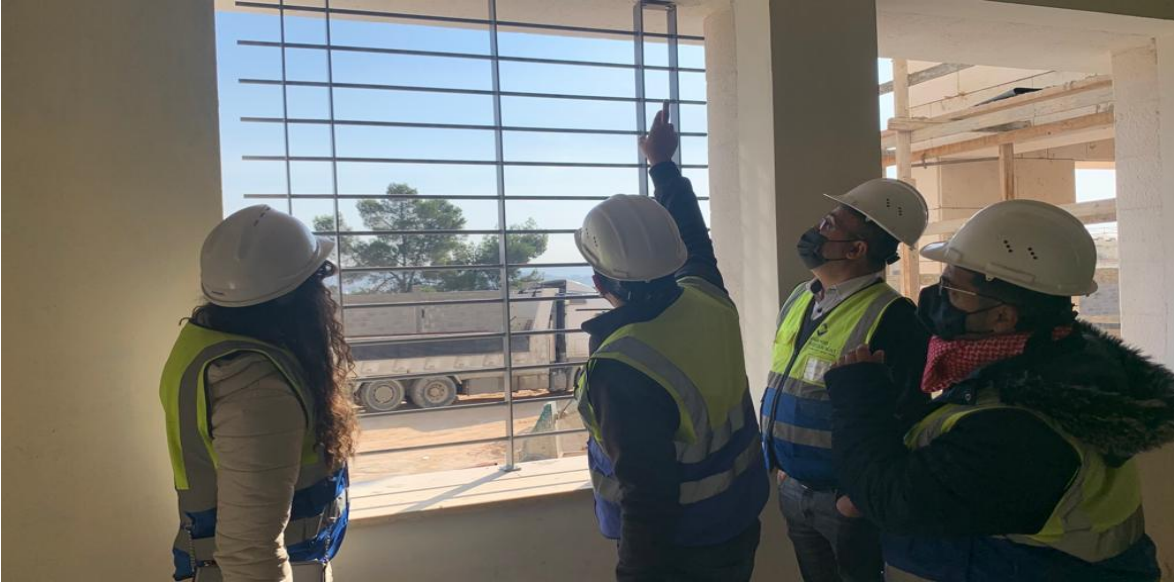
Defects in the steel protection grill

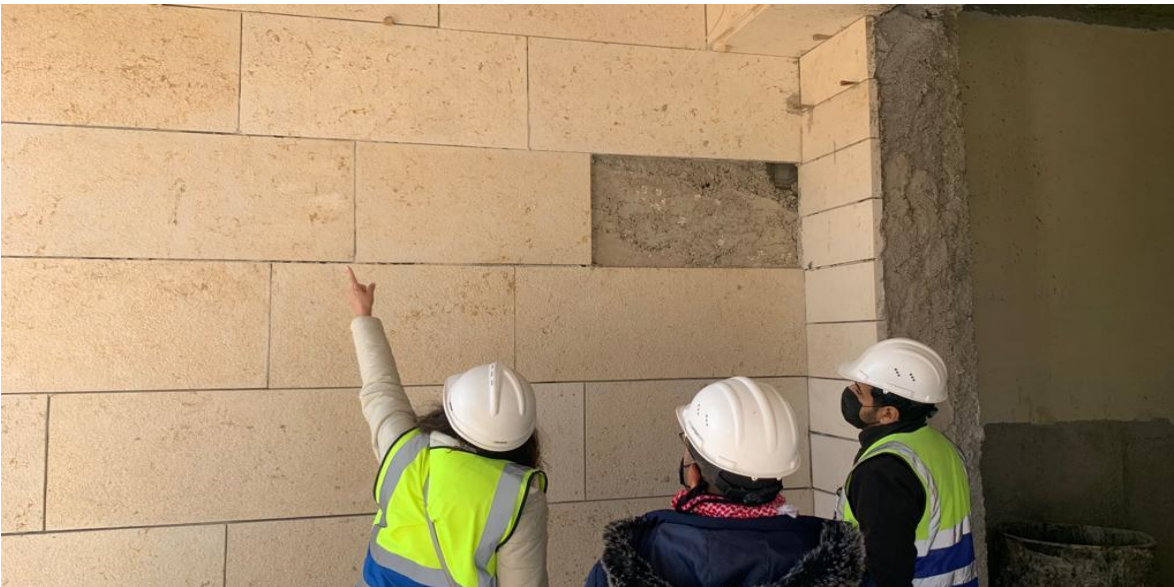
Defected stones at the facades

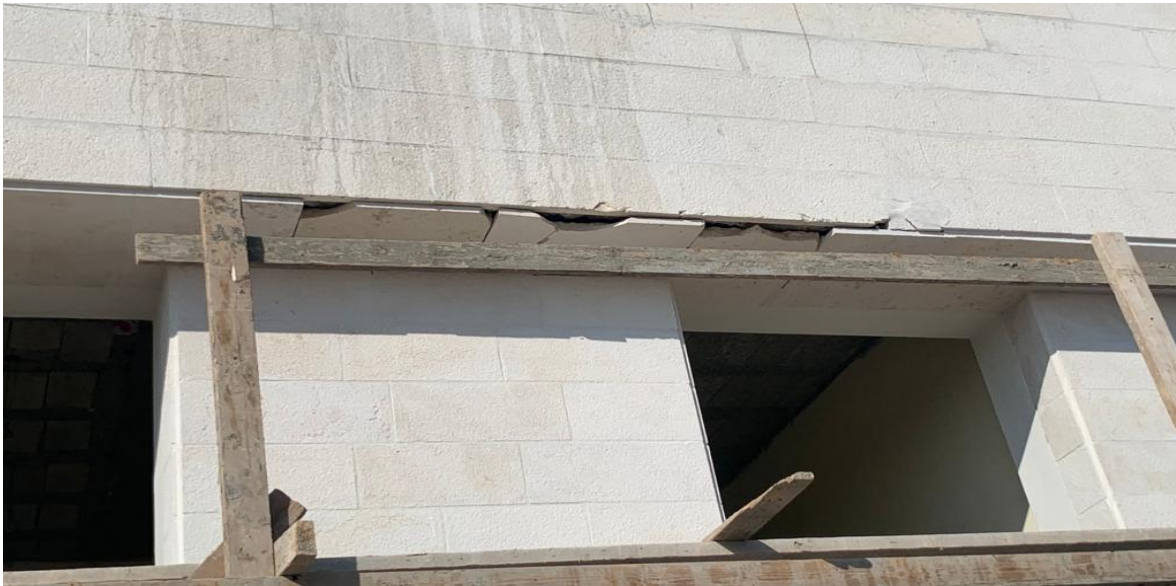
Defected stones at the facades

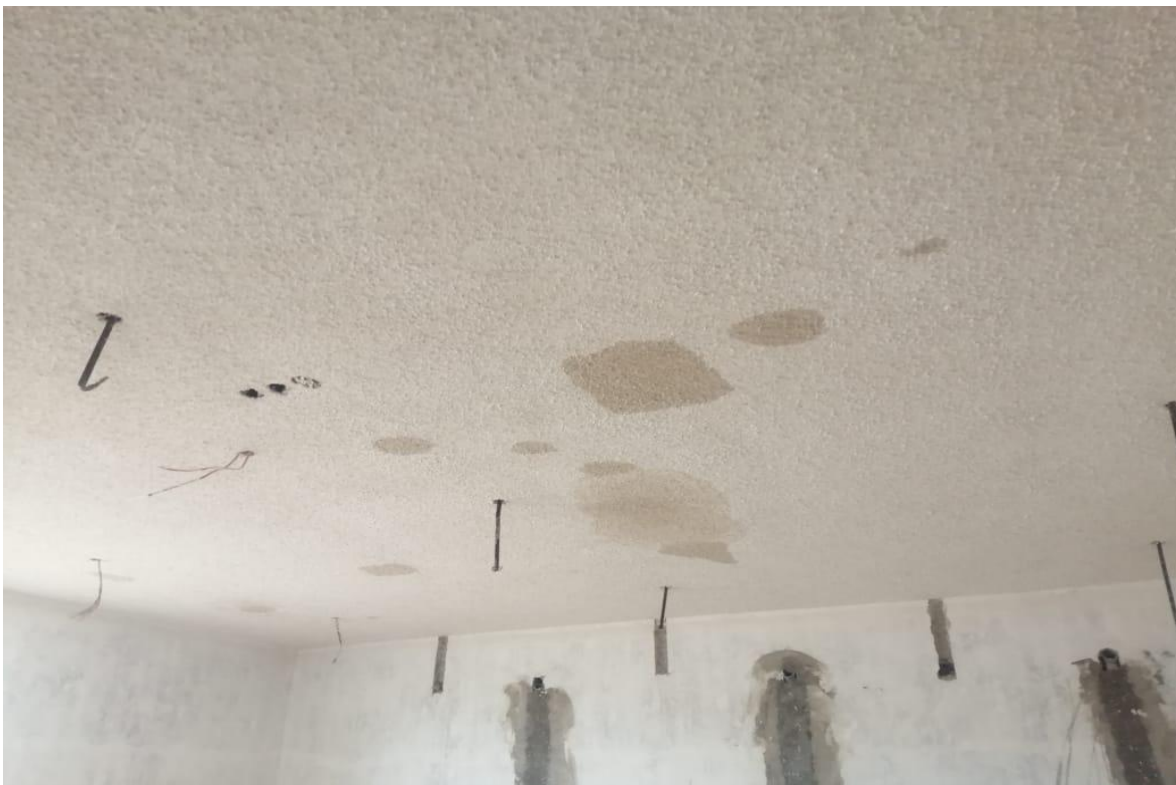
Water penetration due to defects in the waterproofing
