Quality Control Report

Consultant **Wahib Medanat** Consultant Engineers
Site Name **Hay Al Iskan Basic mixed - Jerash**
Package **Package 2**
Contractor **Dijlah Est. Construction Co.**
Tender No. **10/2019/USAID/SKEP/3/2**

Rep No. **QC-21 18**
Date **6 / 03 / 2022**

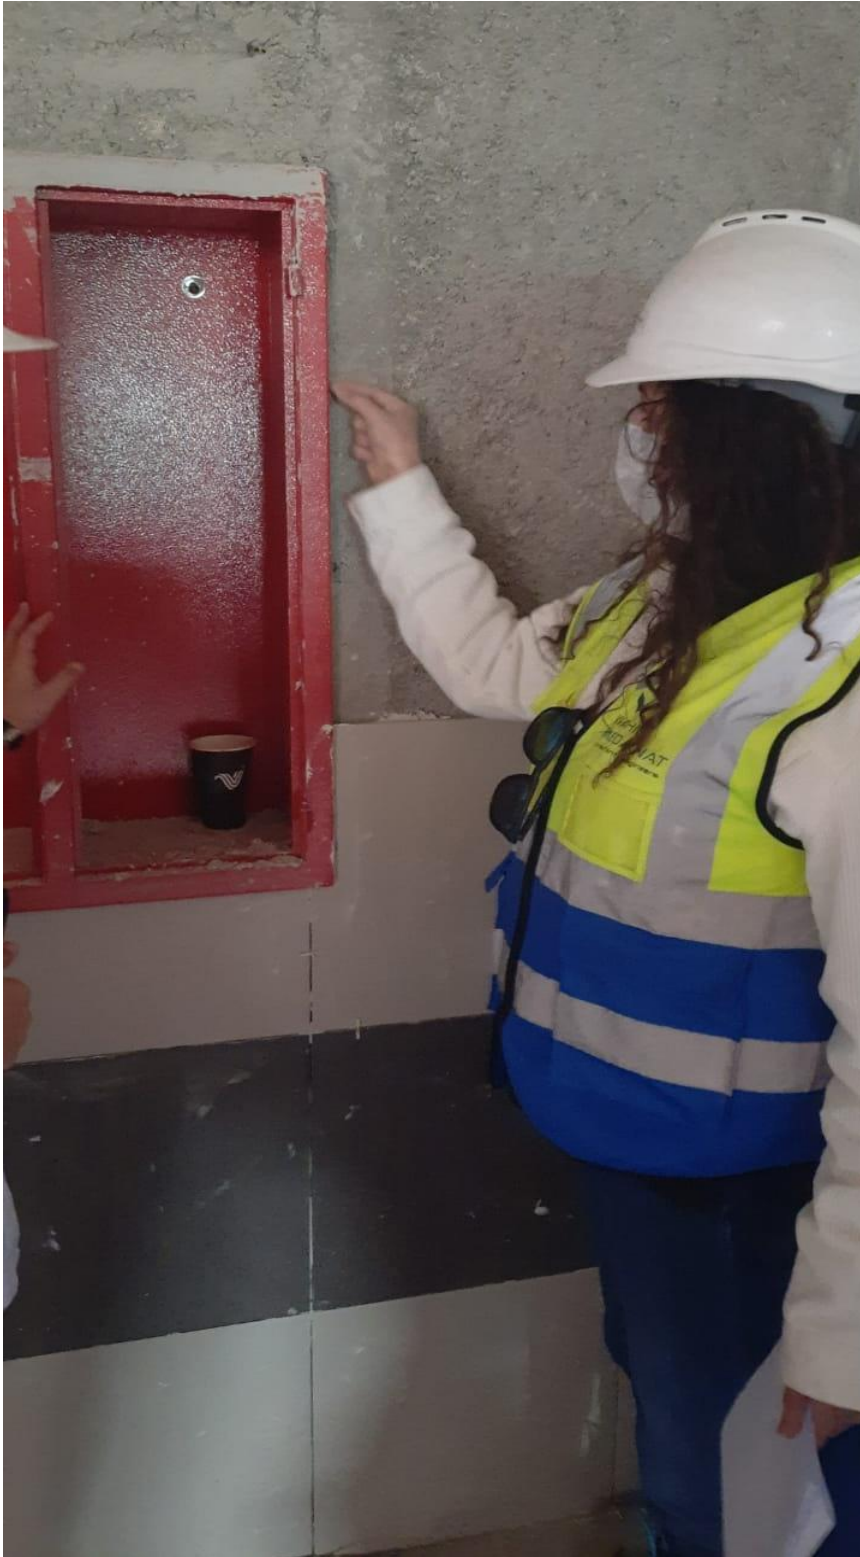
Defects in fire hose cabinet

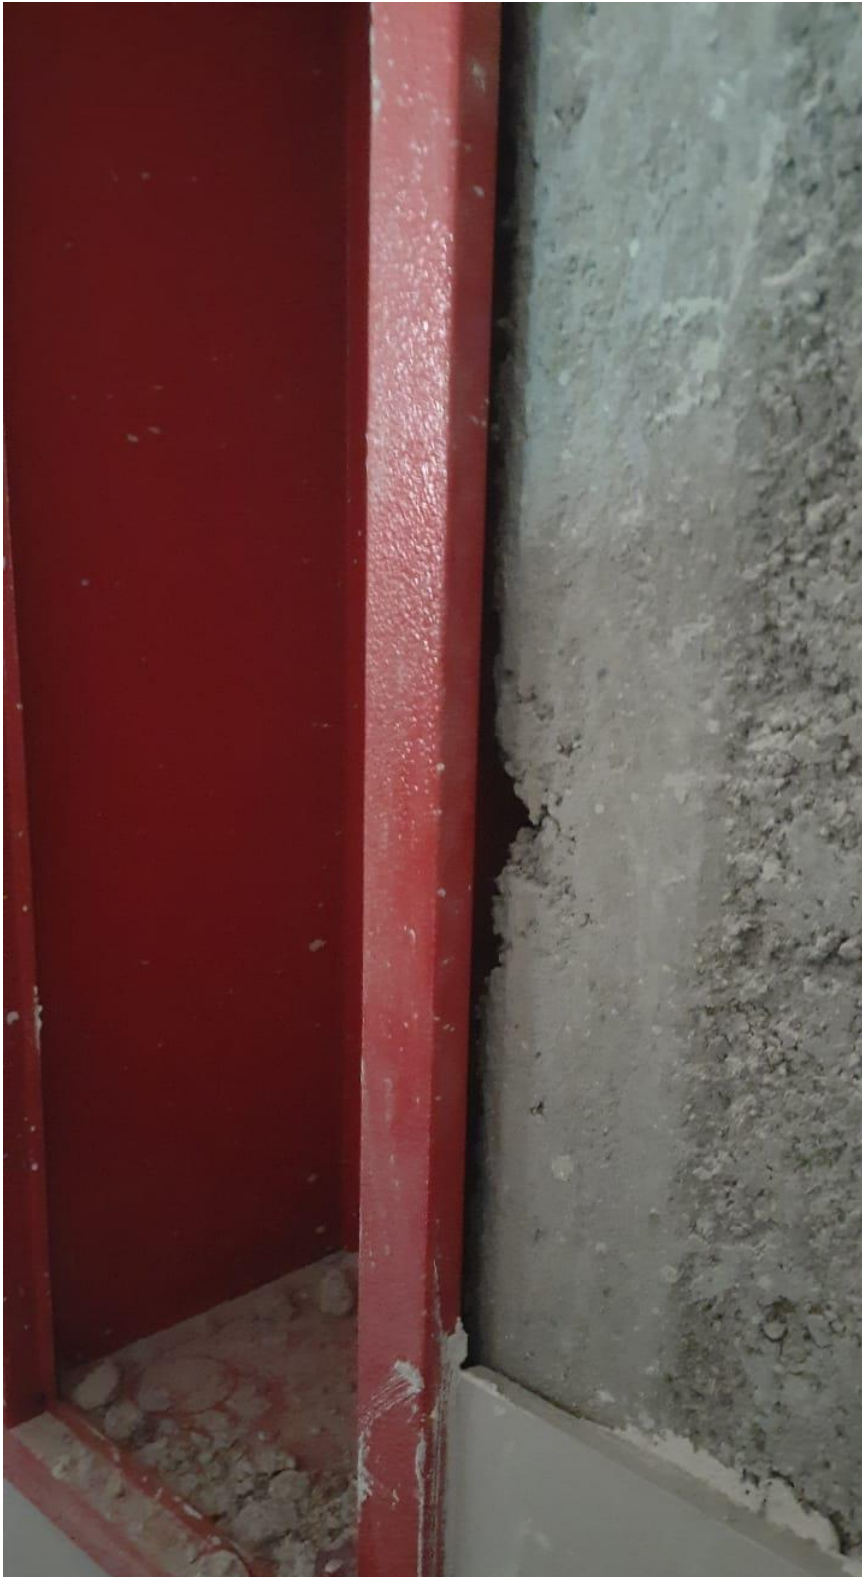
Defects in fire extinguisher cabinet

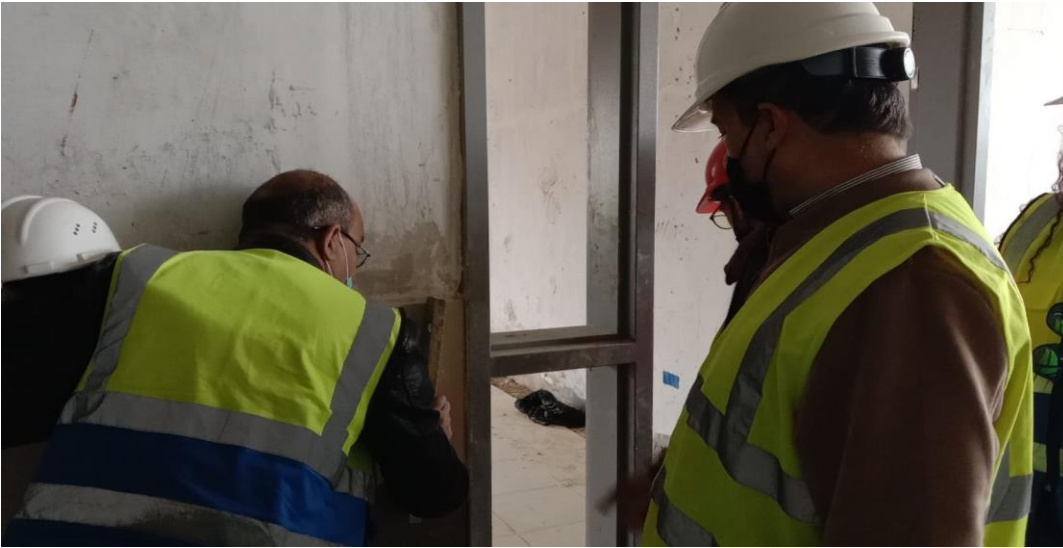
Defects in verticality of parts of porcelain wall tiles

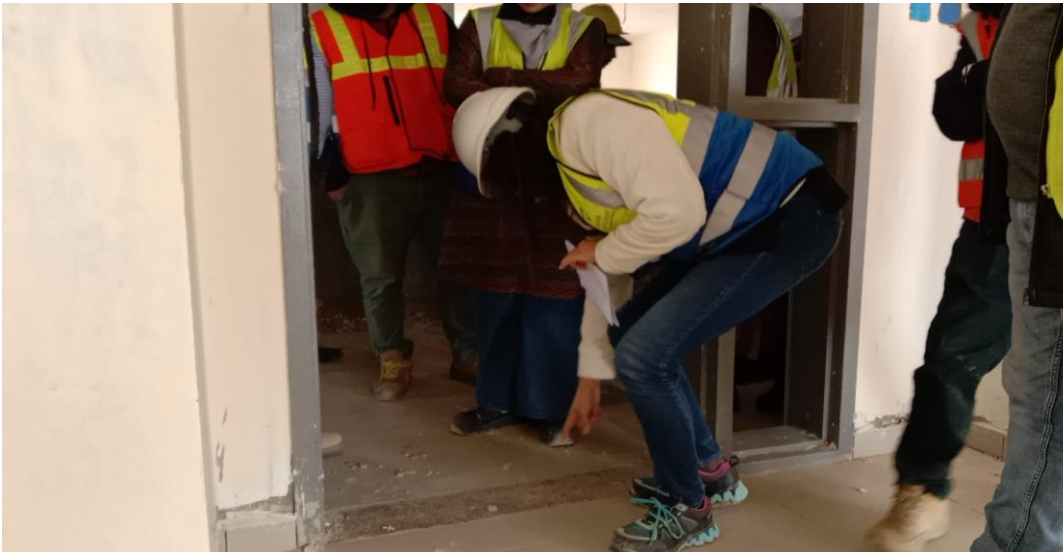
Broken and unlevelled threshold

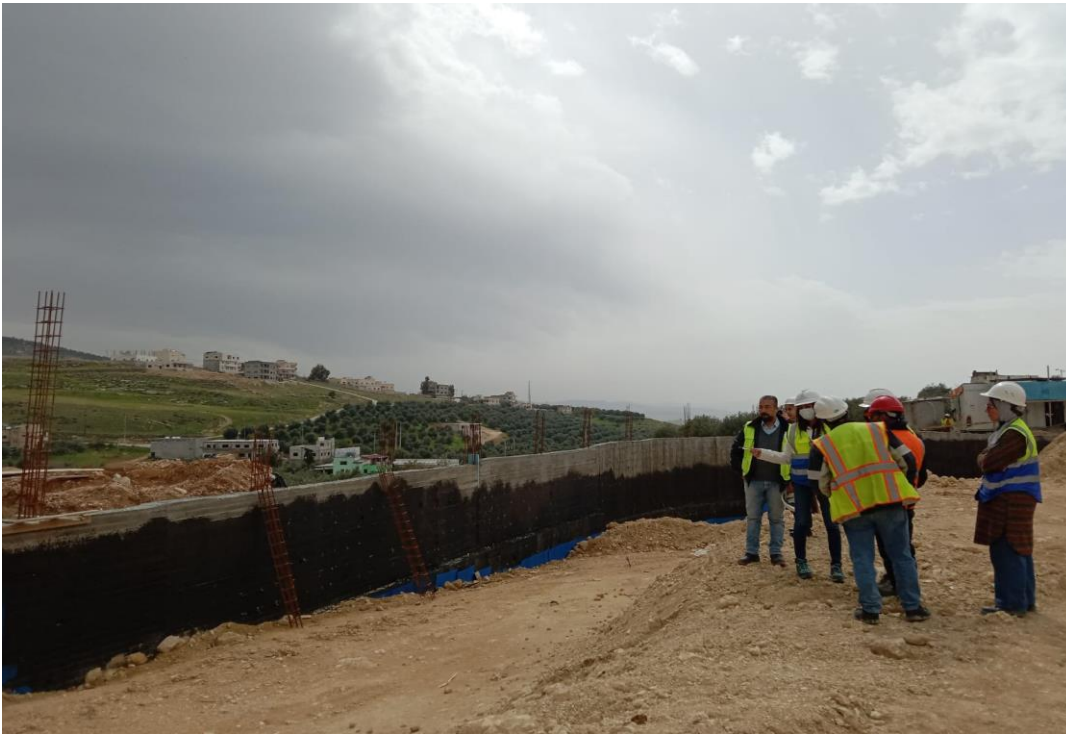
Defects in cartonal boards at boundary walls

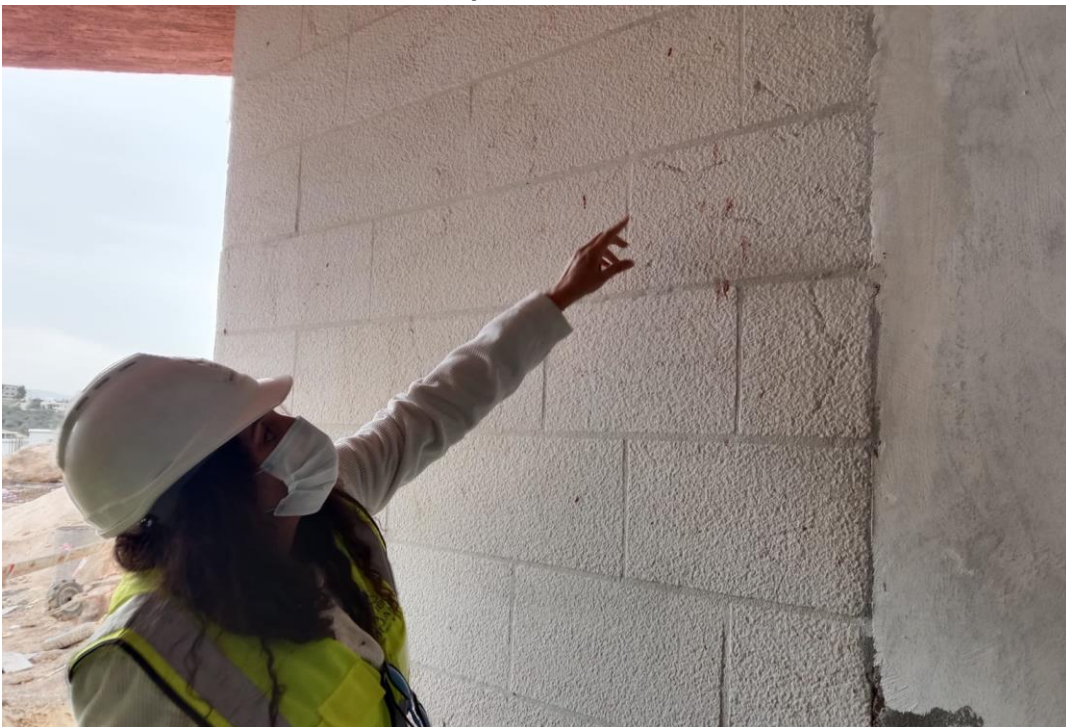
Defects in built stones at the entrance

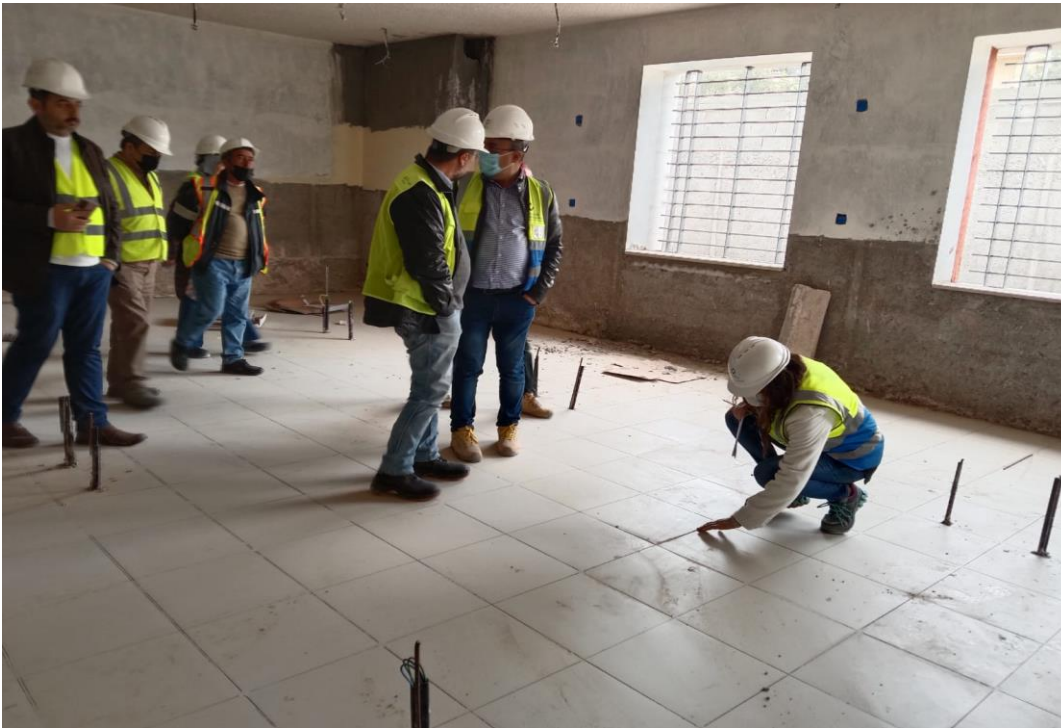
Teething in porcelain floor tiles

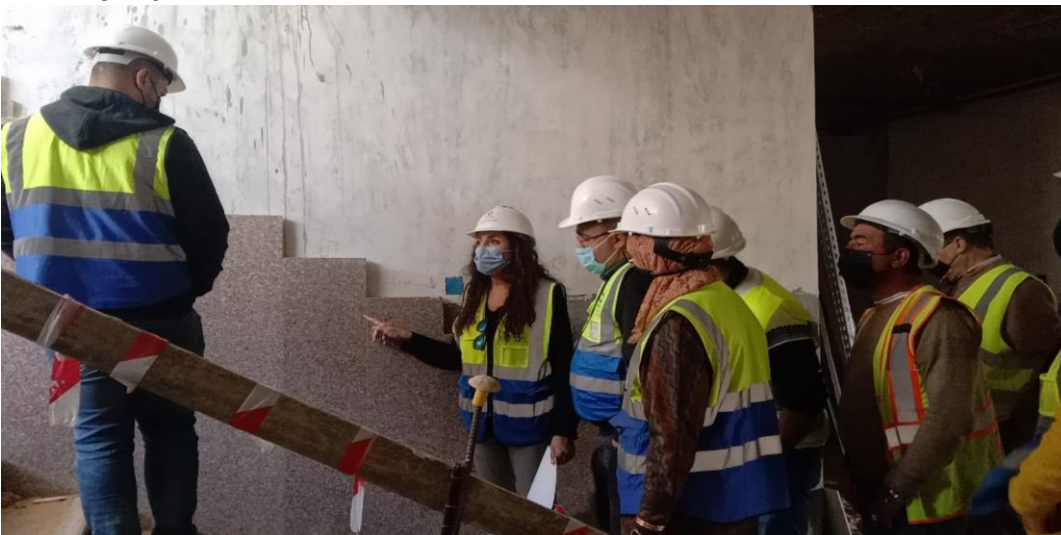
Defects in granite cladding for staircase
