| Consultant | Wahib Medanat Consultant Engineer | Rep No. | 11-19022022 |
| Contractor | Derar Saraireh & Sons for Engineering & Contracting | Tender No. | (11/2019/USAID/SKEP/3/S) Schools for a Knowledge Economy Project (SKEP) - Phase (3) Package (1, 2) |
| Site Name | Um Al Dananir Basic Mixed School- Al Balqa | Day/ Date | Sat. 19/02/2022 |

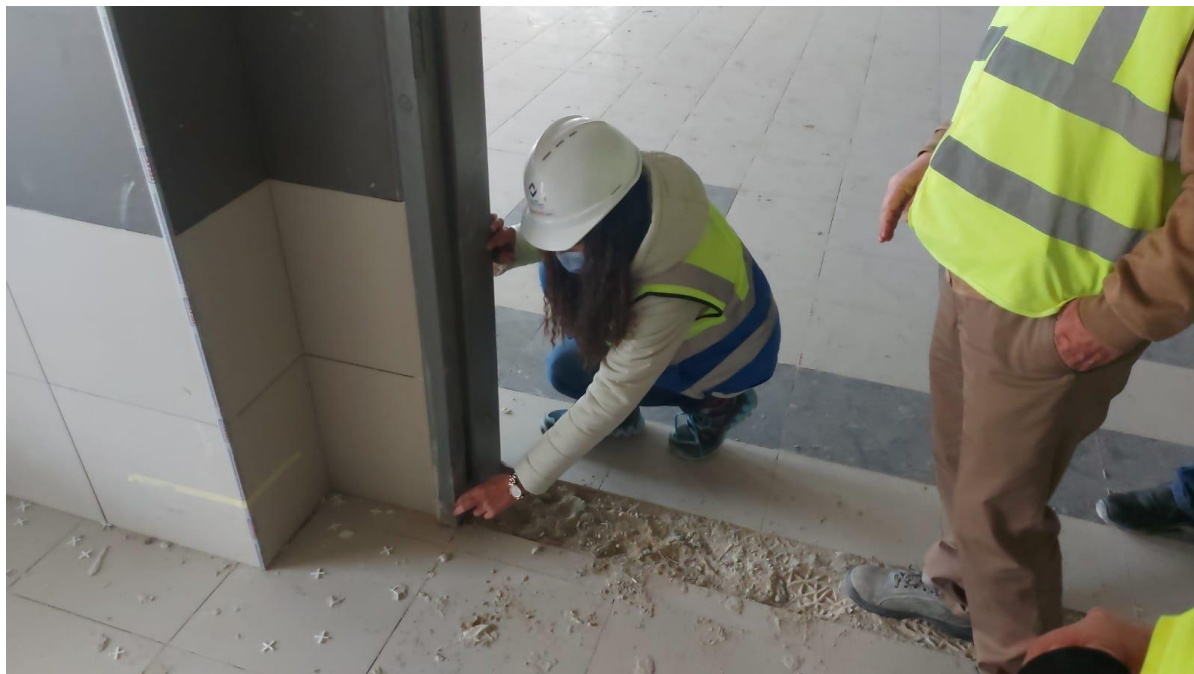
(figure:07)

| No. | Description |
|---|--|
| 2 | The team discussed with the Contractor the dimensions of the sill at the entrance of the multi-purpose hall. |

The team discussed with the Contractor the dimensions of the sill at the entrance of the multi-purpose hall

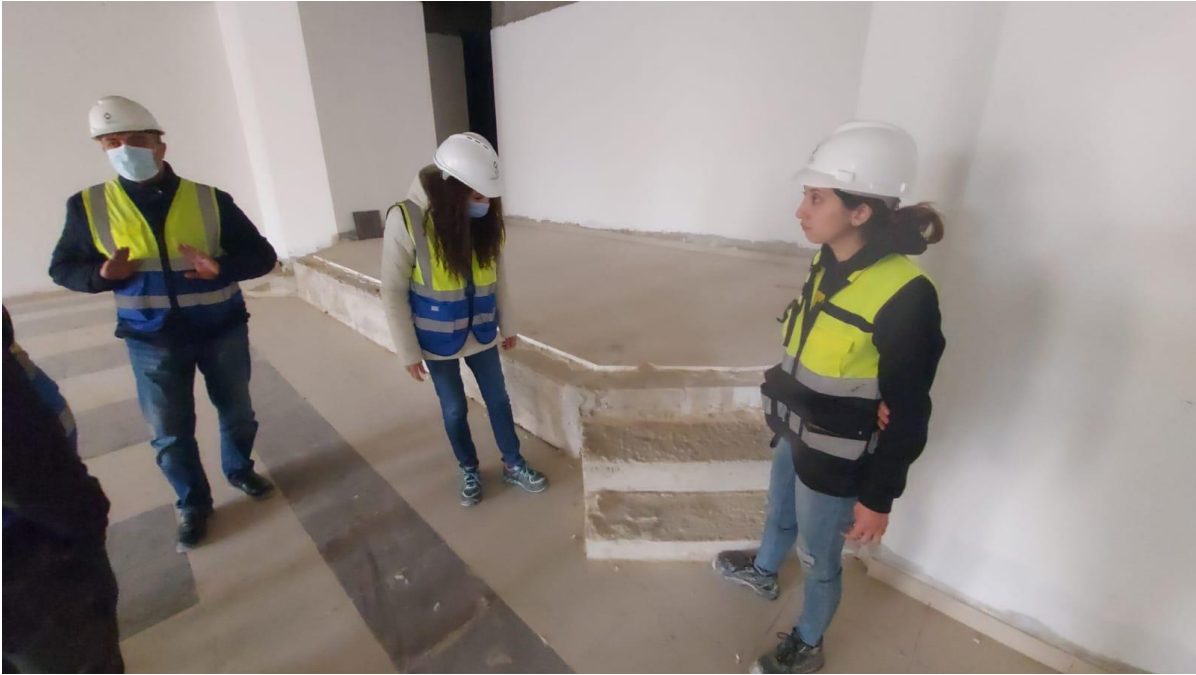
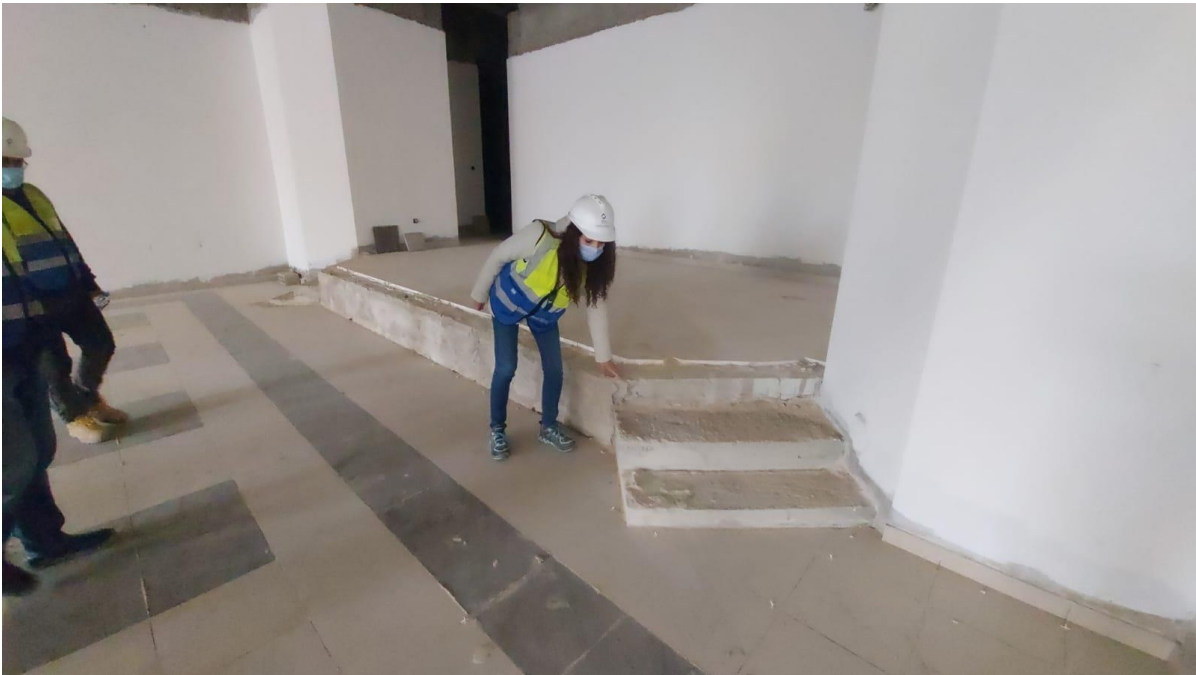
(figure:09 & 10)

| No. | Description |
|---|--|
| 1 | The supervision team inspected the stairs executed inside the multi-purpose hall. |

The supervision team inspected the stairs executed inside the multi-purpose hall

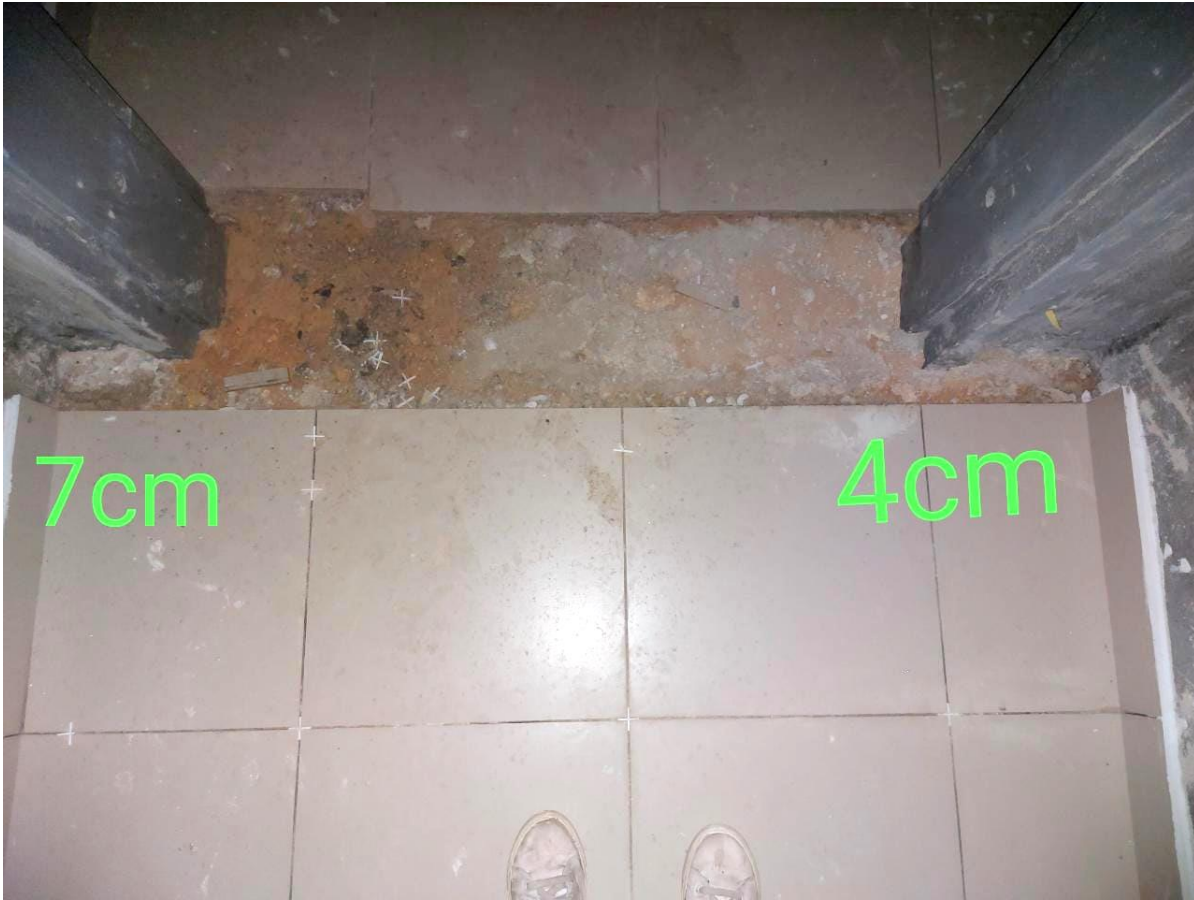
(figure:11)

| No. | Description |
|---|--|
| 3 | The team observed deviation in the floor tiling of the corridor inside the multi-purpose service area. The Contractor was requested to rectify the defect. |

The team observed deviation in the floor tiling of the corridor inside the multi-purpose service area. The Contractor was requested to rectify the defect

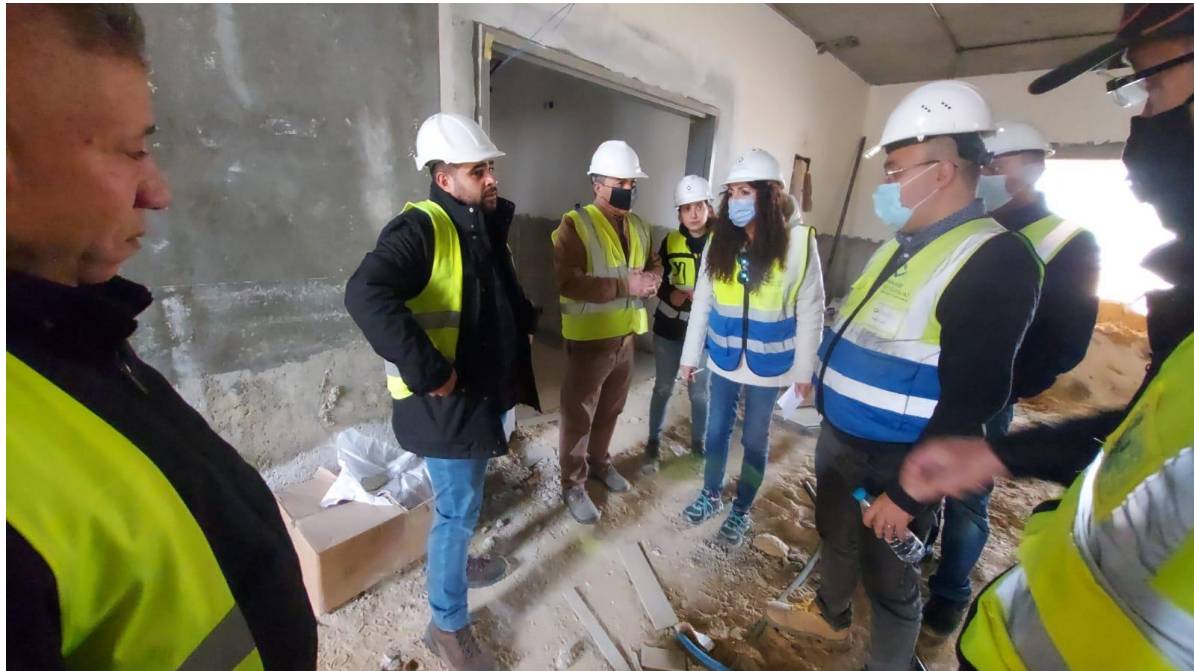
(figure:12)

| 9 | The team discussed with the Contractor the connection between the porcelain tiles and the granite tiles at the staircase area. |

The team discussed with the Contractor the connection between the porcelain tiles and the granite tiles at the staircase area

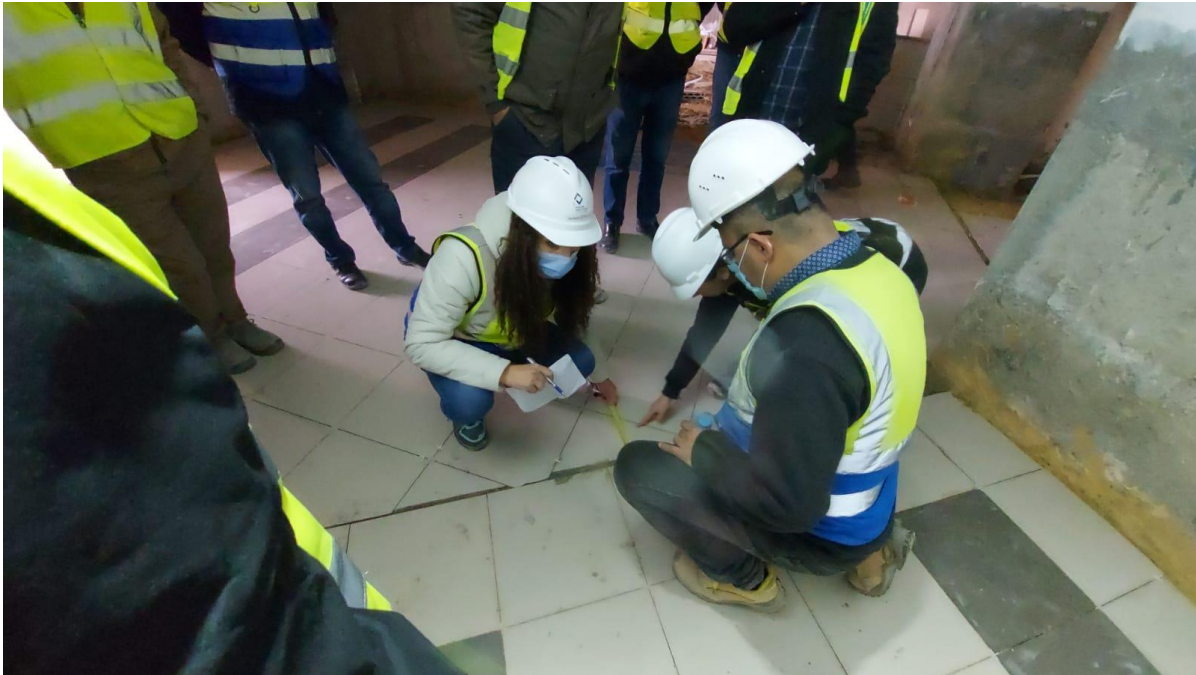
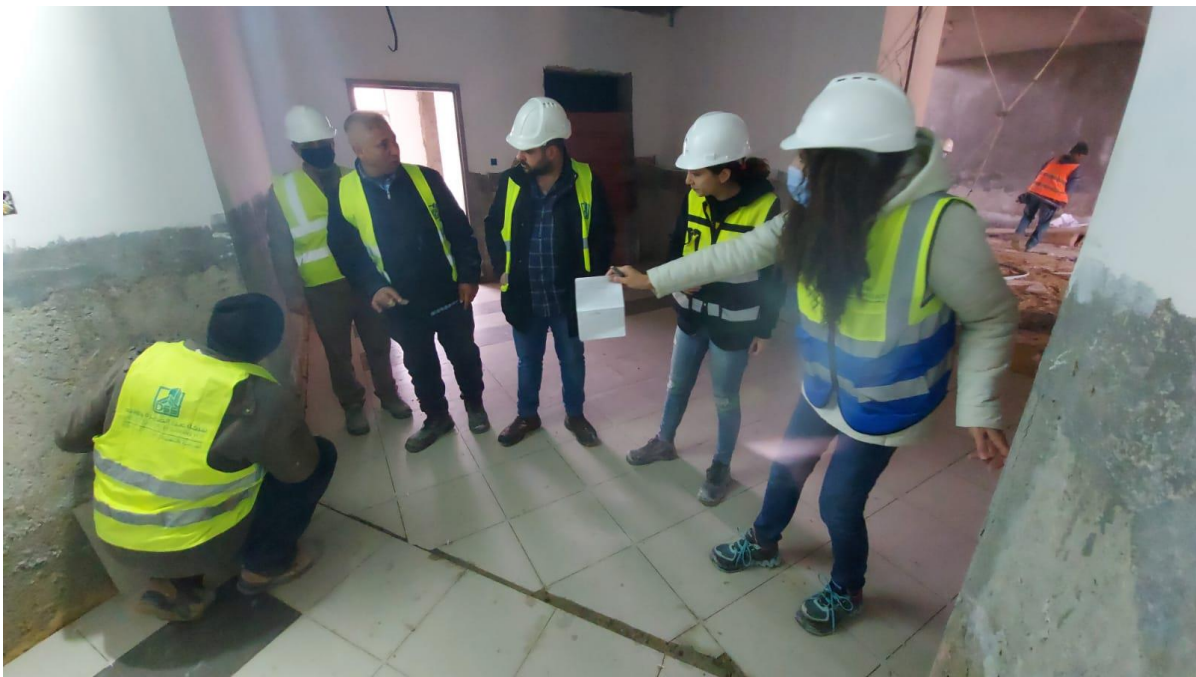
(figure:13 & 14)

| 14 | The team discussed with the Contractor the connection of floor porcelain tiles of two corridors. The Contractor suggested to install a granite piece at the connection line. |

The team discussed with the Contractor the connection of floor porcelain tiles of two corridors. The Contractor suggested to install a granite piece at the connection line

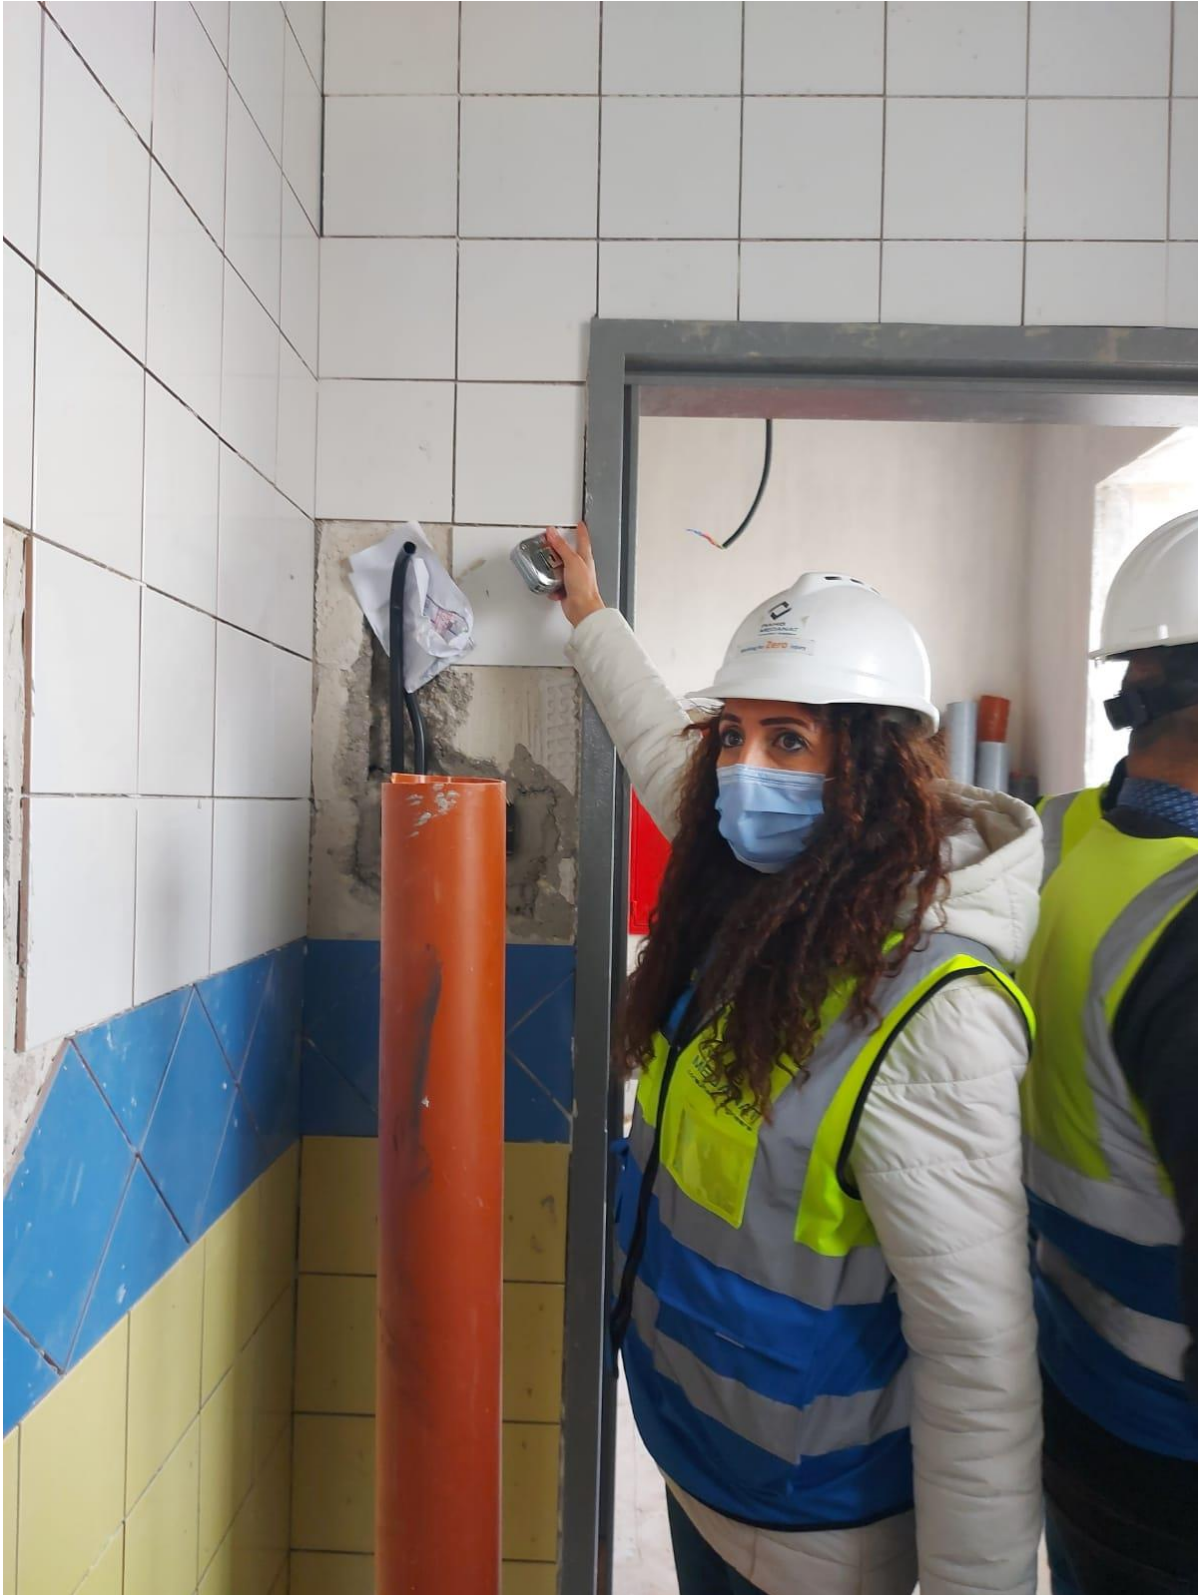
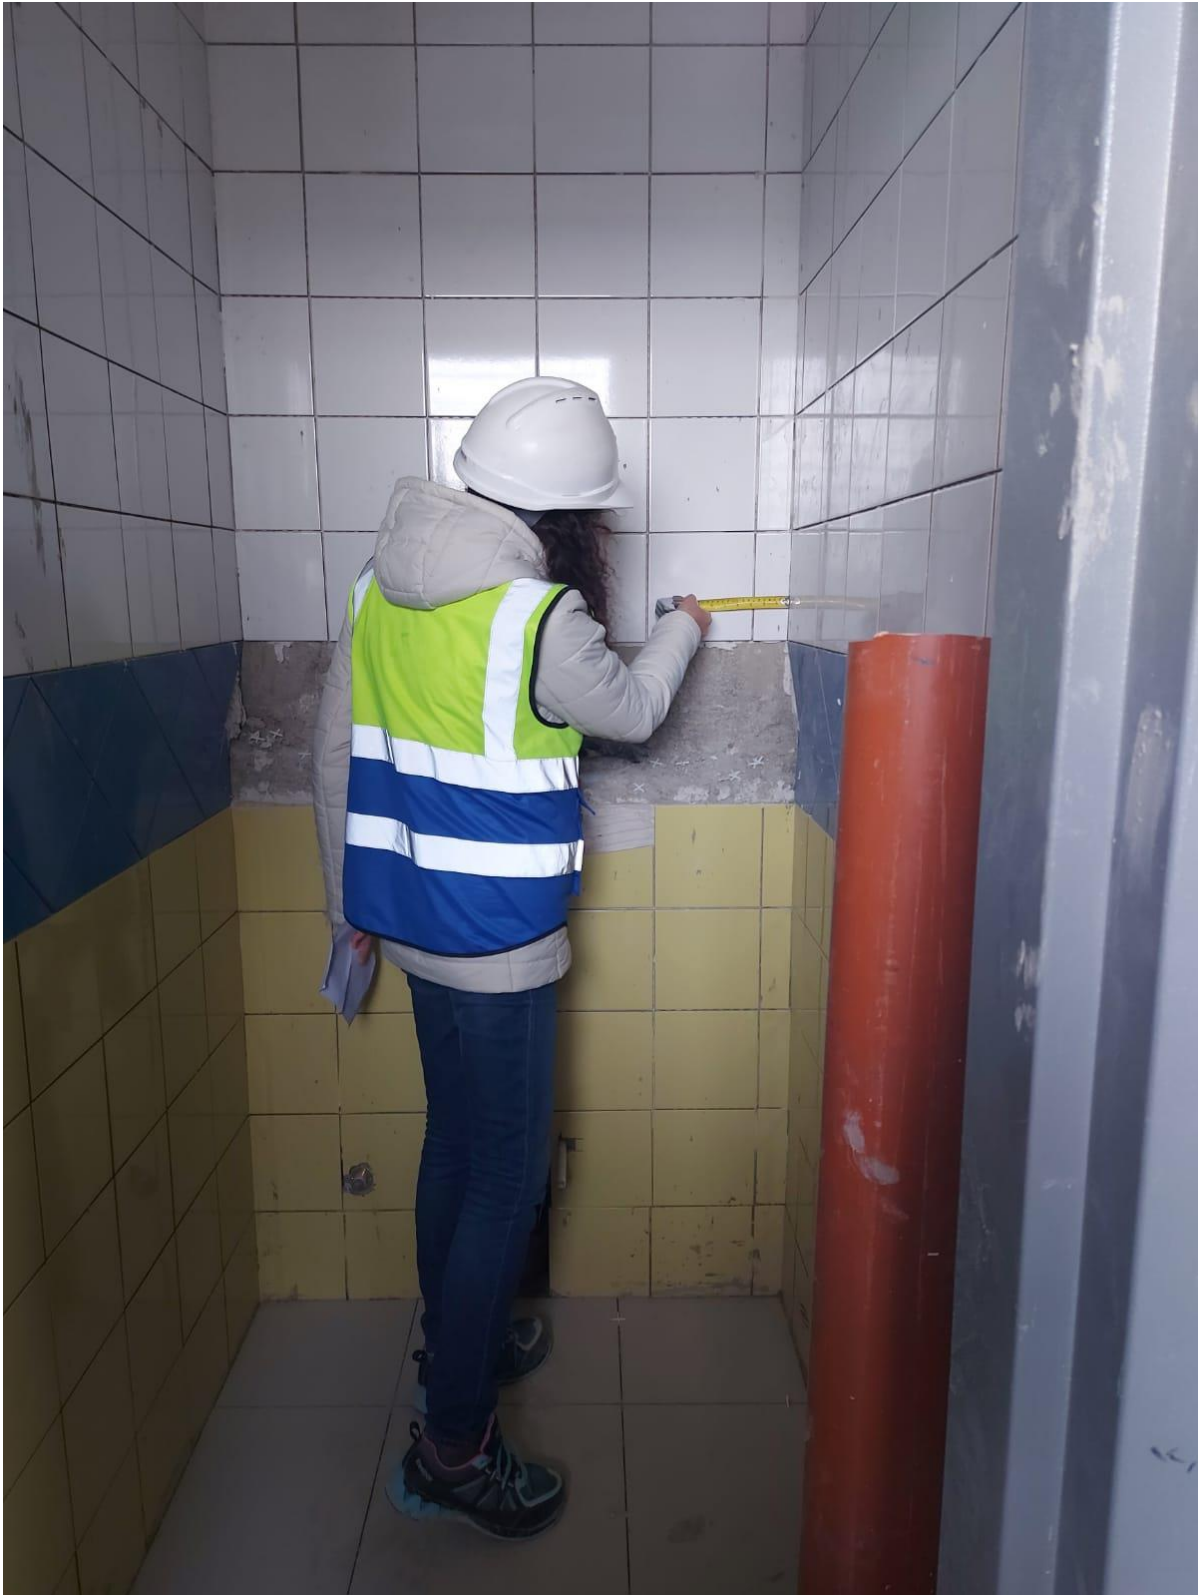
| 10 | The team inspected the wall tiling at the wet areas and observed unaccepted cutting of tiles adjacent to the door frames. |

The team inspected the wall tiling at the wet areas and observed unaccepted cutting of tiles adjacent to the door frames
(figure:17 & 18)

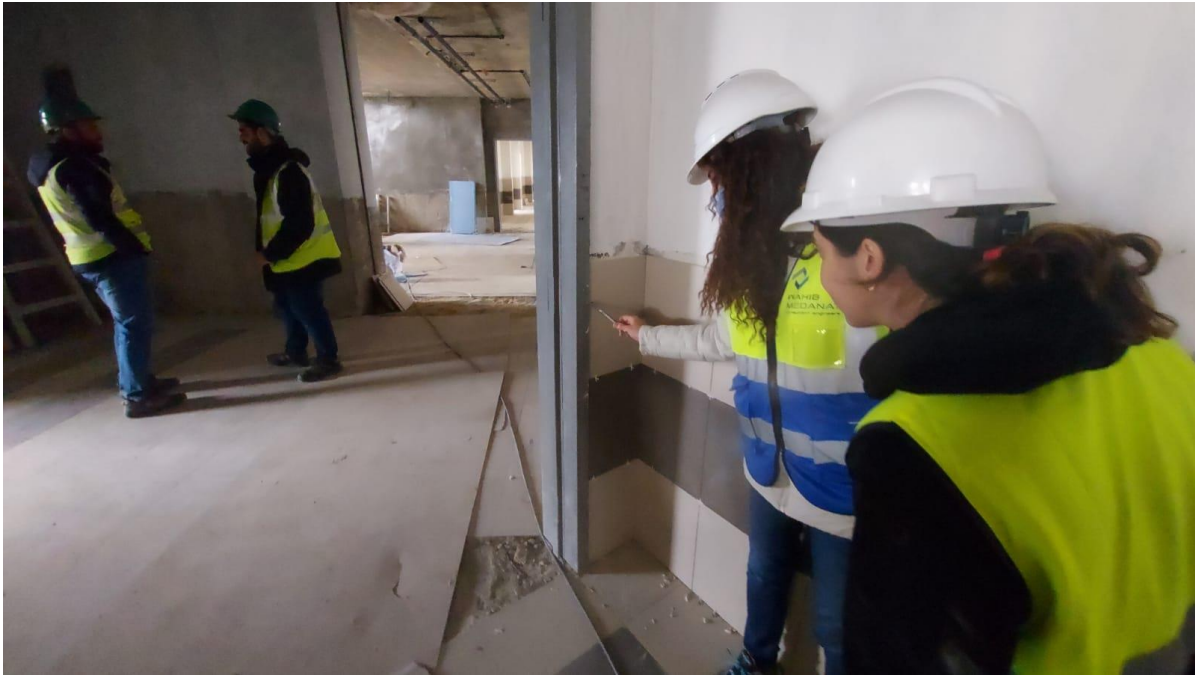
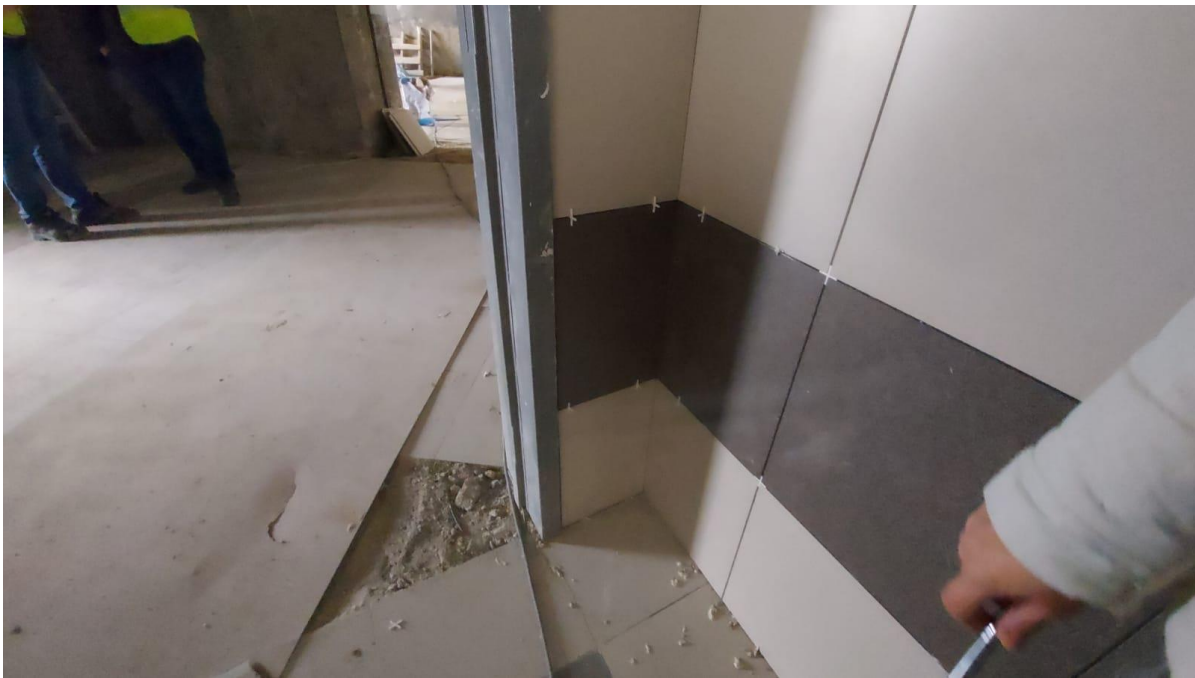
(figure:19 & 20)

| 11 | The team inspected the porcelain tiling for the walls of corridors and observed unacceptable cutting of tiles adjacent to the door frames. |

The team inspected the porcelain tiling for the walls of corridors and observed unacceptable cutting of tiles adjacent to the door frames

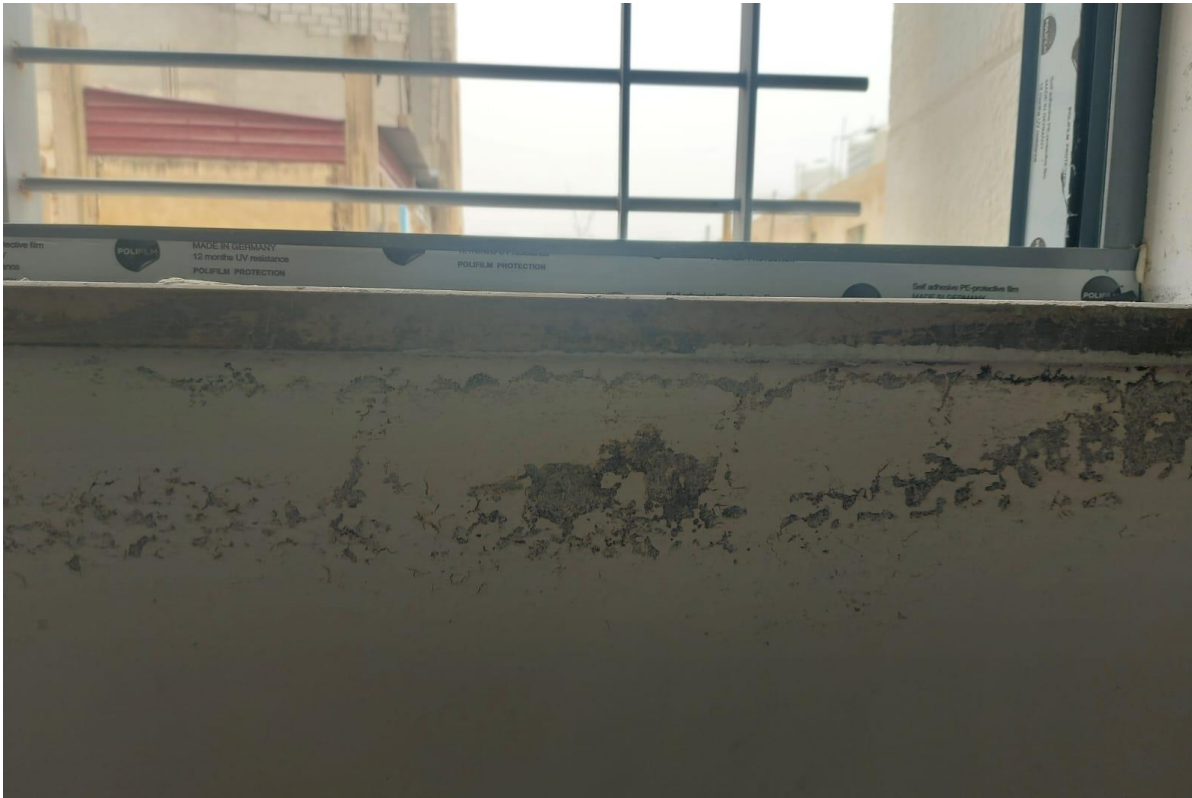
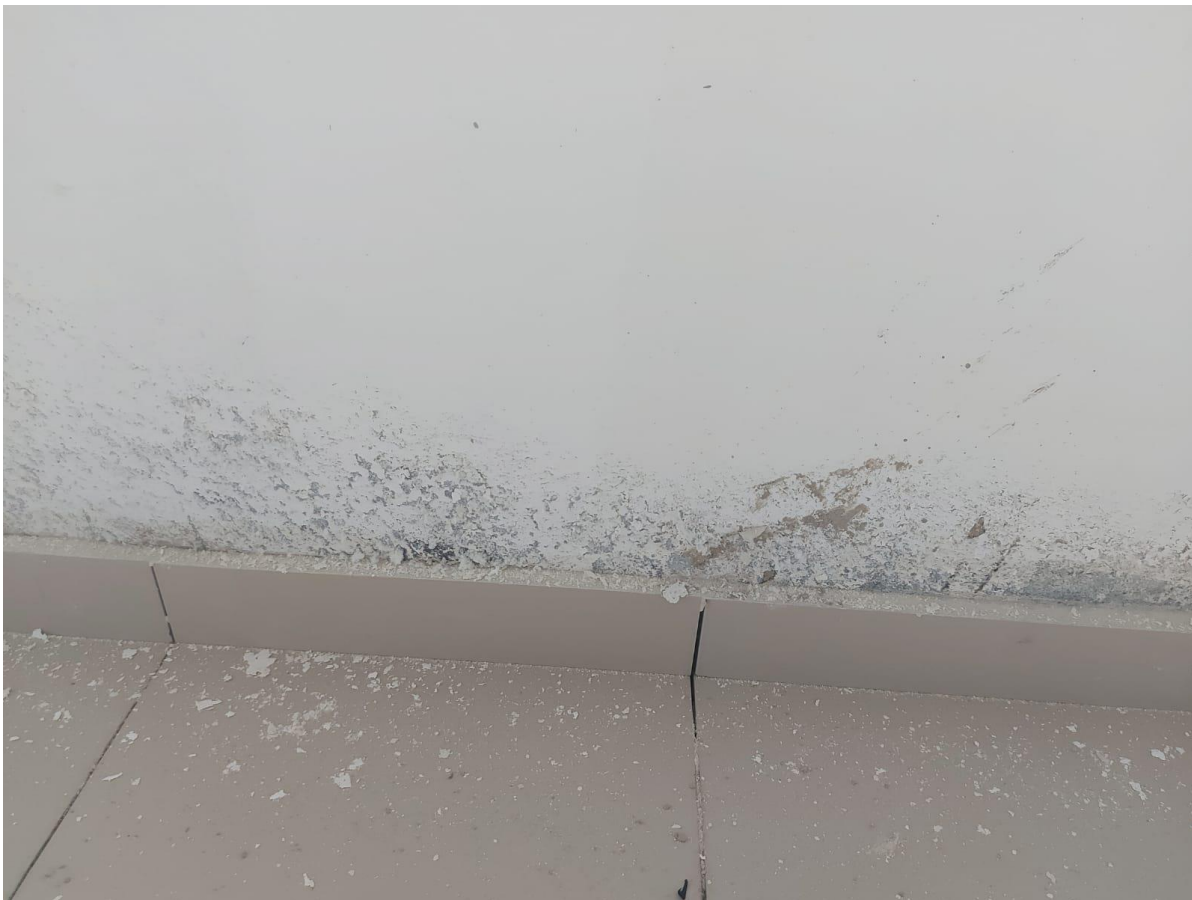
(figure:21 & 22)

| 5 | The team observed internal humidity at the wall below the window sills and up to the skirting. |

The team observed internal humidity at the wall below the window sills and up to the skirting

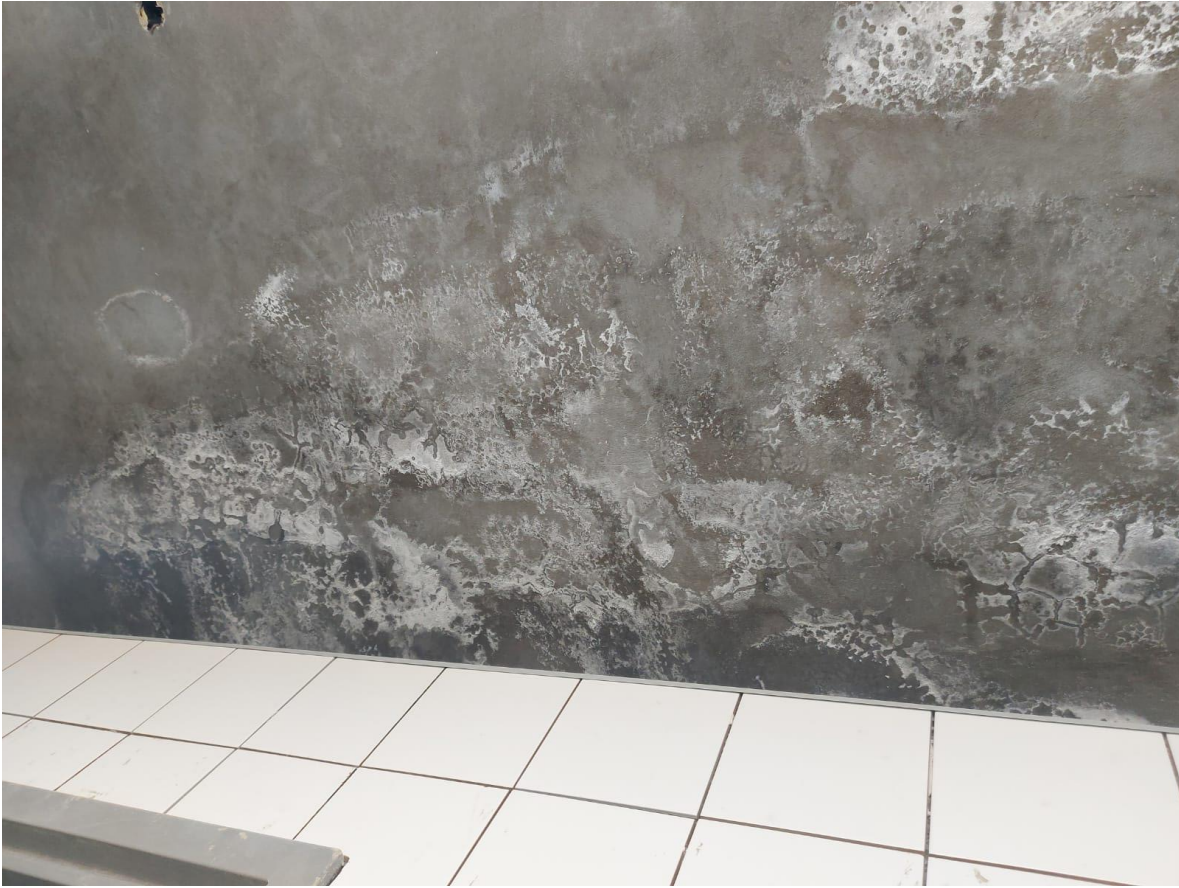
(figure:23)

| 6 | The team observed humidity at the ceiling of the wet areas due to water leakage |

The team observed humidity at the ceiling of the wet areas due to water leakage

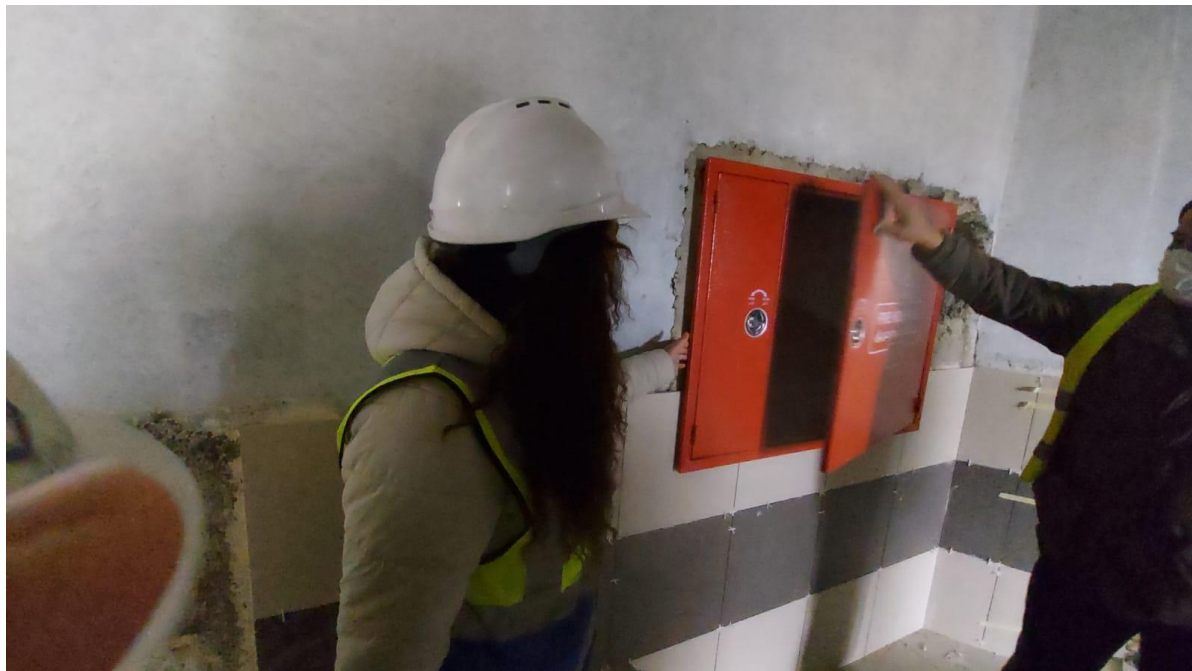
(figure:26)

| 12 | The team inspected the installation of the fire hose cabinets and requested the Contractor to submit two samples in order to choose one to be executed. |

The team inspected the installation of the fire hose cabinets and requested the Contractor to submit two samples in order to choose one to be executed

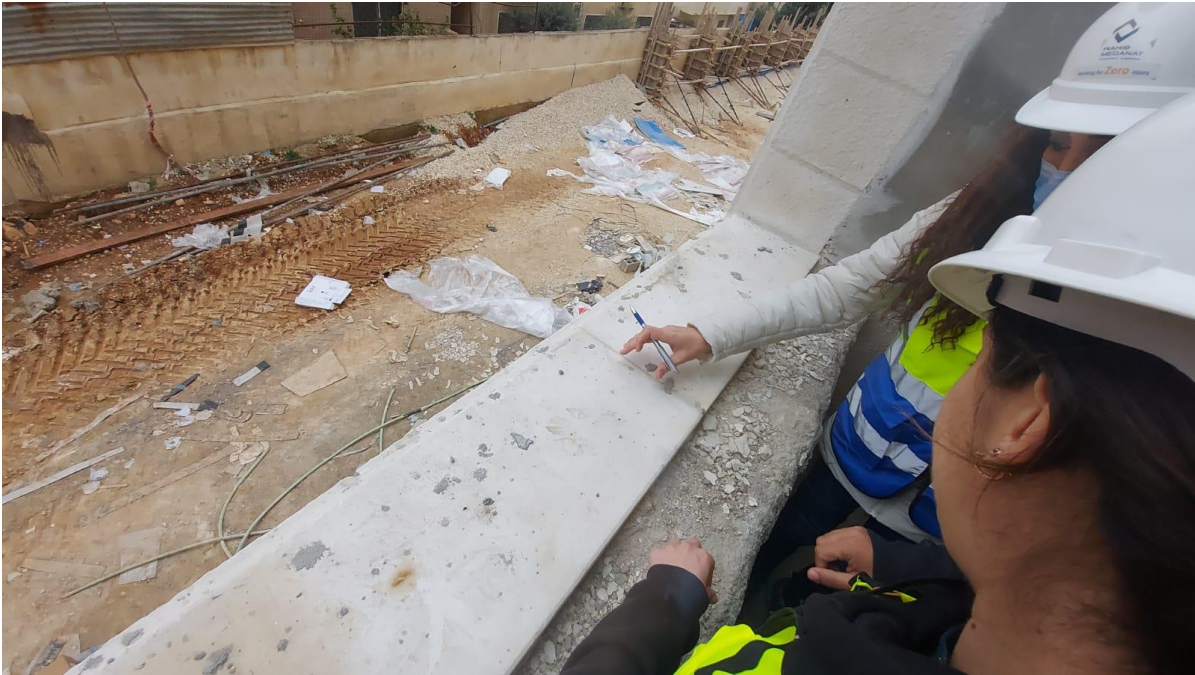
(figure:27)

| 8 | The team observed deviation in the cutting of a number of marble sills and resulted in irregular joint width with the stone sills. The Contractor was requested to replace those sills. |

The team observed deviation in the cutting of a number of marble sills and resulted in irregular joint width with the stone sills. The Contractor was requested to replace those sills

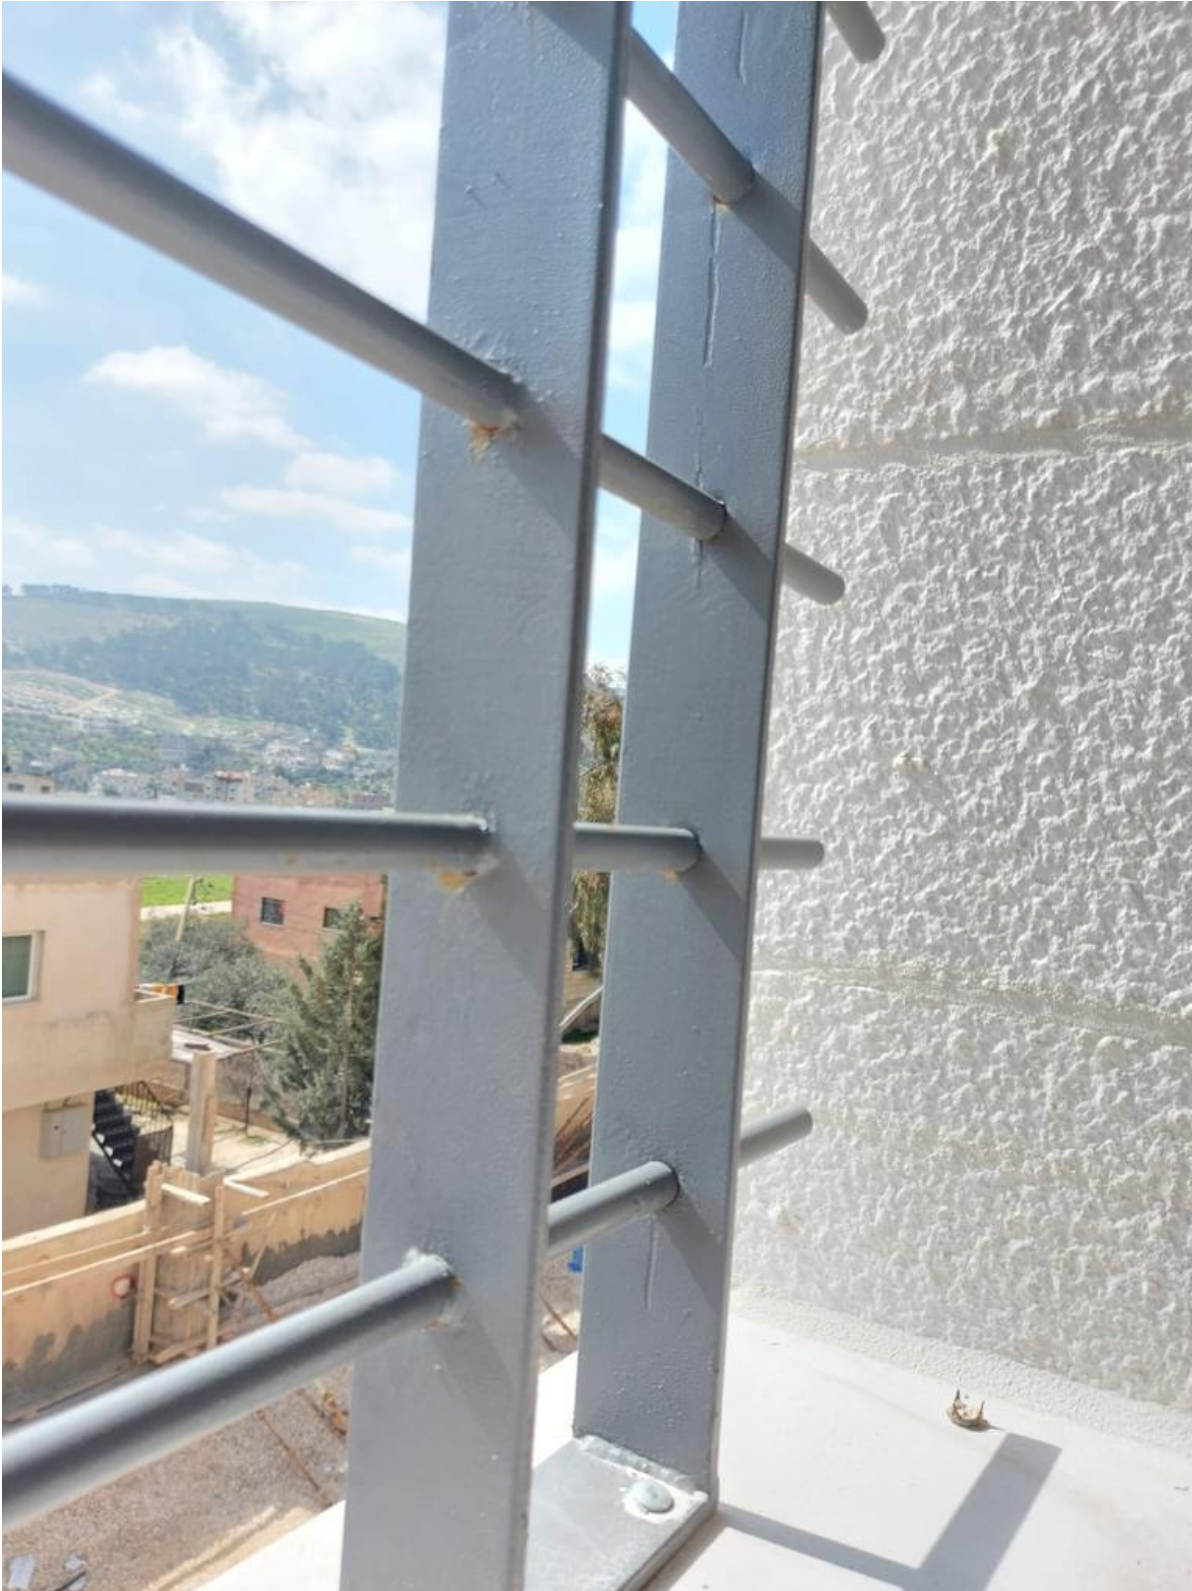
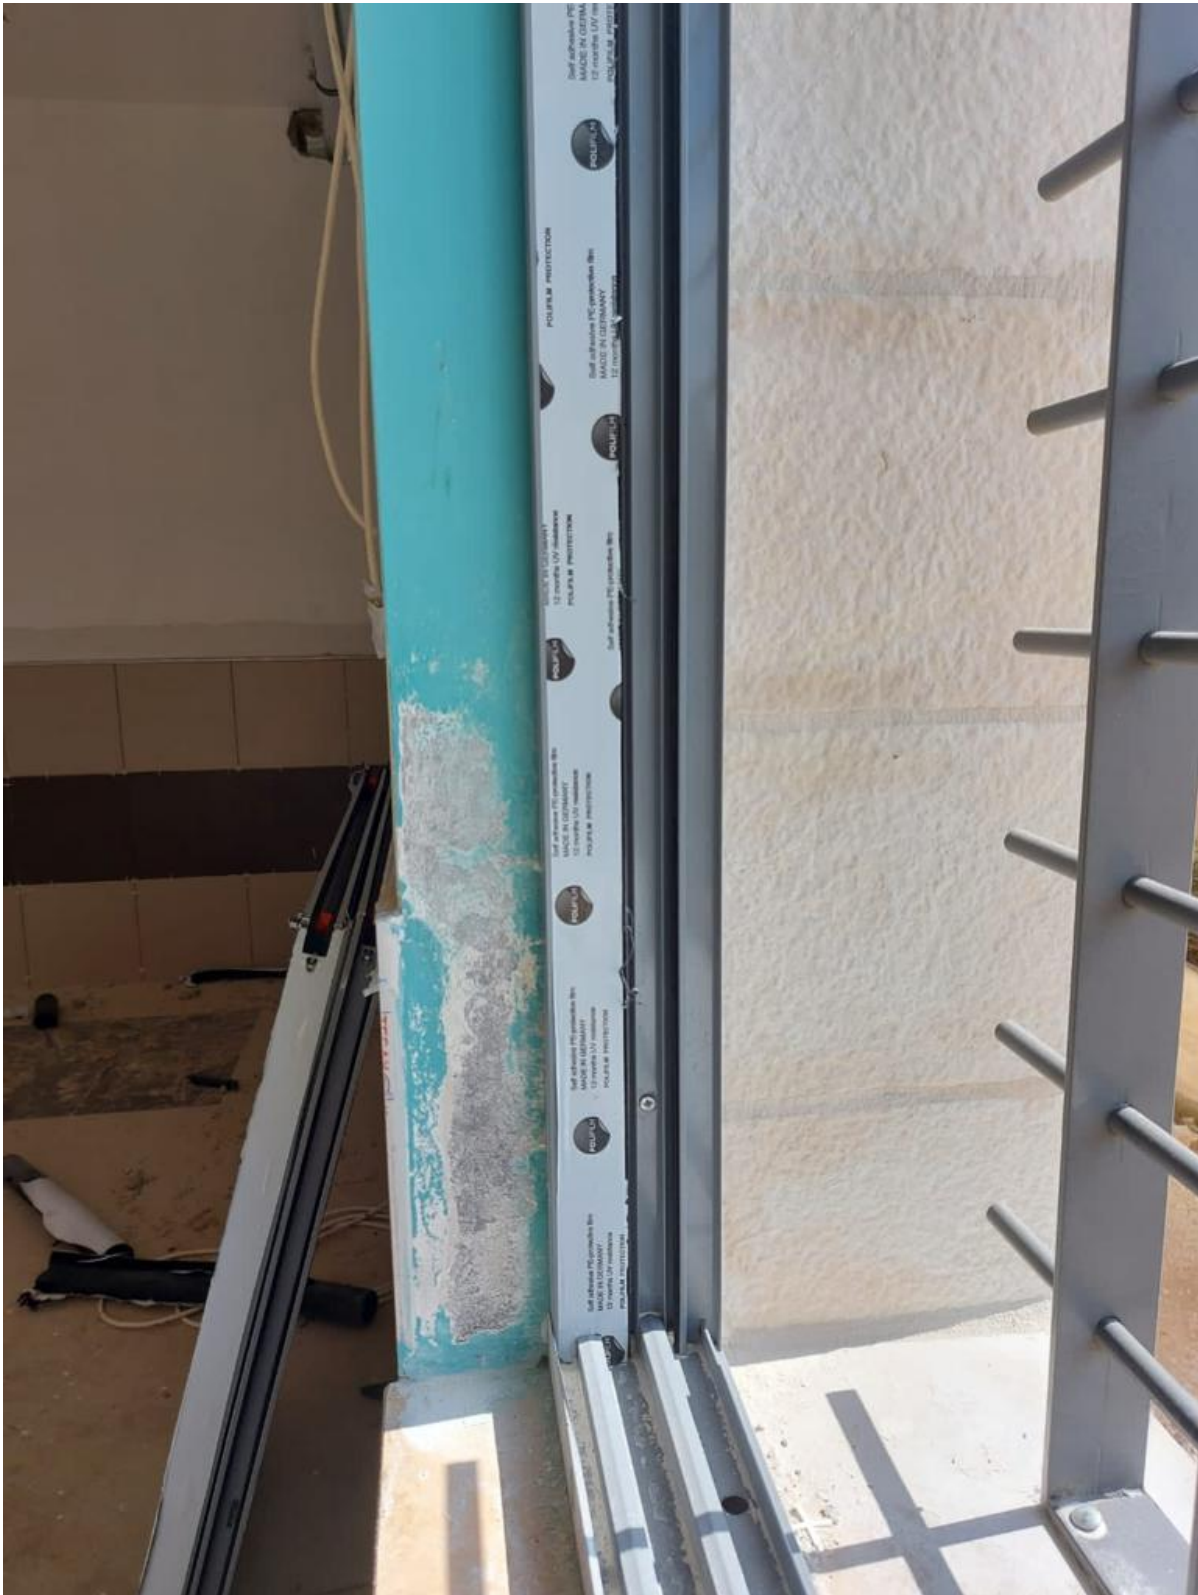
(figure:28 & 29)

| 7 | The team inspected the steel protection screen and observed corrosion at the joints of the sections of the screen. |

The team inspected the steel protection screen and observed corrosion at the joints of the sections of the screen

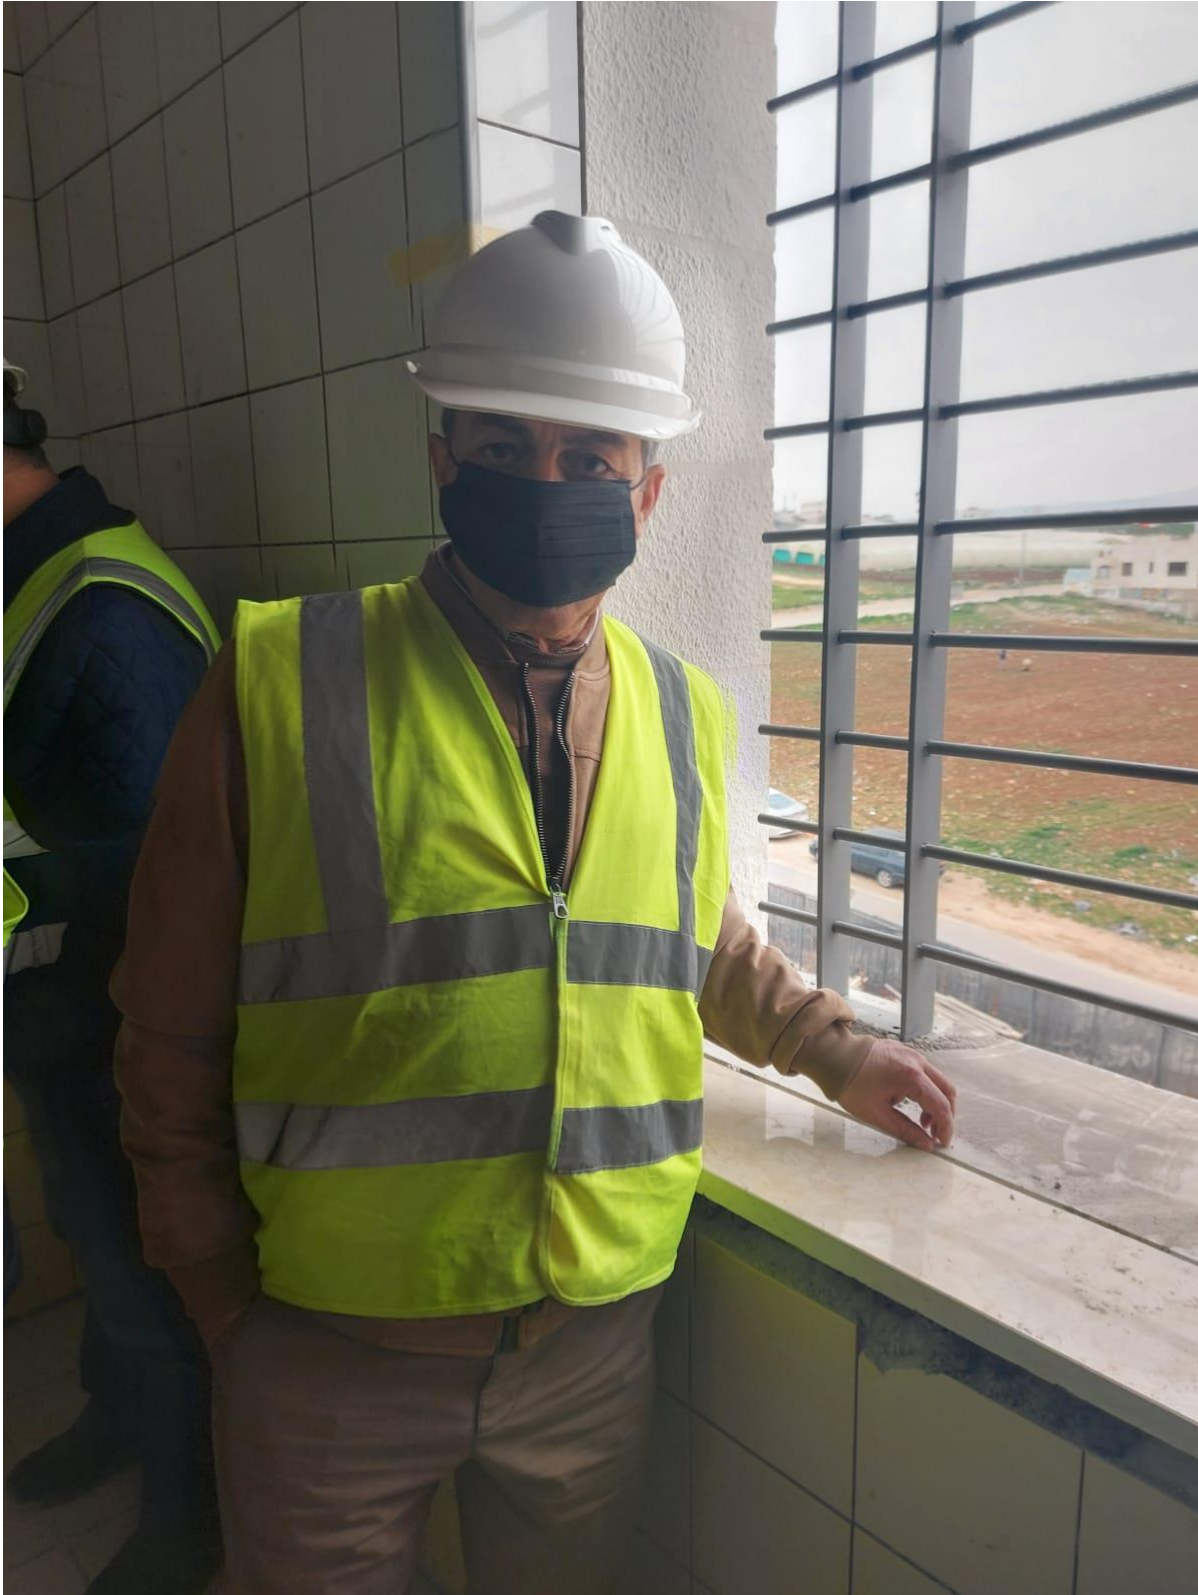
(figure:30)

| 4 | The team inspected the installed window frames and it was observed that a number of jambs have been affected by the rain water, visible part and the part covered by the frame. |

The team inspected the installed window frames and it was observed that a number of jambs have been affected by the rain water, visible part and the part covered by the frame
