SKEP III Home Office Support Site Visit Report

Consultant	Wahib Medanat Consultant Engineer	Rep No.	21-22082022
Contractor	Dijlah Establishment Constr. Contracting	Tender No.	(11/2019/USAID/SKEP/3/S) Schools for a Knowledge Economy Project (SKEP) - Phase (3) Package (1, 2)
Site Name	Hay Al Iskan Basic Mixed School- Jerash	Day/ Date	Mon. 22/08/2022
Duration of Project	450 Calendar Days	Total Project Budget	8,314,983.735 JD

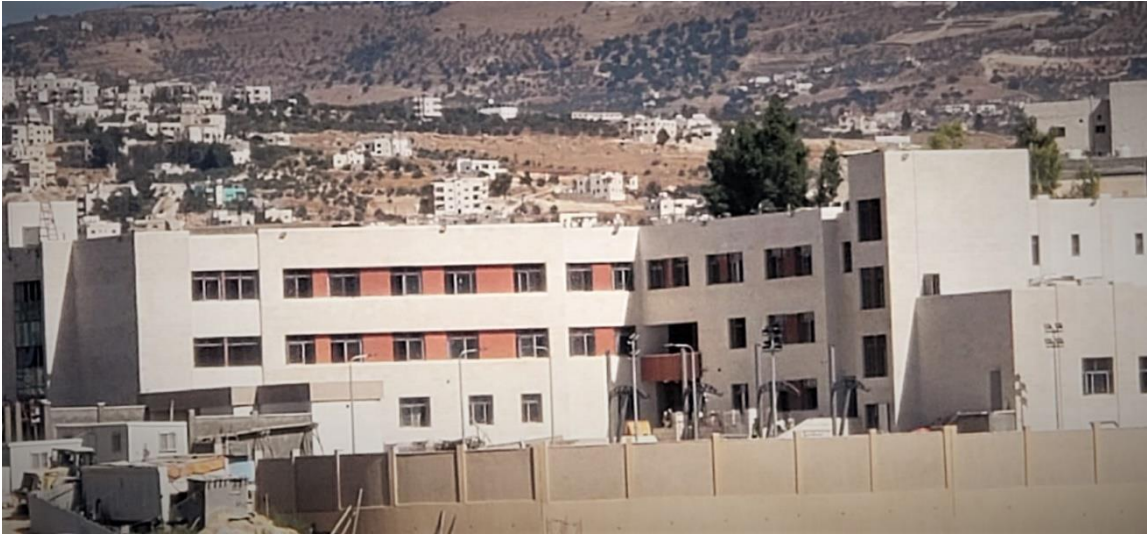
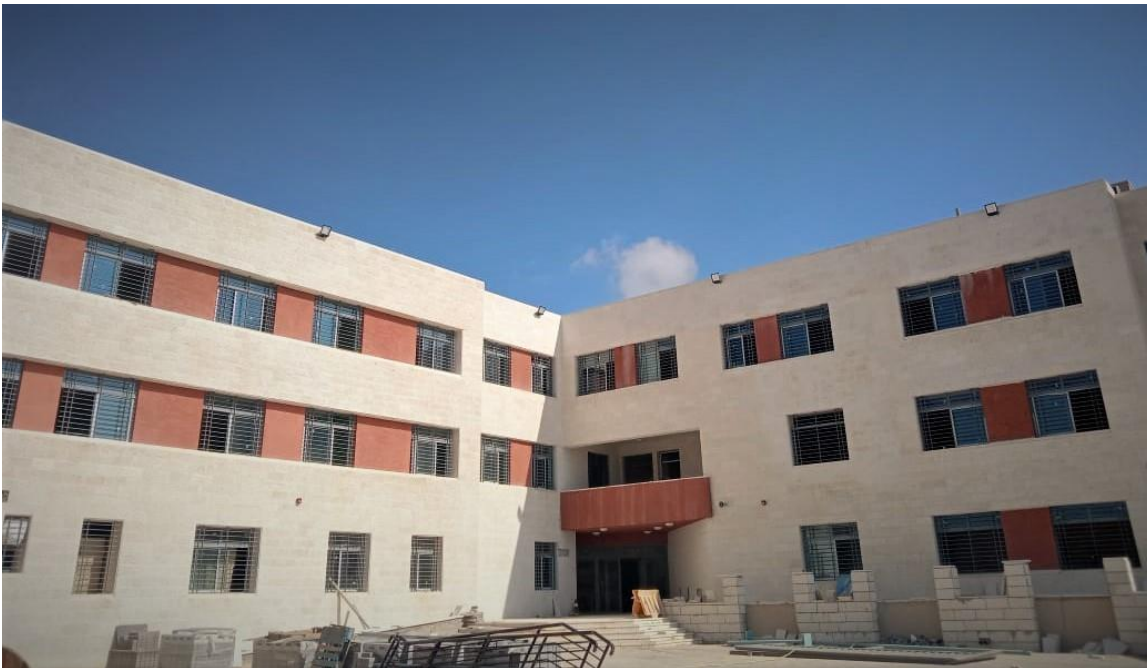
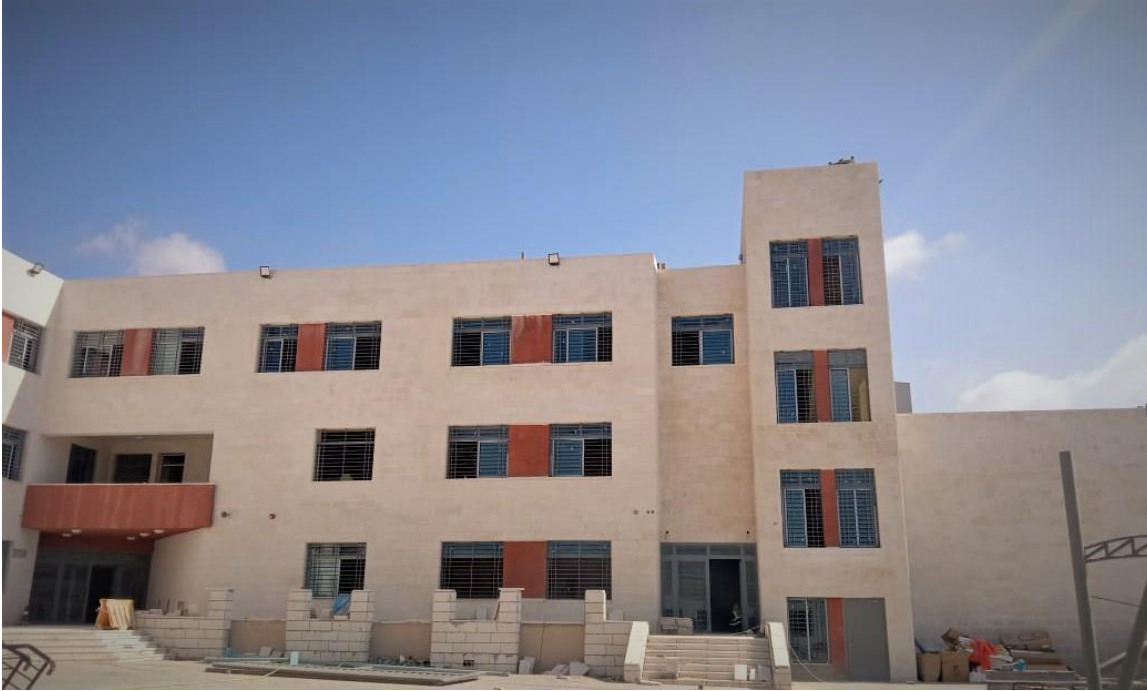
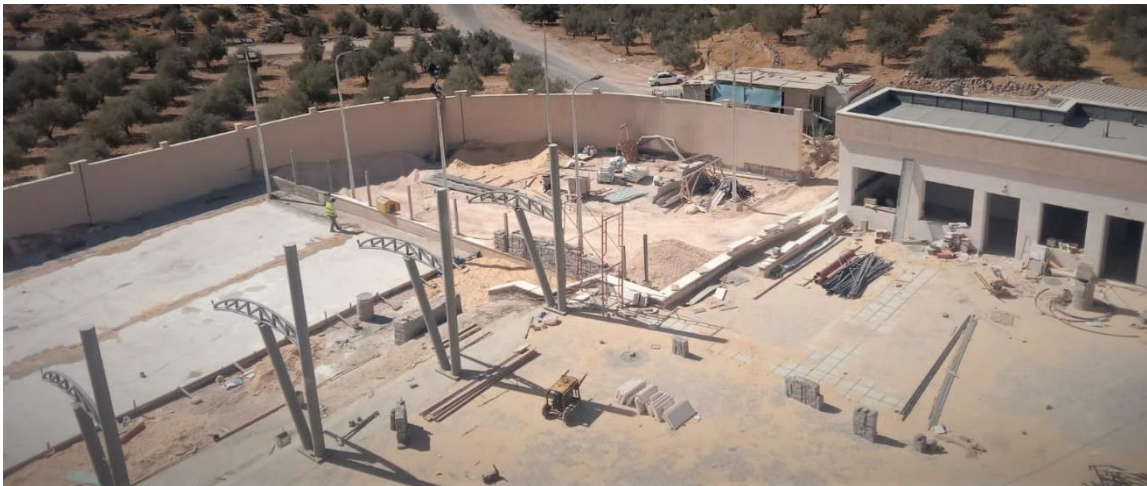
(Figure: 01, 02, 03 & 04)

General view of the project site

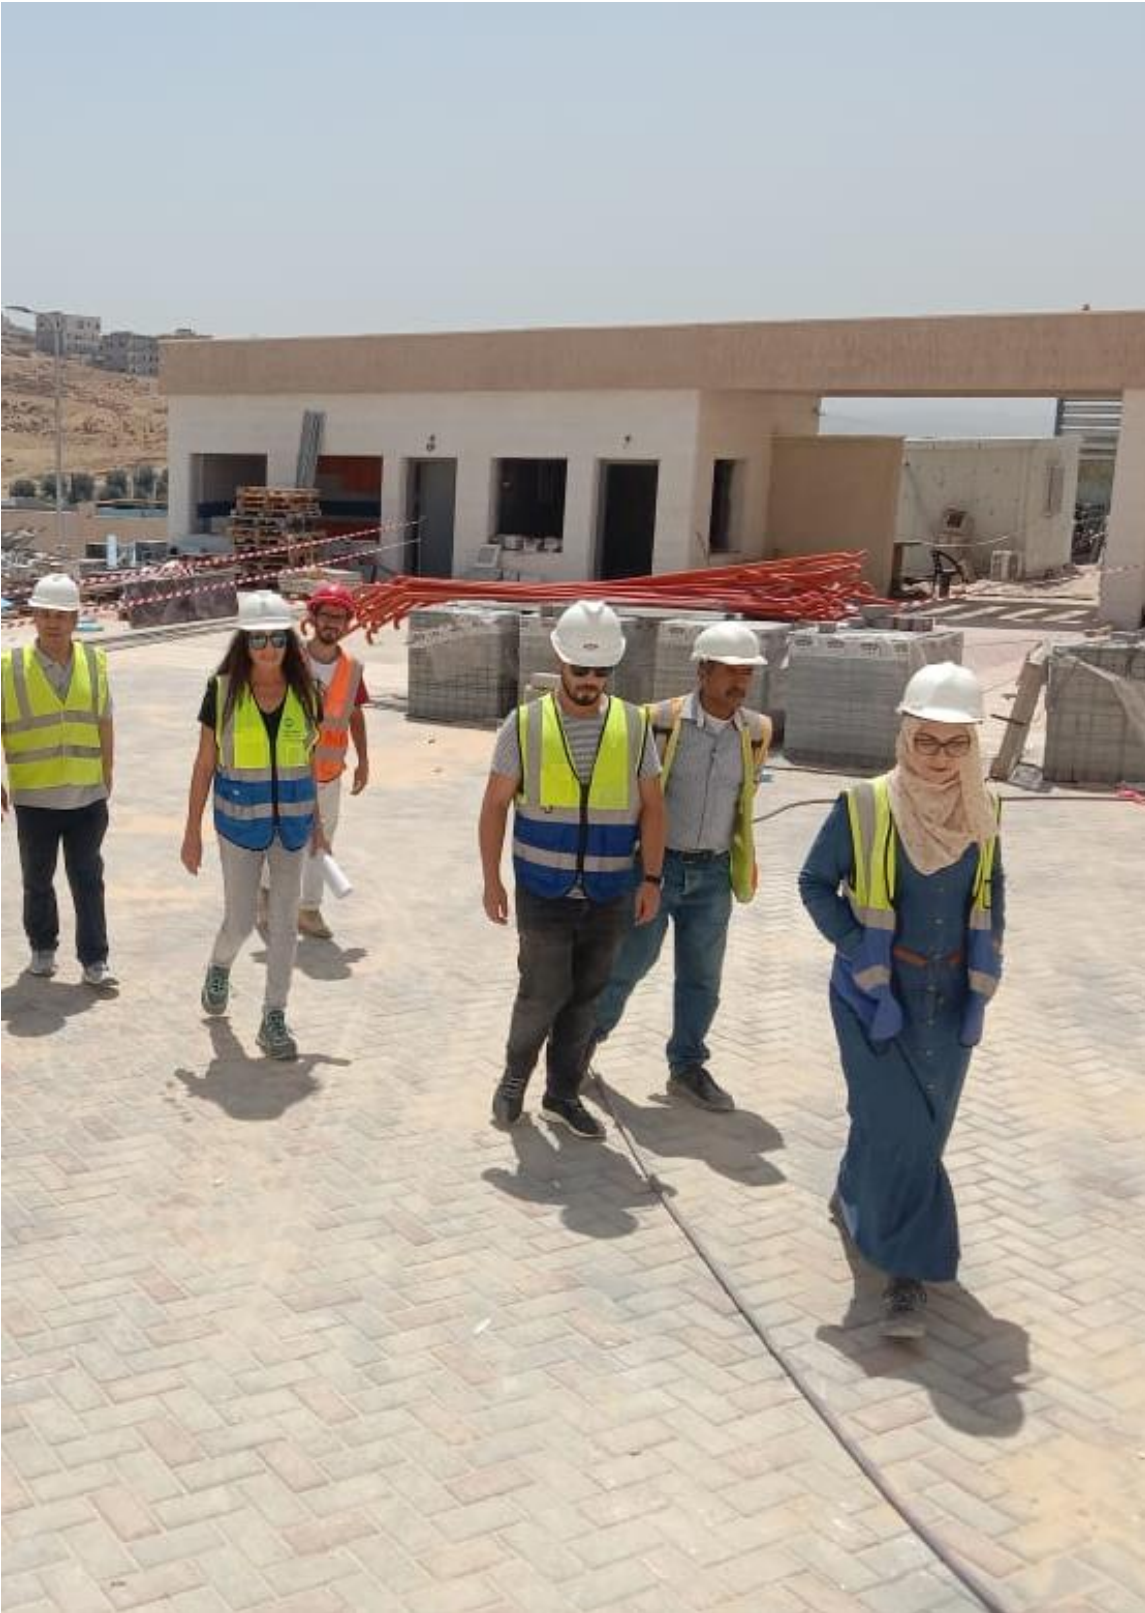
(Figure: 05)

The supervision team conducted a site visit to inspect the progress of works

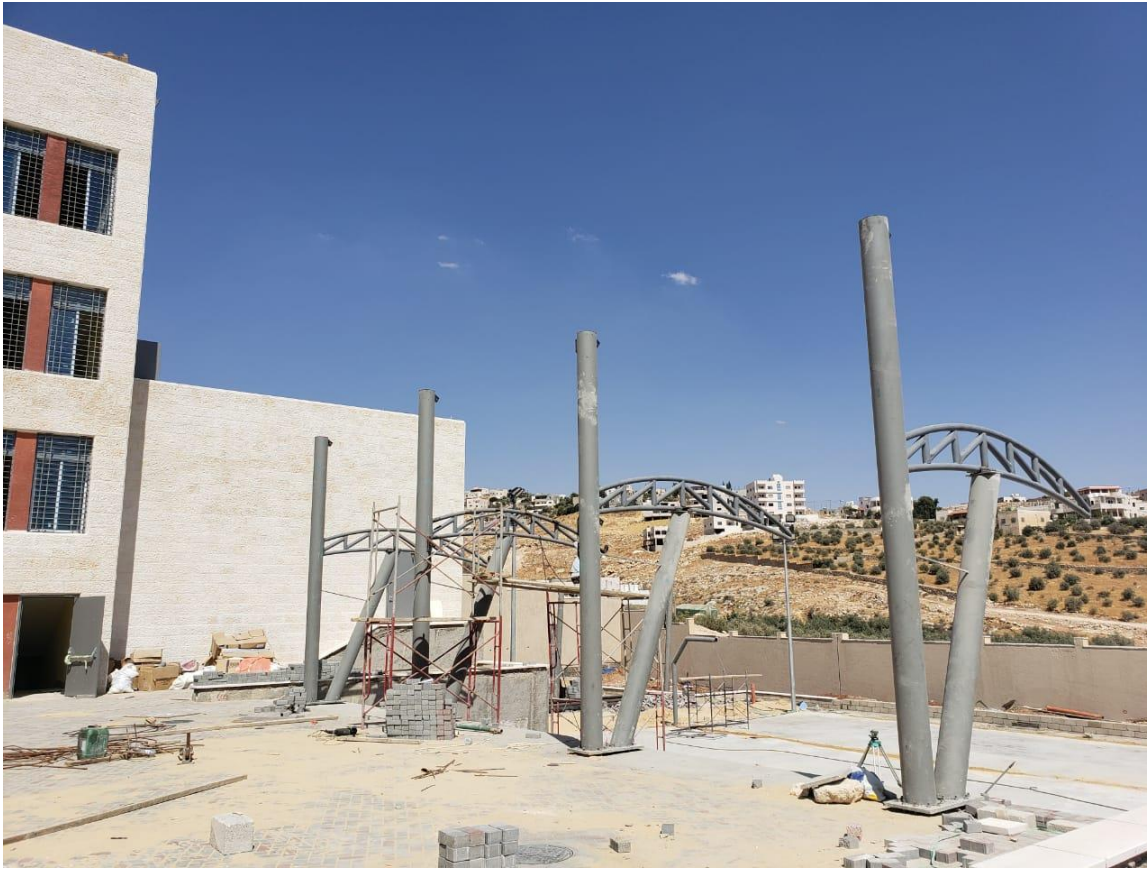
(Figure: 06)

The team inspected the installation of shadings at the external yard

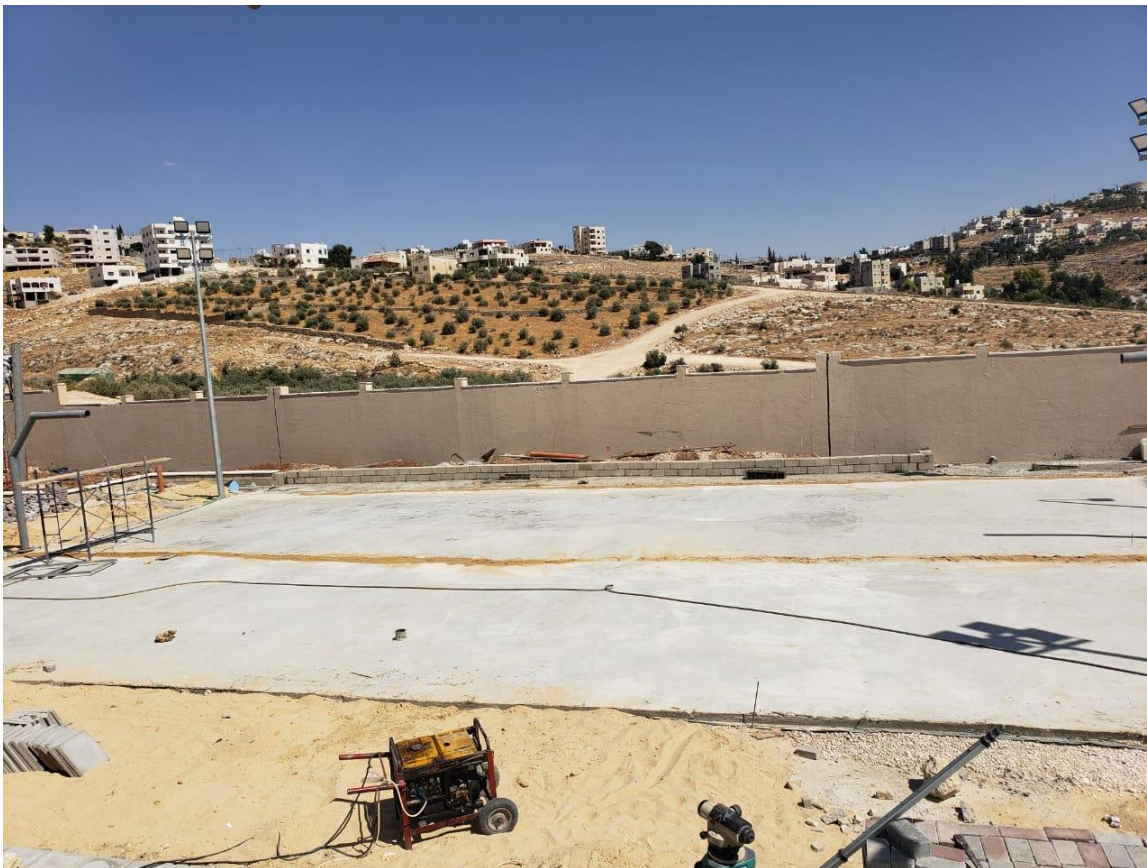
(Figure: 07)

The team inspected concrete casting for SOG of the basketball court

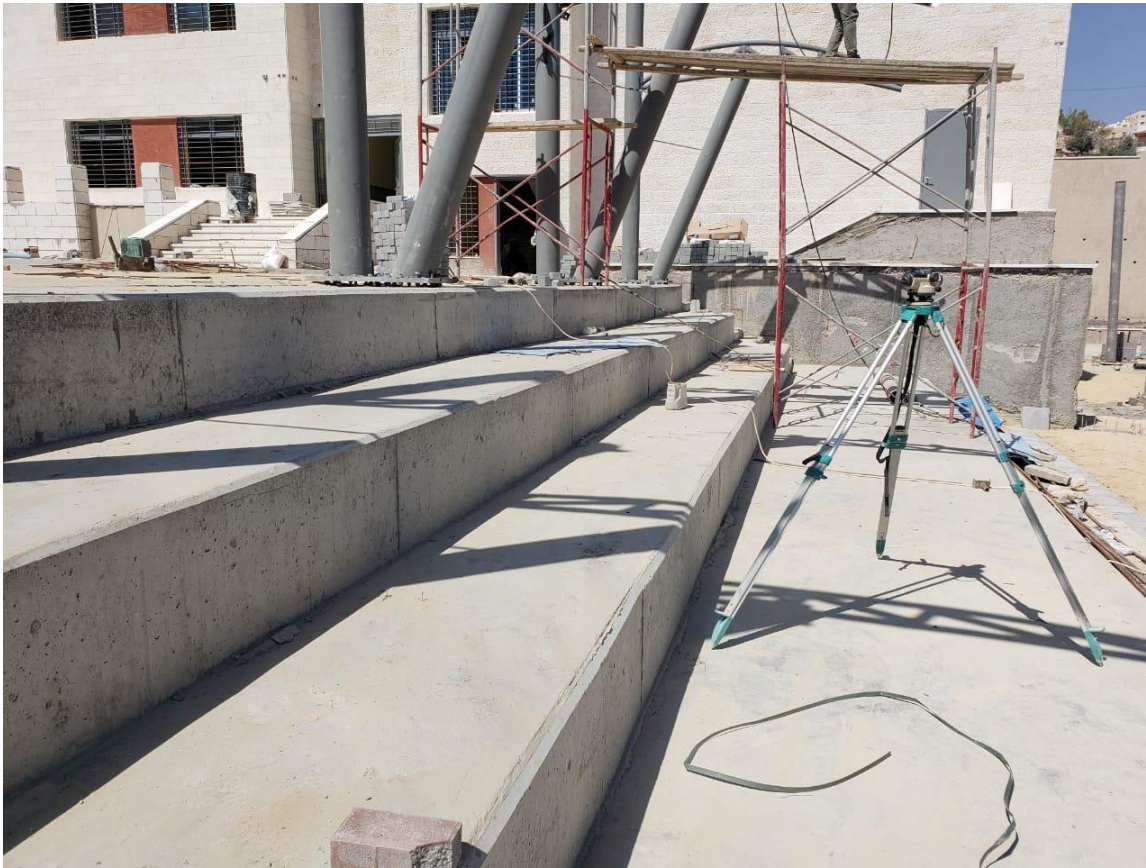
(Figure: 08)

The team observed the executed works for the steps of the amphitheater

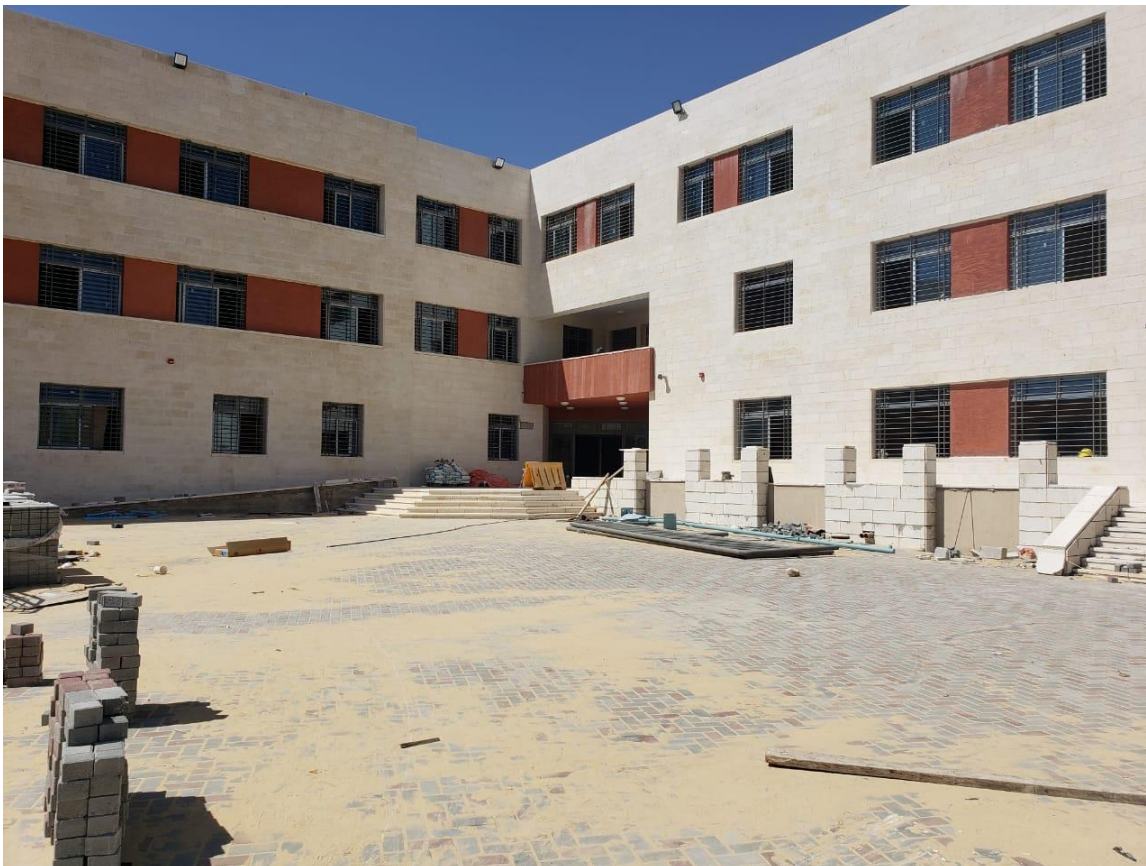
(Figure: 09)

Interlock tiling and stone works at the front of the school building

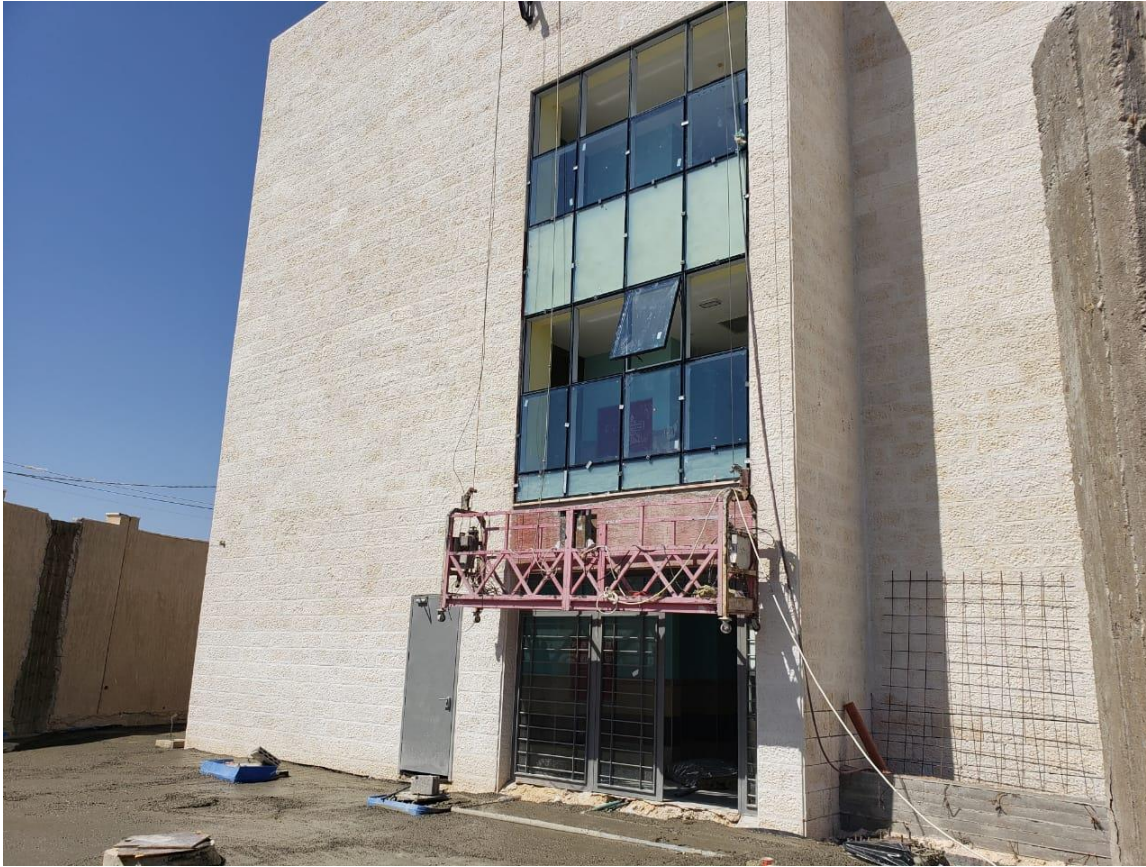
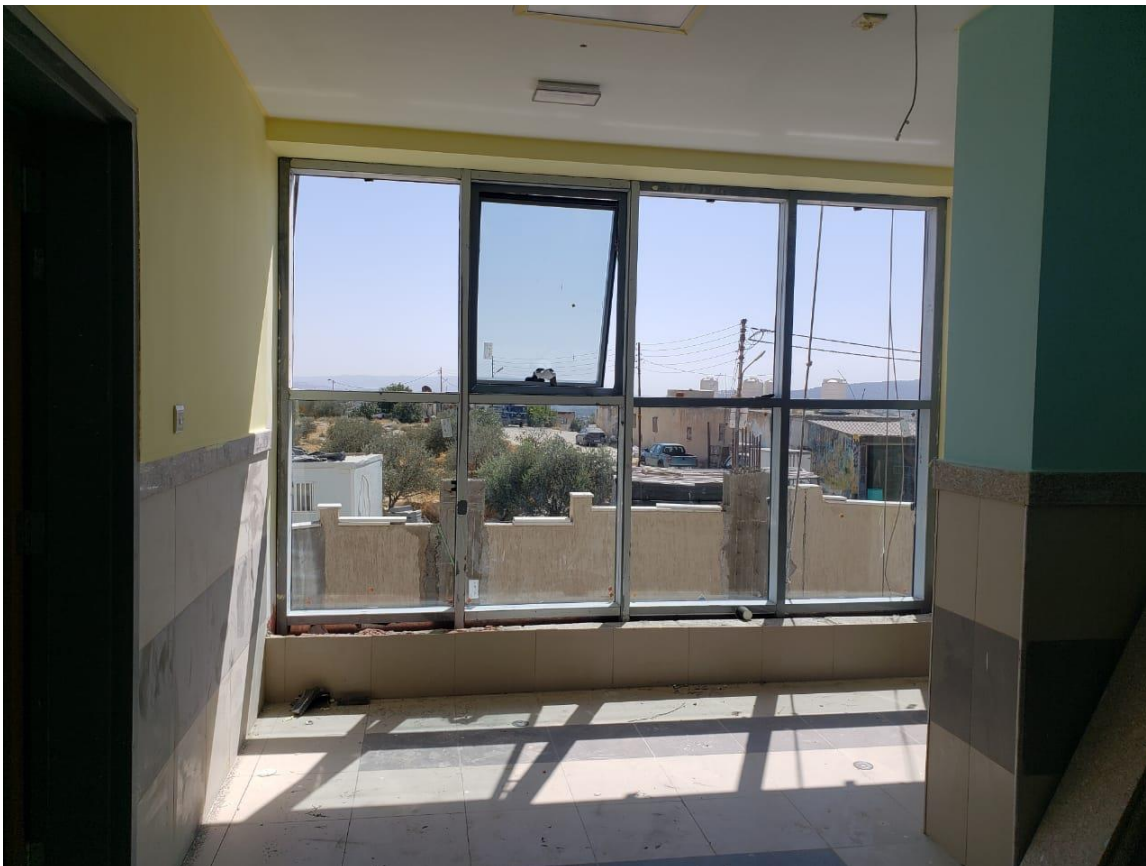
(Figure: 10 & 11)

The team inspected the execution of the curtain wall

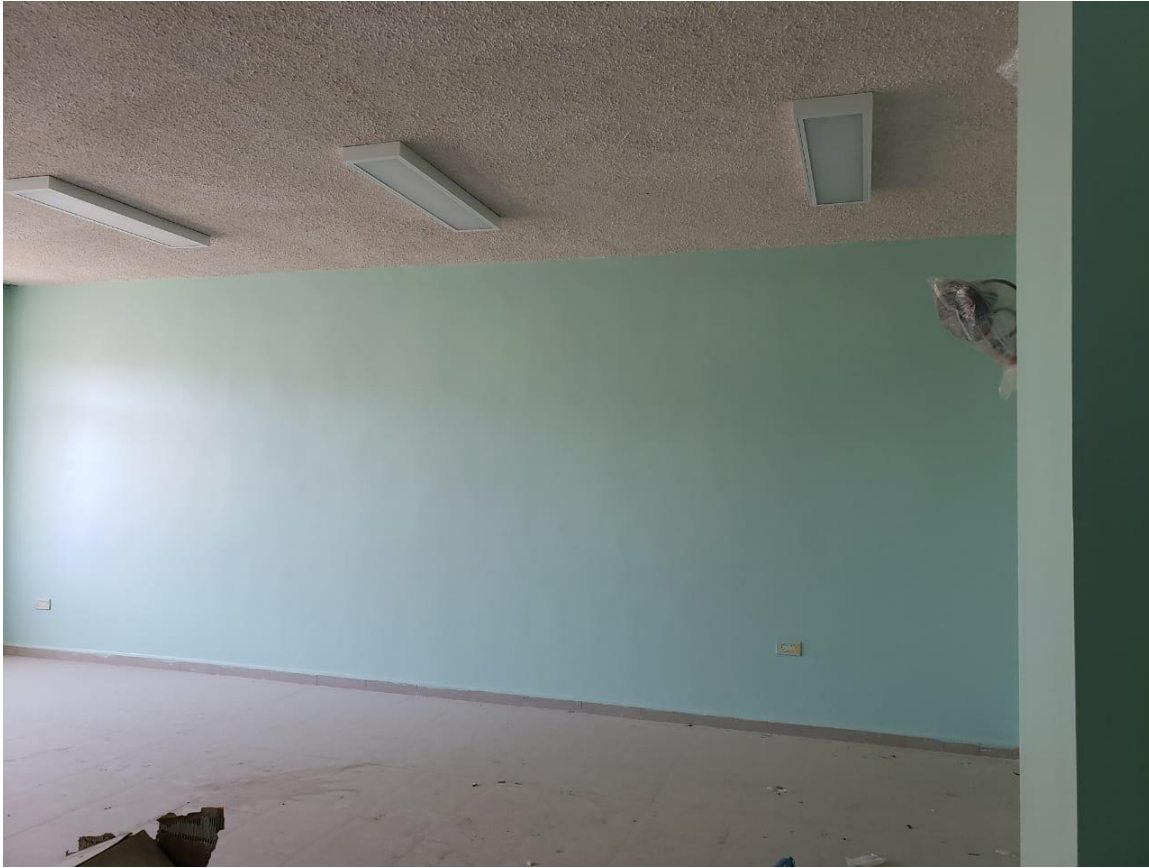
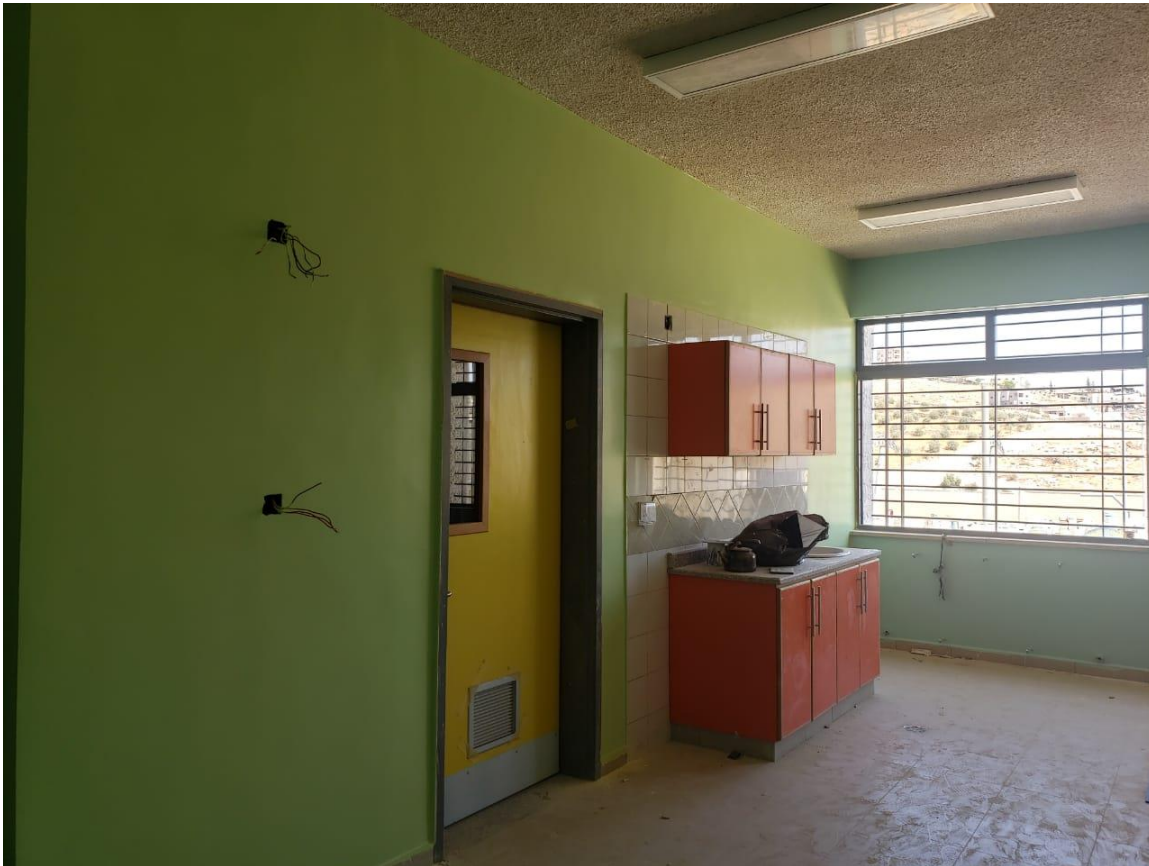
(Figure: 12 & 13)

Observing the progress of painting works

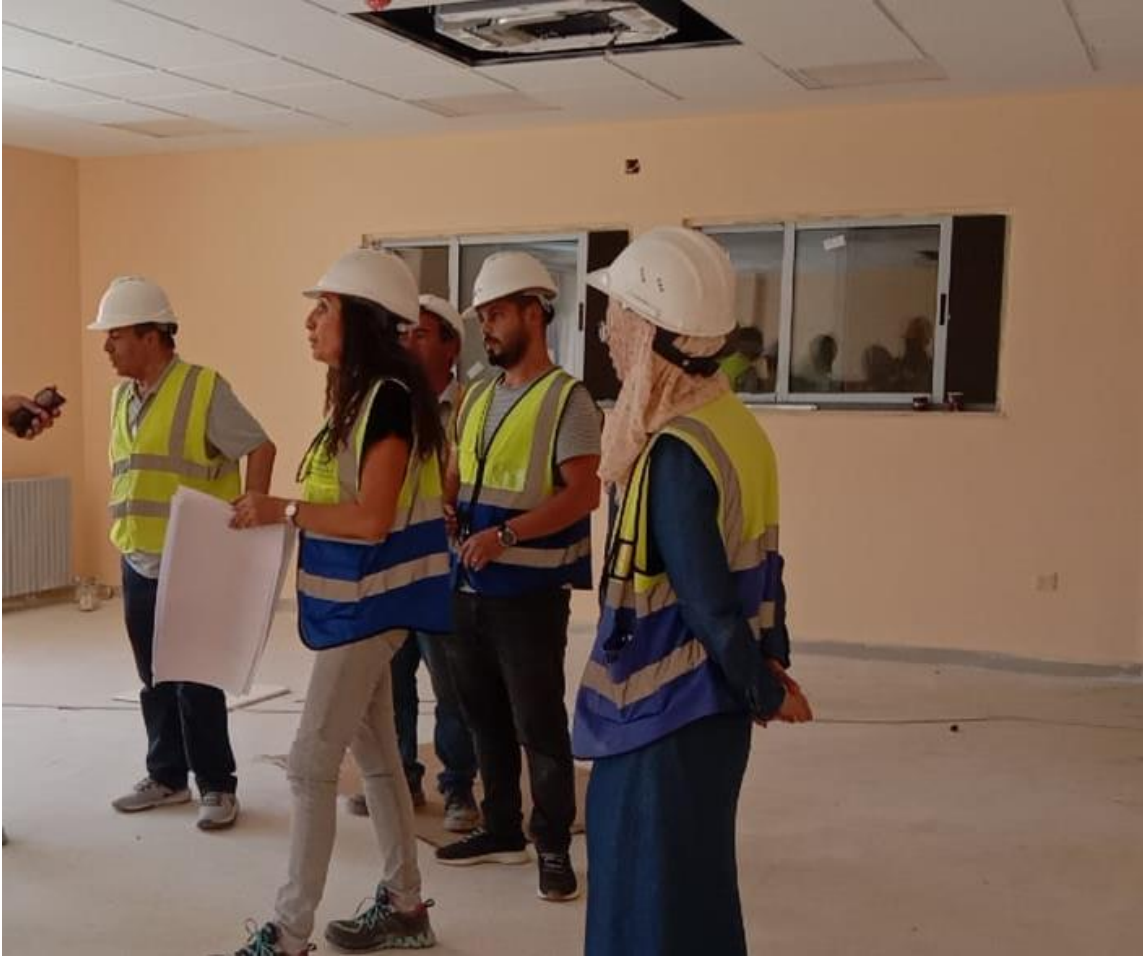
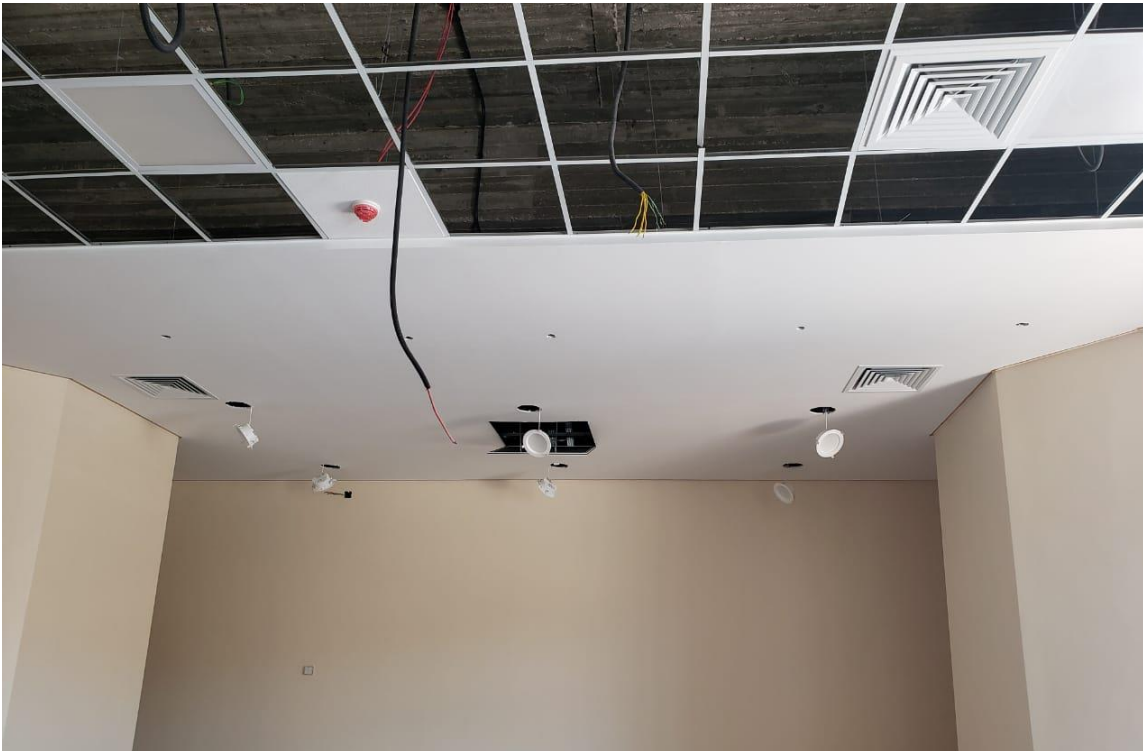
(Figure: 14 & 15)

The team discussed the status of the suspended ceilings works and aluminum windows installation

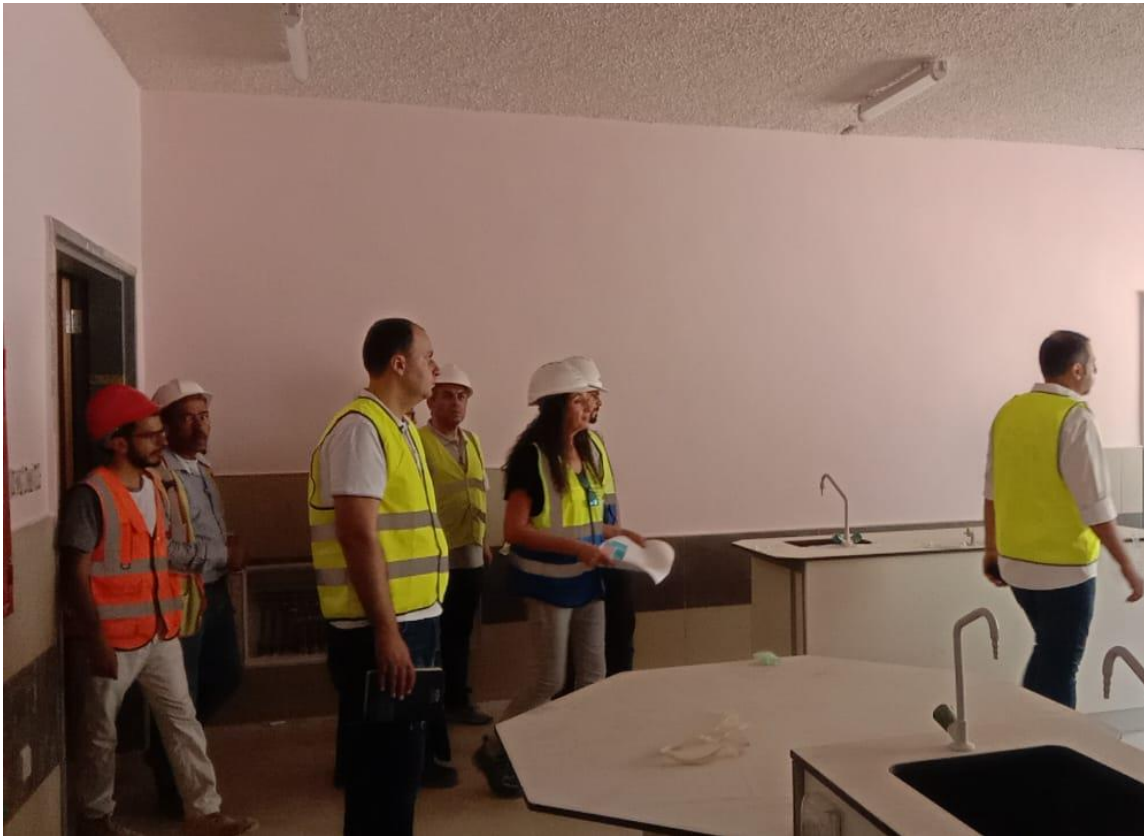
(Figure: 16)

Inspecting laboratories furniture installation and electro-mechanical connections

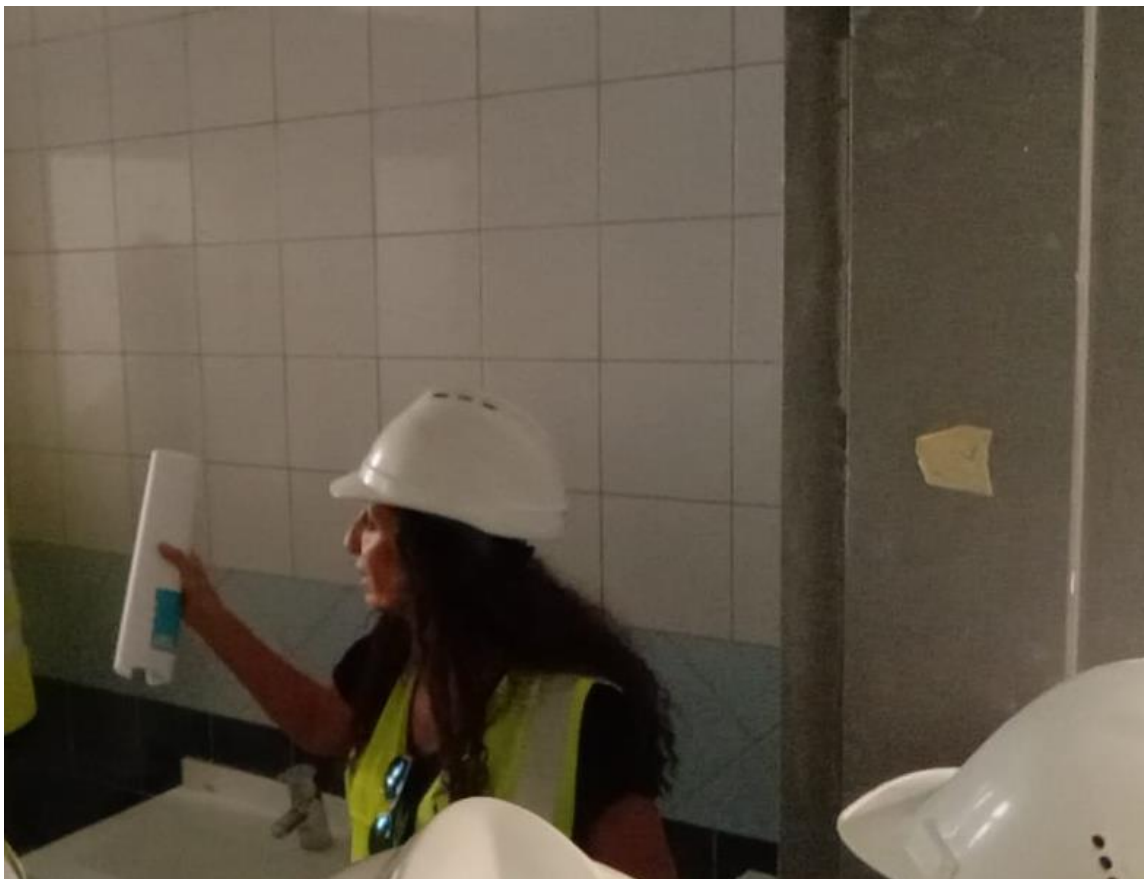
(Figure: 17)

Checking tiling work at the wet areas
