SKEP III Home Office Support Site Visit Report

Consultant	Wahib Medanat Consultant Engineer	Rep No.	12-20032022
Contractor	Derar Saraireh & Sons for Engineering & Contracting	Tender No.	(11/2019/USAID/SKEP/3/S) Schools for a Knowledge Economy Project (SKEP) - Phase (3) Package (1, 2)
Site Name	Al Khansa' Basic Mixed School- Al Balqa	Day/ Date	Sun. 20/03/2022
Duration of Project	450 Calendar Days	Total Project Budget	9,789,417.840 JD

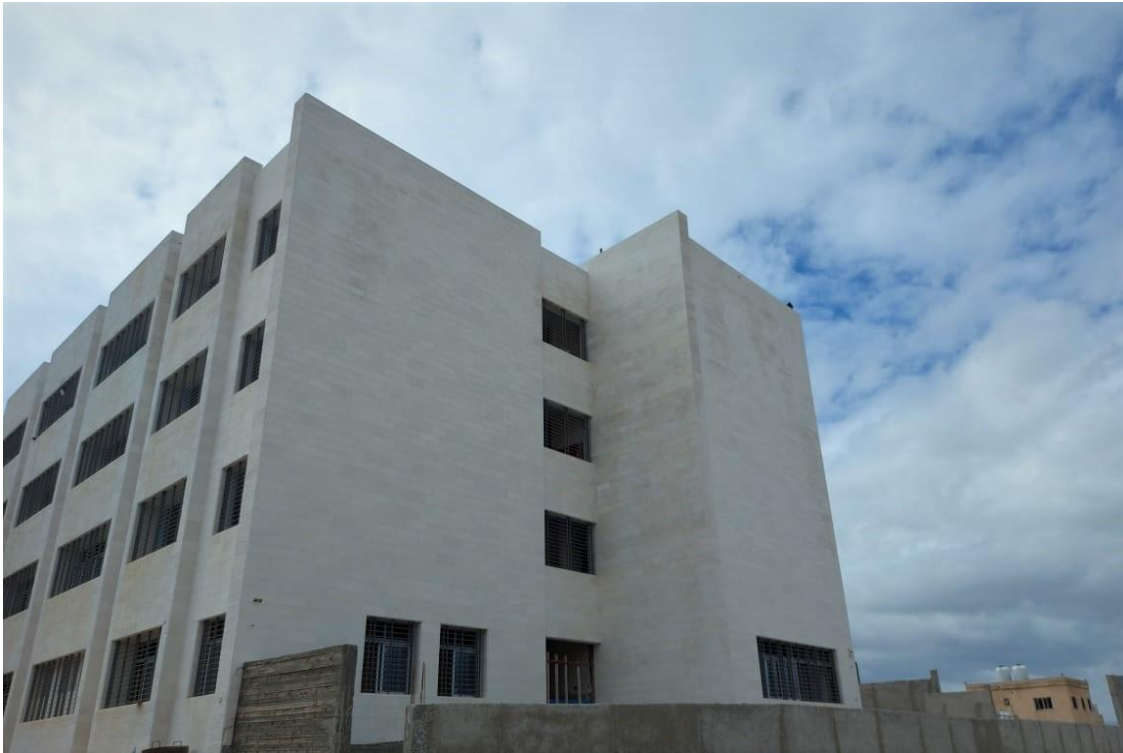
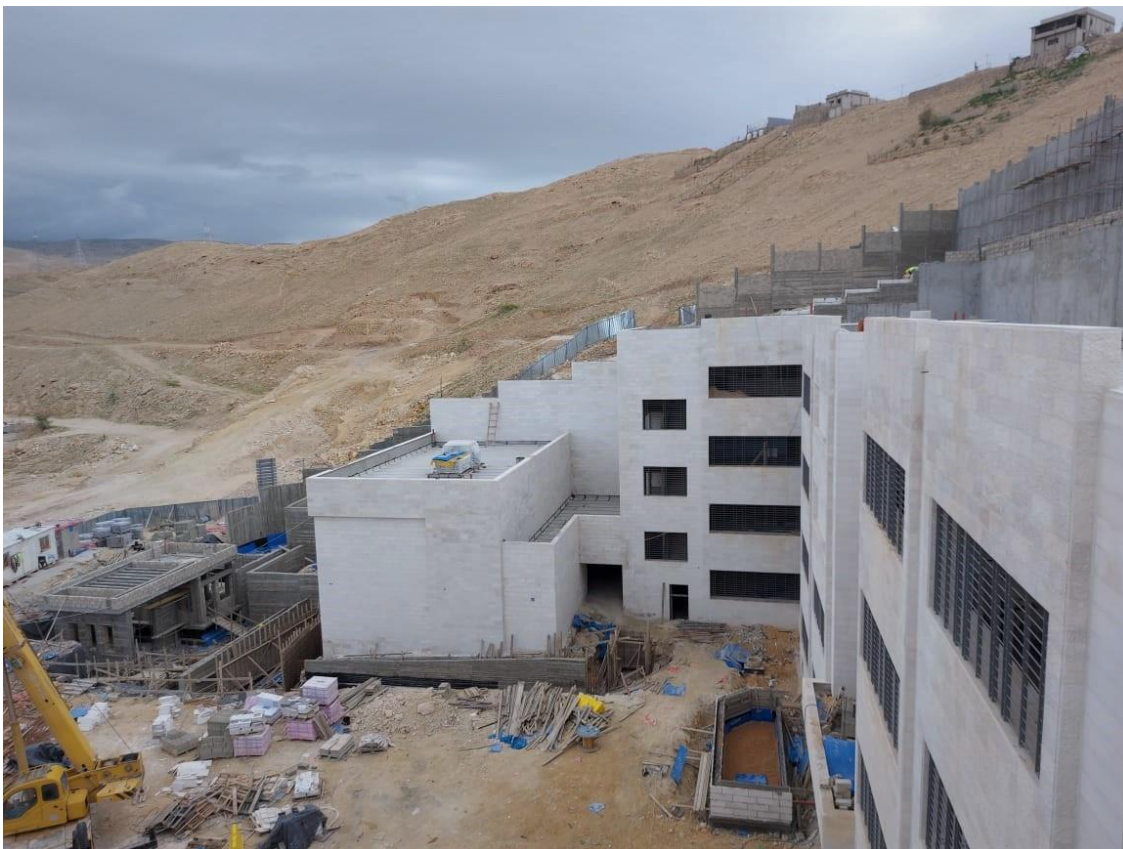
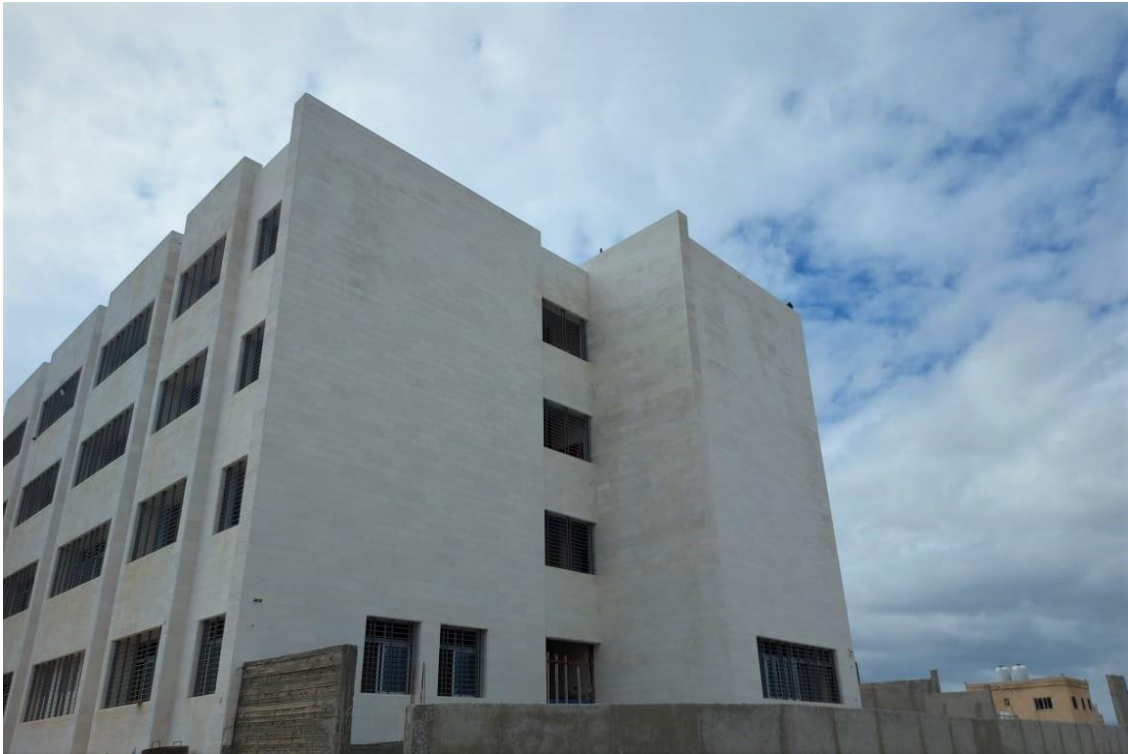
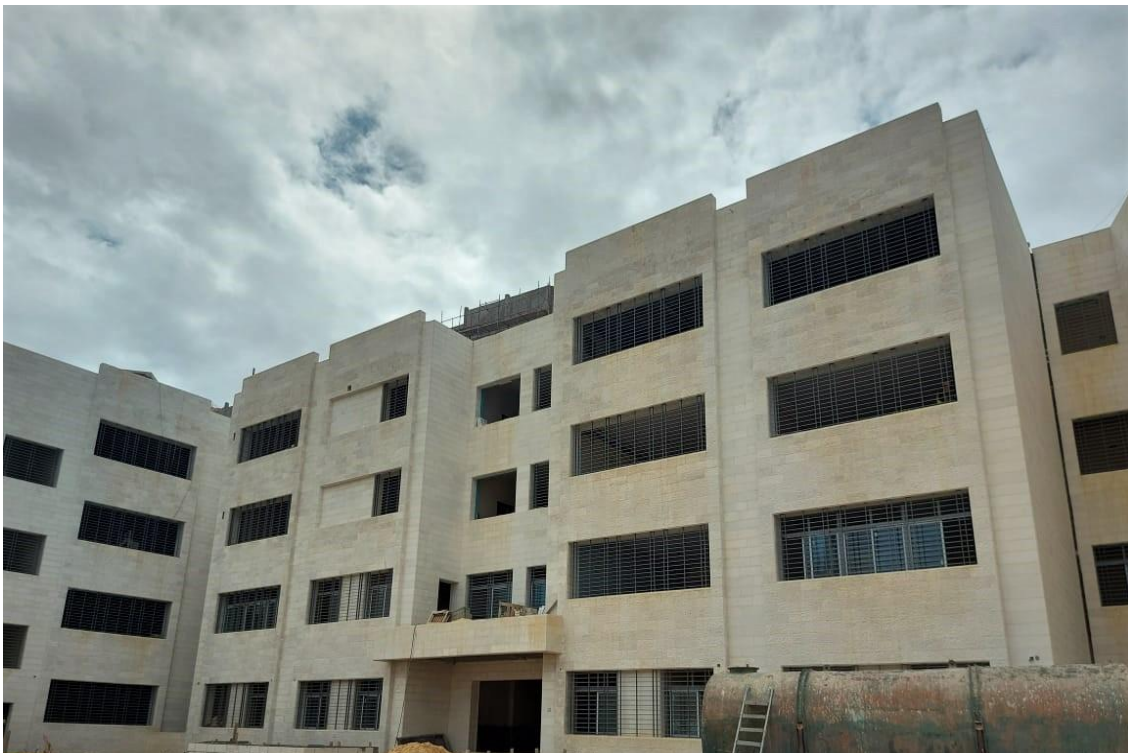
(Figure: 01, 02, 03 & 04)

General view of the project site

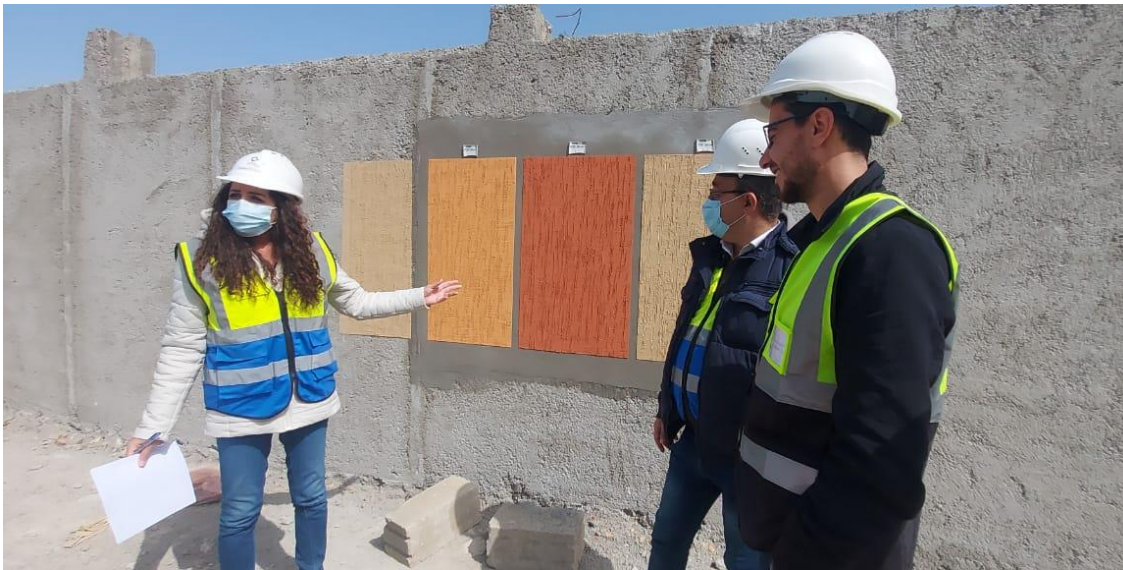
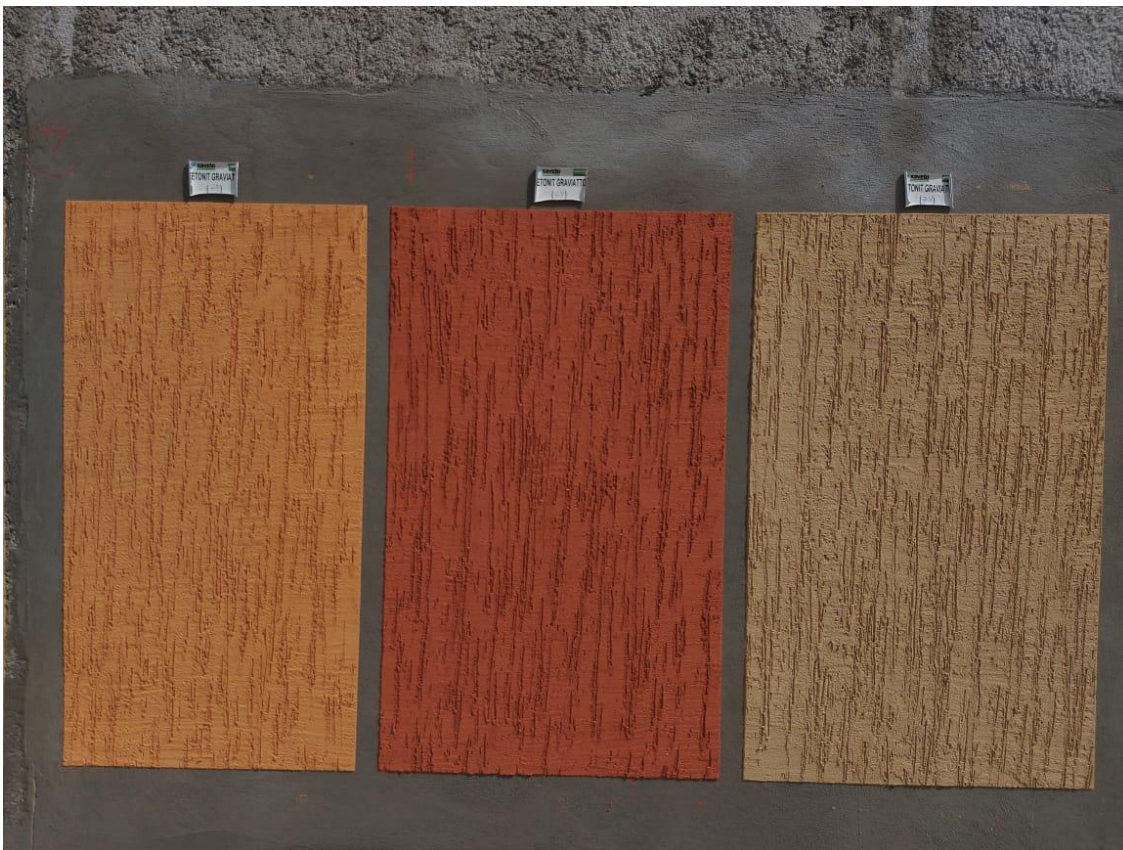
(Figure: 05 & 06)

The team inspected the proposed samples of final finish (texture) for the external plastering. After discussion, the team informed the Contractor with the approved samples and instructed him to submit a method statement for the execution of higher walls

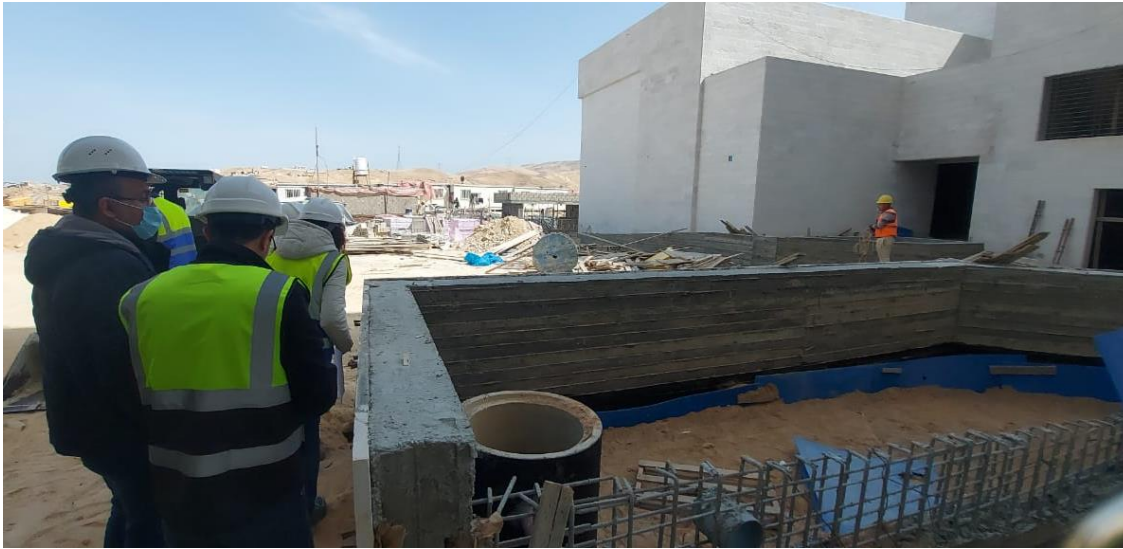
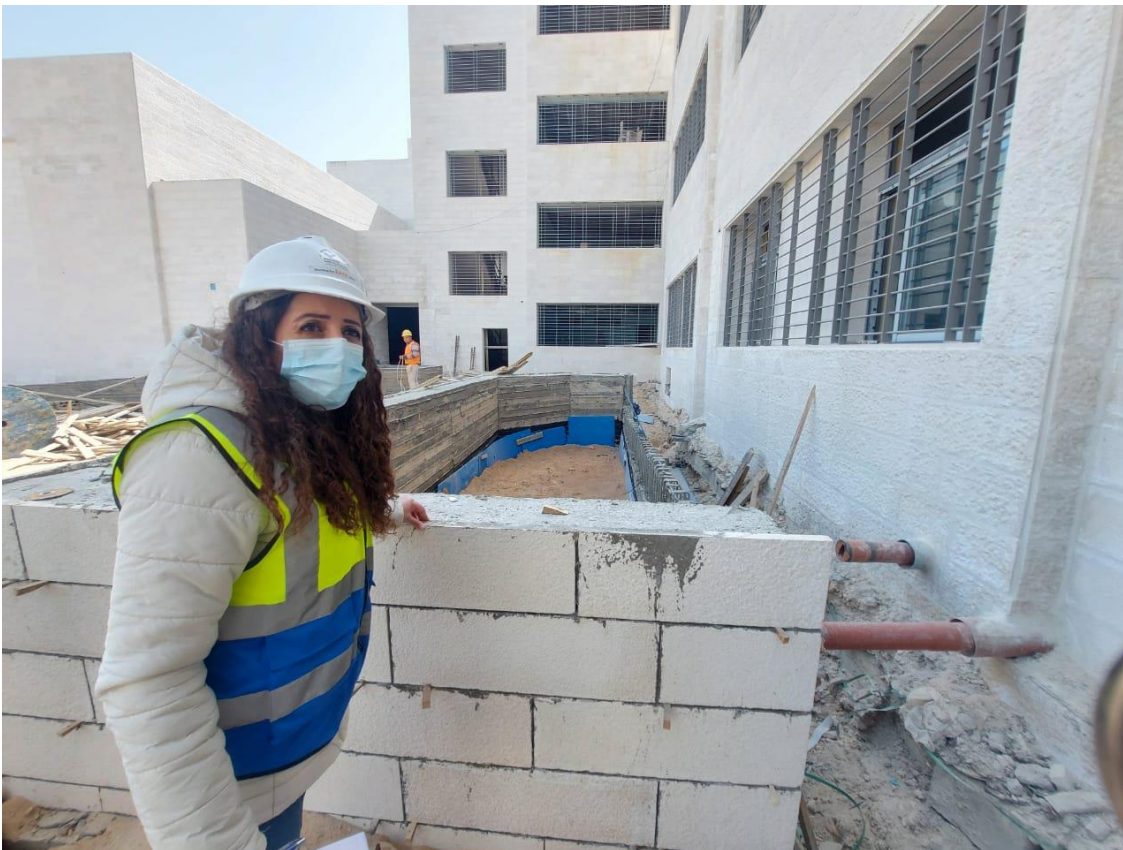
(Figure: 07 & 08)

The team discussed with the Contractor the works related to the ramps in the site and advised him to submit a request for information for any levels not indicated on the drawings

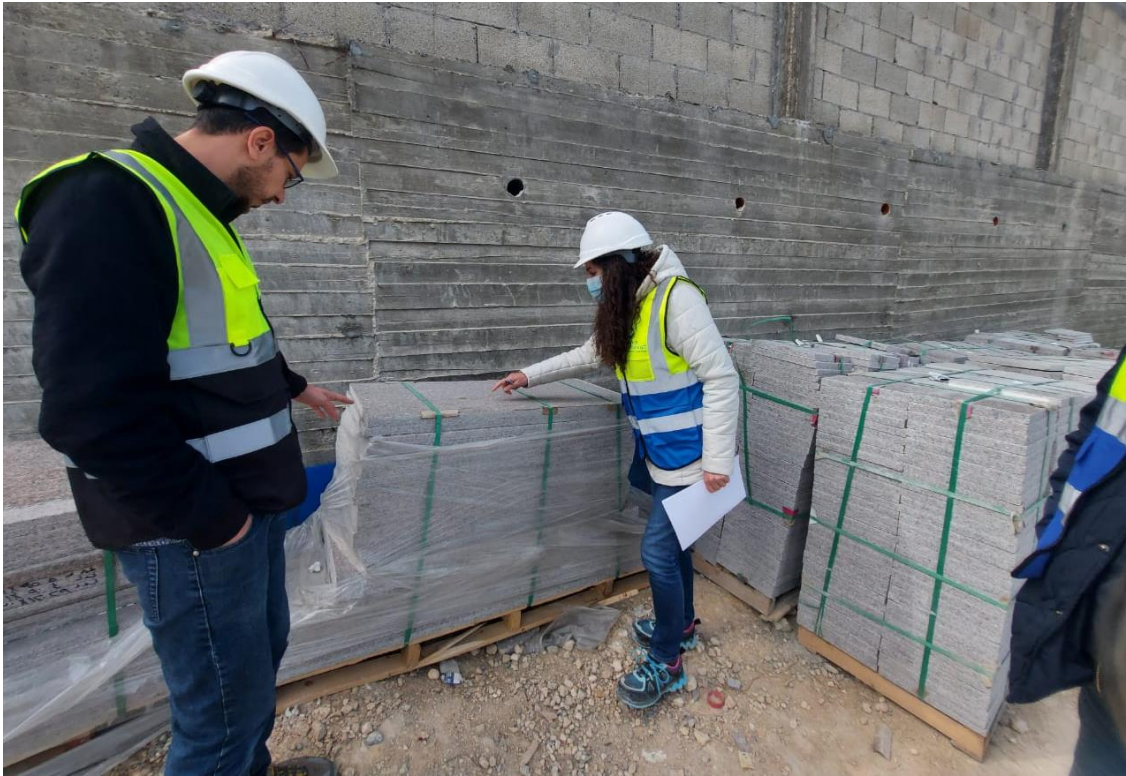
(Figure: 09)

The team inspected the delivered quantities of granite tiles and cladding and stressed on avoiding using any pieces with defects

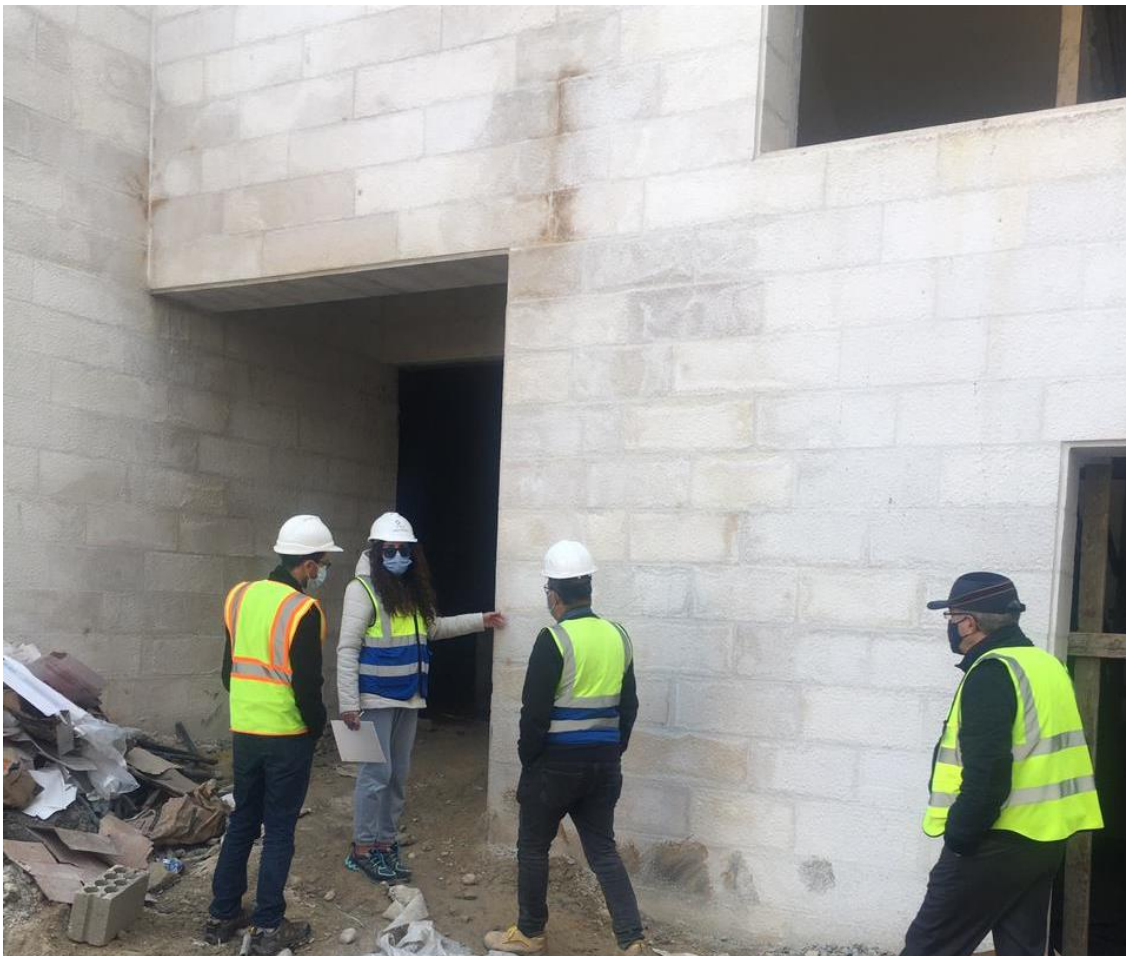
(Figure: 10)

The defective stones of the facades were still not rectified

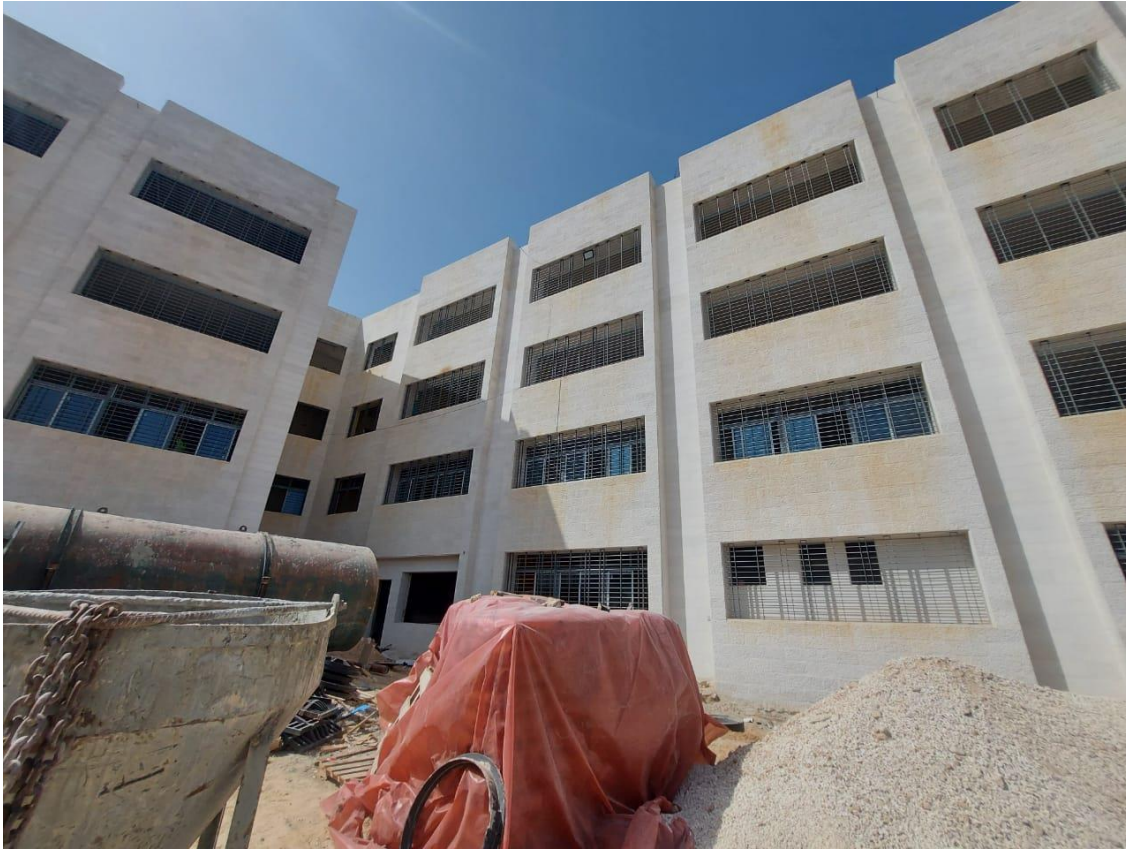
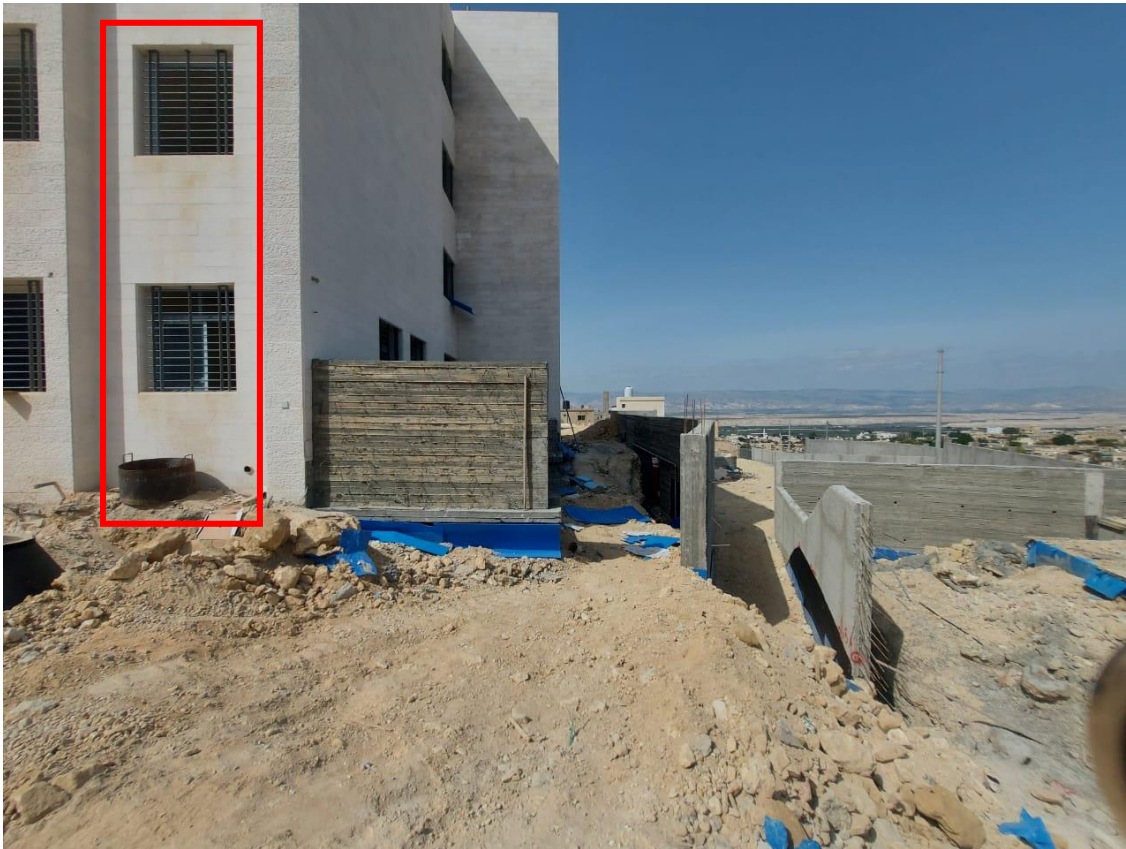
(Figure: 11 & 12)

The team observed that due to other activities the stone facades require cleaning

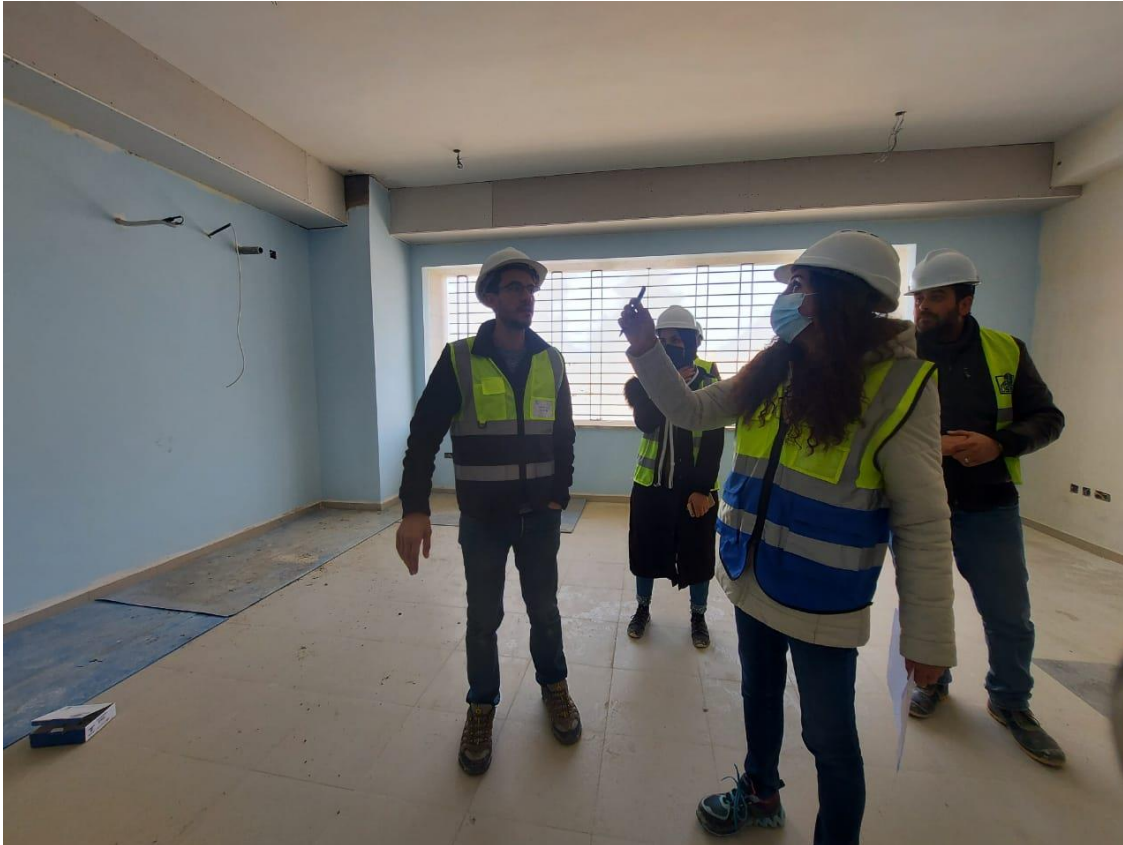
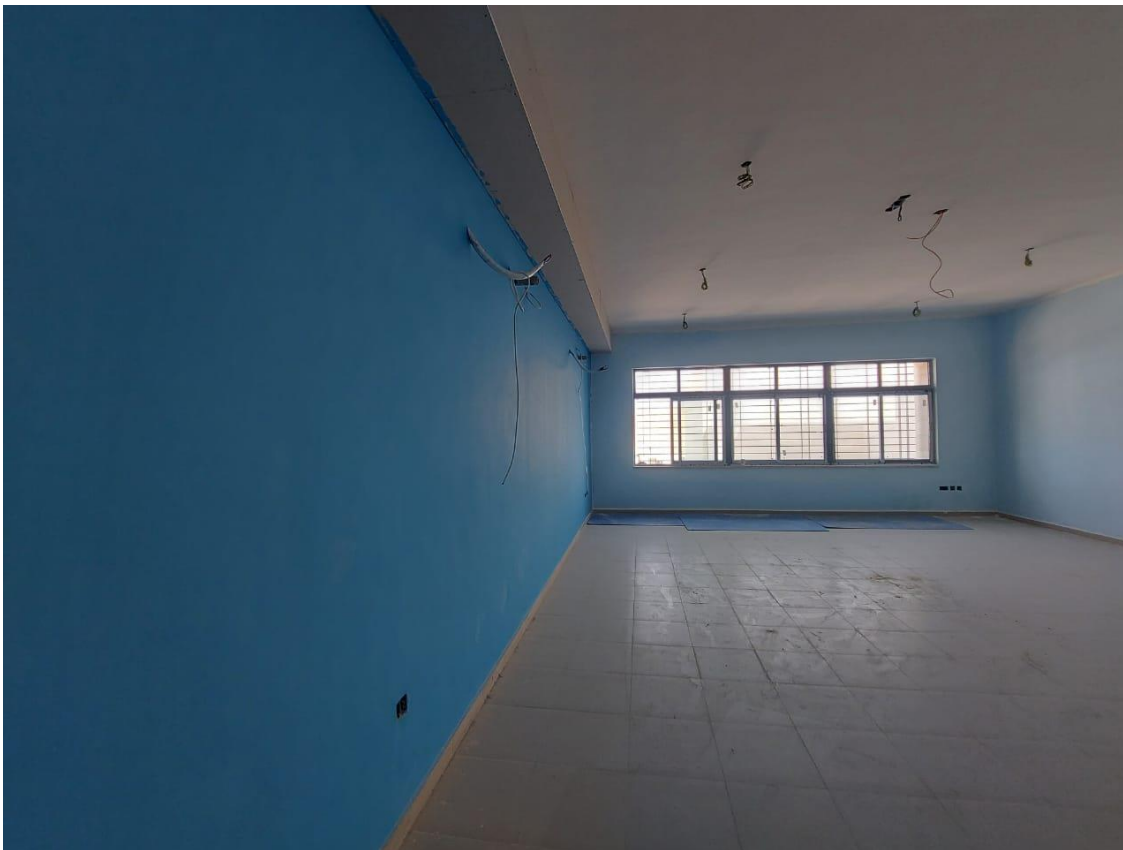
(Figure: 13 & 14)

The team discussed the distribution of colors at the classrooms

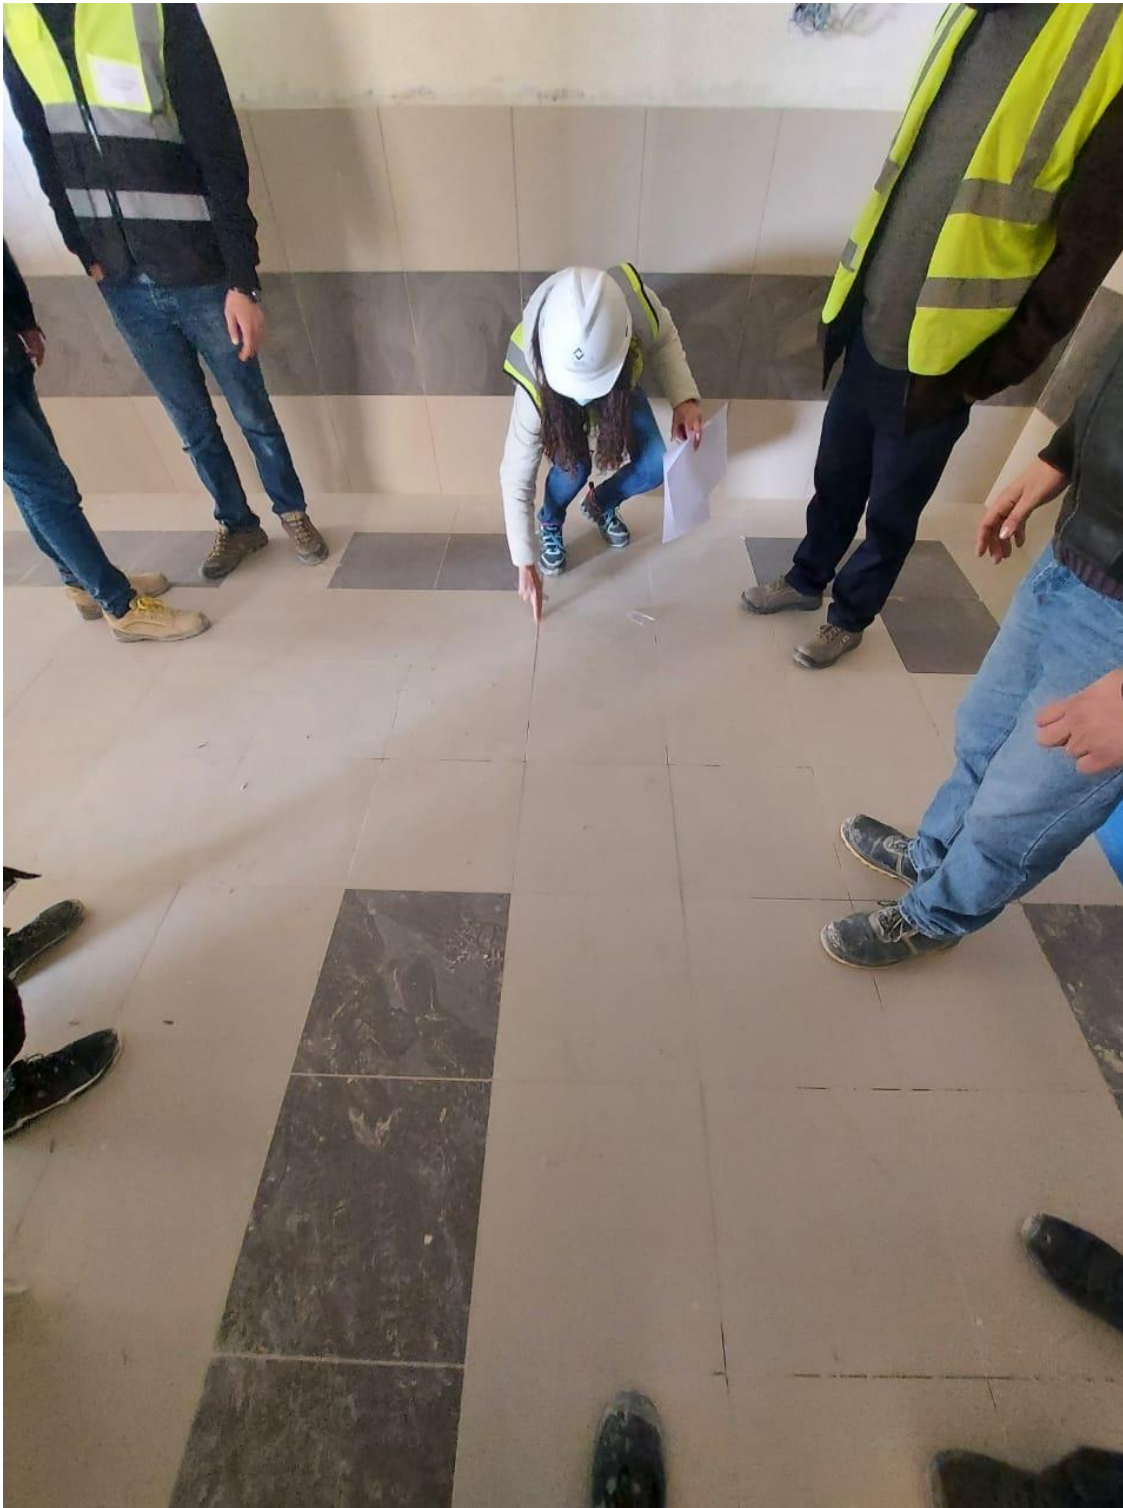
(Figure: 15)

The team observed teething of executed porcelain floor tiles in some parts and request the Contractor to rectify

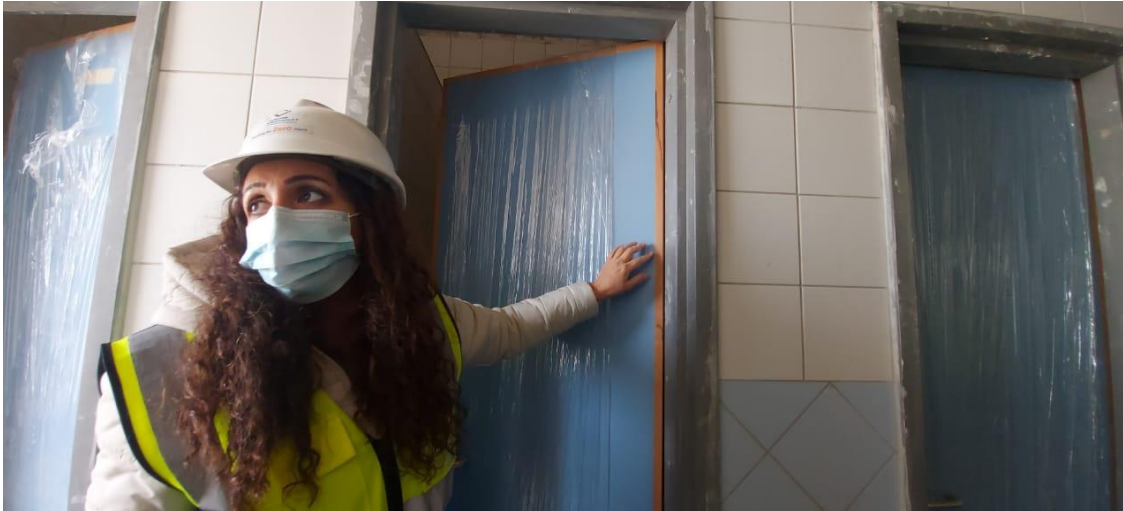
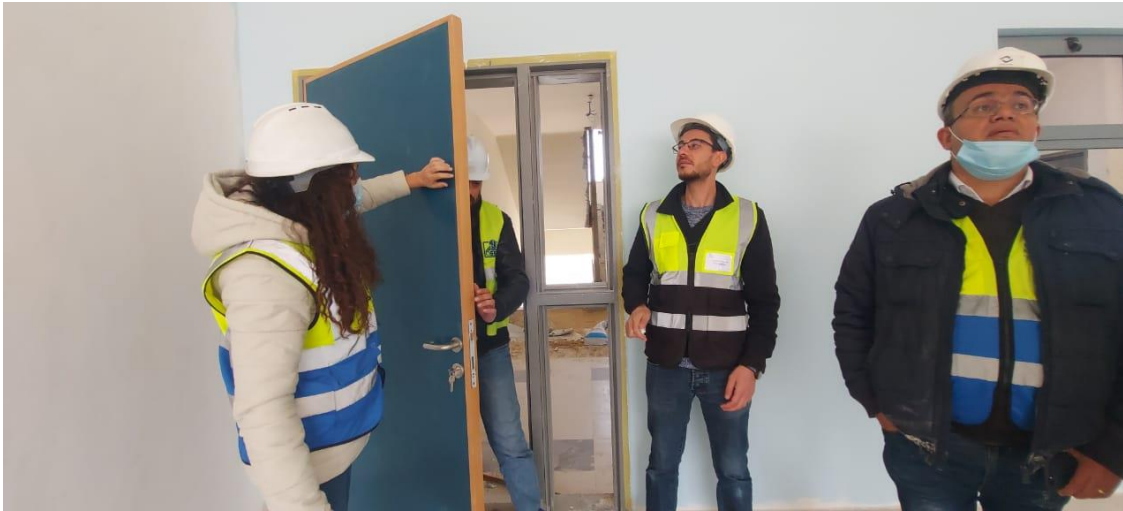
(Figure: 16 & 17)

The team inspected the installed wooden doors and observed that a number of doors have defective beech frames which need to be replaced

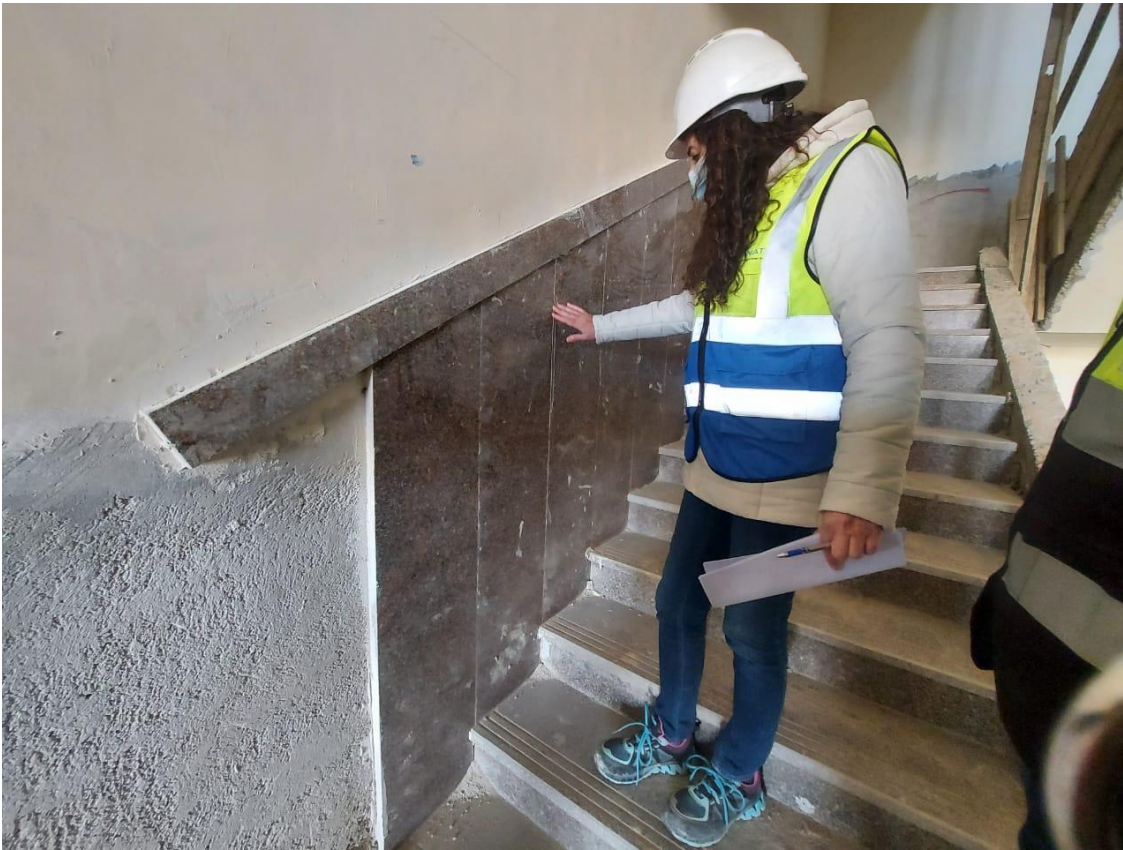
(Figure: 18)

The team inspected the sample prepared by the Contractor for the staircase granite cladding. The team pointed minor remarks to the Contractor, in general, the sample acceptable

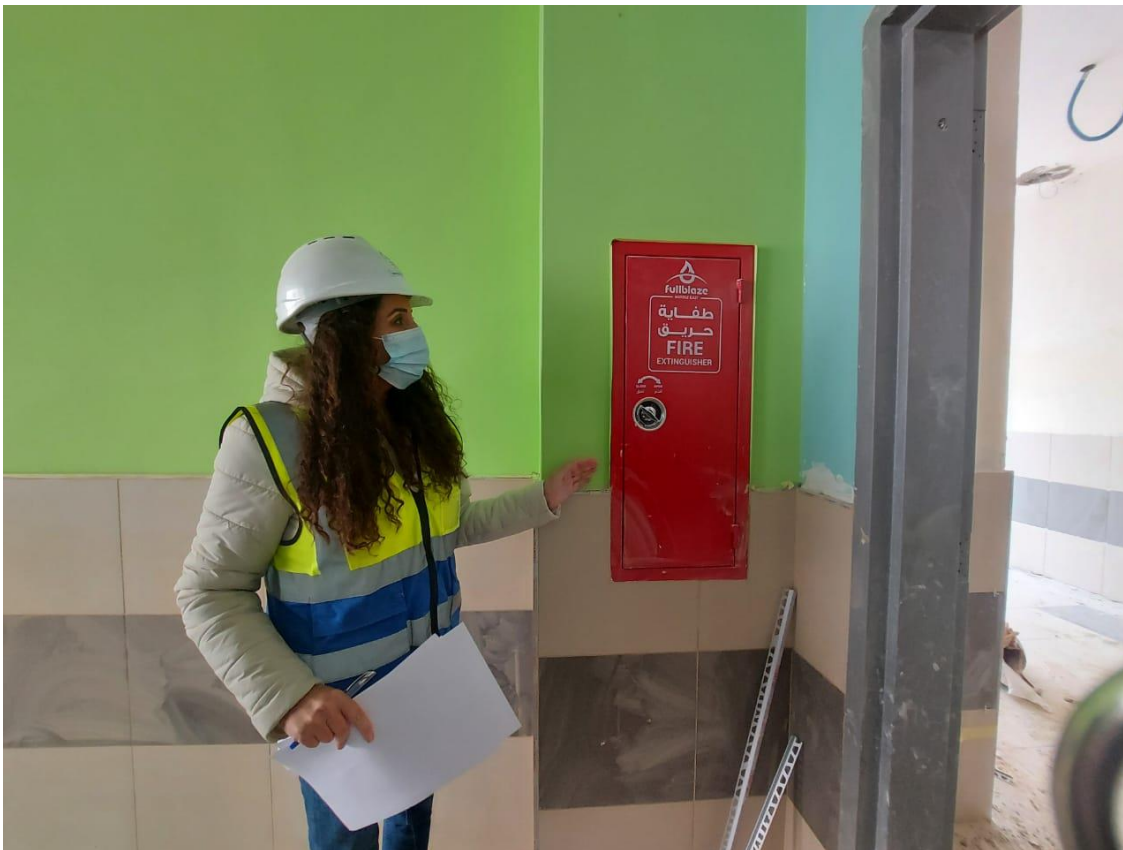
(Figure: 19)

The team inspected the cabinets installed in the building to keep the fire extinguishers

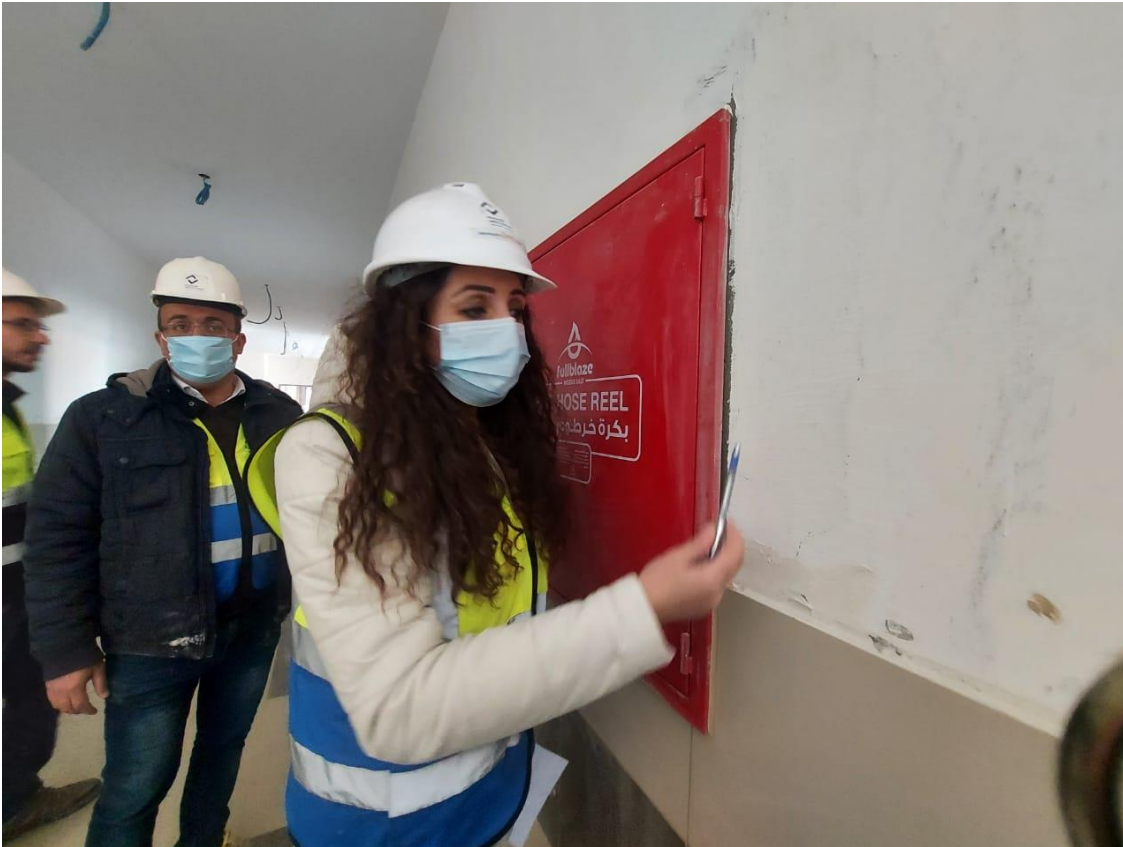
(Figure: 20)

The team discussed with the Contractor the installation of fire cabinets in the corridors and the connection with the installation of granite at walls and the prominence of the said cabinets

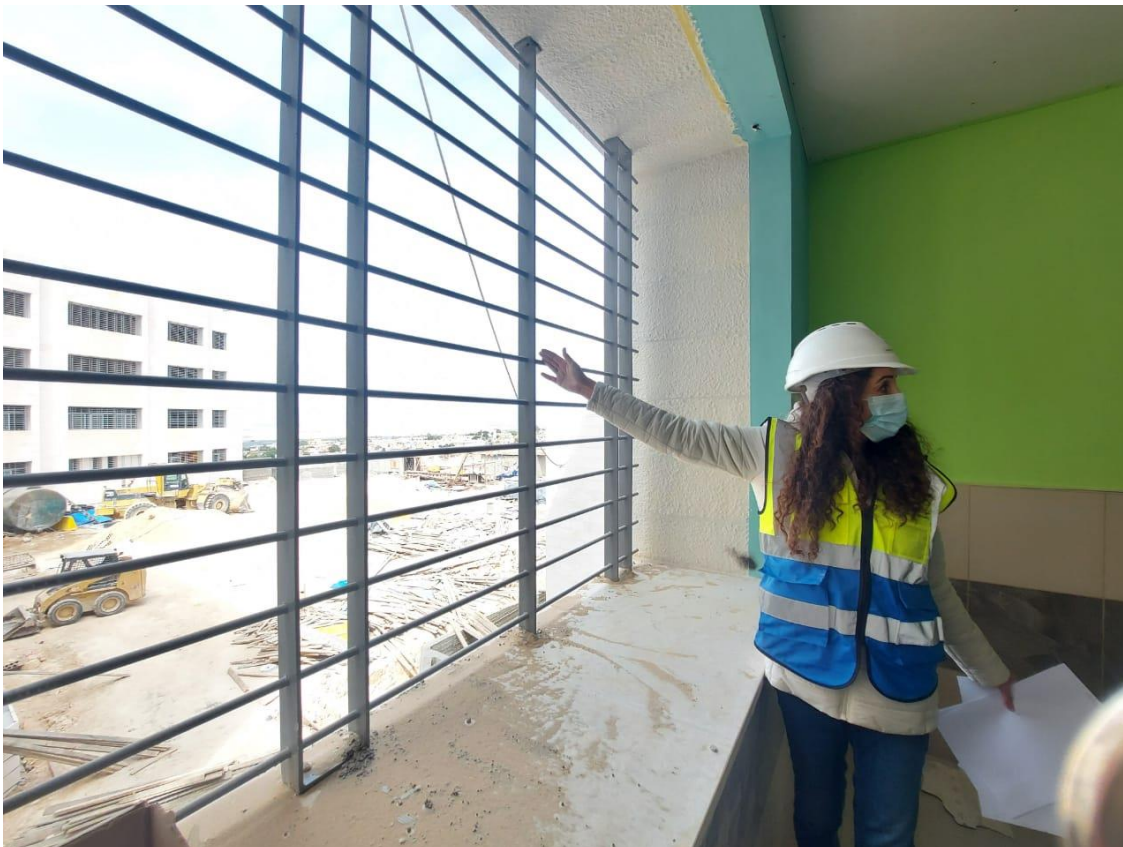
(Figure: 21)

The team inspected the installed steel protection screens. No defects were observed

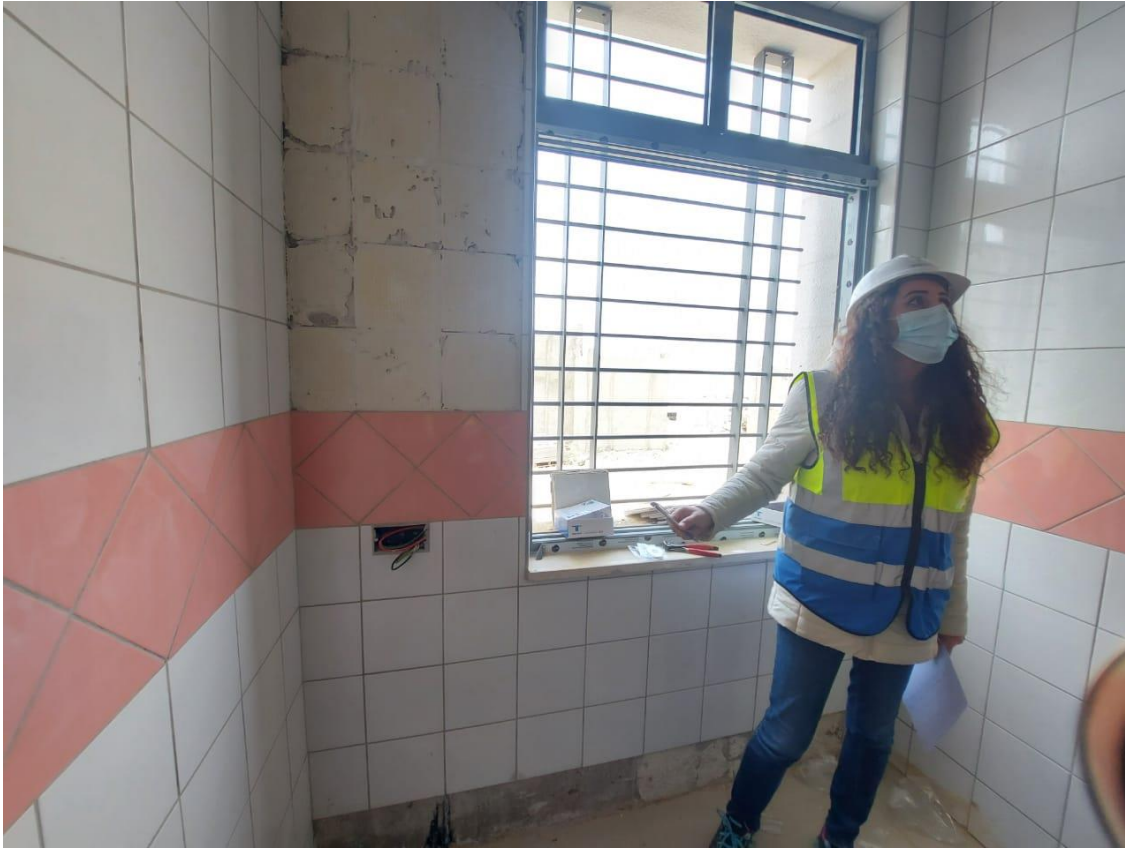
(Figure: 22)

The team observed that the Contractor has removed part of defected wall tiles at the wet area as first step to replace the defected tiles

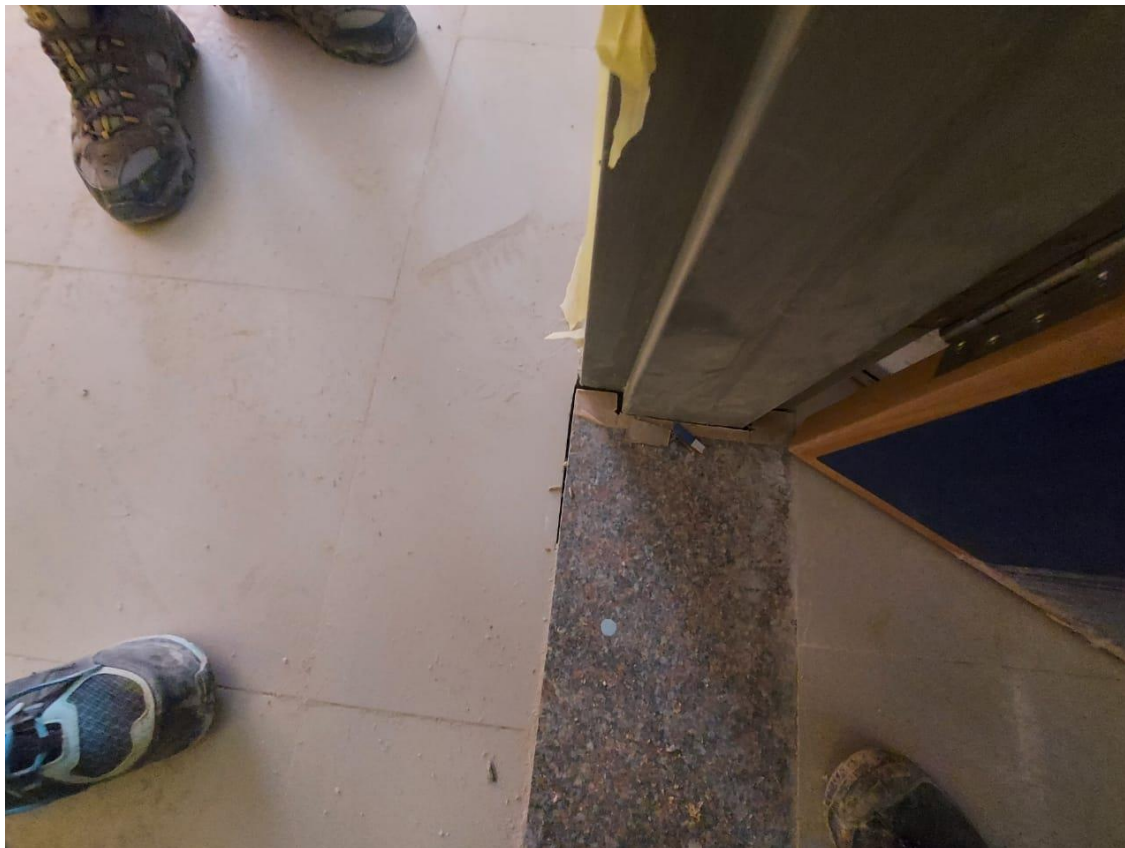
(Figure: 23)

The team inspected the granite thresholds at the wooden doors and requested the Contractor to rectify a number of those thresholds not well installed

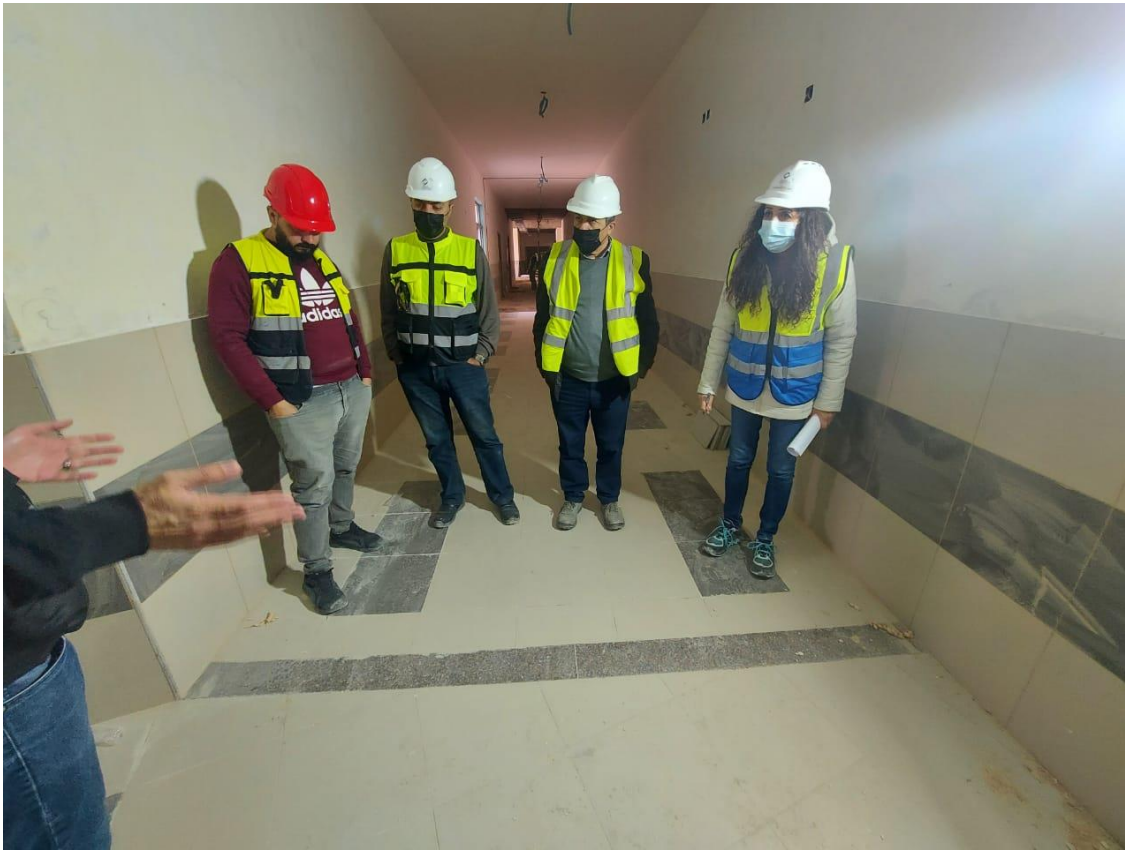
(Figure: 24)

The team inspected the granite thresholds linking the corridors together
