SKEP III Home Office Support Site Visit Report

Consultant	Wahib Medanat Consultant Engineer	Rep No.	12-20032022
Contractor	Derar Saraireh & Sons for Engineering & Contracting	Tender No.	(11/2019/USAID/SKEP/3/S) Schools for a Knowledge Economy Project (SKEP) - Phase (3) Package (1, 2)
Site Name	Al Khansa' Basic Mixed School- Al Balqa	Day/ Date	Sun. 20/03/2022
Duration of Project	450 Calendar Days	Total Project Budget	9,789,417.840 JD

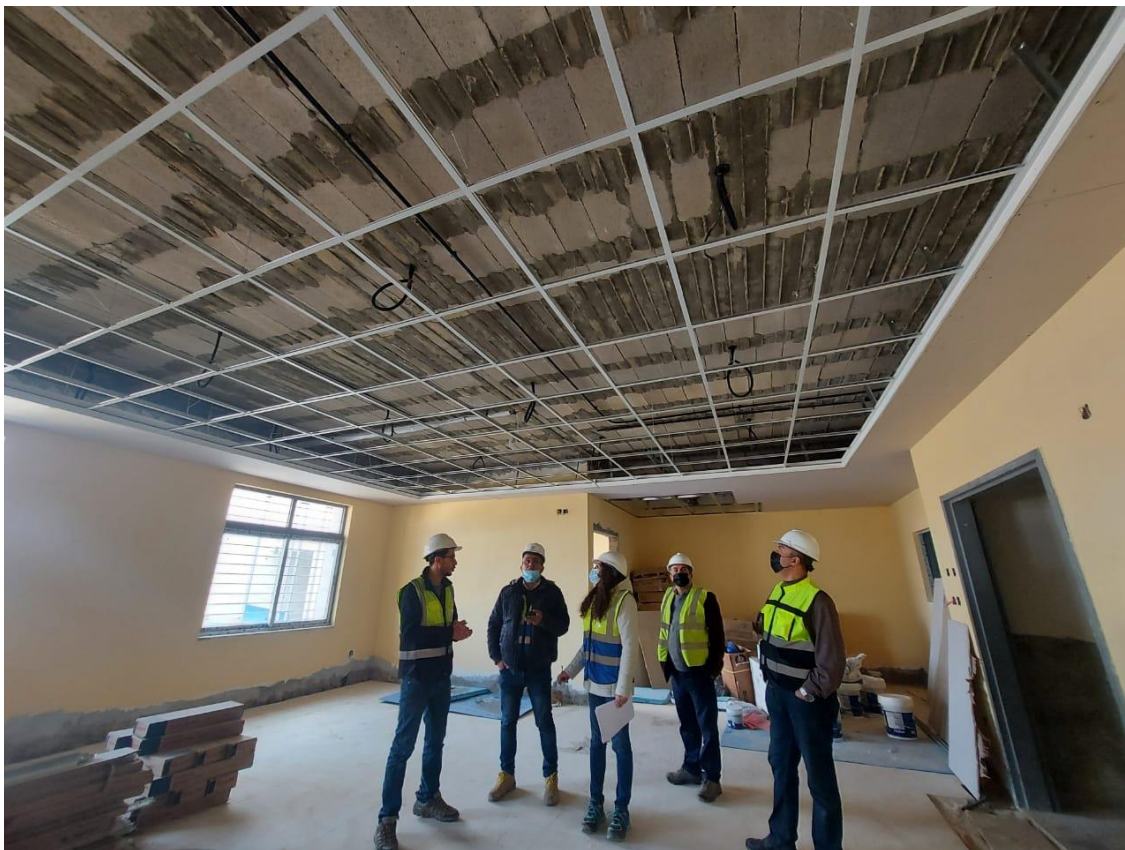
(Figure: 25)

The team inspected the starting of execution of suspended ceiling and stressed on the Contractor to ensure the vertically of frame hangers and to ensure using complete 60cmx60cm tiles at the ends

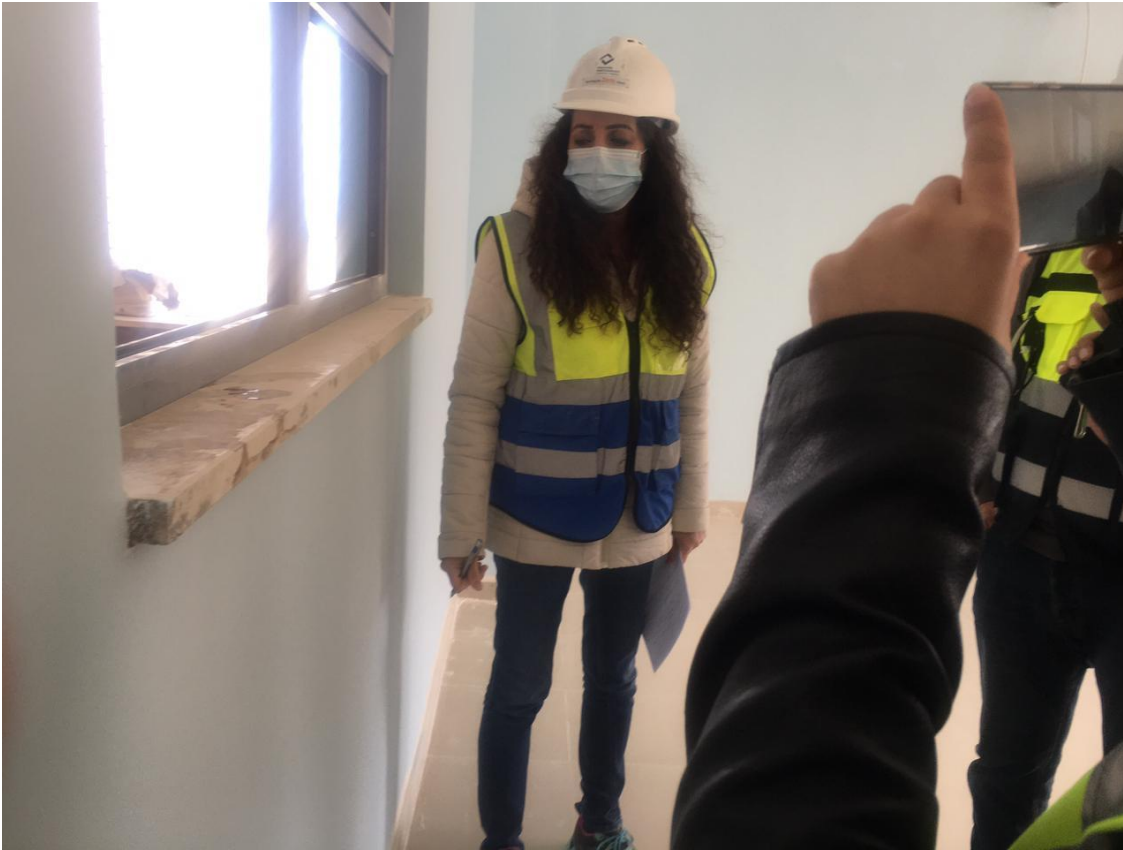
(Figure: 26)

The team inspected the installed window sills and requested the Contractor to rectify the defects and to replace the broken pieces before paint finish at the related areas

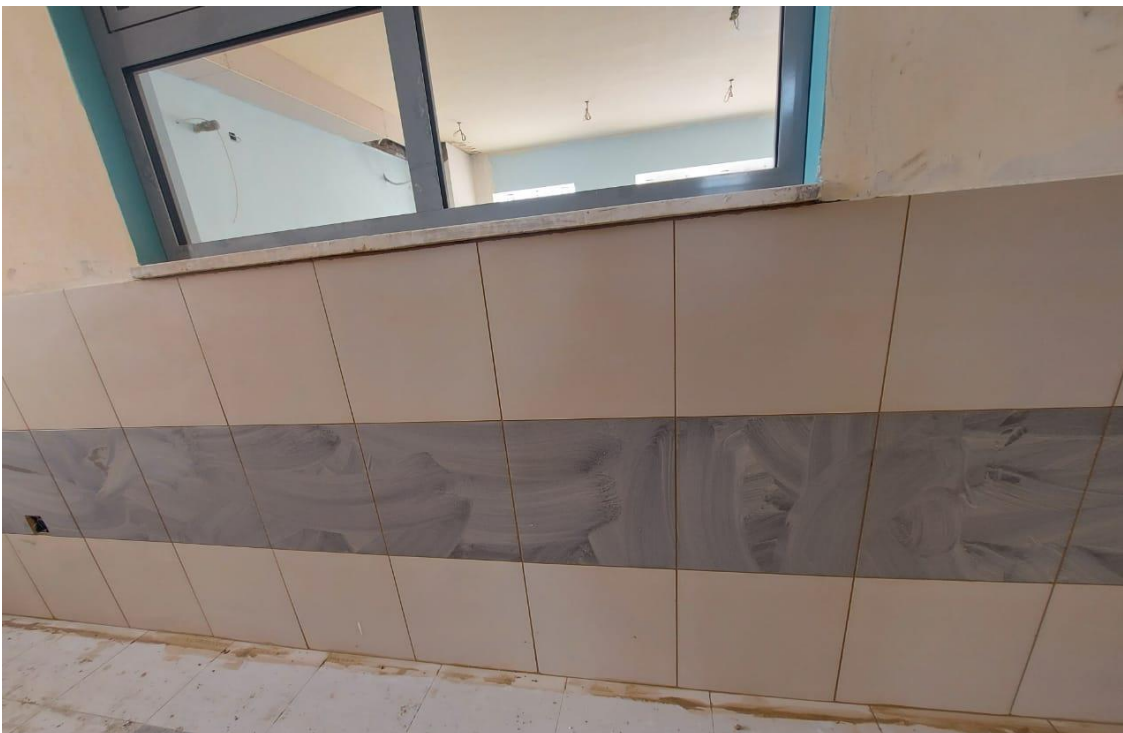
(Figure: 27)

The team observed that the levels of window sills in the corridor are not compatible and need to be checked and rectified

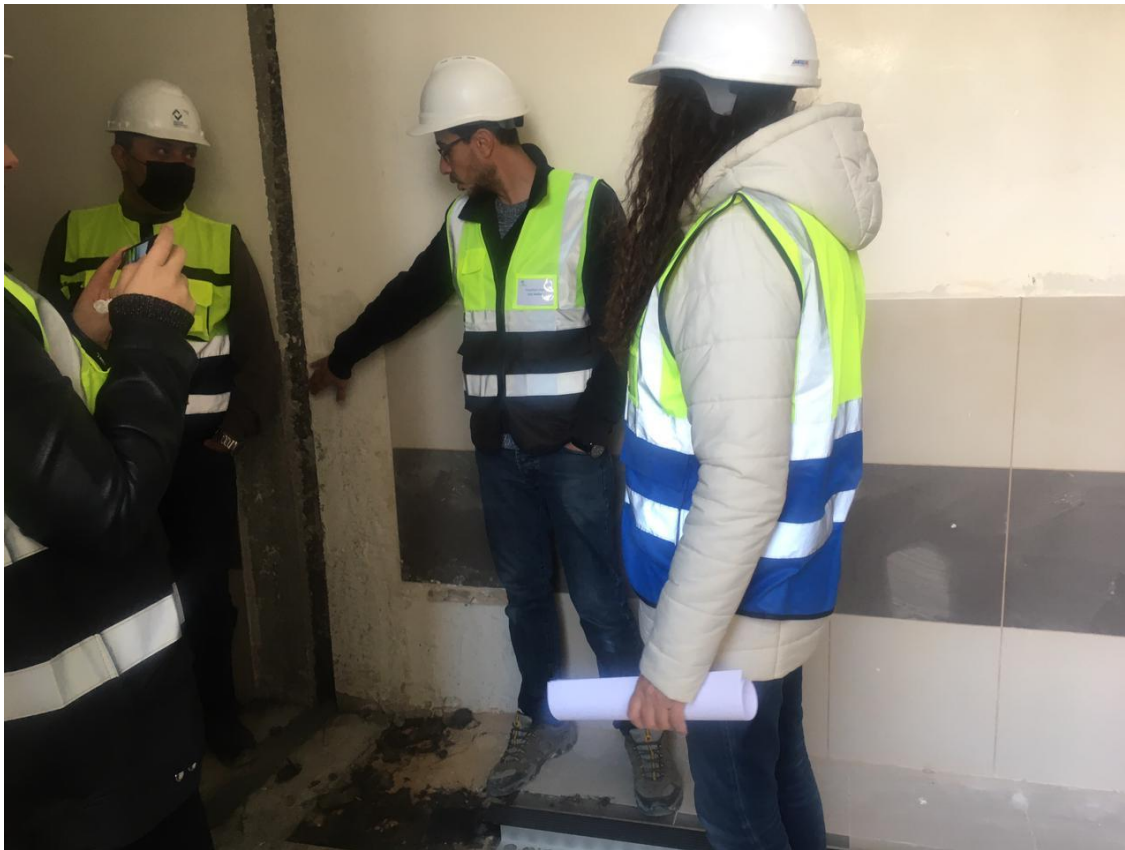
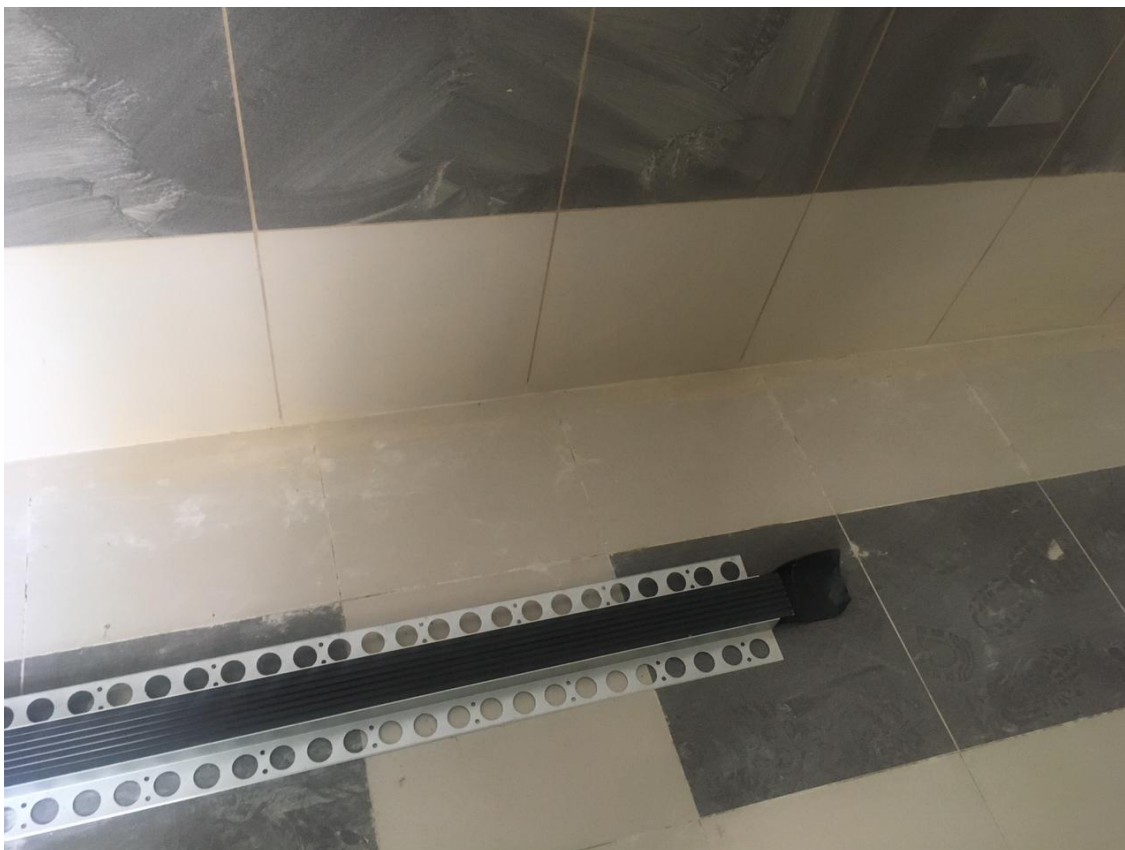
(Figure: 28 & 29)

The team inspected the executed sample of internal expansion joint. In this regard, the team stressed on the Contractor to comply with the approved sample as per contract and the expansion joint cover shall be recessed below the level of porcelain floor tiles
