SKEP III Home Office Support Site Visit Report

Consultant	Wahib Medanat Consultant Engineer	Rep No.	23-15012022
Contractor	Dijlah Establishment Constr. Contracting	Tender No.	(11/2019/USAID/SKEP/3/S) Schools for a Knowledge Economy Project (SKEP) - Phase (3) Package (1, 2)
Site Name	Jumana Bint Abit Taleb Basic Mixed School - Jerash	Day/ Date	Sat. 15/01/2022
Duration of Project	450 Calendar Days	Total Project Budget	8,314,983.735 JD

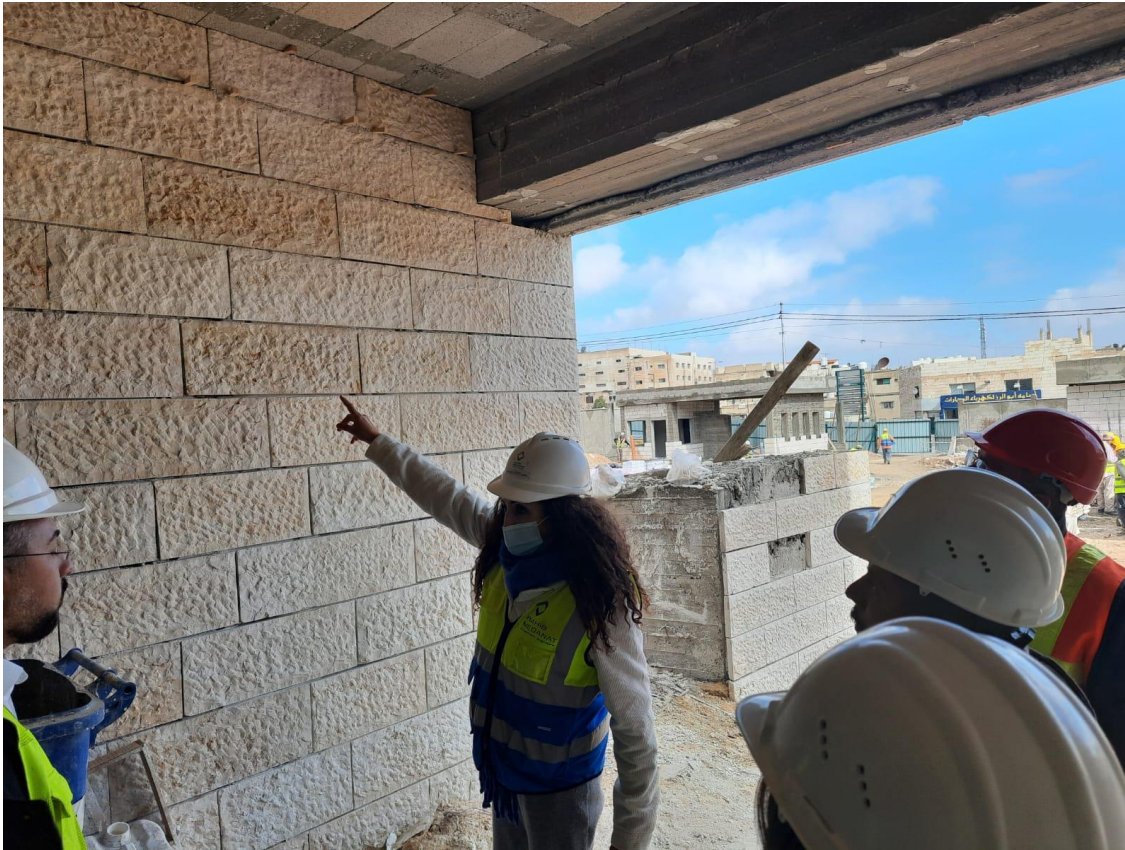
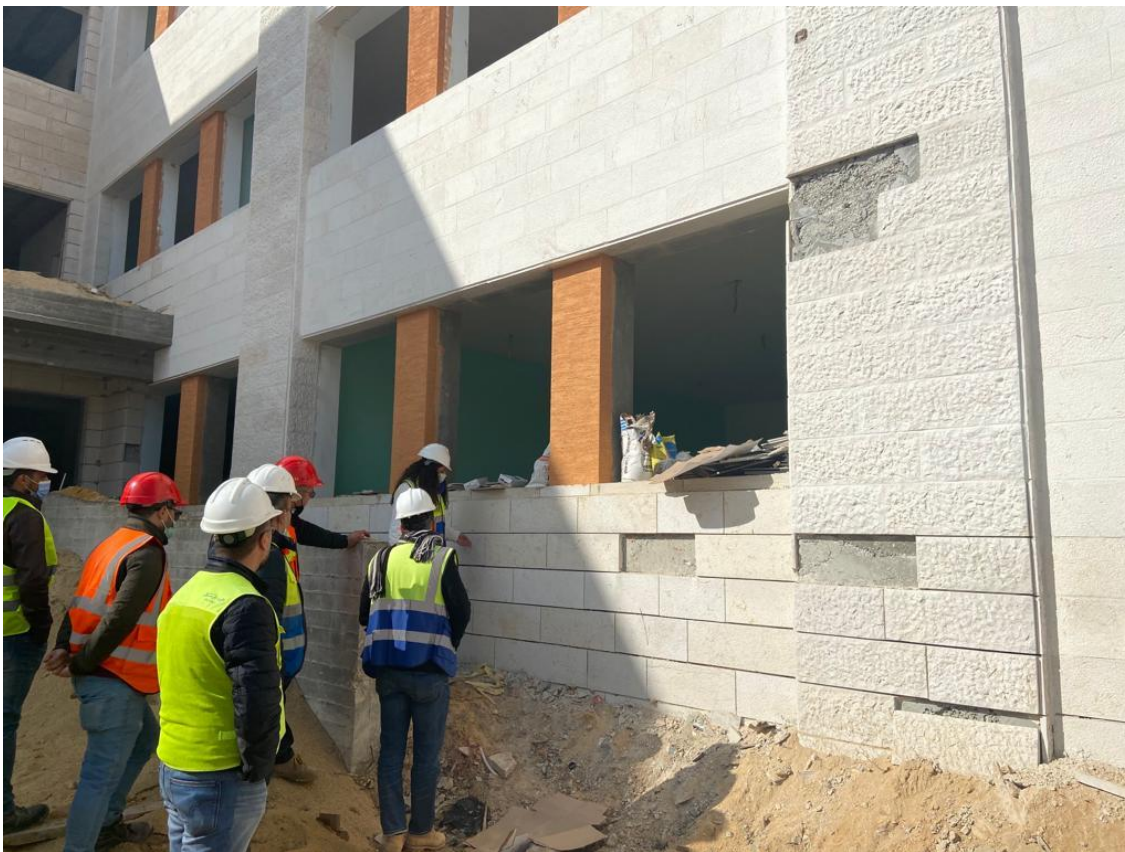
The supervision team inspect the external facades and instructed the Contractor to rectify and replace the defected pieces

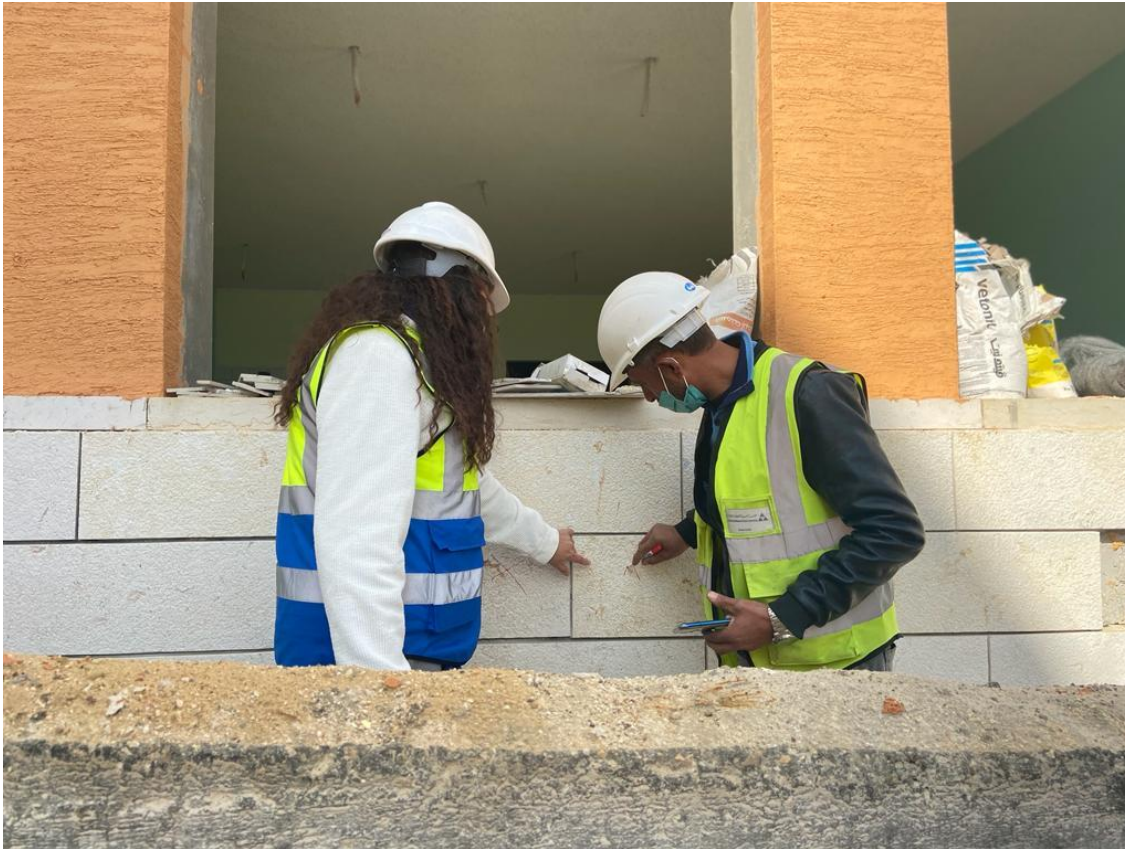
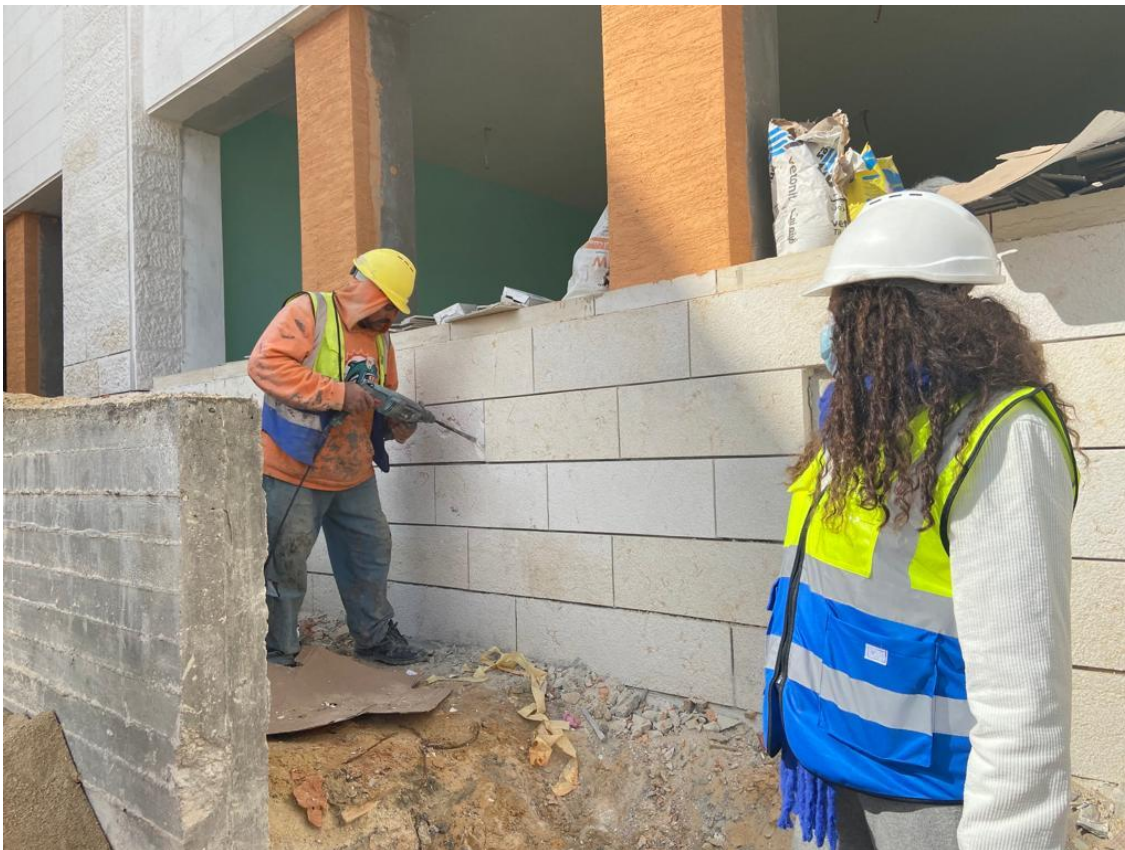
And the Contractor responded positively and took action during the tour in the site

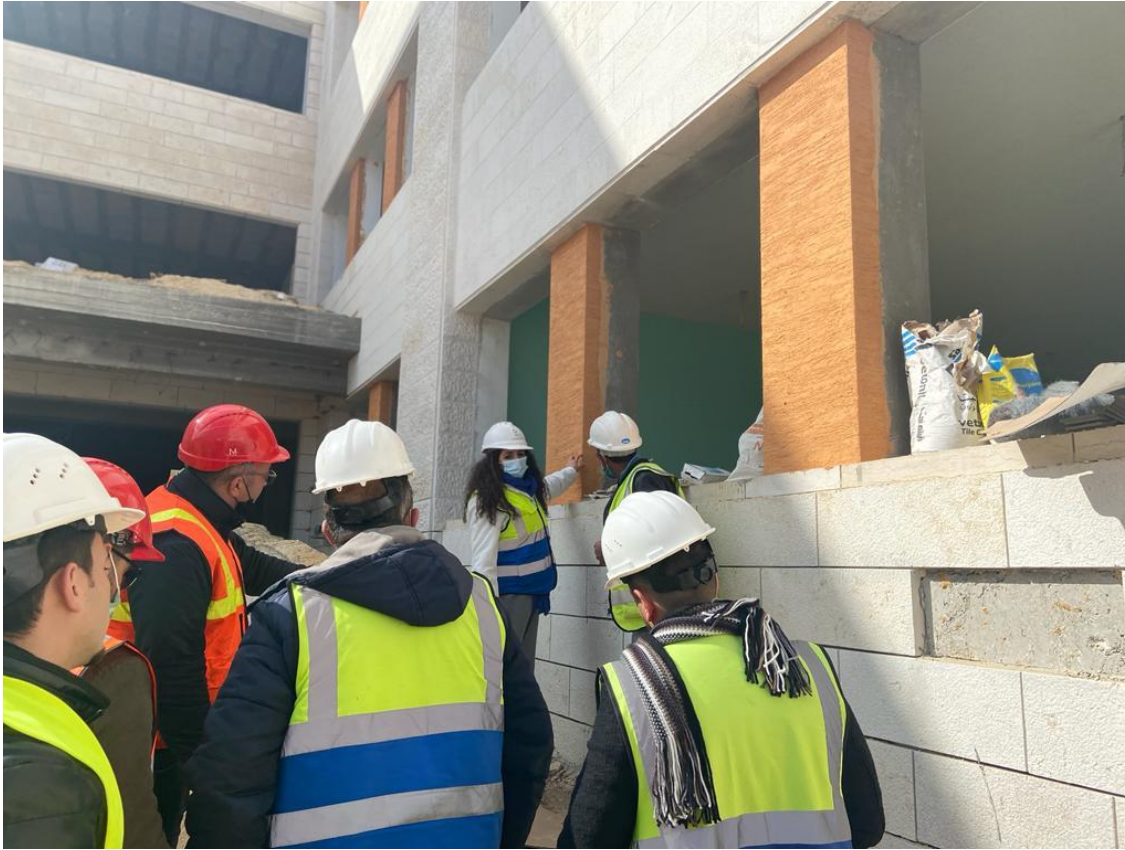
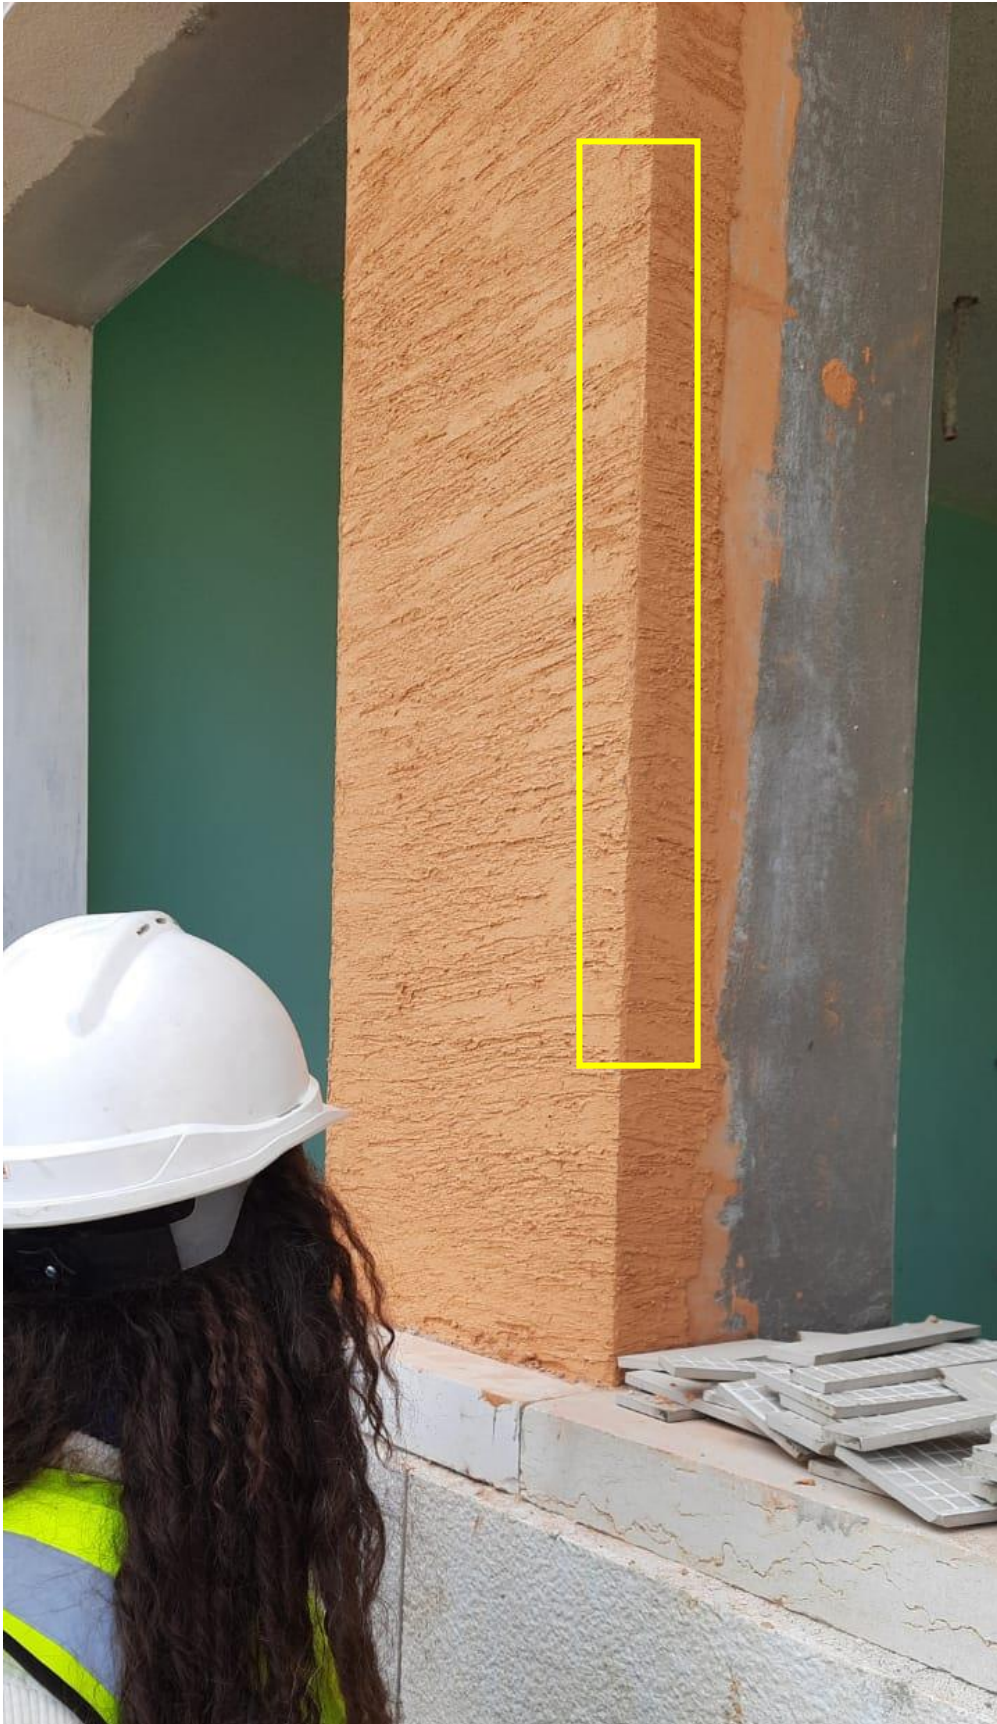
The team inspected the execution of colored plastering and observed that the areas adjacent to the window jambs need to be covered the colored plaster properly

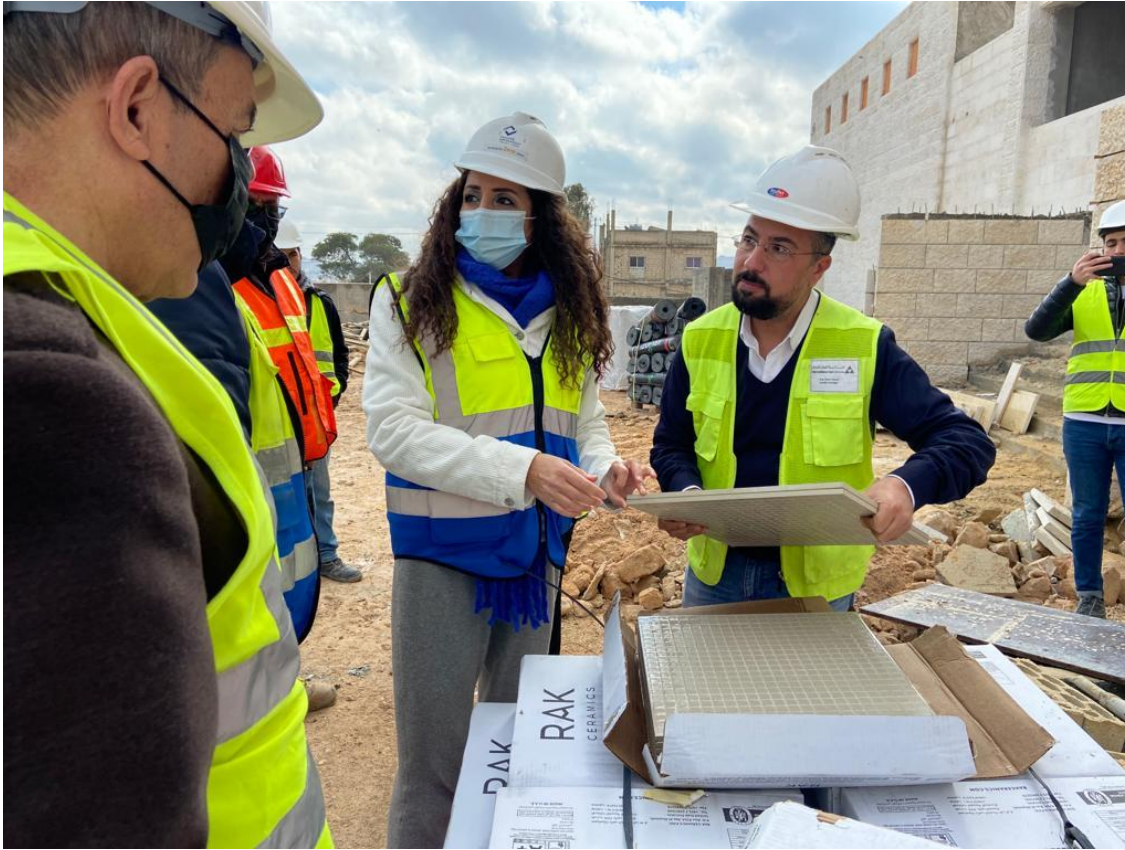
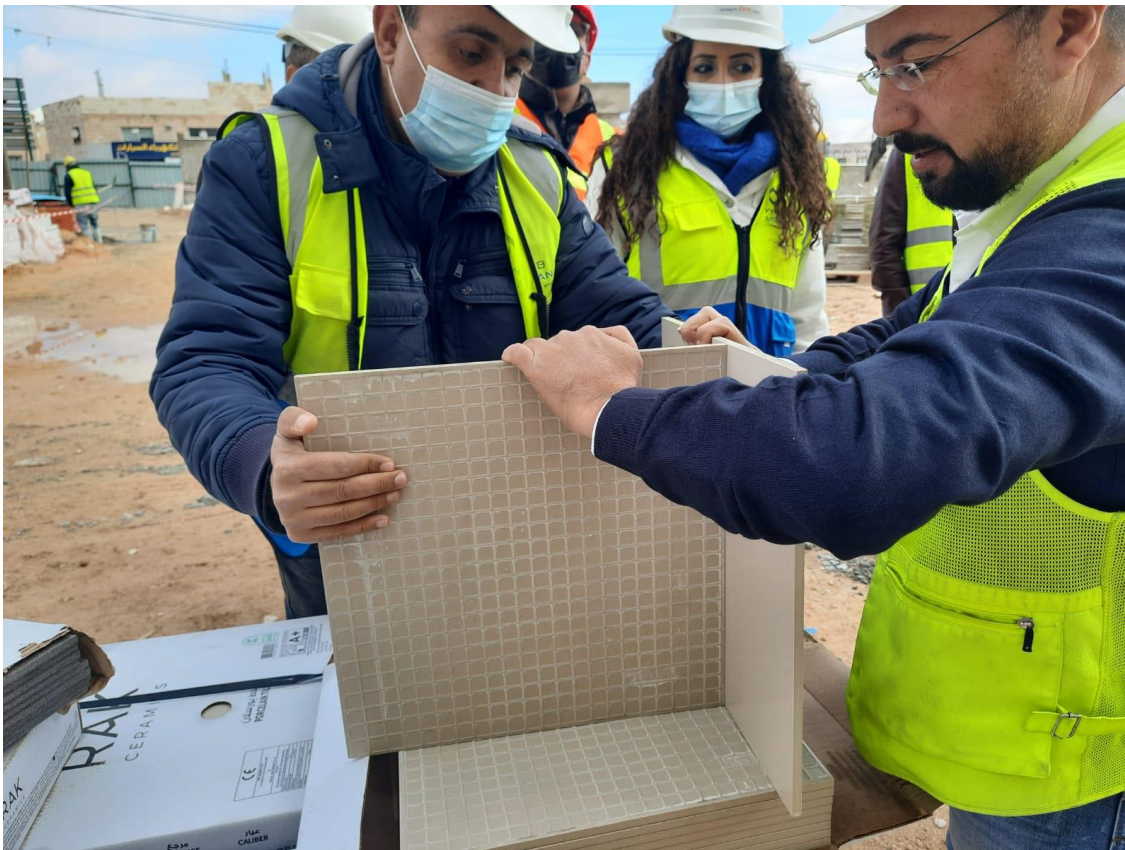
The supervision team inspected the newly delivered porcelain floor tiles and observed that it is manufactured at UAE, (RAK)

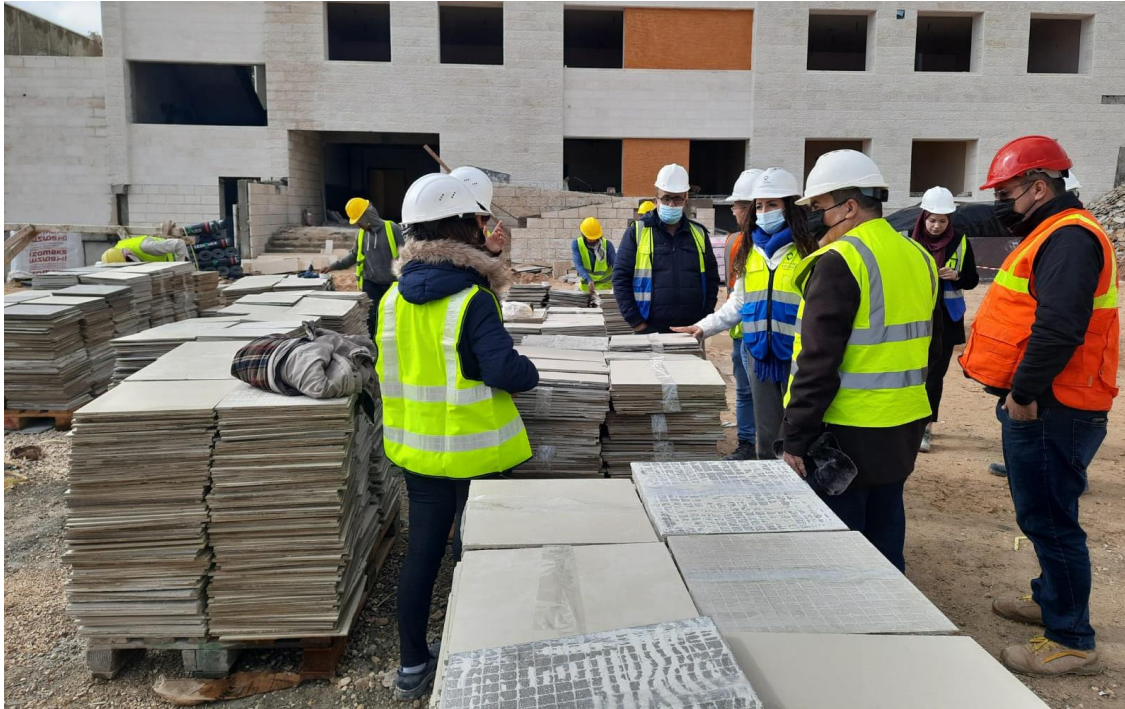
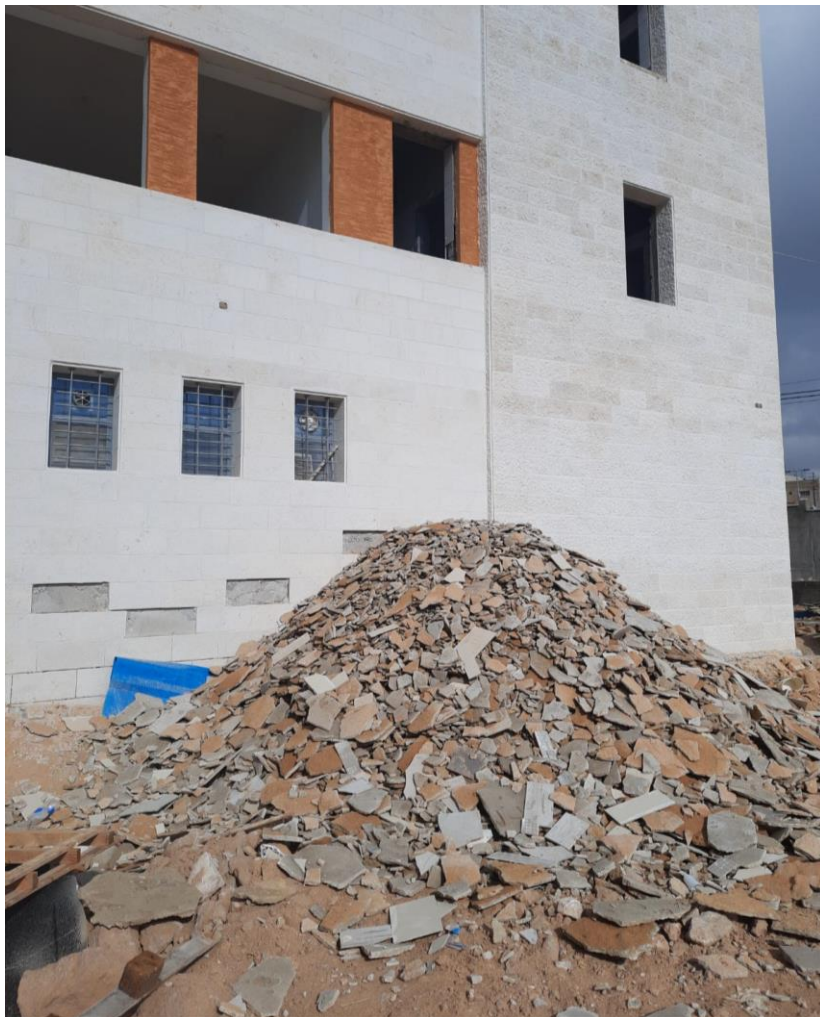
The supervision team observed that the Contractor completed the removal of the tiled defected tiles

and cumulated the debris in contact with the stone walls which might resulted in defects to the built stones in the site to be removed outside the site by the supplier

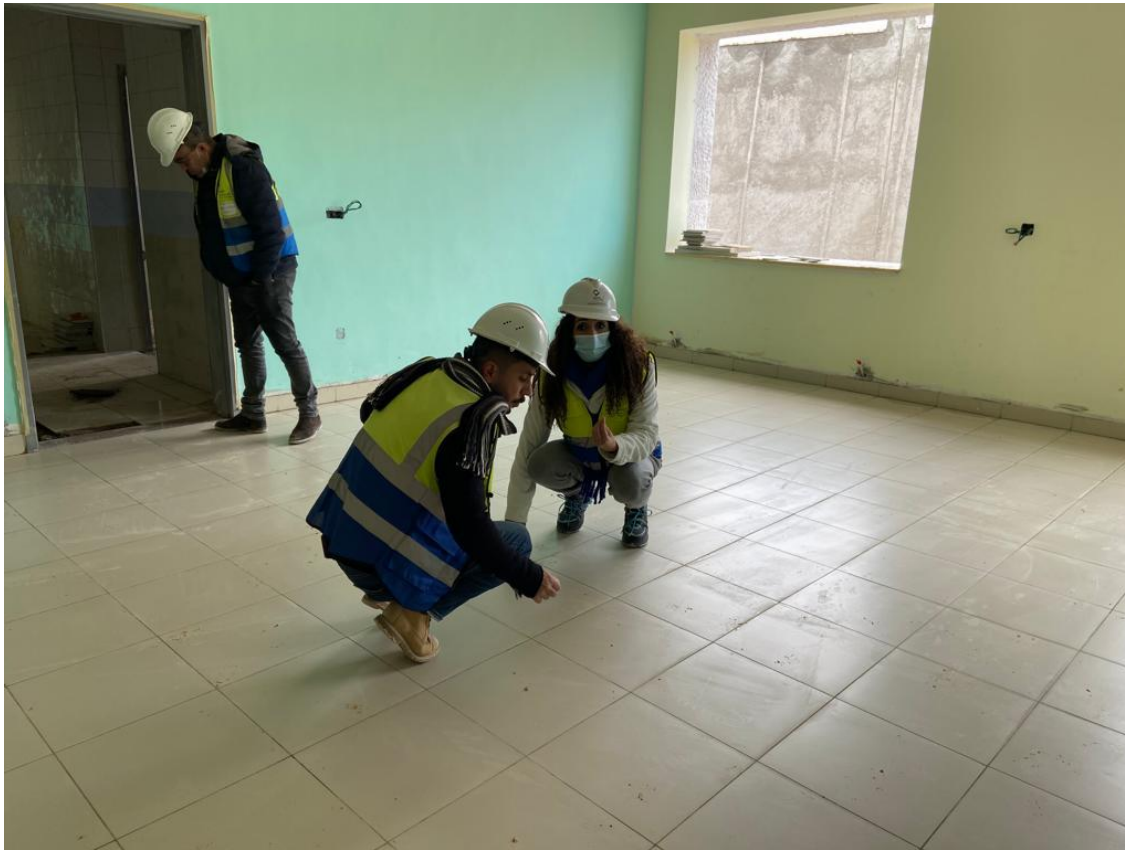
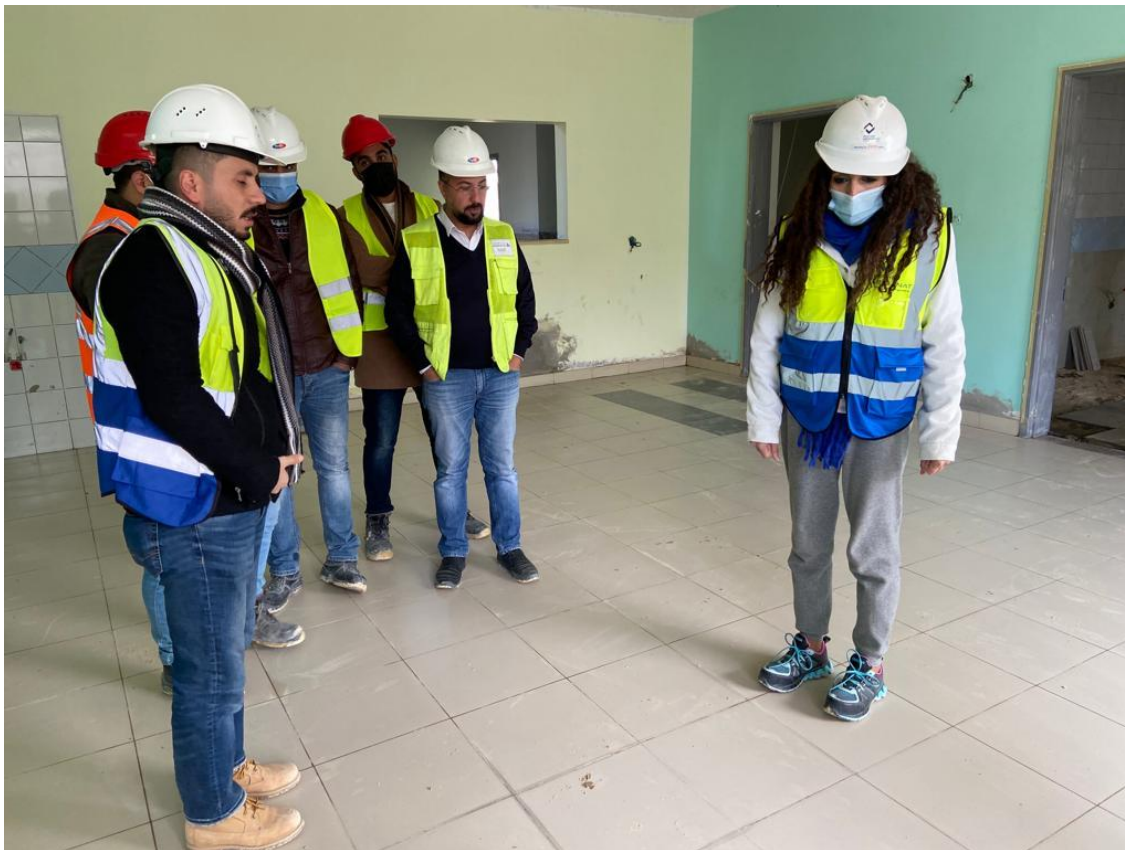
The supervision team inspected the porcelain floor tiling work using the new delivered tiles replacing the removed defected tiles. The team observed that the quality of work is much better than before except some remarks specially in pointing and the Contractor was instructed to rectify

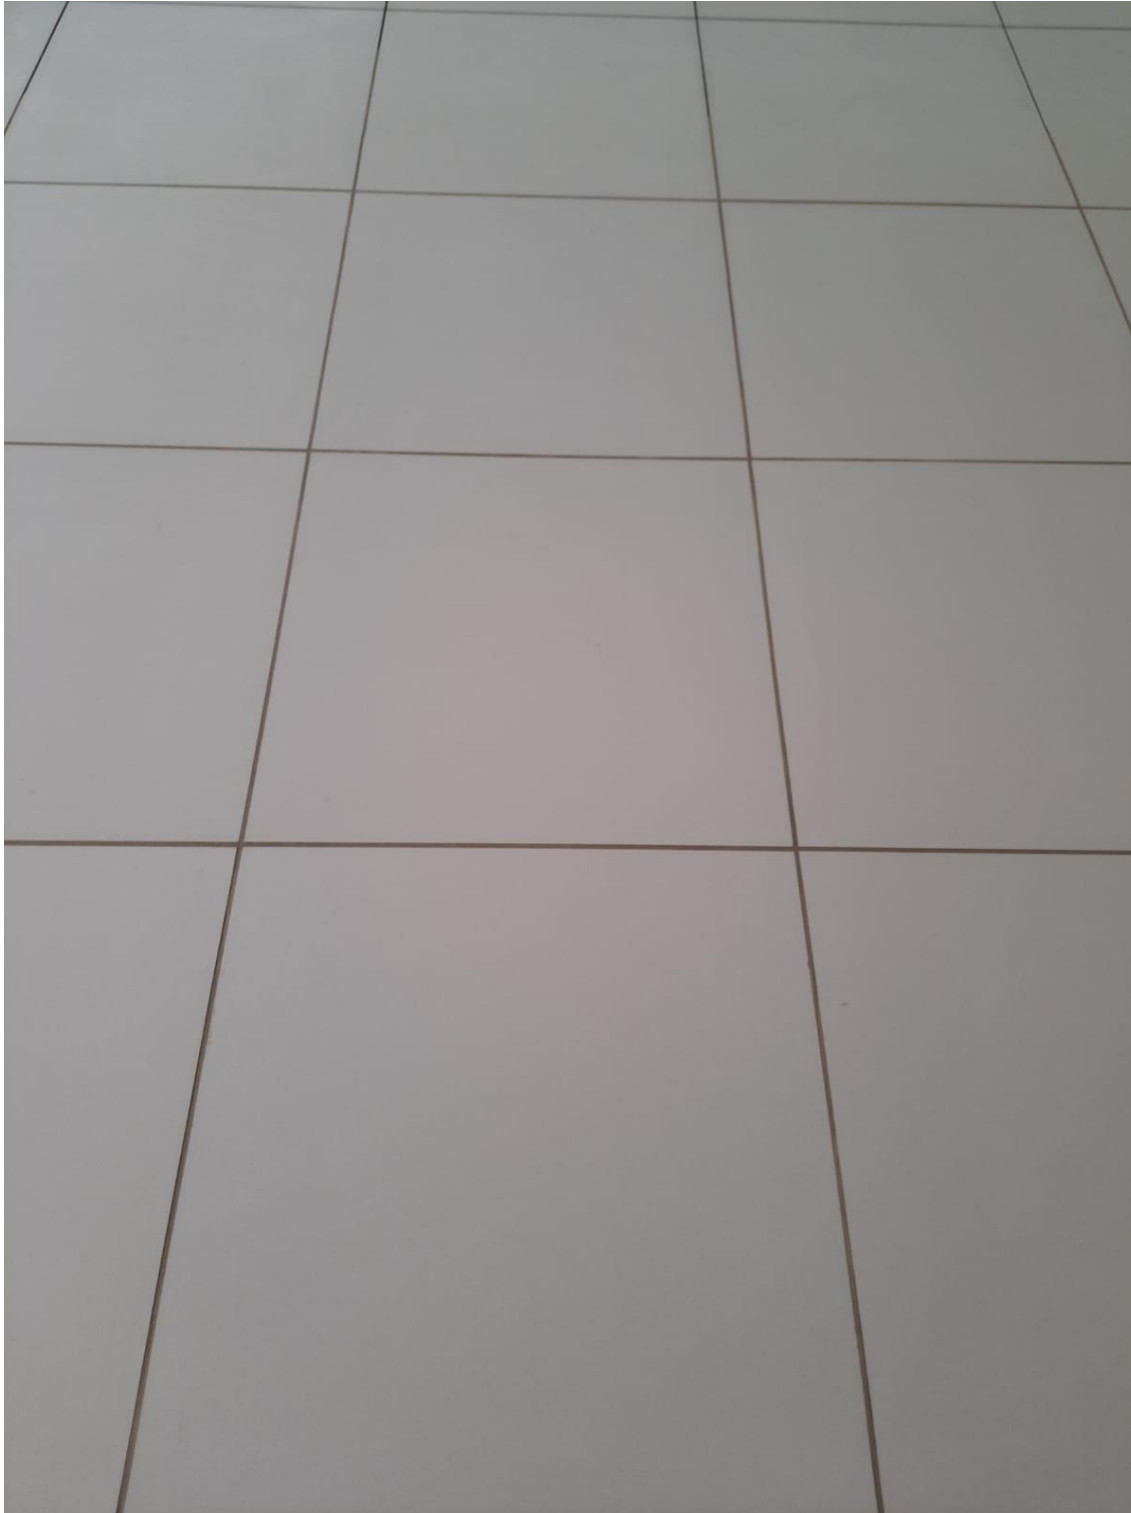
The supervision team agreed with the Contractor on how to do the grout tile perfectly

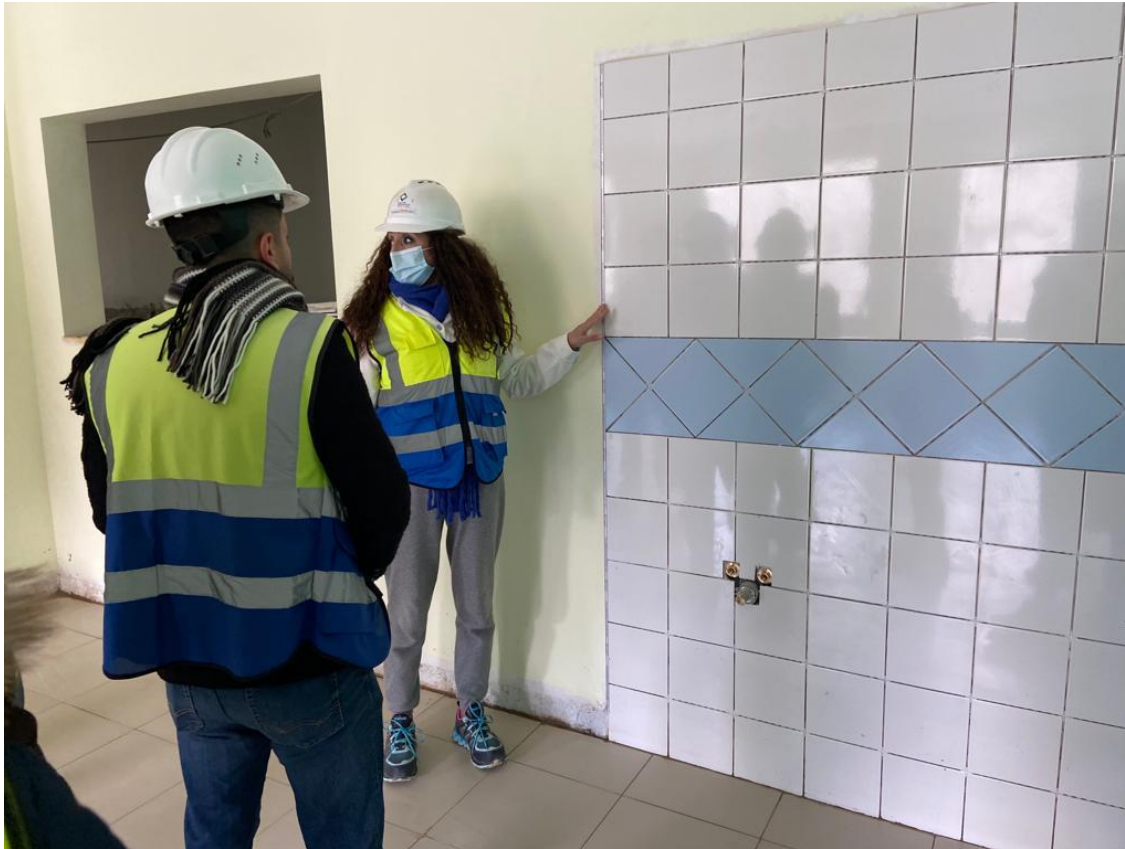
The supervision team observed that the Contractor installed stainless beads to finish wall tile edges

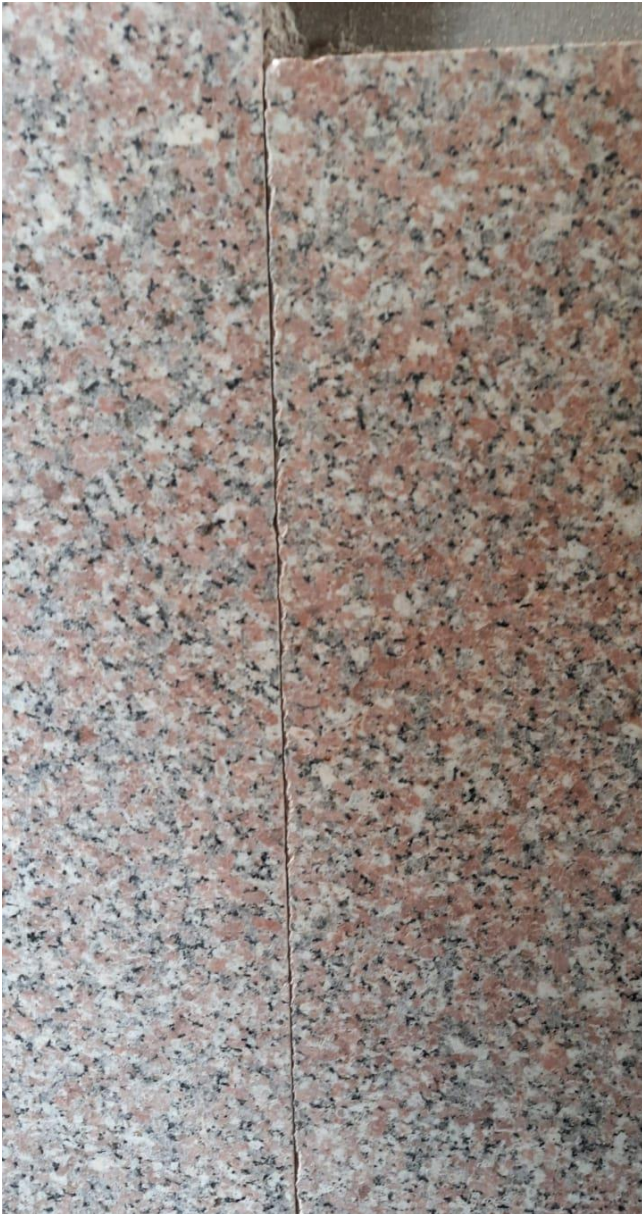
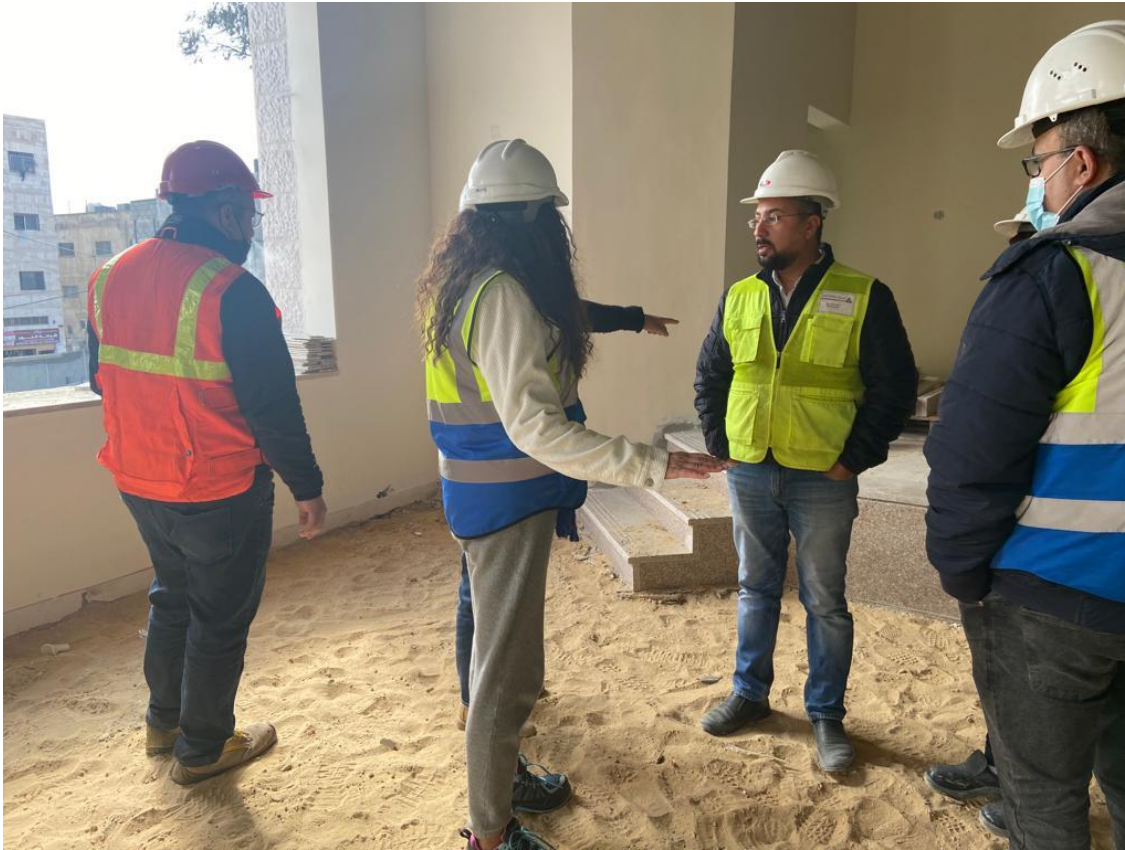
The team observed that the Contractor has not removed the defected granite pieces for the staircases (wall granite and skirting). One of the major defects is that the cutting off is not done properly
