Consultant	Wahib Medanat Consultant Engineer	Rep No.	12-27082022
Contractor	Derar Saraireh & Sons for Engineering & Contracting	Tender No.	(11/2019/USAID/SKEP/3/S) Schools for a Knowledge Economy Project (SKEP) - Phase (3) Package (1, 2)
Site Name	Al Khansa' Basic Mixed School- Al Balqa	Day/ Date	Sat. 27/08/2022
Duration of Project	450 Calendar Days	Total Project Budget	9,789,417.840 JD

Visit Notes

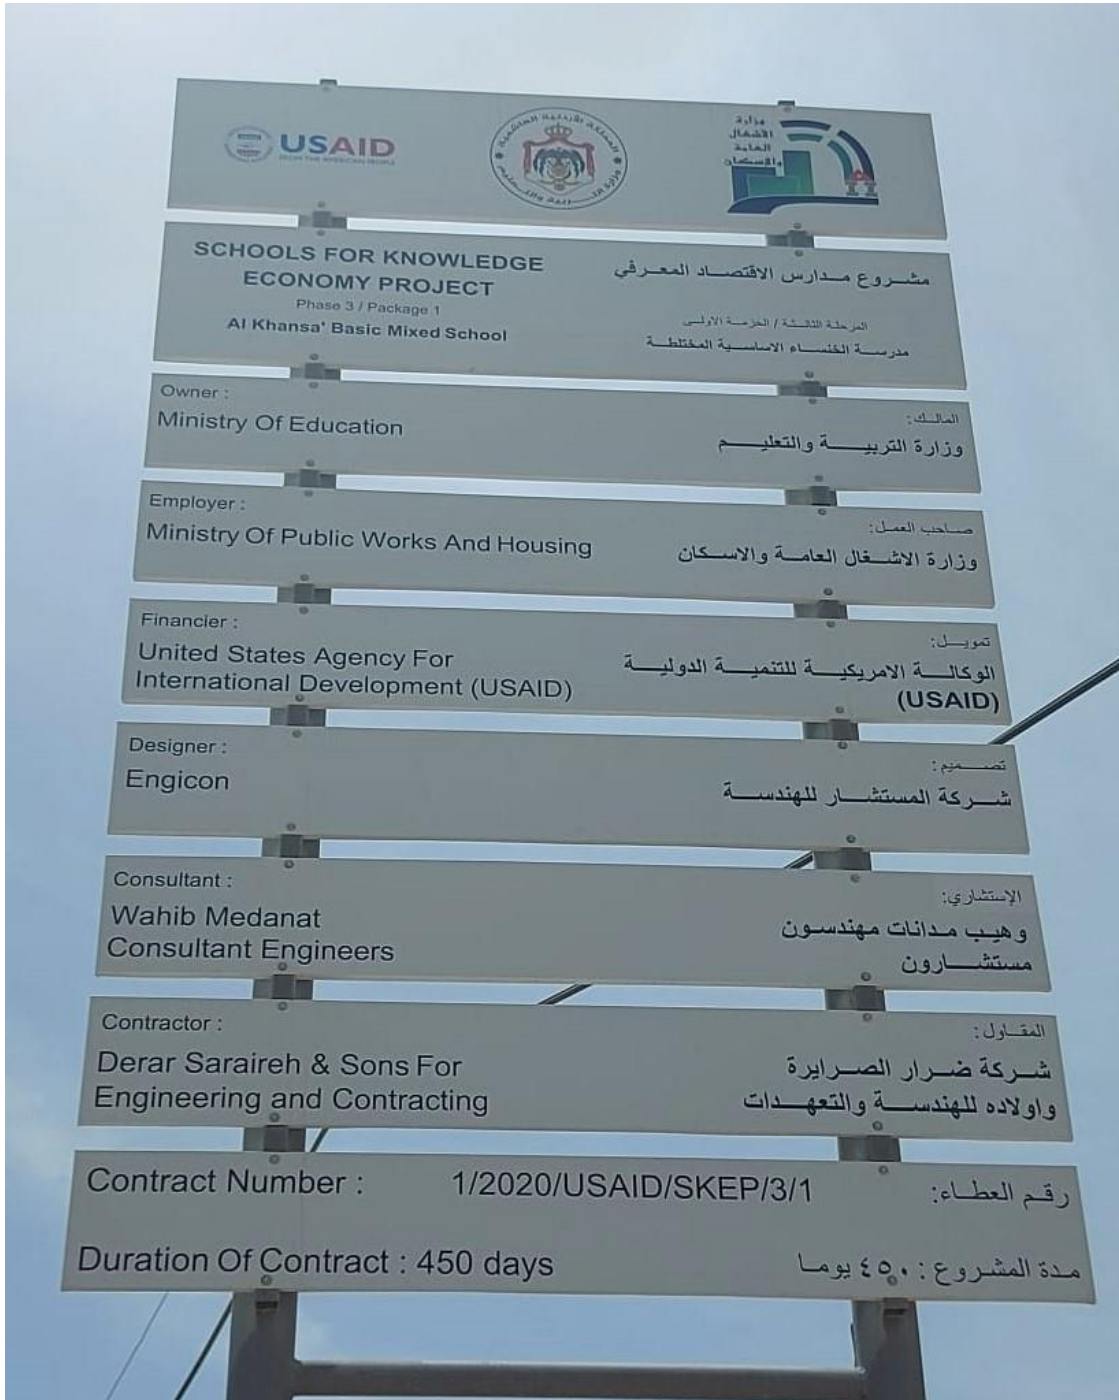
(Figure:01)

Project ID
Sign on Site

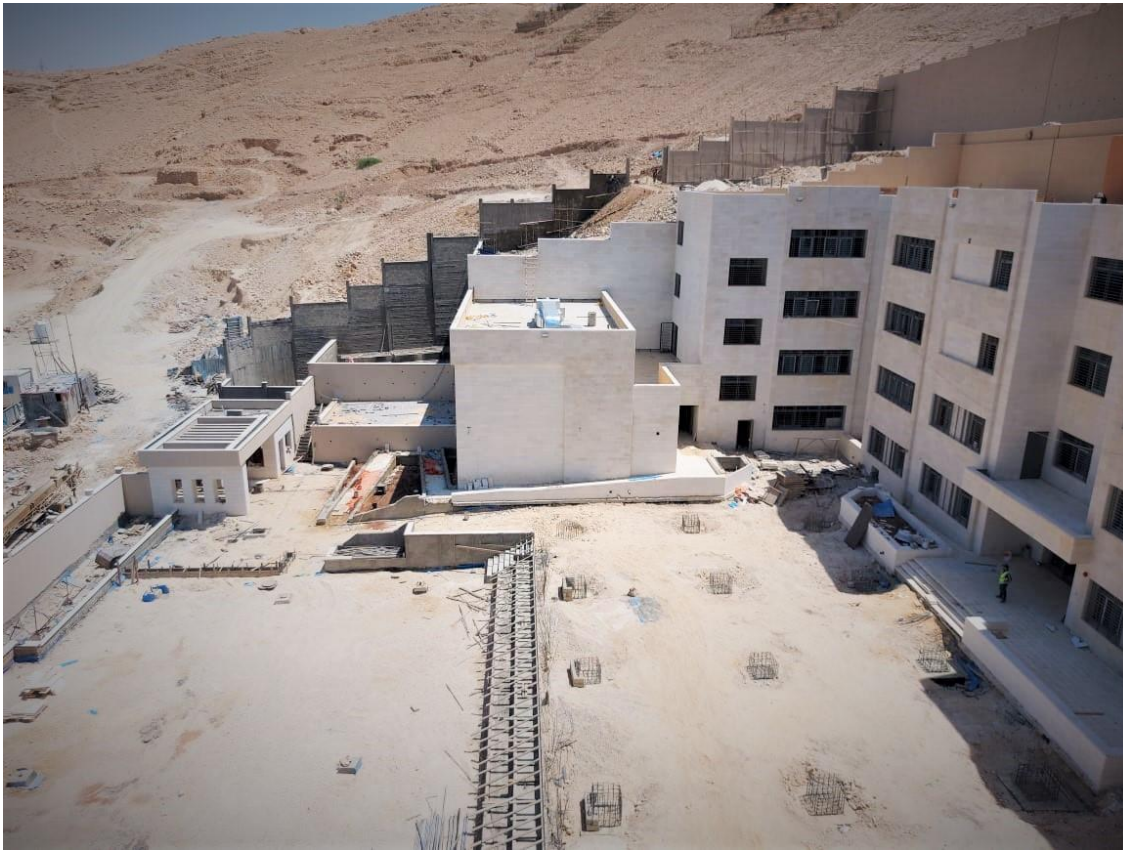
(figure:02)

General view of the project site

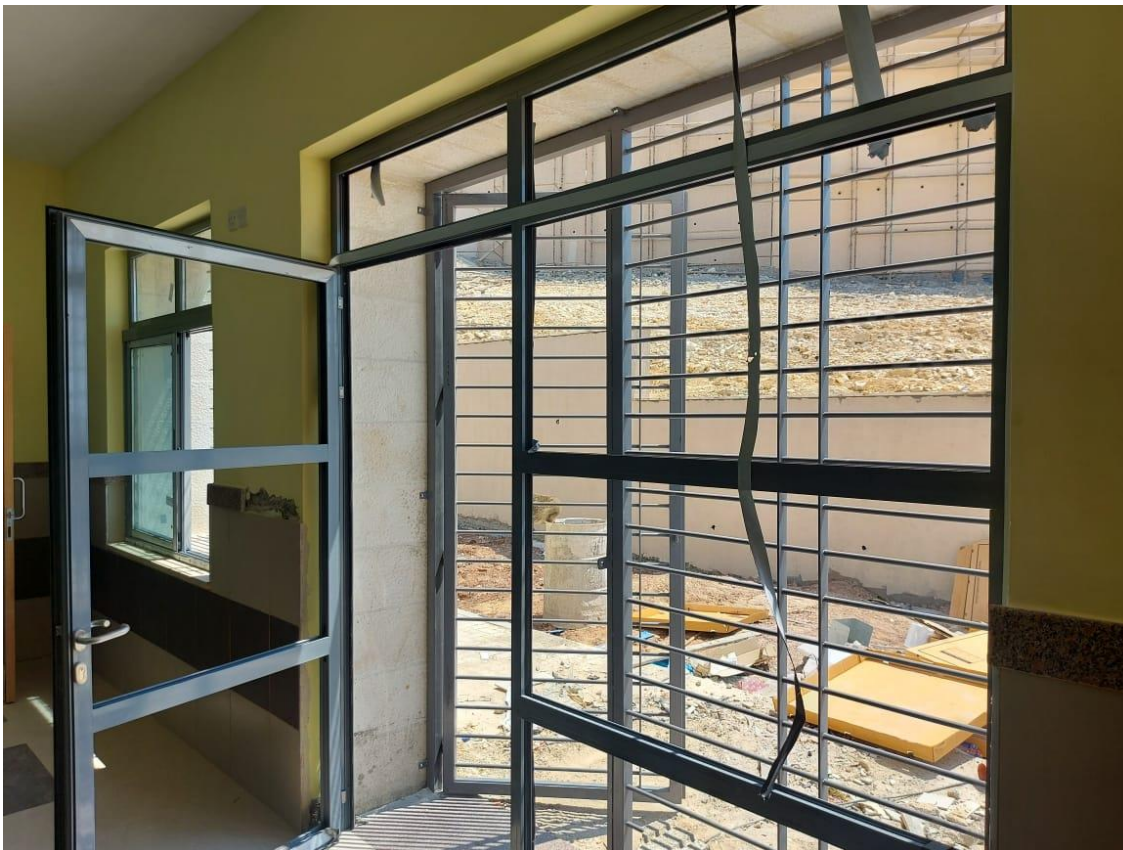
(figure:18)

The team inspected the installation of steel doors and their accessories
(figure:18 & 19)
