Consultant Wahib Medanat Consultant Engineers Rep No. QC-12 14

Site Name Al Khansa'a Basic Mixed - Balqa Date 11 / 04 / 2022

Package Package 1

Tender No. 1/2020/USAID/SKEP/3/1

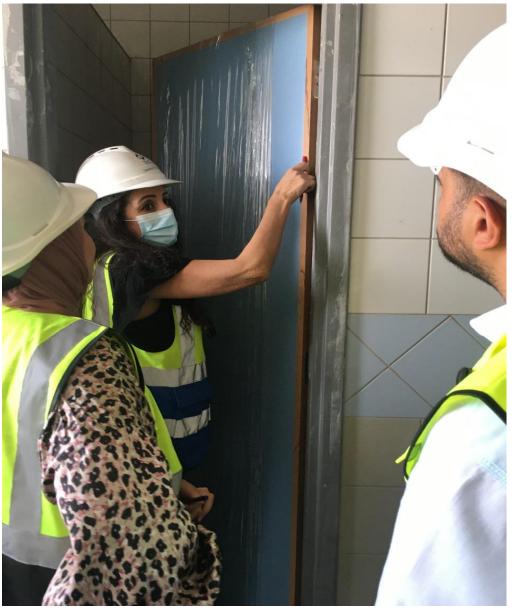
Defects in beech wood frame

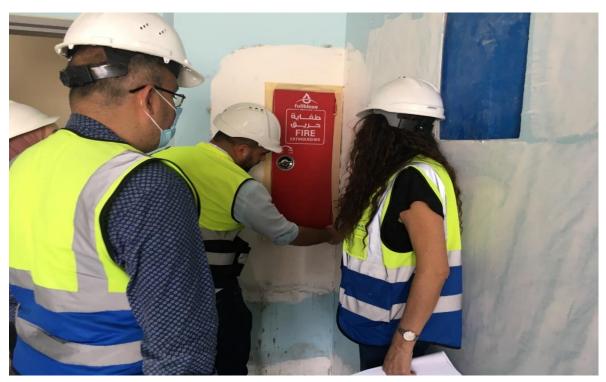
Gap between the cabinets and the wall

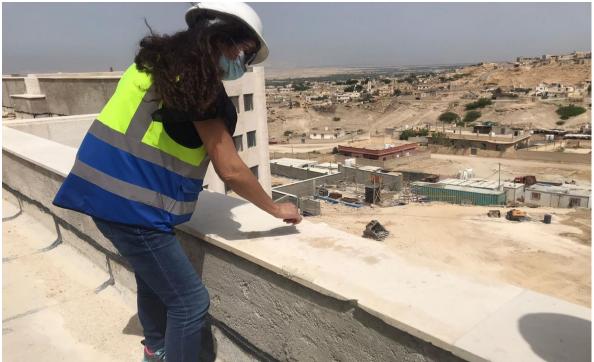
**Broken stone coping**

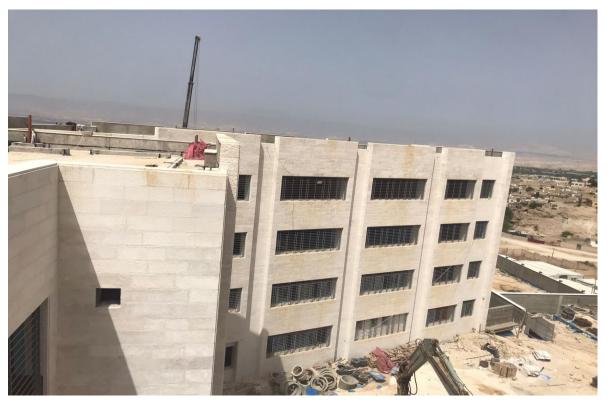
Dirt at the stone facades

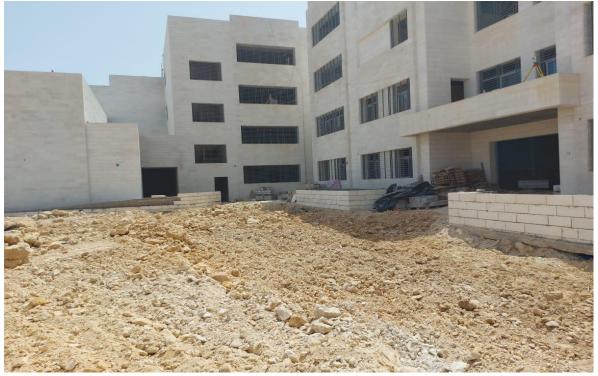
Dirt at the stone facades

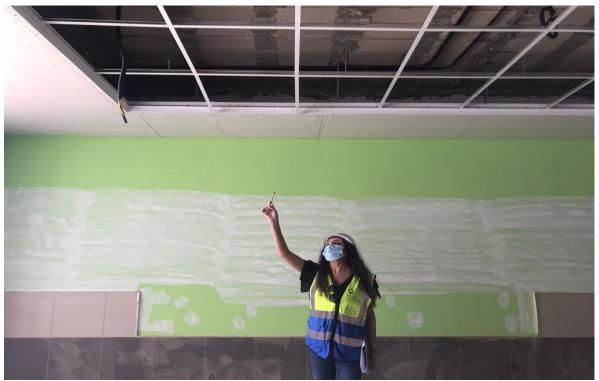
Hangers holding suspended ceiling are not vertical

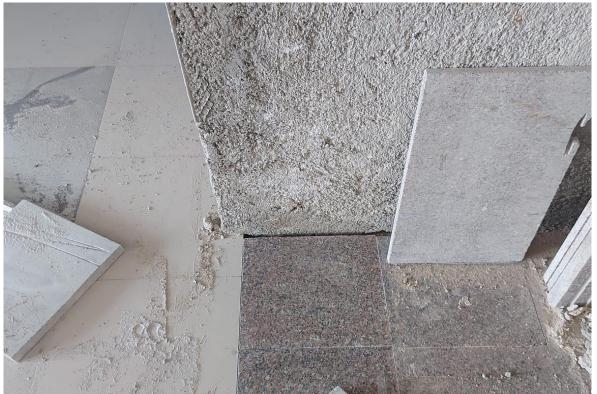
Tiling not complying with workshop drawings
