SKEP III Home Office Support Site Visit Report

Consultant	Wahib Medanat Consultant Engineer	Rep No.	22-23052022
Contractor	Dijlah Establishment Constr. Contracting	Tender No.	(11/2019/USAID/SKEP/3/S) Schools for a Knowledge Economy Project (SKEP) - Phase (3) Package (1, 2)
Site Name	Thahr Al Sarow Basic School for Boys- Jerash	Day/ Date	Mon. 23/05/2022
Duration of Project	450 Calendar Days	Total Project Budget	8,314,983.735 JD

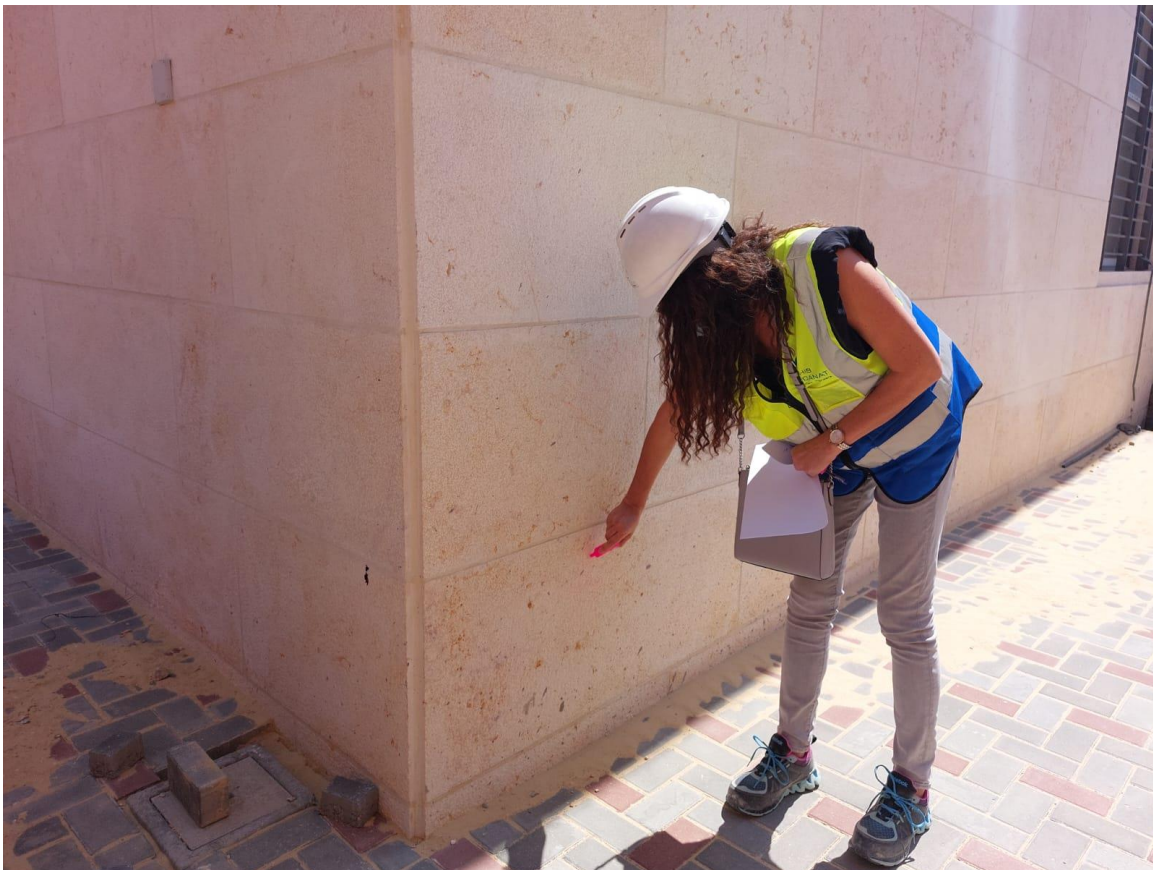
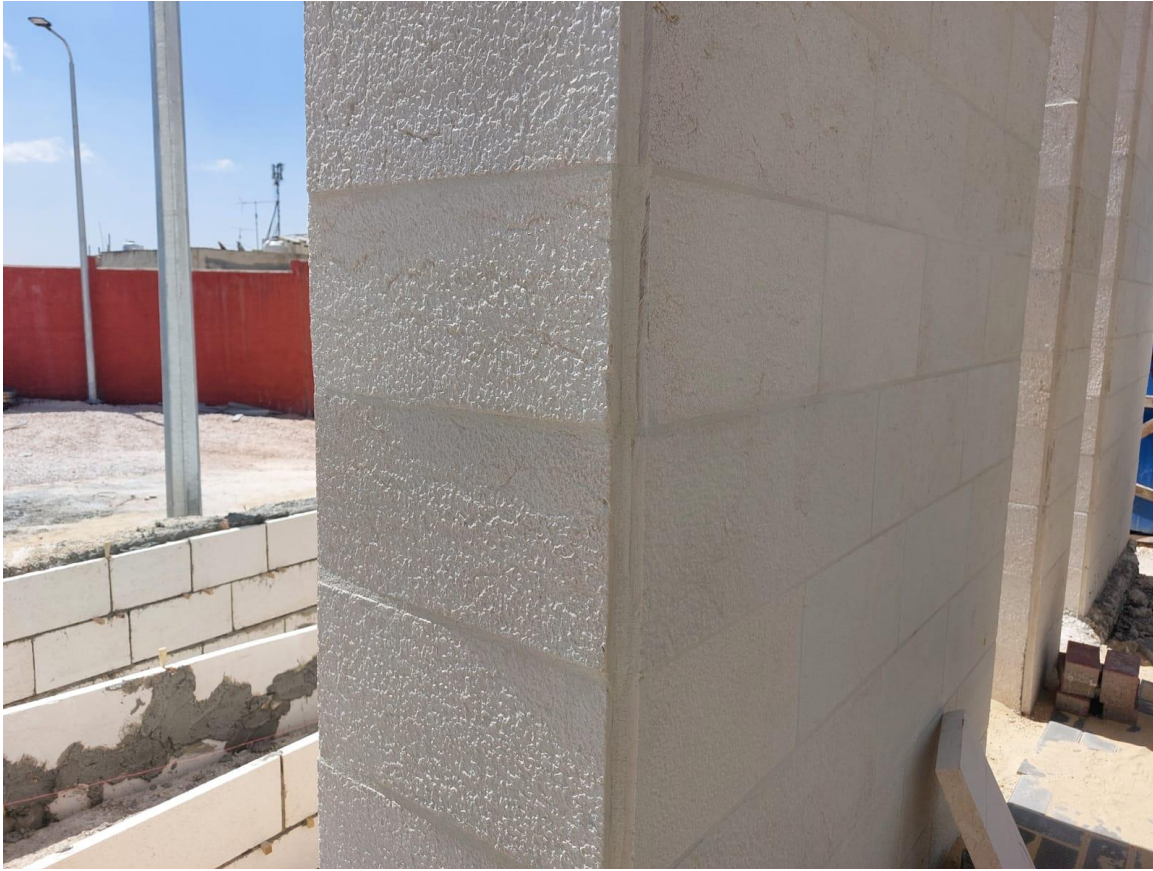
(Figure: 07 & 08)

The supervision team inspected the built stones at façades and the defects previously observed and agreed with the Contractor in the presence of the supplier to replace the stone of the front elevation. And to re-execute according to the method of statement

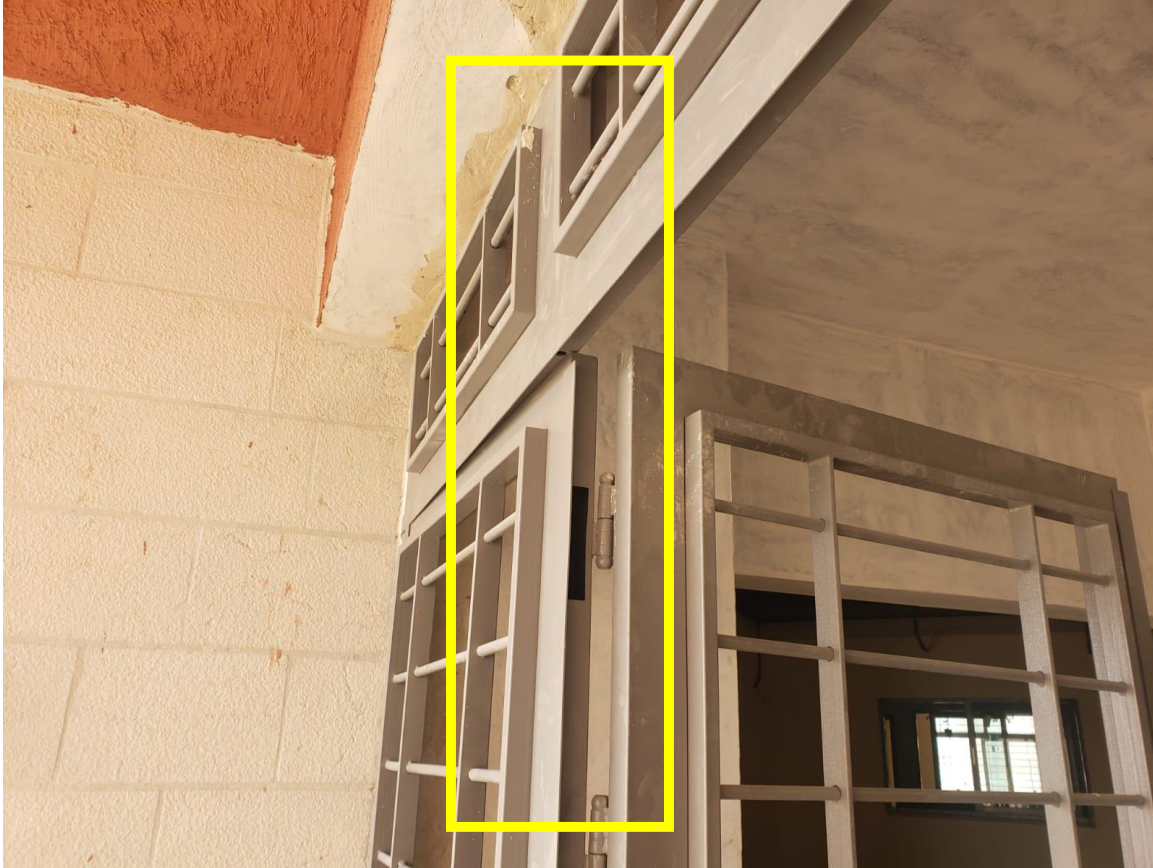
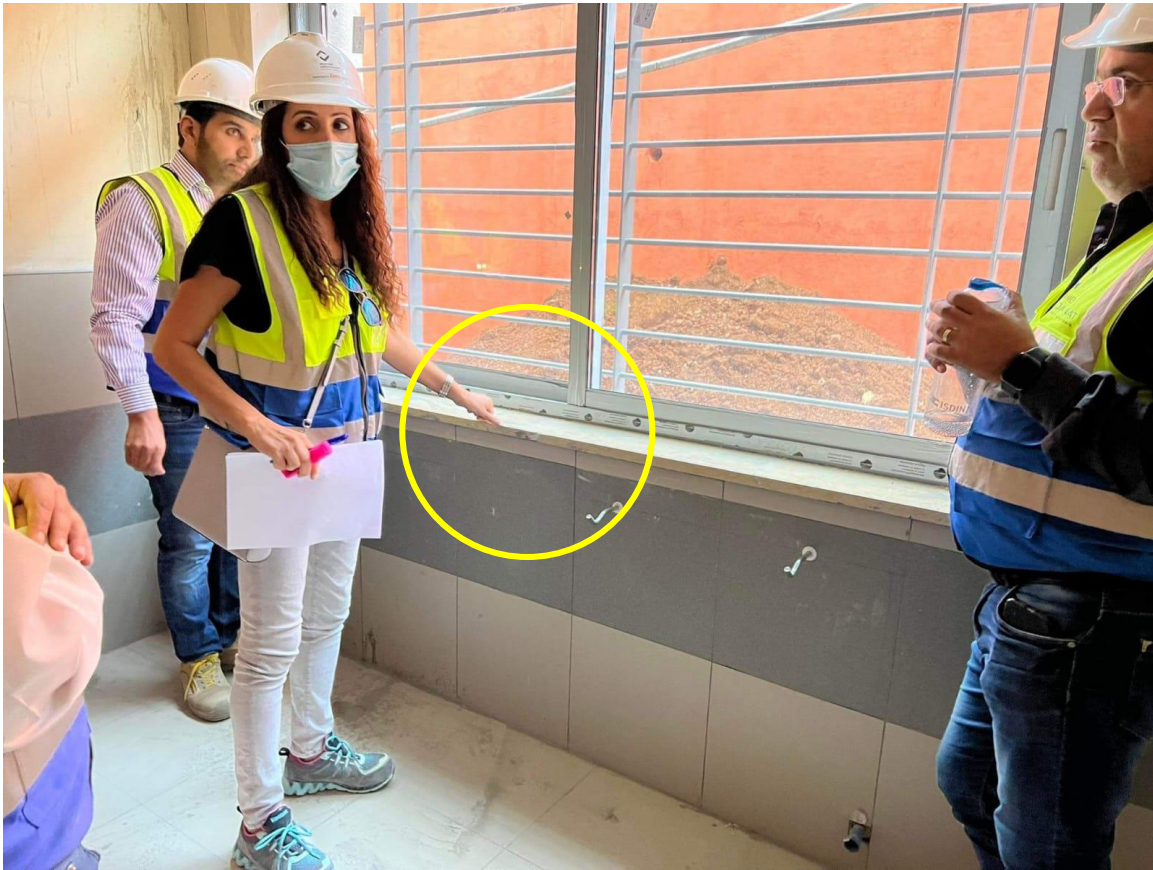
(Figure: 12 & 13)

The team inspected the installed main steel doors at the entrances of the building and observed deviation from the workshop drawings and architectural details. Difficulties in using the external door handle were observed due to wrong dimensions of steel sections

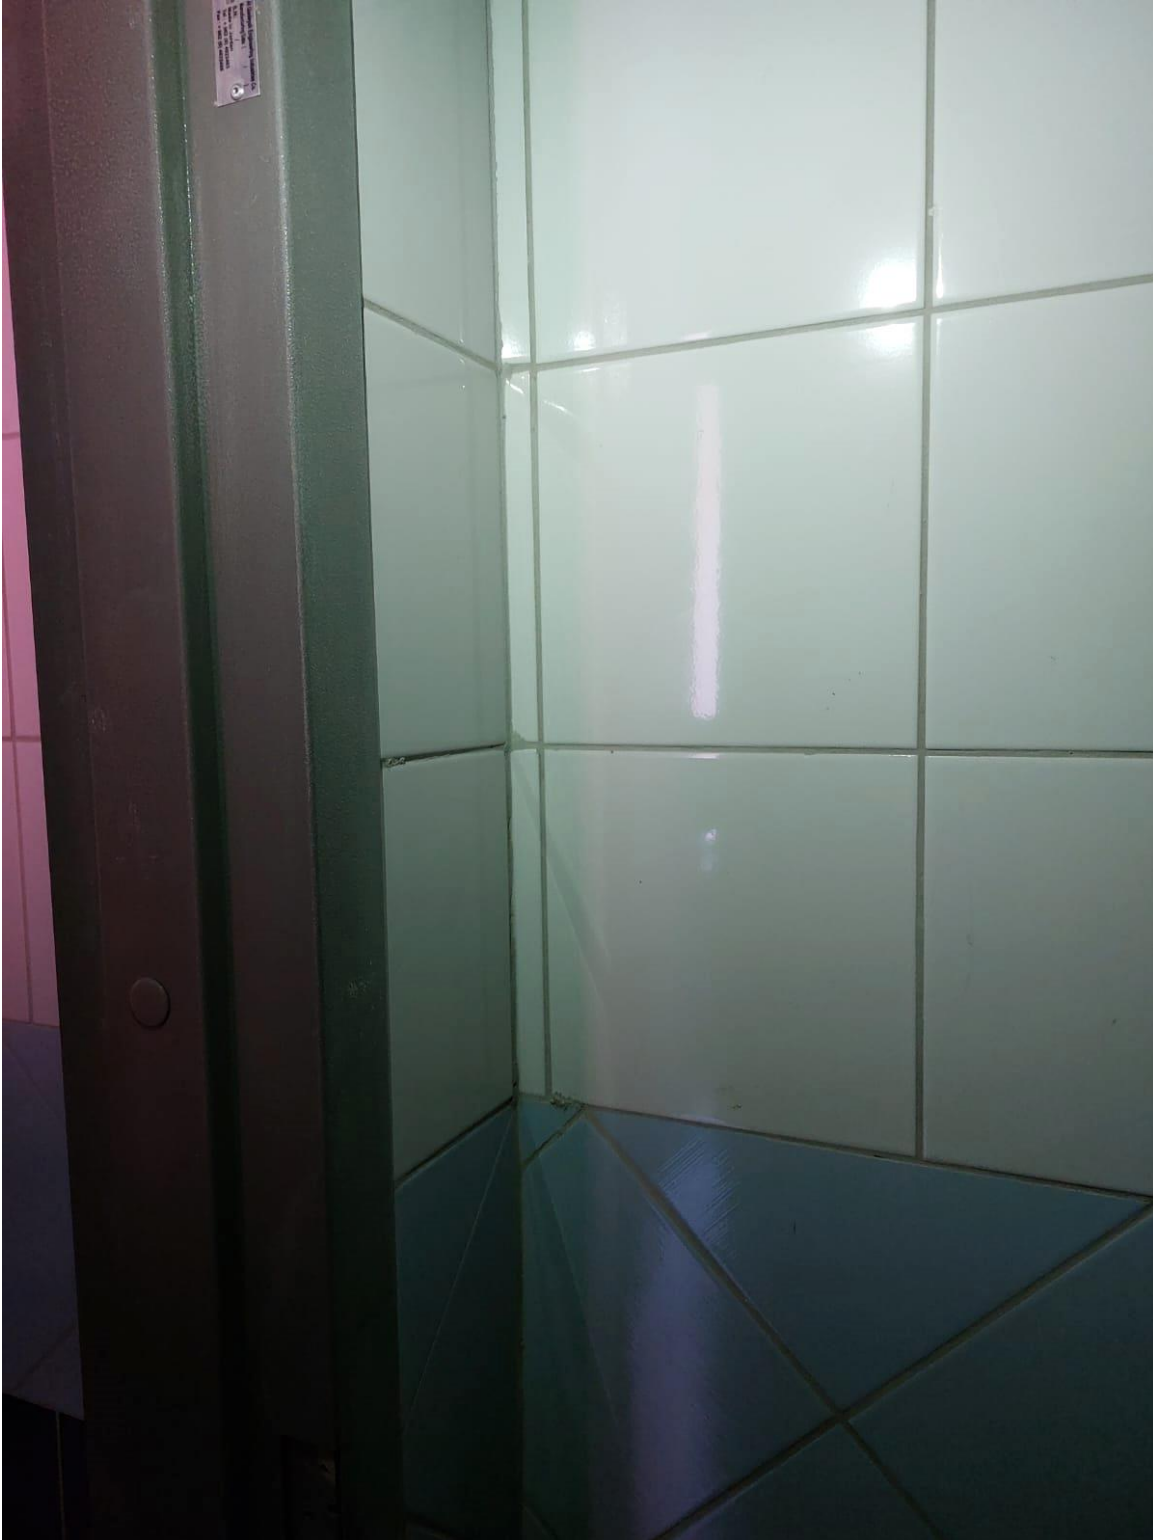
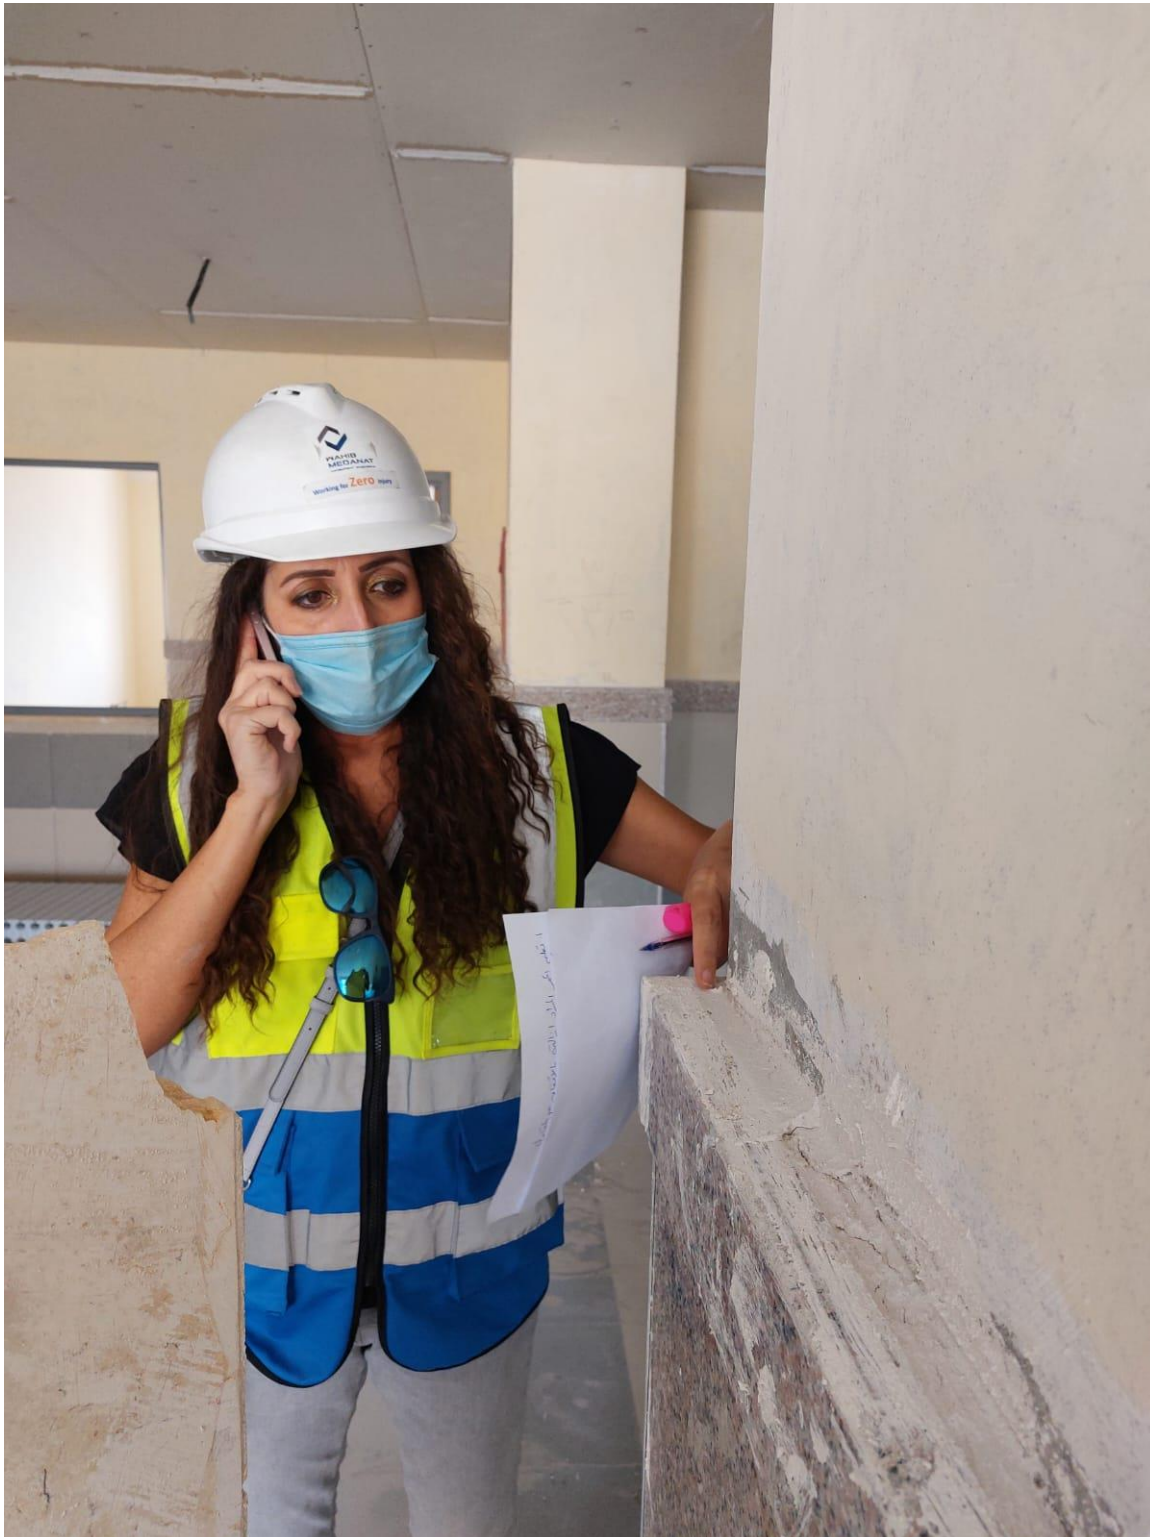
(Figure: 15 & 16)

The team observed that the wall tiling in some areas has been executed not in compliance with the workshop drawings. That led to cut-off pieces around 2.5 cm which is considered not acceptable
