Consultant	Wahib Medanat Consultant Engineer	Rep No.	13-11042022
Contractor	Derar Saraireh & Sons for Engineering & Contracting	Tender No.	(11/2019/USAID/SKEP/3/S) Schools for a Knowledge Economy Project (SKEP) - Phase (3) Package (1, 2)
Site Name	Khadija Bint Khwailed Basic Mixed School- Shouna Janoubia	Day/ Date	Mon. 11/04/2022
Duration of Project	450 Calendar Days	Total Project Budget	9,789,417.840 JD

### Visit Notes

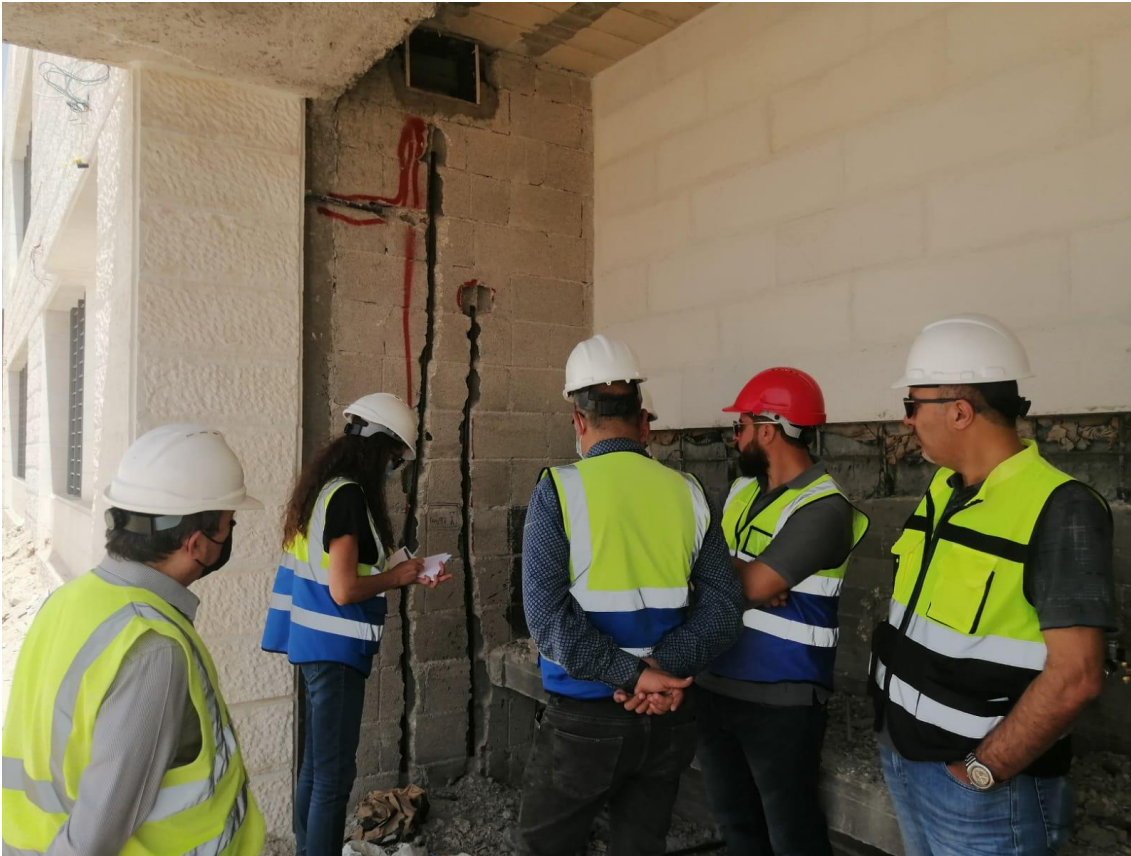
(Figure: 07)

The team discussed with the Contractor the distribution of stones and ceramic tiles at the drinking fountain, and instructed him to install the tiles up to a certain height and then complete with stone to ensure good fixing of the stone

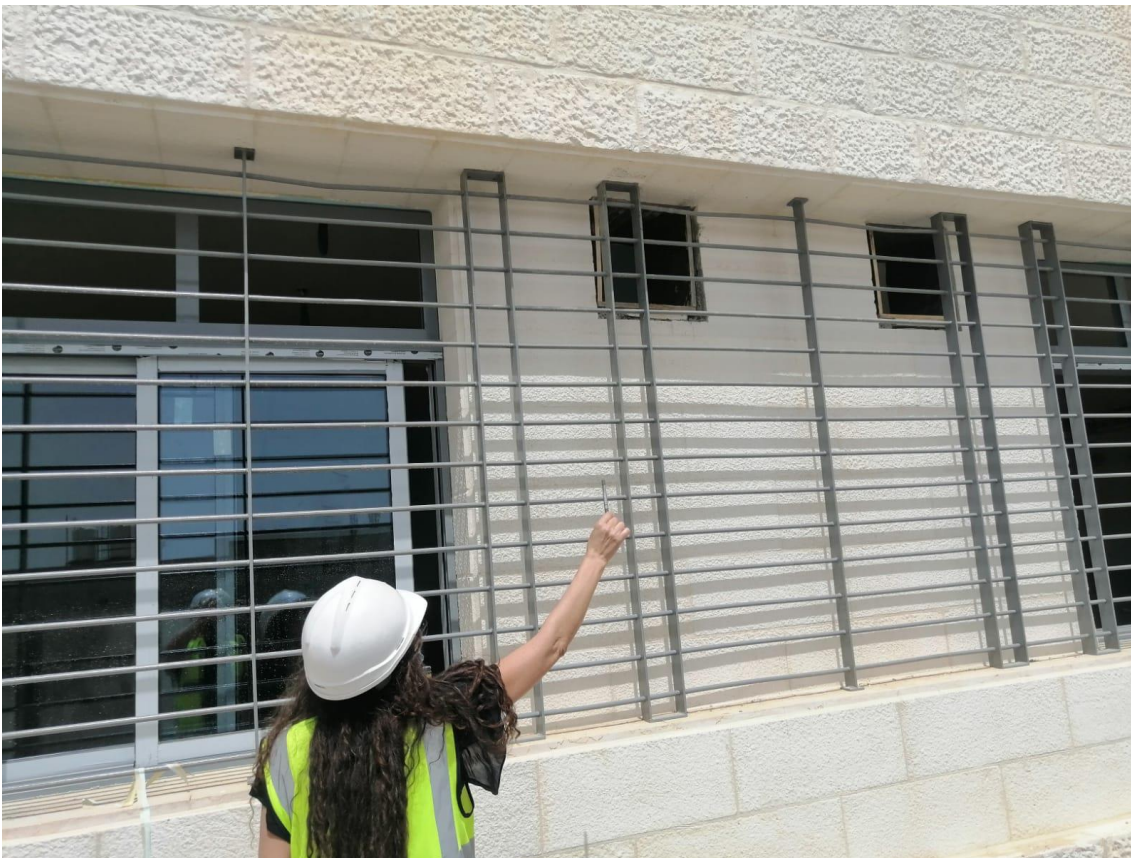
(Figure: 08)

The team observed that the Contractor has not repaired the defected steel protection screens as requested by the team at the latest visit

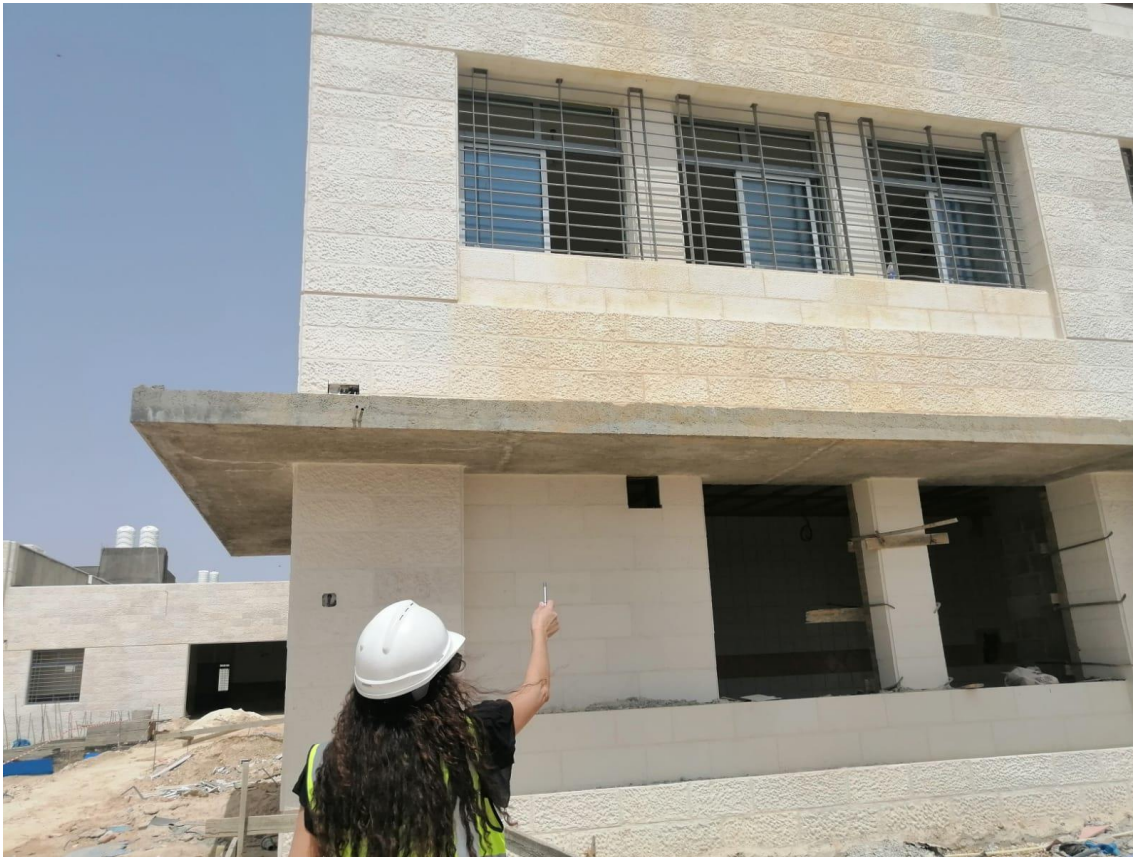
(Figure: 09)

Stones at the facades are cover with dirt and need cleaning

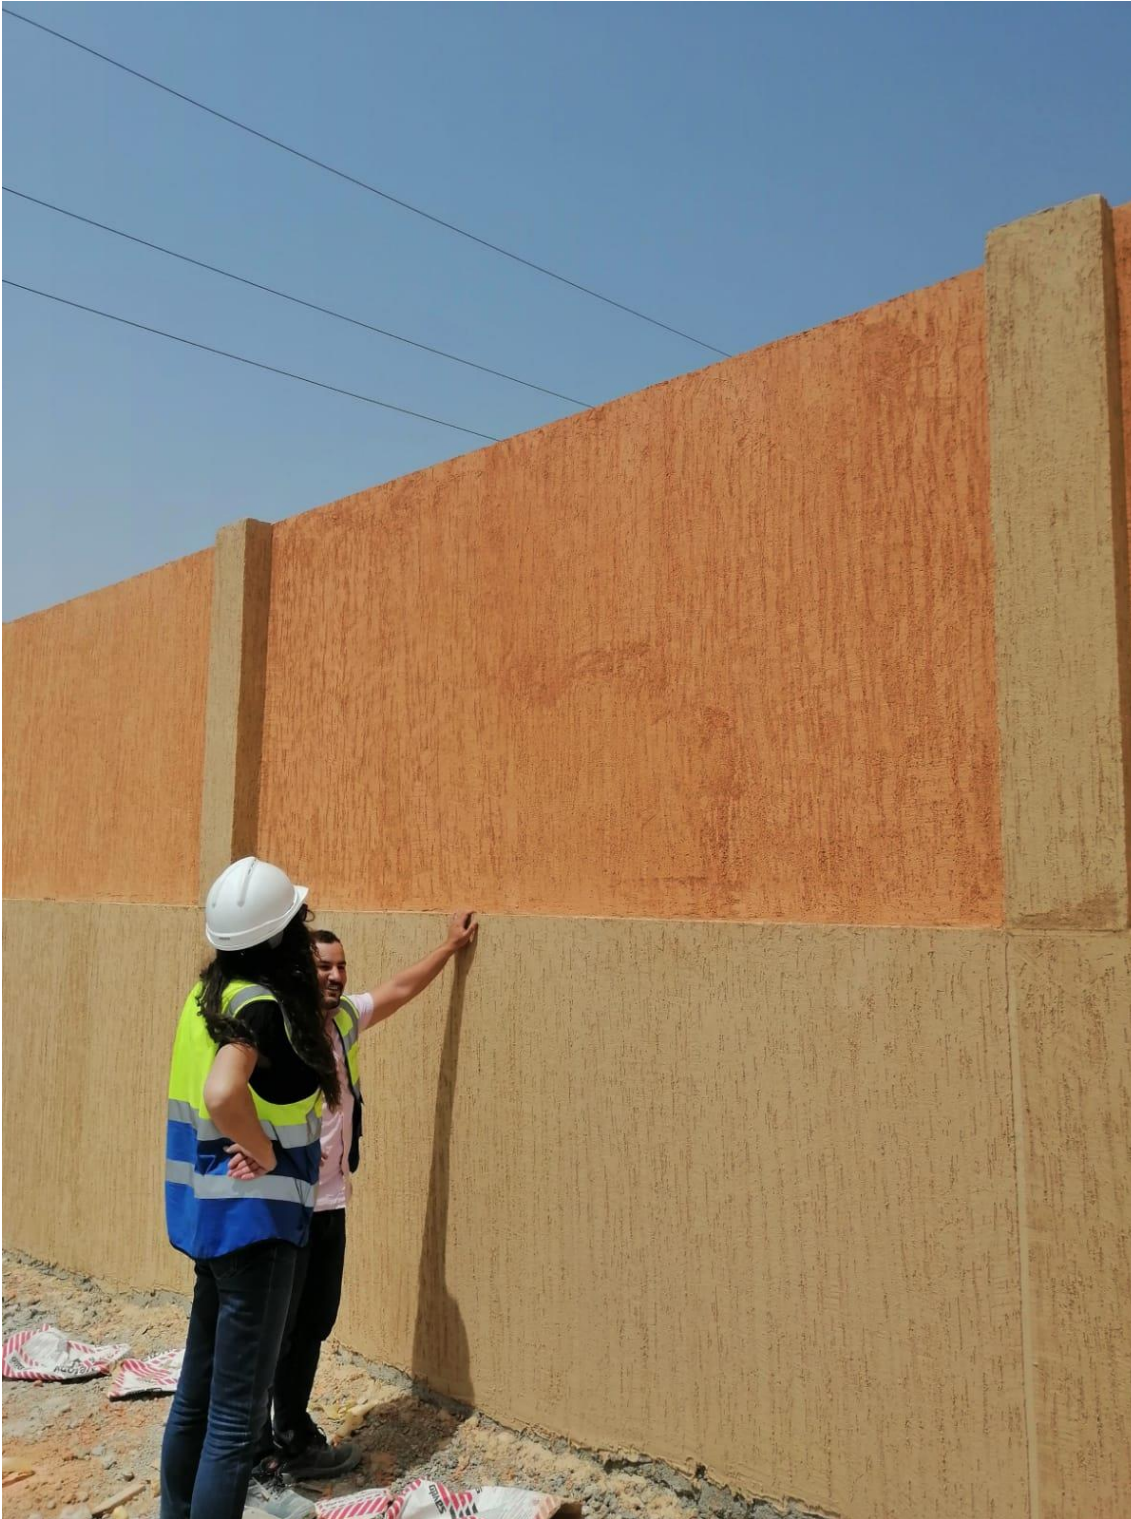
(Figure: 11)

The supervision team inspected the colored plastering for the external walls and the team did not approve the groove between patterns suggested by the Contractor

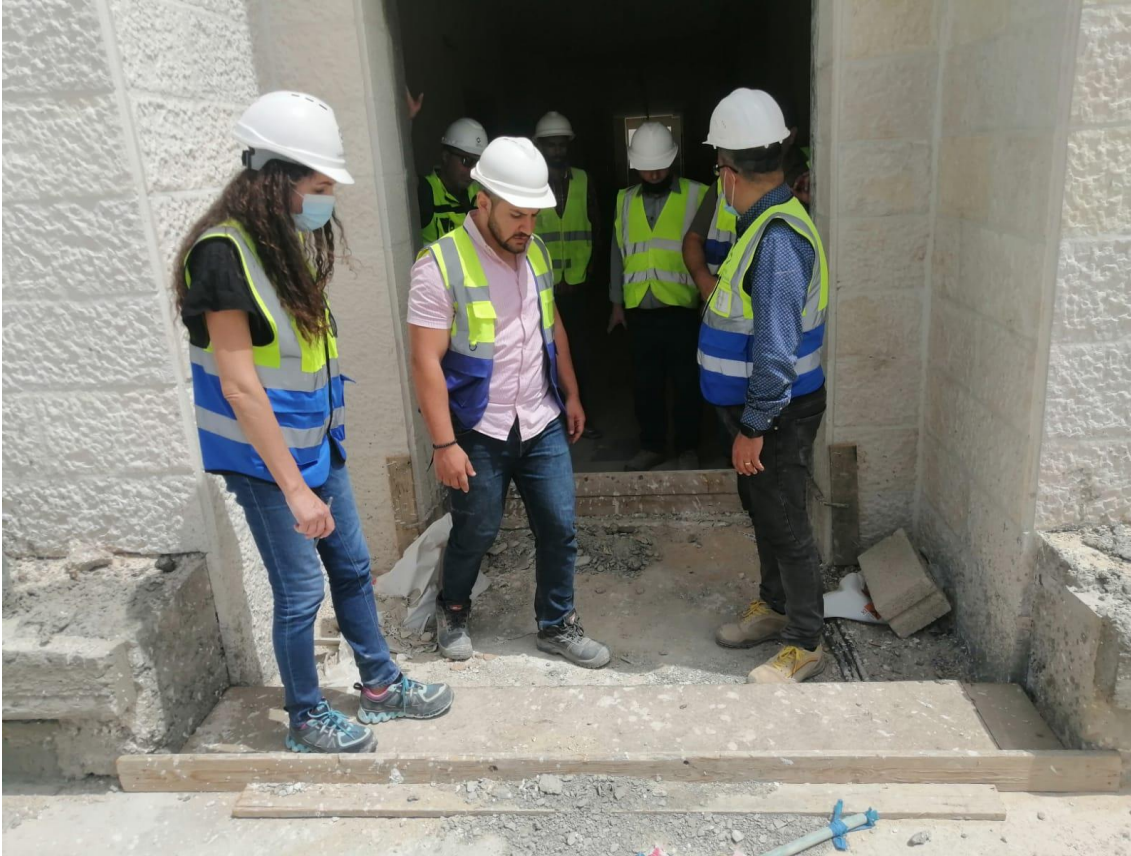
(Figure: 12)

The team inspected the execution of the expansion joint at the roof of the building

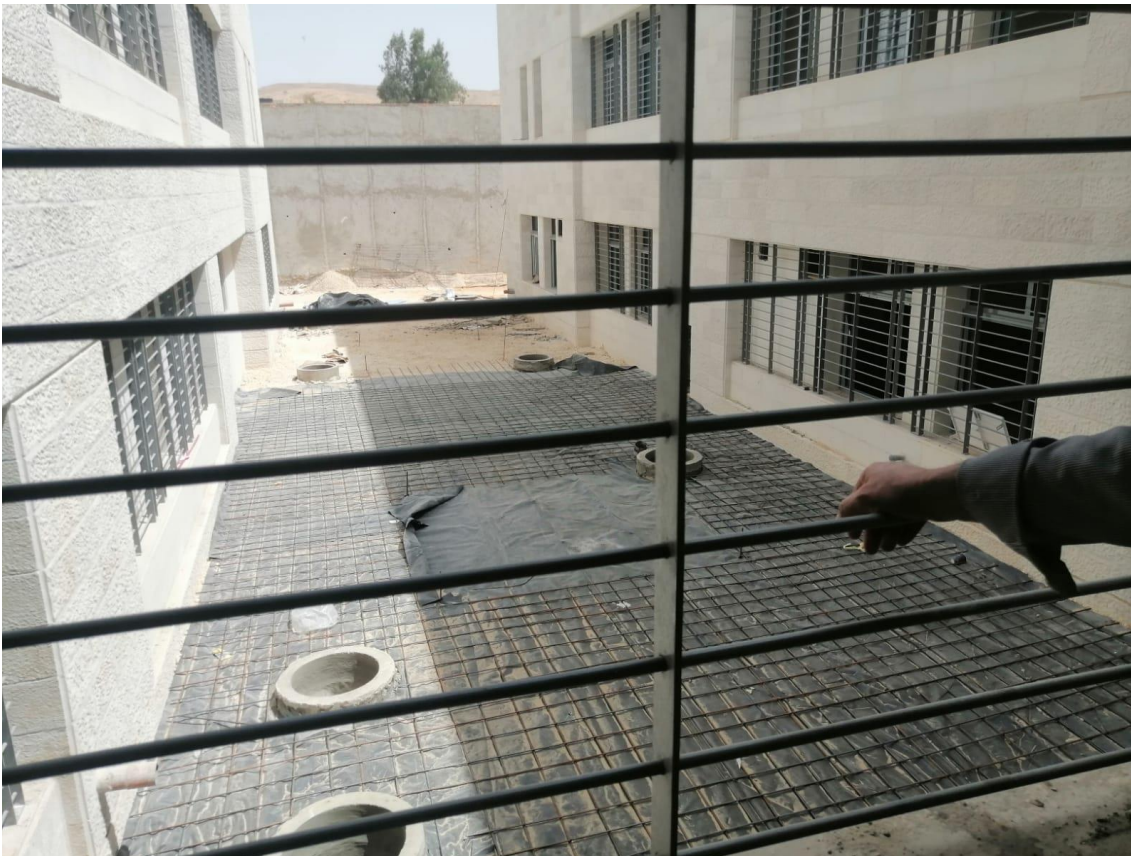
(Figure: 13)

The team observed that the Contractor executed the layer of vapor retarder and that the steel reinforcement at the top of the base course did not comply with requirements. The team requested the Contractor to remove everything

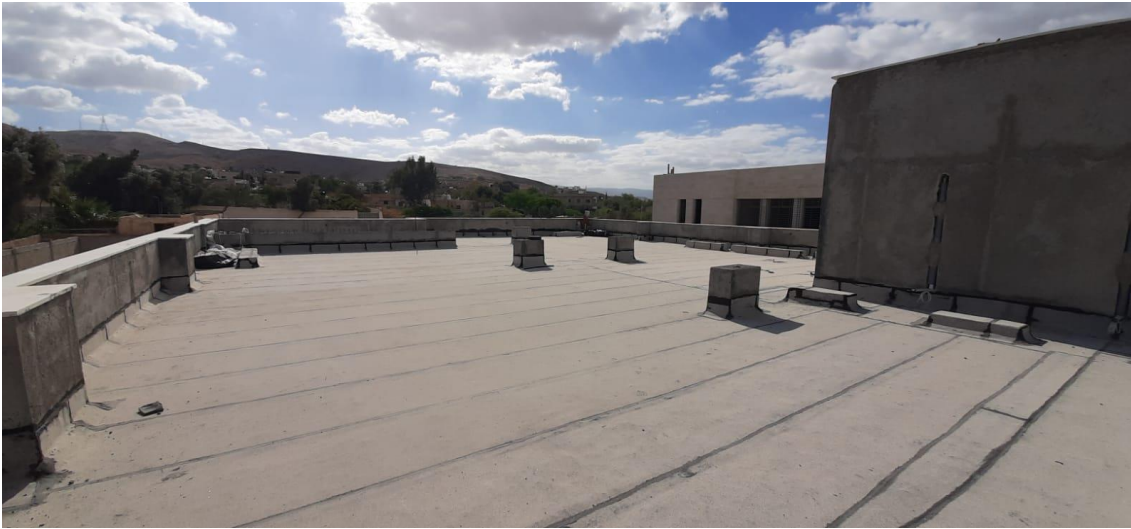
(Figure: 14)

the Contractor has not repaired the sheet waterproofing at the roof as requested by the team the last visit

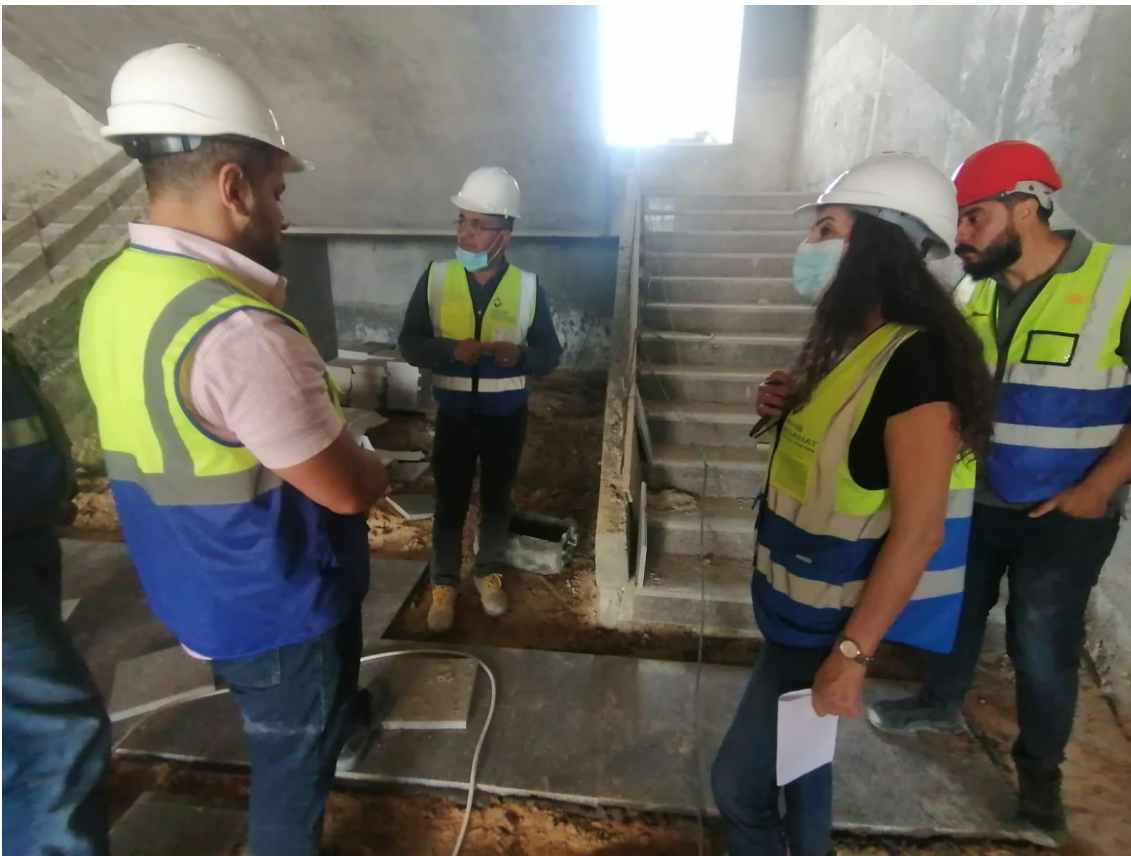
(Figure: 15)

The team inspected the installed granite for the staircases and requested the Contractor to prepare a sample showing the installation of granite at the start and end of stairs and the installation of handrail to inspect the final view of the two installed items

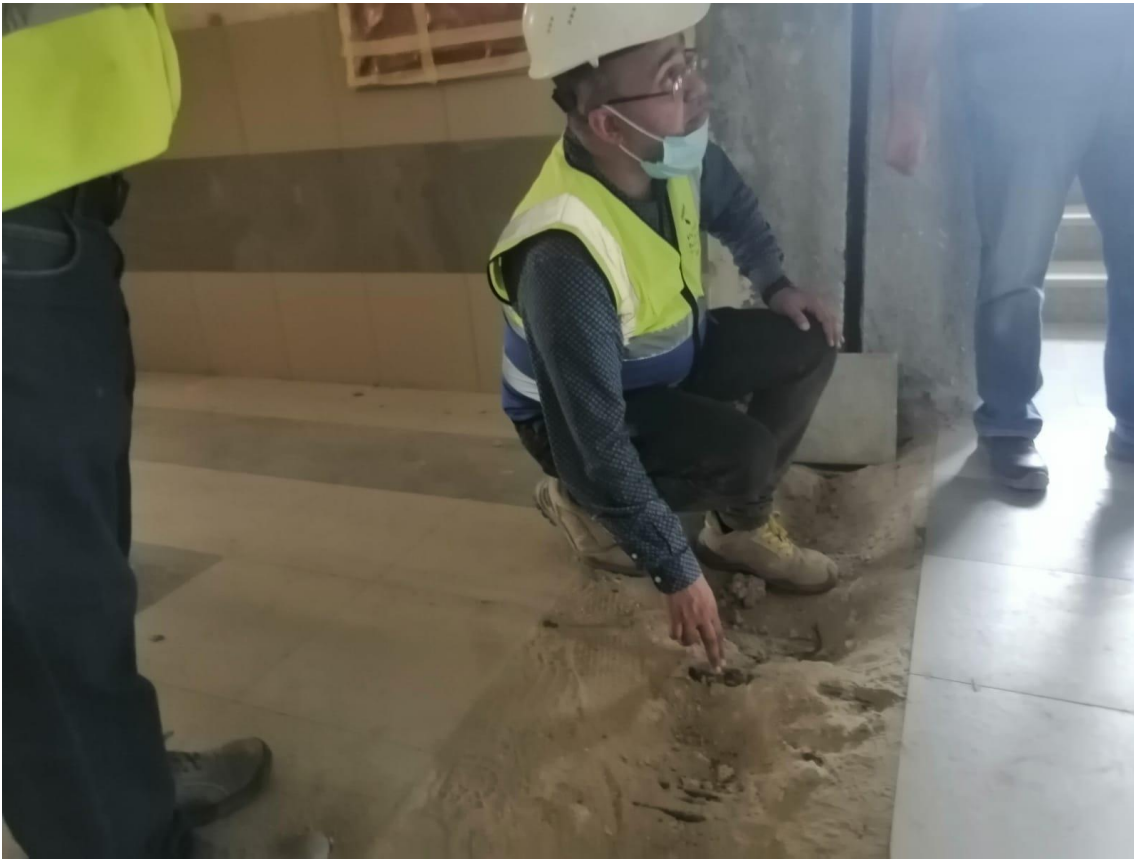
(Figure: 16)

In the first floor, the team observed an electrical conduit installed at a high level and conflict with the installation of expansion joint cover

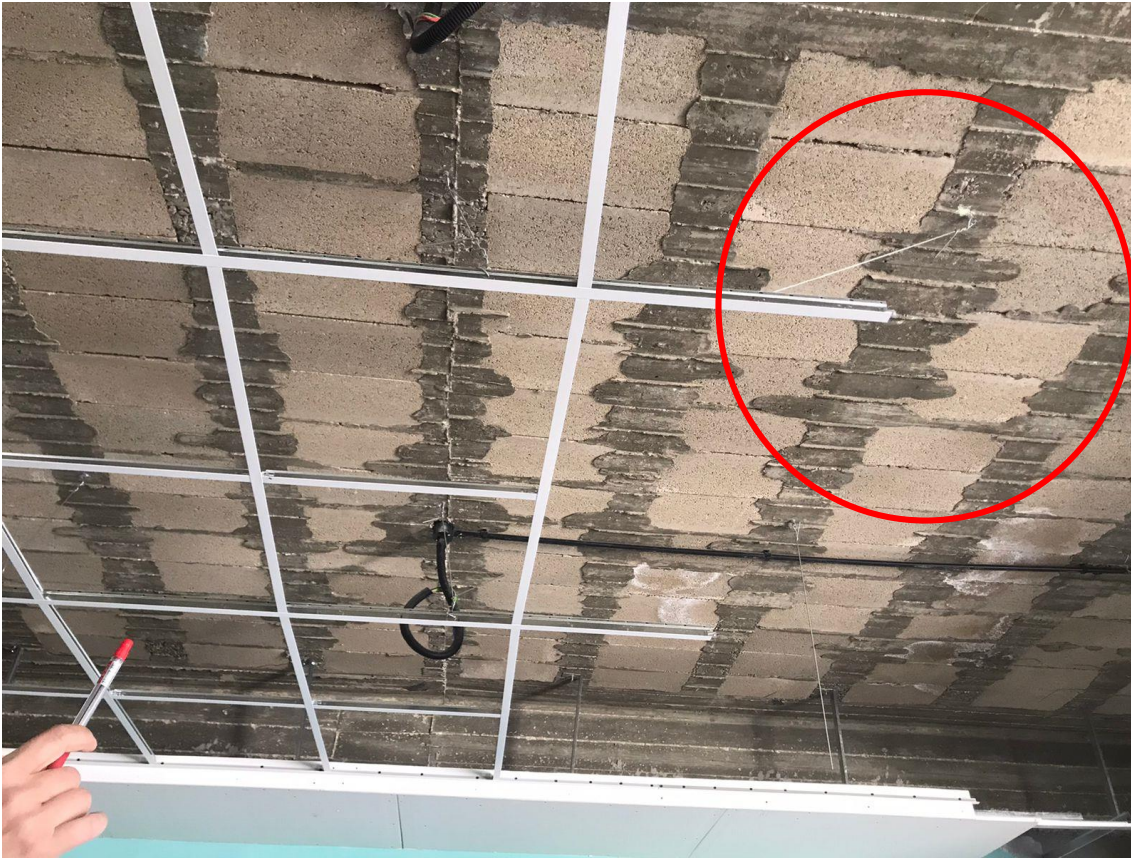
(Figure: 18)

The team observed that the hangers used to hold the suspended ceiling frame, some of them are not vertical. The Contractor was requested to ensure the verticality of those hangers

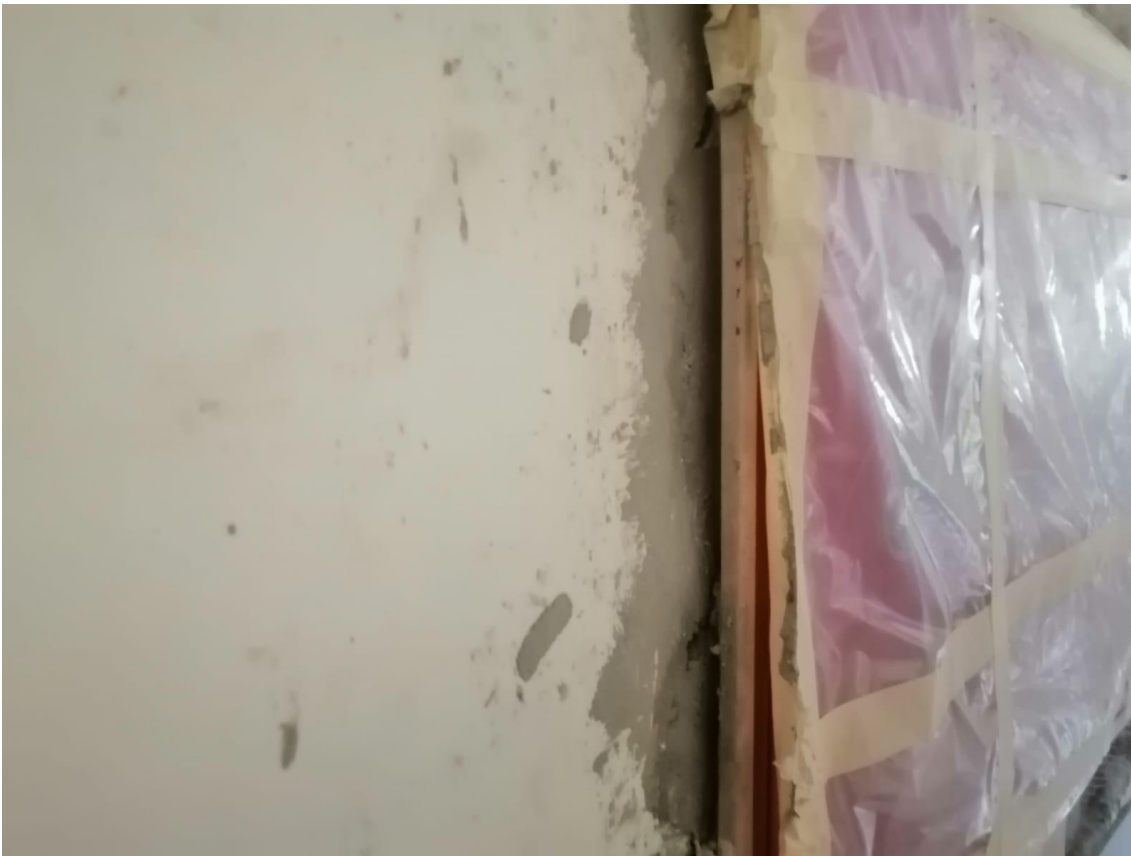
(Figure: 19)

The team observed the gaps between the edge of extinguisher cabinets and the plastered wall and discussed with the Contractor suggestions to appropriate solutions

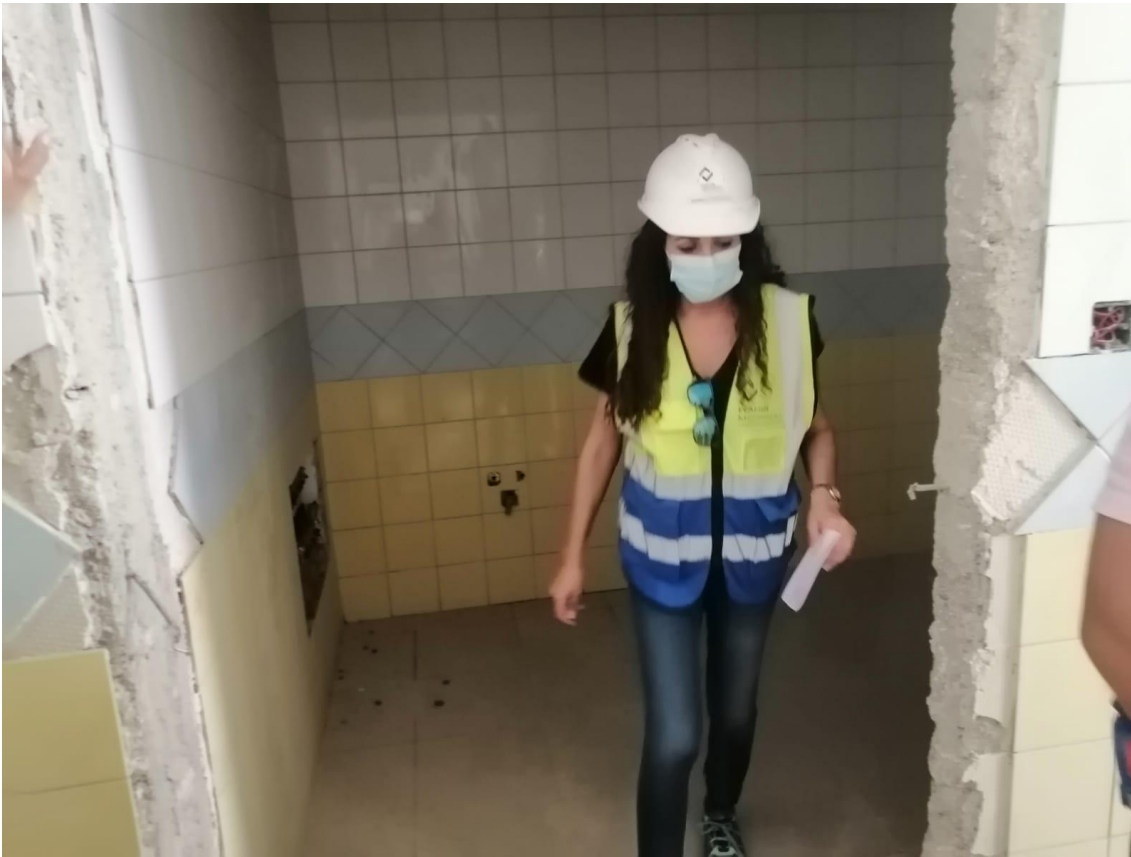
(Figure: 20)

The team observed that the Contractor removed an installed frame in order to re-study the distribution of ceramic tiles adjacent to the door to avoid small cut-off pieces

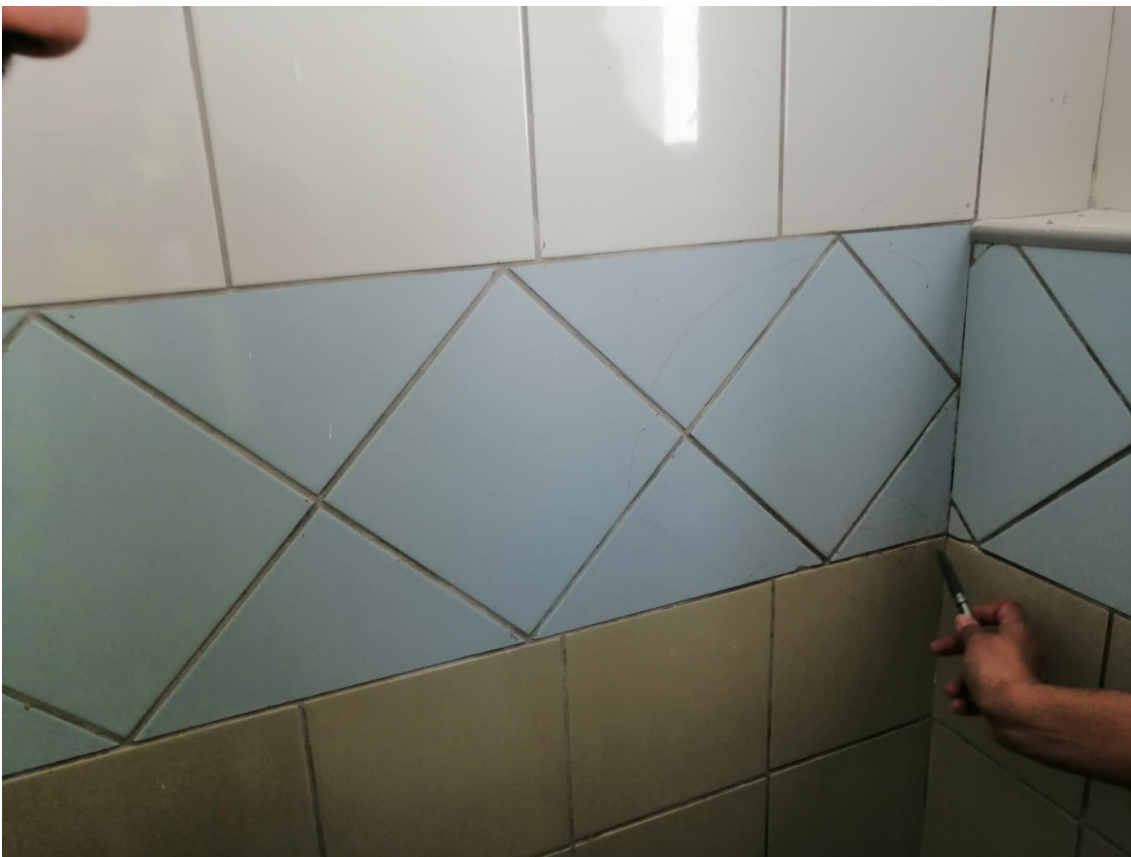
(Figure: 21)

The team reminded the Contractor to replace the broken ceramic tiles at the wet areas walls

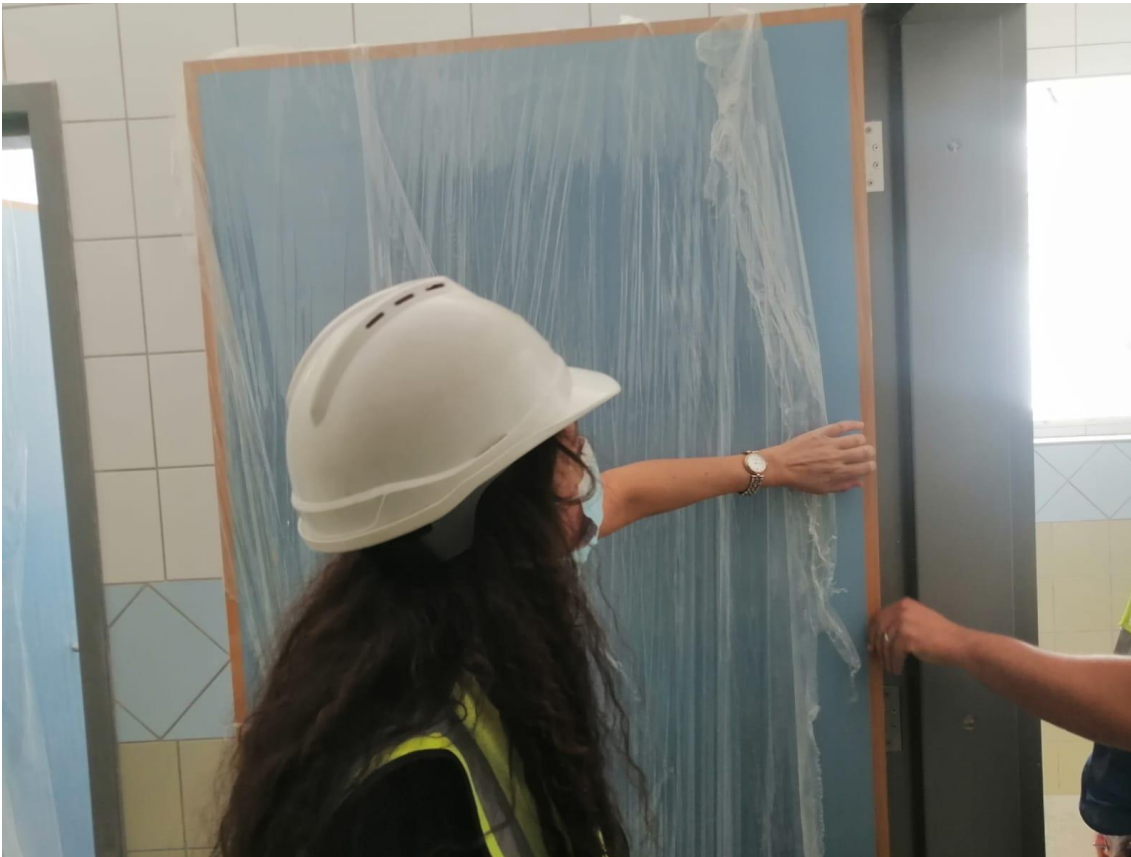
(Figure: 22)

The team inspected the delivered wooden door leafs focusing on the beech frames

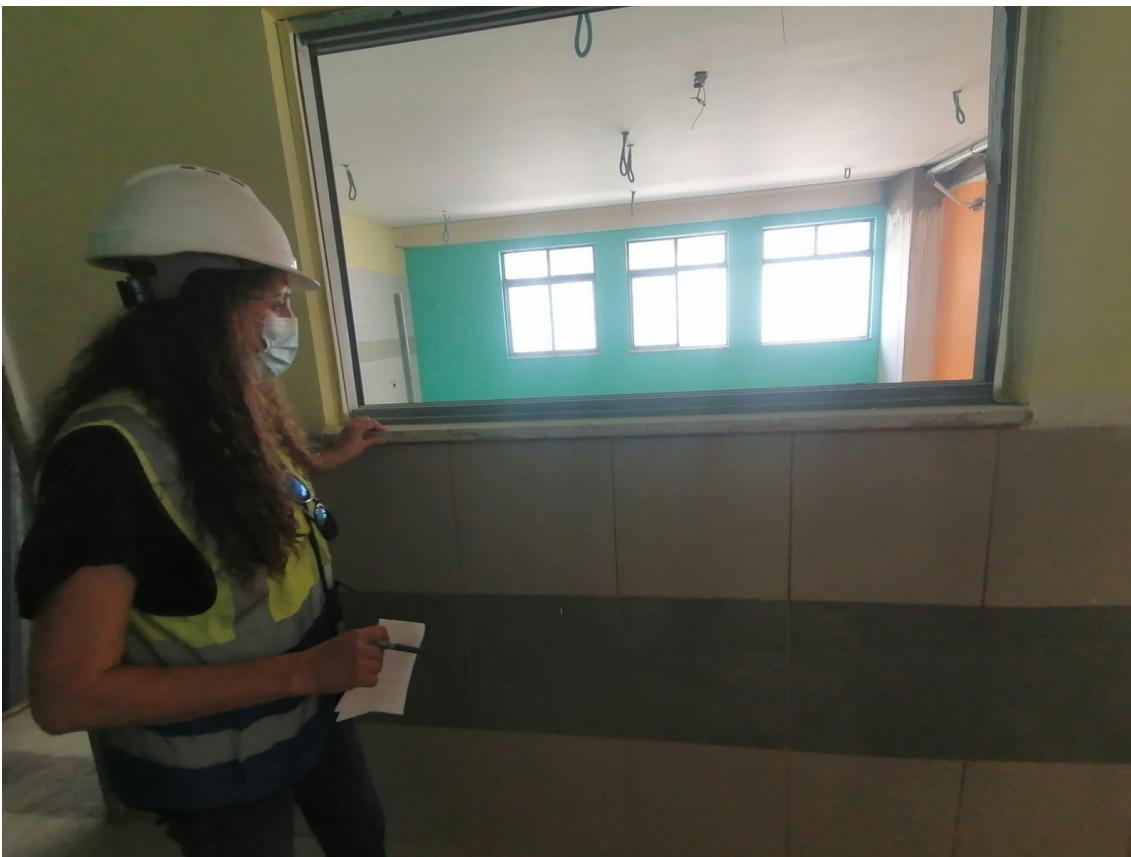
(Figure: 23)

The team observed that the Contractor conducted the necessary rectification needed to unify the level of sills of the internal windows as requested before
