Quality Control Report

Consultant **Wahib Medanat** Consultant Engineers
Site Name **Thahr Al Sarow Basic Boys - Jerash**
Package **Package 2**
Contractor **Dijlah Est. Construction Co.**
Tender No. **10/2019/USAID/SKEP/3/2**

Rep No. **QC-22 18**
Date **17 / 07 / 2022**

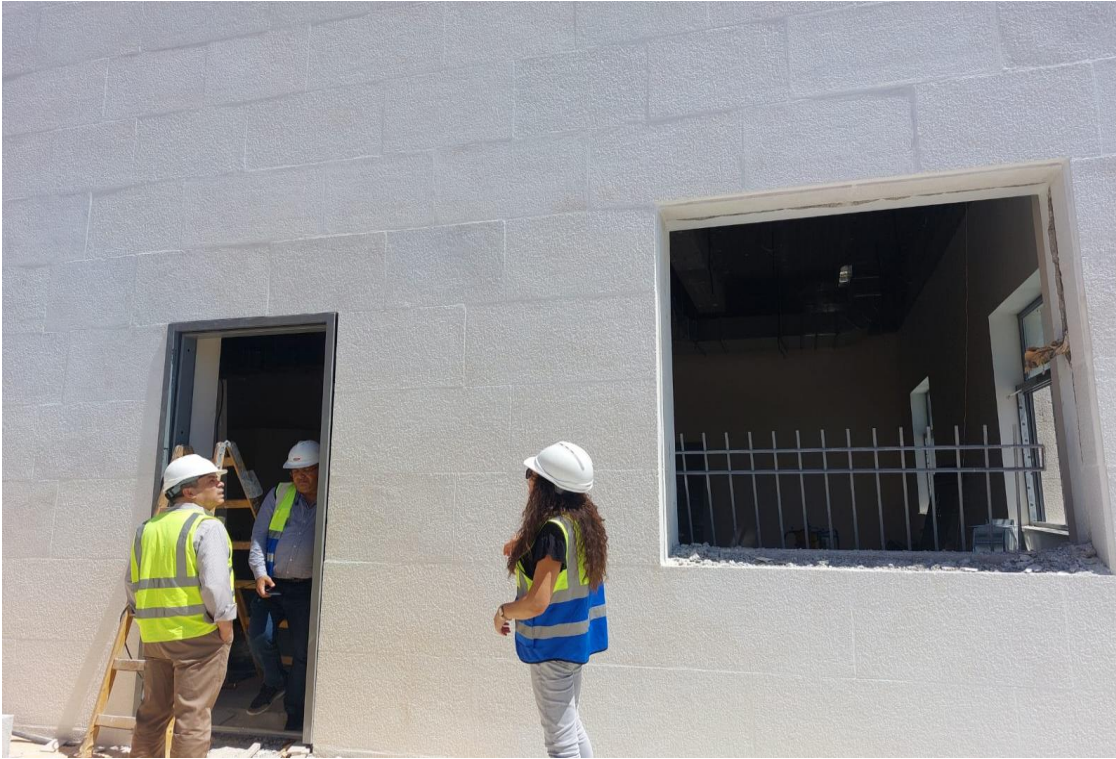
Teething in the built stone at the front façade

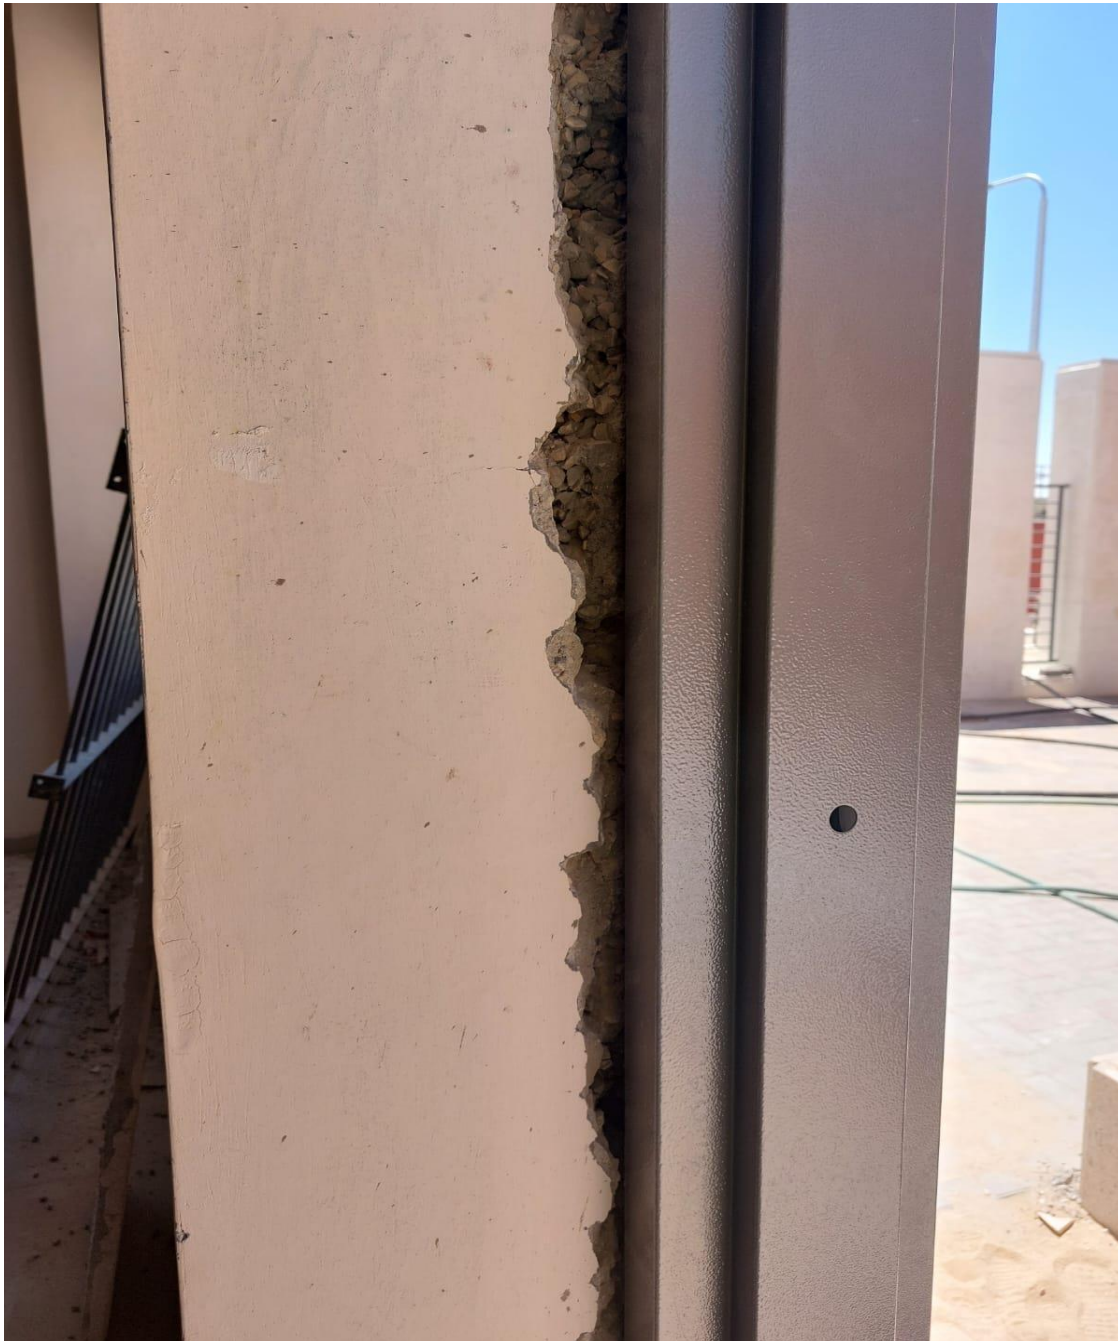
Incorrect finish for the door jamb of the multi-purpose hall

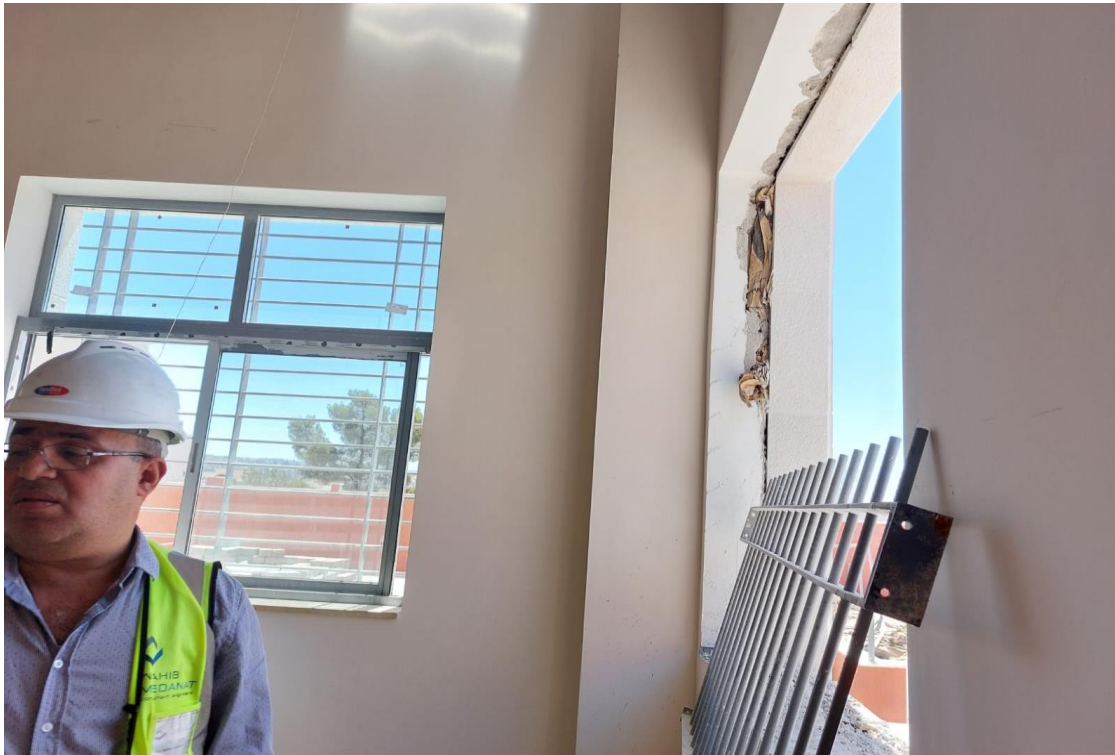
Using empty cement bags in the window jamb of the multi-purpose hall

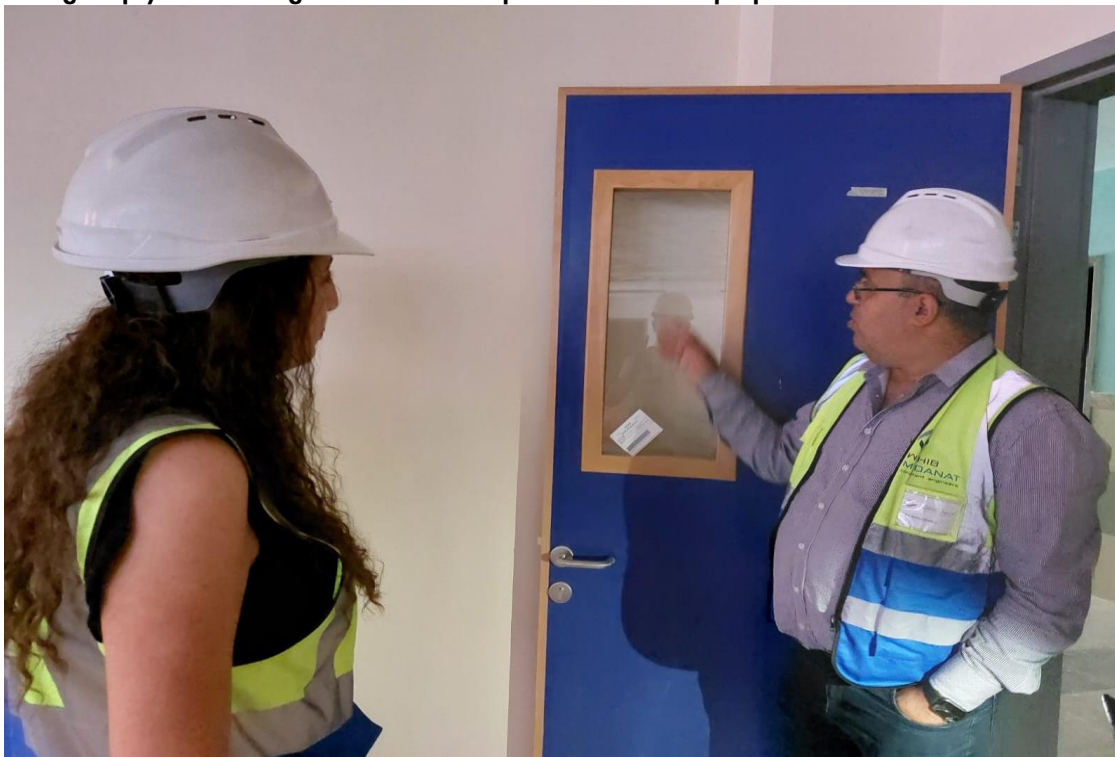
Dimensions of the vision panel of the wooden doors are less than specified

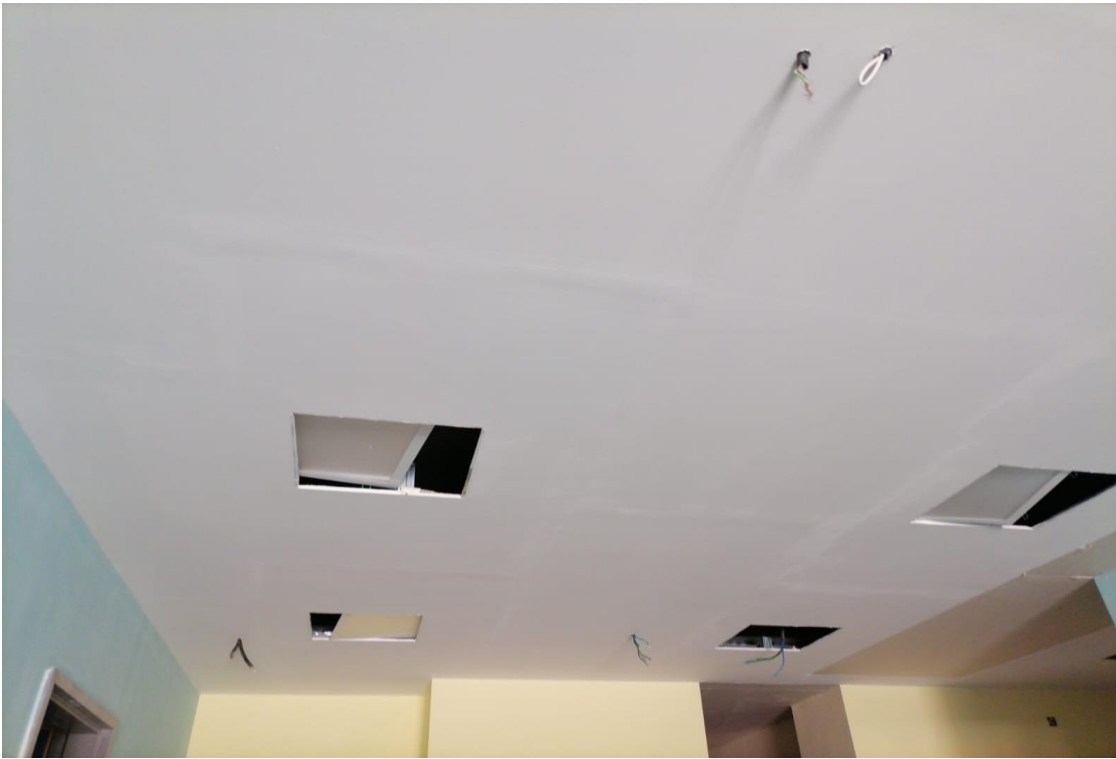
Waving in the painting of the suspended ceilings

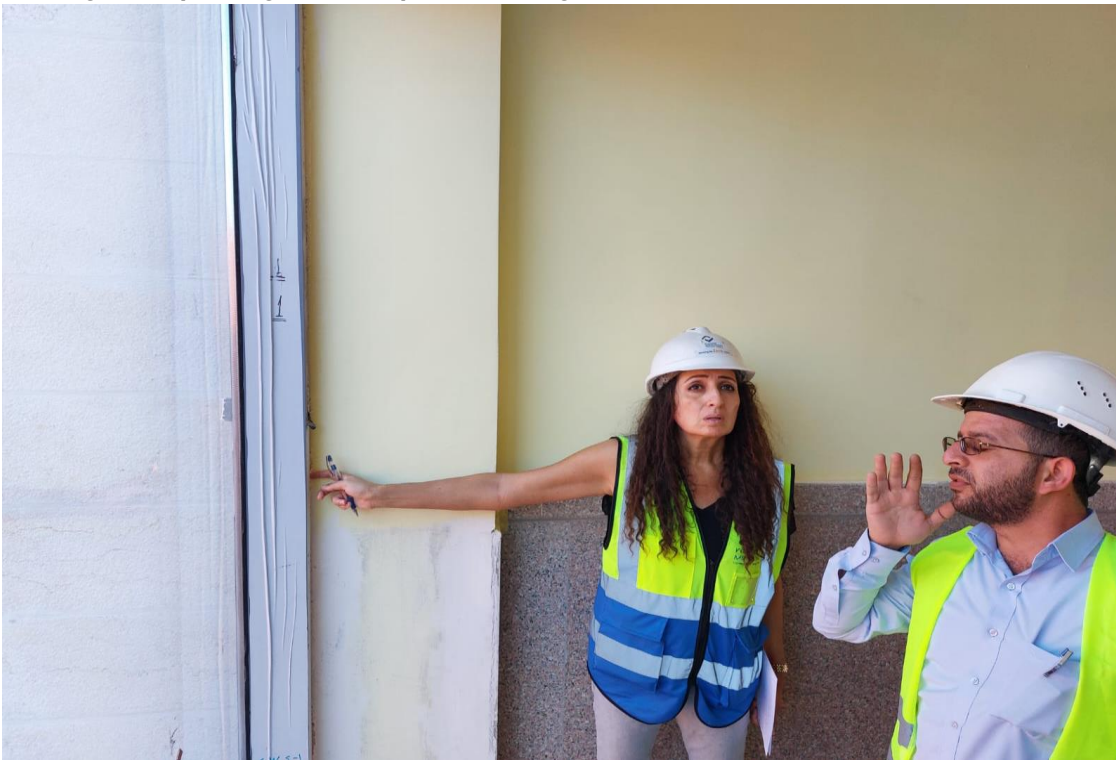
Curtain wall is installed completely at the stone

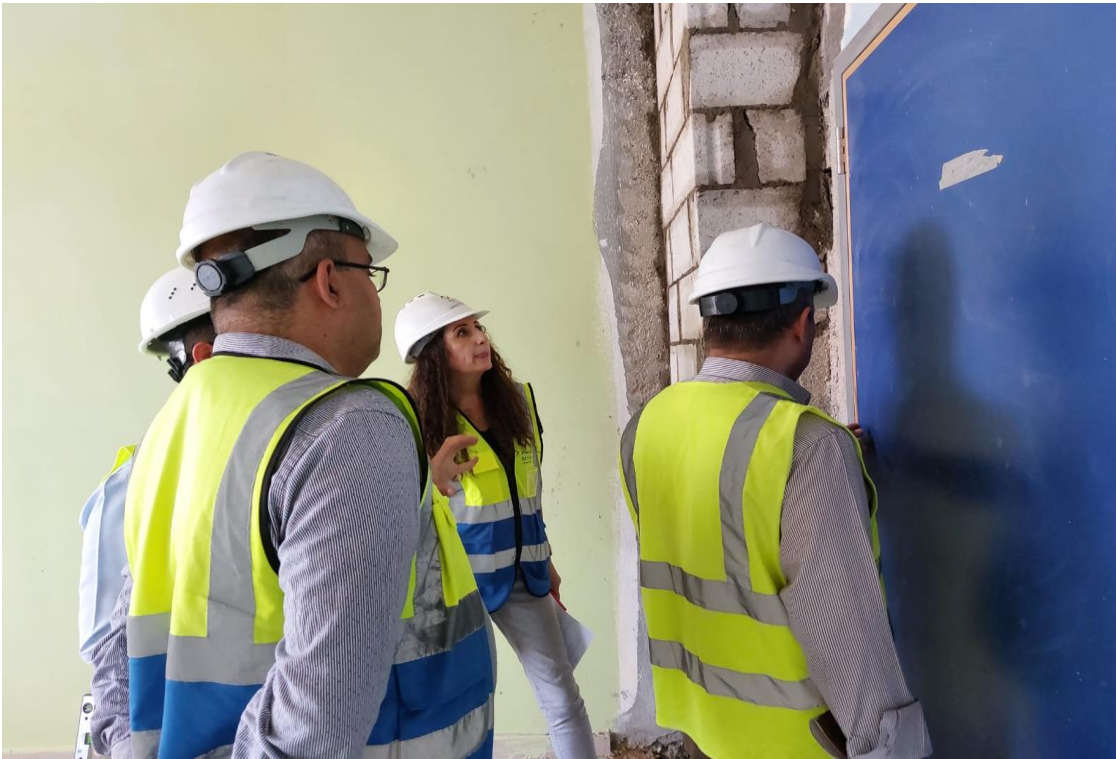
Defects in the cutting of laminated sheet and beech wood frame of the doors

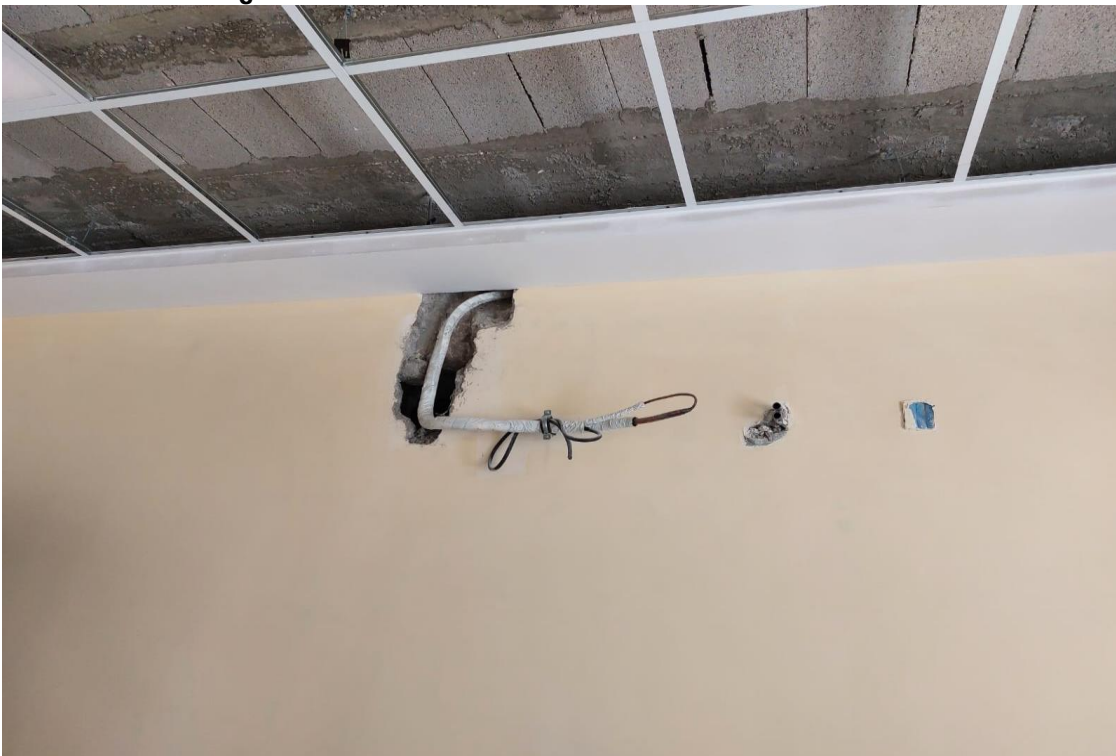
Installing suspended ceiling frame before completing the mechanical piping

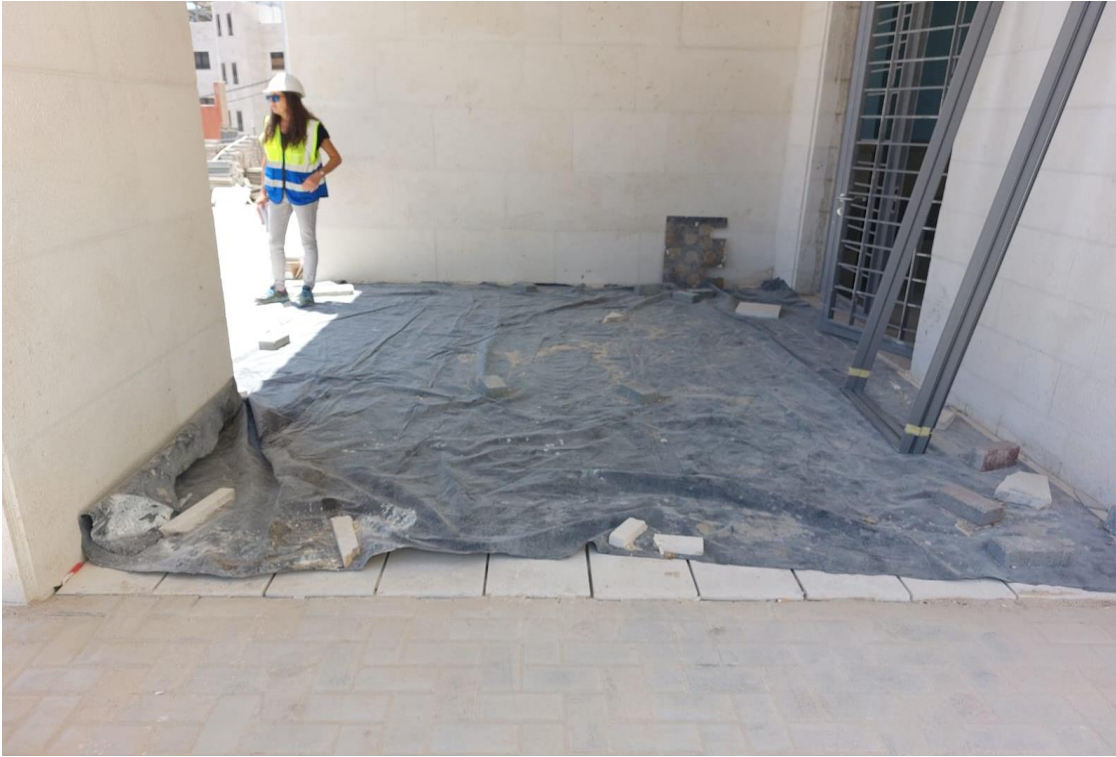
Defects in the level of the stone tiling at the entrance
