Quality Control Report

Consultant **Wahib Medanat** Consultant Engineers
Site Name **Thahr Al Sarow Basic Boys - Jerash**
Package **Package 2**
Contractor **Dijlah Est. Construction Co.**
Tender No. **10/2019/USAID/SKEP/3/2**

Rep No. **QC-22 16**
Date **23 / 05 / 2022**

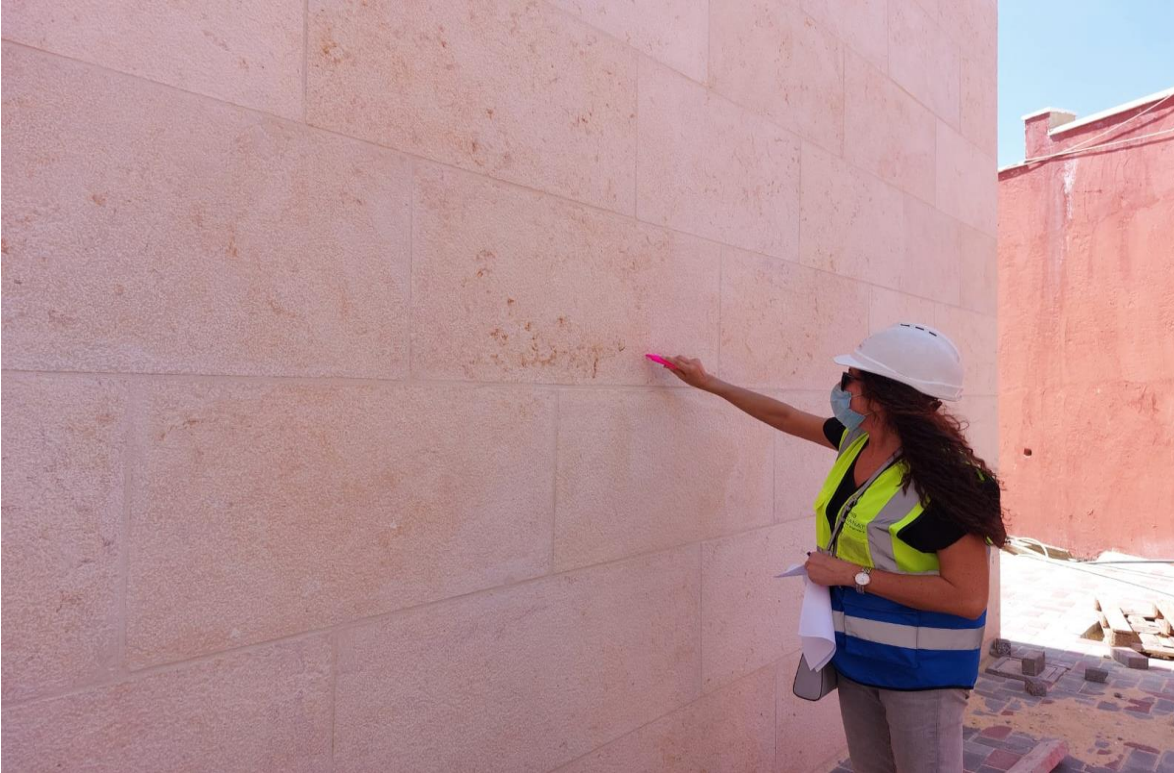
Defects in the built stones

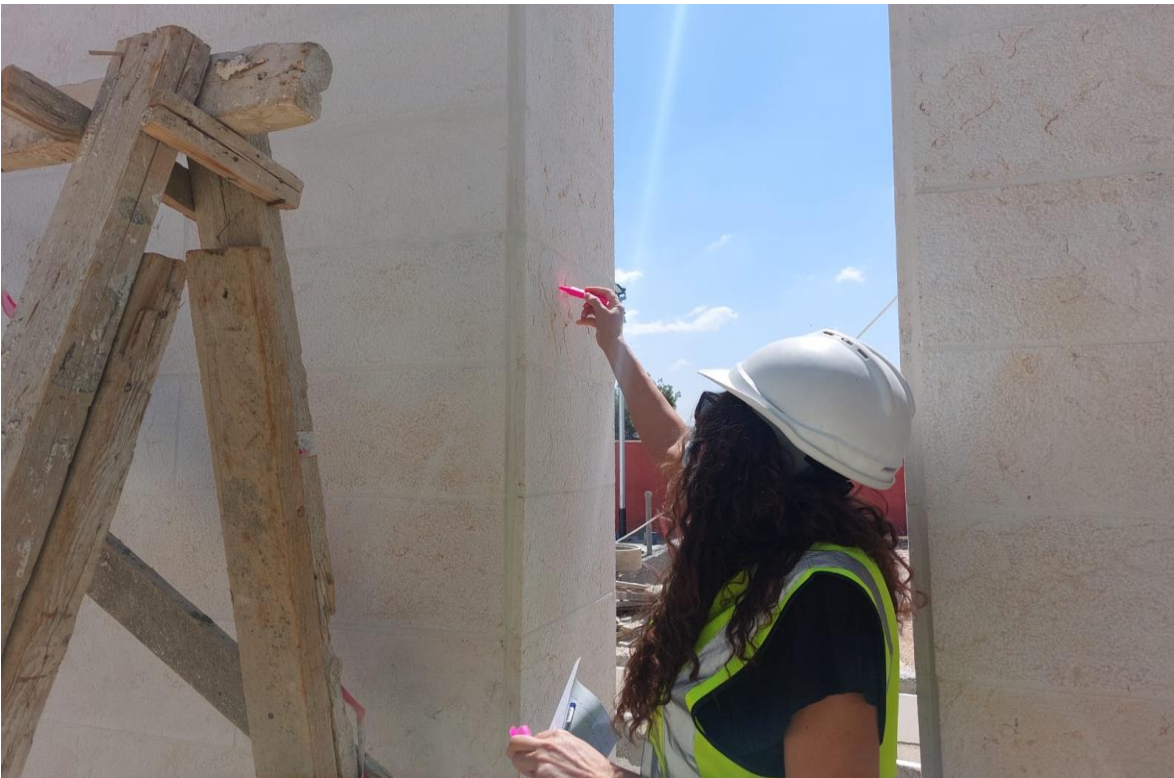
Defects in the built stones

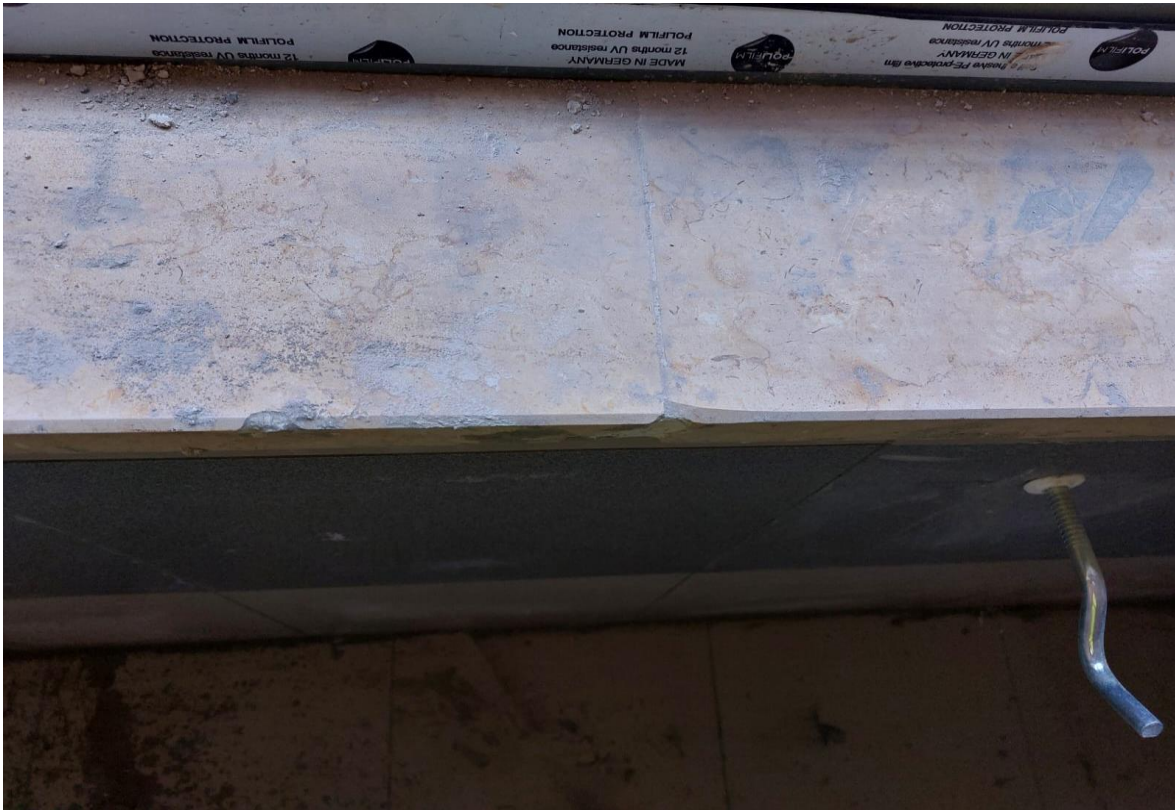
Broken window sill

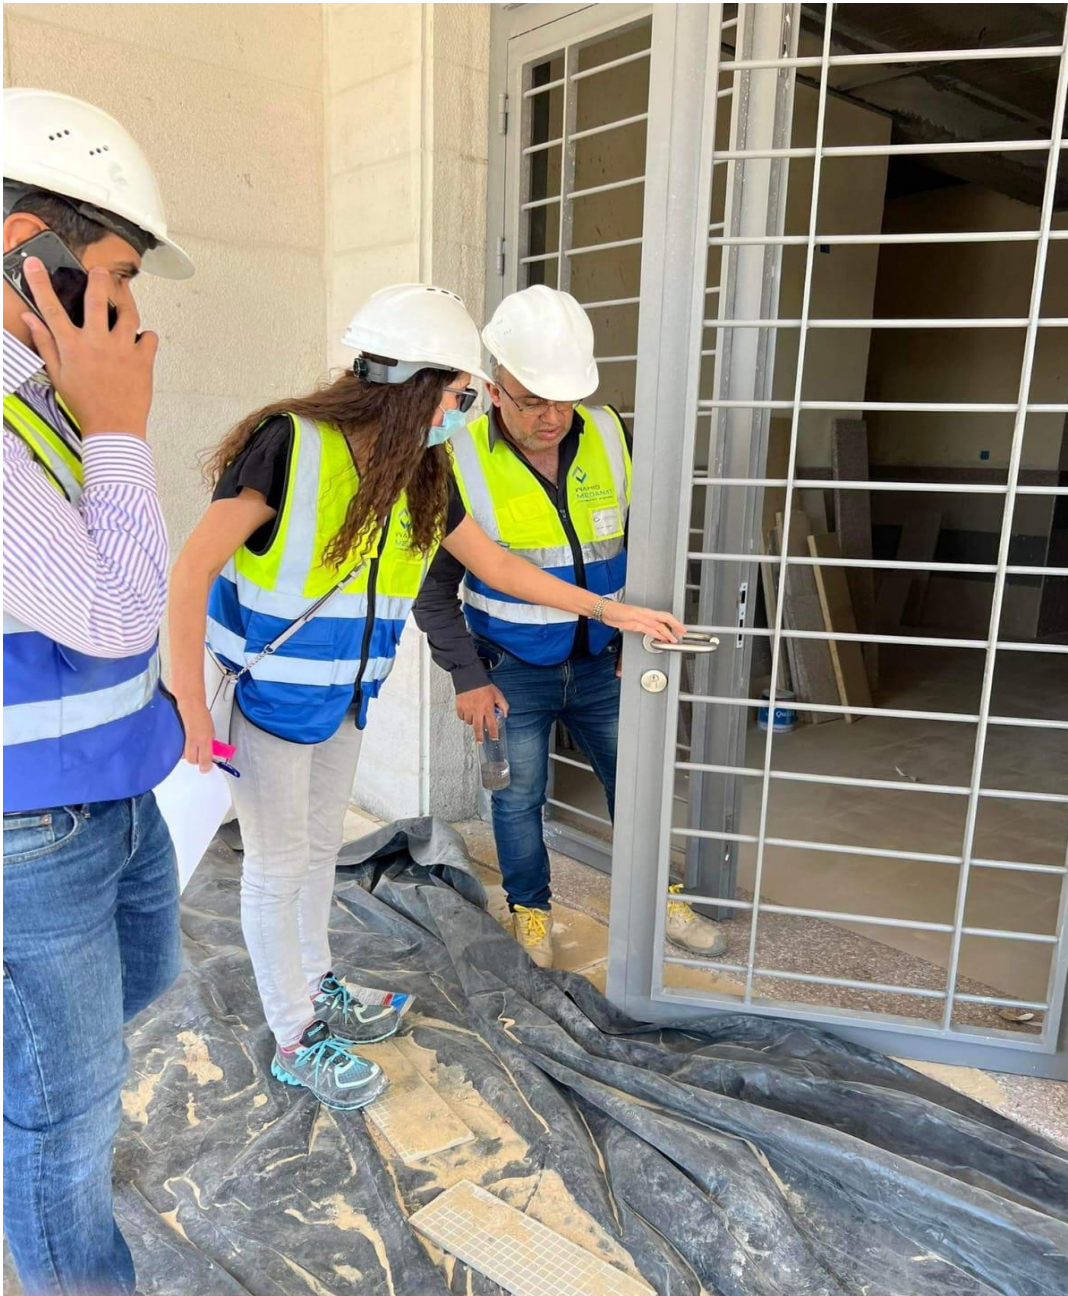
Defects in the main steel doors

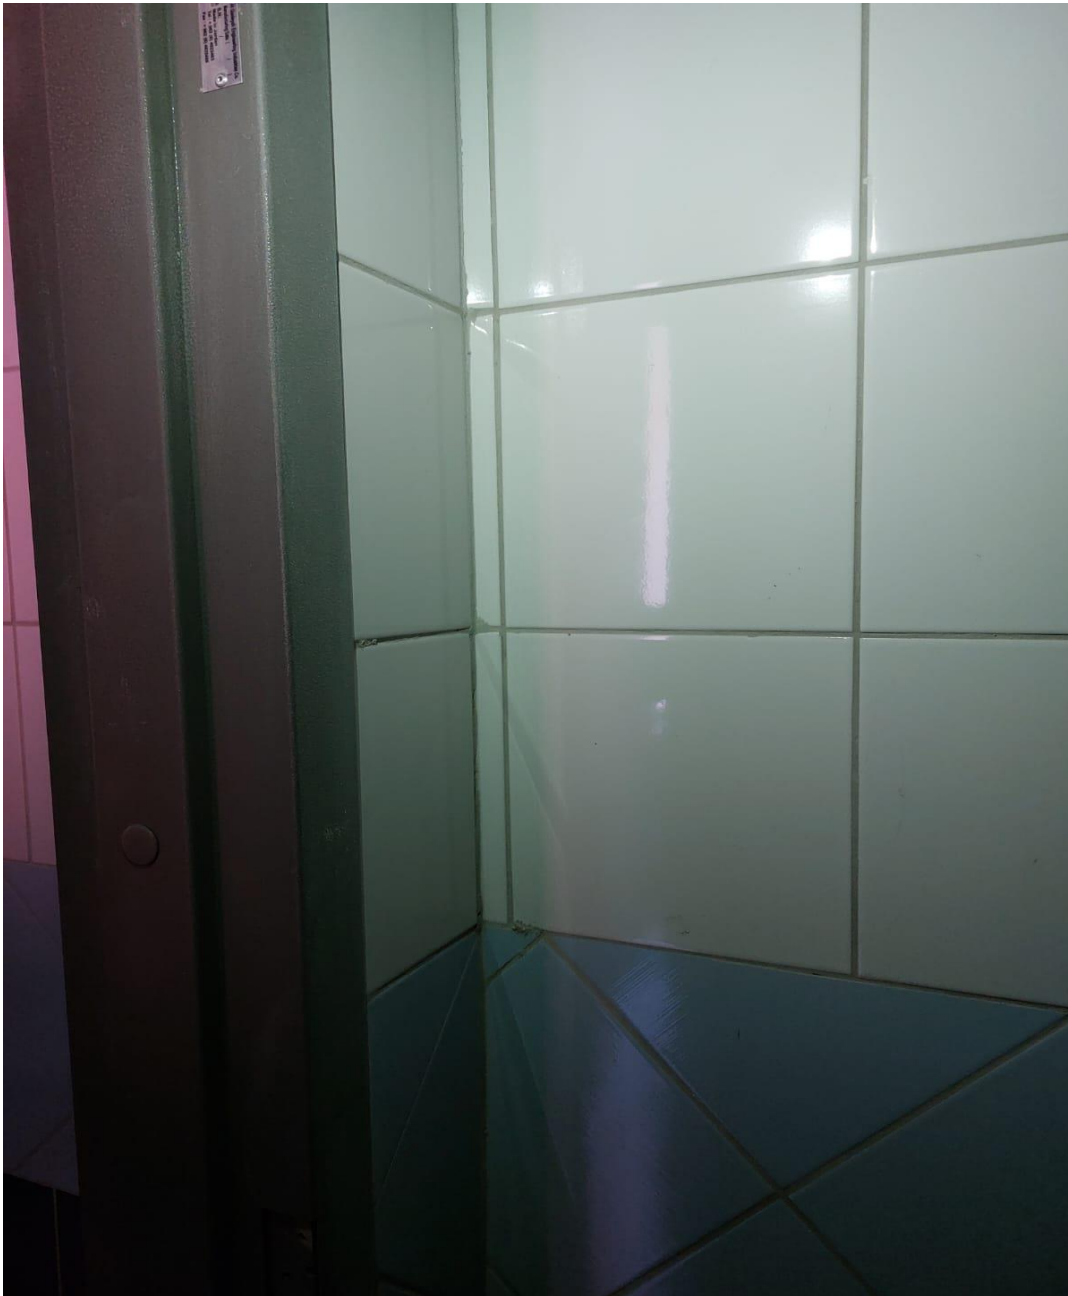
Small cut-off ceramic tiles

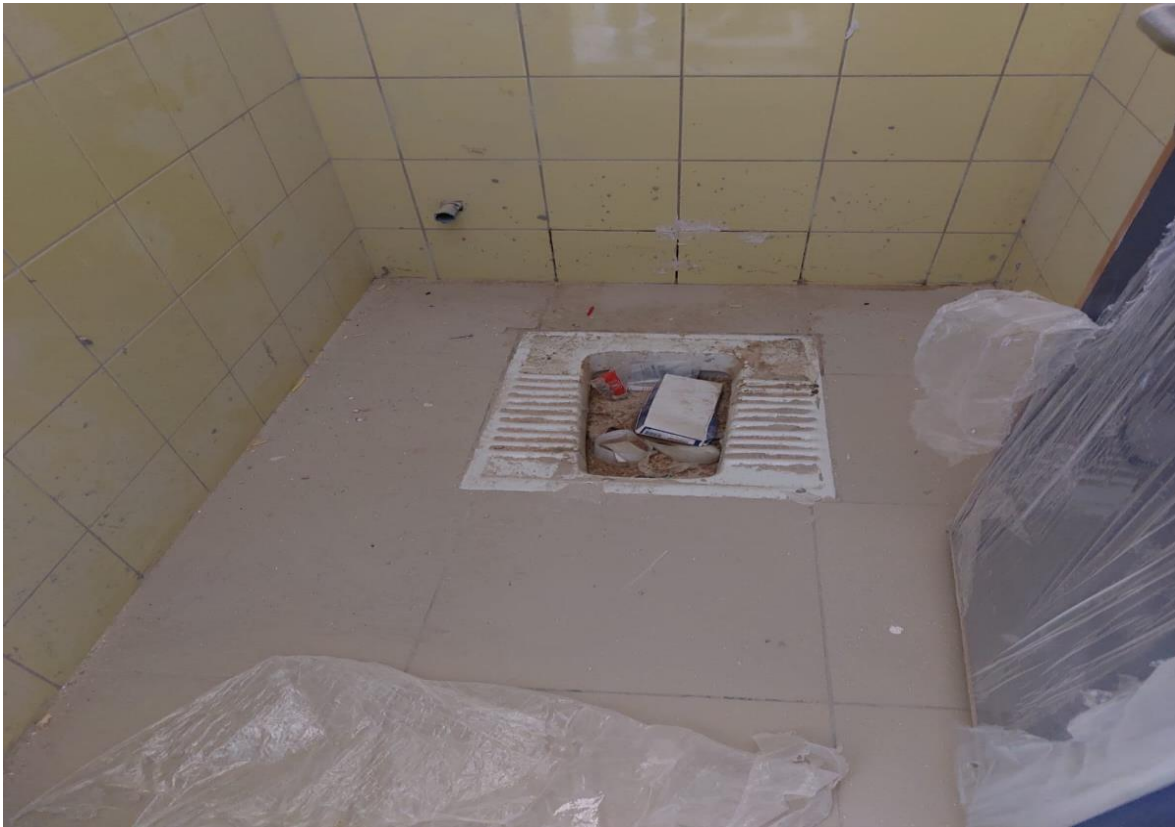
Accumulated debris and dirt at the sanitary fixtures

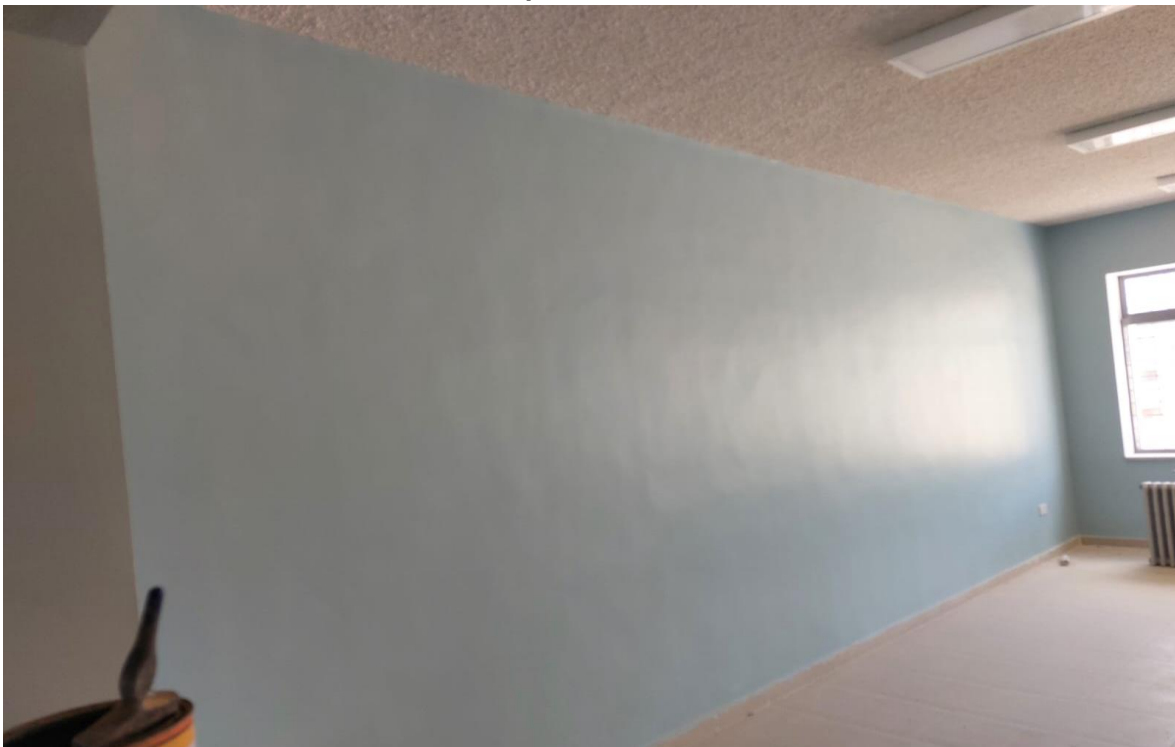
Waving in plastering

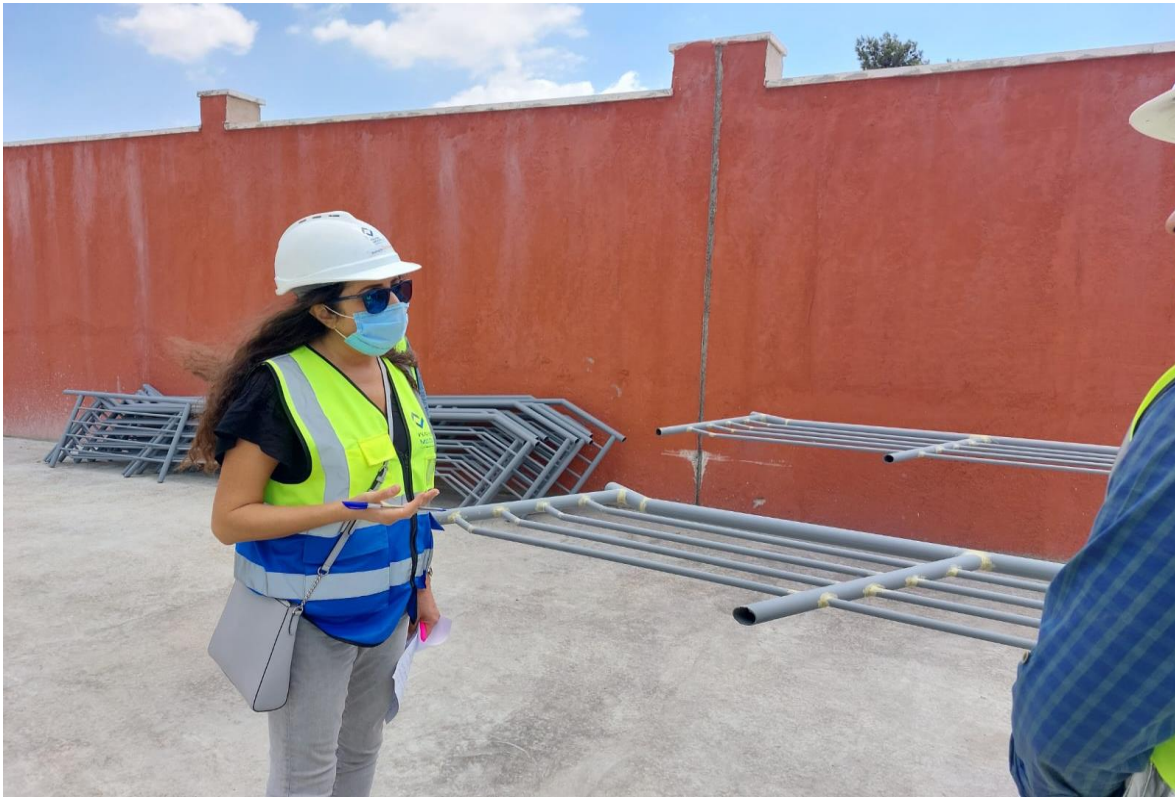
Defects in the handrails and dirt at the boundary walls
