# SKEP III Home Office Support Site Visit Report

**WAHIB  
MEDANAT**  
consultant engineers

Consultant	Wahib Medanat Consultant Engineer	Rep No.	13-12012022
Contractor	Derar Saraireh & Sons for Engineering & Contracting	Tender No.	(11/2019/USAID/SKEP/3/S) Schools for a Knowledge Economy Project (SKEP) - Phase (3) Package (1, 2)
Site Name	Khadija Bint Khwailed Basic Mixed School- Shouna Janoubia	Day/ Date	Wed. 12/01/2022
Duration of Project	450 Calendar Days	Total Project Budget	9,789,417.840 JD

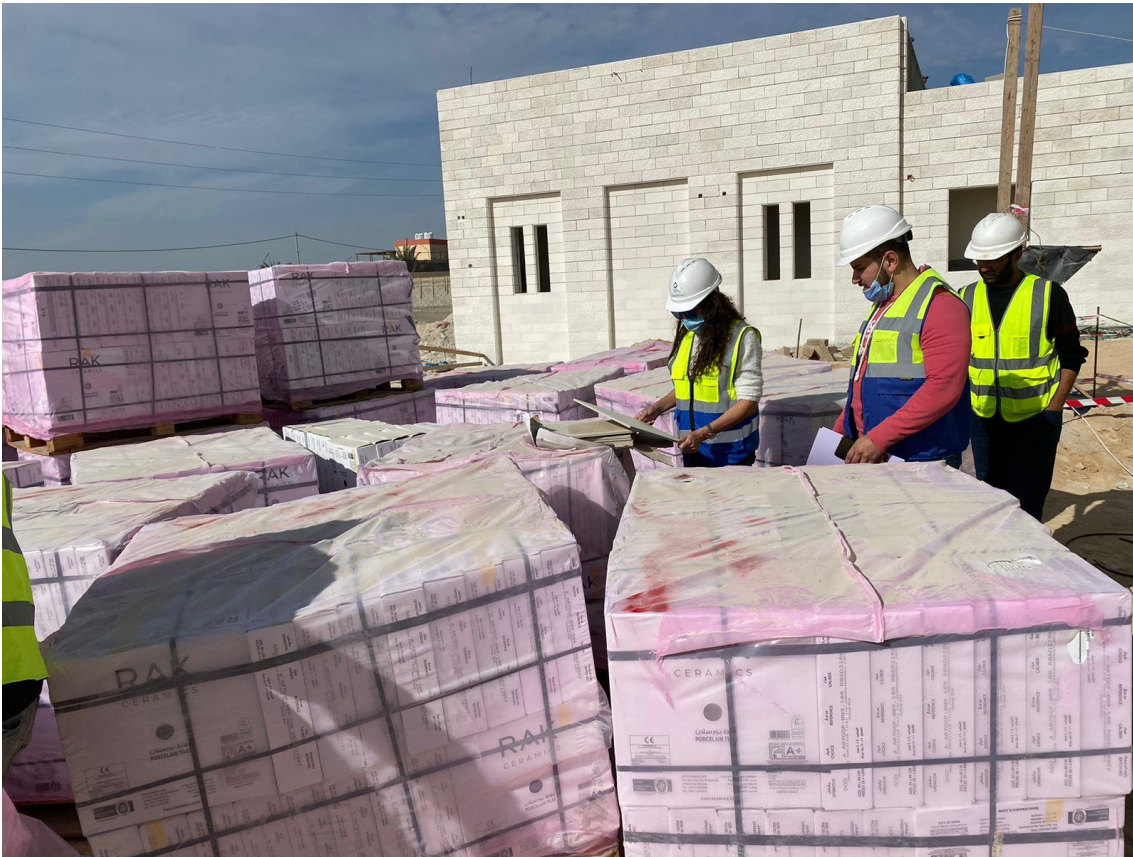
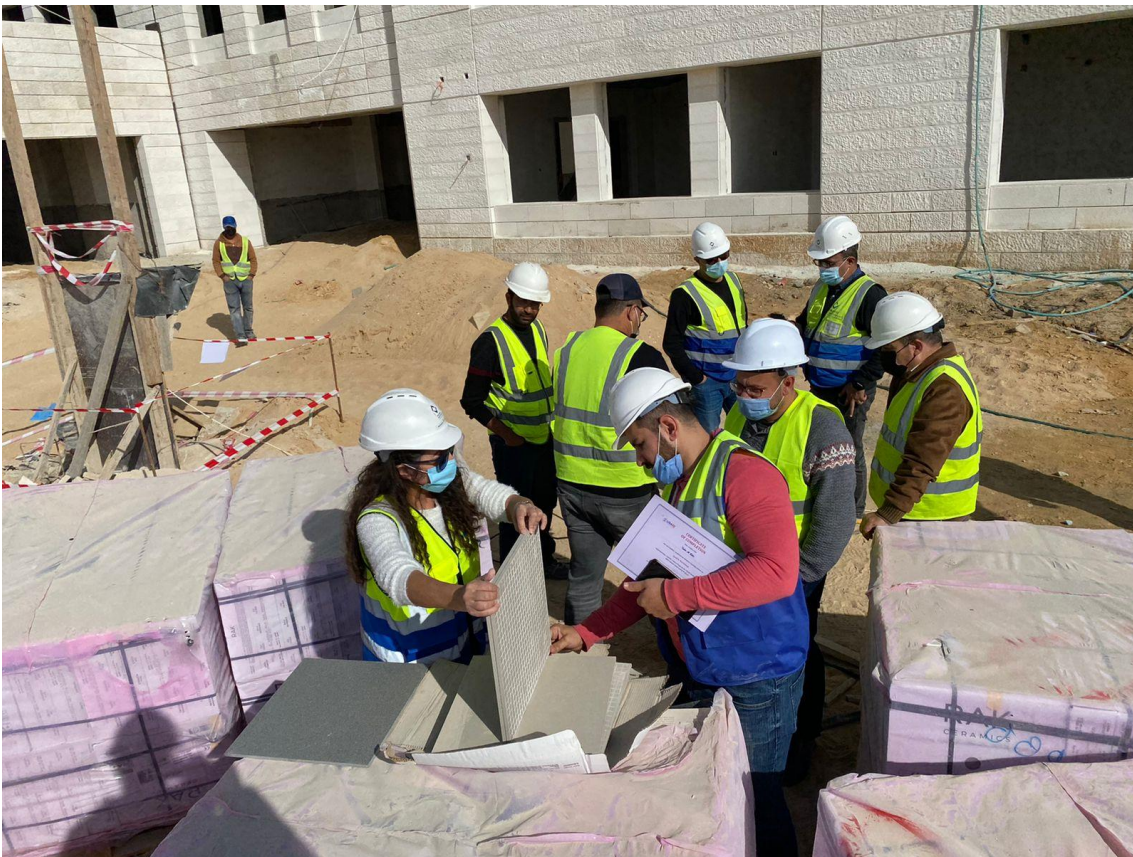
(Figure: 04)

The supervision team inspected the newly delivered porcelain floor tiles and observed that it is manufactured at UAE, (RAK)

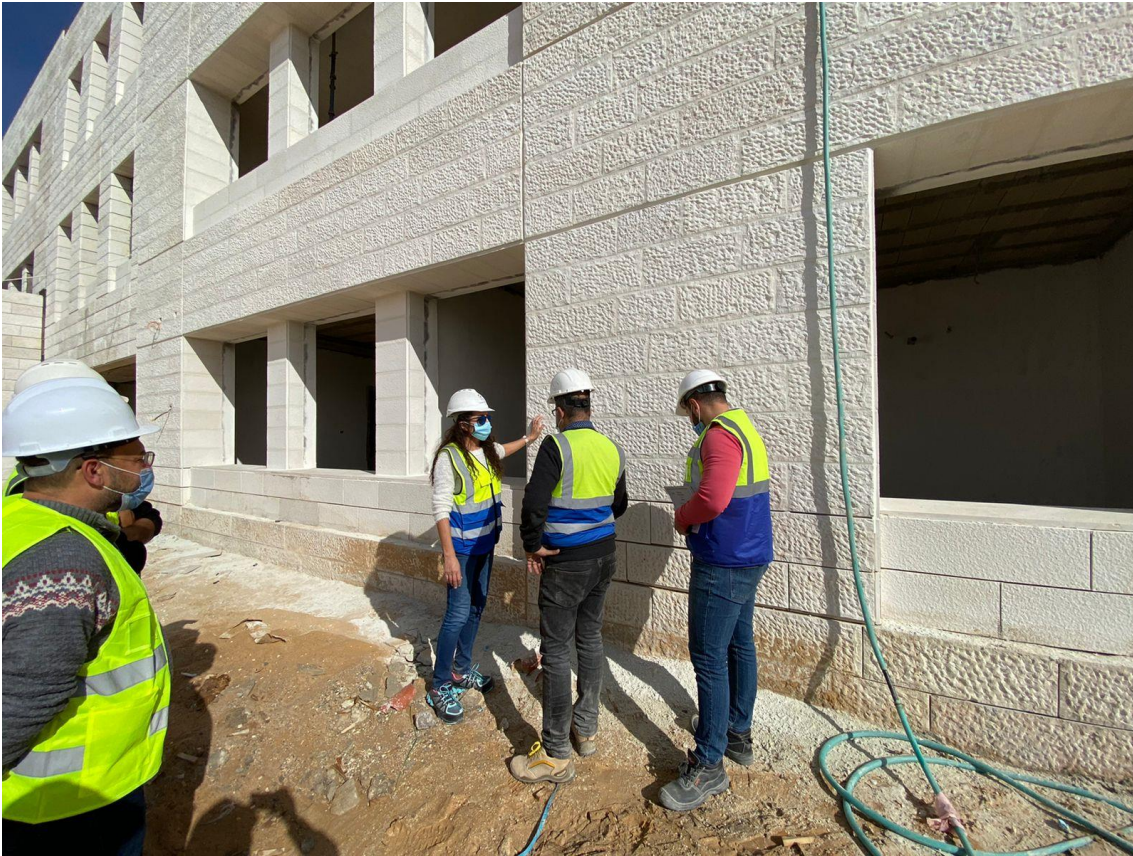
(Figure: 06)

The supervision team inspected the external facades and instructed the Contractor to rectify some minor remarks

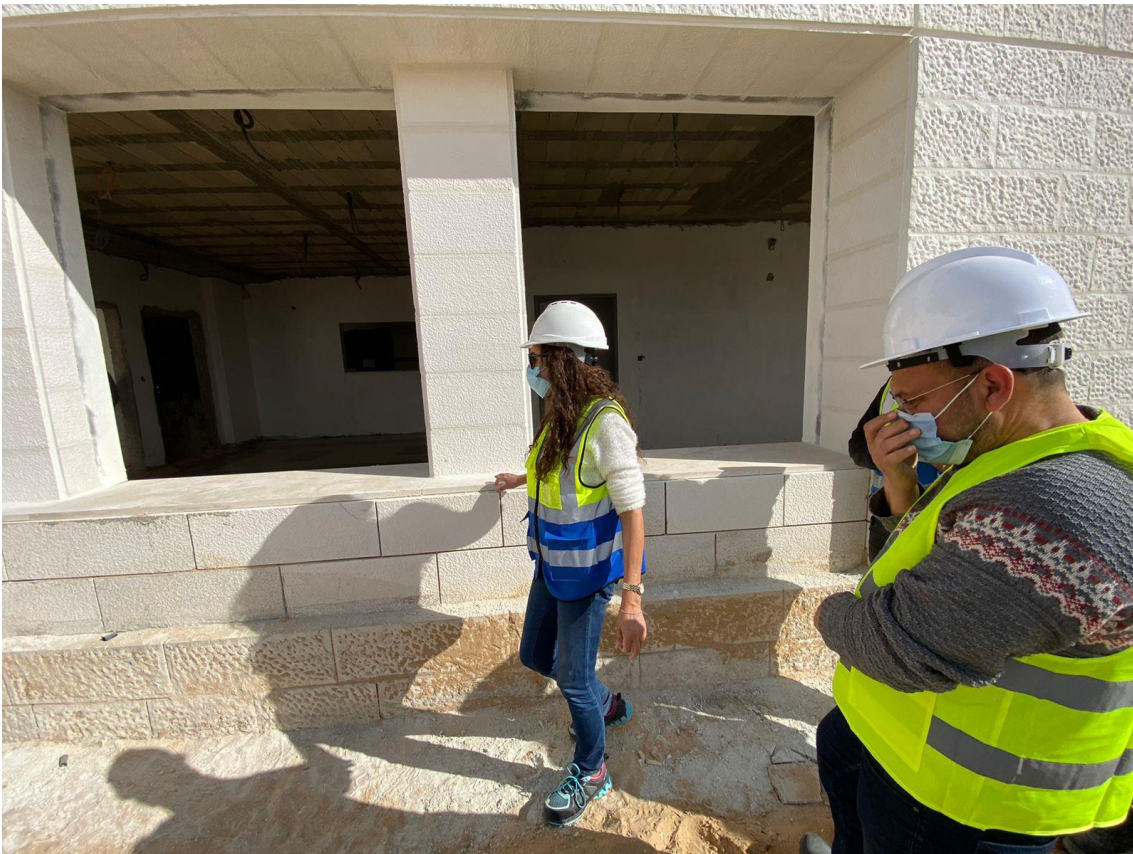
(Figure: 07)

The team inspected the process of installing the window sills

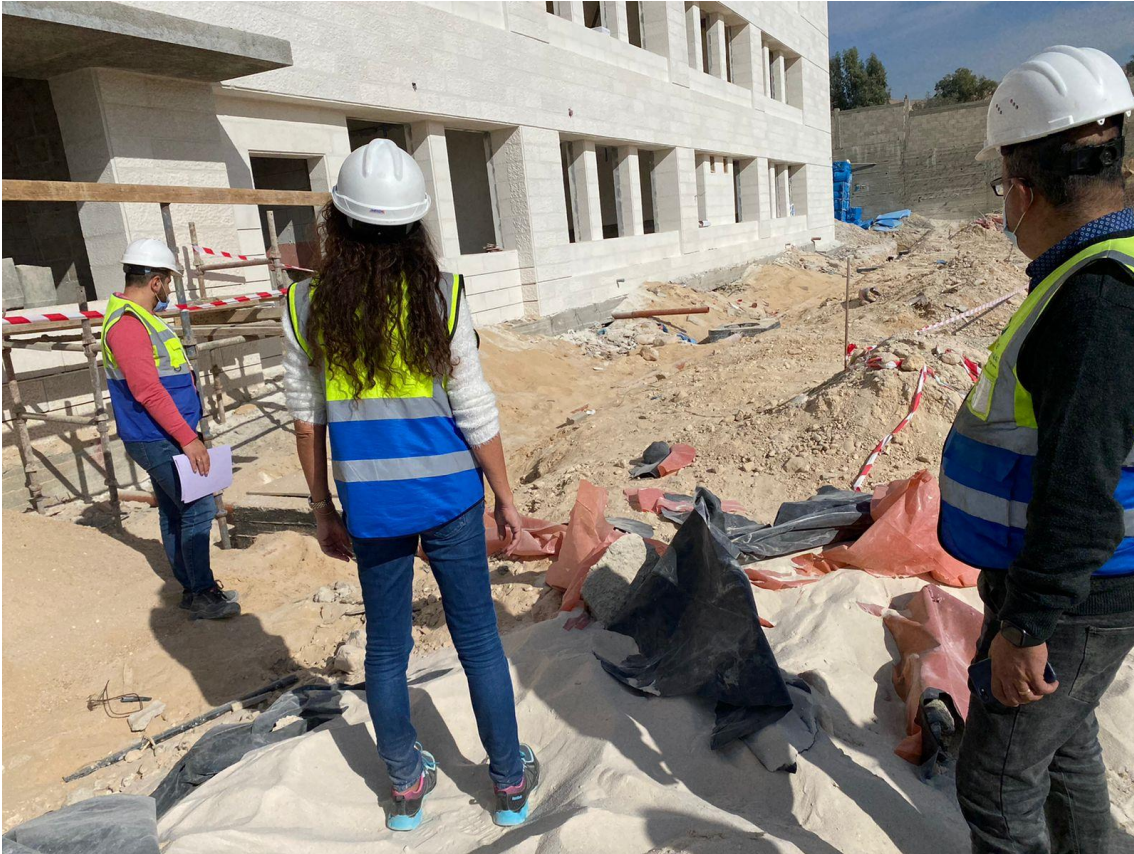
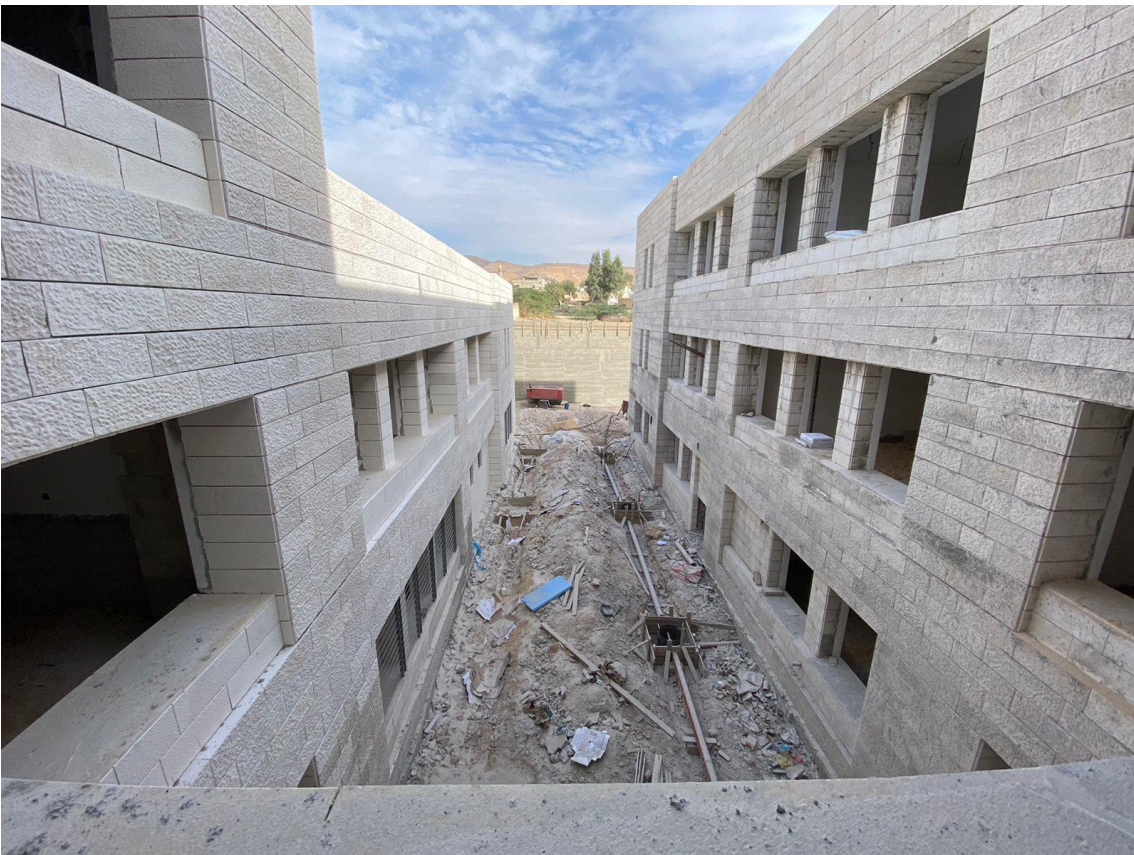
(Figure: 08 & 09)

The team conducted general inspection to the executed works in the external sewage network

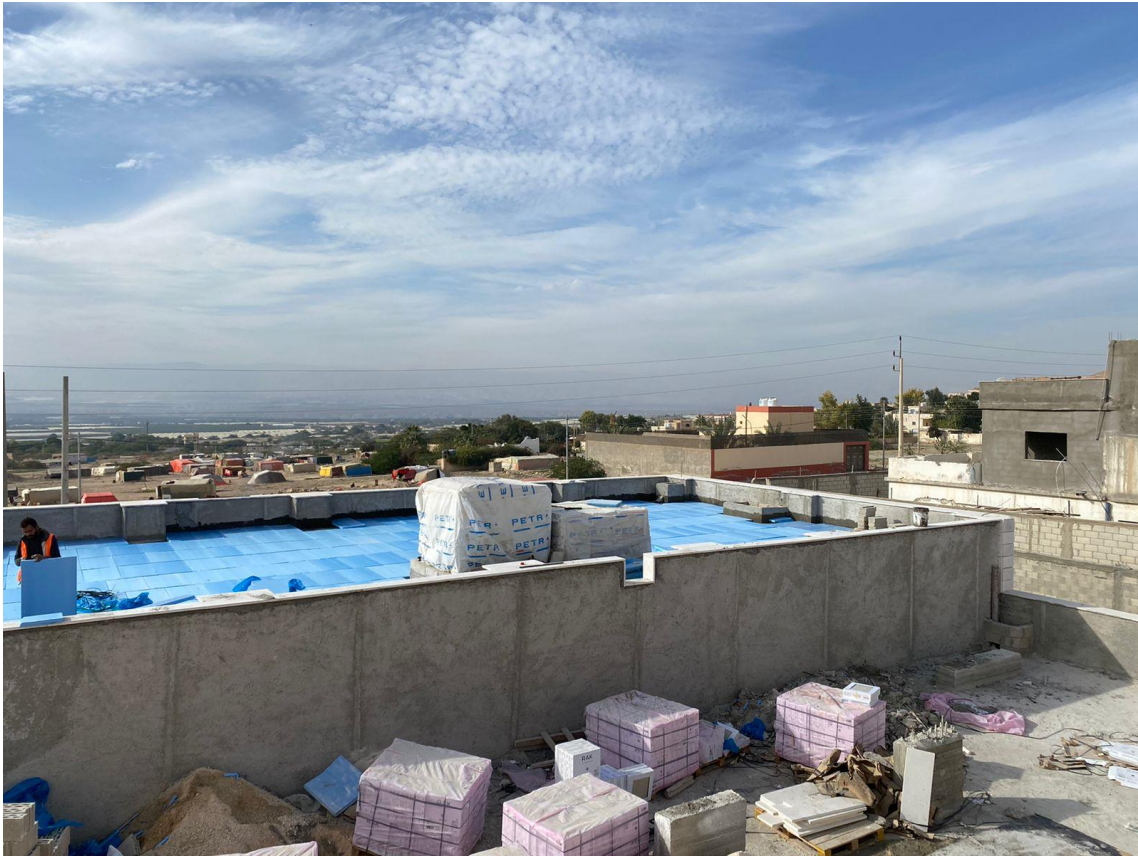
(Figure: 10)

The team observed that the Contractor executed the screed layer on the roof of the multi-purpose hall and also installing the cartonal boards at the top of screed layer

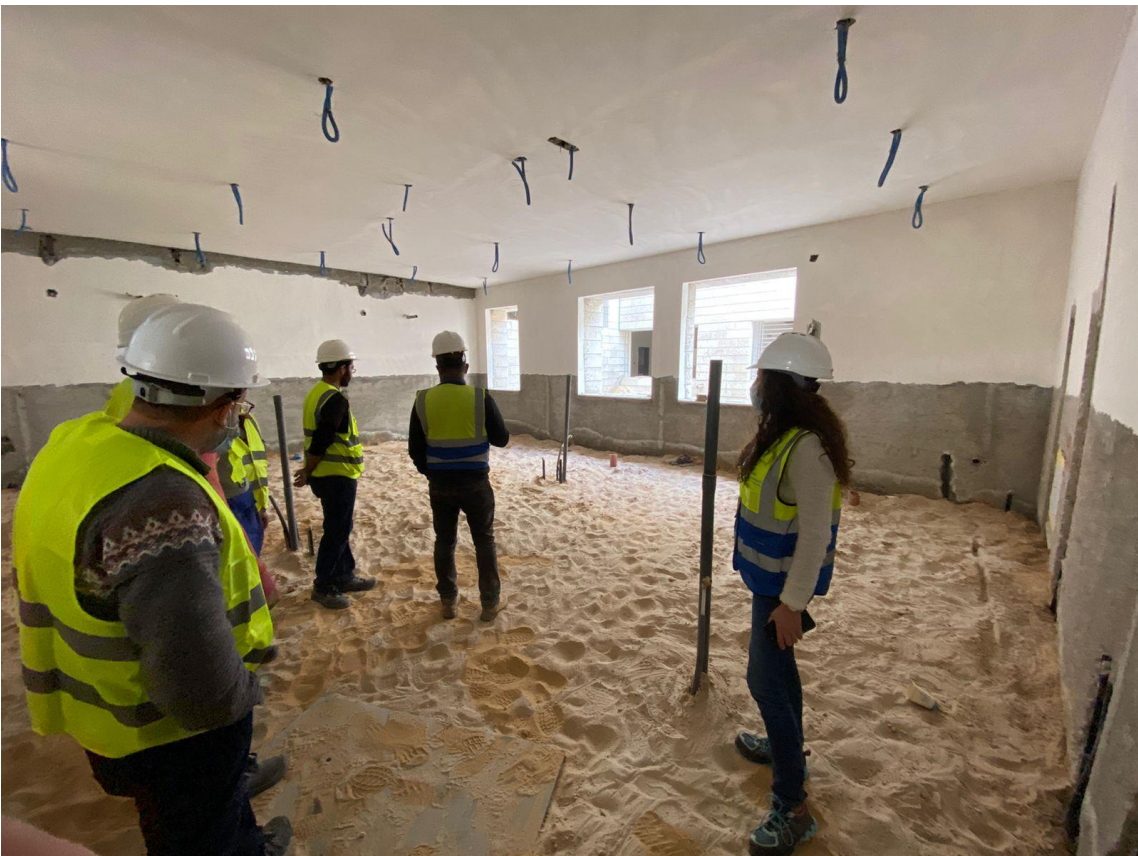
(Figure: 11)

The supervision team conducted general inspection to the executed electro-mechanical works at the laboratories

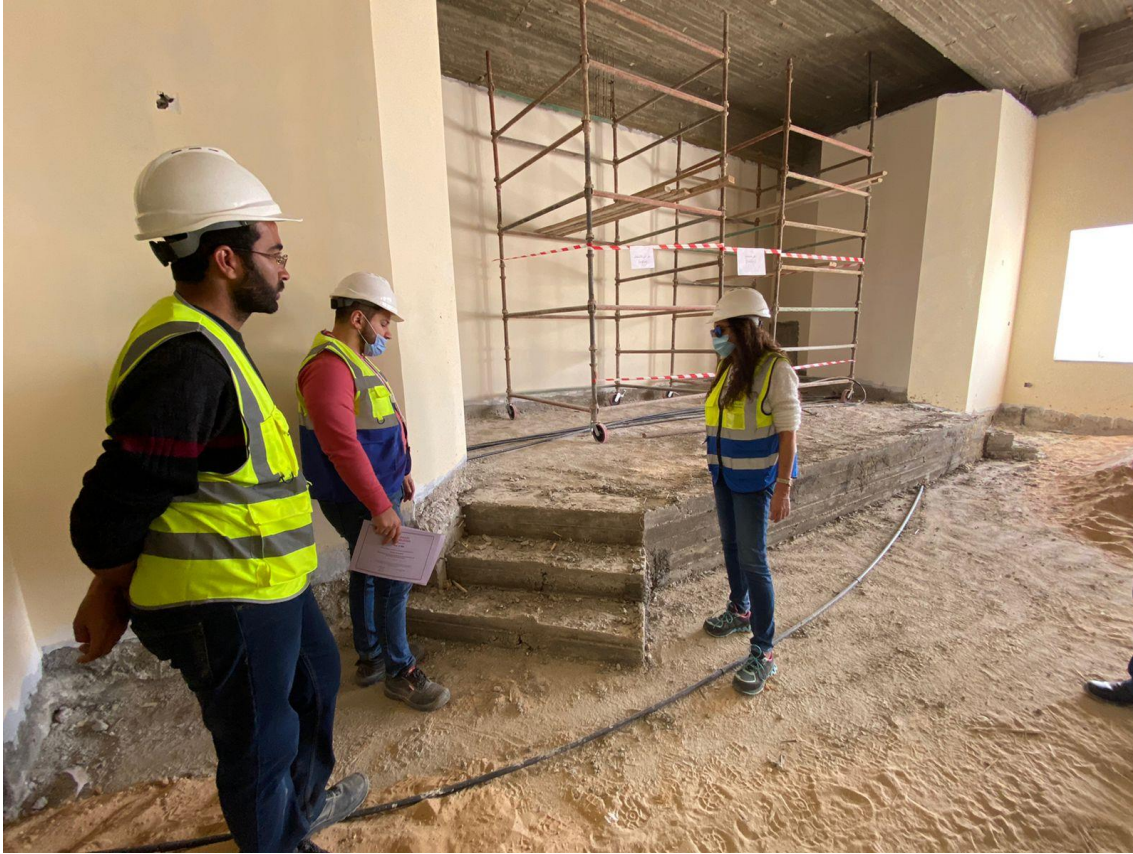
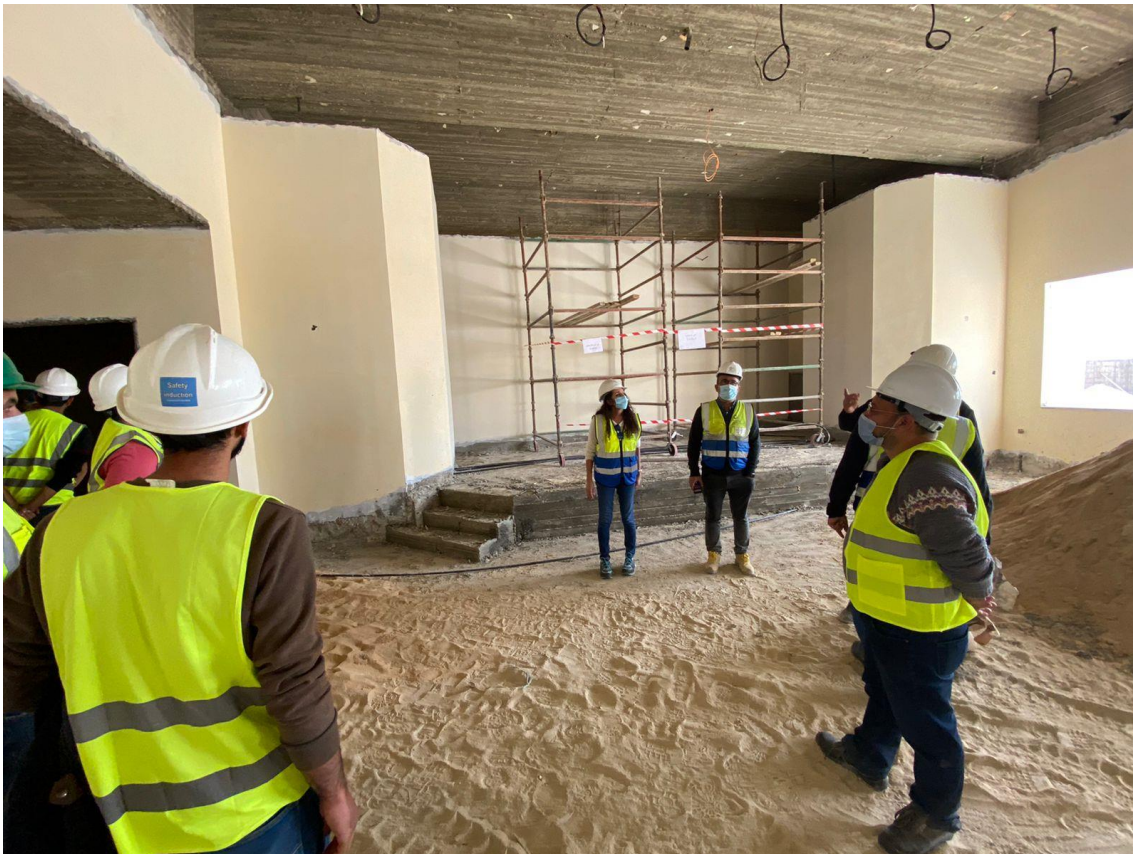
(Figure: 12 & 13)

The team inspected the executed works at the multi-purpose hall and insured the correct execution of the stairs inside the hall

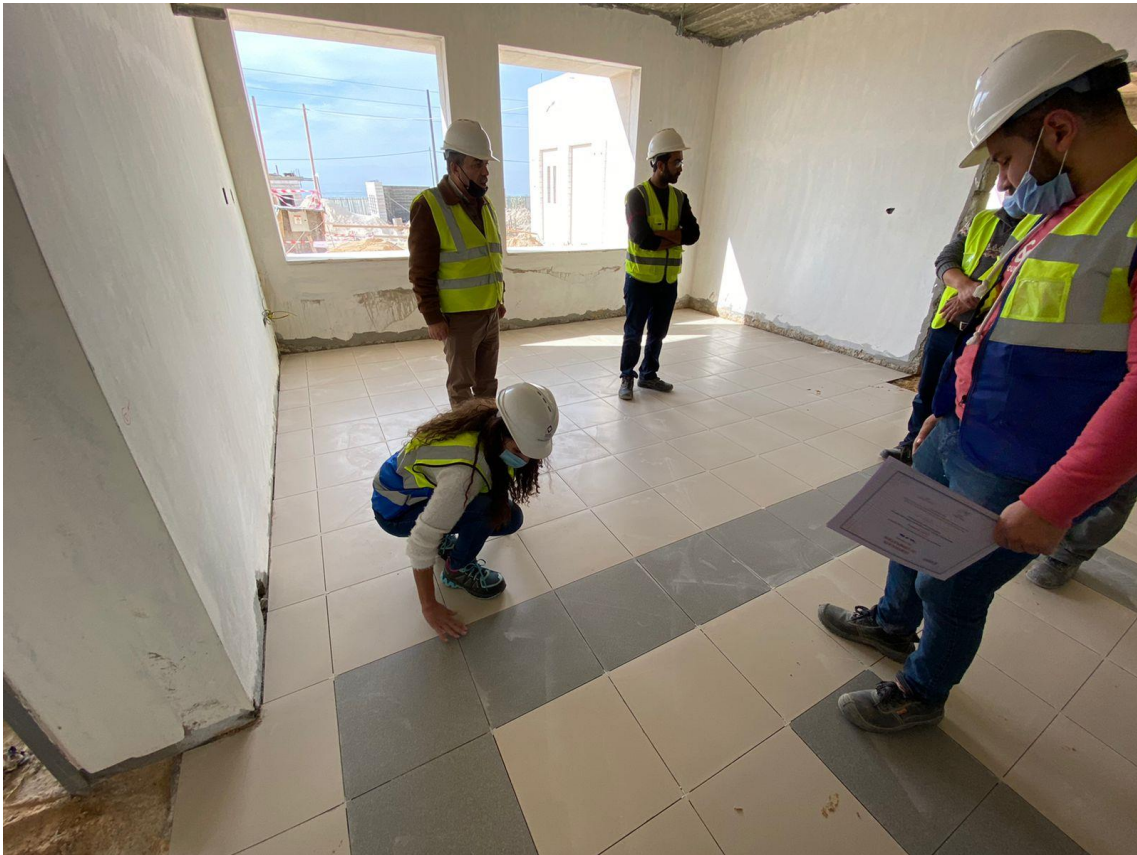
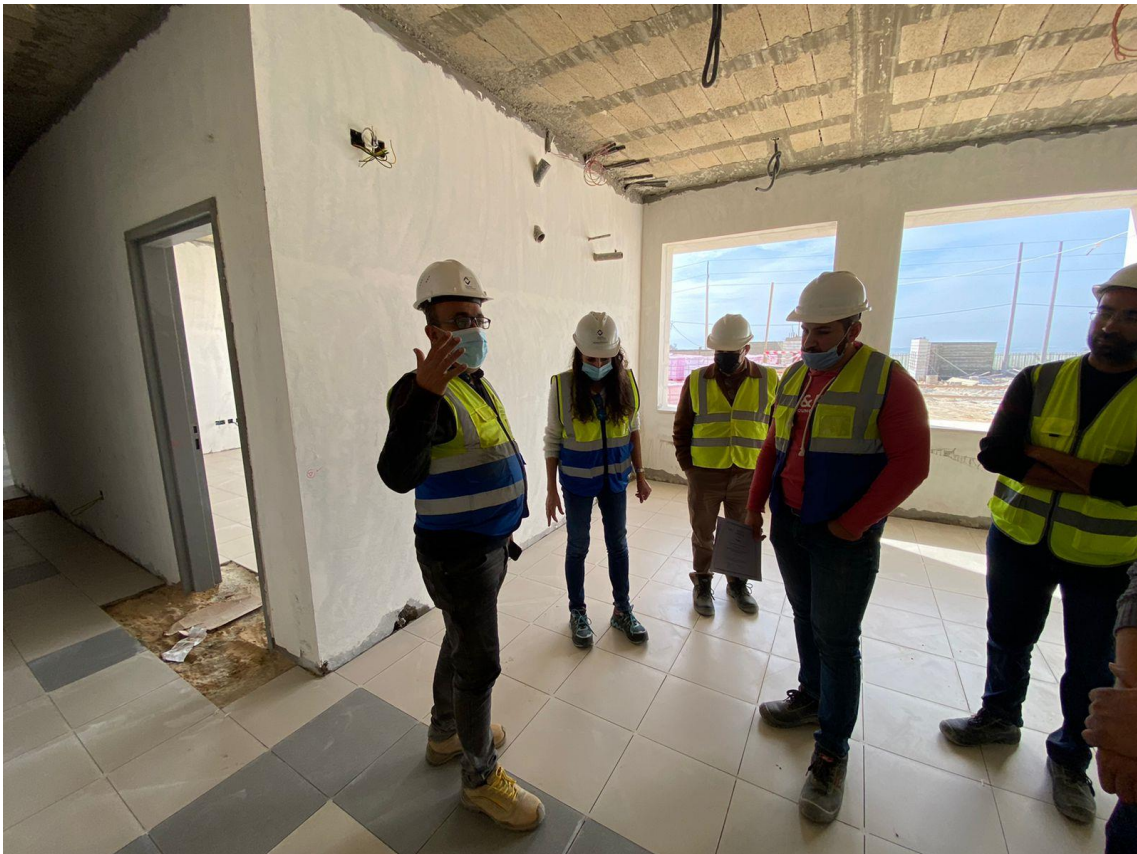
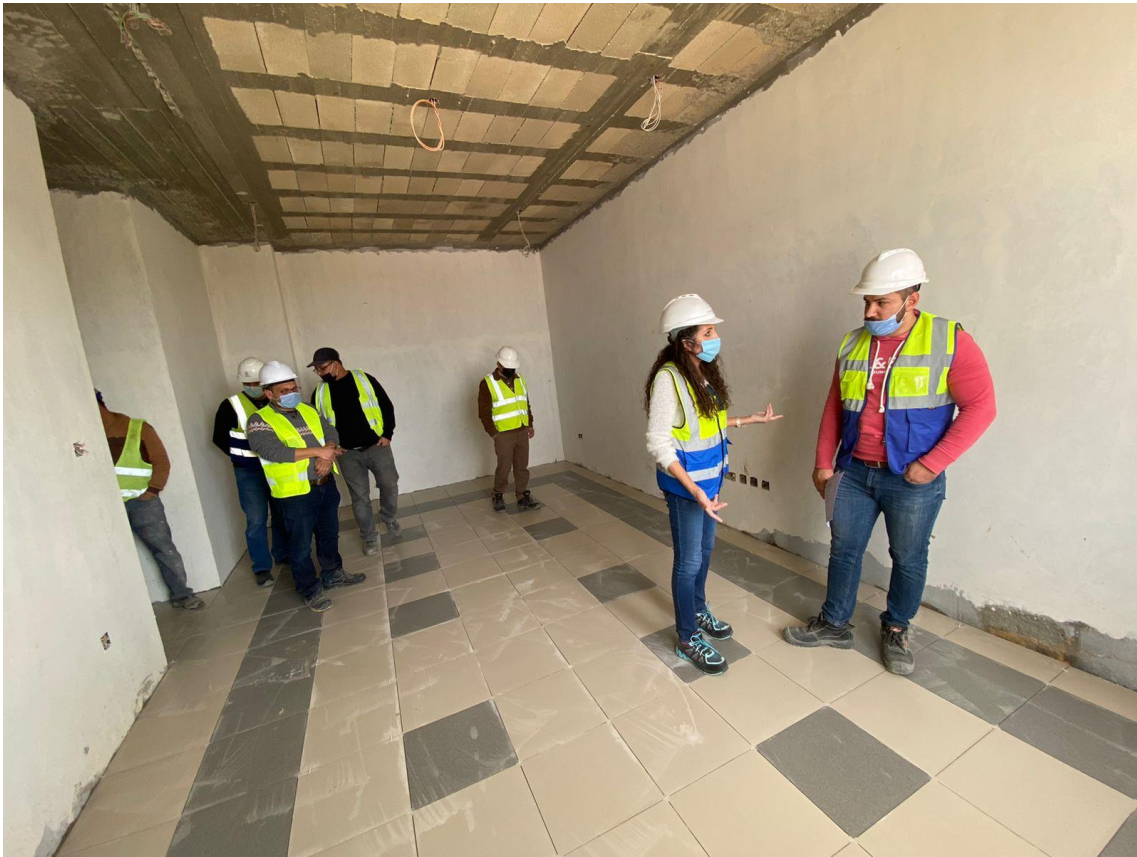
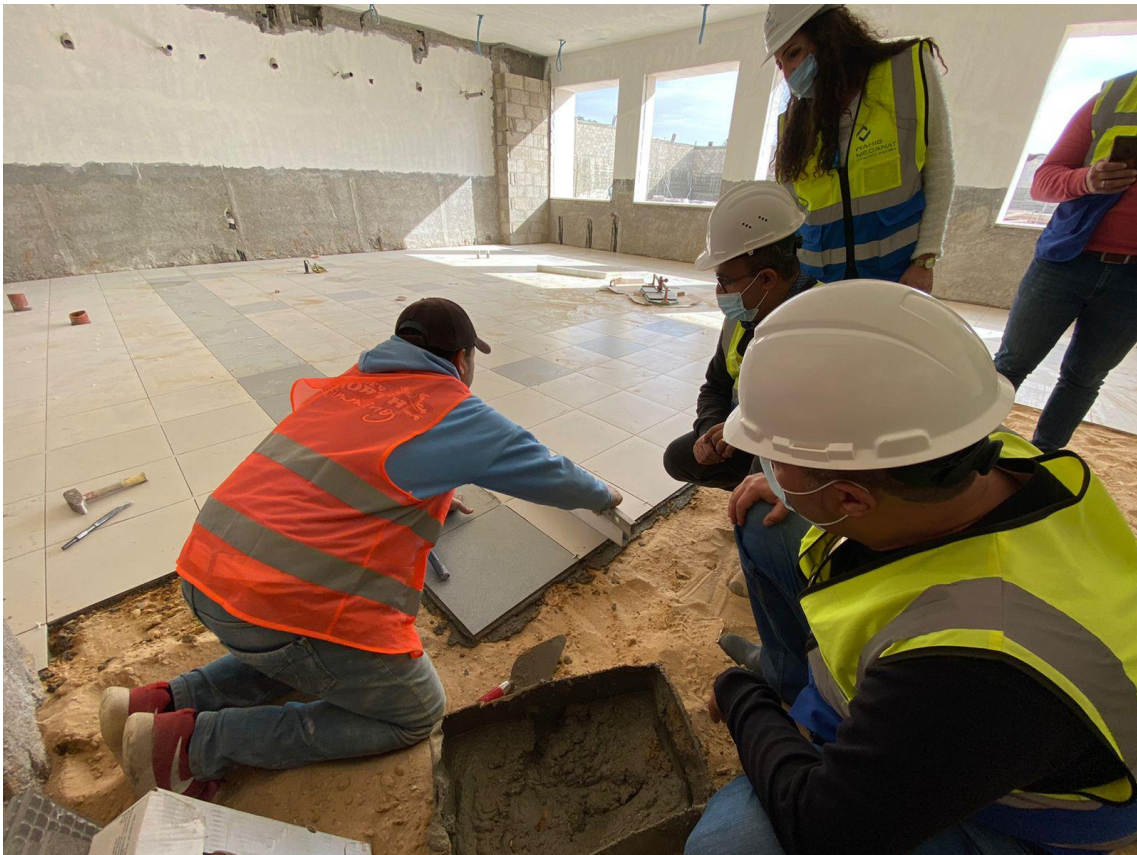
(Figure: 14, 15, 16 & 17)

The supervision team inspected the porcelain floor tiling work using the new delivered tiles replacing the removed defected tiles. The team observed that the quality of work is much better than before except some remarks the Contractor was instructed to rectify

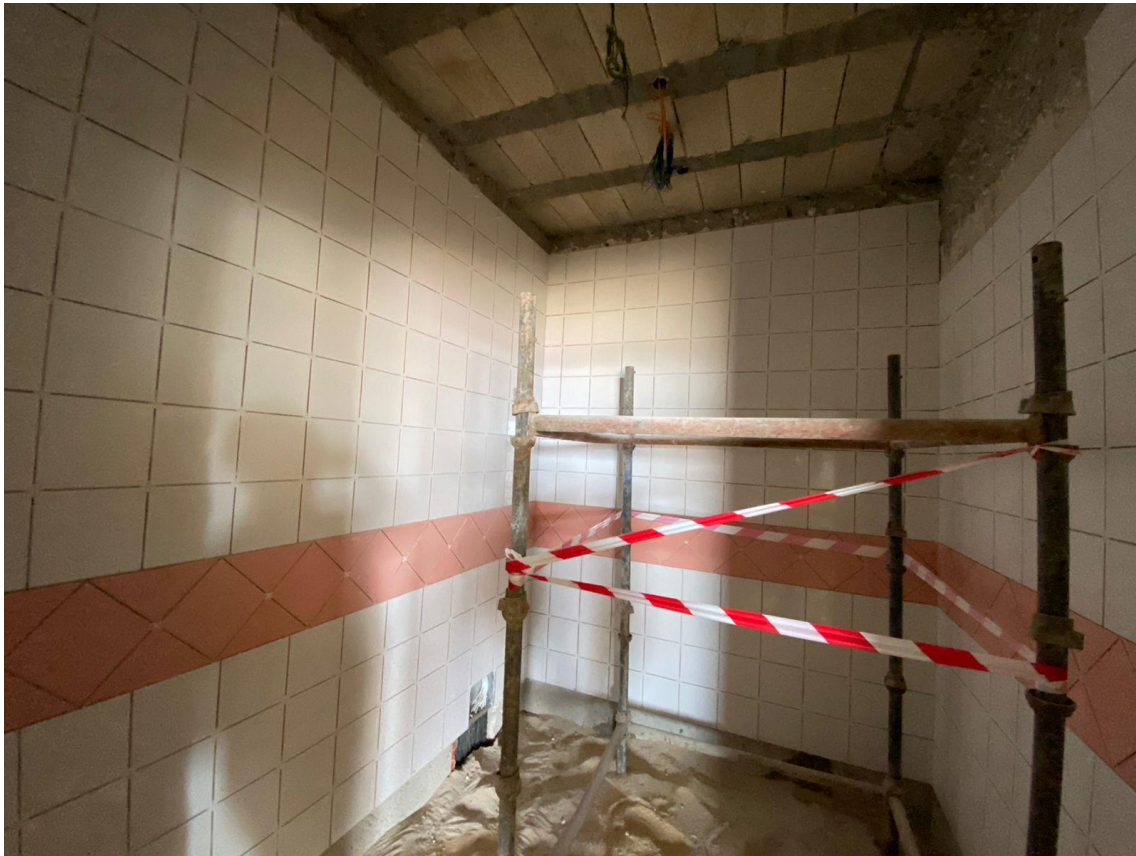
(Figure: 18)

The supervision team inspected the executed works for the ceramic wall tiles at the wet areas

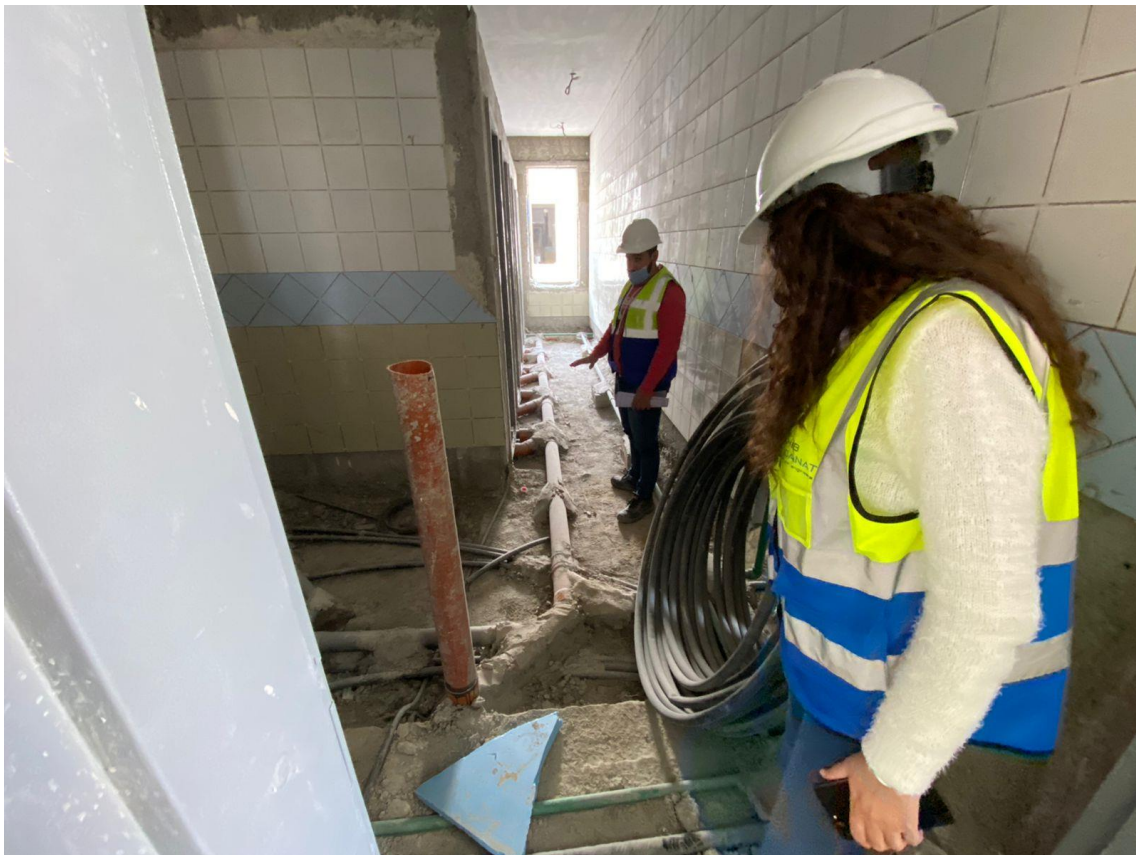
(Figure: 19)

The team conducted general inspection to the water supply and drainage networks inside the wet areas

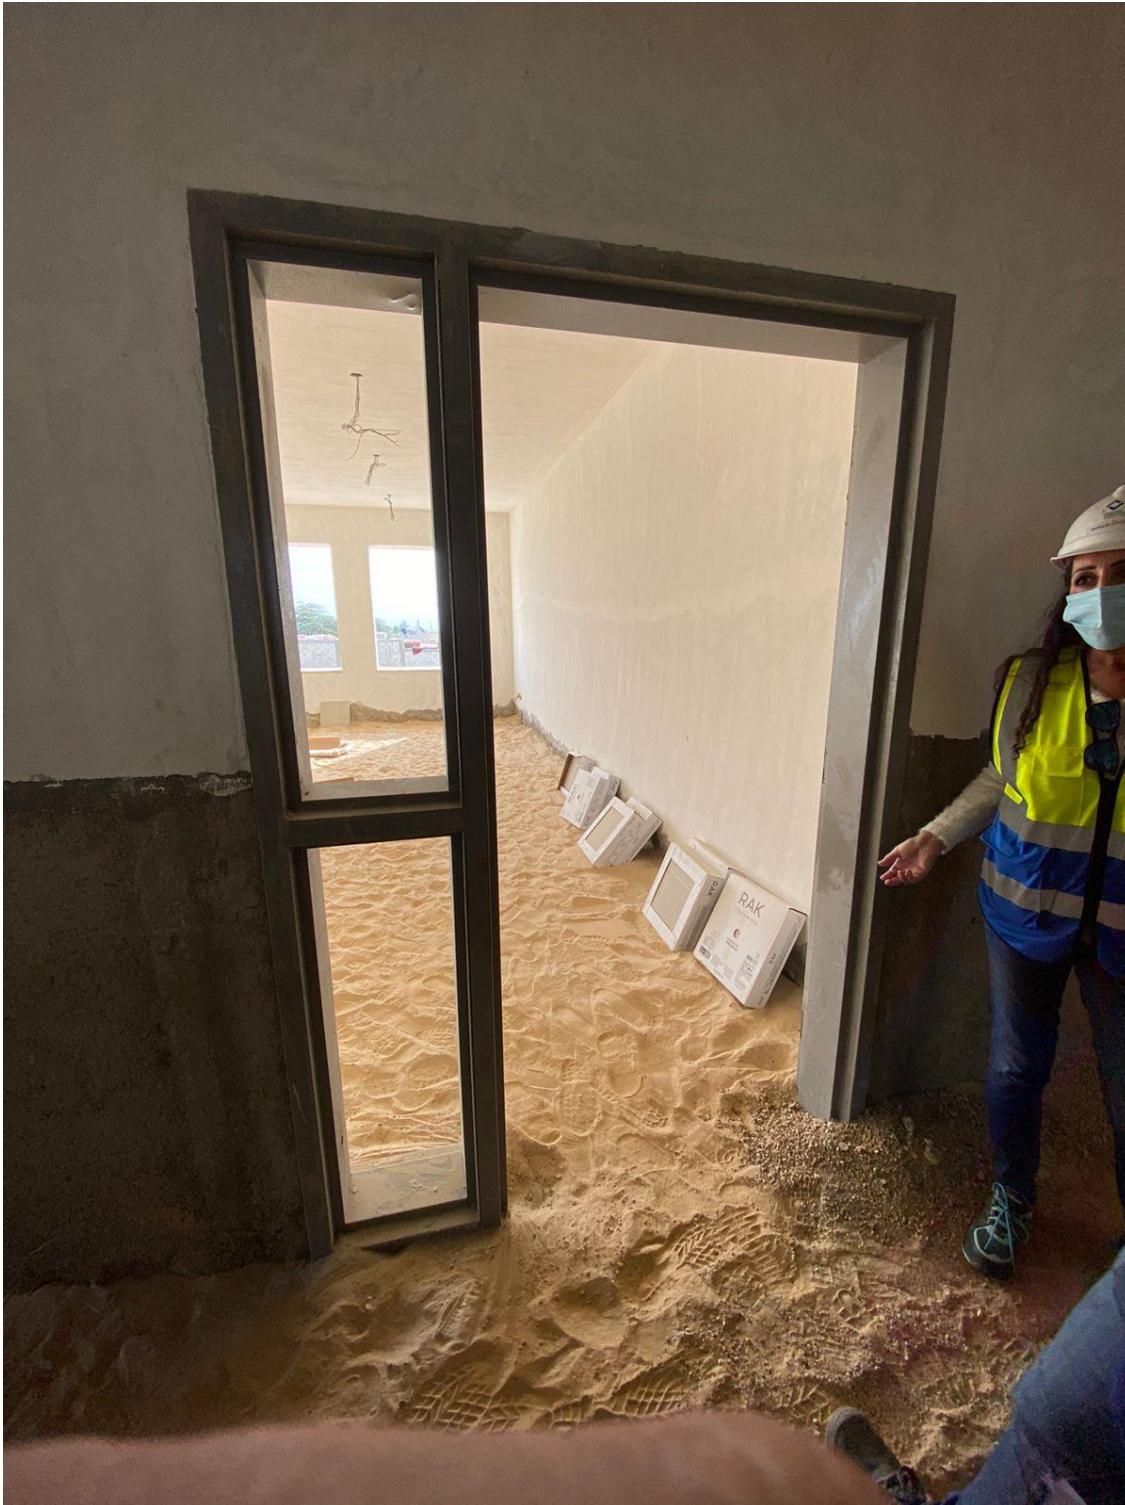
(Figure: 20)

The team observed that the Contractor has not wrapped part of steel door frames as required
