### Site Visit Report Form

School Name: Supervisory Engineer (SE) : Construction Contractor (CC): Date and Time of Field Trip: Date of Report: Weather During Visit Prepared By: Submitted By: SKEP III Package I Hai Al Iskan Basic School for Boys Medanat Consultant Engineers Dijlah Contracting May 23,2021 May 26,2021 Sunny 24° Osama Obeid **CMTO/Trigon** Osama Obeid **CMTO/Trigon**

### FTR # QR387

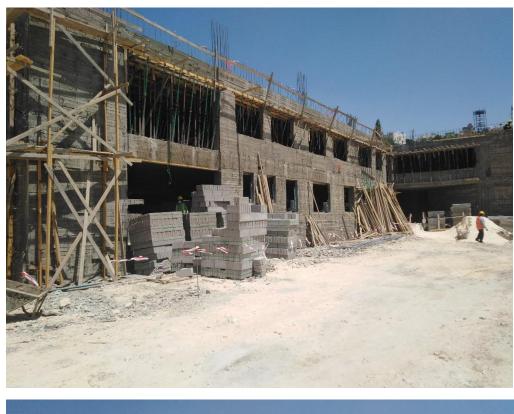
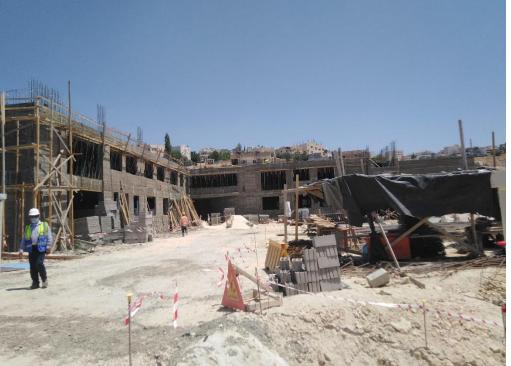
#### FIGURE #02 &03:

The School consists of four floors and roof with total surface area of 5400 sq.m, in addition to other site works of total surface 4520 sq.m. The basement, ground and first floor slabs are completed

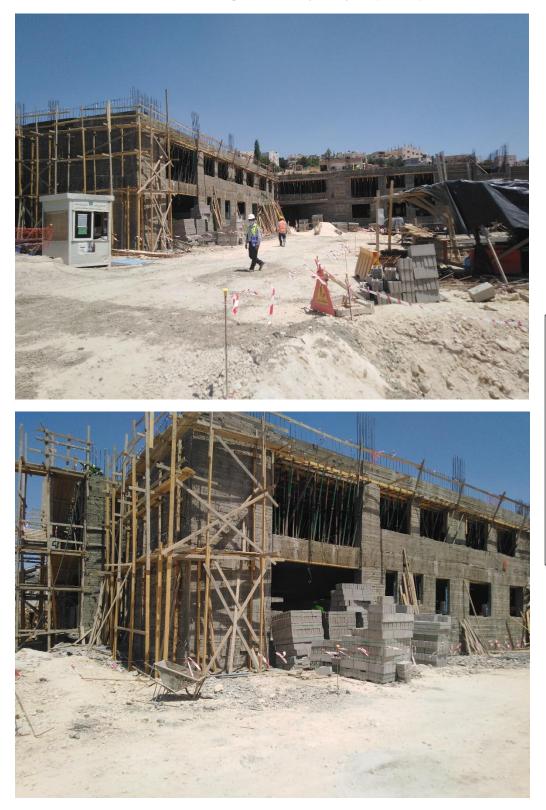
### FIGURE #04&05:

The School consists of four floors and roof with total surface area of 5400 sq.m, in addition to other site works of total surface 4520 sq.m. The basement, ground and first floor slabs are completed

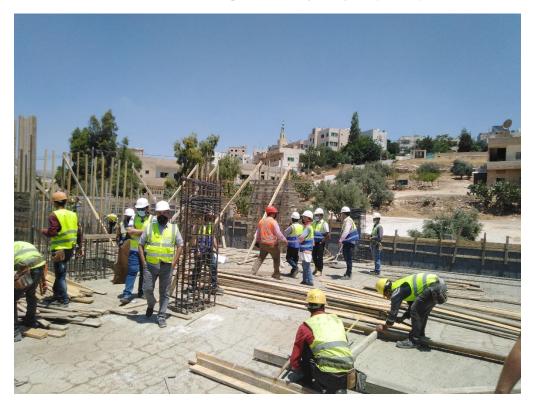
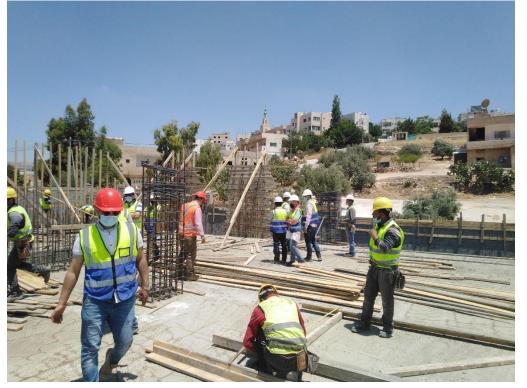
#### FIGURE #06&07:

Preparation works for placing concrete for the columns of the second floor

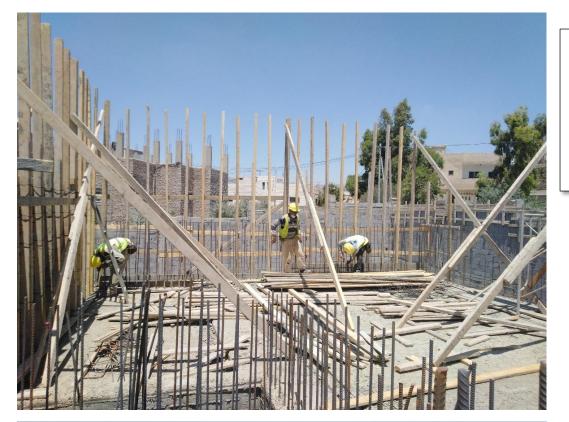
### FIGURE #09:

Preparation works for placing concrete for the stairwell

There is no edge protection (unsafe for workers, site staff and visitors)

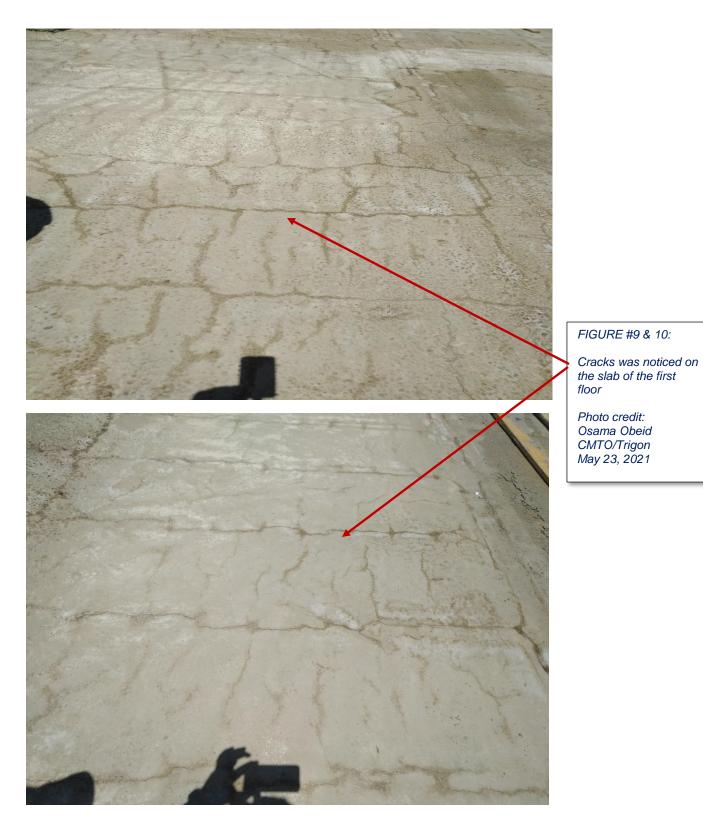
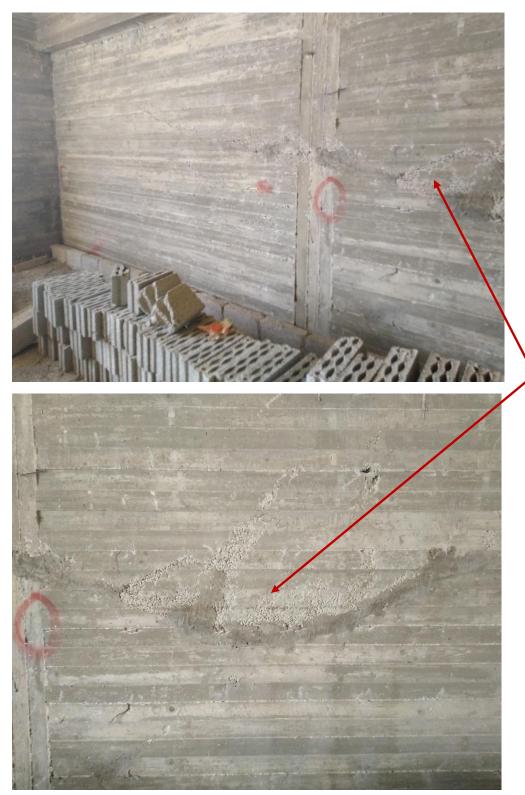
#### FIGURE #11 & 12:

Roughness and segregation in concrete was noticed on walls

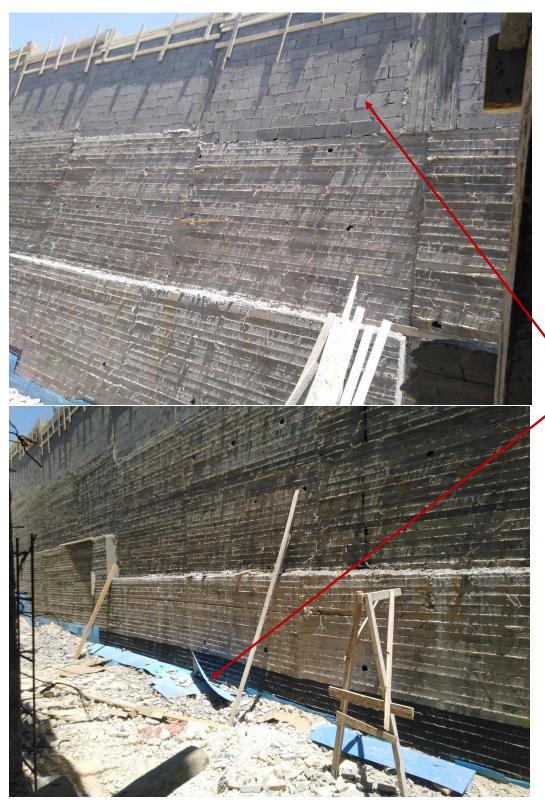
### FIGURE #10 & 11:

Poor workmanship was noticed in the cement block walls of the retaining walls

Damaged Cartonal Sheets must be replaced

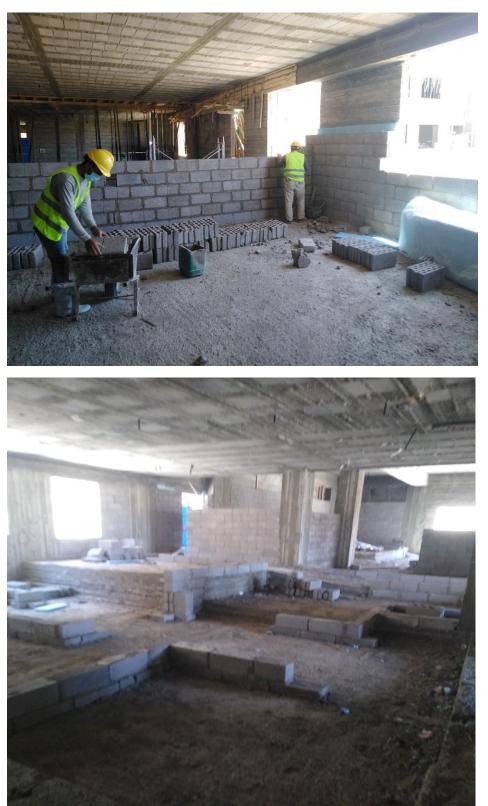
### FIGURE #12 & 13:

The CC start building the cement block walls in the ground floor

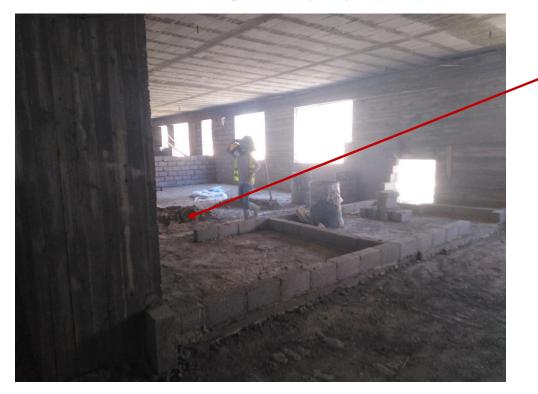
#### FIGURE #14

Mixing the cement with water on the floor without using a container will not keep the water/cement ratio as per specs and will make the area wet under floor tiles
