Quality Control Report

Consultant **Wahib Medanat** Consultant Engineers
Site Name **Jumana Bint Abi Taleb Basic Mixed - Marka**
Package **Package 2**
Contractor **Dijlah Est. Construction Co.**
Tender No. **10/2019/USAID/SKEP/3/2**

Rep No. **QC-23 15**
Date **12 / 02 / 2022**

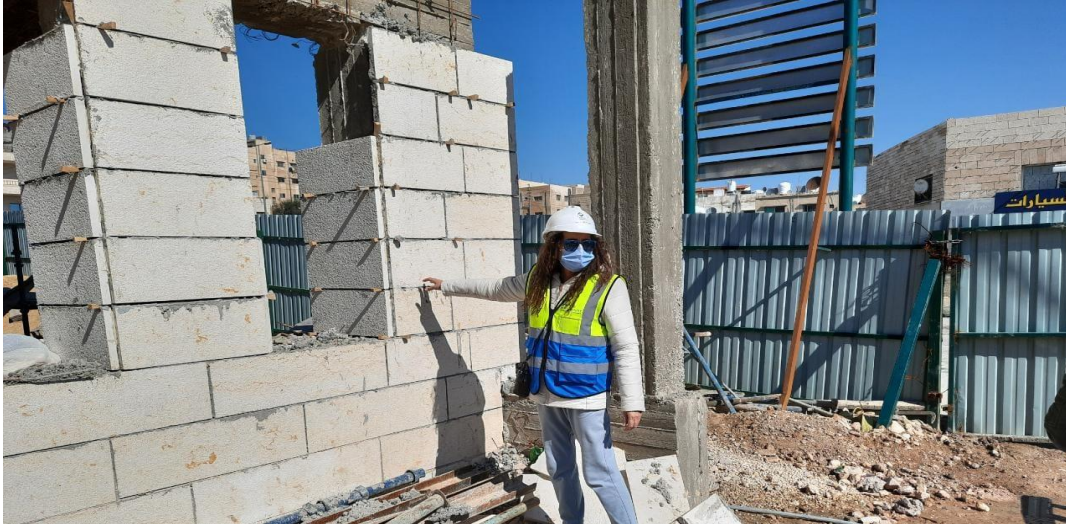
Defected stones at the guard room

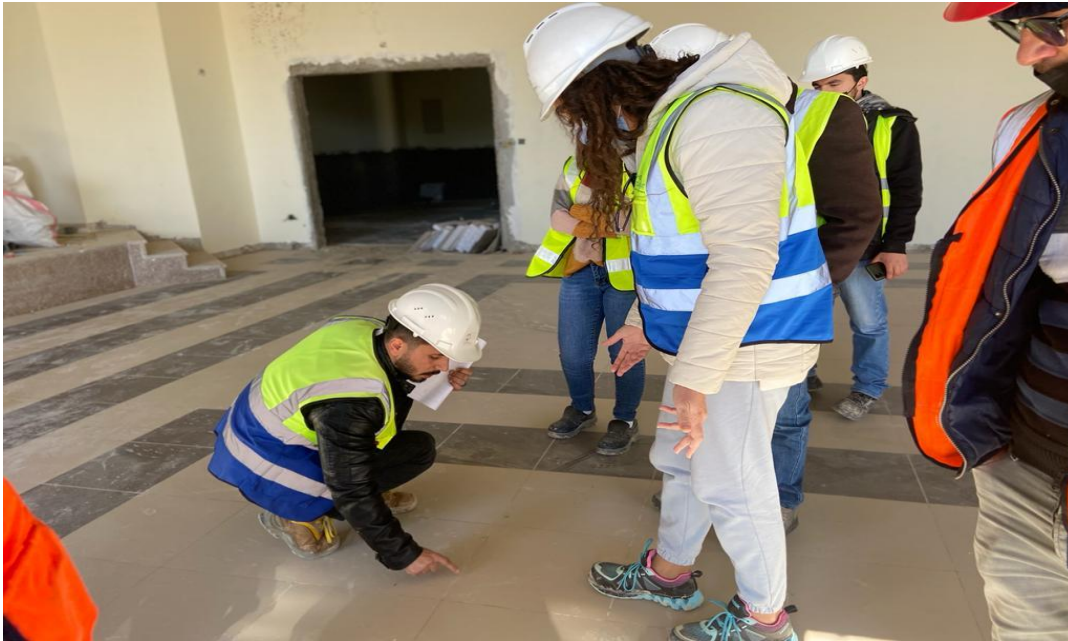
Teething at the porcelain floor tiles

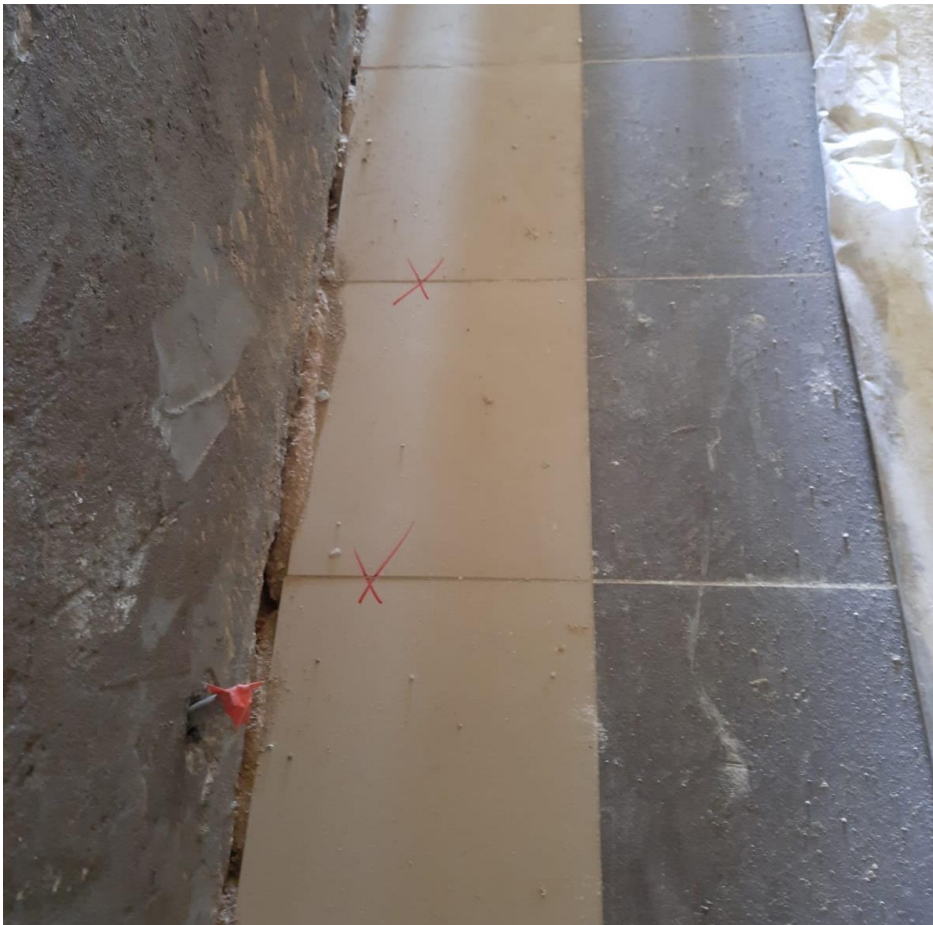
Teething at the porcelain floor tiles at the corridor

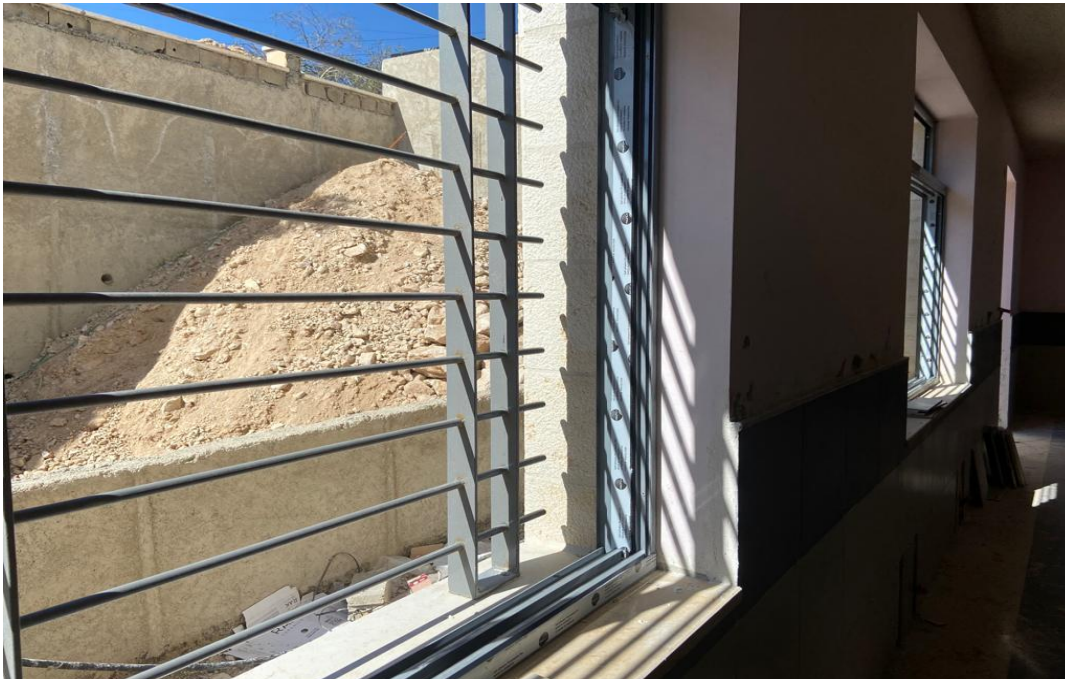
Corrosion at the steel protection screen

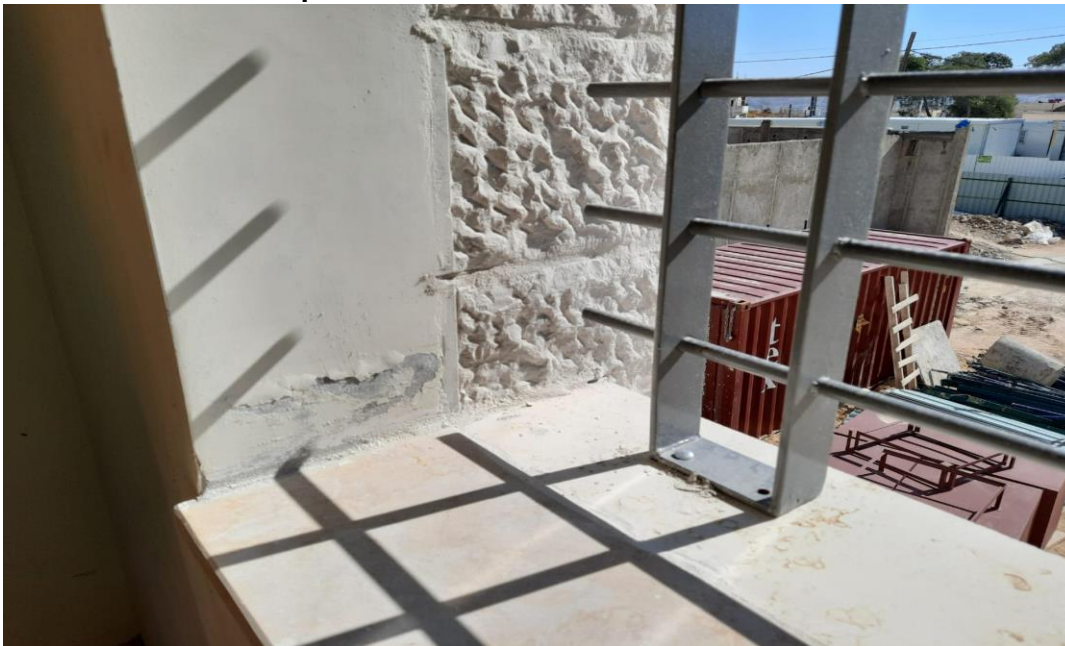
Defect at the window jamb

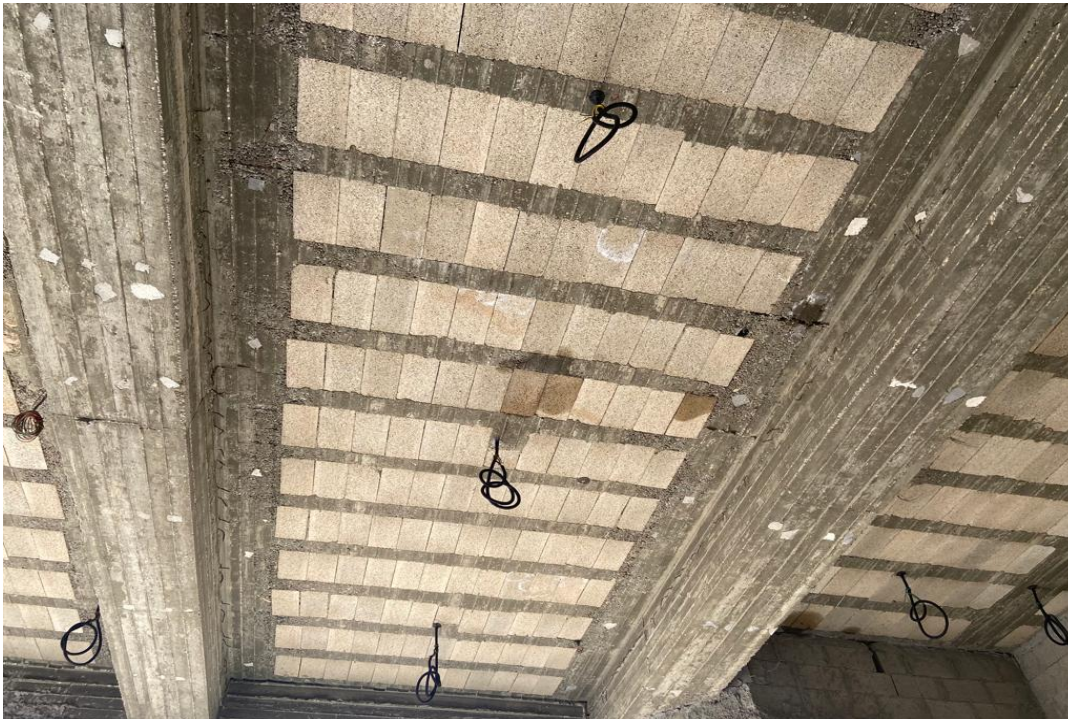
Leakage at the ceiling of the multi-purpose hall

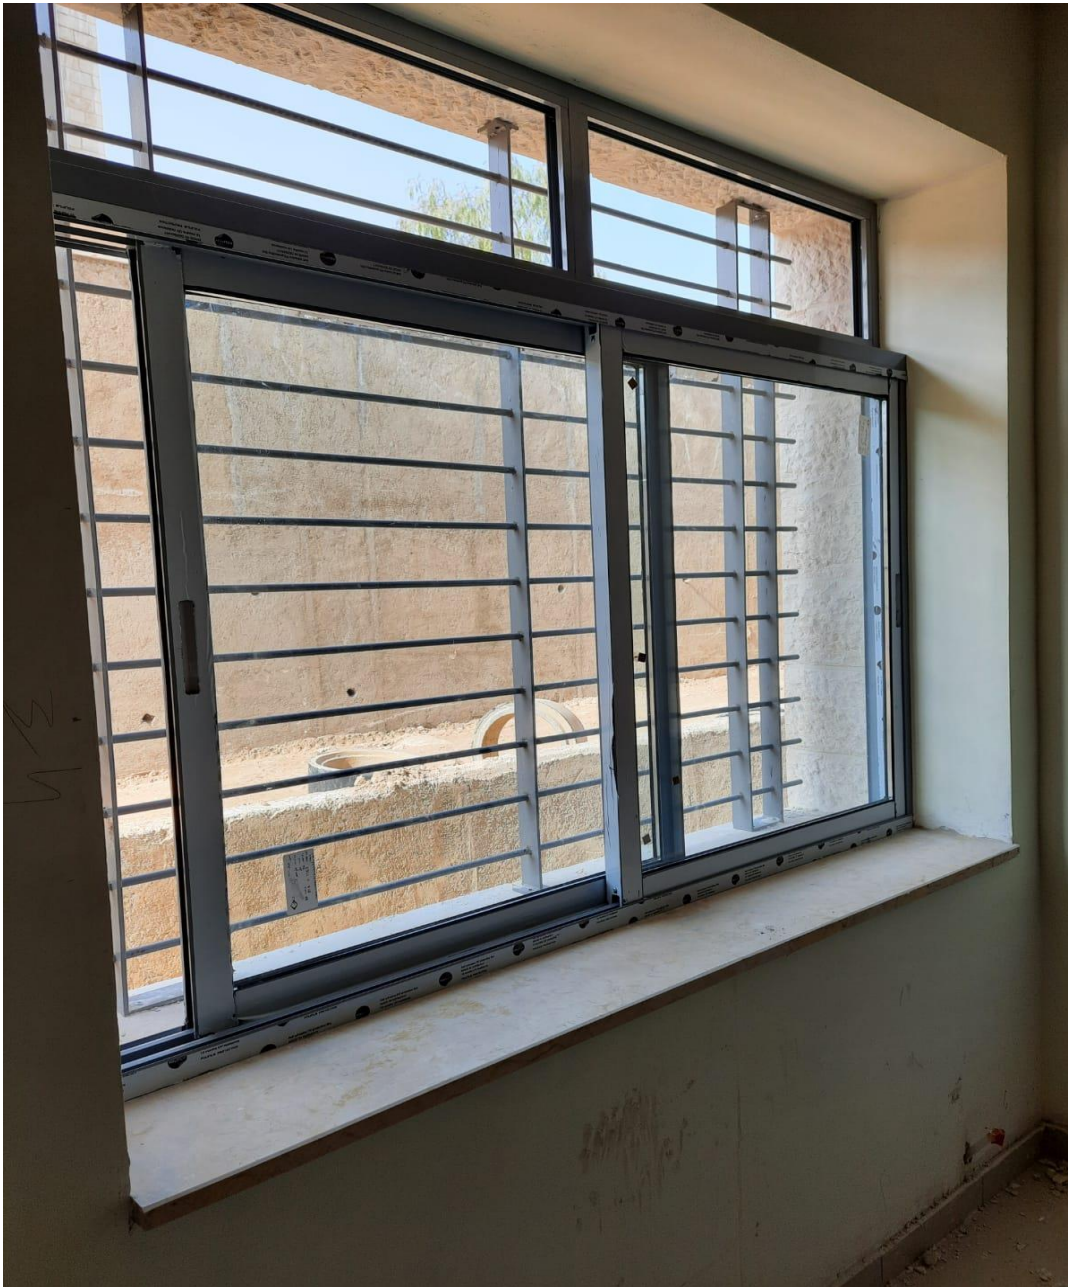
Defects in installed aluminum window
