## SKEP III Home Office Support Site Visit Report

Consultant	Wahib Medanat Consultant Engineer	Rep No.	22-22082022
Contractor	Dijlah Establishment Constr. Contracting	Tender No.	(11/2019/USAID/SKEP/3/S) Schools for a Knowledge Economy Project (SKEP) - Phase (3) Package (1, 2)
Site Name	Thahr Al Sarow Basic School for Boys- Jerash	Day/ Date	Mon. 22/08/2022
Duration of Project	450 Calendar Days	Total Project Budget	8,314,983.735 JD

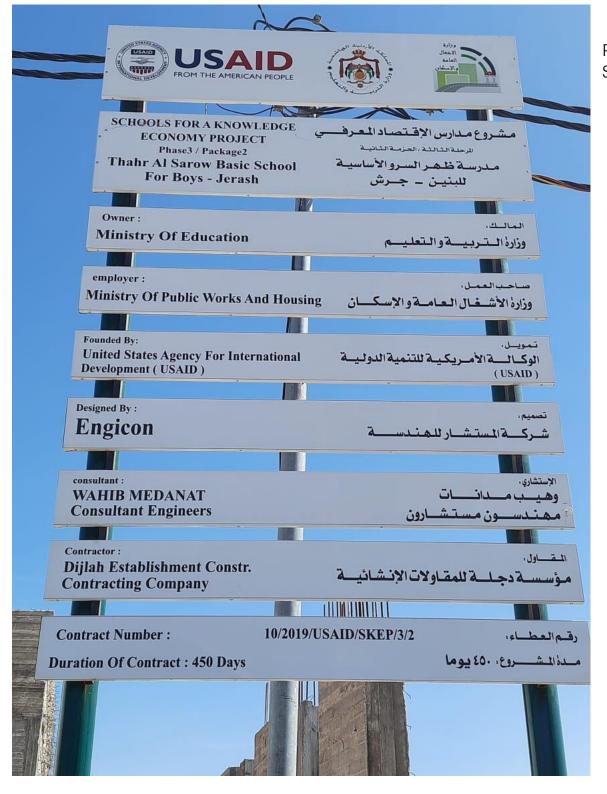
Project ID Sign on Site

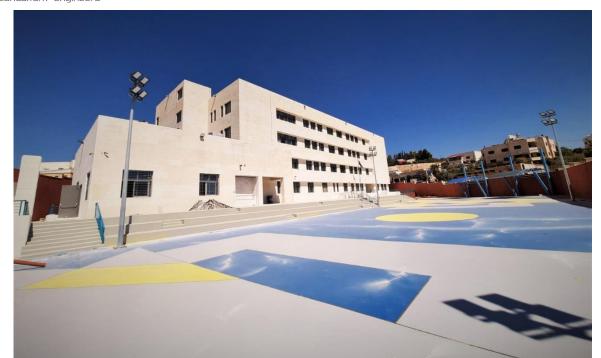
(Figure: 01)

General view of the project site

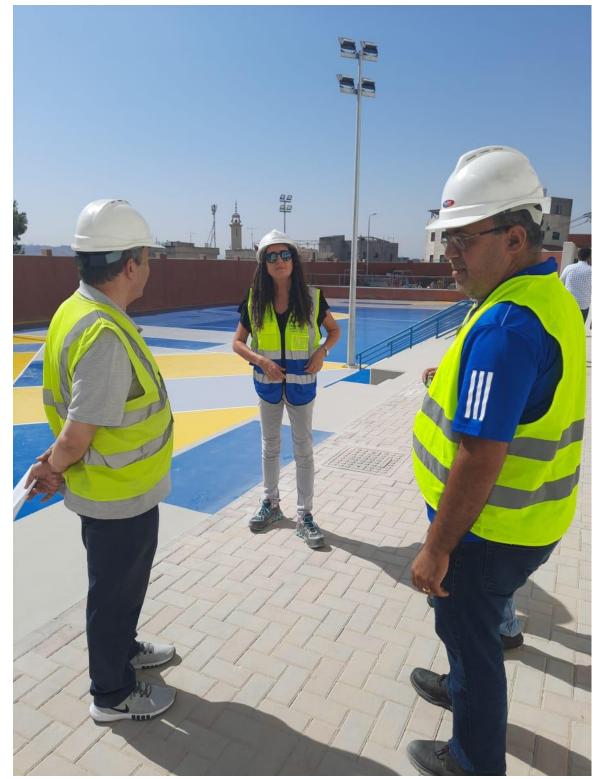
(Figure: 05)

The Supervision team inspecting the execution of external works

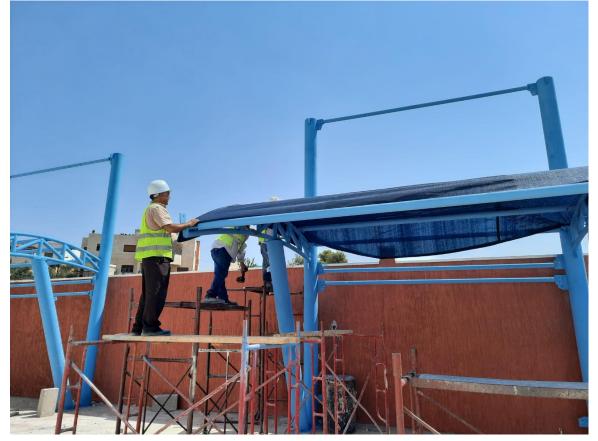
Shadings fixation

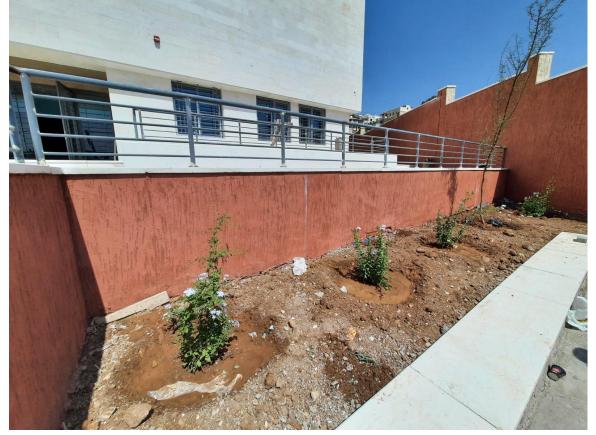
(Figure: 07)

Observing planting planters with trees

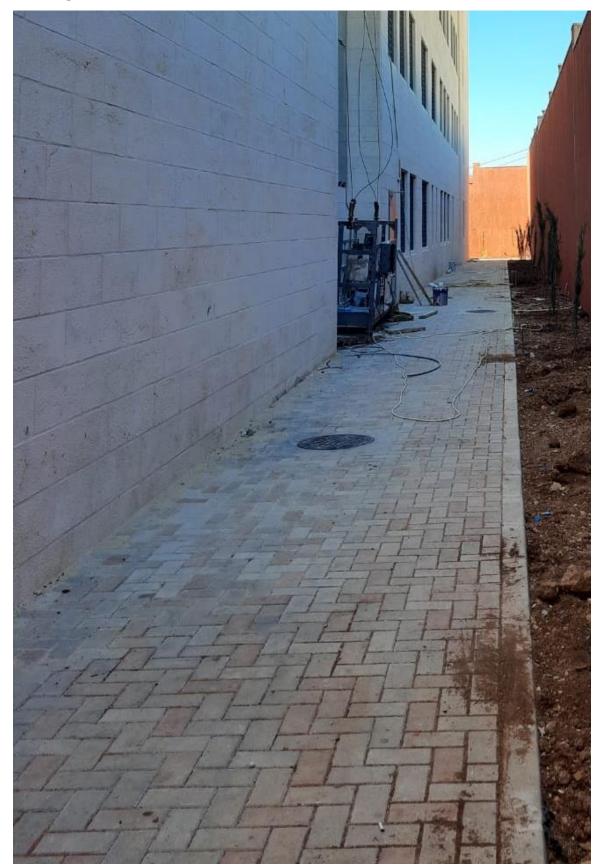
(Figure: 08)

Interlock tiling works around the school building

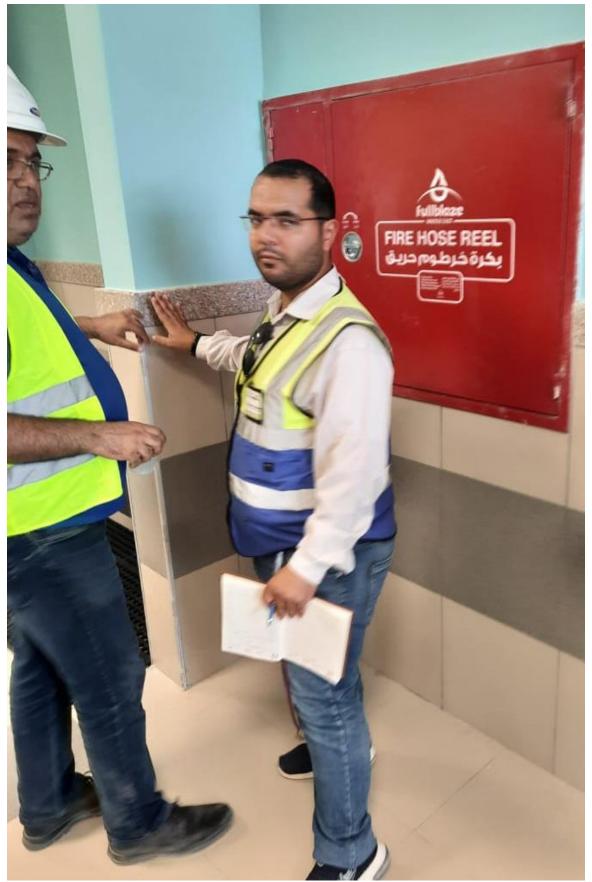
(Figure: 09)

The team inspecting granite coping and of fire hose cabinets installation at the corridors

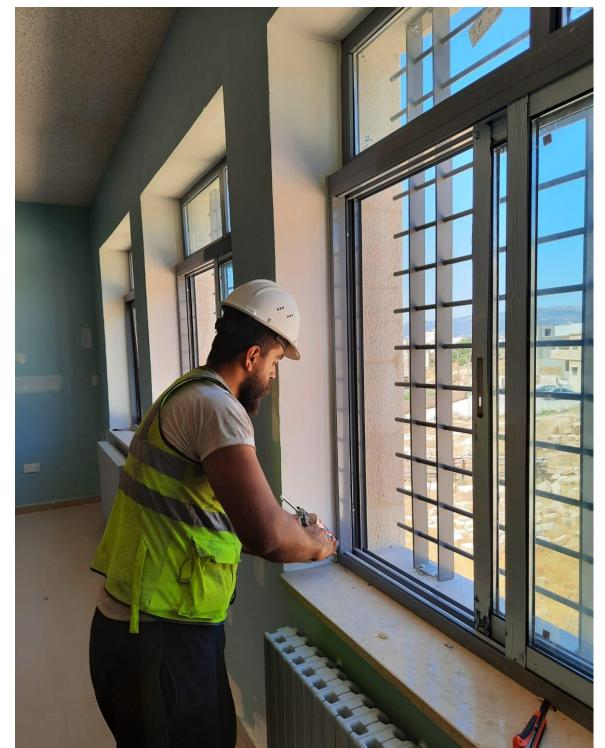
(Figure: 10)

Observing aluminum windows fixation

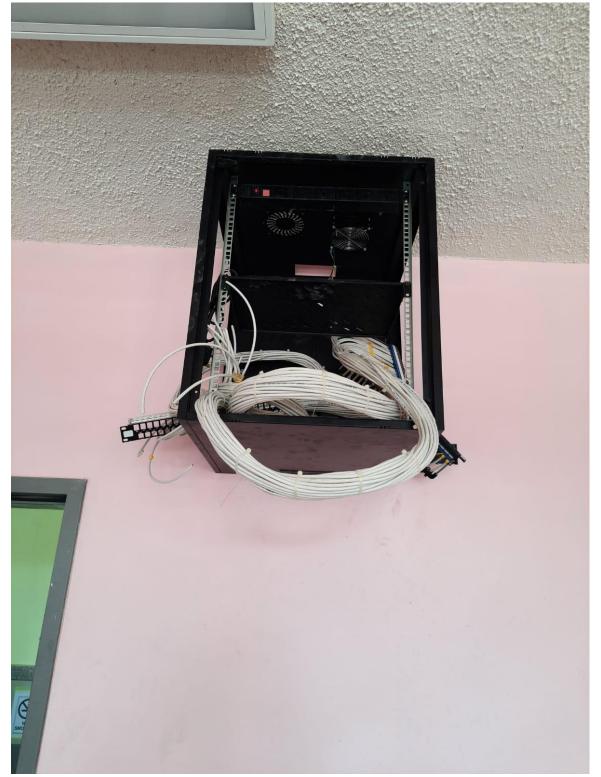
(Figure: 11)

Installation of data systems

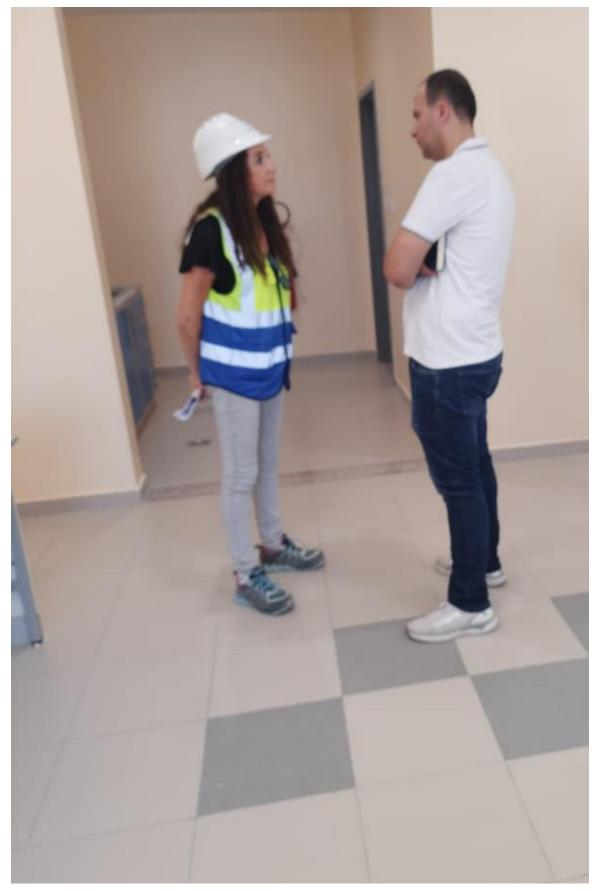
(Figure: 12)

The team inspected floor tiling and painting work

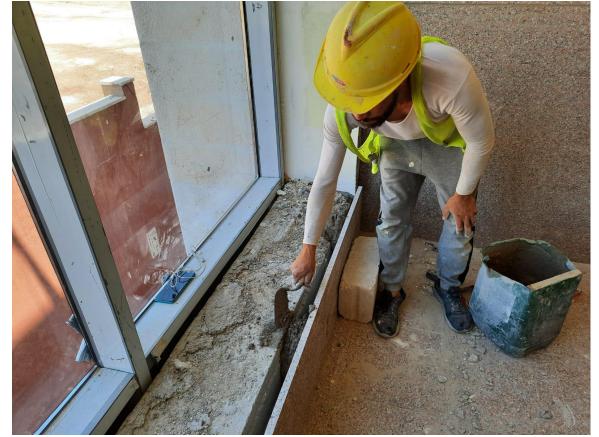
(Figure: 13)

executed works for the curtain wall
