Quality Control Report

Consultant **Wahib Medanat** Consultant Engineers
Site Name **Khadija Bint Khwailed Basic Mixed - Balqa**
Package **Package 1**
Contractor **Derar Saraireh & Sons for Engineering & Contracting**
Tender No. **1/2020/USAID/SKEP/3/1**

Rep No. **QC-13 16**
Date **11 / 04 / 2022**

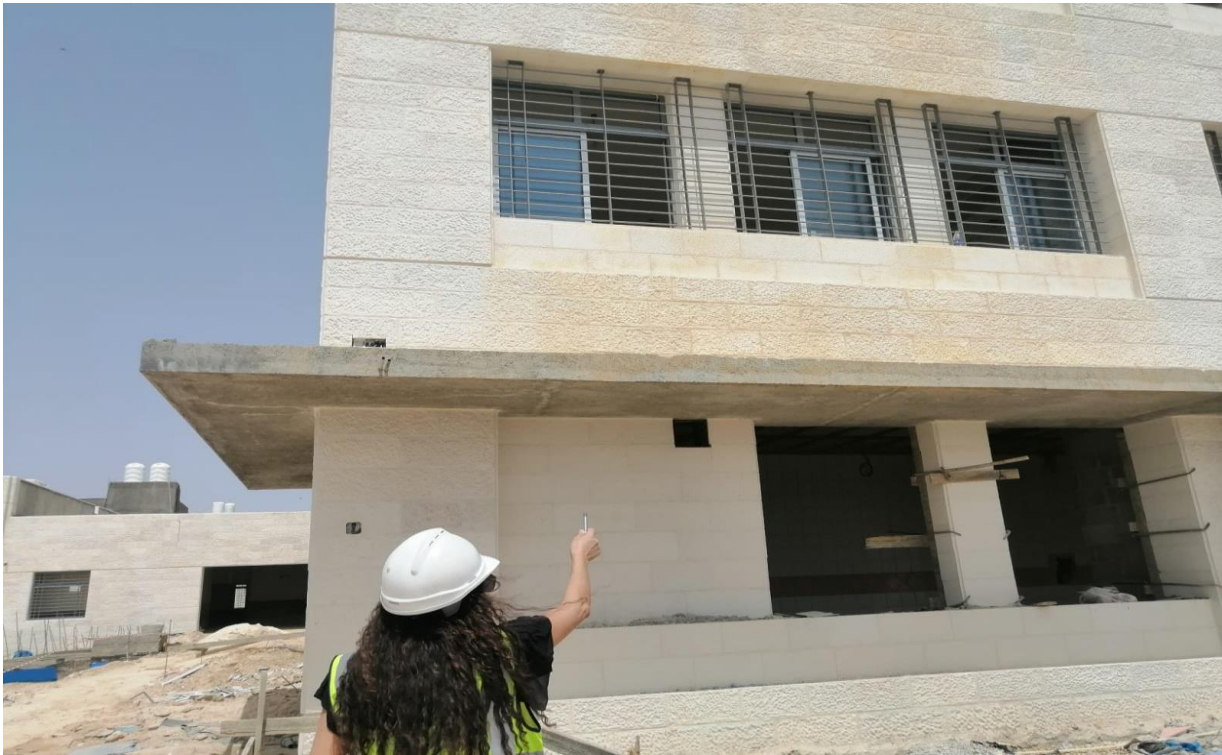
Defected stones and dirt

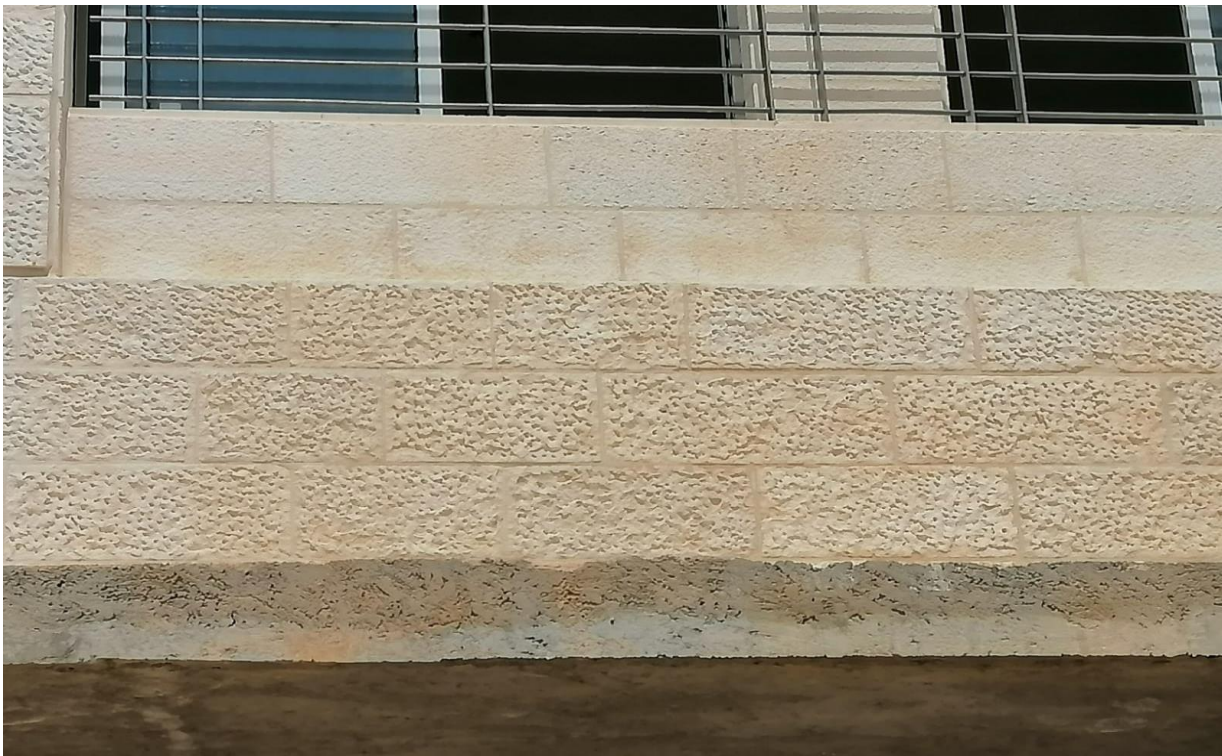
Defected stones and dirt

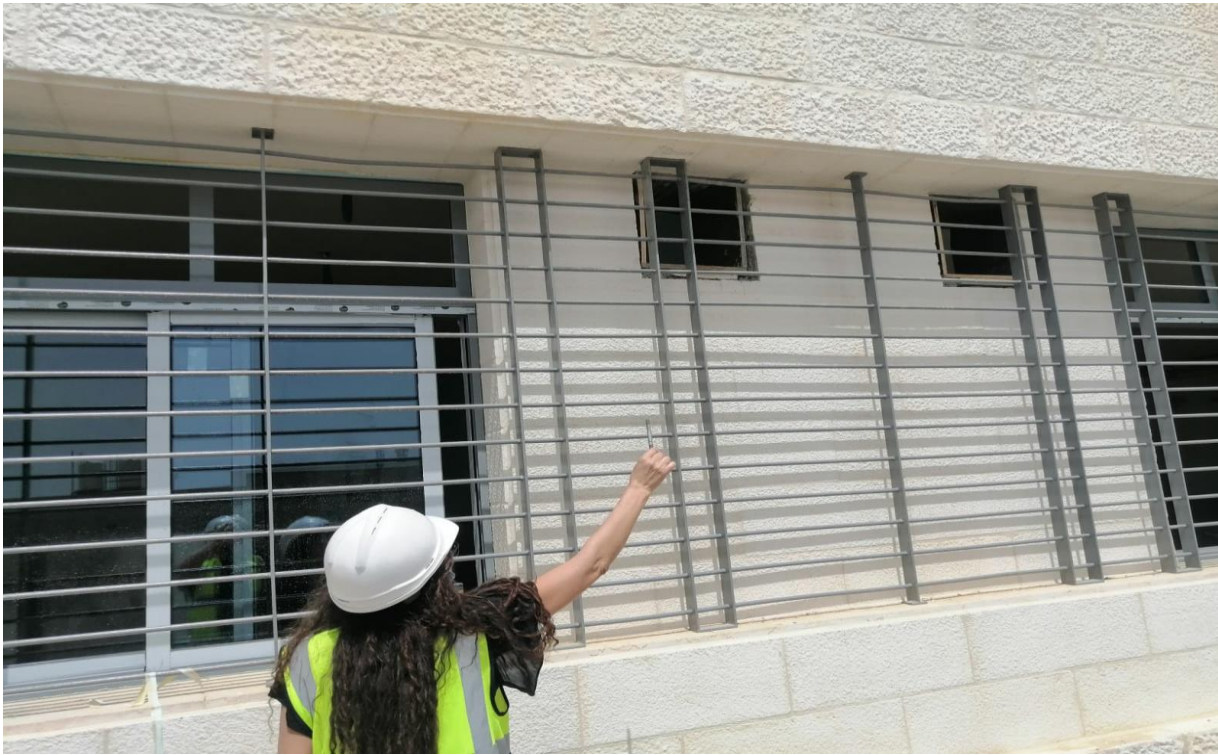
Unrepaired steel protection screens

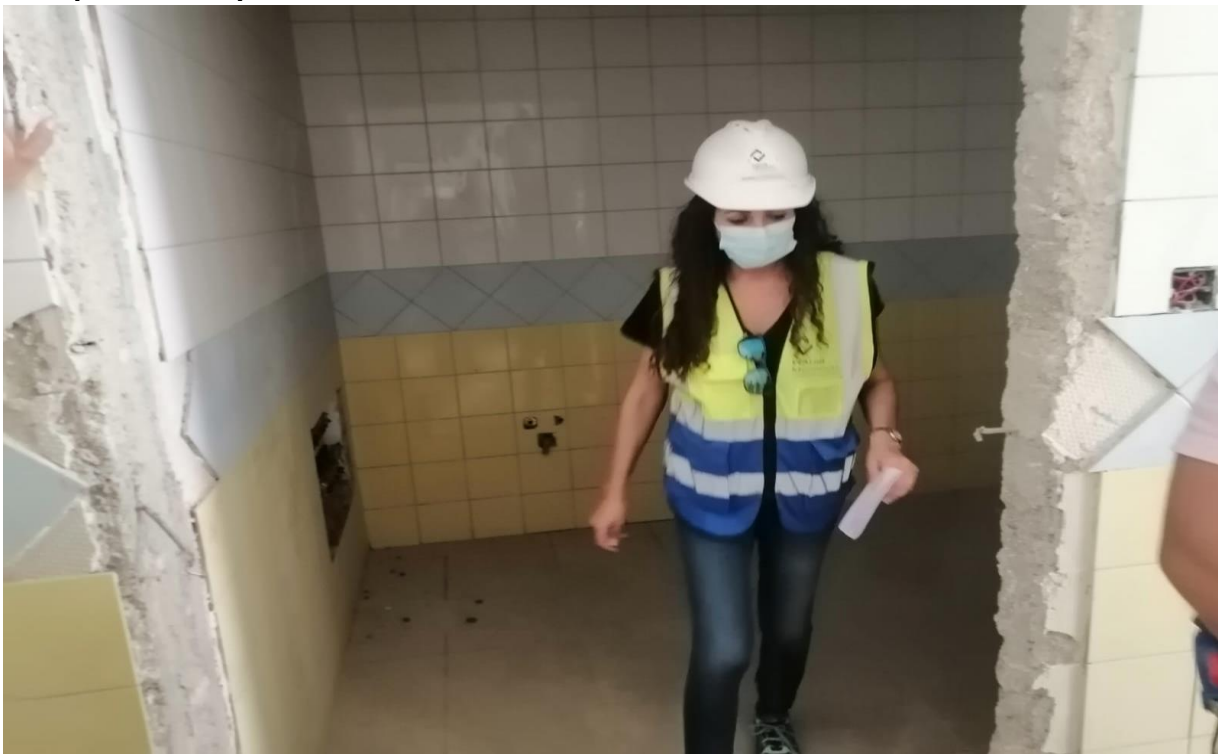
Broken ceramic wall tiles

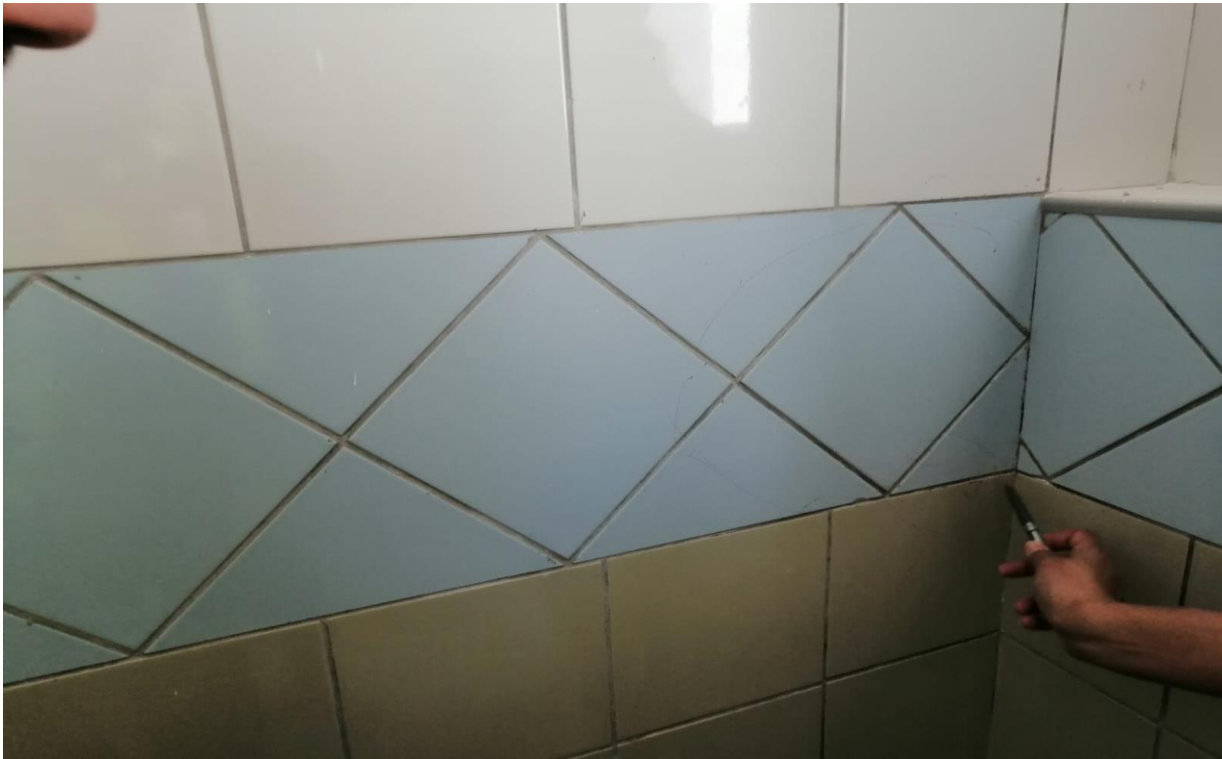
Broken ceramic wall tiles

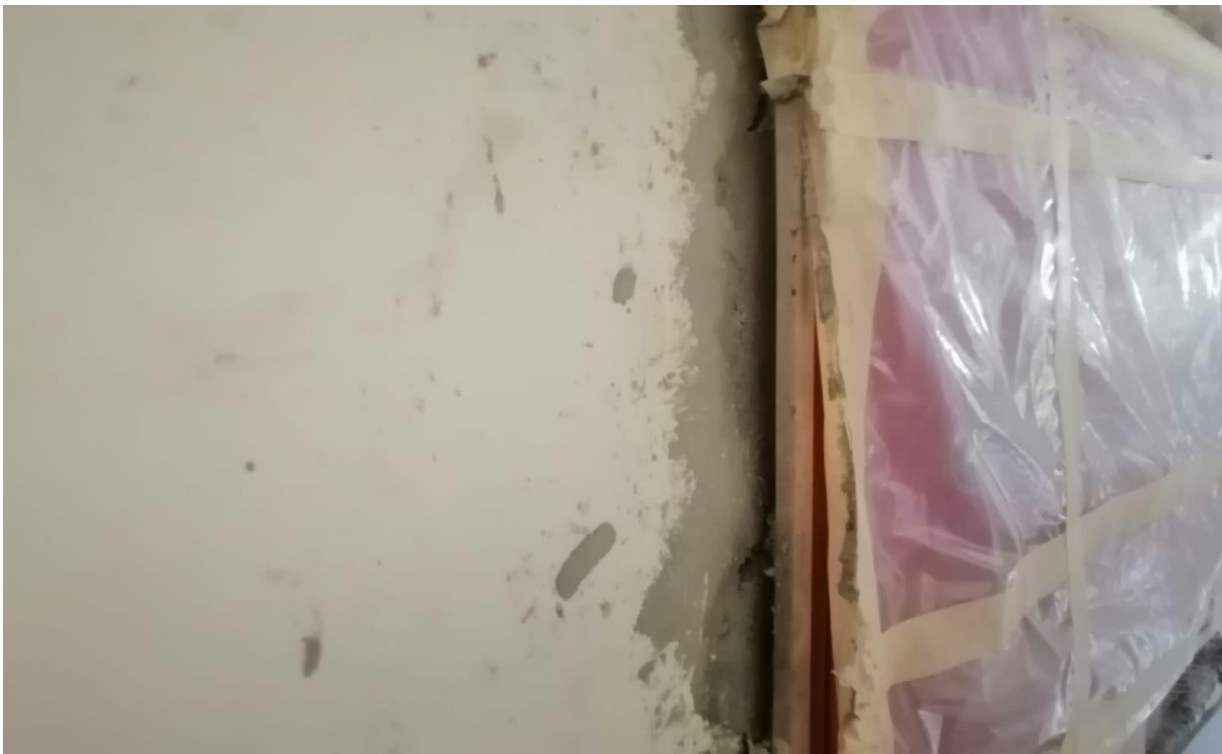
Gap between the cabinets and the wall

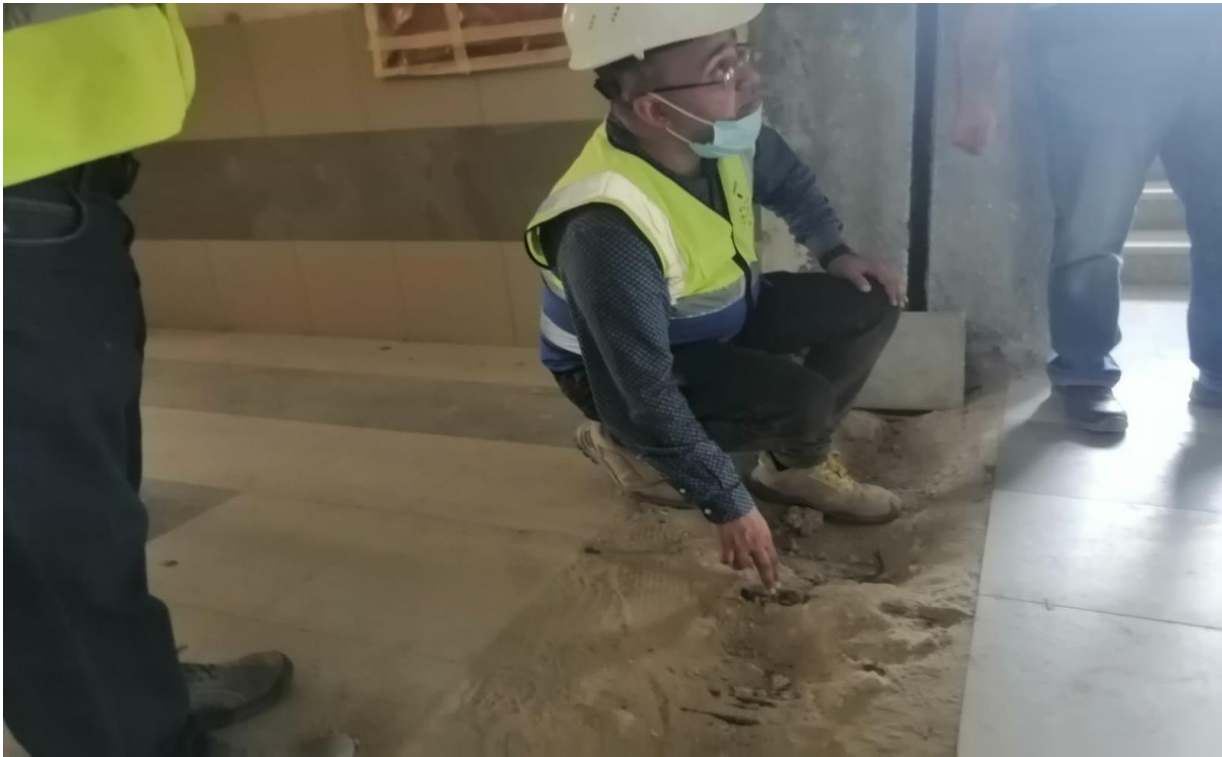
The level of conduit contradicts with tiling

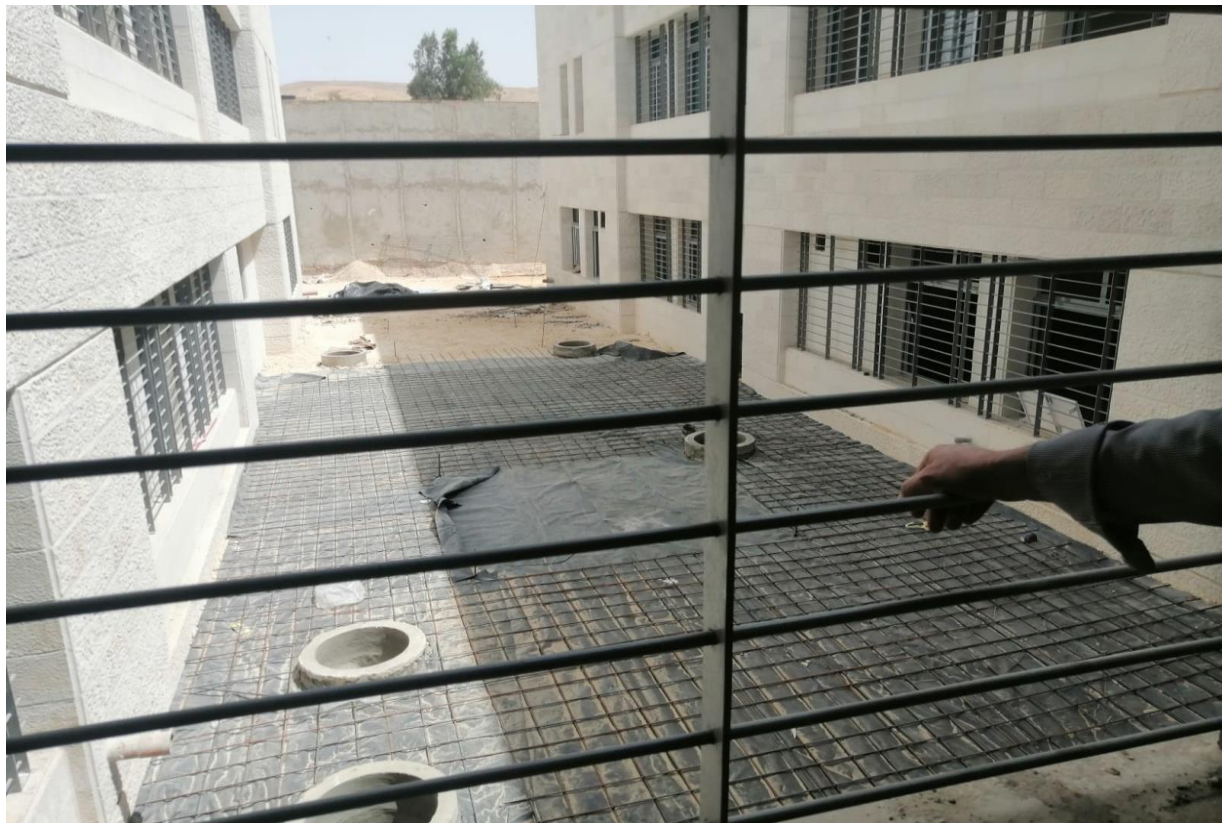
Laying vapor retarder and steel reinforcement over non-conforming base course

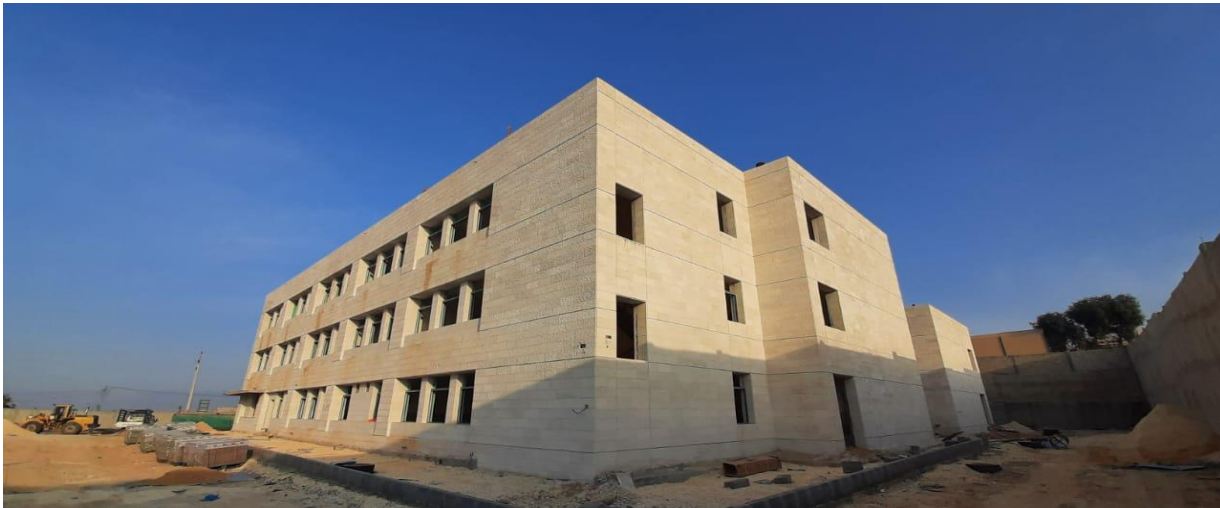
Base course at the walkways not conforming to the requirements

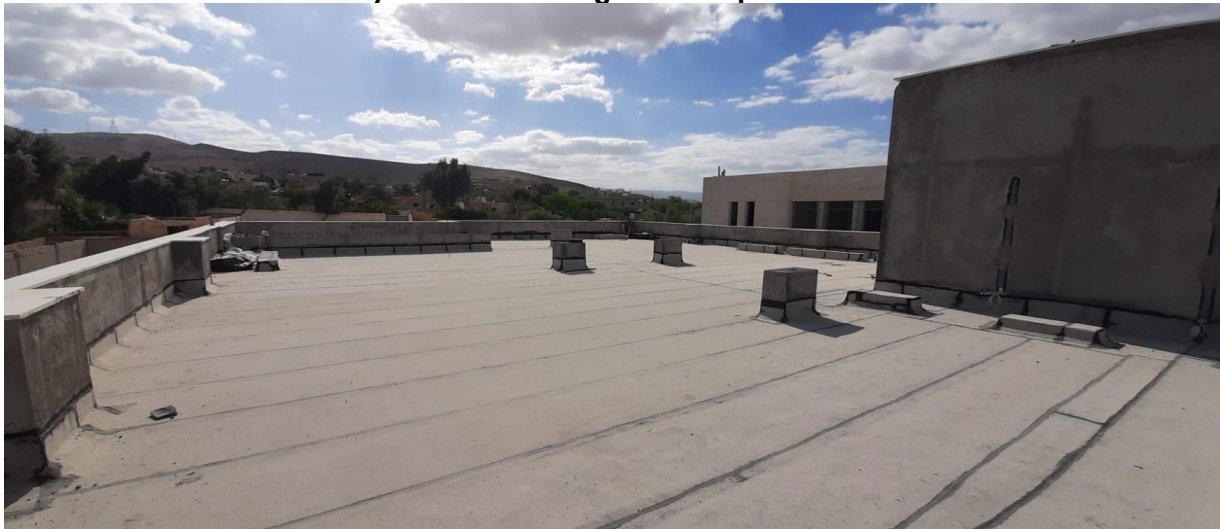
Defects in sheet waterproofing
