# Quality Control Report

**Consultant** **Wahib Medanat** Consultant Engineers  
**Site Name** **Hay Al Iskan Basic mixed - Jerash**  
**Package** **Package 2**  
**Contractor** **Dijlah Est. Construction Co.**  
**Tender No.** **10/2019/USAID/SKEP/3/2**

**Rep No.** **QC-21 19**  
**Date** **19 / 04 / 2022**

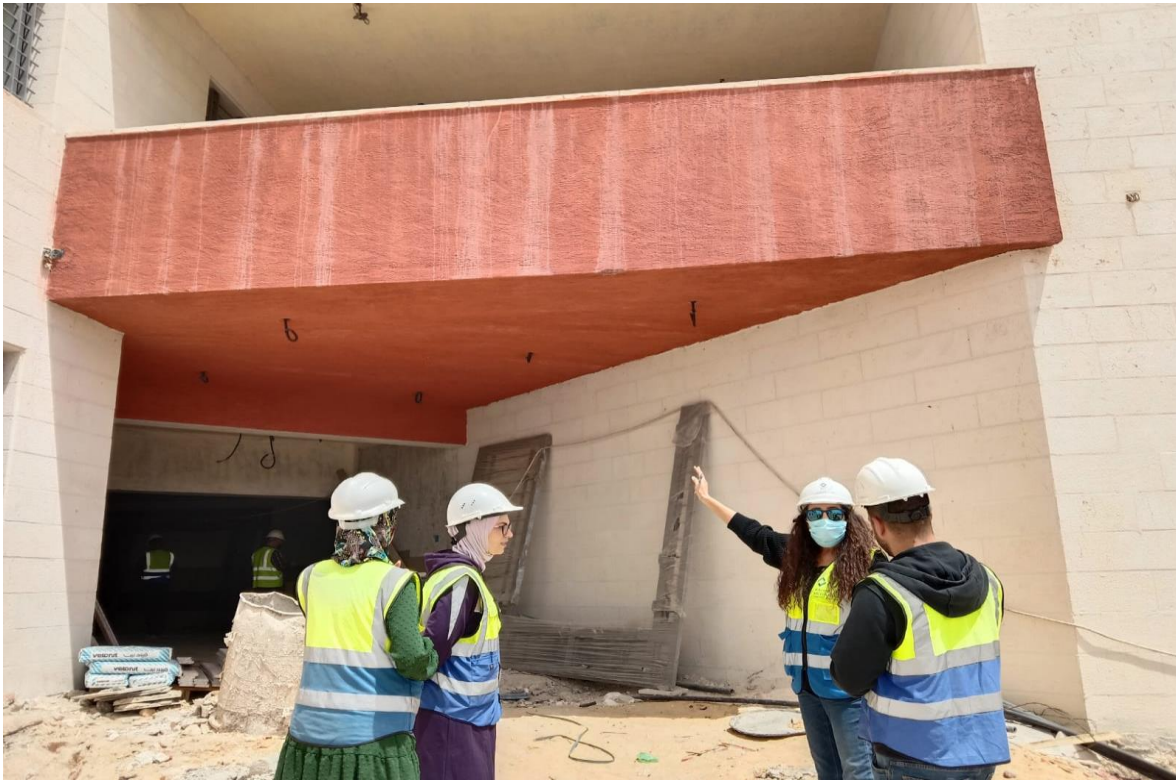
White color appears on facades

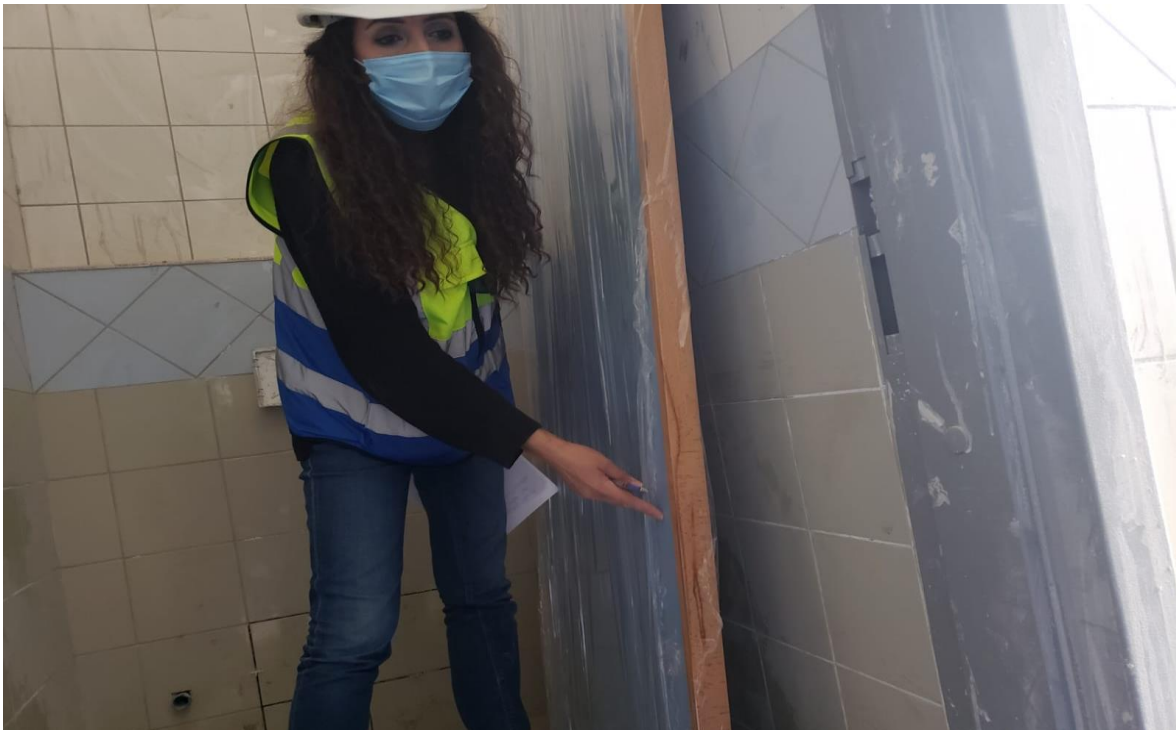
Defected wooden door frames

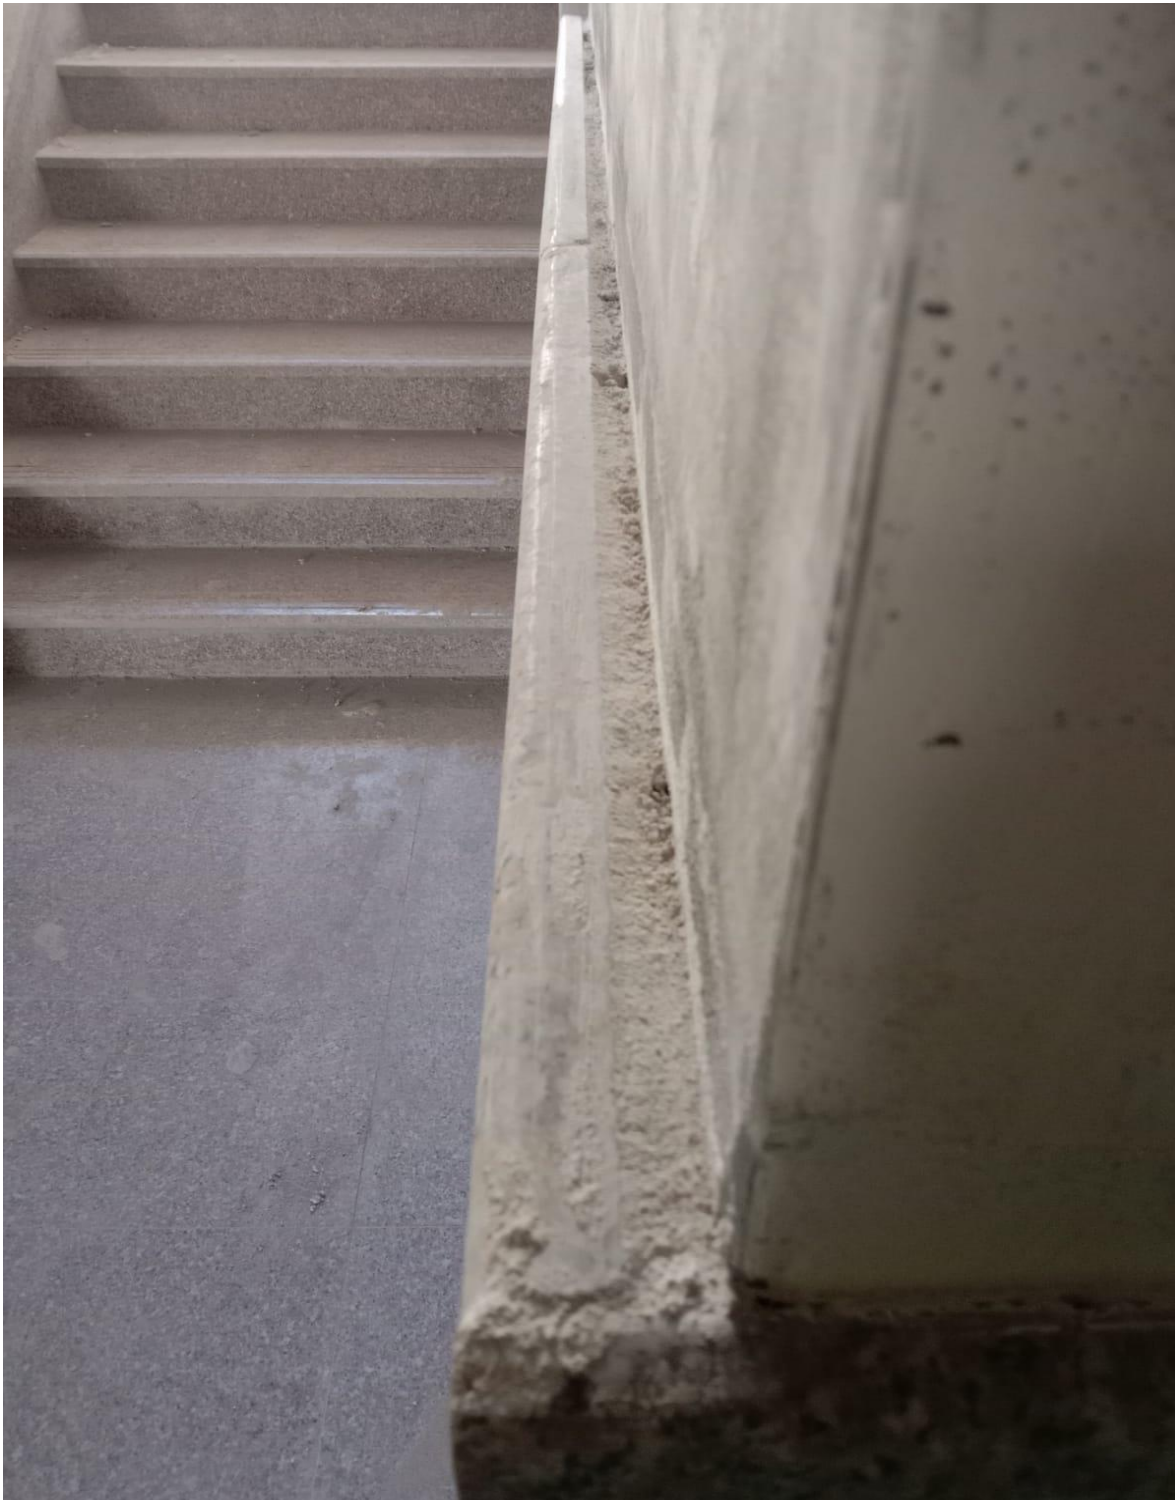
**Defects in installation of granite coping**

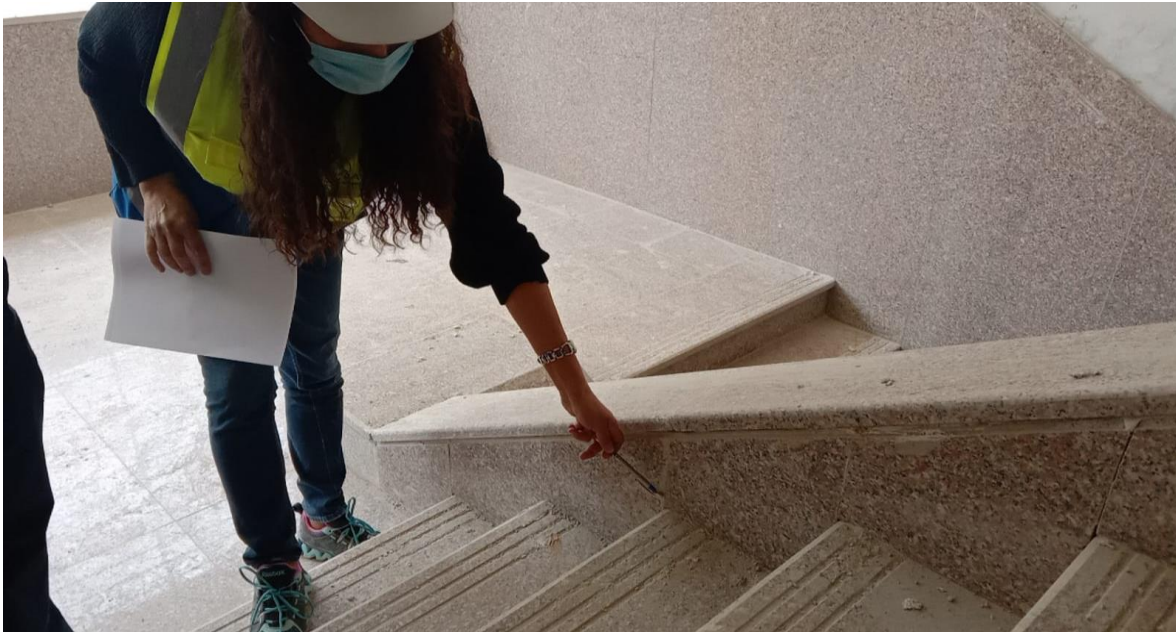
**Gaps between granite pieces appeared**

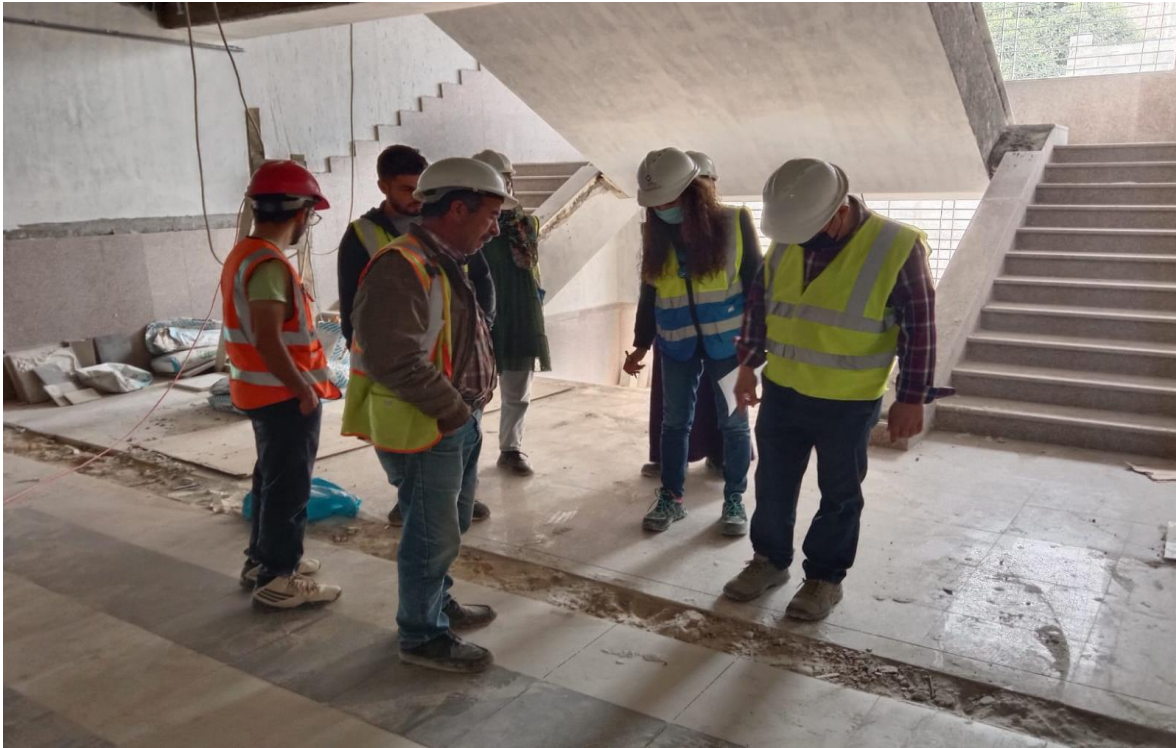
**Defects in connection line between porcelain and granite**

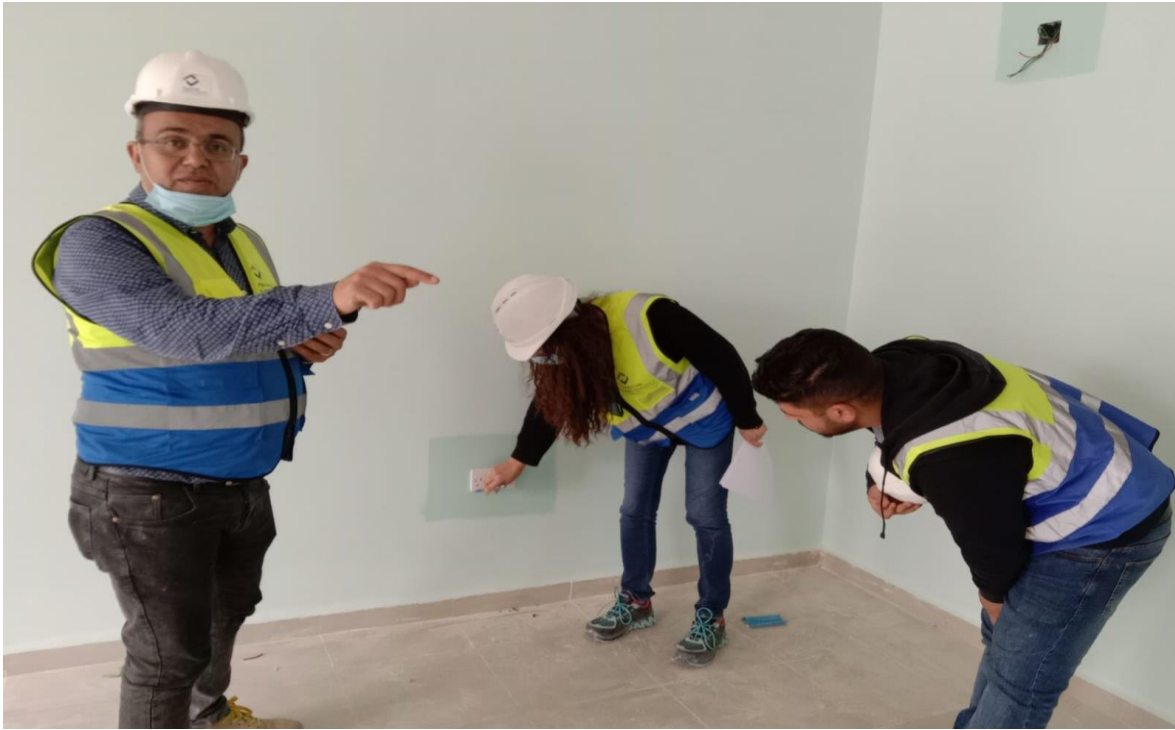
**Fixing sockets before completing the paint work**
