# Quality Control Report

**Consultant** **Wahib Medanat** Consultant Engineers  
**Site Name** **Jumana Bint Abi Taleb Basic Mixed - Marka**  
**Package** **Package 2**  
**Contractor** **Dijlah Est. Construction Co.**  
**Tender No.** **10/2019/USAID/SKEP/3/2**

**Rep No.** **QC-23 18**  
**Date** **14 / 05 / 2022**

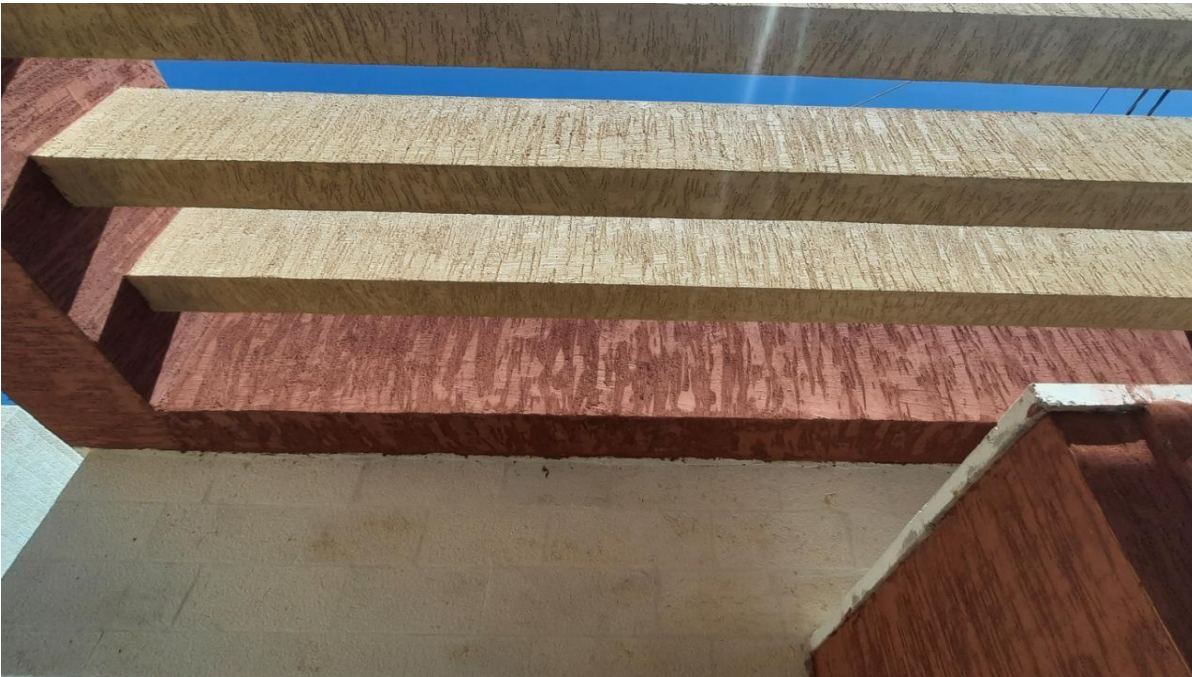
**Defects in the texture of colored plastering**

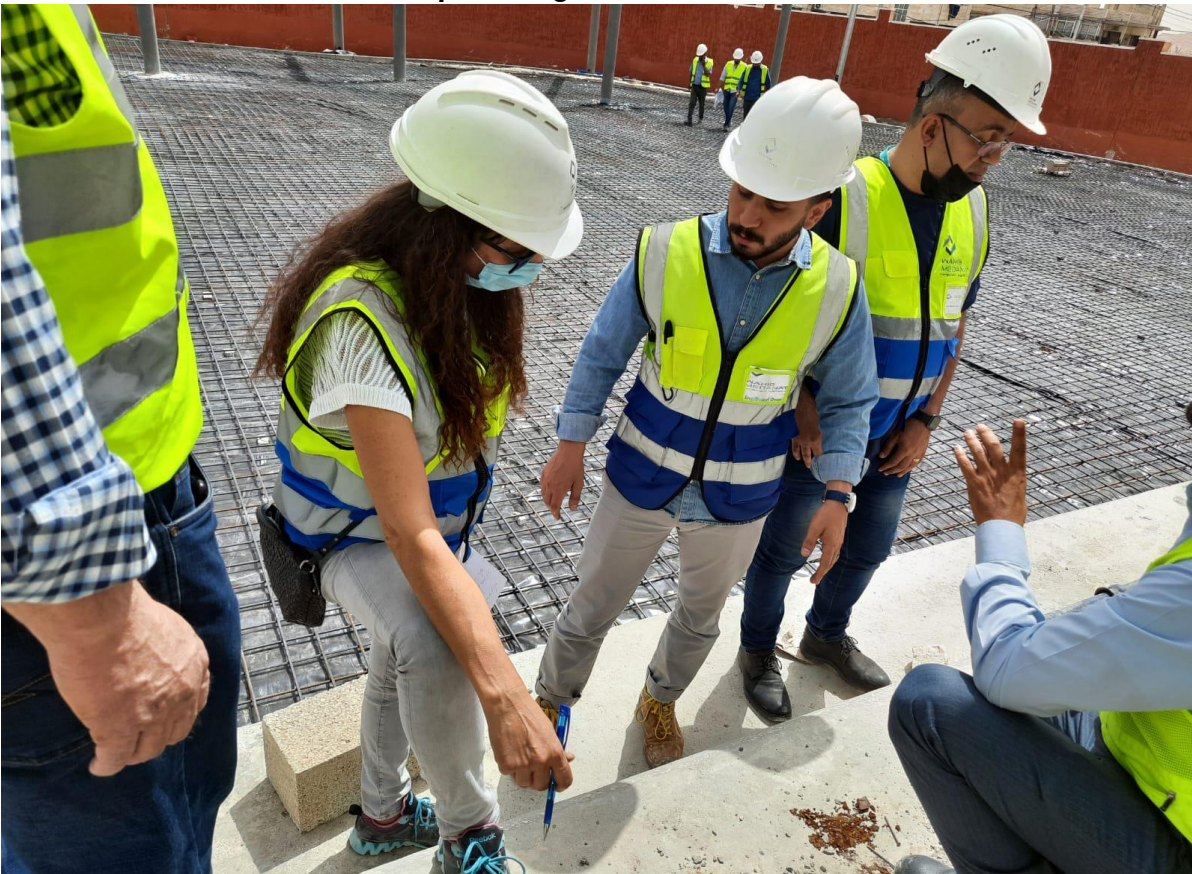
**Voids at the surface of the amphitheater seats**

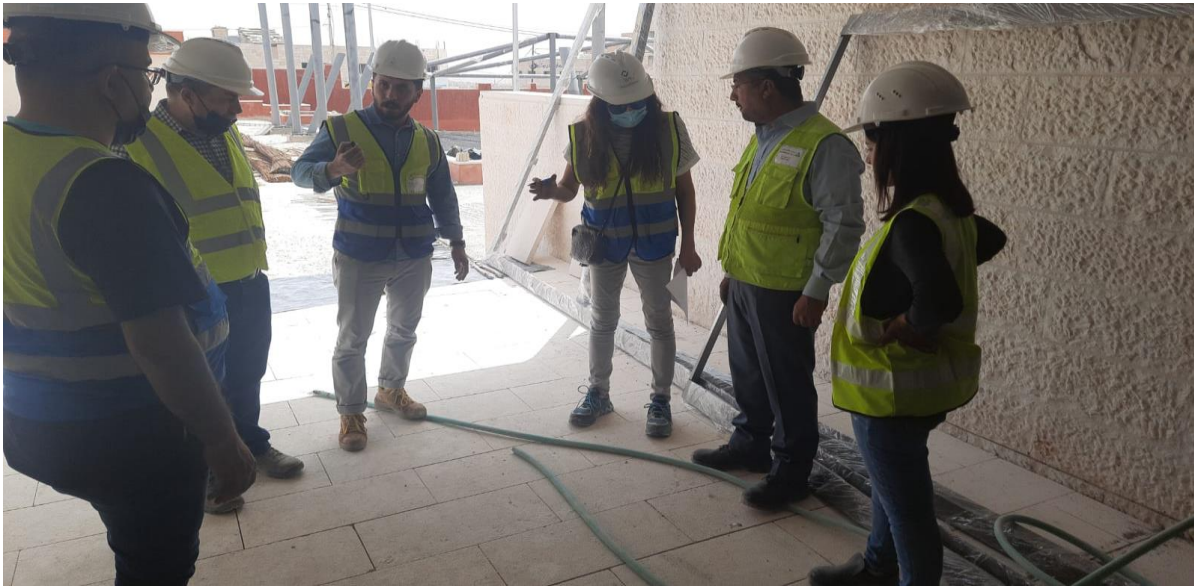
**Broken stones at the entrance floor**

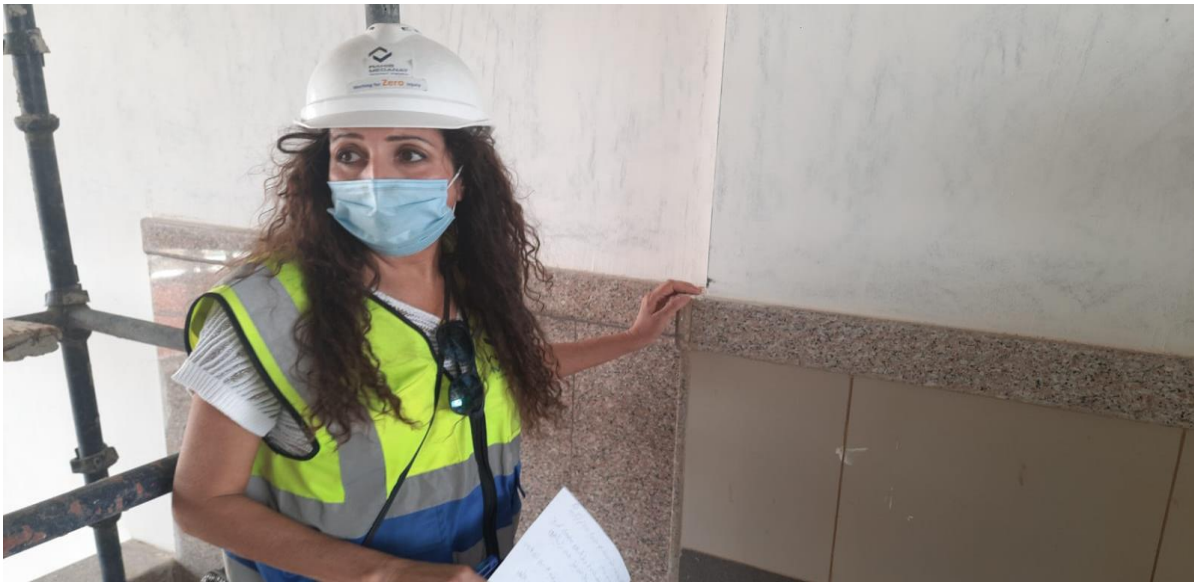
**Defects in granite coping installation**

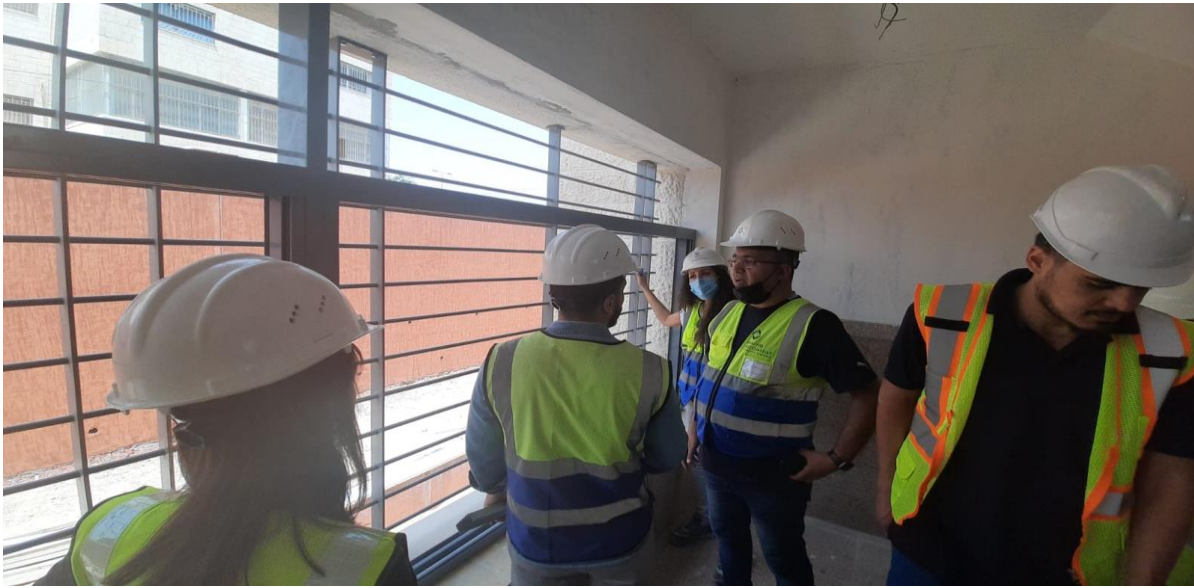
**Defects in the steel protection screens**

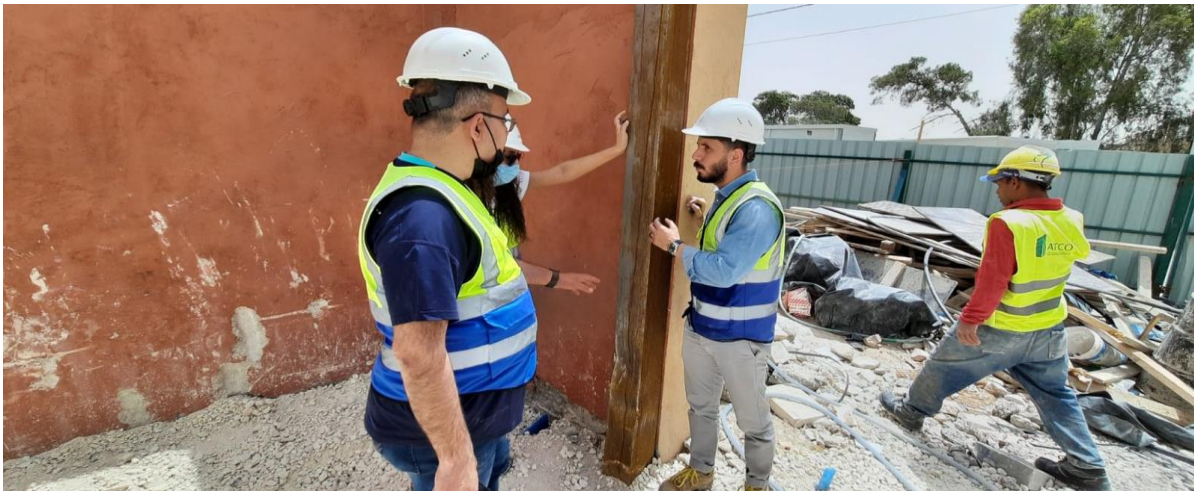
**Dirt at the colored plastering**
