Quality Control Report

Consultant **Wahib Medanat** Consultant Engineers
Site Name **Jumana Bint Abi Taleb Basic Mixed - Marka**
Package **Package 2**
Contractor **Dijlah Est. Construction Co.**
Tender No. **10/2019/USAID/SKEP/3/2**

Rep No. **QC-23 17**
Date **9 / 04 / 2022**

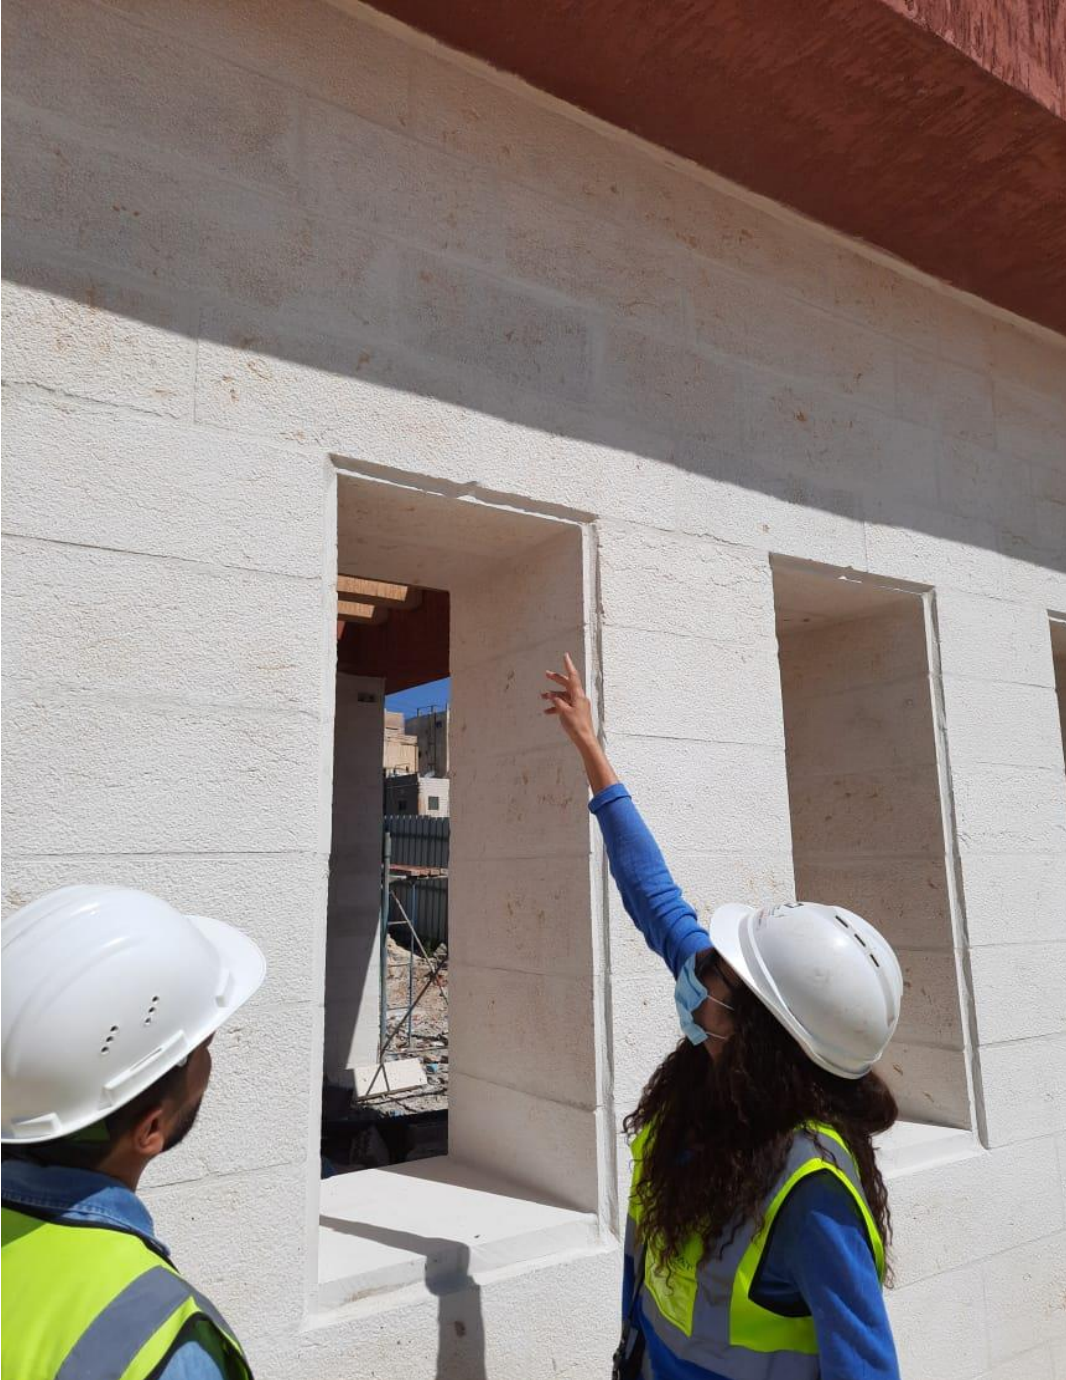
Defected stones at guard house

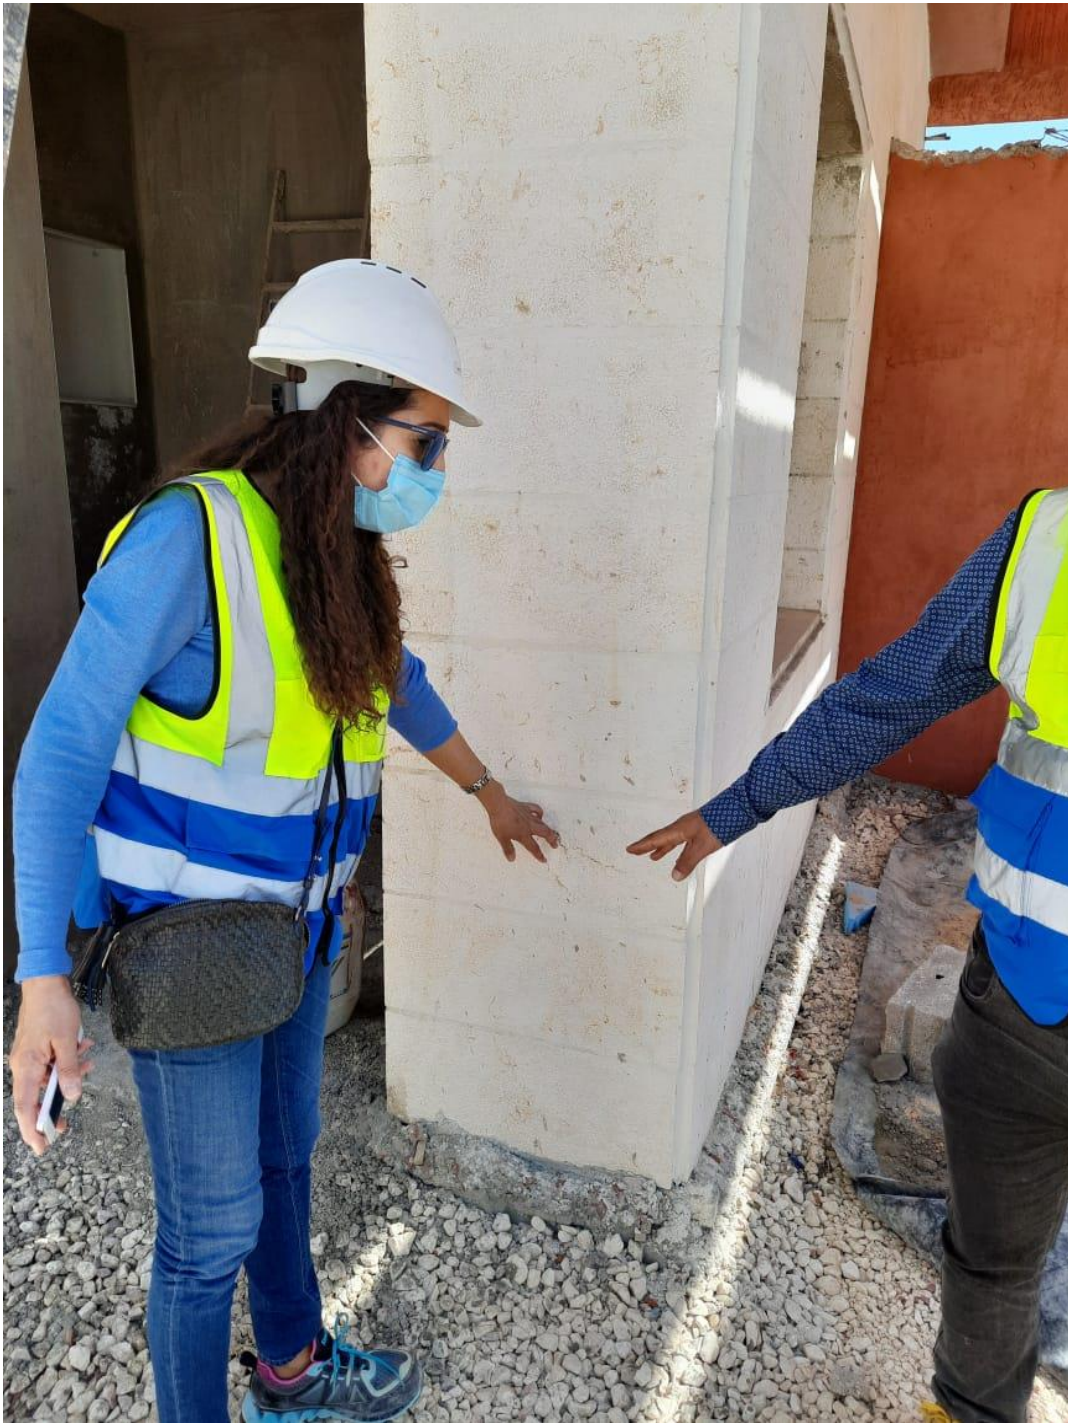
Defected stone at the guard house

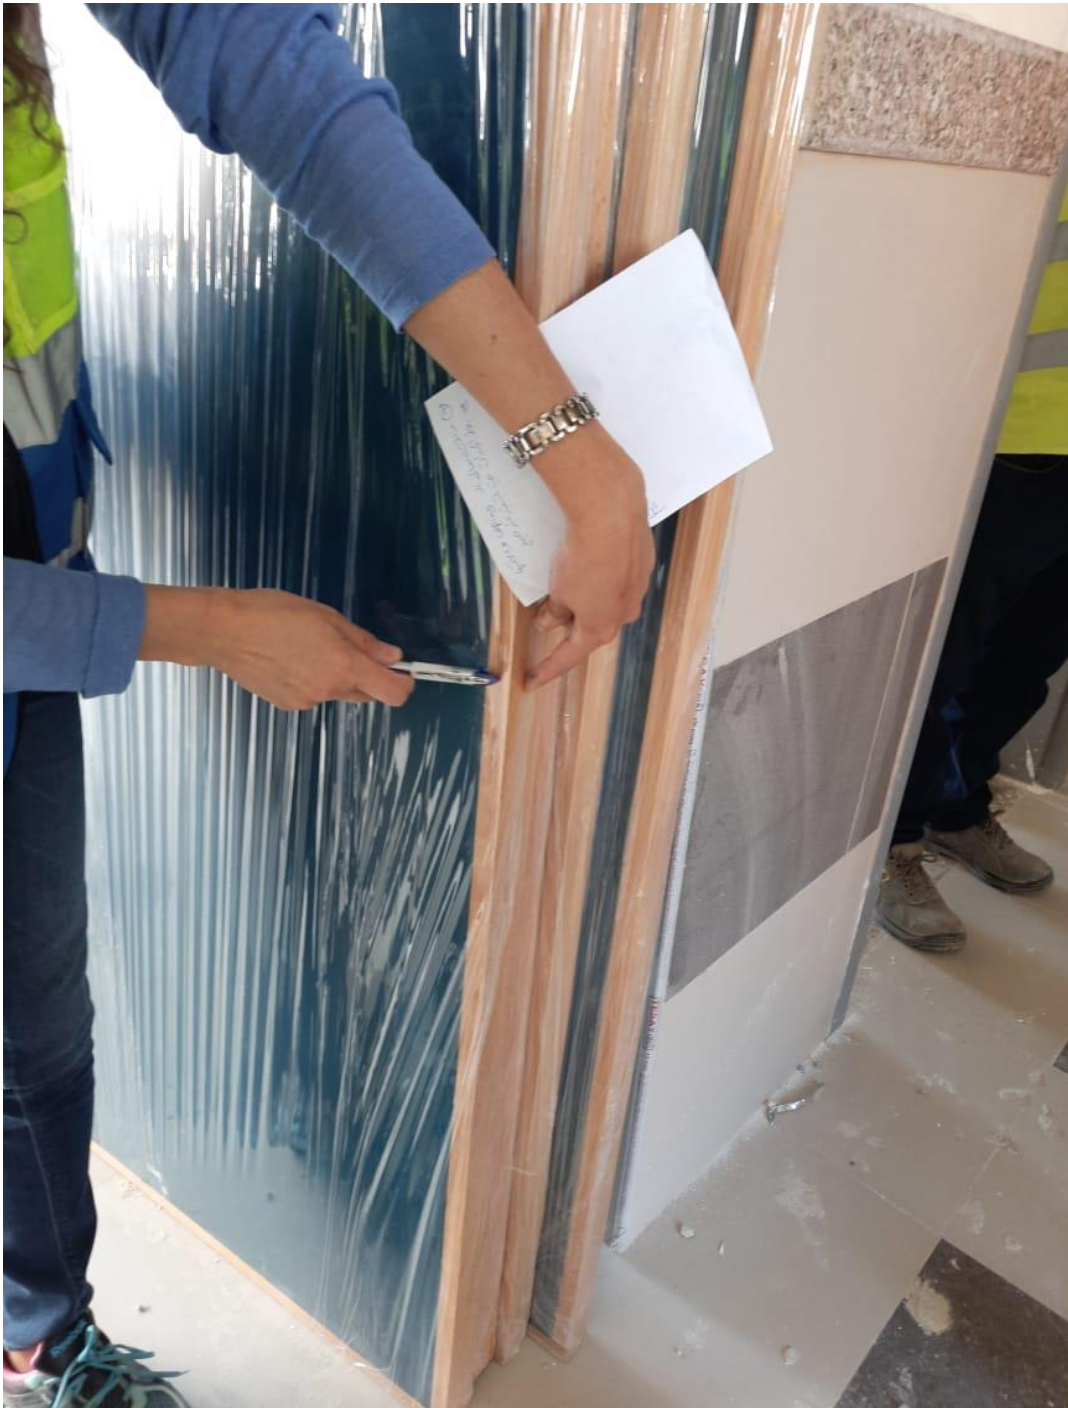
Defects in beech wood frame

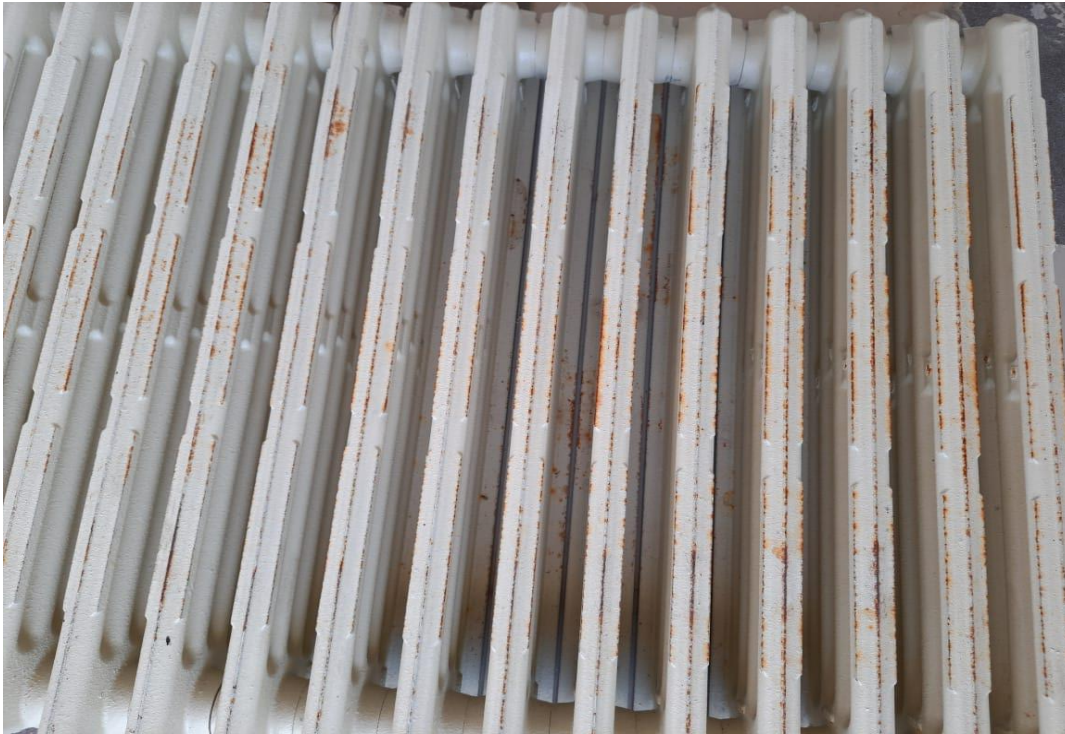
Corrosion observed on the radiators

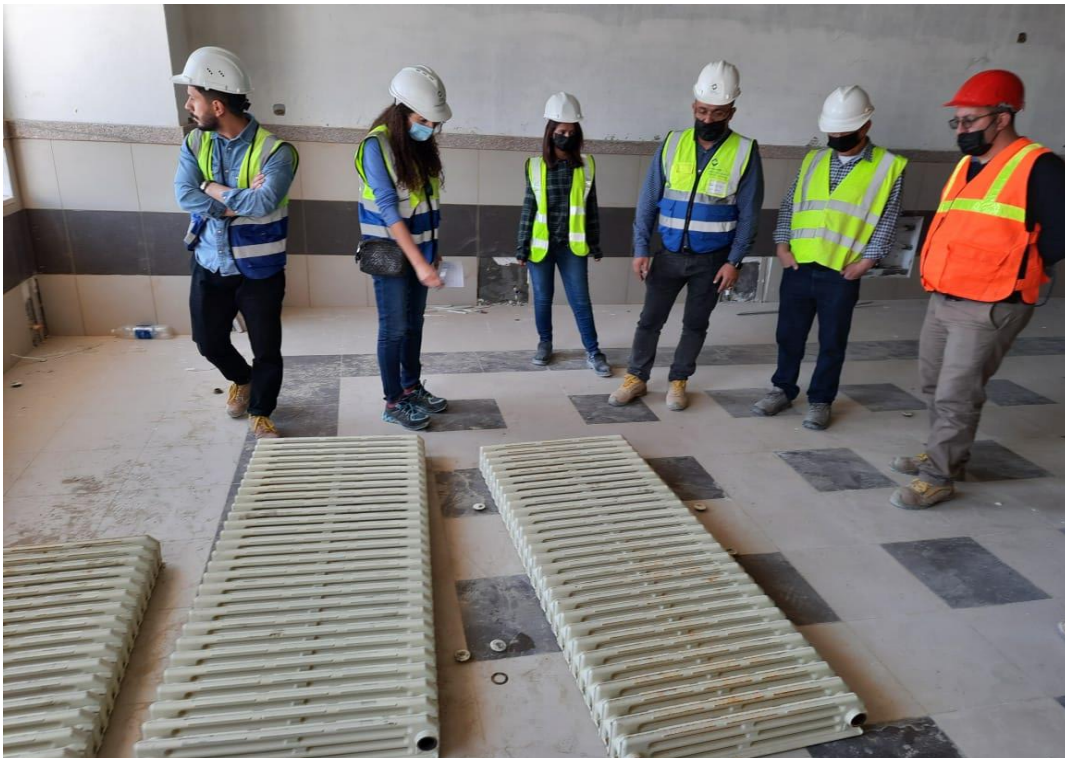
Scattered radiators on the floor tiles

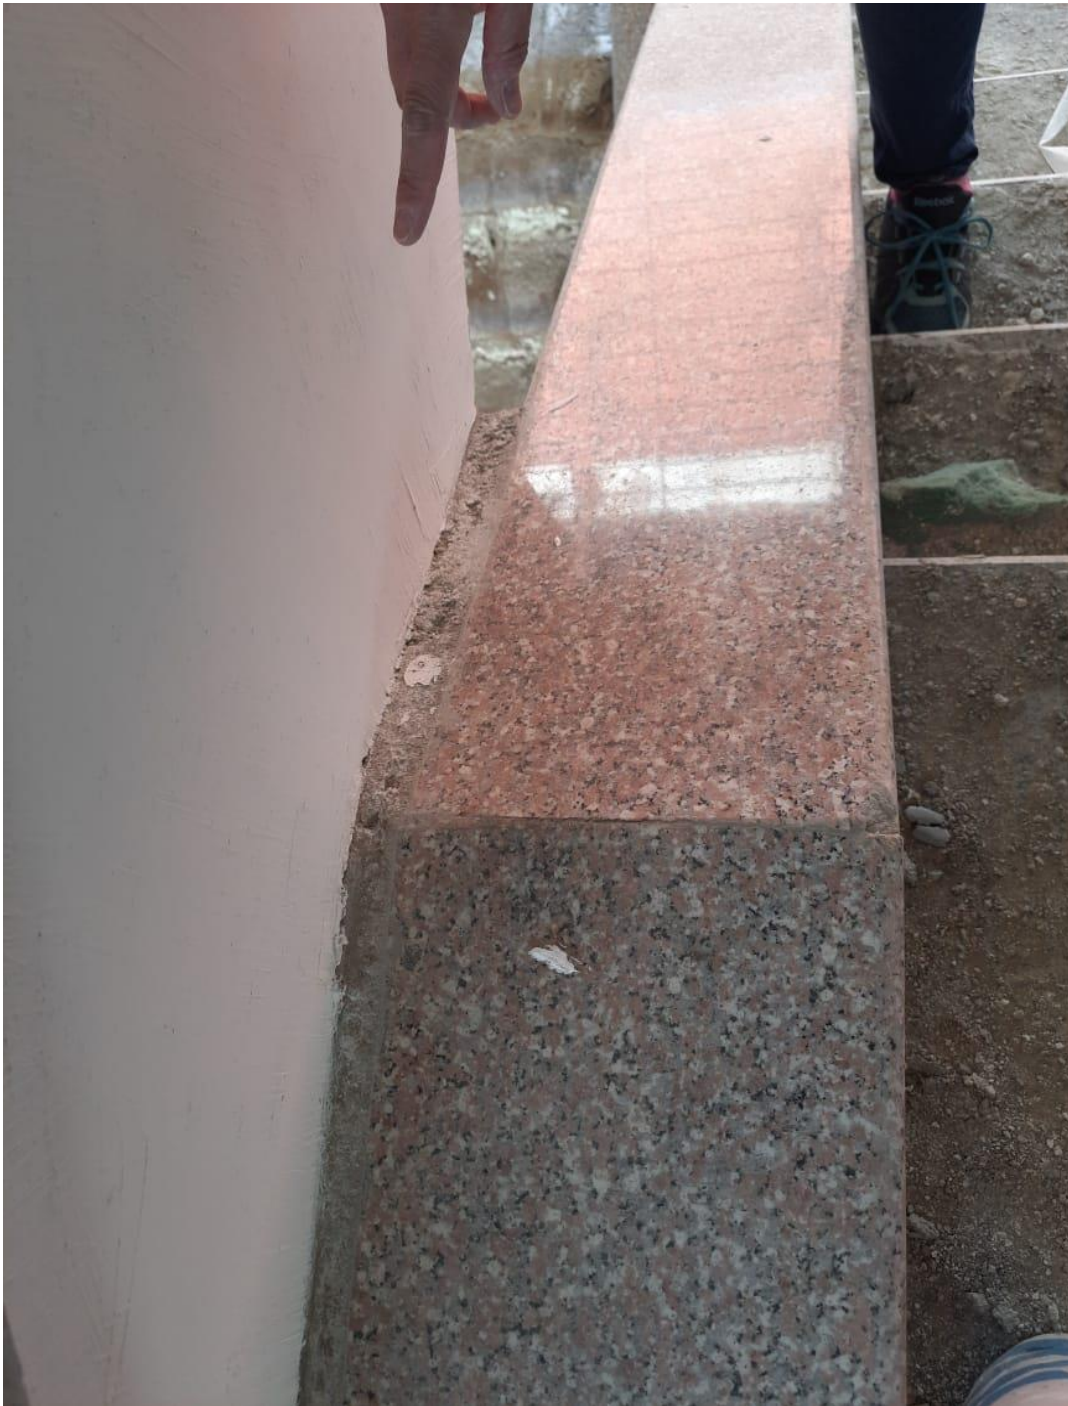
Defects in tiling

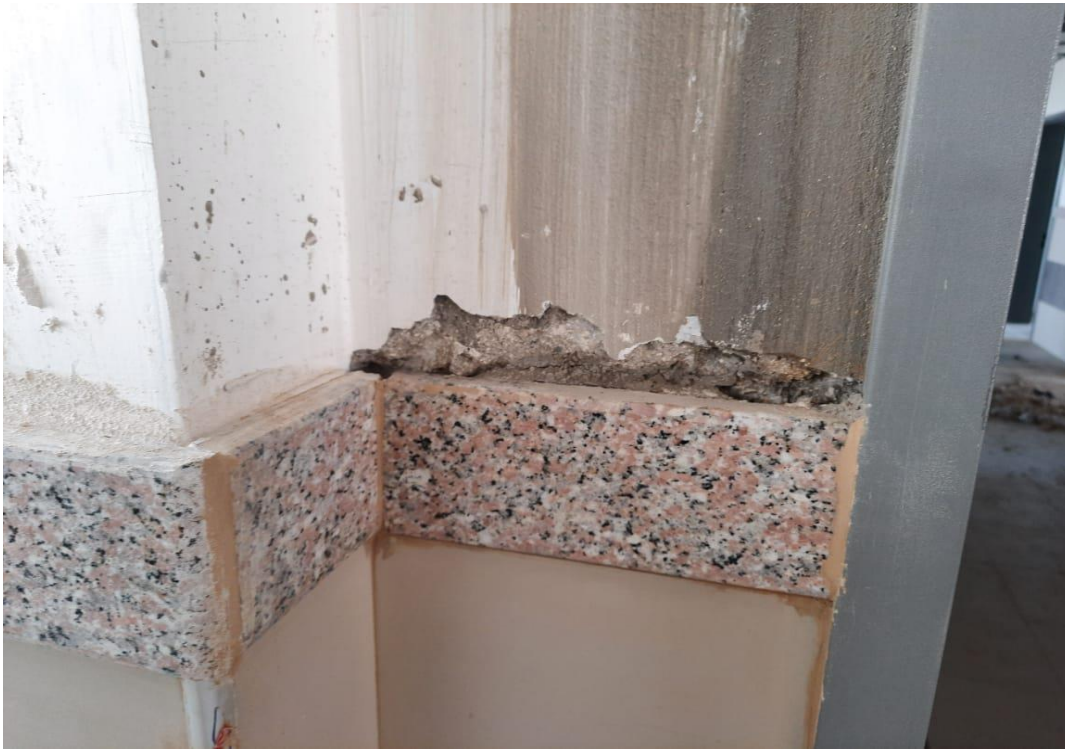
Defects in granite coping

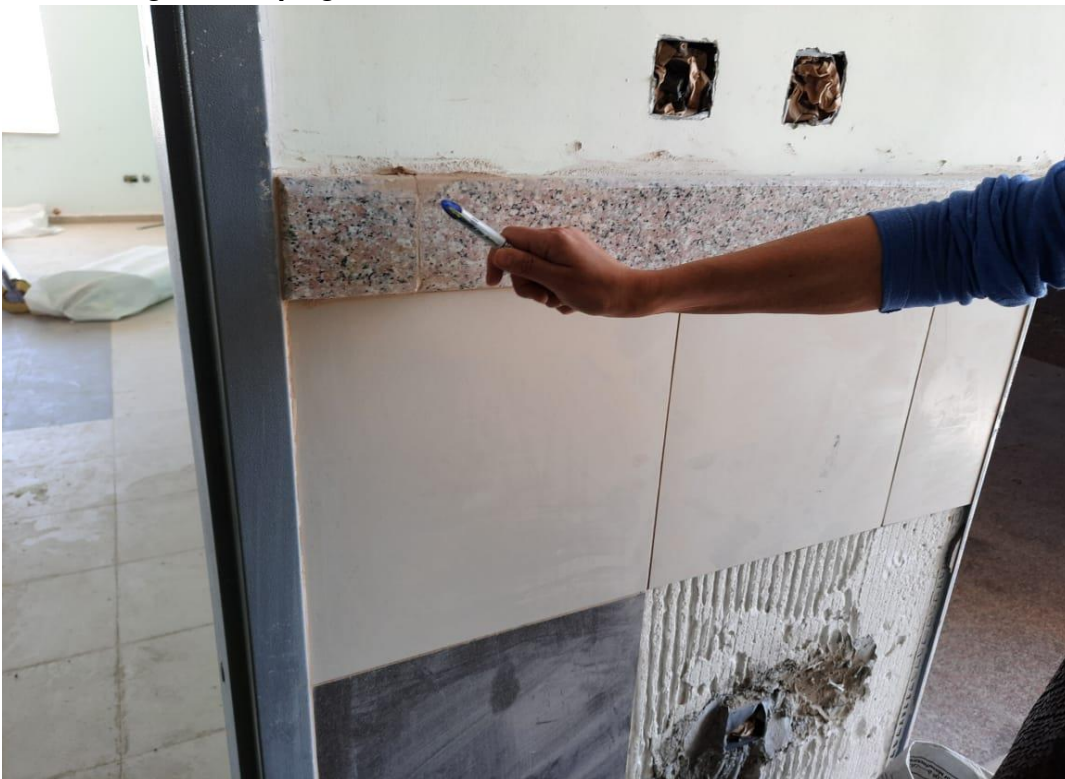
Defects in granite coping
