Rep No. QC-23 02 Wahib Medanat Consultant Engineers

Jumana Bint Abi Taleb Basic Mixed - Marka **Site Name Date** 24 / 02 / 2021

Package Package 2

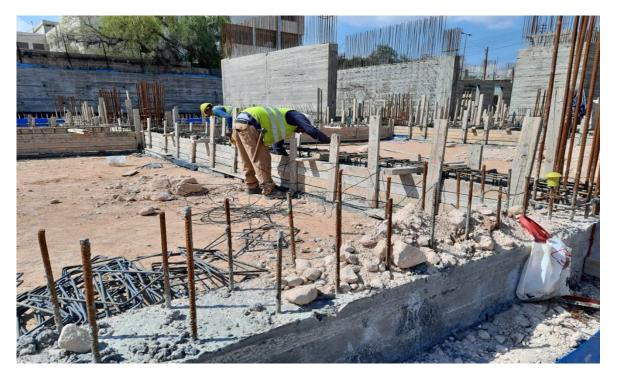
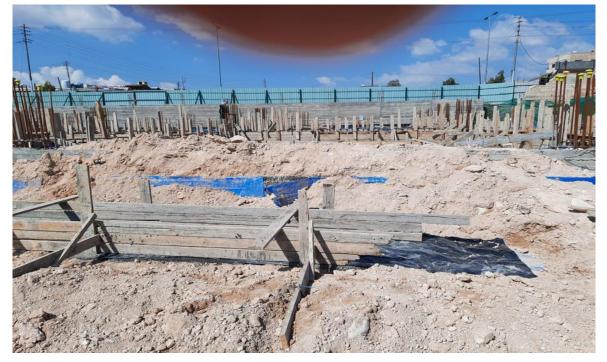
Contractor Dijlah Est. Construction Co. Tender No. 10/2019/USAID/SKEP/3/2		
Description of Non Conformance	Corrective Action	Required by / When
1. Over used shuttering woods for	Defected parts need to be replaced	The Contractor is Requested to Take Action to Repair All Stated Defects
ground beams.		Under Close Follow Up by The Supervision Site Staff. Action is

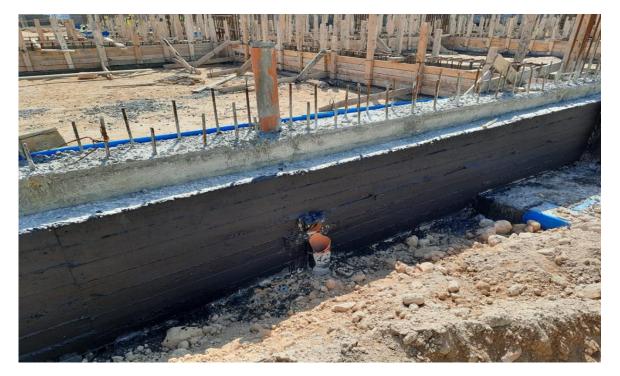
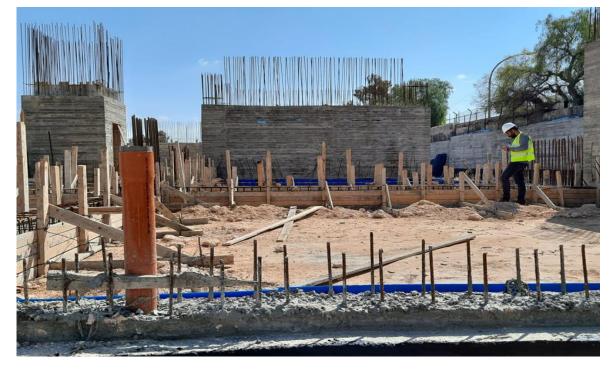
2. Damaged cartonal boards in several parts	2. Damaged boards need to be replaced	
3. Weak fixing of cartonal boards led		
to accumalating backfilling materials	3. Remove boards, clean and fix properly new boards	
between those boards and the concrete		
members.

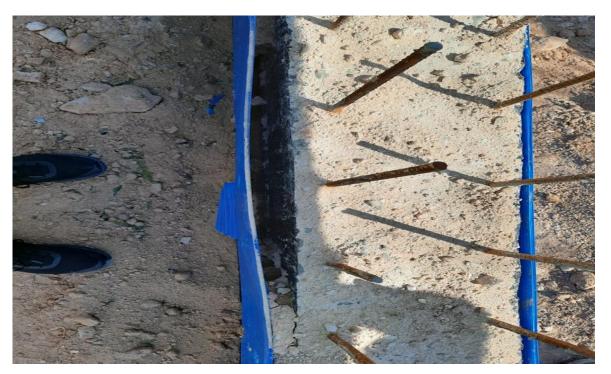
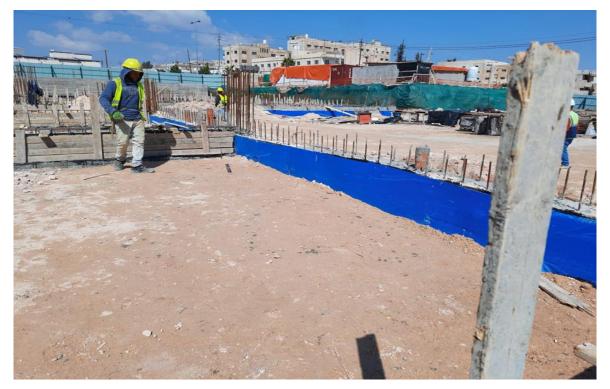
4. Number of electromechanical pipes have	4. Remove broken parts, repair, fix properly	
broken ends. Electrical first fix pipes were		
obsereved at the face of casted wall	Protect all pipes permanently.

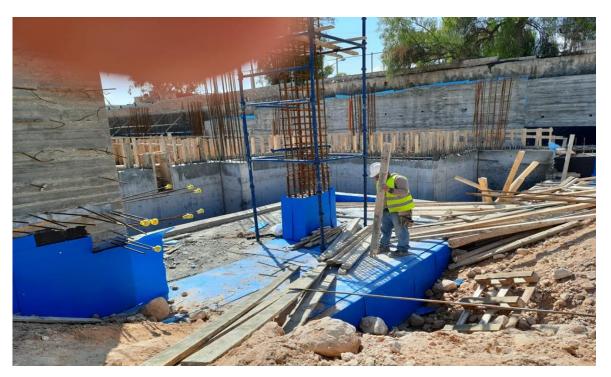
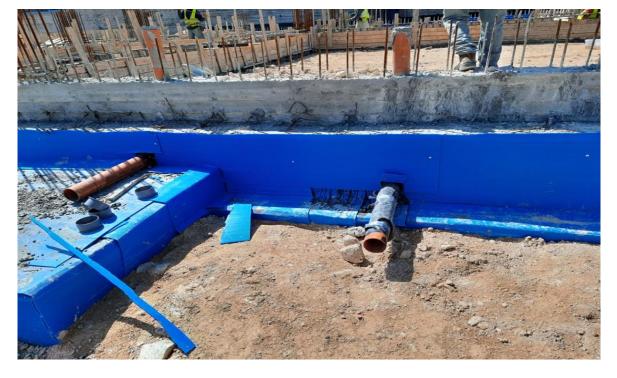
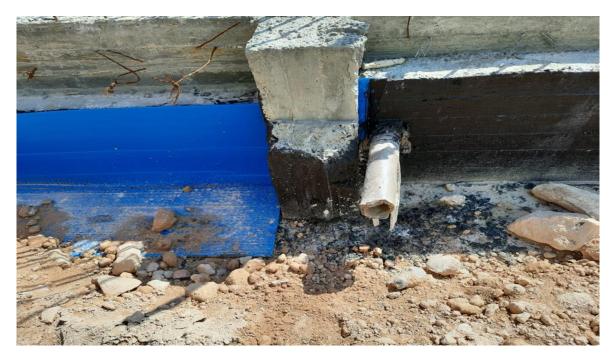
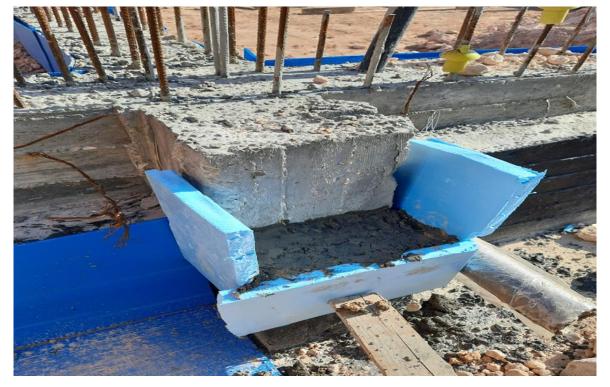
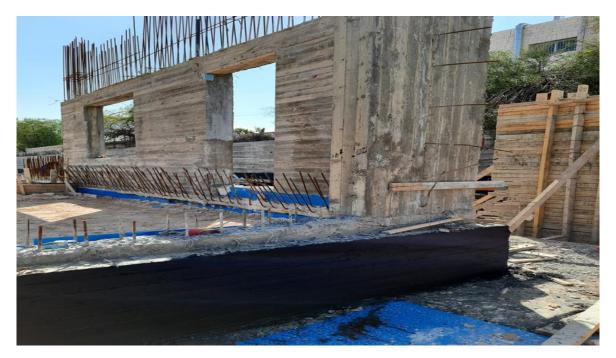
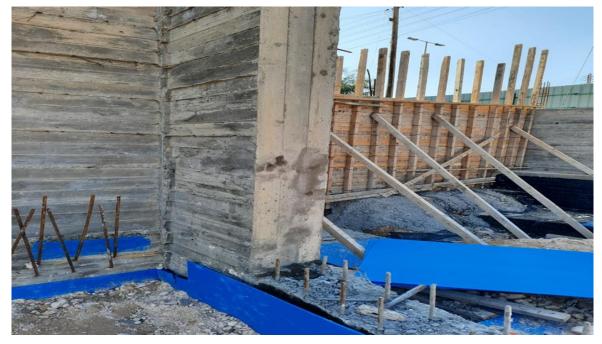
5. Two points in casted concrete were	5. Repair using approved materials	
observed having segregation and broken ends		
6. Boulders were observed in backfilling	6. Remove all boulders	
material	1	
Report Prepared by	Hassan Shaqbua, Supervision Quality Control Manager	
Contractor's Response		
The Contracor started with repair on the same day.		
Notes
