Consultant	Wahib Medanat Consultant Engineer	Rep No.	12-25062022
Contractor	Derar Saraireh & Sons for Engineering & Contracting	Tender No.	(11/2019/USAID/SKEP/3/S) Schools for a Knowledge Economy Project (SKEP) - Phase (3) Package (1, 2)
Site Name	Al Khansa' Basic Mixed School- Al Balqa	Day/ Date	Sat. 25/06/2022
Duration of Project	450 Calendar Days	Total Project Budget	9,789,417.840 JD

Visit Notes

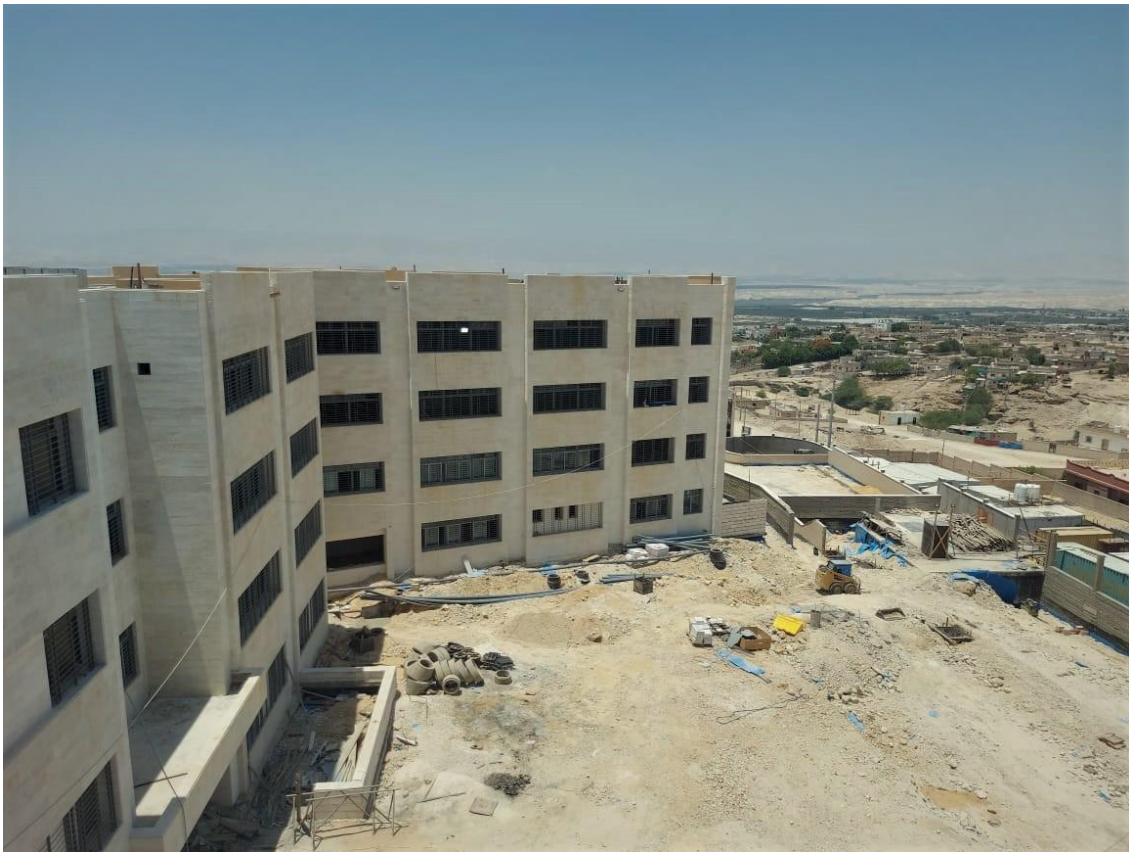
(Figure: 01)

General view of the project site

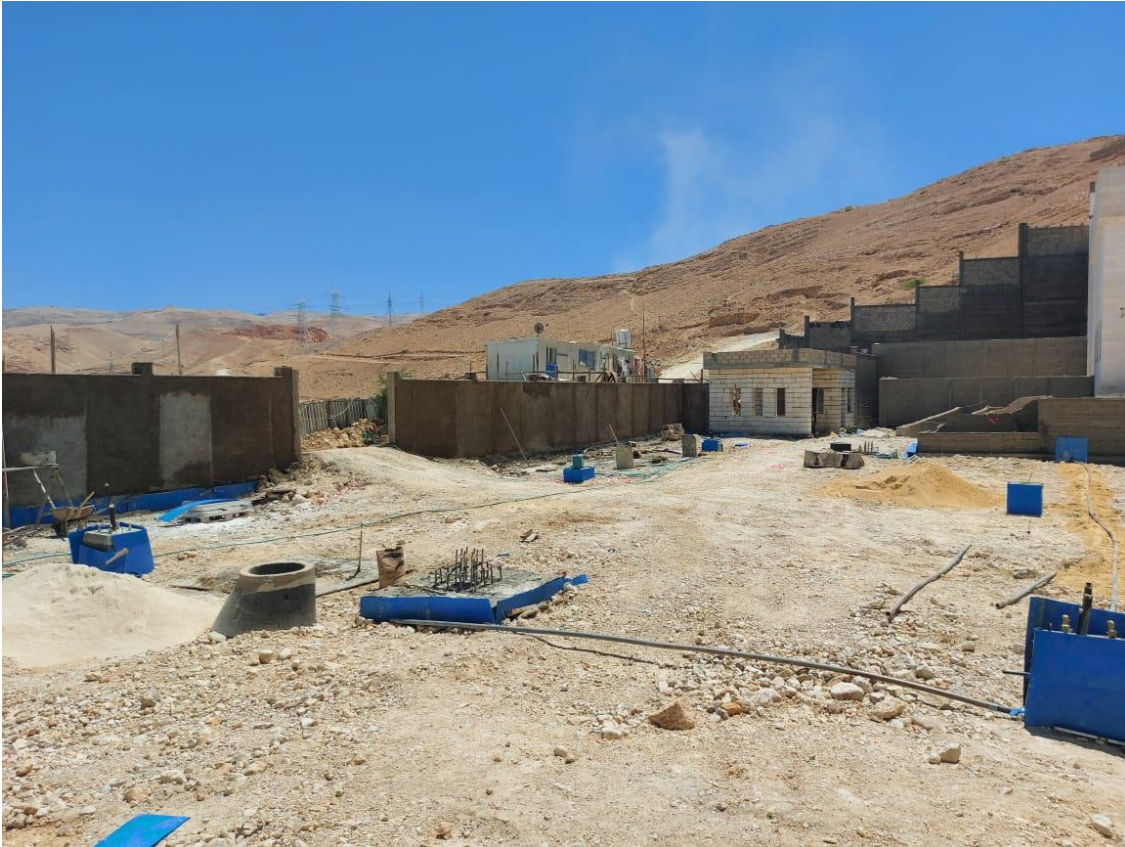
(Figure: 06)

The team inspected the current stage of work in the excavations of the playing yard and the external wall

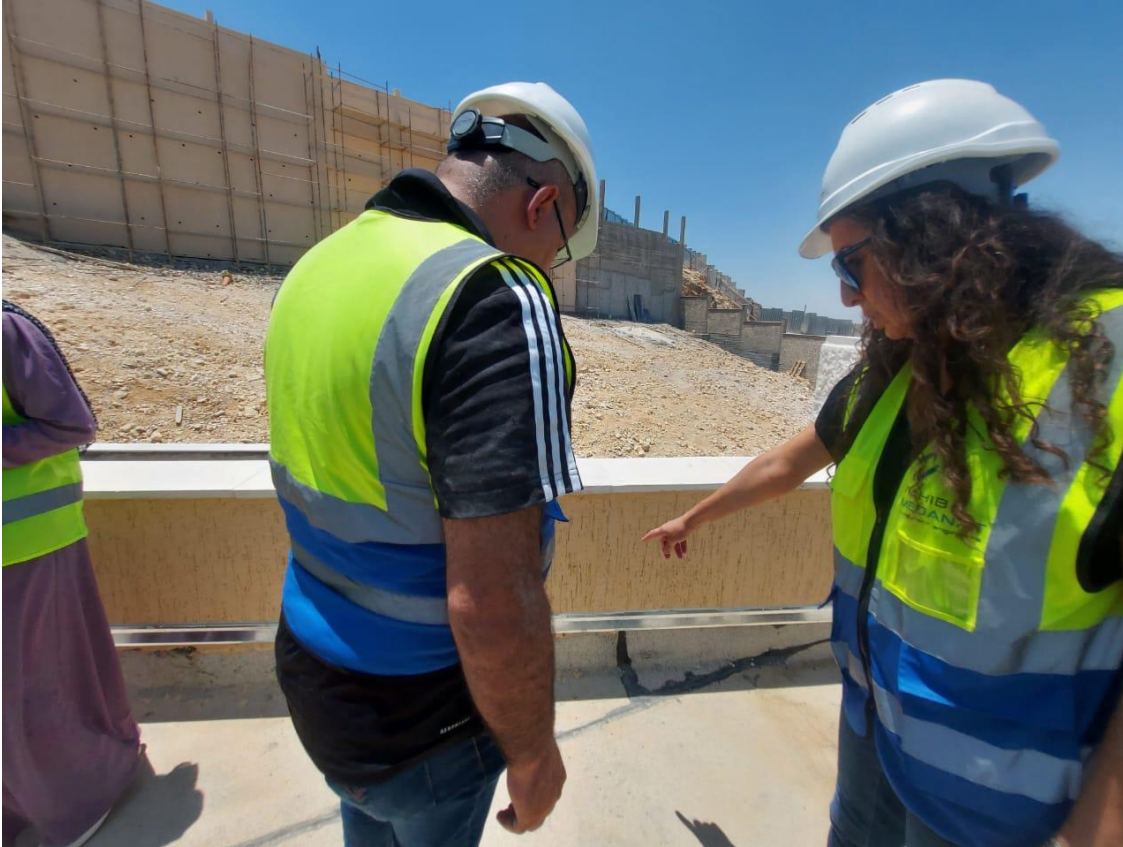
(Figure: 08)

The team inspected the parapet at the roof and observed a broken stone coping. The Contractor was requested to replace

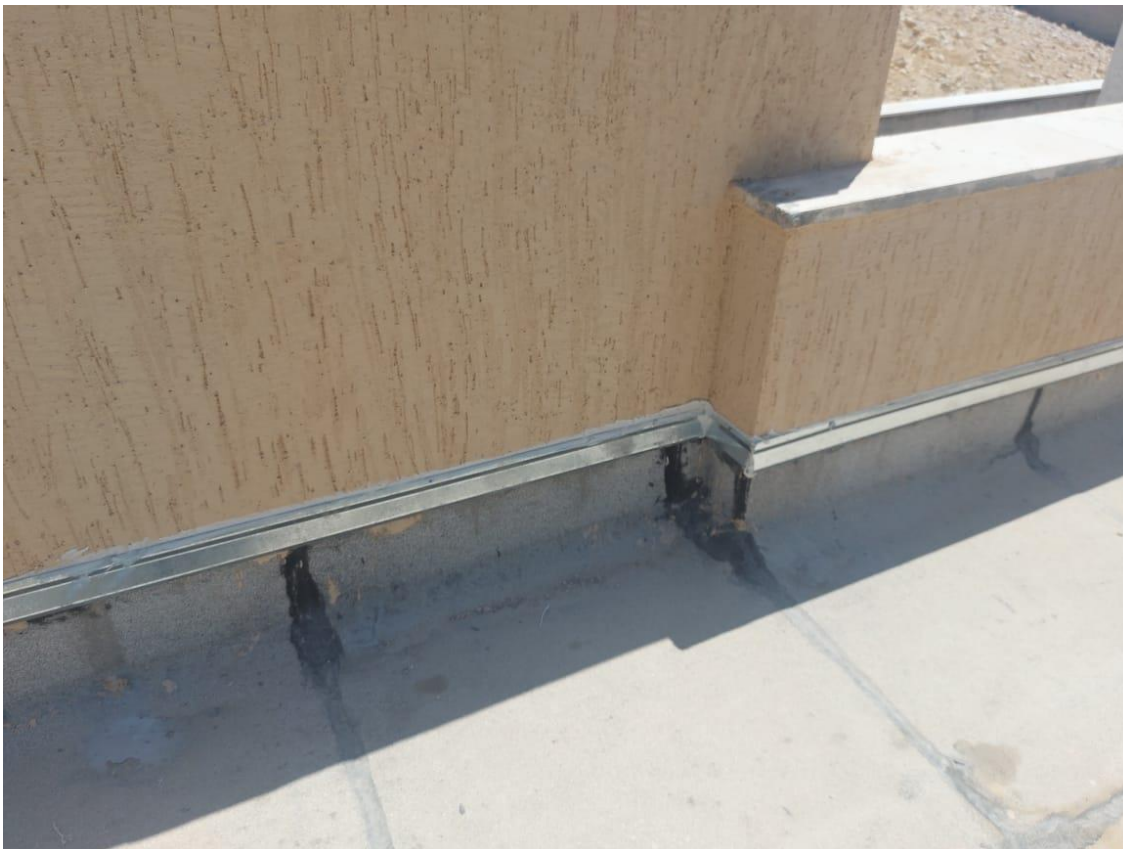
(Figure: 09)

12	The team observed that the relation between the Plaster limit and flashing requires refinement
13	The team inspected the parapet at the roof and observed a broken stone coping. The Contractor was requested to replace
14	The team inspected the wet areas' in the building to check the status of all executed items.

The team observed that the relation between the Plaster limit and flashing requires refinement

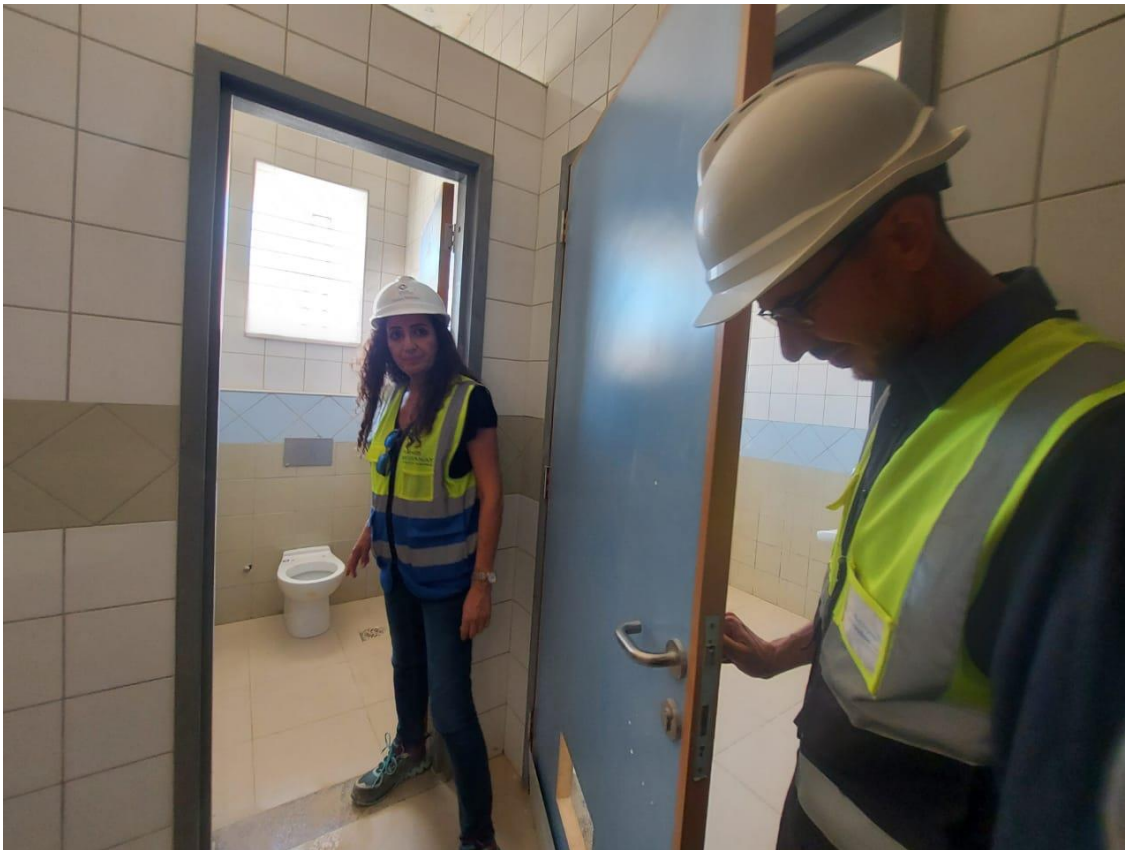
(Figure: 11)

The team inspected the wet areas' in the building to check the status of all executed items

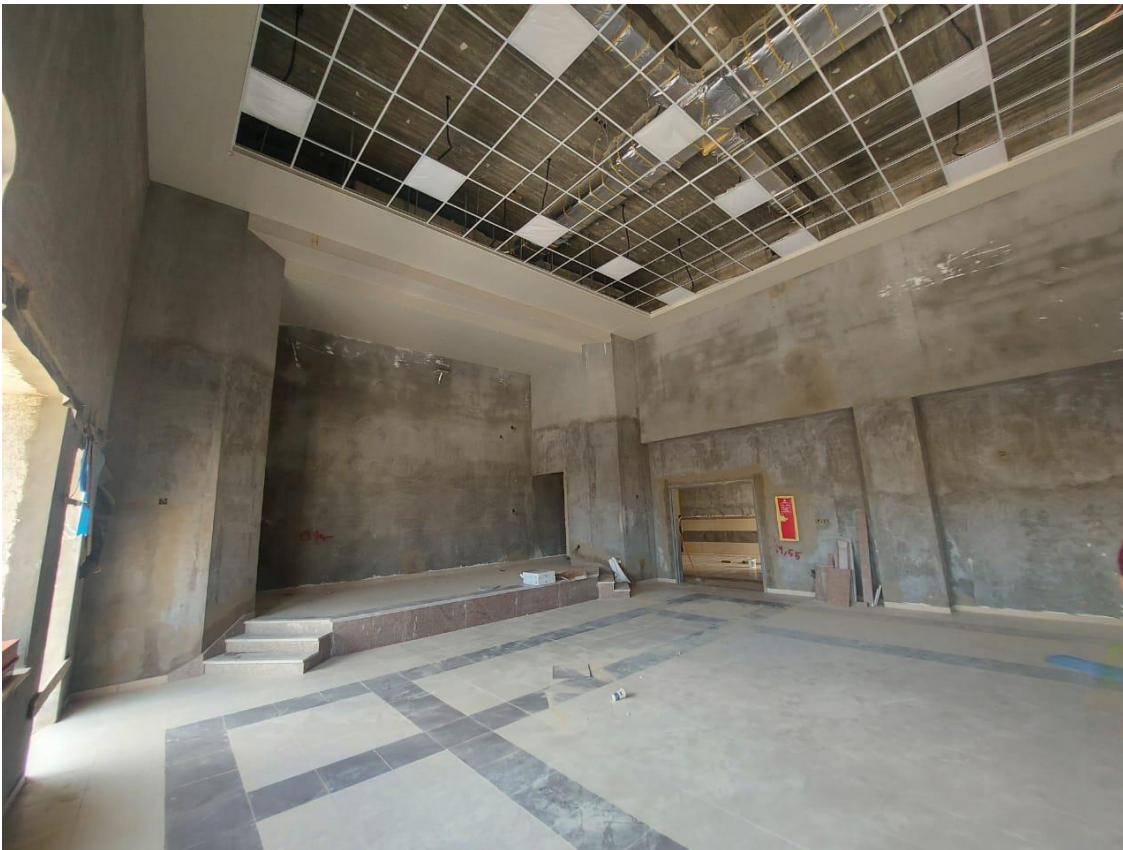
(Figure: 14)

The team inspected the progress of work at the multi-purpose hall

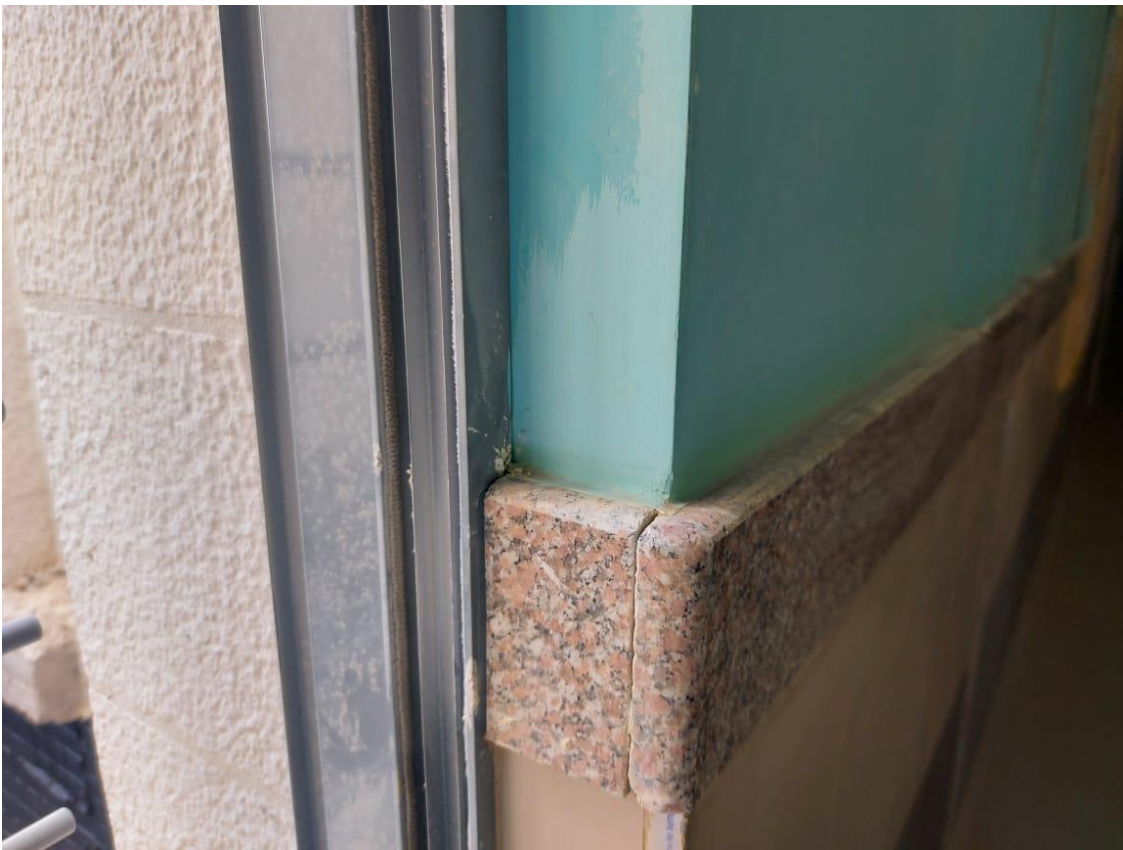
(Figure: 16)

3	The team inspected the wall tiles and the relation with the door frame at the child care at the (KG) area.
4	The team inspected the installed electrical sockets with cover at the (KG) area to ensure that the work is executed according to the approved workshop drawings.
5	The team found out that the defected delivered cabinets for the (KG) had been rectified.
6	The team inspected the current works going on in the multi-purpose hall.
7	The team inspected the preparation by the Contractor to install the granite coping at the corridors, chipping of plastering at the coping line to ensure compliance with drawings.
8	The team inspected the executed expansion joints at the corridors.
9	The team observed that there is some waving in the plastering and painting at the corridors and ceilings. The Contractor was requested to rectify
10	The team inspected the executed granite skirting for the staircases.
11	The team inspected the executed granite coping at the window jamb and observed a contradiction with the approved sample regarding the prominence of the granite piece. The Contractor was requested to rectify.

The team previously observed a contradiction of the granite coping with the approved sample regarding the prominence of the granite piece
