Quality Control Report

Consultant **Wahib Medanat** Consultant Engineers
Site Name **Um Al Dananir Basic Mixed - Balqa**
Package **Package 1**
Contractor **Derar Saraireh & Sons for Engineering & Contracting**
Tender No. **1/2020/USAID/SKEP/3/1**

Rep No. **QC-11 16**
Date **19 / 02 / 2022**

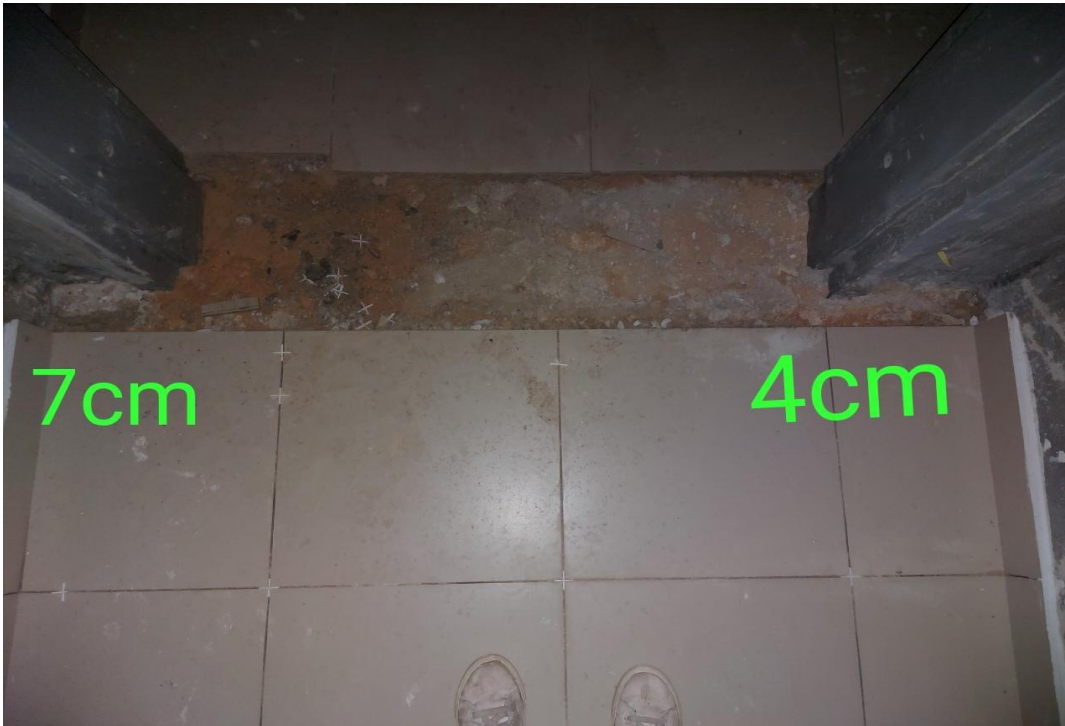
Deviation in the tiled corridor

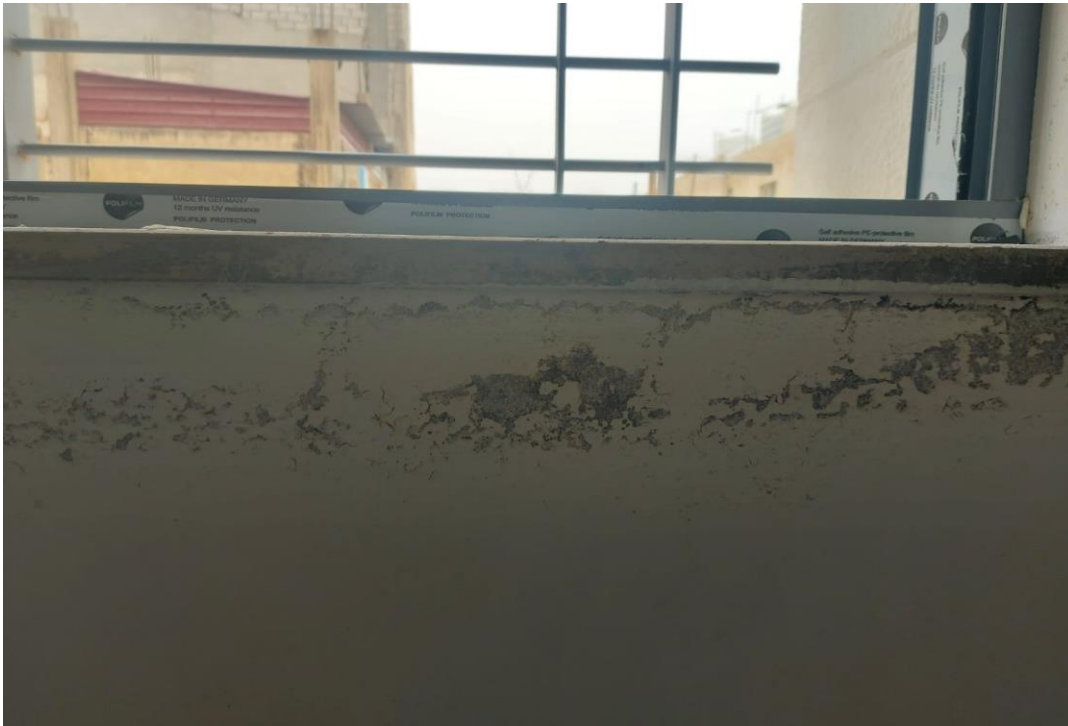
Humidity under the window sill

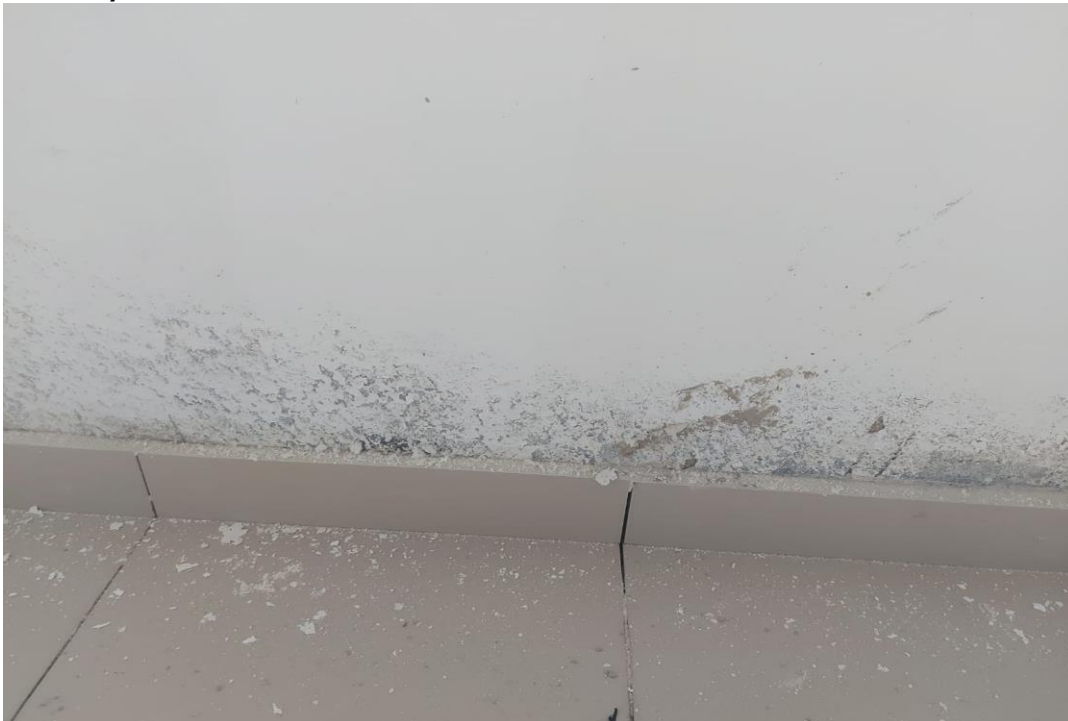
Humidity over the skirting

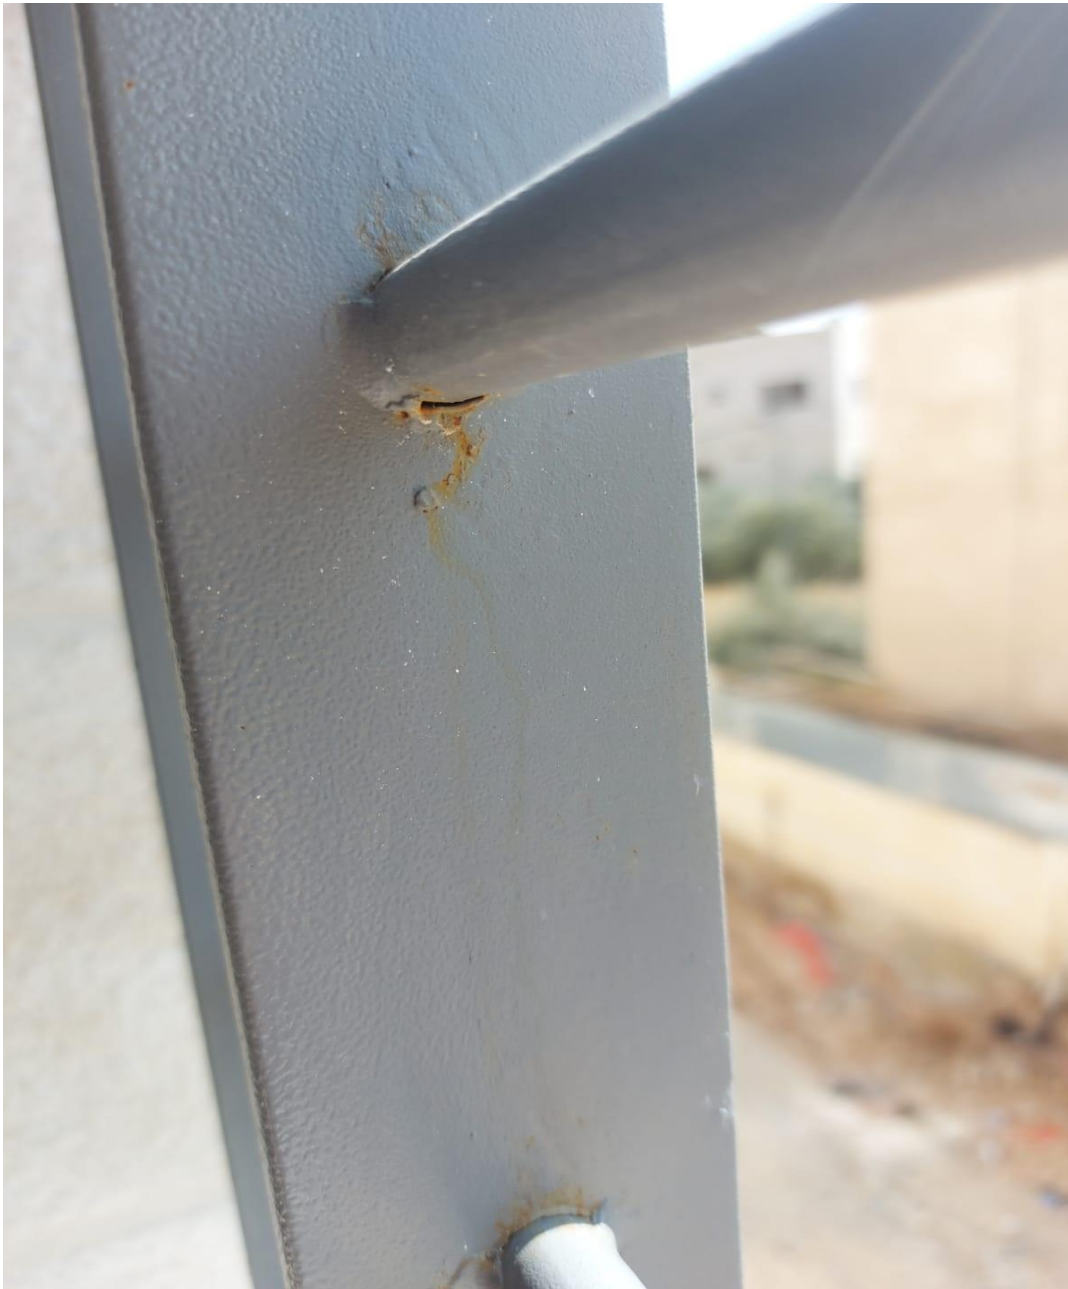
Corrosion in the steel protection screens

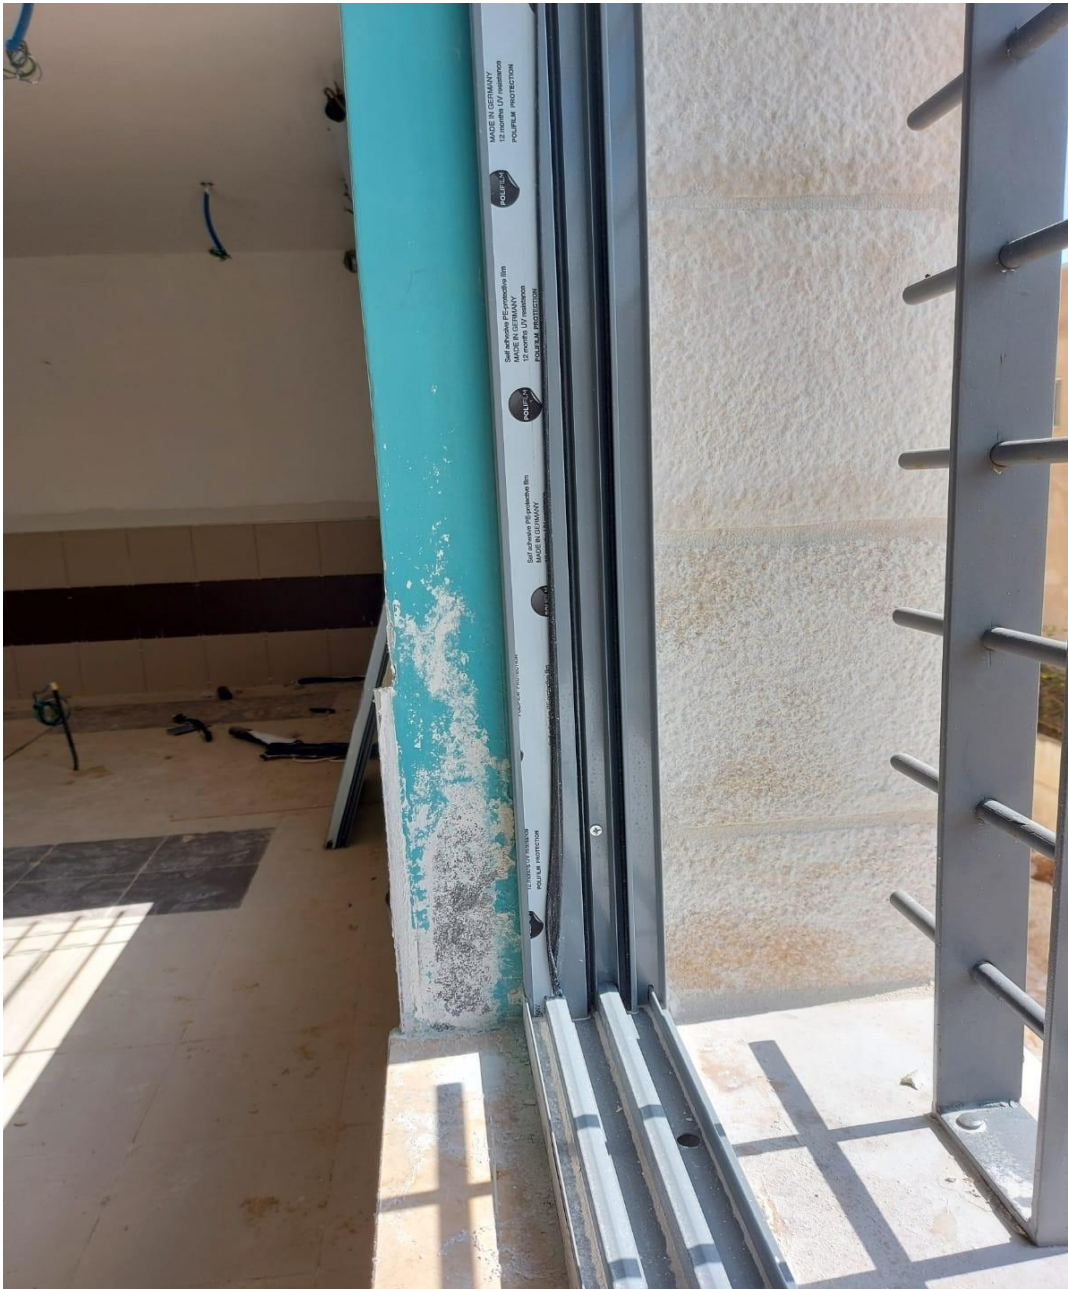
Window jambs not finished to receive aluminum sections
