Quality Control Report

Consultant **Wahib Medanat** Consultant Engineers
Site Name **Khadija Bint Khwailed Basic Mixed - Balqa**
Package **Package 1**
Contractor **Derar Saraireh & Sons for Engineering & Contracting**
Tender No. **1/2020/USAID/SKEP/3/1**

Rep No. **QC-13 03**
Date **6 / 03 / 2021**

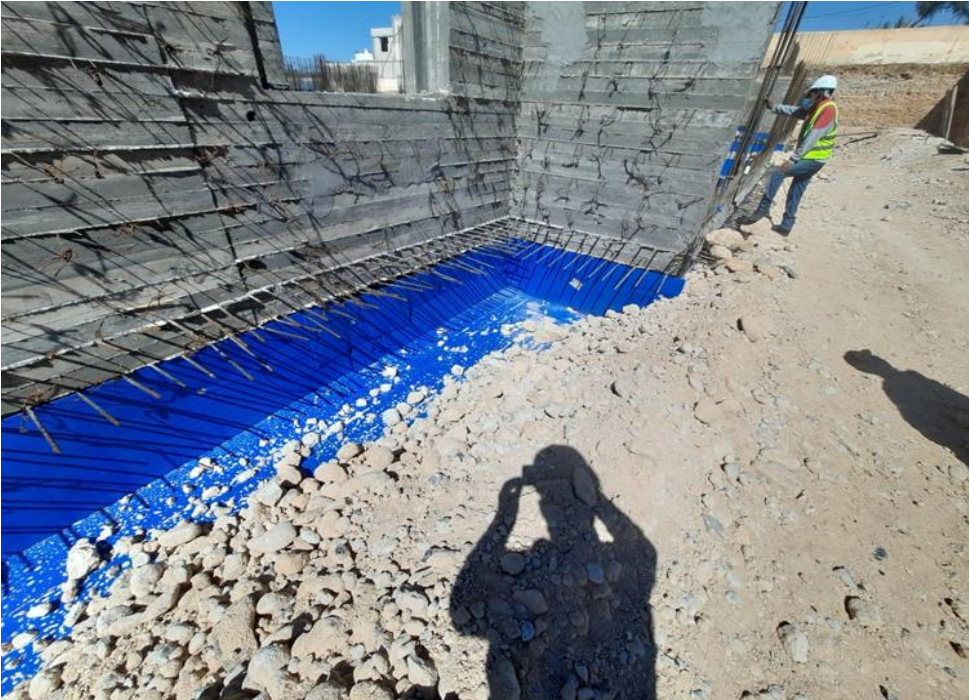
Description of Non Conformance	Corrective Action	Required by / When
1- Filling material contains boulders not conforming to the technical specifications. 2- Casted retining wall having a height over 5m. The contractor started removing shuttering after nearly 40 hours instead of 72 hours	1- The Contractor was requested to remove the boulders as per the technical specifications. 2- The contractor was stopped by supervision engineer and requested to wait for the right time	1- Immediate action by contractor. 2- Immediate action by contractor

Boulders Existing- QC Report 1301

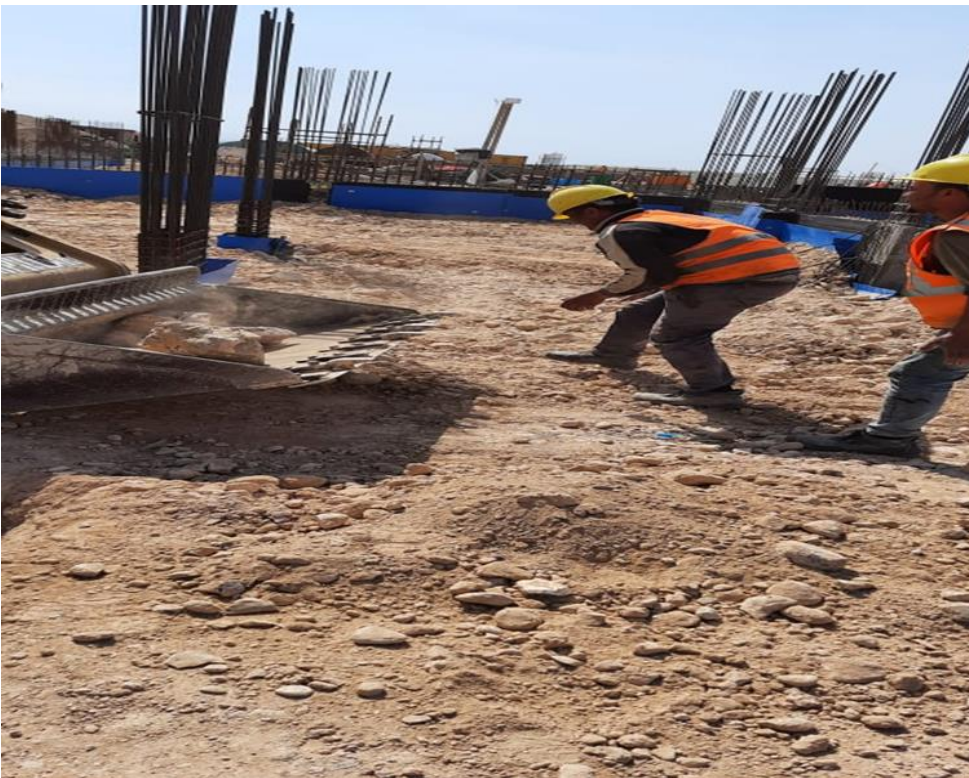
Removal of Boulders- QC Report 1301

The contractor responded promptly and removed all boulders and postponed the removal of formwork as	
---	--
