SKEP III Home Office Support Site Visit Report

Consultant	Wahib Medanat Consultant Engineer	Rep No.	21-23052022
Contractor	Dijlah Establishment Constr. Contracting	Tender No.	(11/2019/USAID/SKEP/3/S) Schools for a Knowledge Economy Project (SKEP) - Phase (3) Package (1, 2)
Site Name	Hay Al Iskan Basic Mixed School- Jerash	Day/ Date	Mon. 23/05/2022
Duration of Project	450 Calendar Days	Total Project Budget	8,314,983.735 JD

Visit Notes

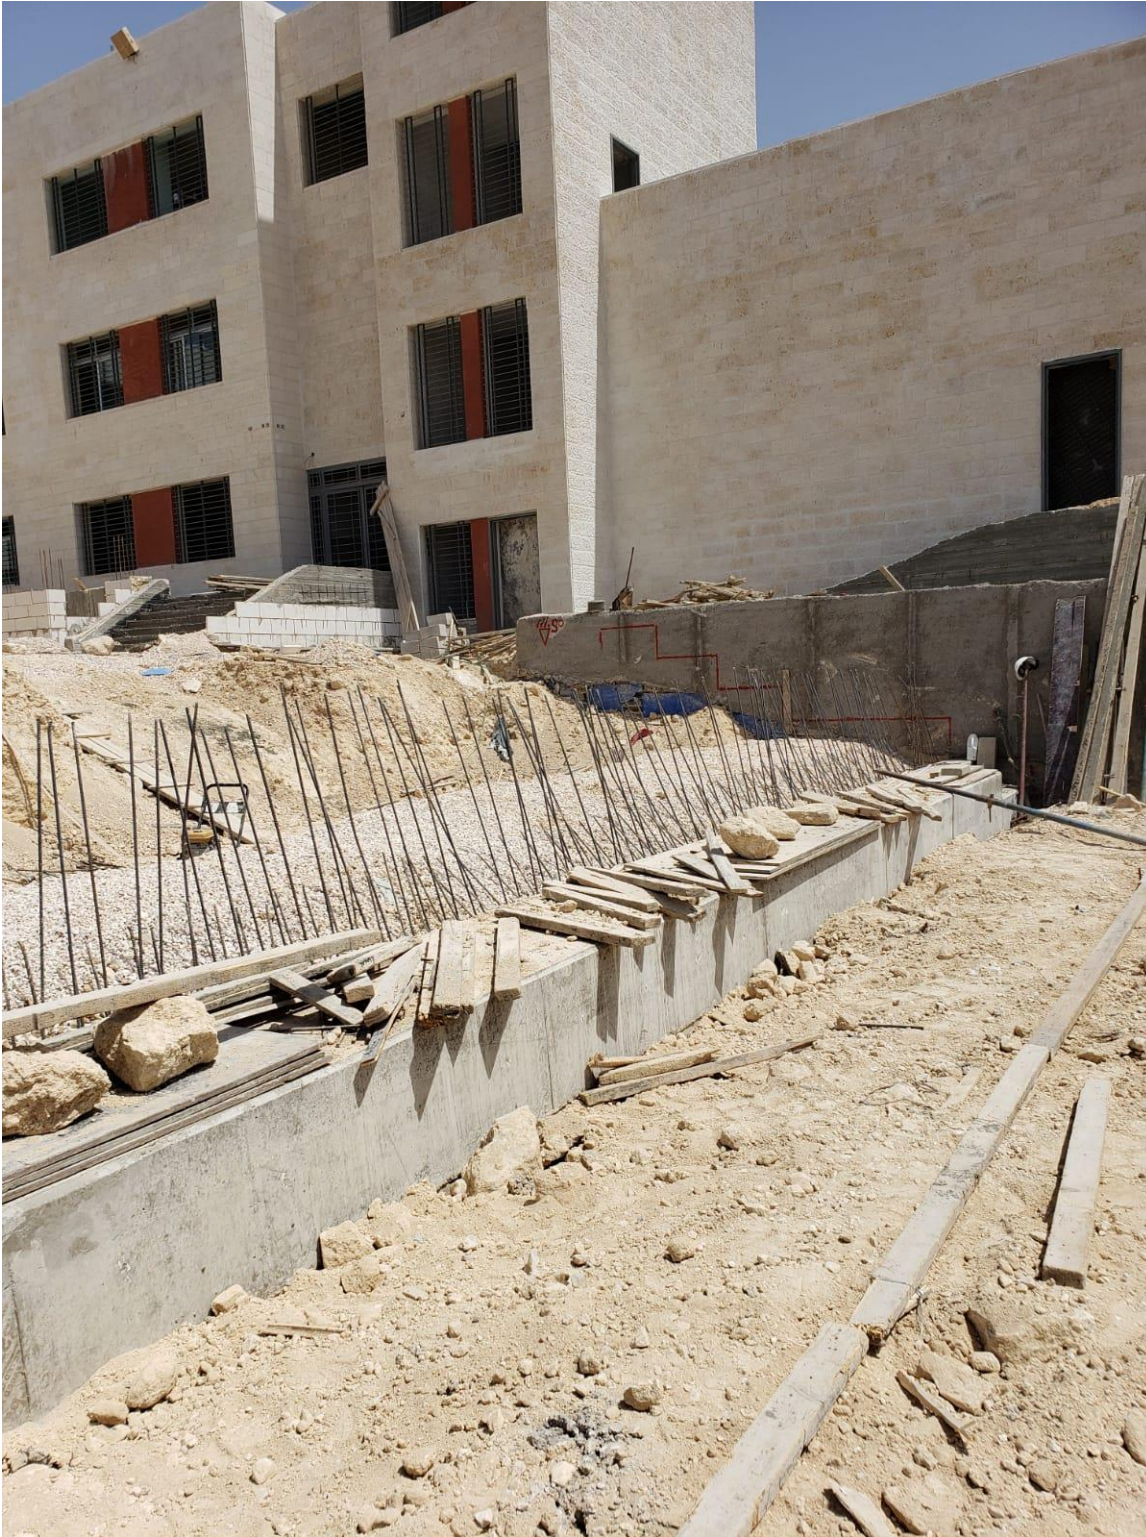
(Figure: 06)

The team discussed with the Contractor the required works for the guard house and the drinking fountain and the relation with the boundary walls

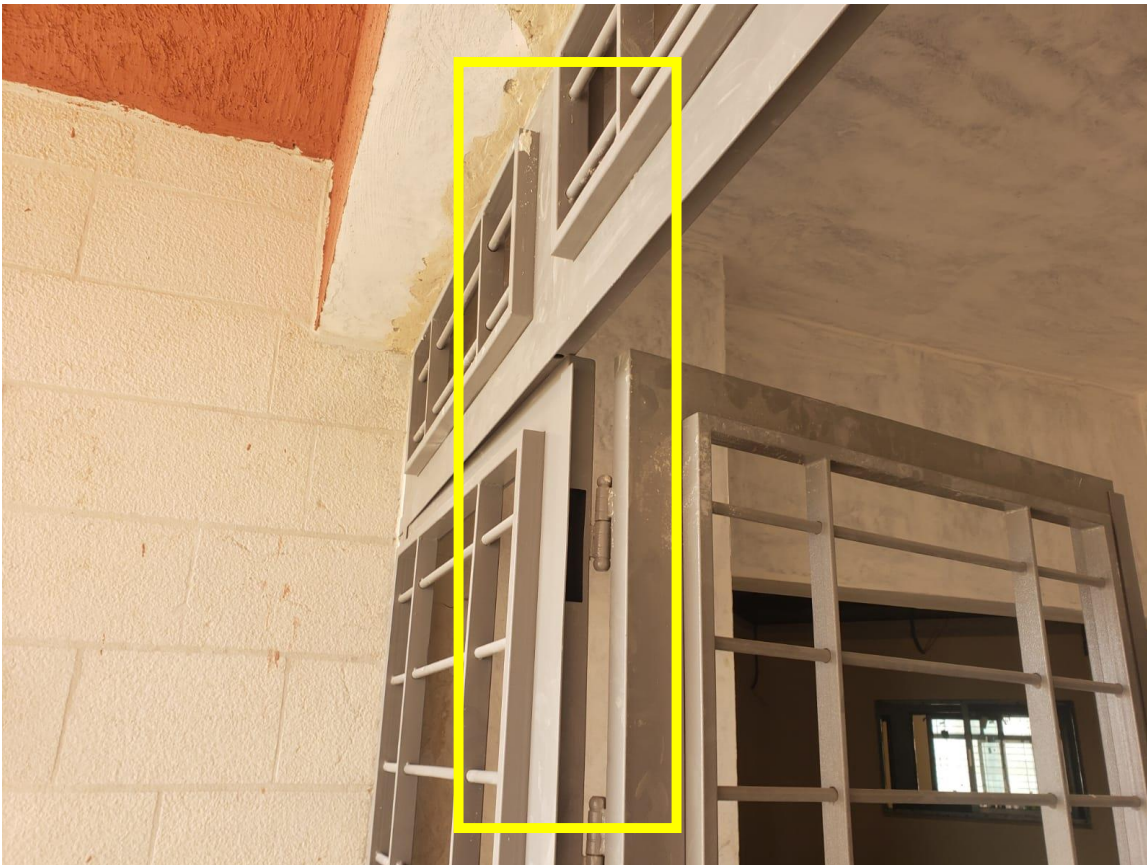
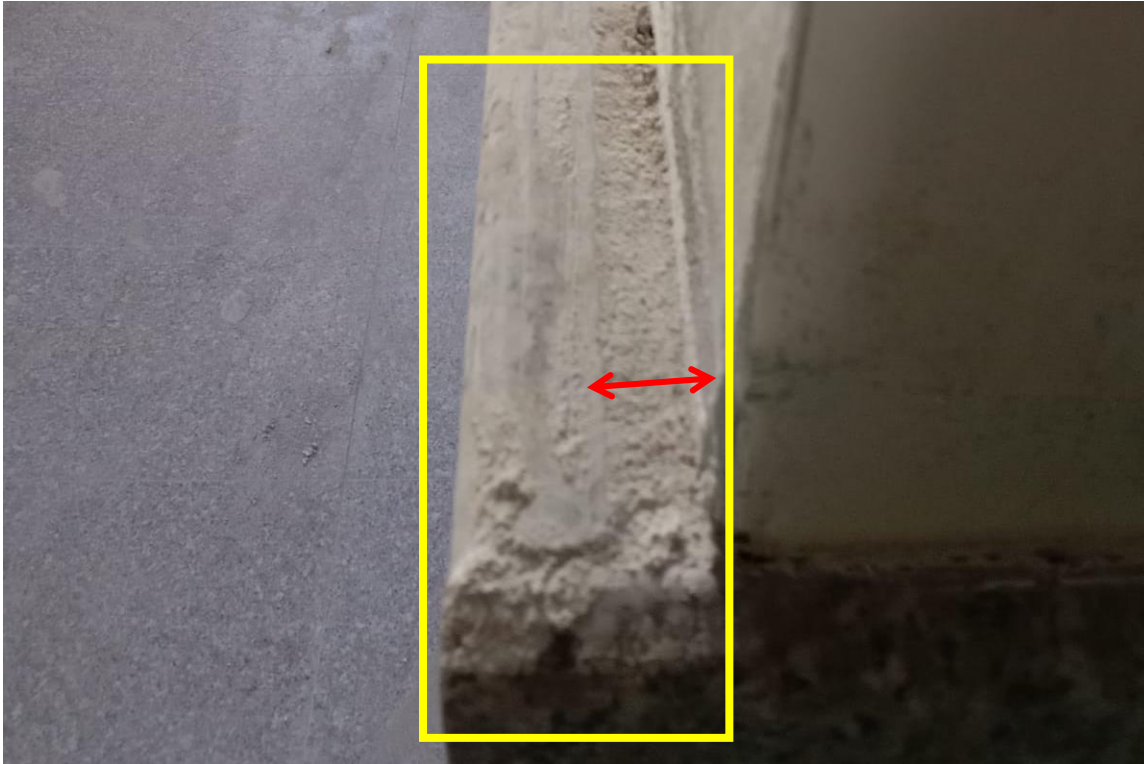
(Figure: 08 & 09)

The team inspected the installed main steel doors at the entrances of the building and observed deviation from the workshop drawings and architectural details. Difficulties in using the external door handle were observed due to wrong dimensions of steel sections

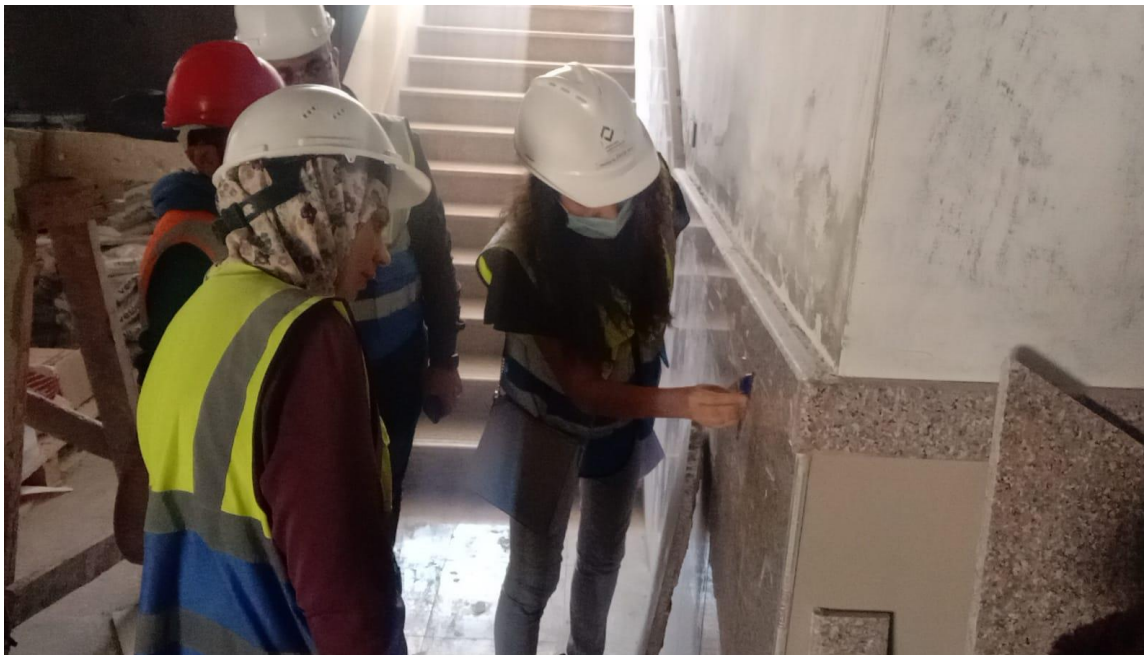
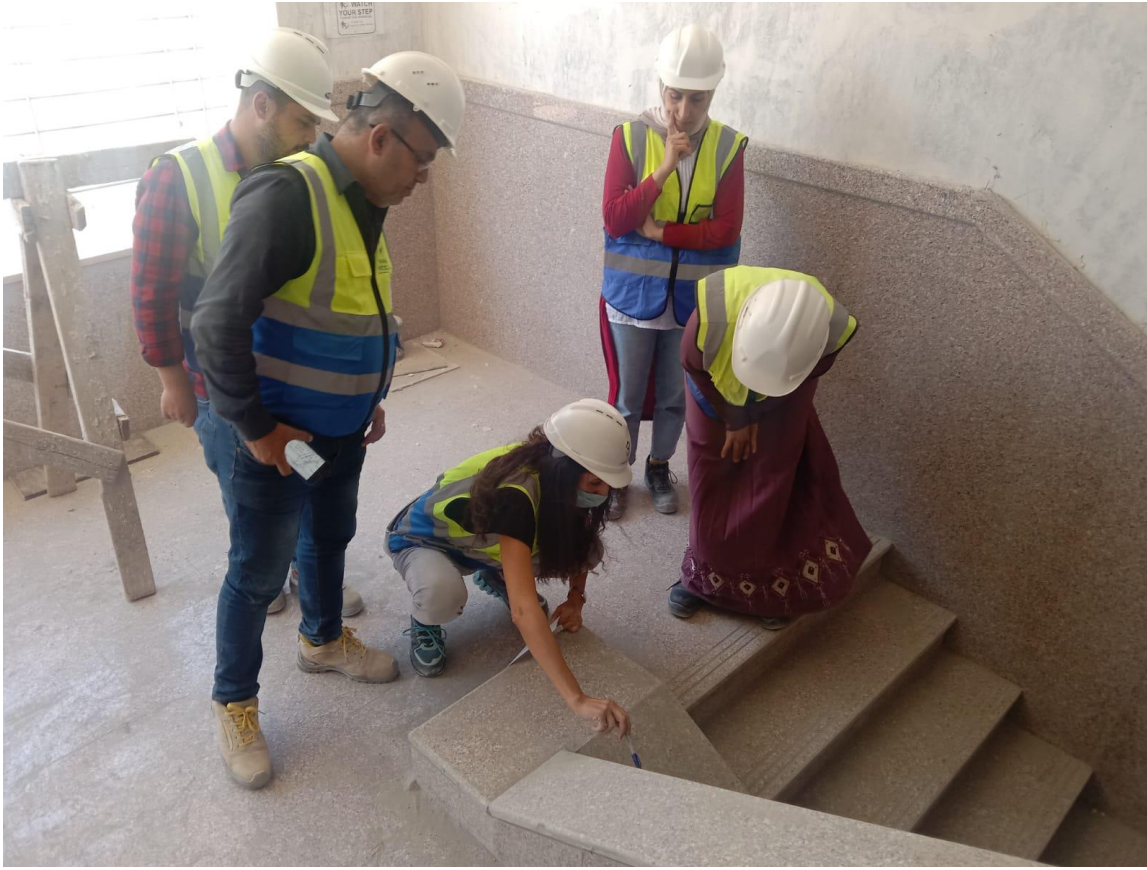
(Figure: 10 & 11)

The team discussed with the Contractor the suggestions to resolve the defects related to the granite cladding and coping at the corridors and staircases' areas

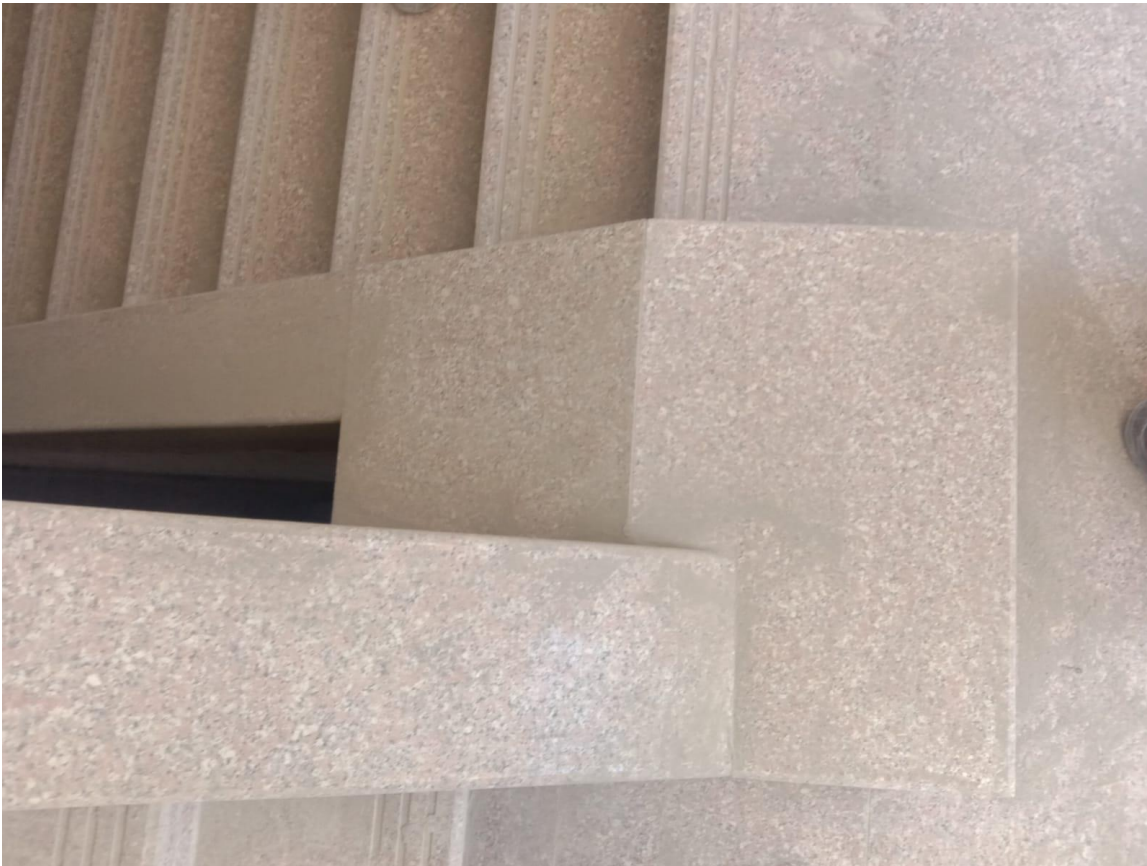
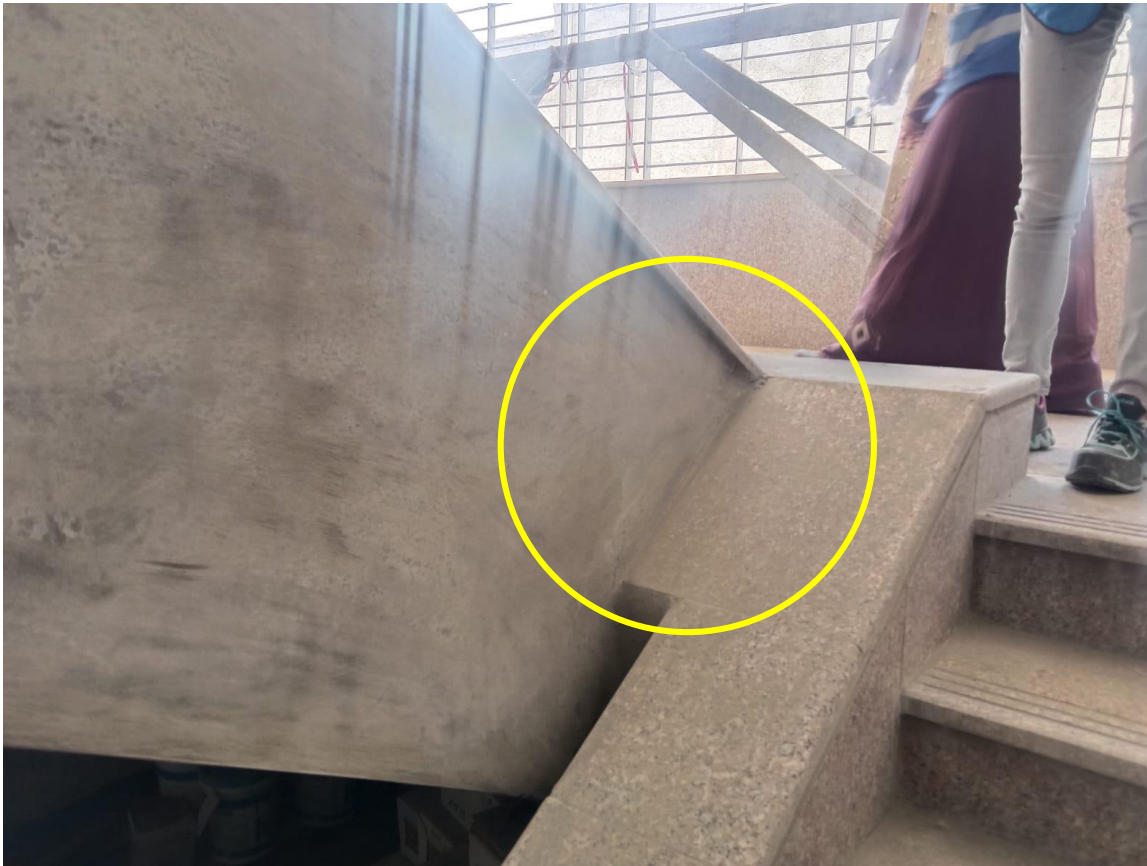
(Figure: 12 & 13)

The team observed dissimilarity regarding the ends of the parapets at the two sides of the main staircase at the same landing

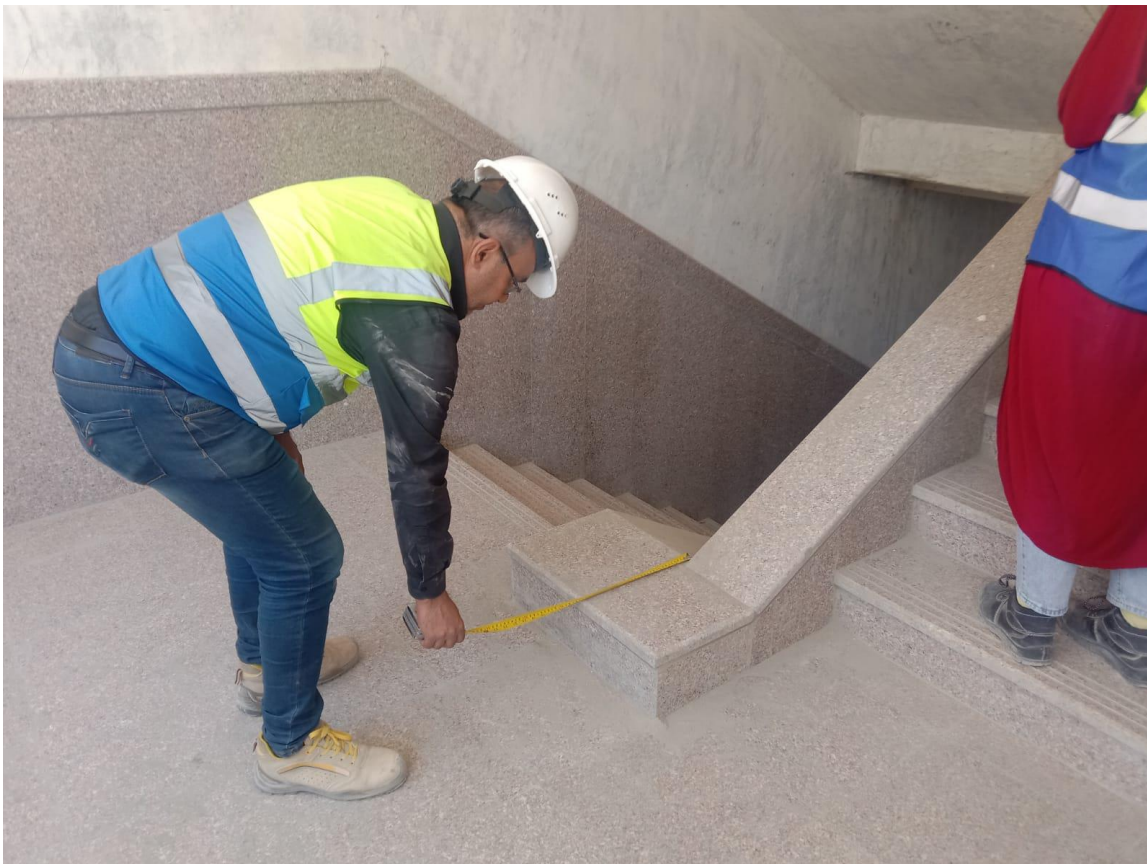
(Figure: 14)

Also, the team observed wide gap between the parapet cover and the skirting. The Contractor was requested to rectify

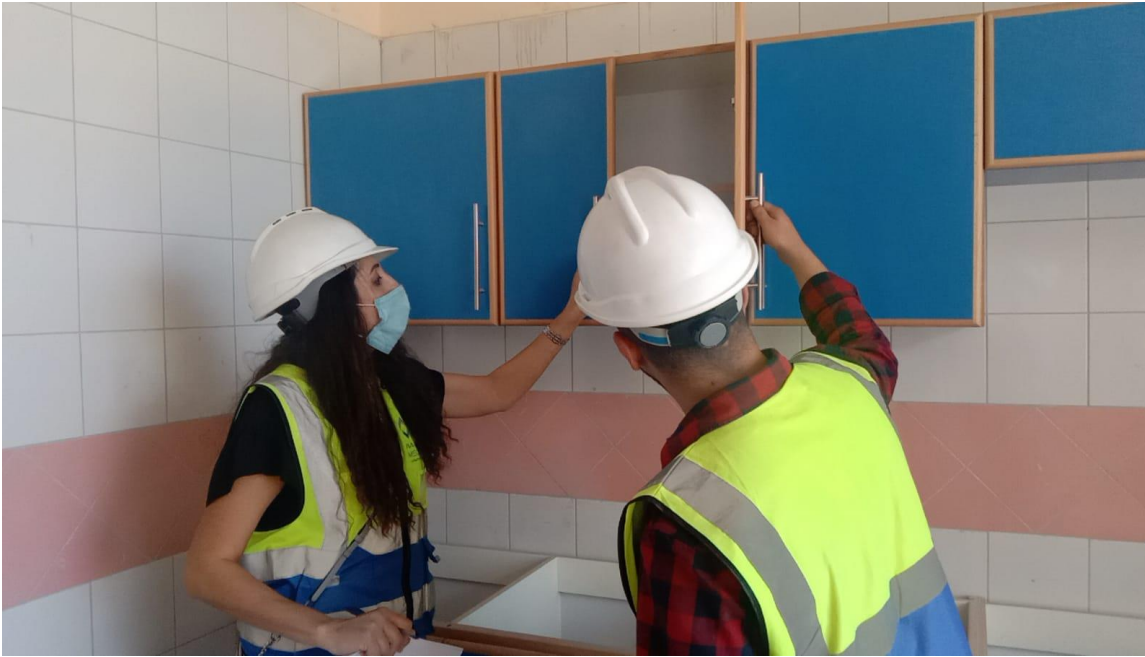
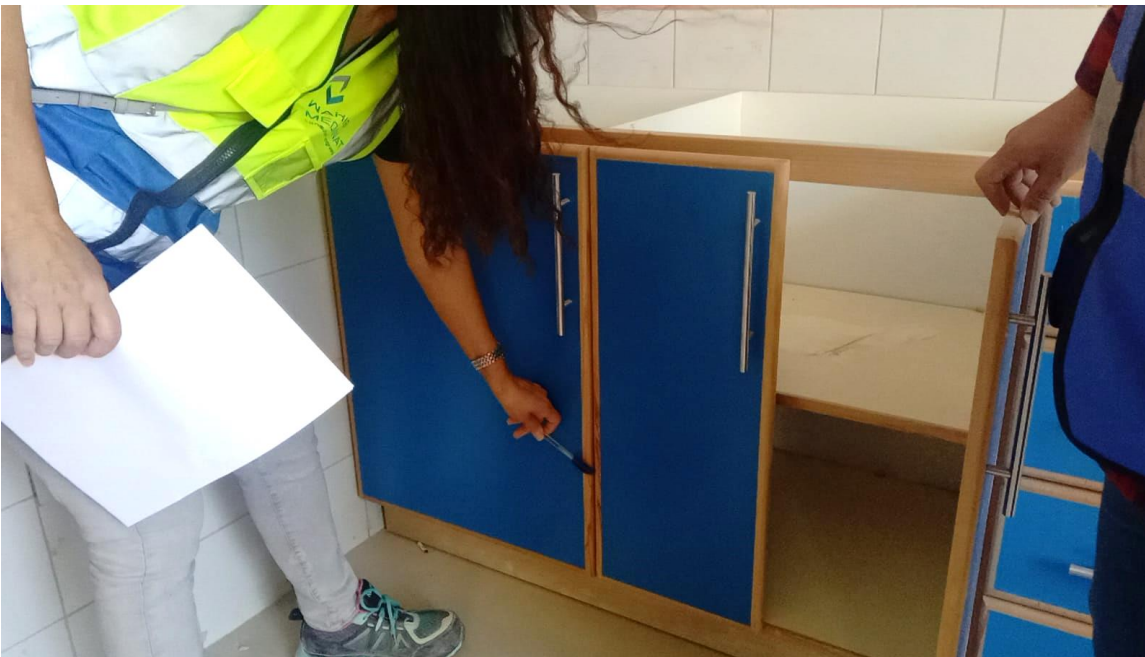
(Figure: 25 & 26)

The team inspected the delivered wooden cabinets and found a number of defects including the laminated partitions, unvertical ironmongery handles and defects in beech wood sections
