SKEP III Home Office Support Site Visit Report

| Consultant | Wahib Medanat Consultant Engineer | Rep No. | 13-09052022 |
| Contractor | Derar Saraireh & Sons for Engineering & Contracting | Tender No. | (11/2019/USAID/SKEP/3/S) Schools for a Knowledge Economy Project (SKEP) - Phase (3) Package (1, 2) |
| Site Name | Khadija Bint Khwailed Basic Mixed School- Shouna Janoubia | Day/ Date | Mon. 09/05/2022 |

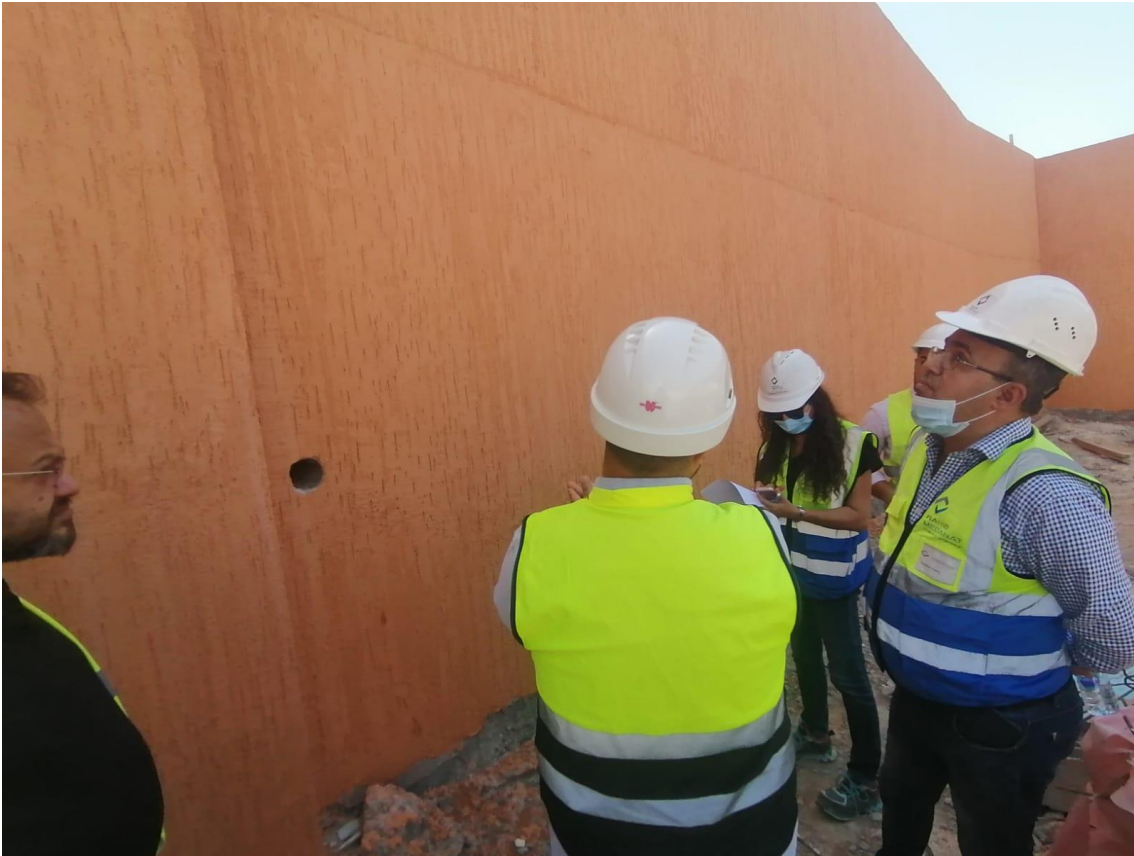
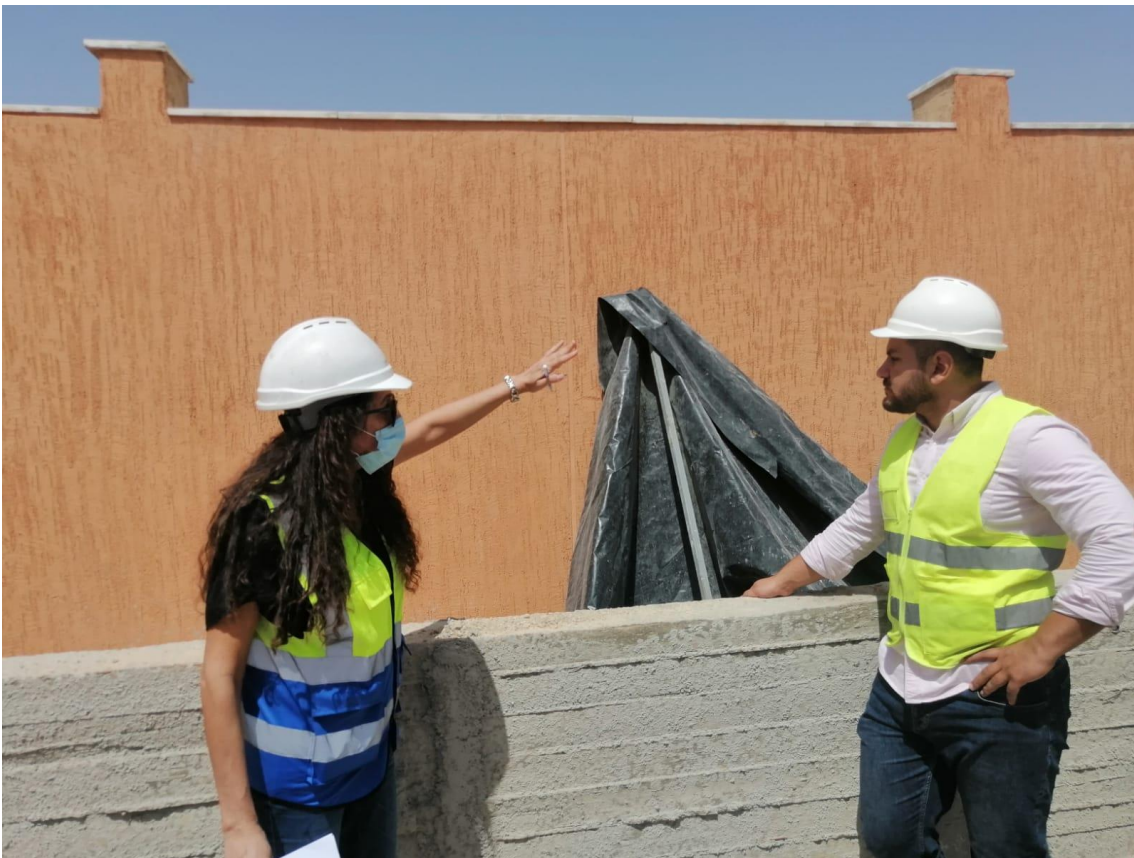
(Figure: 07 & 08)

| No. | Description |
|---|---|
| 1 | The supervision team discussed with the Contractor the method of execution of the colored plastering for the external walls. Both agreed that the Contractor shall prepare a sample to be approved by the Engineer in order to be as a reference for all color plastering in the project. |

The supervision team discussed with the Contractor the method of execution of the colored plastering for the external walls. Both agreed that the Contractor shall prepare a sample to be approved by the Engineer in order to be as a reference for all color plastering in the project

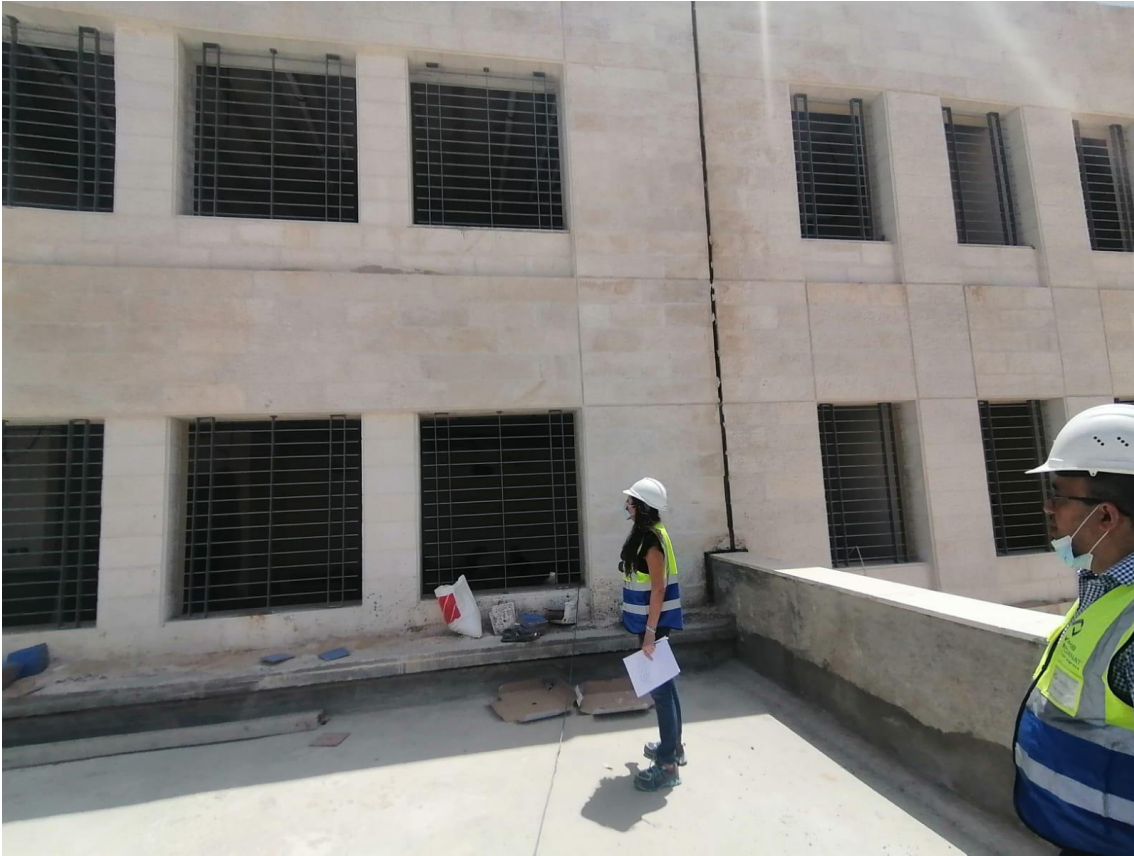
(Figure: 09)

| 14 | The team inspected the steel protection screens and reminded the Contractor to rectify the defects observed previously in the relation to the scratches and straightness of sections |

The team inspected the steel protection screens and reminded the Contractor to rectify the defects observed previously in the relation to the scratches and straightness of sections

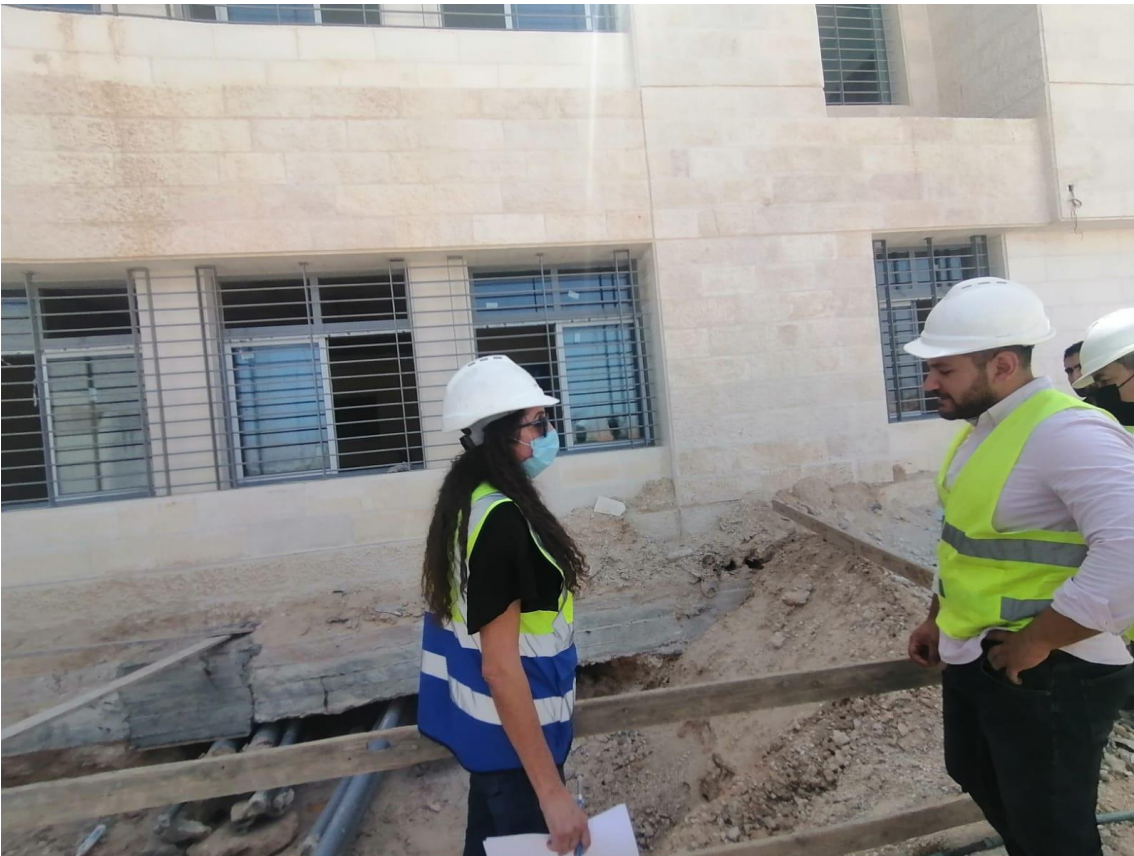
(Figure: 10)

| No. | Description |
|---|---|
| 2 | The team inspected the built stone at the facades and reminded the Contractor to conduct cleaning of the dirt as requested previously. |

The team inspected the built stone at the facades and reminded the Contractor to conduct cleaning of the dirt as requested previously

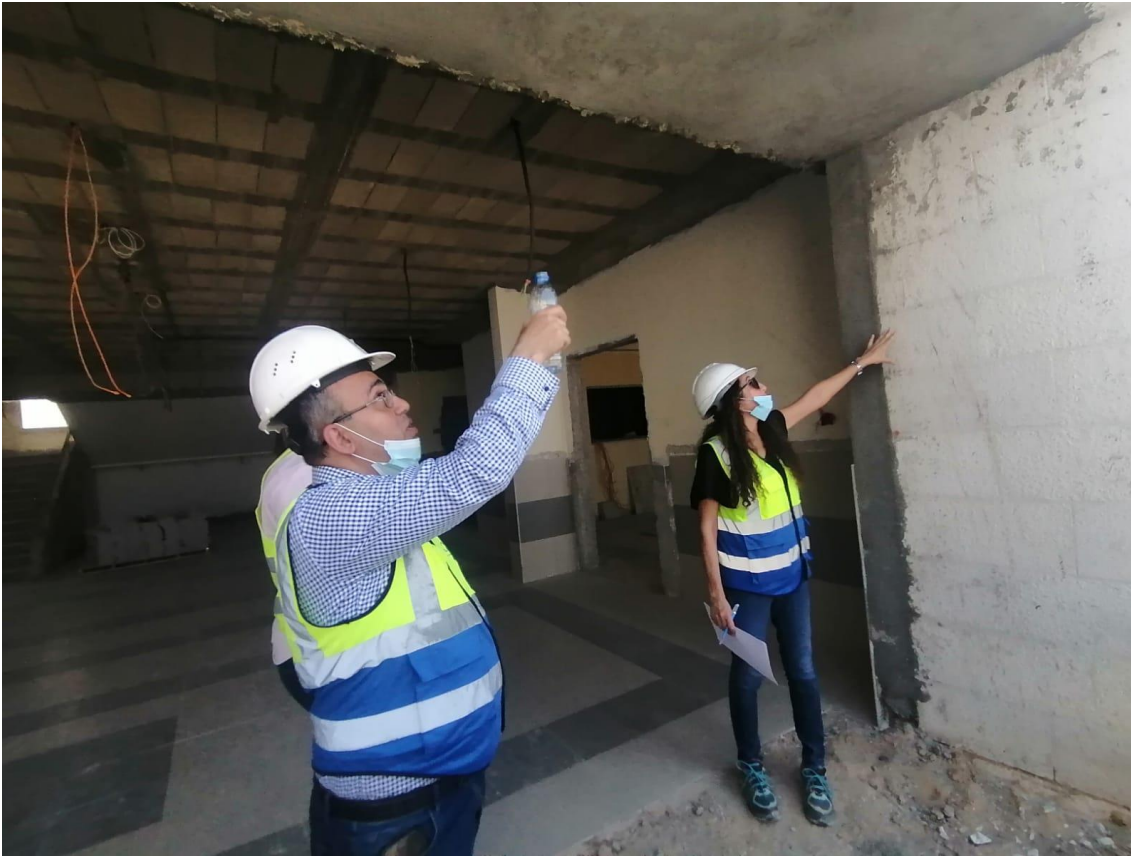
(Figure: 11)

| No. | Description |
|---|---|
| 3 | The team discussed with the Contractor the details of the building entrances in relation to the jambs, connection of stones with plastering and the width of granite thresholds. |

The team discussed with the Contractor the details of the building entrances in relation to the jambs, connection of stones with plastering and the width of granite thresholds

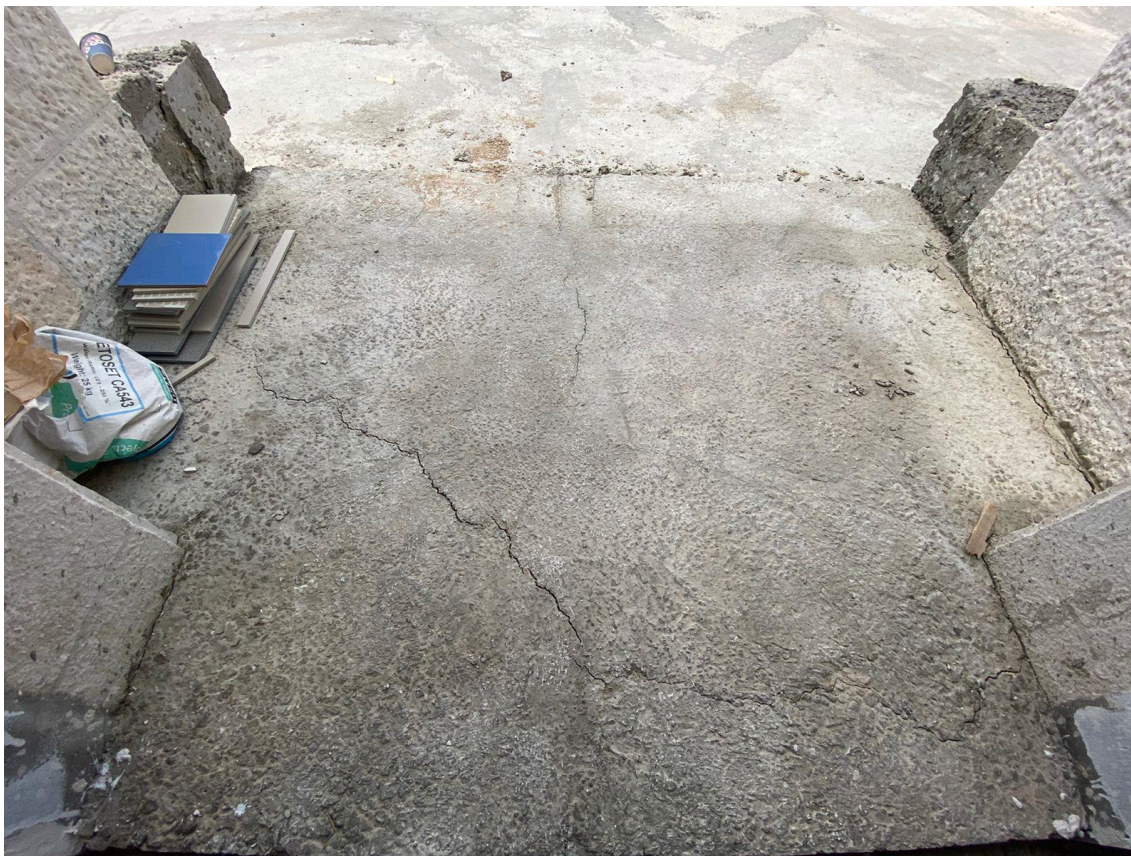
(Figure: 12)

| 13 | The team observed cracks in the casted concrete over the expansion joint at the roof of the multi-purpose hall. The Contractor was requested to rectify using special materials. |

The team observed cracks in the casted concrete over the expansion joint at the roof of the multi-purpose hall. The Contractor was requested to rectify using special materials

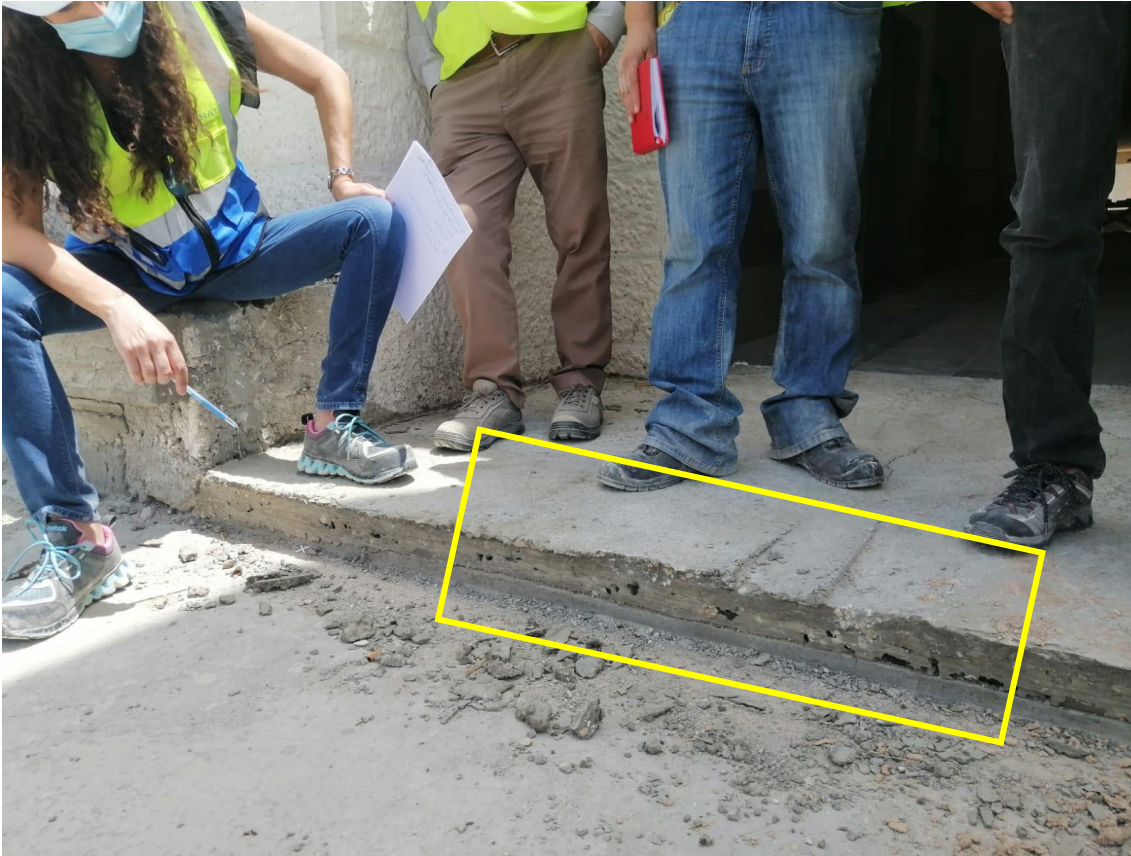
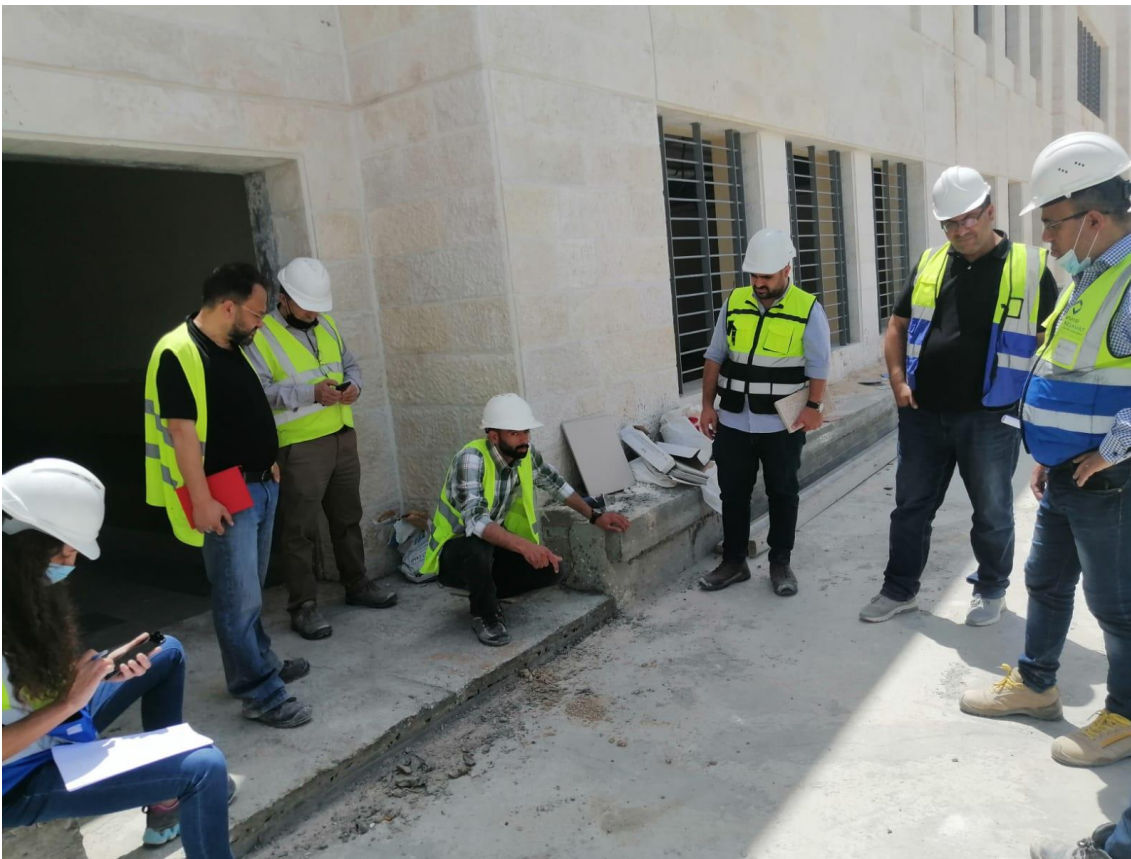
(Figure: 13 & 14)

| 12 | The team discussed with the Contractor the waterproofing at the roof of the multi-purpose hall and requested him to fix waterproofing sheets at the concrete cover of the expansion joint at the entrance to the corridor and overlap with the waterproofing sheets at the said roof. The sheets over the expansion joint shall be free, not pasted to allow for movement. |

The team discussed with the Contractor the waterproofing at the roof of the multi-purpose hall and requested him to fix waterproofing sheets at the concrete cover of the expansion joint at the entrance to the corridor and overlap with the waterproofing sheets at the said roof. The sheets over the expansion joint shall be free, not pasted to allow for movement

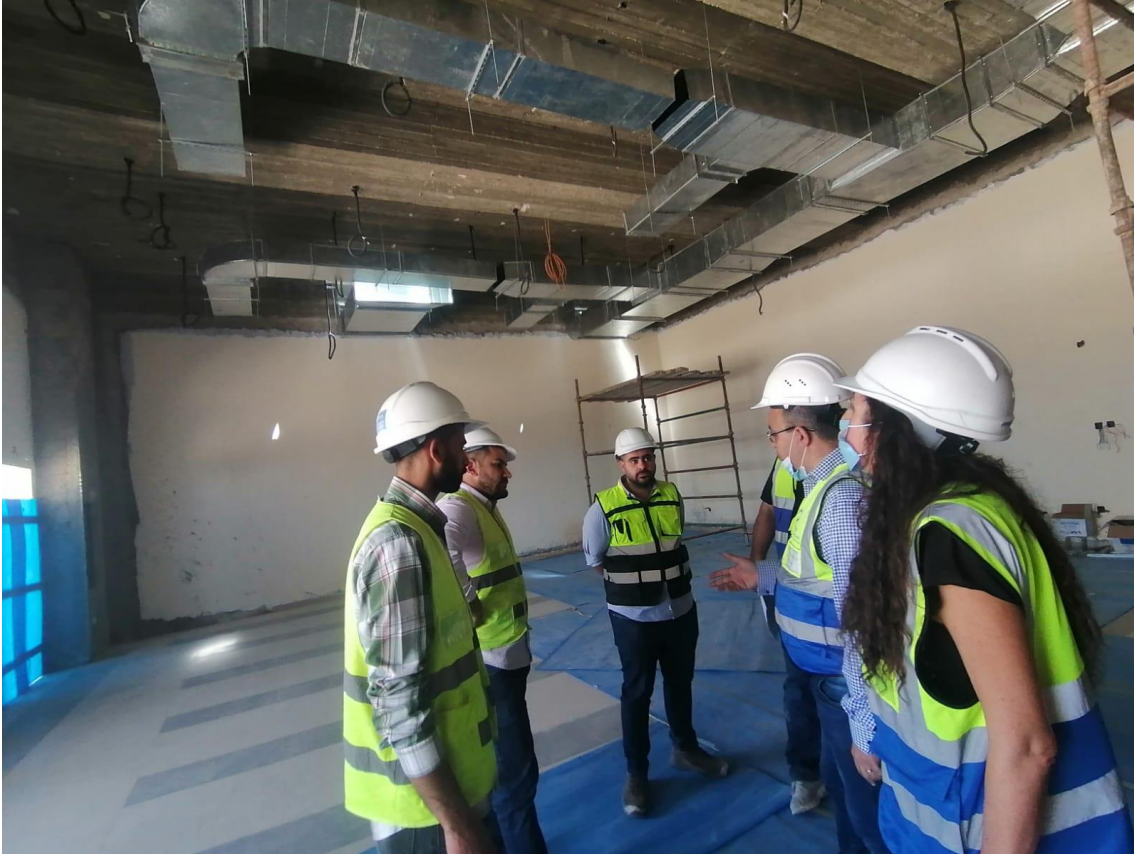
(Figure: 15)

| 7 | The team inspected the duct work undergoing in the multi-purpose hall. |

The team inspected the duct work undergoing in the multi-purpose hall

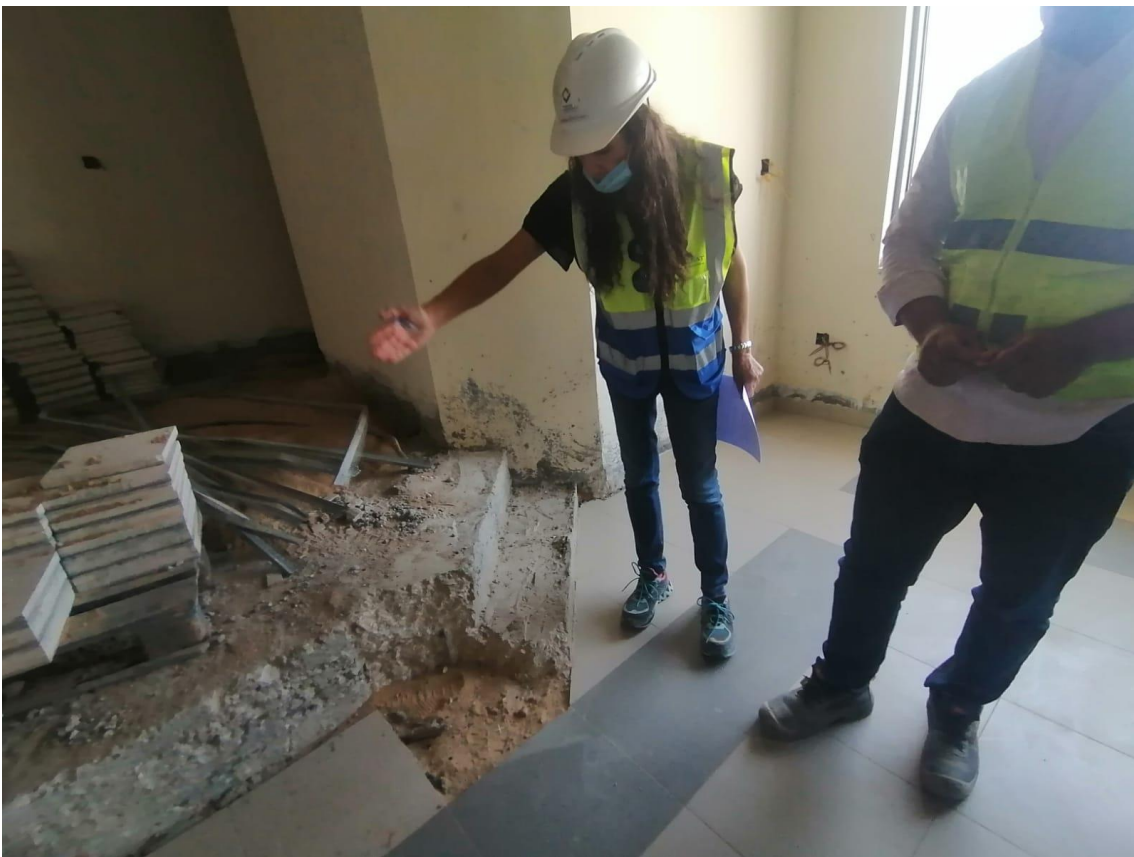
(Figure: 16)

| 6 | The team inspected and discussed with the Contractor the current status of the multi-purpose hall and discussed the execution of granite tiles for the stage and the stairs and the connection with porcelain floor tiles. |

The team inspected and discussed with the Contractor the current status of the multi-purpose hall and discussed the execution of granite tiles for the stage and the stairs and the connection with porcelain floor tiles

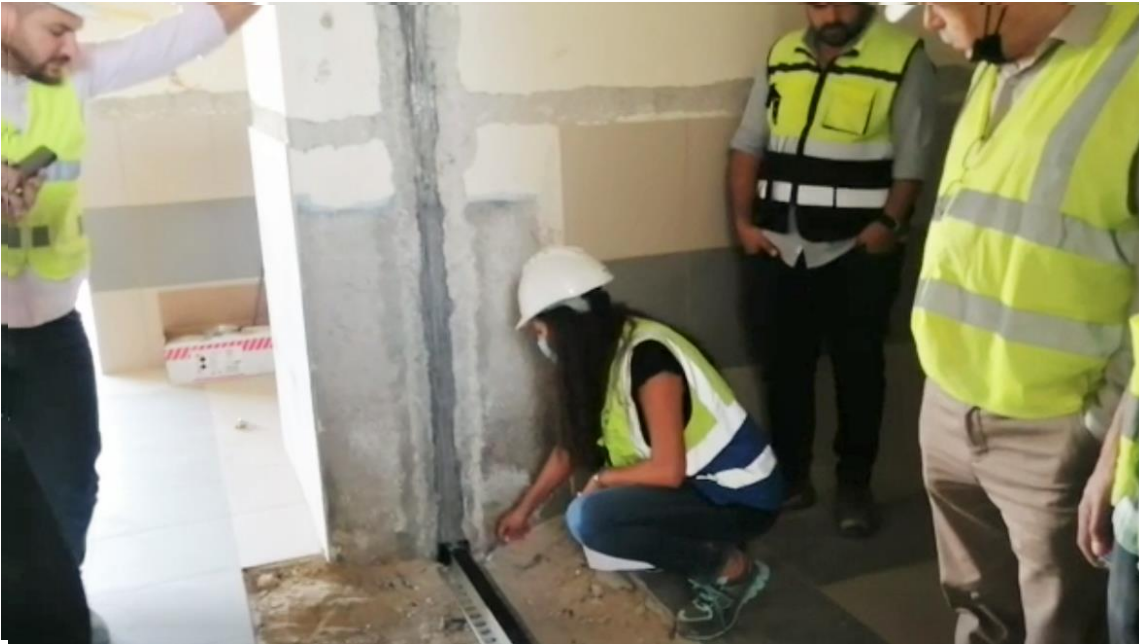
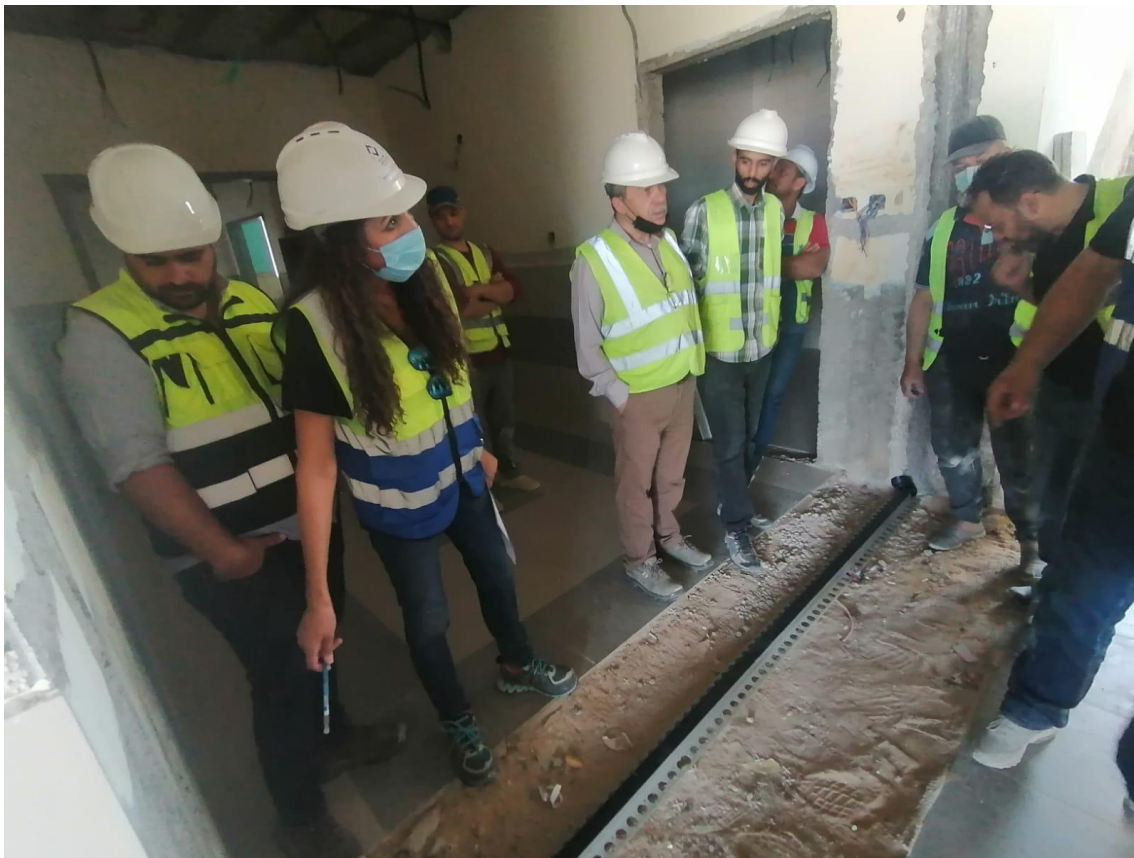
(Figure: 17 & 18)

| 9 | The team inspected the current status of the expansion joint at the corridor and approved the Contractor's method to complete the remaining work there with no objection to fix an extension to the metal part of the joint to cover the whole required length. |

The team inspected the current status of the expansion joint at the corridor and approved the Contractor’s method to complete the remaining work there with no objection to fix an extension to the metal part of the joint to cover the whole required length

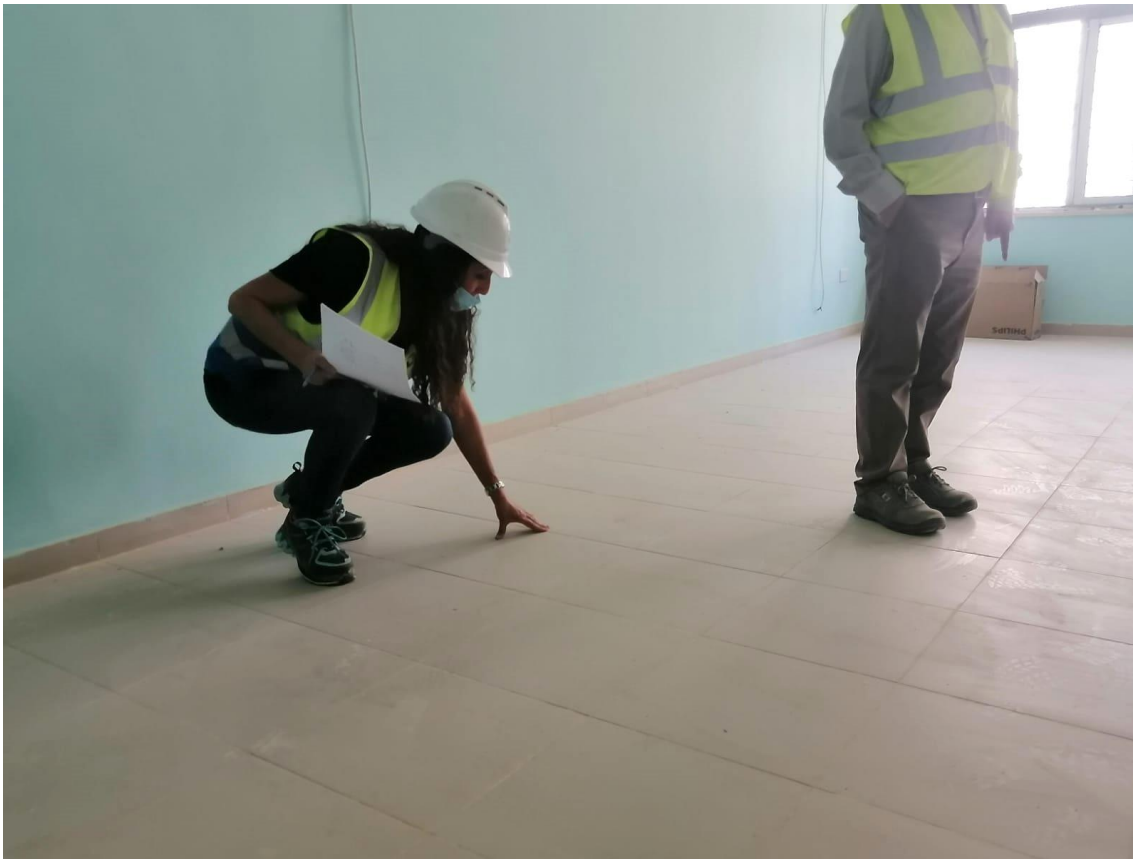
(Figure: 19)

| 11 | The team observed teething in floor porcelain tiles in one room and requested the Contractor to rectify. |

The team observed teething in floor porcelain tiles in one room and requested the Contractor to rectify

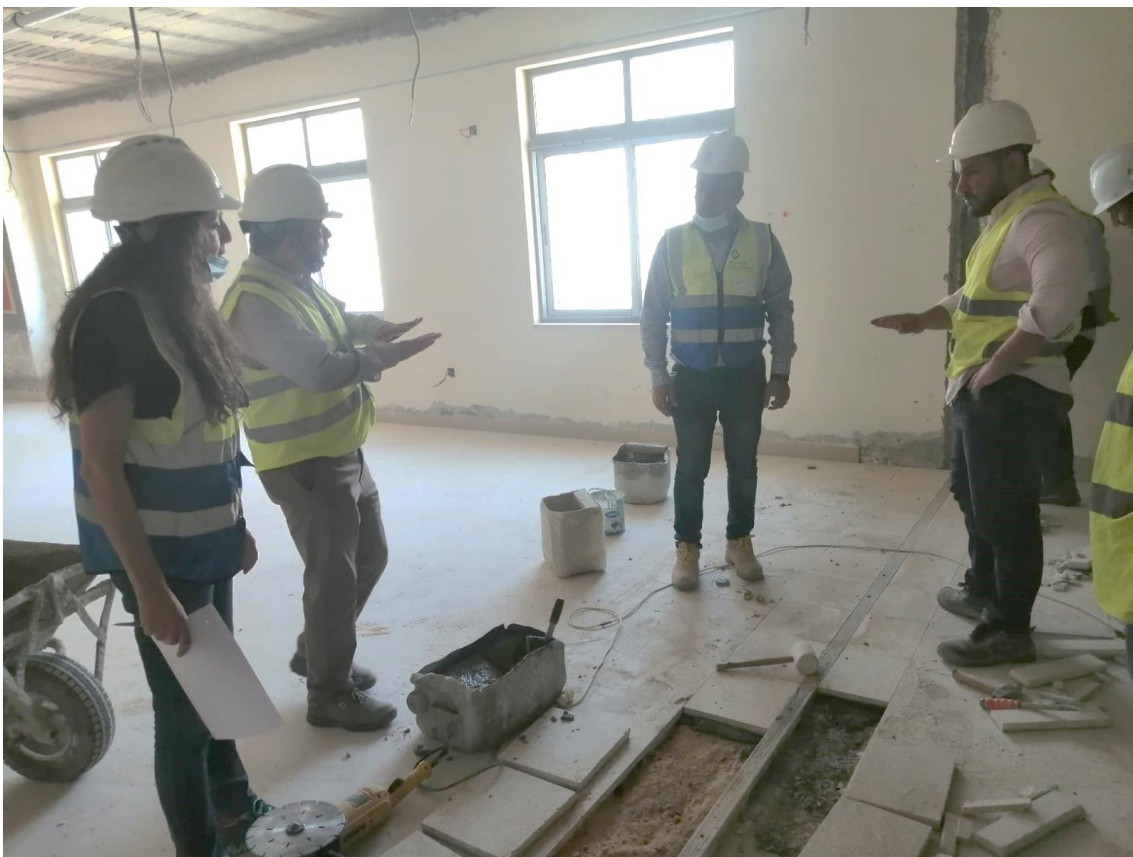
(Figure: 20)

| 8 | The team discussed with the Contractor the method of carpet tiles fixing in the library in relation to the expansion joint there. |

The team discussed with the Contractor the method of carpet tiles fixing in the library in relation to the expansion joint there

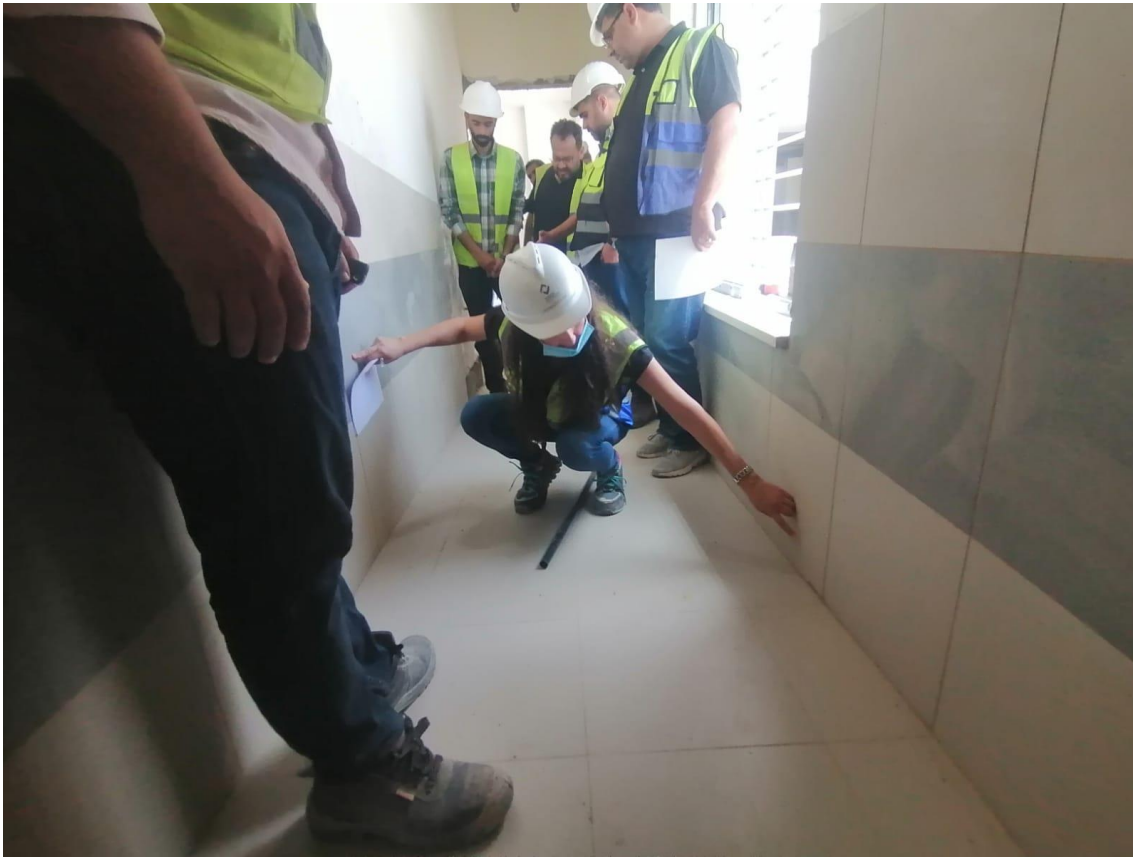
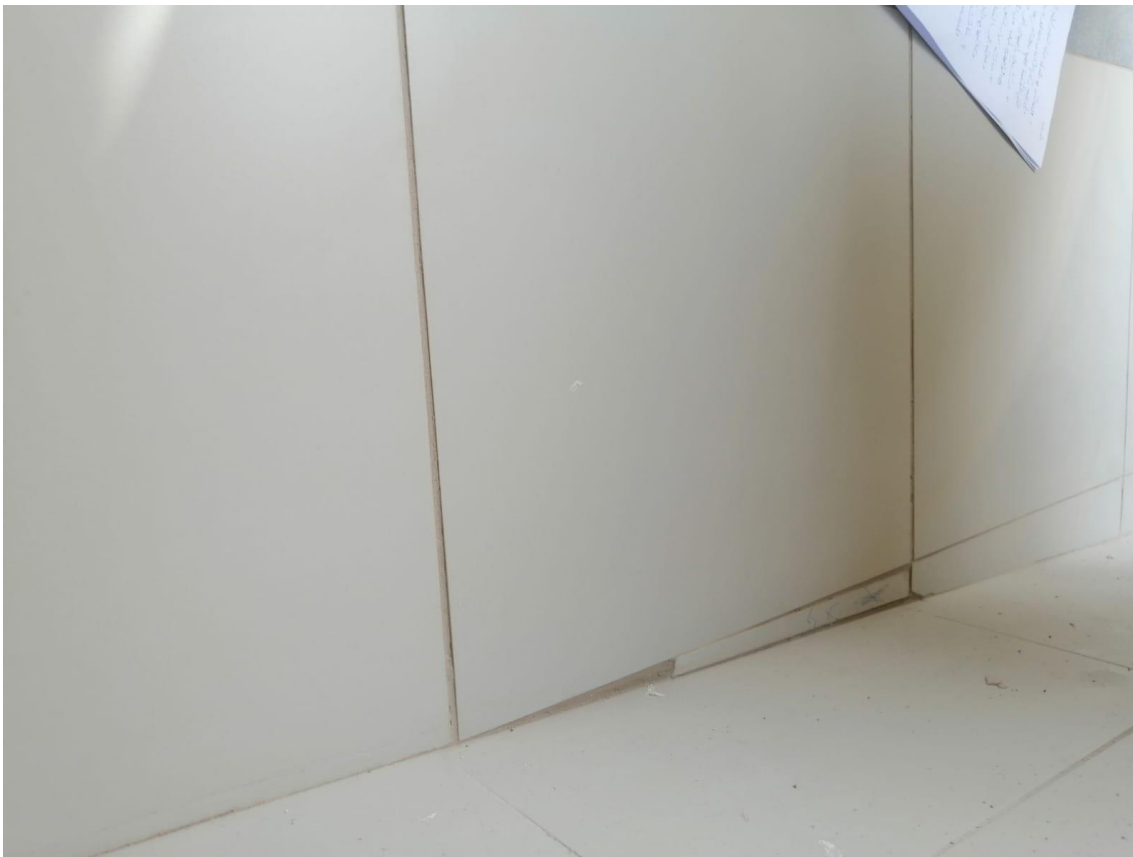
(Figure: 21 & 22)

| 5 | The team inspected the details related to the porcelain cladding surrounding the internal ramps in the school building and observed unaccepted porcelain cut-off pieces led to fill large gaps with grout. The Contractor was requested to rectify. |

The team inspected the details related to the porcelain cladding surrounding the internal ramps in the school building and observed unaccepted porcelain cut-off pieces led to fill large gaps with grout. The Contractor was requested to rectify

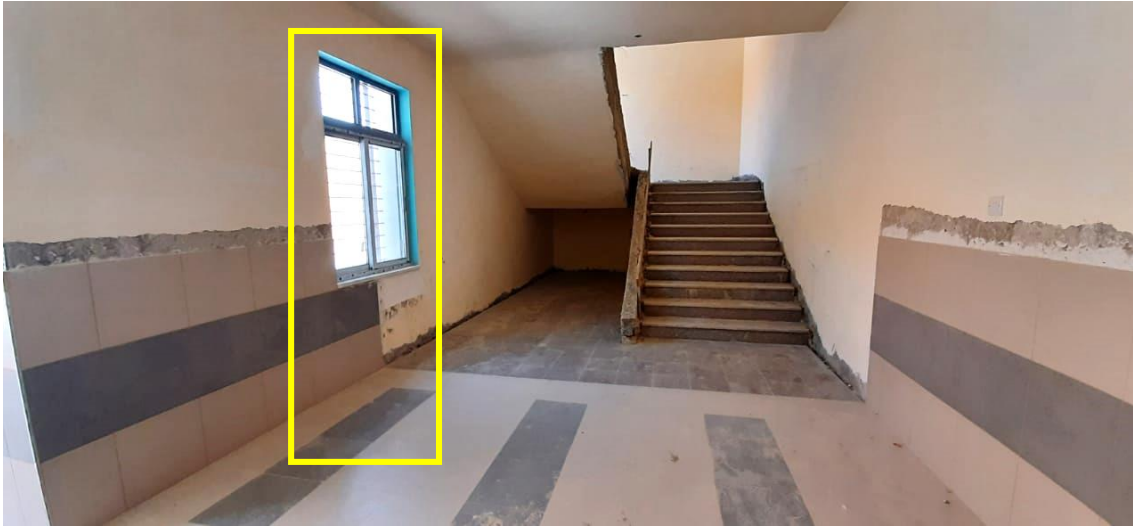
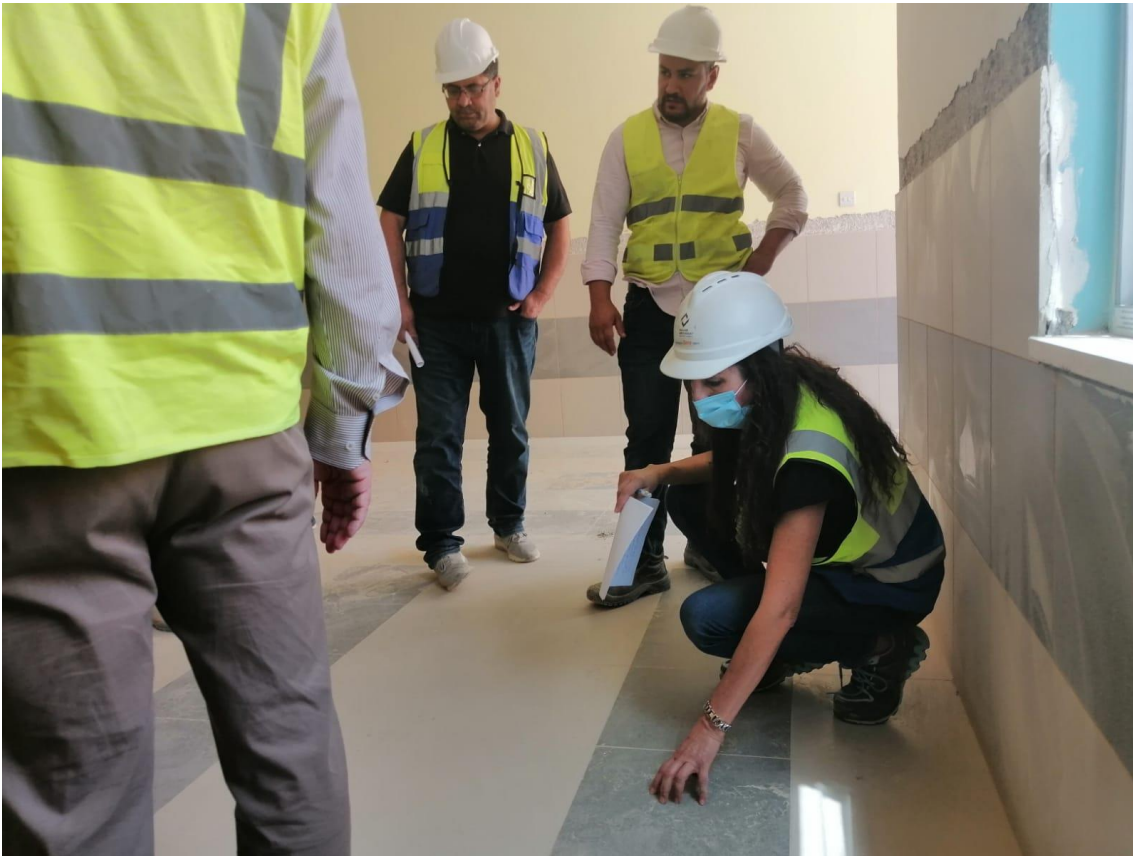
(Figure: 23 & 24)

| 10 | The team inspected the executed porcelain floor and wall tiles and granite at the staircase area and instructed the Contractor to limit the porcelain tiles of the corridor for wall and floor to the nearest side of the window where the granite floor tiles and cladding shall start. |

The team inspected the executed porcelain floor and wall tiles and granite at the staircase area and instructed the Contractor to limit the porcelain tiles of the corridor for wall and floor to the nearest side of the window where the granite floor tiles and cladding shall start

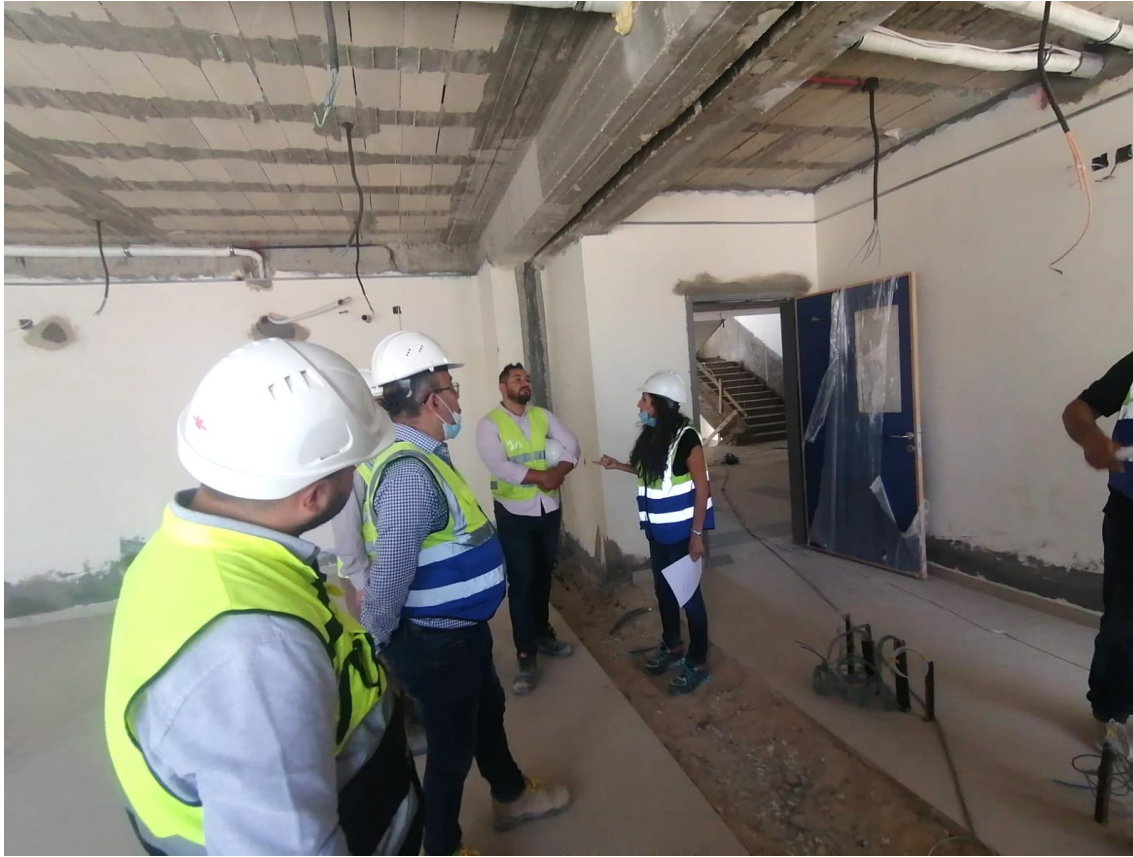
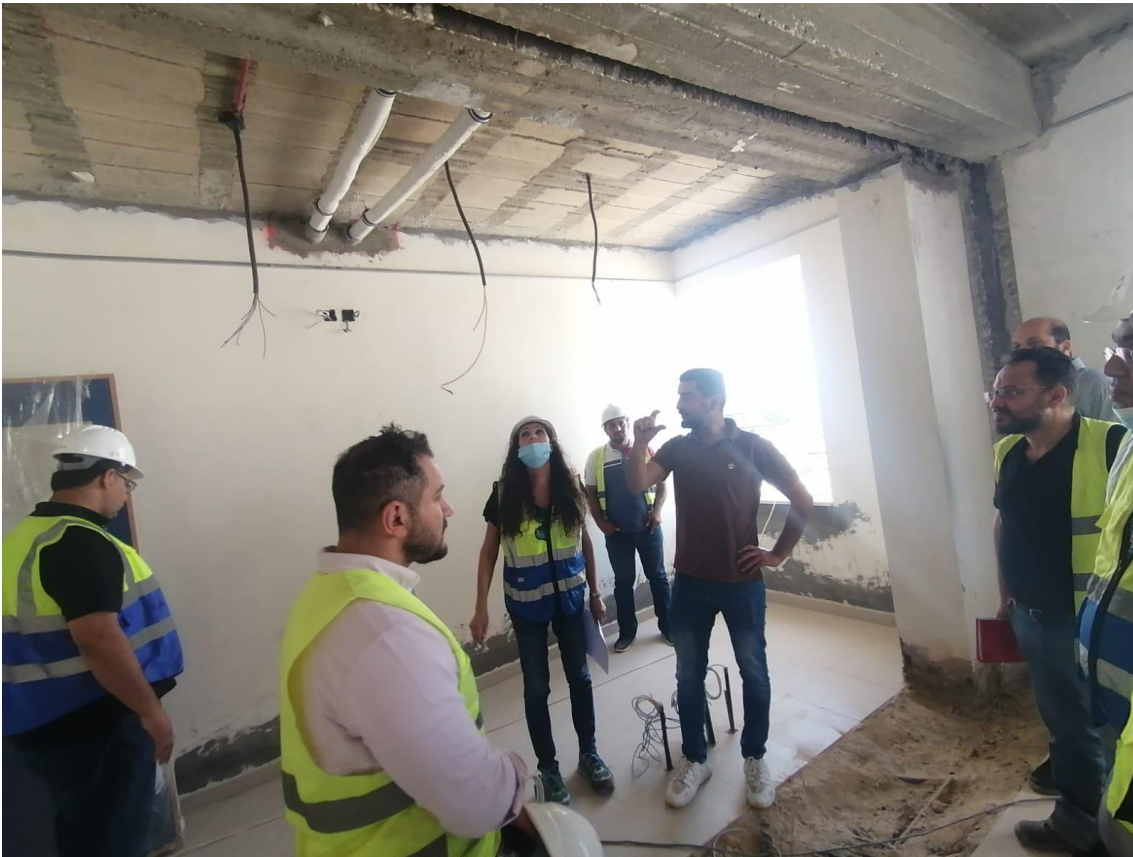
(Figure: 25 & 26)

| 15 | The supervision team inspected the work execution of the suspended ceiling at teachers' center/ first floor and discussed with the Contractor the contradiction between the actual status and the workshop drawings due to the existing dropped beam. Accordingly, the team requested the Contractor to submit revised workshop drawing taking into consideration the actual status of the structural elements including the expansion joint and the dropped beam. |

The supervision team inspected the work execution of the suspended ceiling at teachers' center/ first floor and discussed with the Contractor the contradiction between the actual status and the workshop drawings due to the existing dropped beam. Accordingly, the team requested the Contractor to submit revised workshop drawing taking into consideration the actual status of the structural elements including the expansion joint and the dropped beam

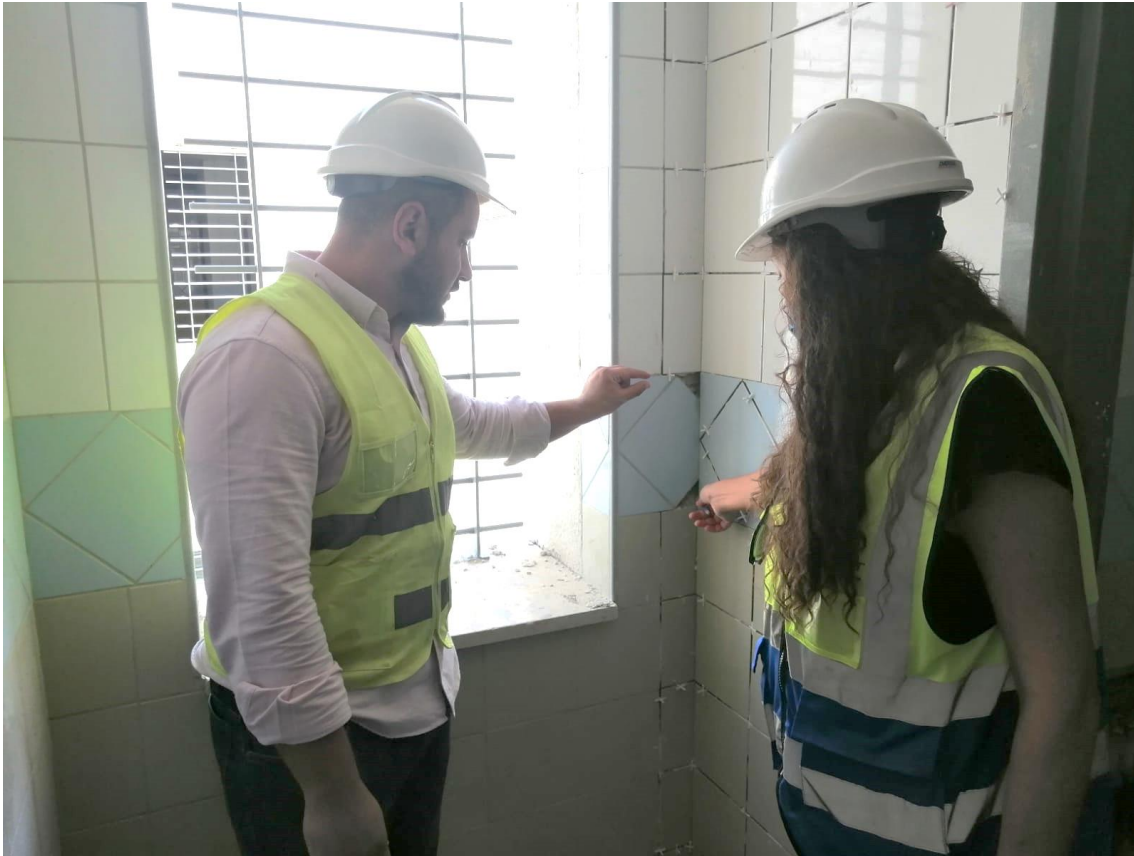
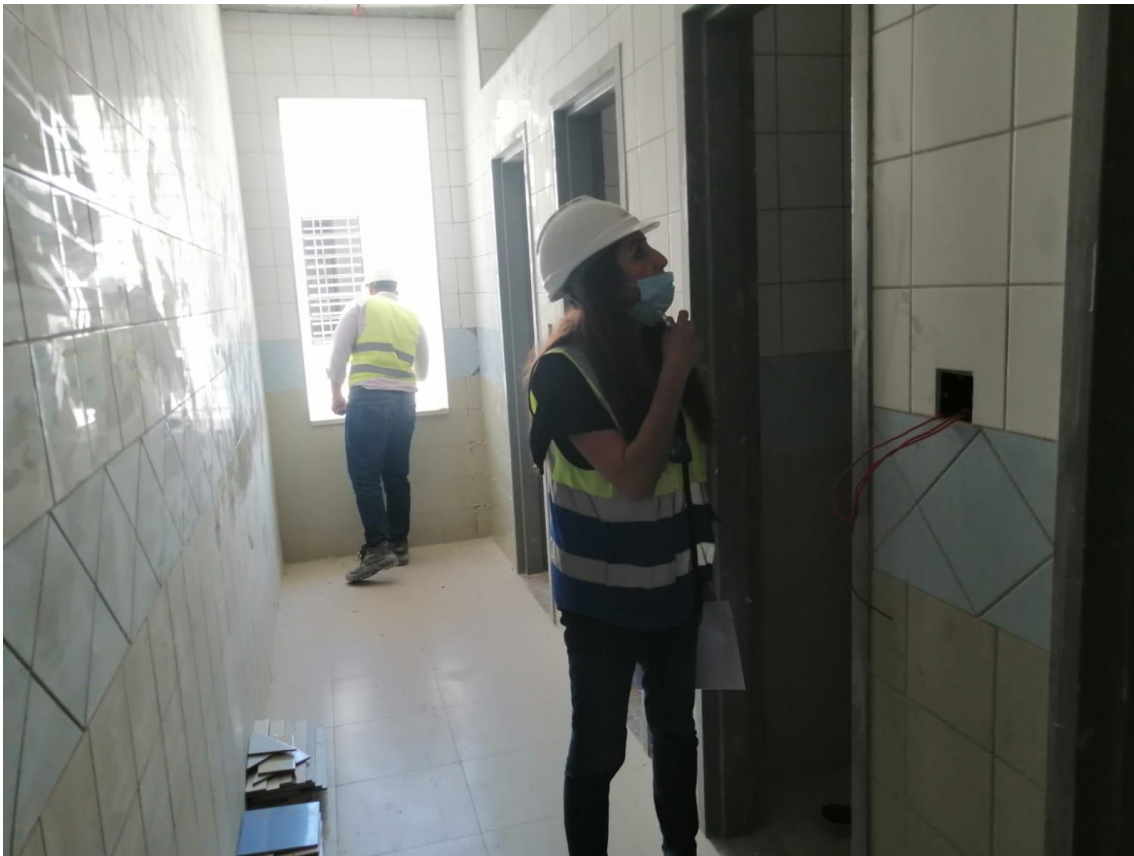
(Figure: 27 & 28)

| 16 | Inspecting the executed wall tiles at the wet area and notes were given to the Contractor. |

Inspecting the executed wall tiles at the wet area and notes were given to the Contractor
