Site Visit Report Form

FTR # QR 279

School Name: Hay Al Iskan Basic Mixed School

Pate and Time of Field Trip: Feb 9, 2021 11:00 AM

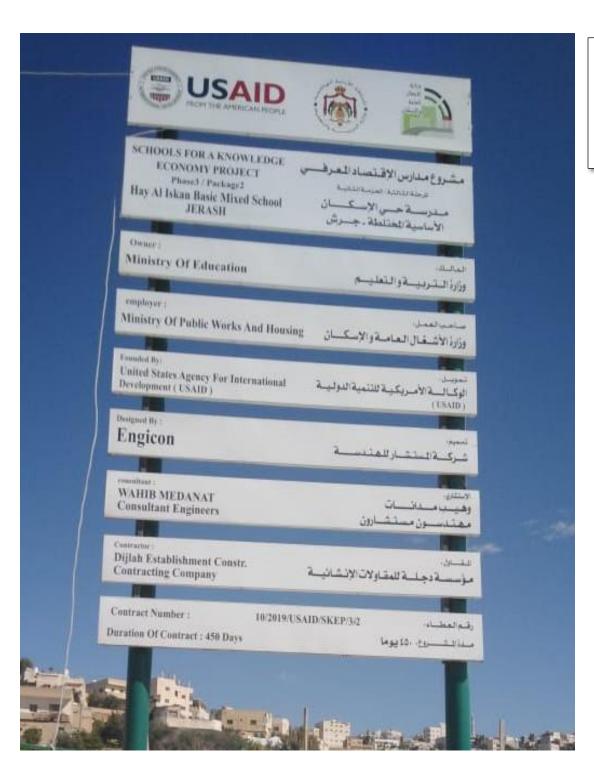
FIGURE #01:

Project ID Sign on

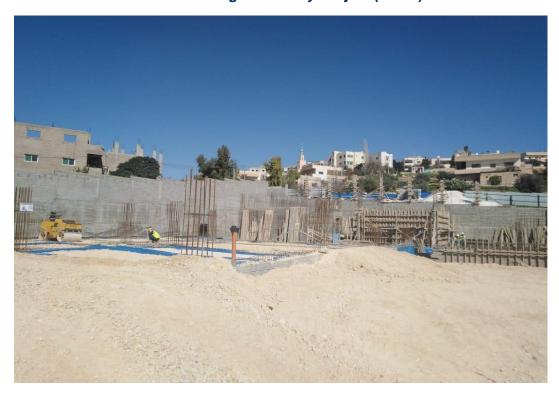
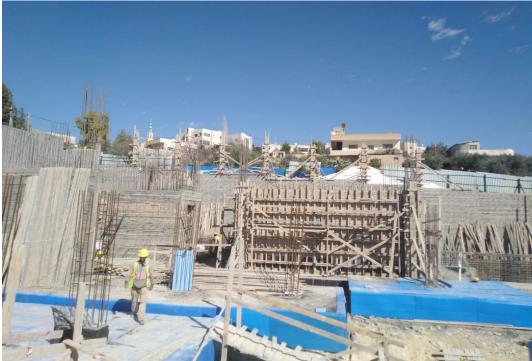
FIGURE #02&03: The School consists of five floors with total surface area of 5400 sq.m, in addition to other site works of total surface 4520 sq.m. The proposed building's foundations is completed.

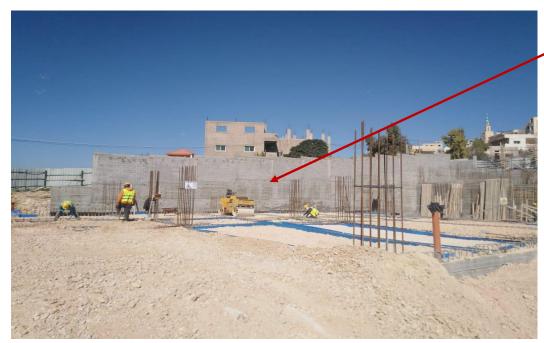
FIGURE #04:

North-West side of the boundary wall is completed.

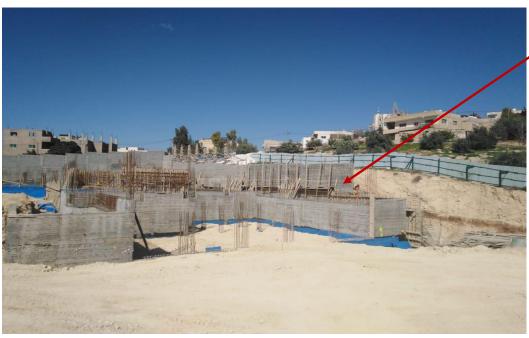
FIGURE #05:

North-East side of the boundary wall is 90% completed.

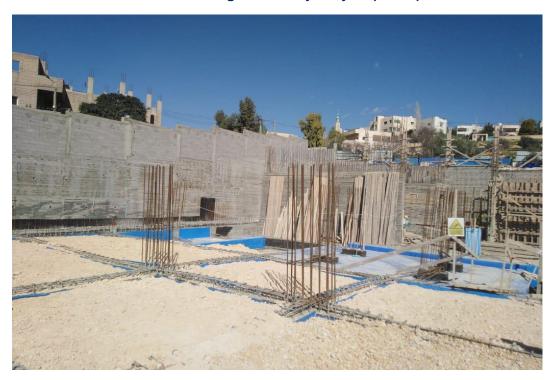
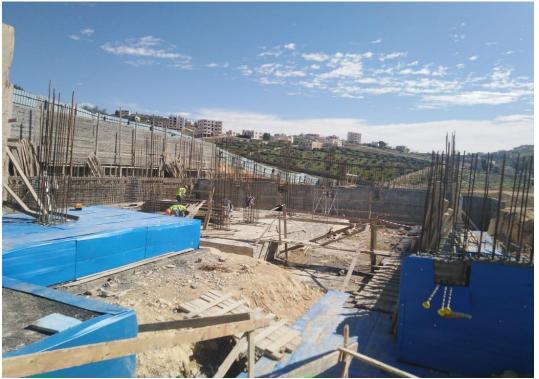
FIGURE #06 &07:

Cartonal sheet s and bitumen coats applied to foundations.
Preparation works
(Backfilling) for the slab on grade. Ground beams is ongoing.
