Site Visit Report Form

FTR # QR237

Program (JSEP or SKEP): SKEP PHASE :III PACKAGE: 2 School Name: Thahr Al Sarow Basic School for Boys Supervisory Engineer (SE) Name: Wahib Medanat Consultant Engineers Construction Contractor (CC) Name: Dijlah Establishment Contracting Co. Date and Time of Field Trip: December 08, 2020 Date of Report: December 11, 2020 Weather During Visit Sunny Report Submitted By: Osama Obeid

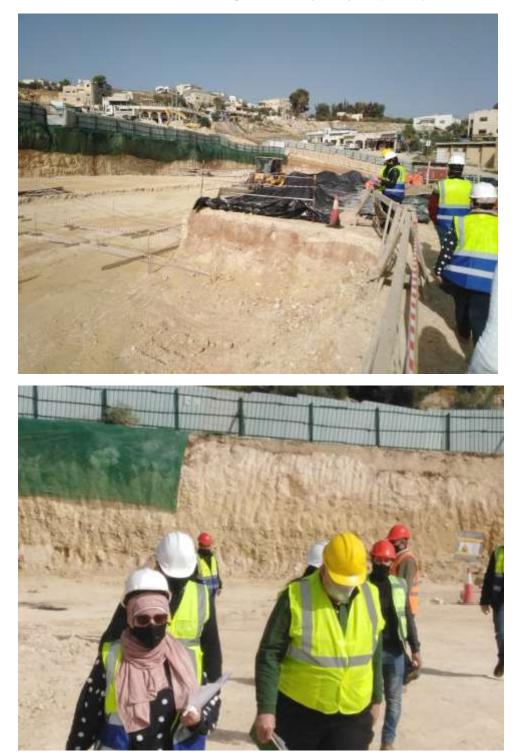
FIGURE #02 & 03: During the site tour carried out by USAID, CMTO, SE and the Contractor to inspect the excavation works

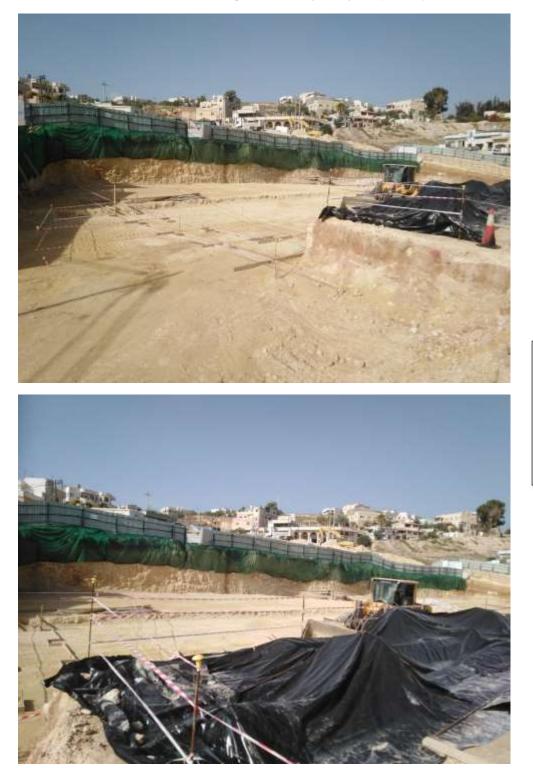
• The excavation is completed as per site team's confirmation.

FIGURE #04 & 05: The excavation works is completed. The total surface area of proposed new building is 4615 sq.m and 2827 sq.m for the external works

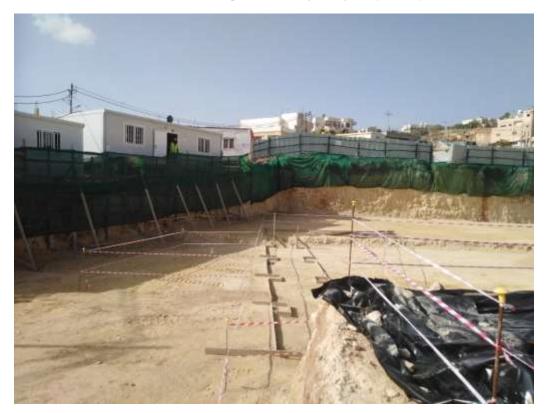
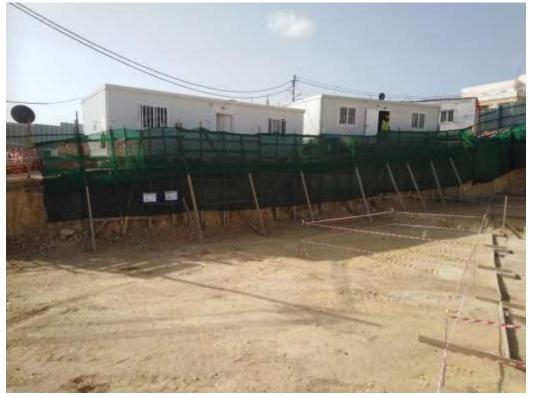
- High unsafe vertical excavated slope
- Site office must be protected and supported properly from soil sliding

FIGURE # 06 & 07: Site offices must be Protected and supported properly from soil sliding

- The Geotech Engineer must provide technical report with clear recommendations.
- The Supervisor Engineer will instruct the Contractor to take prompt actions based on the Geotech recommendations in coordination with the MPWH and the SE shall inform USAID and CMTO on the planned steps to be implemented.
- The Contractor must be ready for any action is requested by the SE to protect the excavate area from soil sliding
- To expediate the construction of retaining walls based on the Geotech report
