Consultant	Wahib Medanat Consultant Engineer	Rep No.	11-07062022
Contractor	Derar Saraireh & Sons for Engineering & Contracting	Tender No.	(11/2019/USAID/SKEP/3/S) Schools for a Knowledge Economy Project (SKEP) - Phase (3) Package (1, 2)
Site Name	Um Al Dananir Basic Mixed School- Al Balqa	Day/ Date	Tue. 07/06/2022
Duration of Project	450 Calendar Days	Total Project Budget	9,789,417.840 JD

Visit Notes

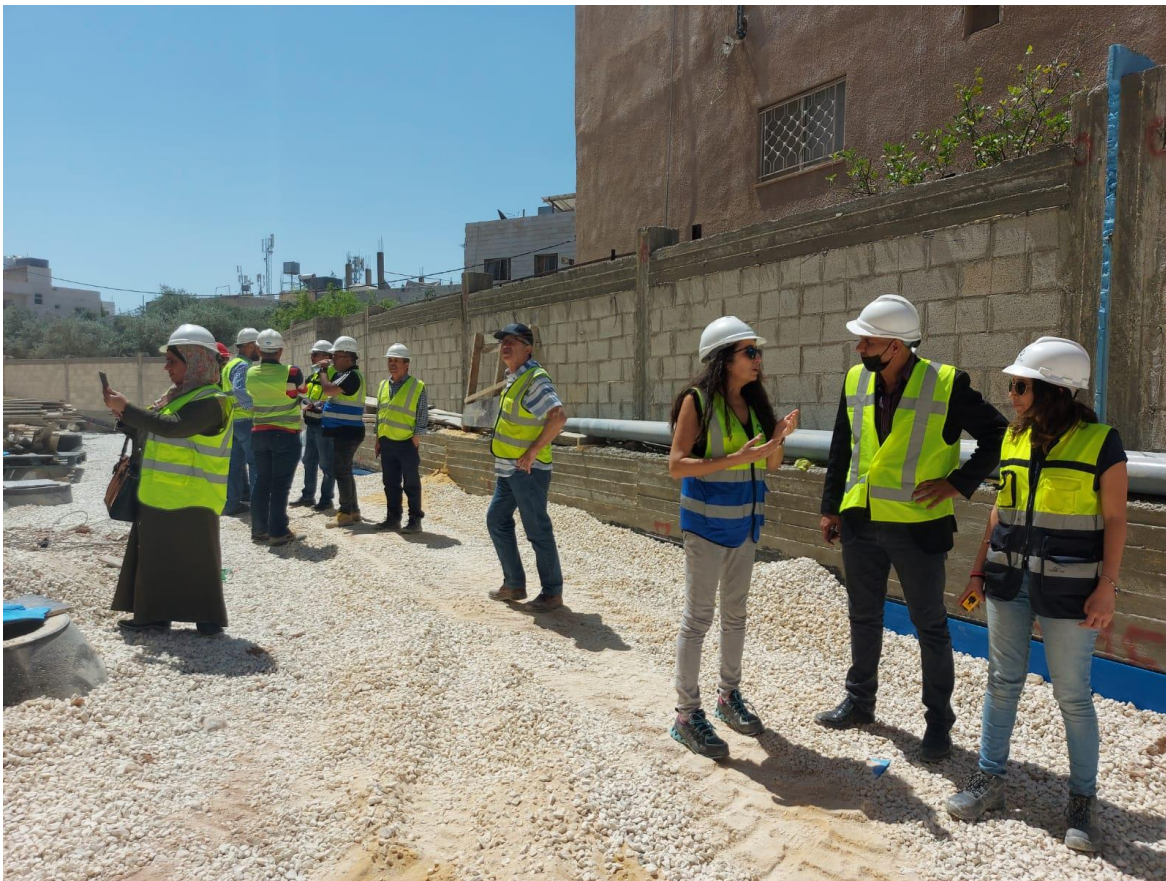
(figure:05)

The supervision team visit coincided with the visit of the engineers of the Control and Inspection Directorate at the Ministry of Public Works and Housing. A joint tour has been conducted in the site to check the progress and the current works in the project

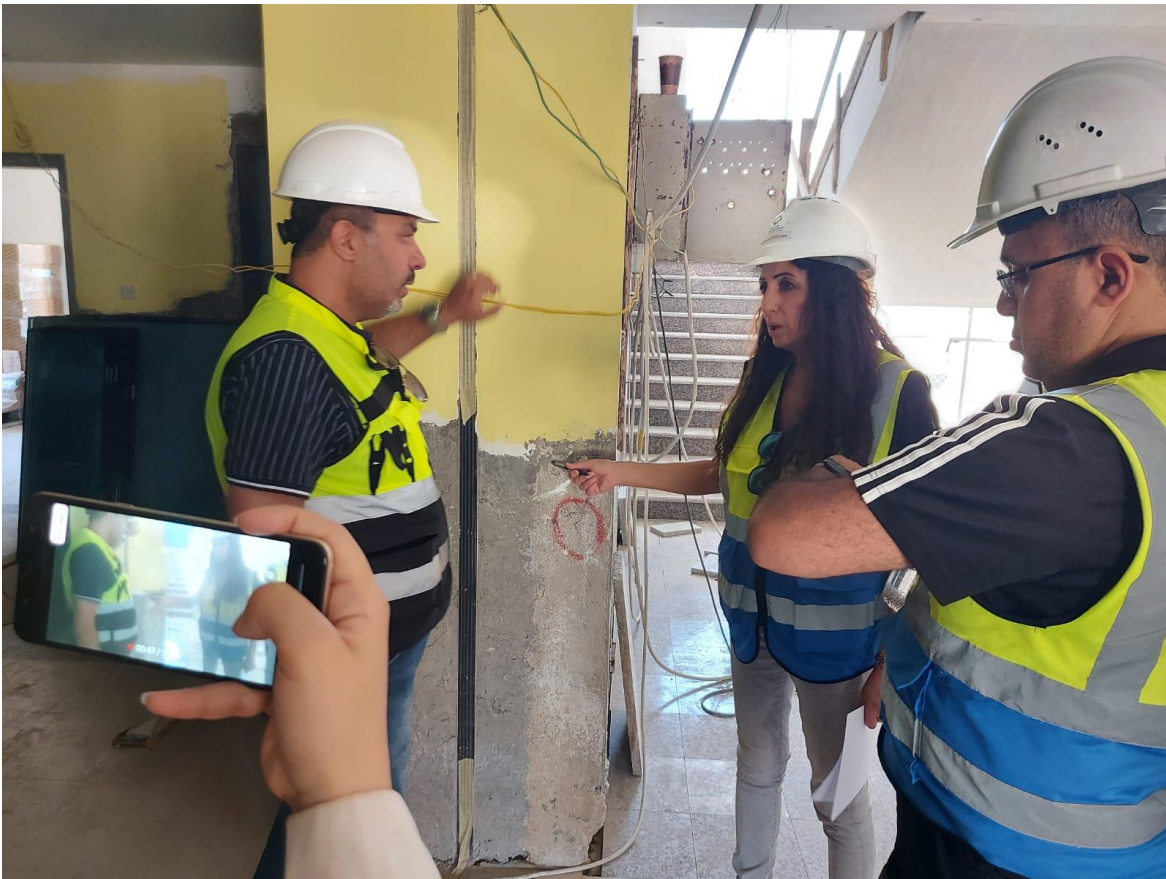
(figure:07)

The team inspected the granite at the staircase parapet and requested the Contractor to remove small pieces and replace by one piece

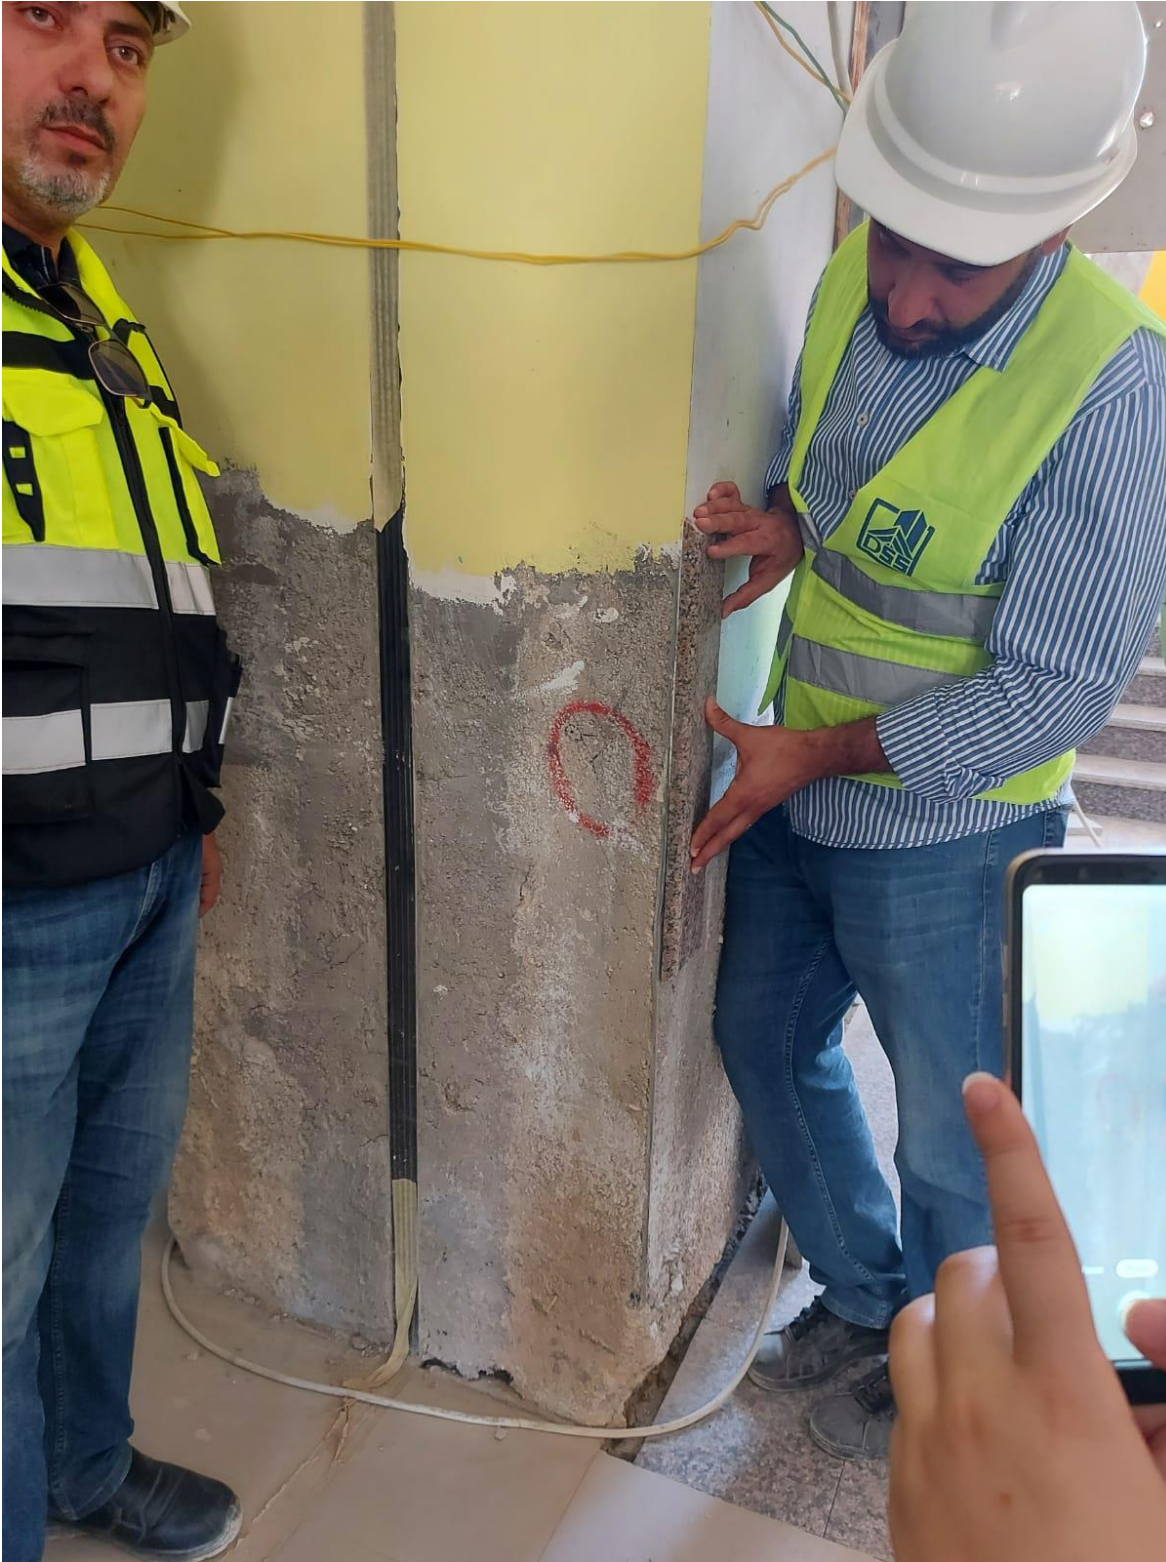
(figure:08)

The team discussed with the Contractor the connection point between the porcelain cladding at the corridors and the granite cladding at the entrance for the purpose of separation between the entrance and the kindergarten area

The team instructed the Contactor to limit the granite cladding to the staircase wall, and the cladding for the opening jamb shall be of porcelain using special beads to separate the granite from the porcelain

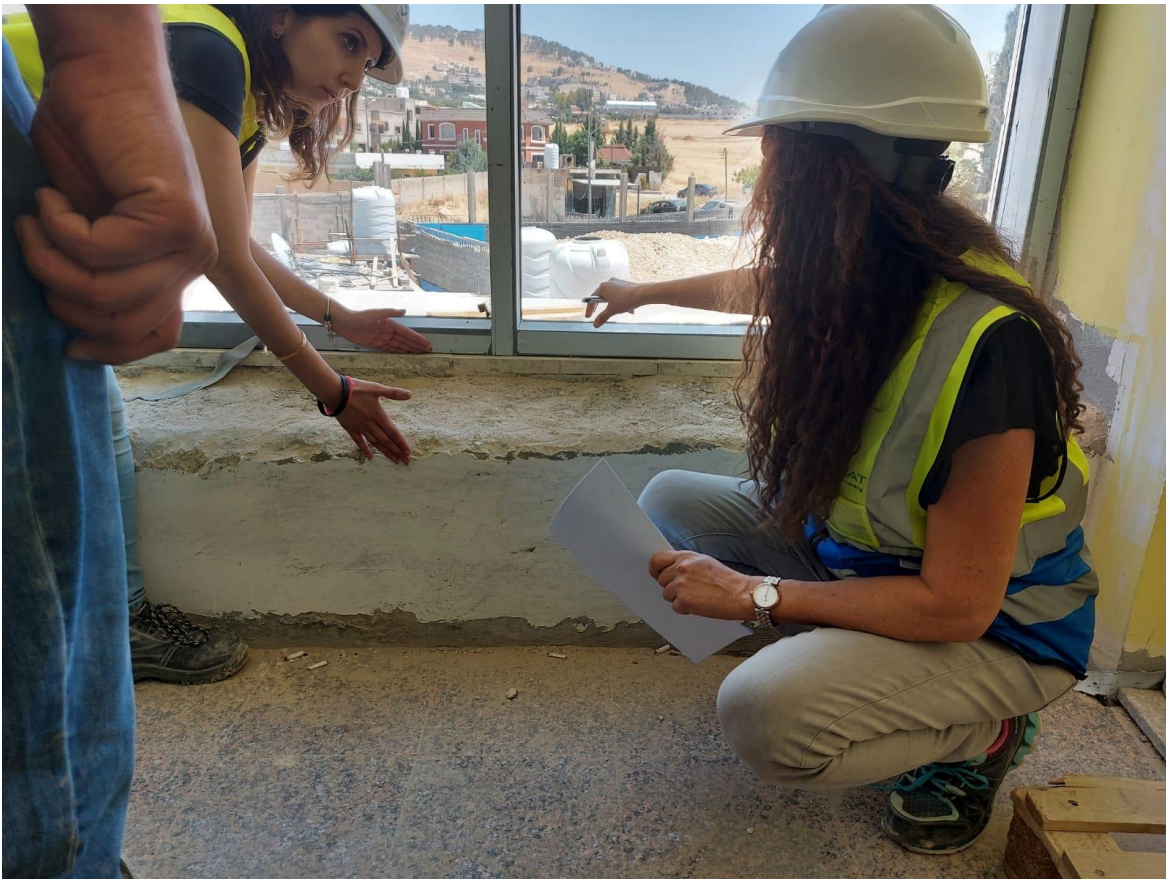
(figure:10)

The team observed using red grout for granite coping at the corridors which does not comply with the approved grout in relation to color. The Contractor was requested to remove this grout and replace it with the approved one

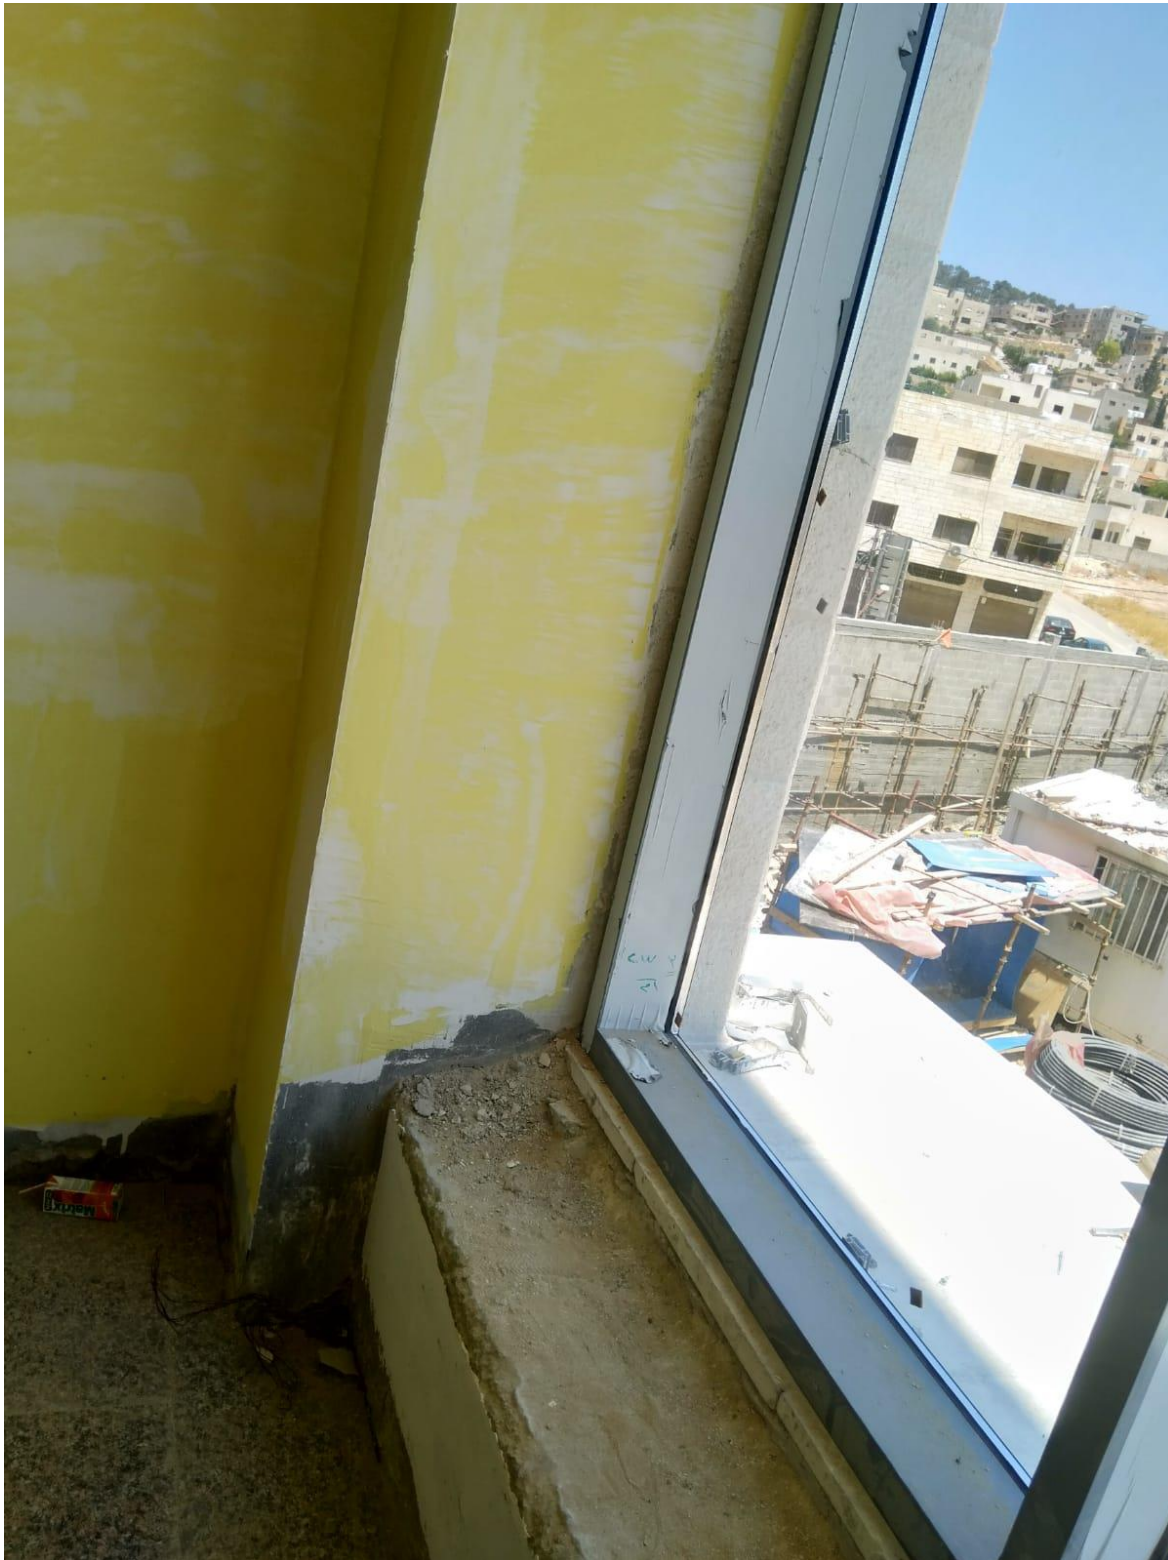
(figure:11)

The team inspected the executed curtain wall at the staircase façade and observed variations regarding the fixation points, relation with the built stones at the window jambs and the window sills as well

The team requested the Contractor to check and dismantle the sections at the whole façade which are fixed incorrectly and rectify other works if needed in coordination with the supervision team. The relation between stone at the jambs, window sills, internal plastering and aluminum curtain walls should be corrected

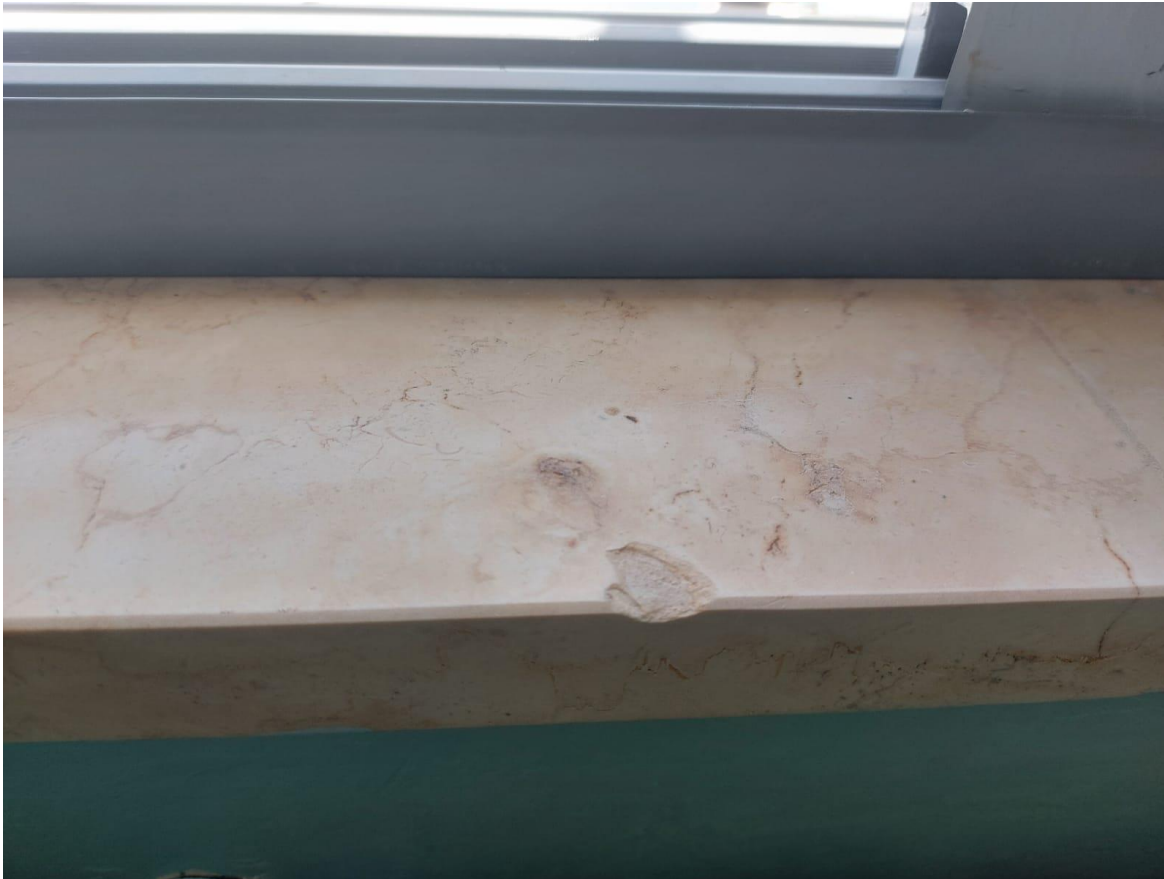
(figure:15)

the team inspected the installed aluminum windows and observed that the installation is correct in relation to the stone, window sills and aluminum sections
