SKEP III Home Office Support Site Visit Report

Consultant	Wahib Medanat Consultant Engineer	Rep No.	23-09042022
Contractor	Dijlah Establishment Constr. Contracting	Tender No.	(11/2019/USAID/SKEP/3/S) Schools for a Knowledge Economy Project (SKEP) - Phase (3) Package (1, 2)
Site Name	Jumana Bint Abit Taleb Basic Mixed School - Jerash	Day/ Date	Sat. 09/04/2022
Duration of Project	450 Calendar Days	Total Project Budget	8,314,983.735 JD

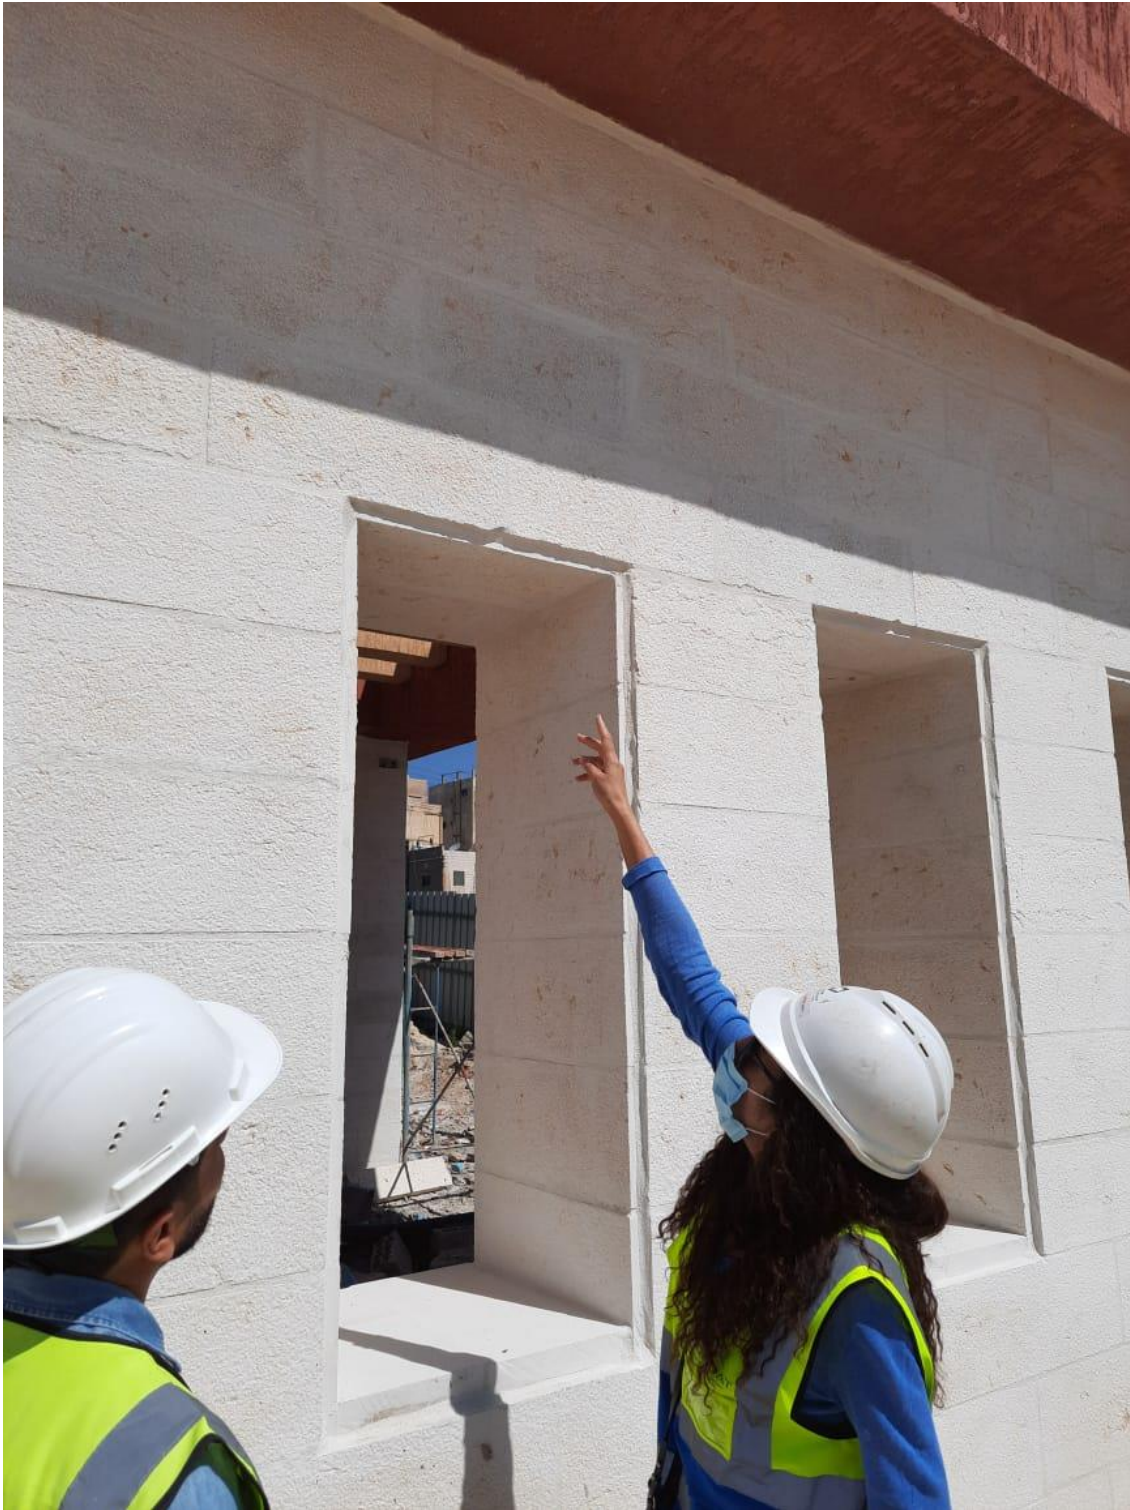
(Figure: 04)

The supervision team observed that the defective stones at the guard room are not replaced and the Contractor was requested again to replace the stones with defects such as broken edges and existence of extended pockets.

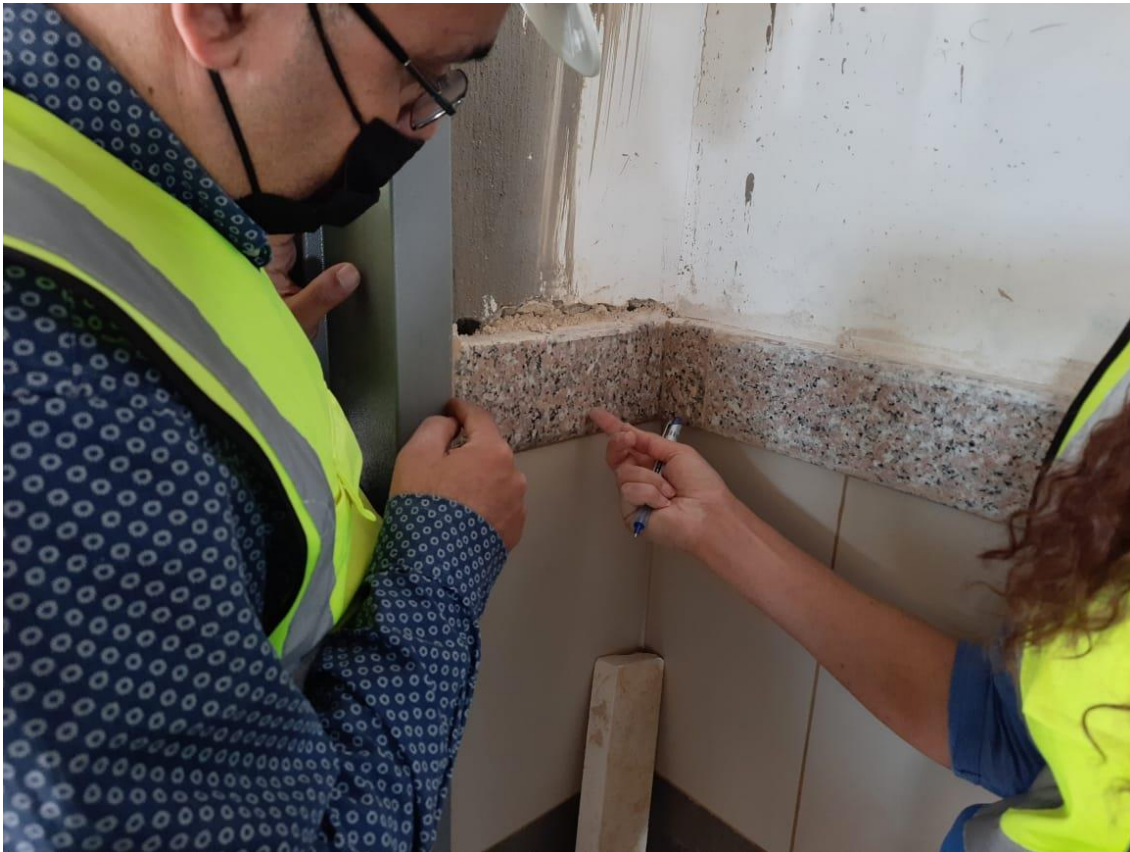
(Figure: 11)

The team observed in several locations that the granite coping at the top of wall porcelain tiles that the plastering, door frames, and the coping are not matching together. The Contractor was requested to repair the broken plastering at the place and rectify accordingly ensuring the prominence of the door frame as required

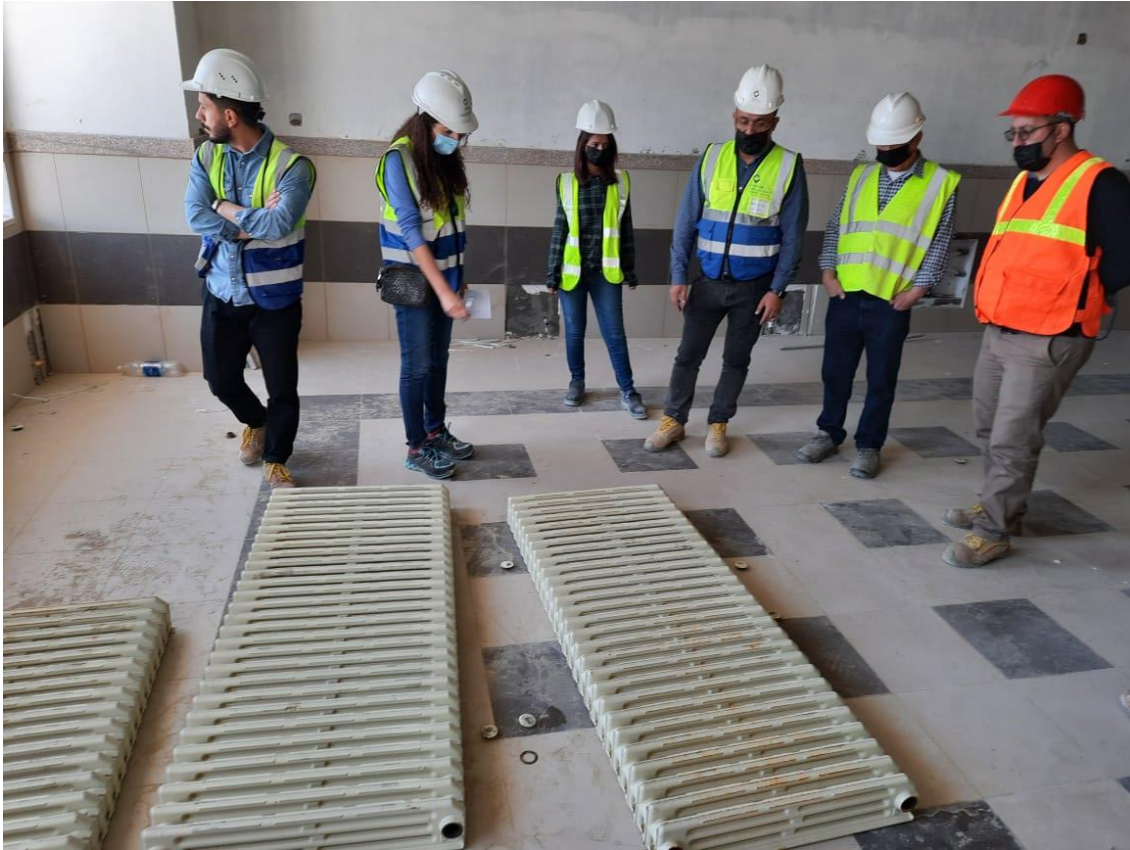
(Figure: 13)

The team observed that radiators' sections have corrosion on some parts and need to be repaired before applying the final coat. In addition, the team observed that the installed floor tiles are not protected and many radiators' sections are scattered directly on the floors without any support which might damage the tiles

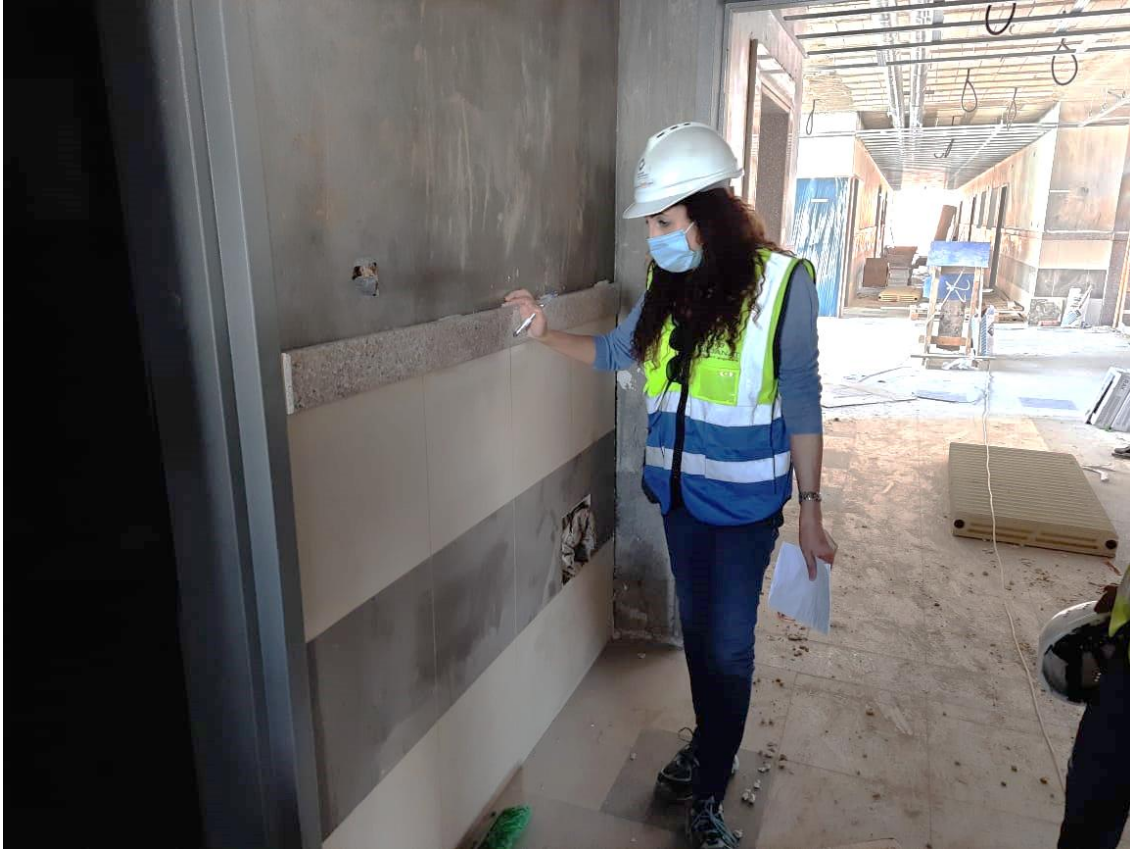
(Figure: 15)

The team inspected the installed porcelain wall tiles at the corridors

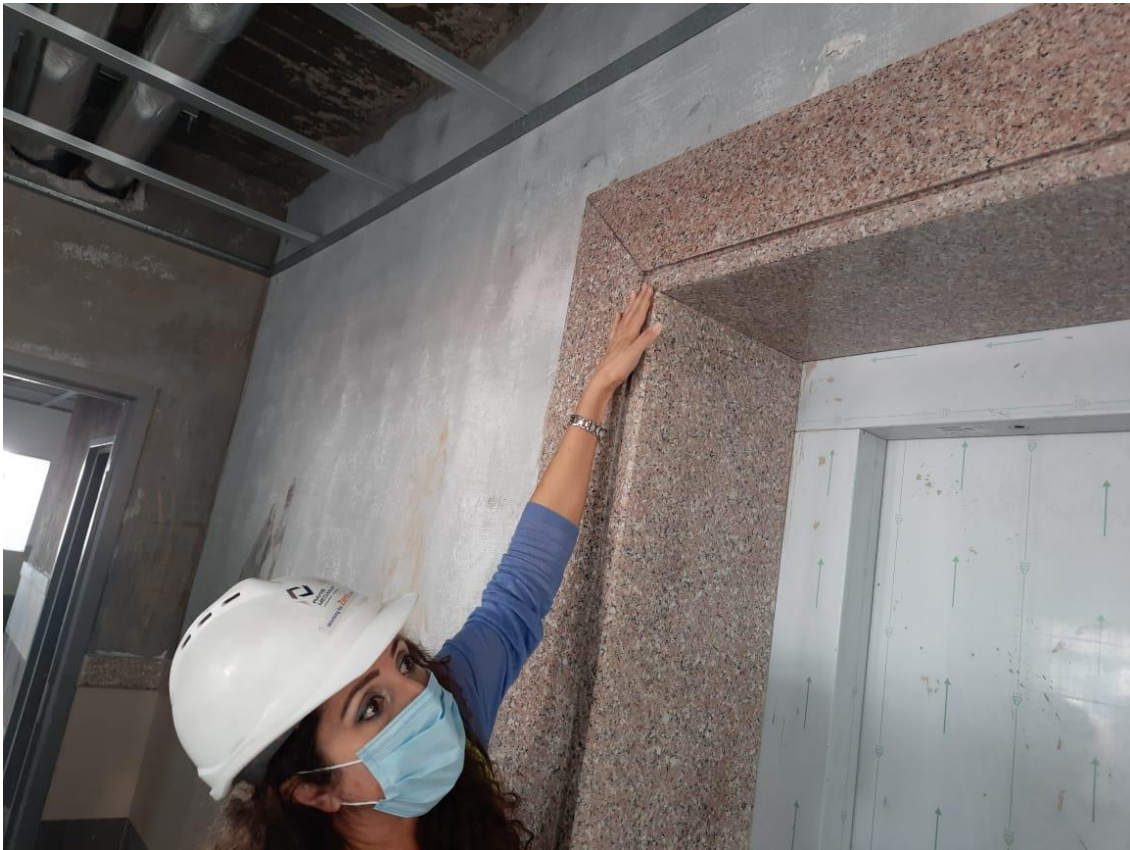
(Figure: 16)

The team inspected the installed granite frame around the elevator's door and informed the Contractor with some minor remarks

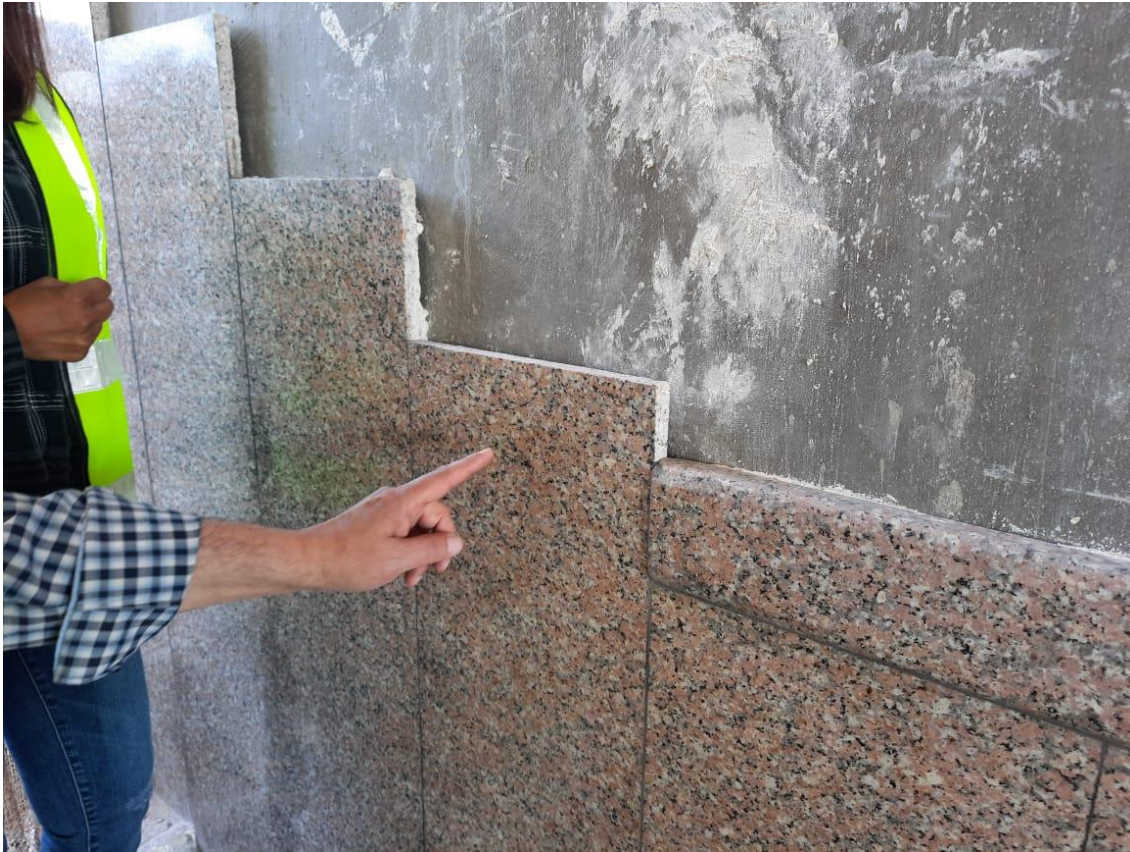
(Figure: 17)

The team discussed with the Contractor the final details of granite cladding at the start of the staircase after cutting the granite of the staircase in inclined directions

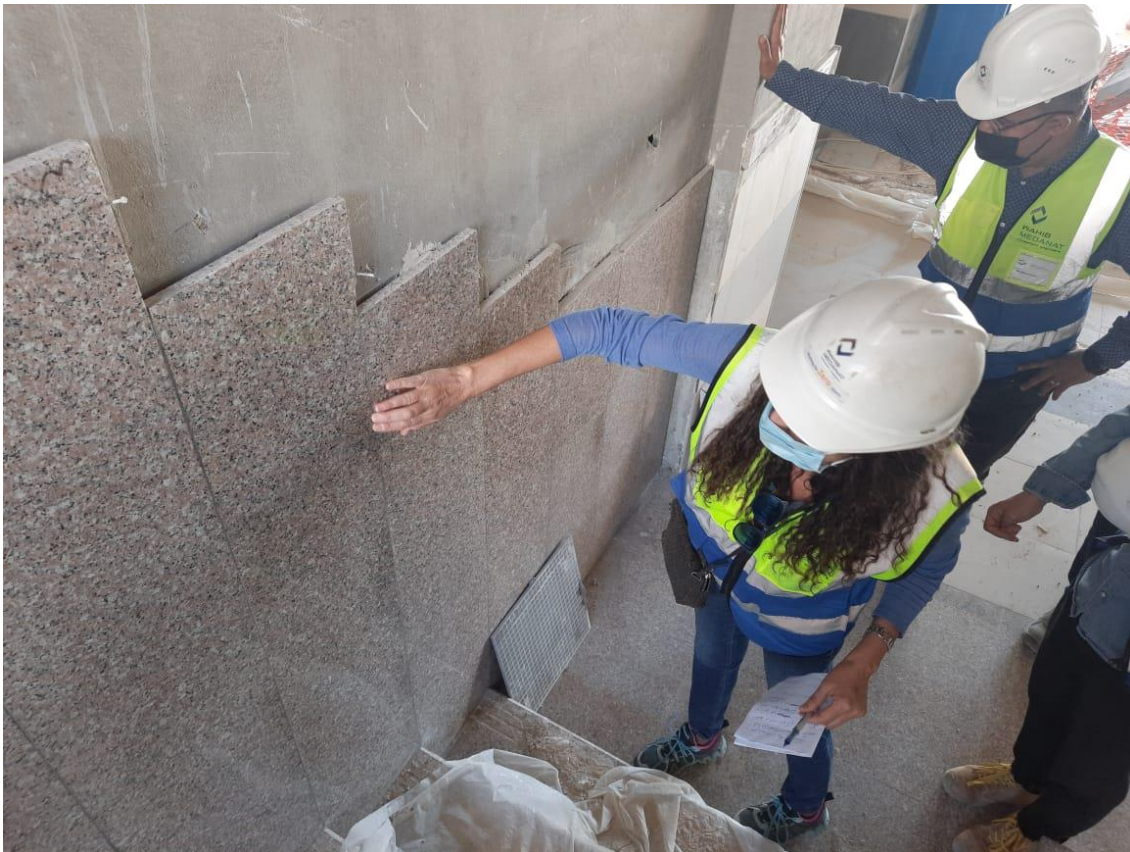
(Figure: 18)

The team inspected the conducted repairs on the installed granite cladding for the staircases. The repairs are acceptable and the team requested the Contractor to replace just few broken pieces

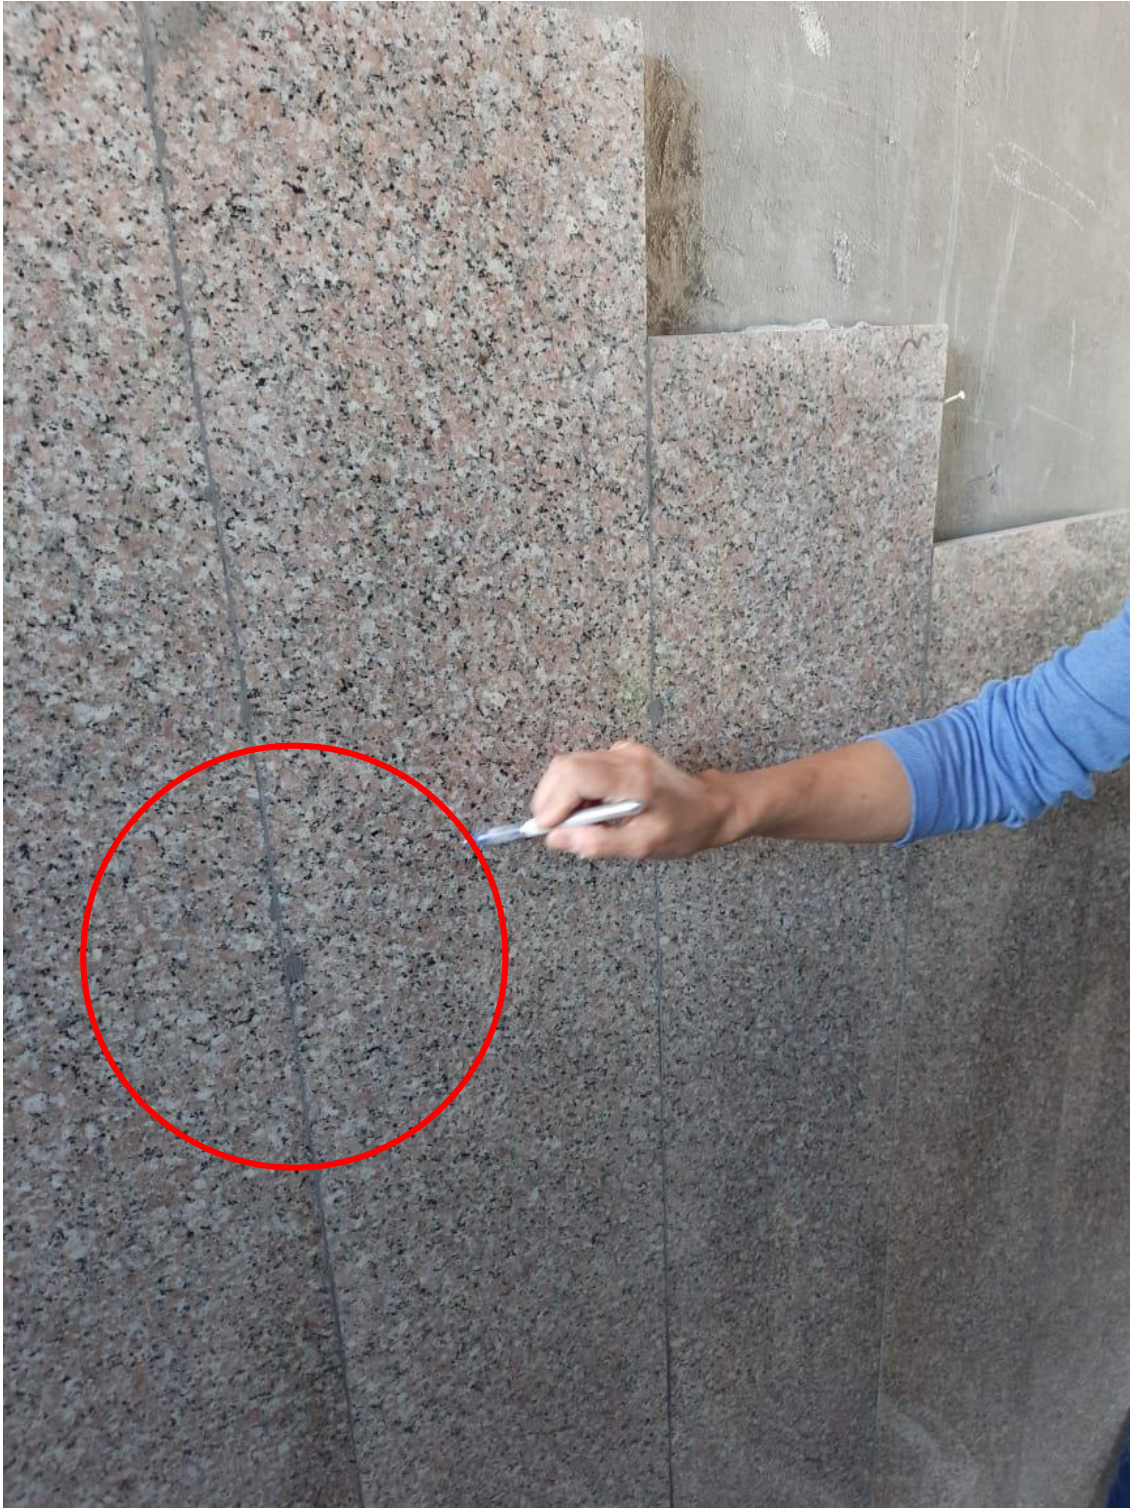
(Figure: 19)

The team observed defects in the straightness of the plastering/ granite coping of the staircase at the landing between the ground and first floors. The Contractor was requested to check and rectify as needed

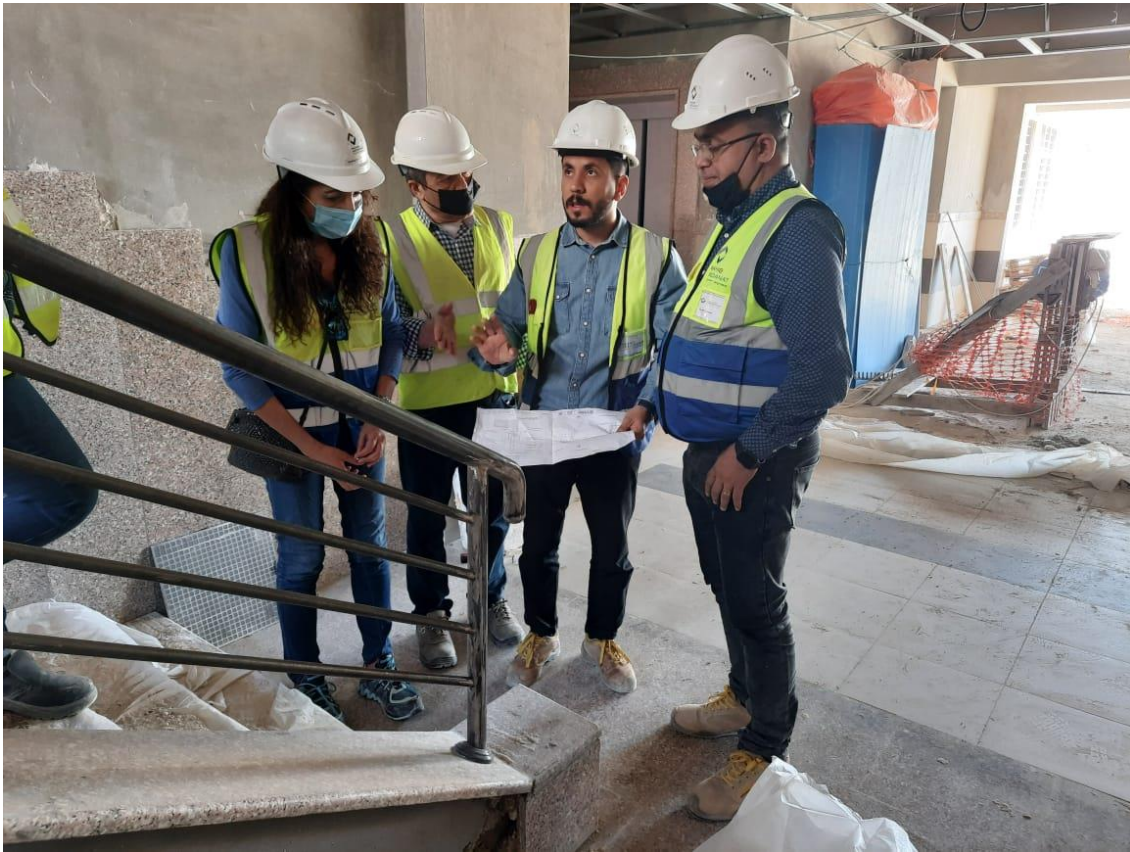
(Figure: 21)

The team inspected the installed sample for the stair handrail. The team informed the Contractor with remarks on the sample mainly the height of the handrail and the details of fixing

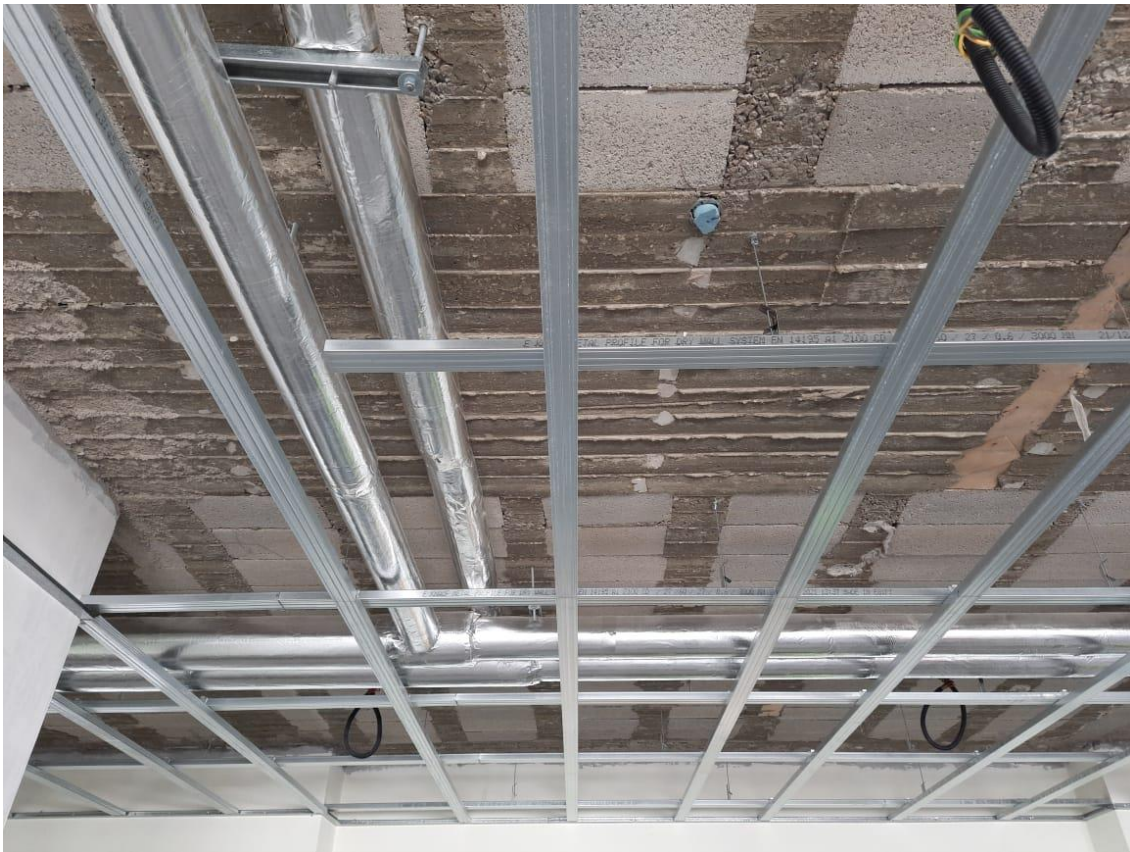
(Figure: 22)

The team observed the installed frames for the suspended ceilings

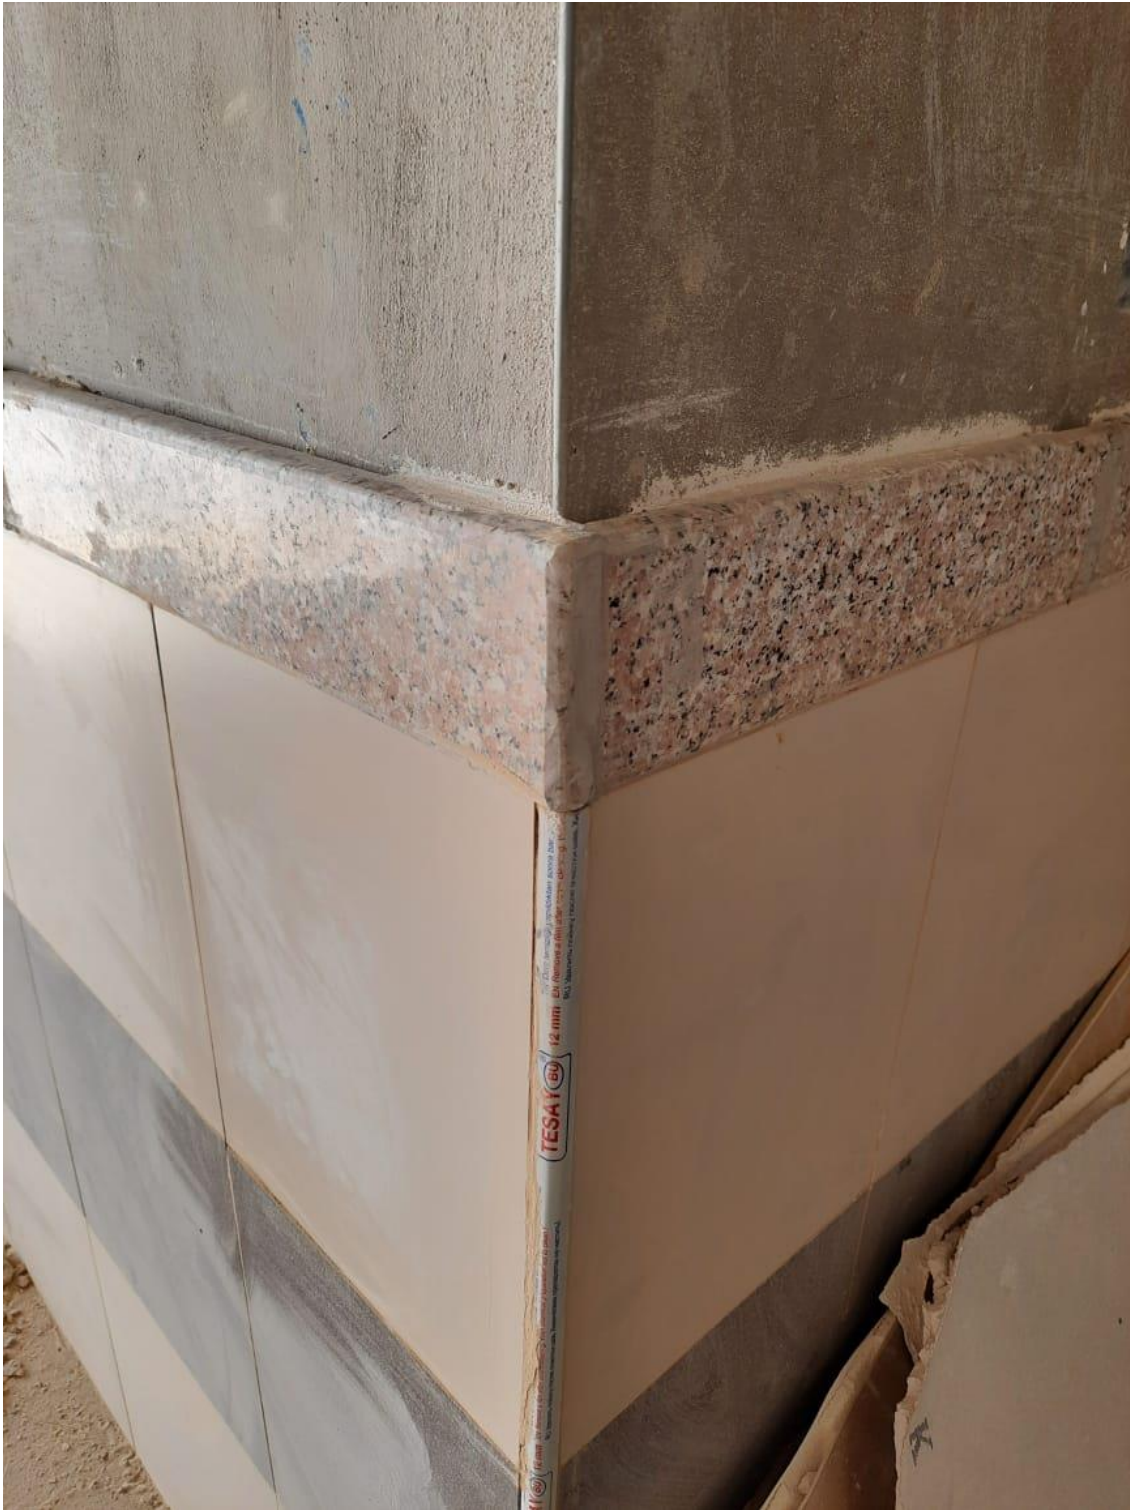
(Figure: 23)

The team inspected the granite coping at the corridors in general and informed the Contractor to ensure the grinding of edges
