Consultant	Wahib Medanat Consultant Engineer	Rep No.	13-16022022
Contractor	Derar Saraireh & Sons for Engineering & Contracting	Tender No.	(11/2019/USAID/SKEP/3/S) Schools for a Knowledge Economy Project (SKEP) - Phase (3) Package (1, 2)
Site Name	Khadija Bint Khwailed Basic Mixed School- Shouna Janoubia	Day/ Date	Wed. 16/02/2022
Duration of Project	450 Calendar Days	Total Project Budget	9,789,417.840 JD

Visit Notes

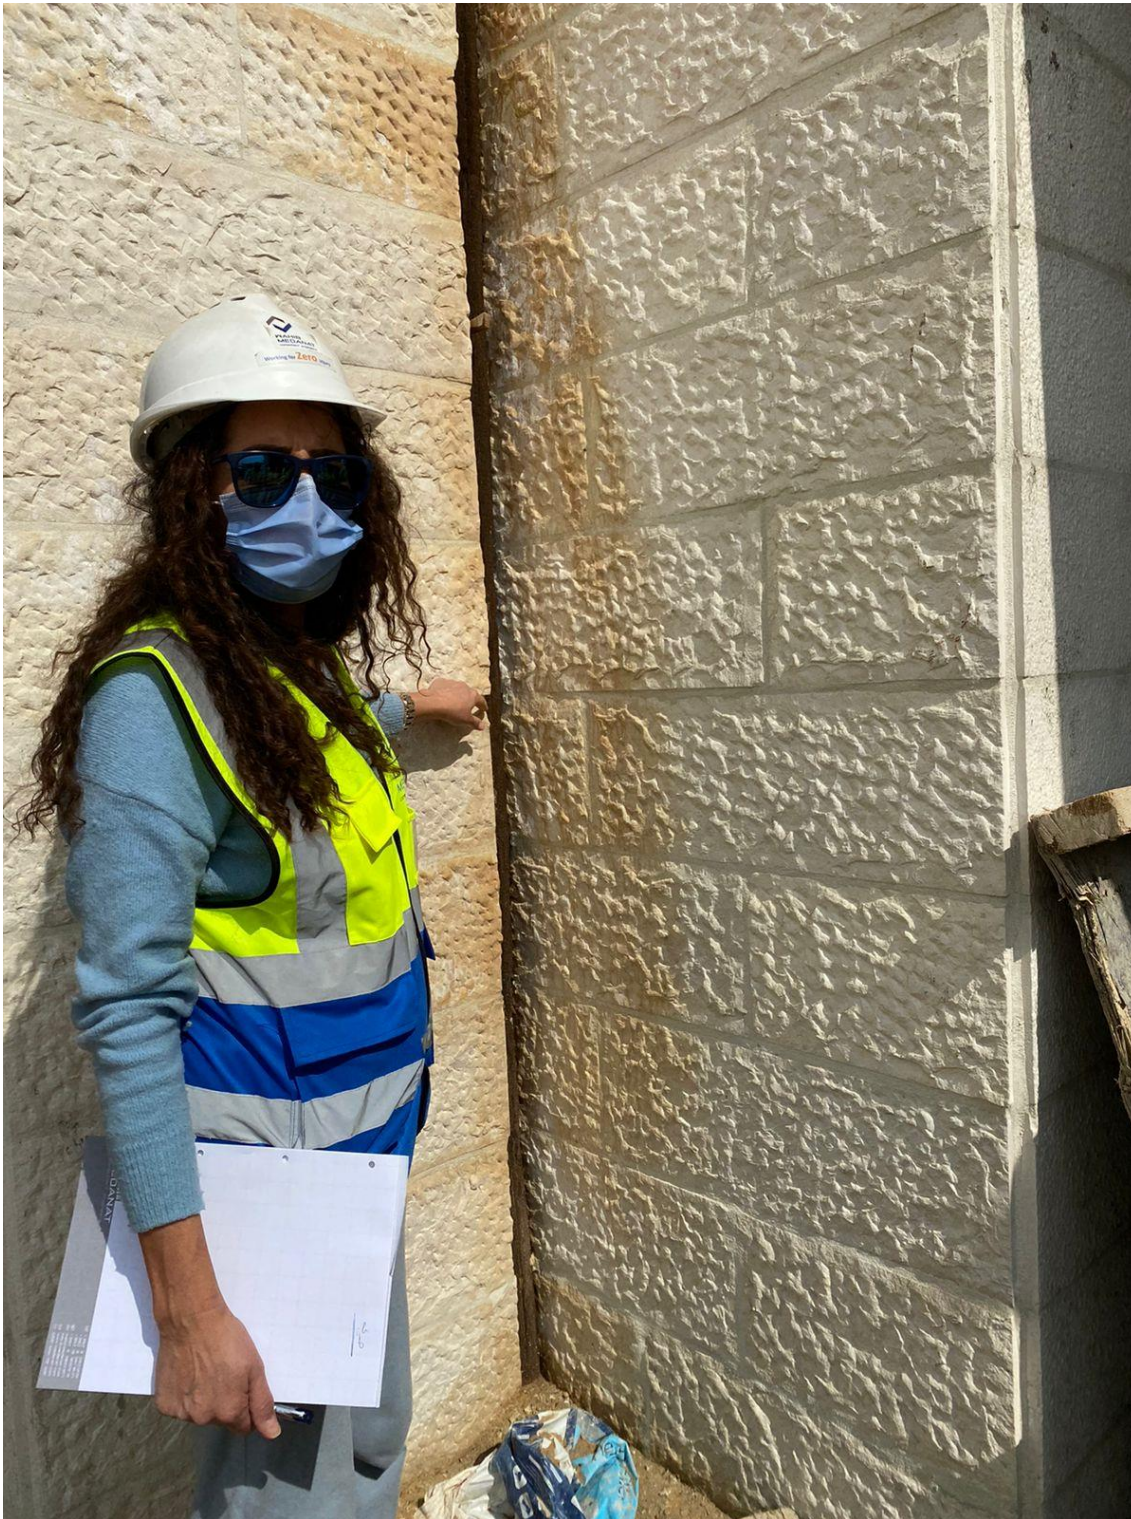
(Figure: 05)

The team observed some stone areas in the facades need to be cleaned as shown in the photos

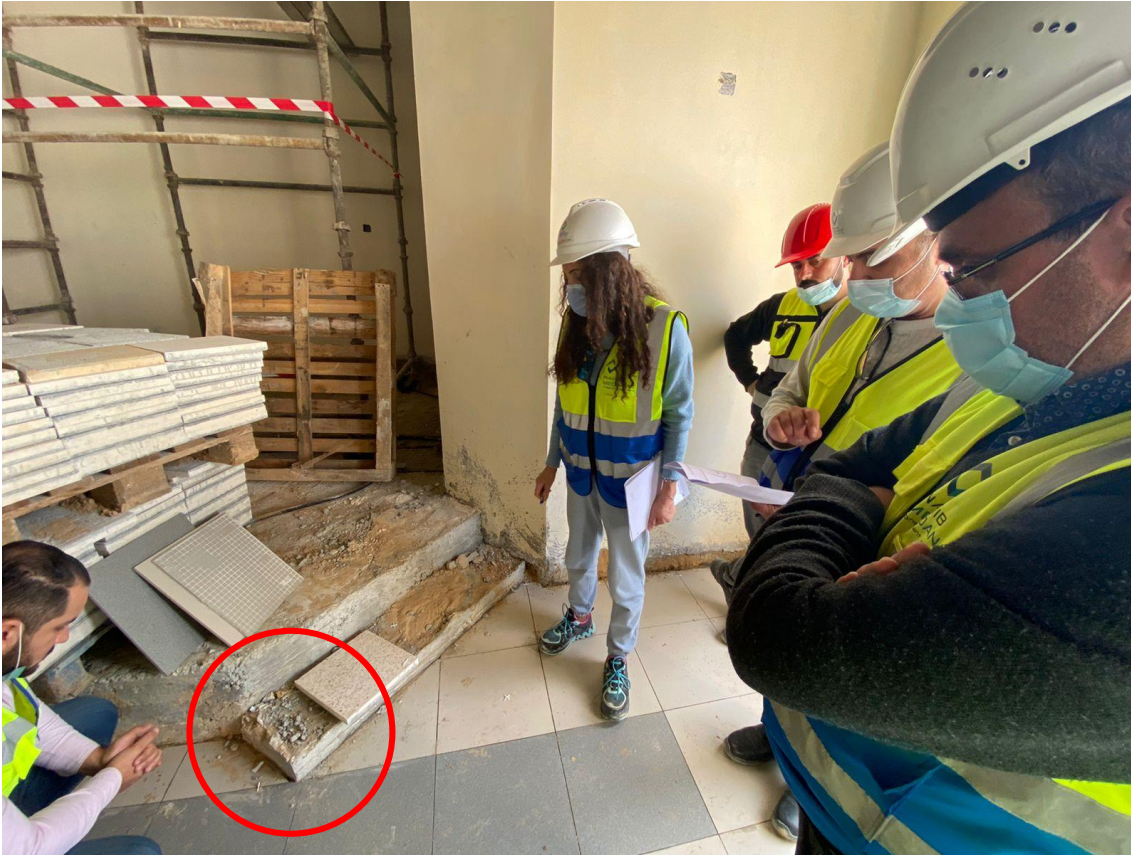
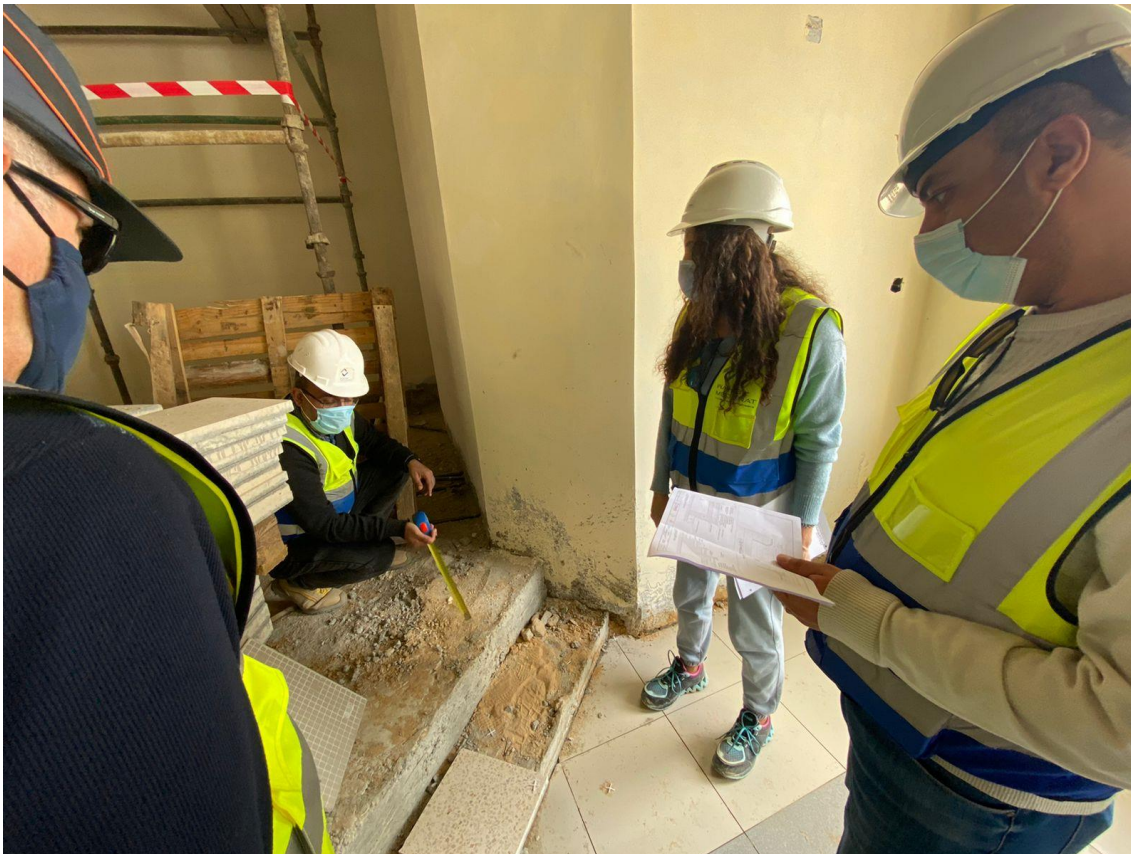
(Figure: 06 & 07)

The supervision team discussed with Contractor the executed stairs at the multi-purpose hall and requested the Contractor to submit as built sketch to resolve the issue of the prominence of the stairs into the dark color porcelain floor line

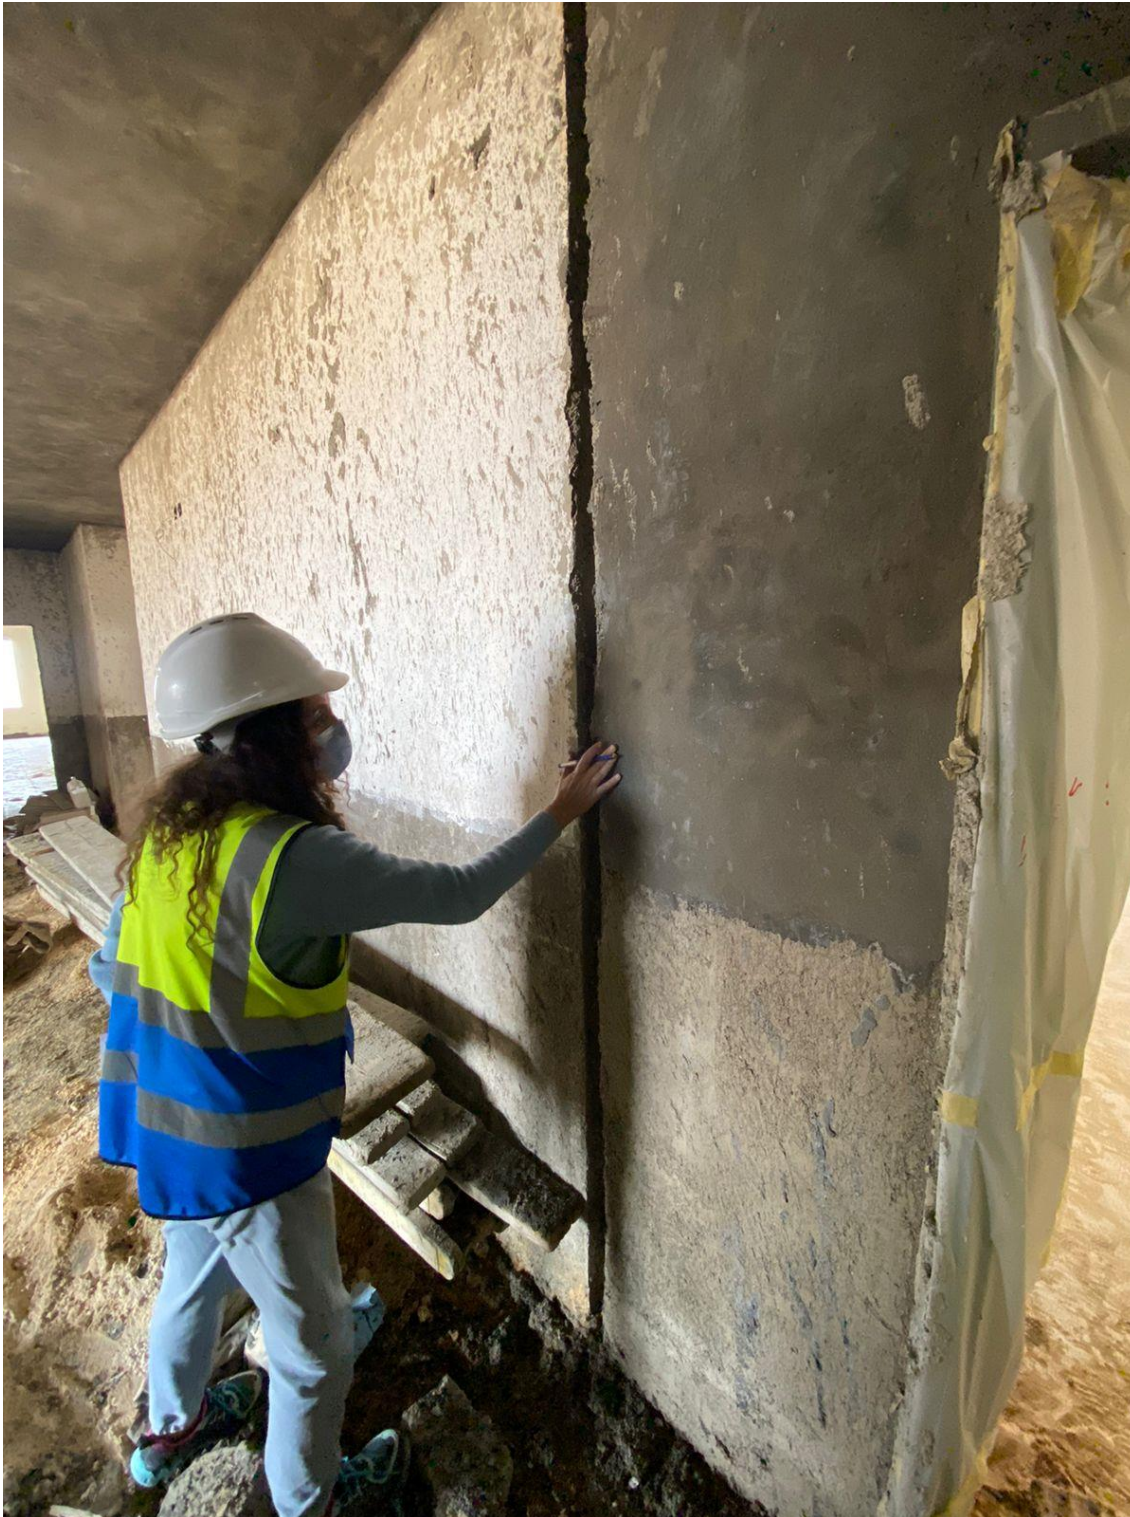
(Figure: 08)

The team noticed that the Contractor has rectified the deviation in plastering level at the corridor

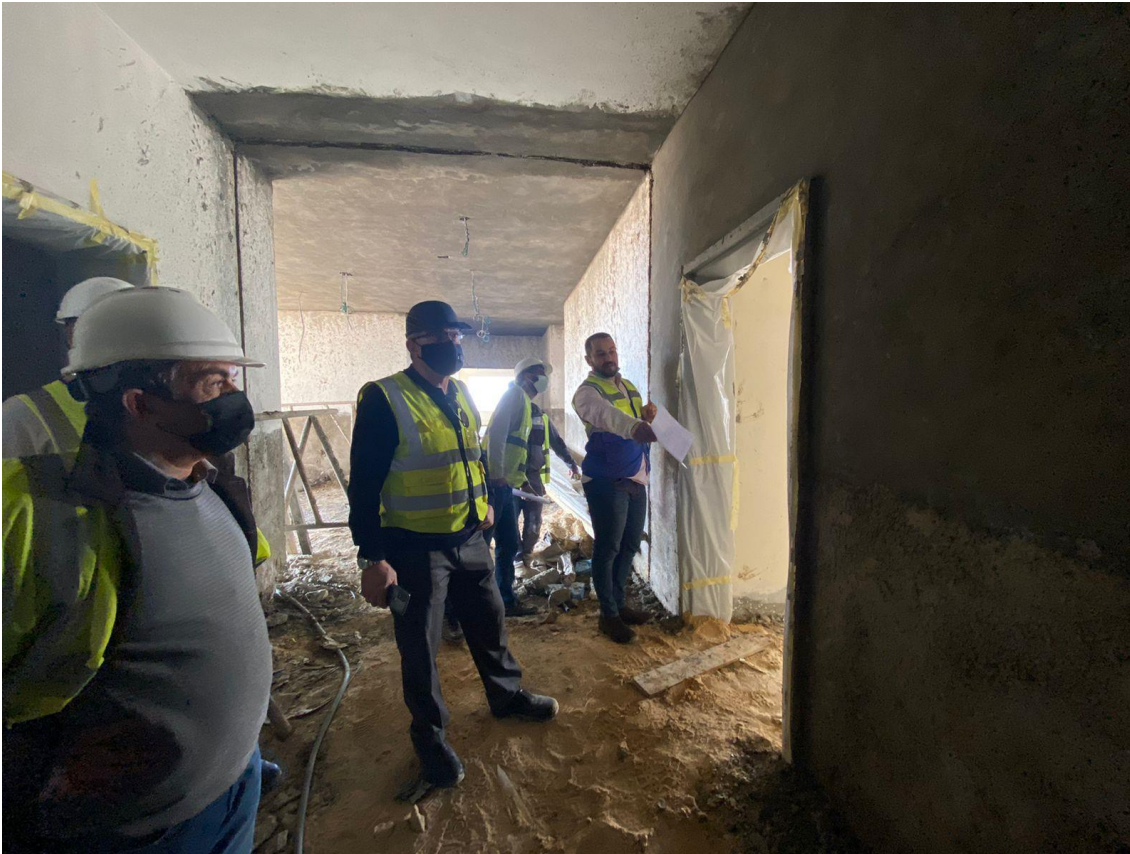
(Figure: 09)

The supervision team requested the Contractor to replace one door frame due to the thickness which does not comply with the technical specification

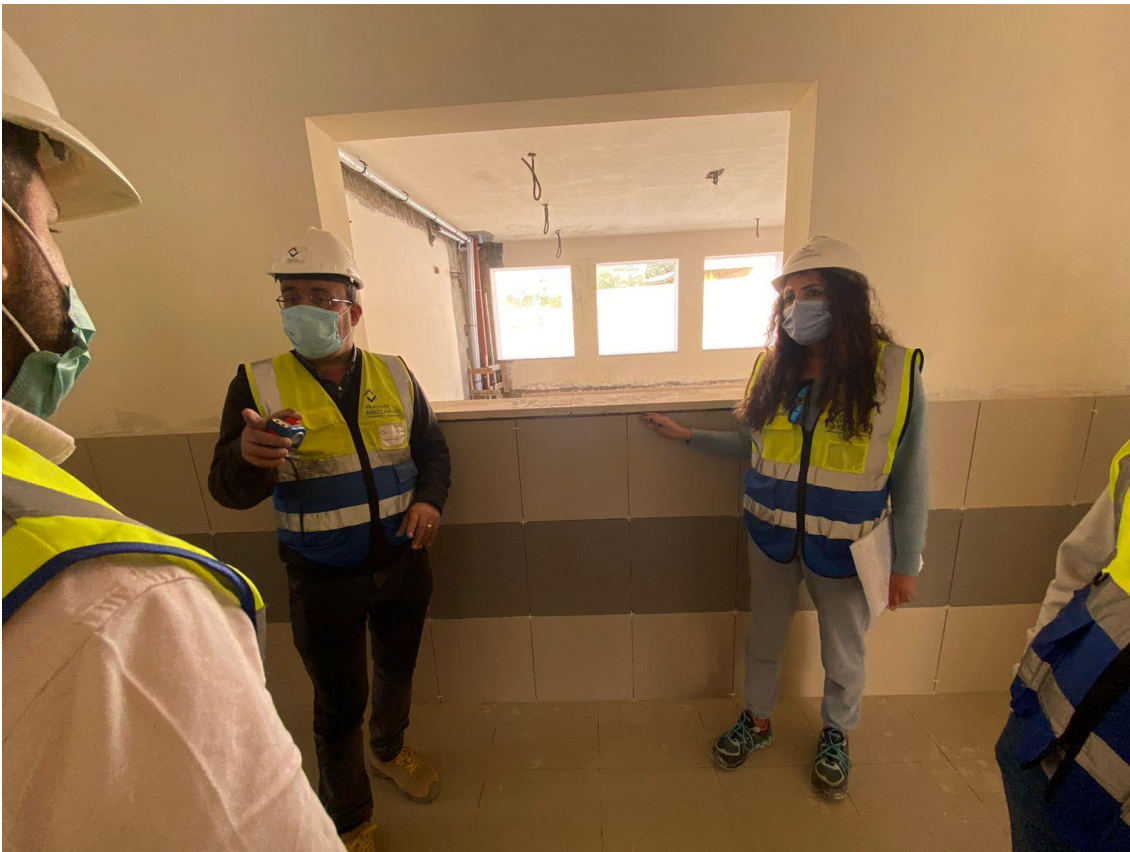
(Figure: 10)

The team discussed with the Contractor the wall tile cladding for corridors and the top level of cladding and the relation with window sills at corridors and the lockers below window levels

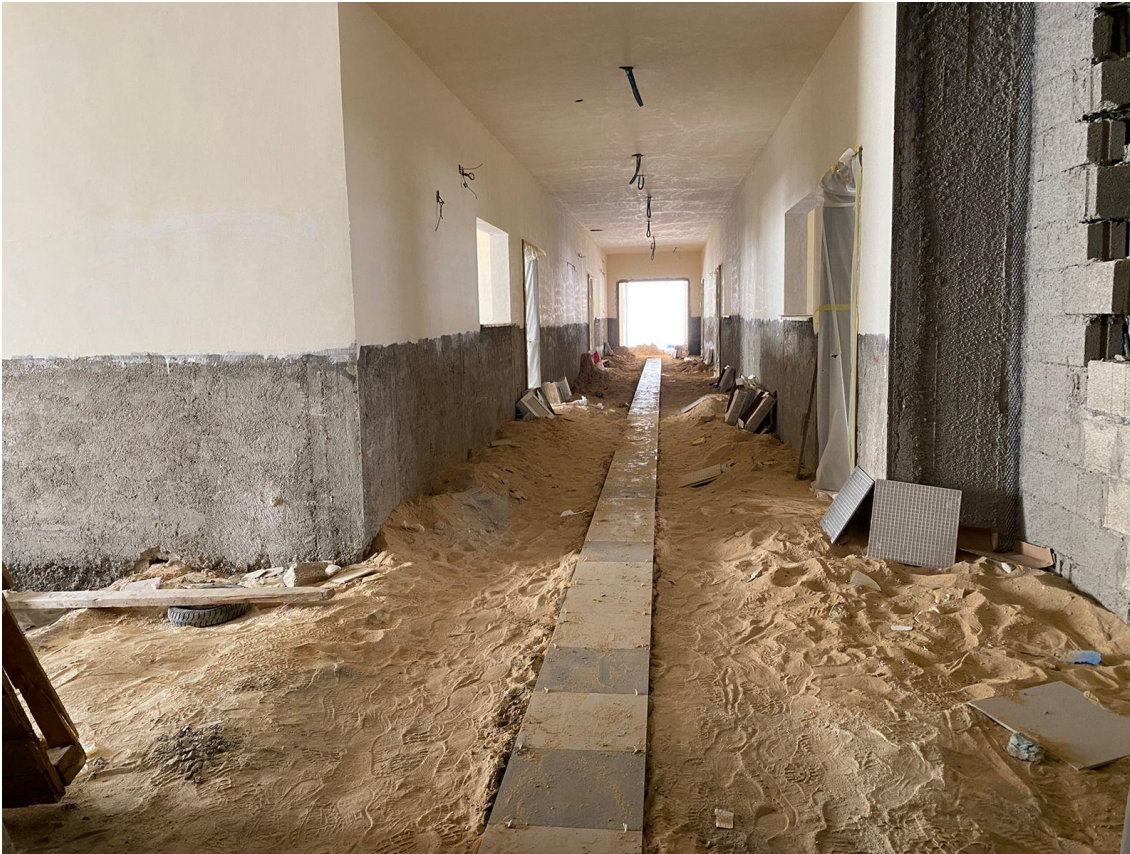
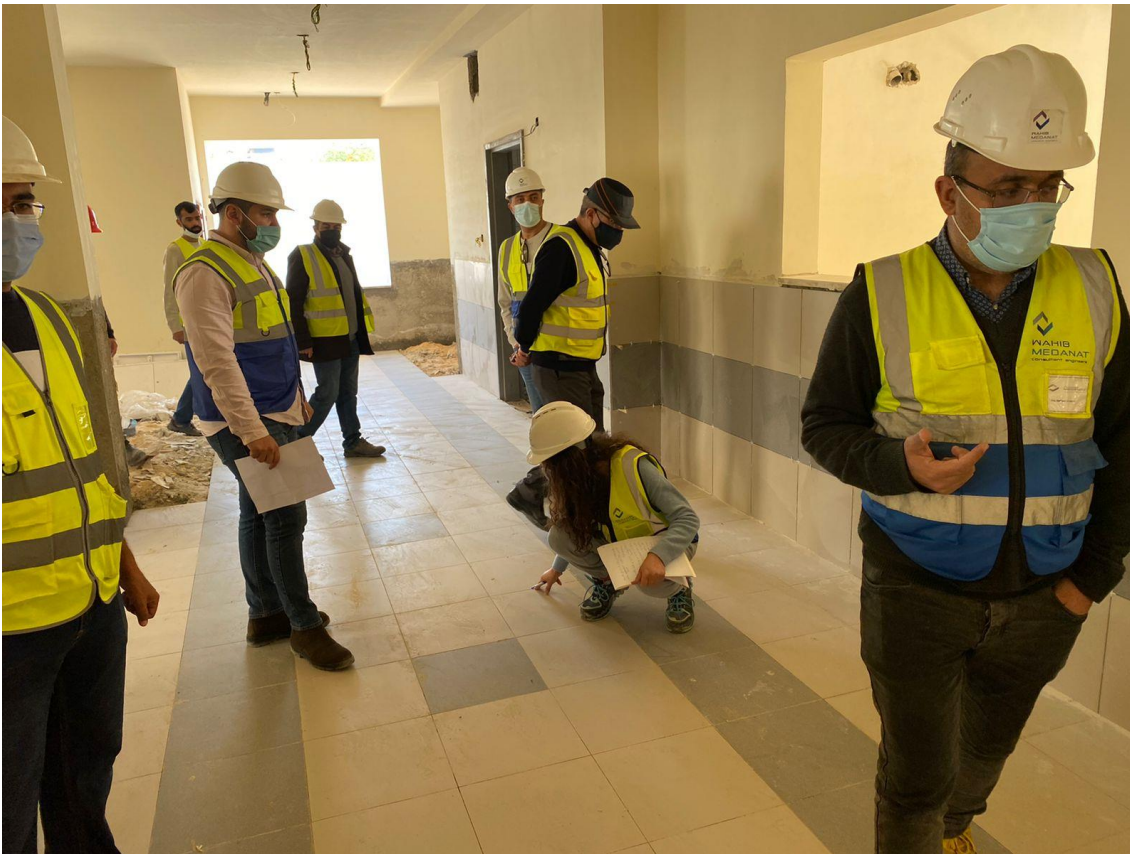
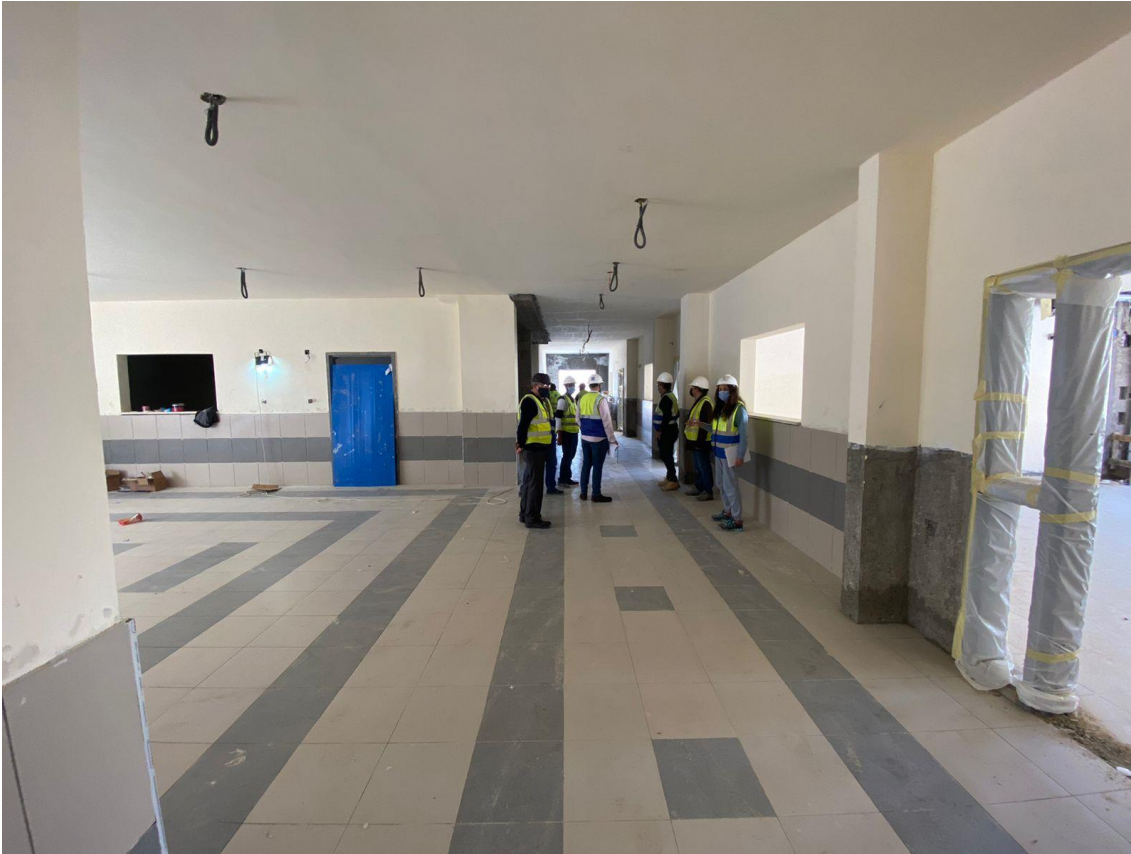
(Figure: 11, 12 & 13)

The team inspected the floor tiled areas and observed minor number of tiles have teething, the Contractor was requested to replace

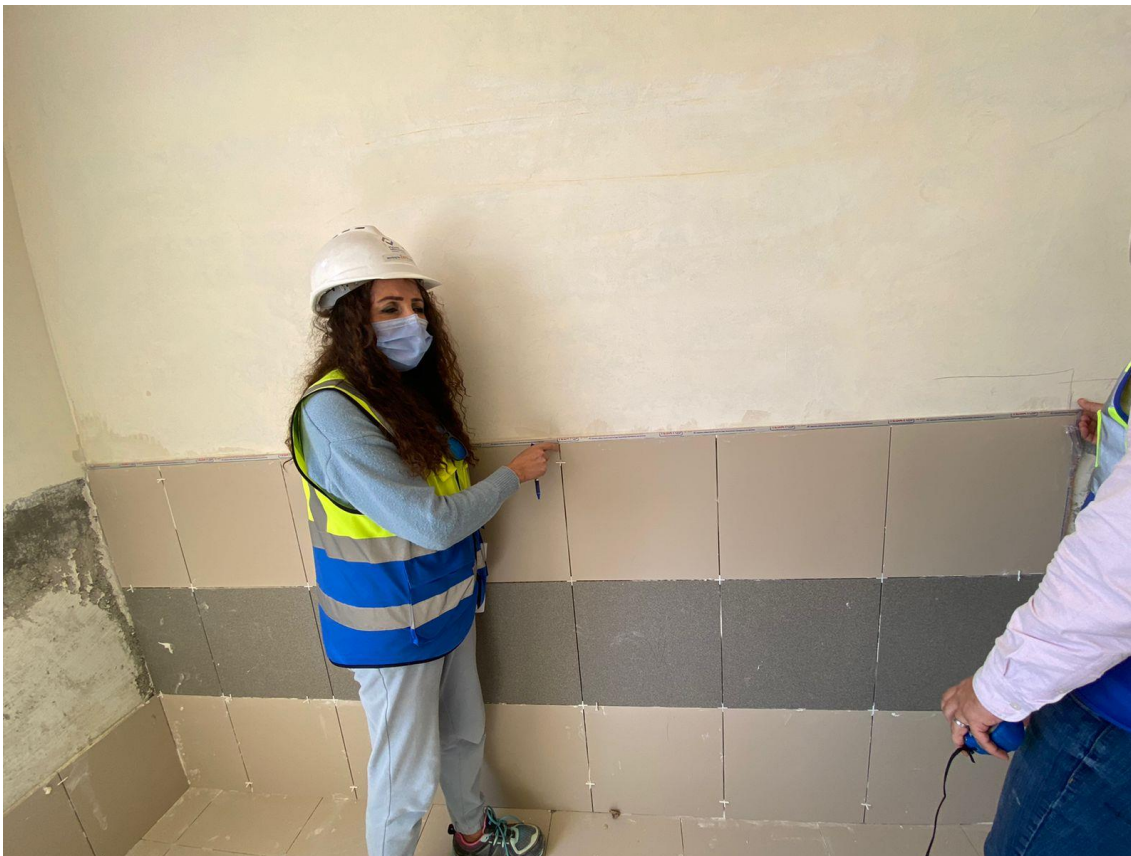
(Figure: 14)

Inspecting the execution of wall tiles

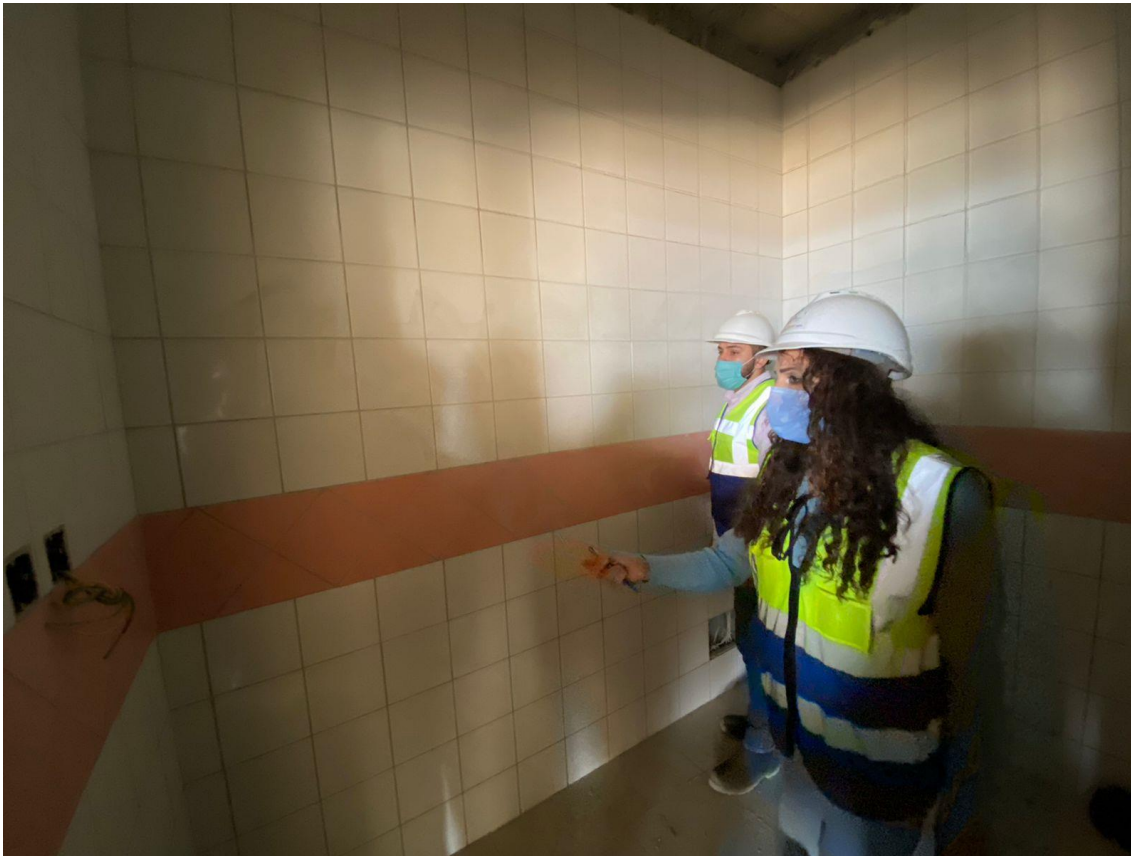
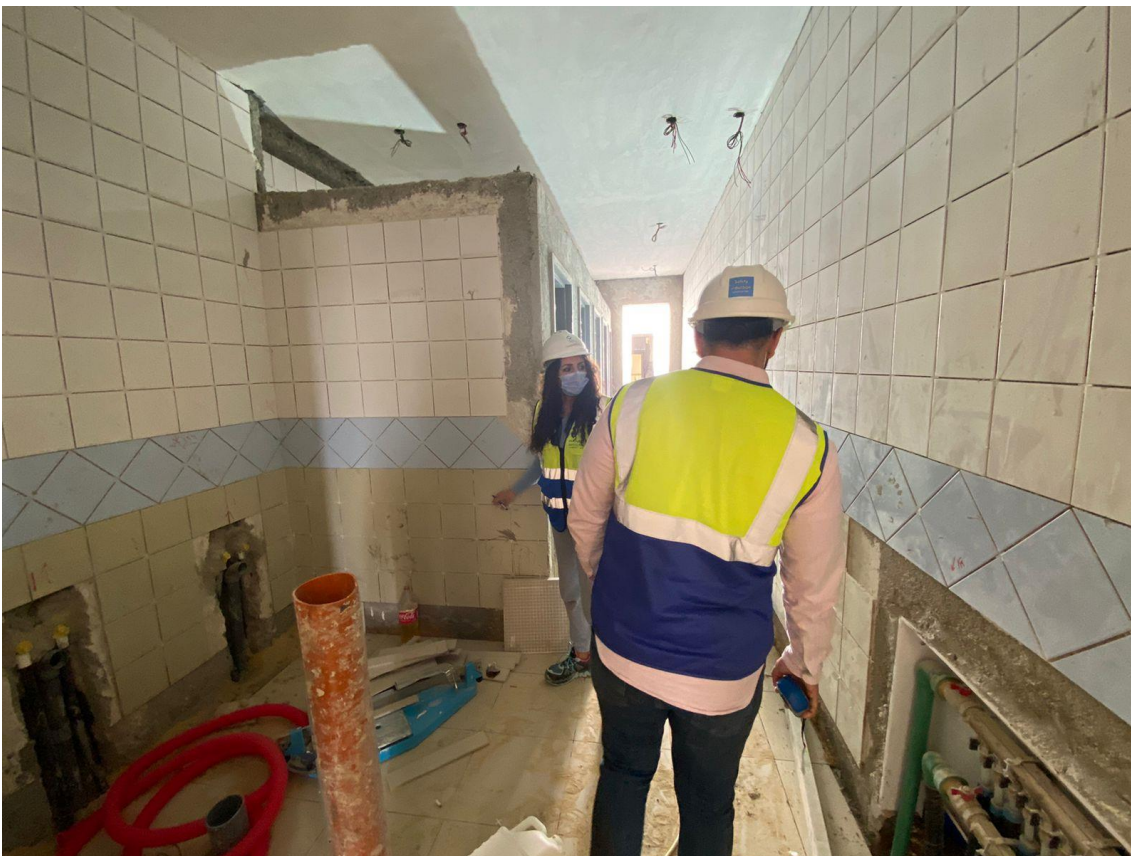
(Figure: 15 & 16)

The team inspected the executed wall tiling at the wet areas

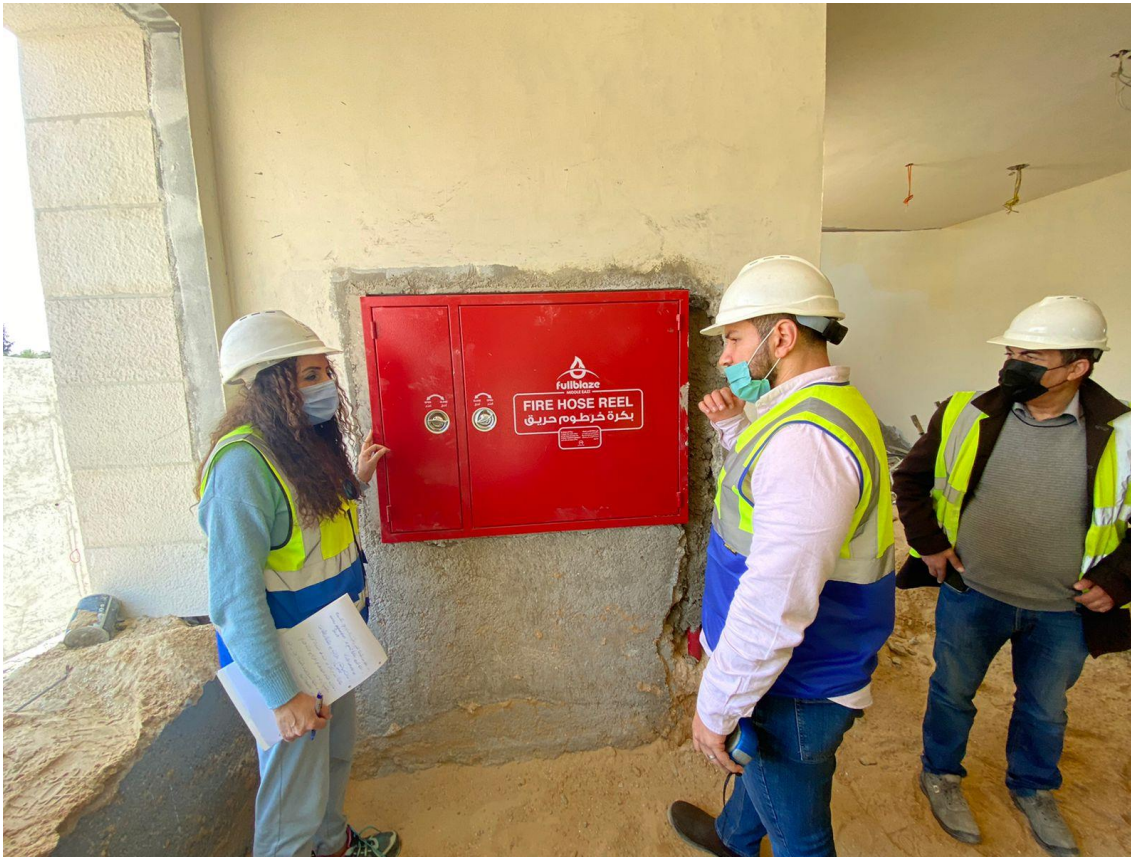
(Figure: 17)

The team discussed with the Contractor the installation of fire cabinets in the corridors and the connection with the installation of granite at walls and the prominence of the said cabinets

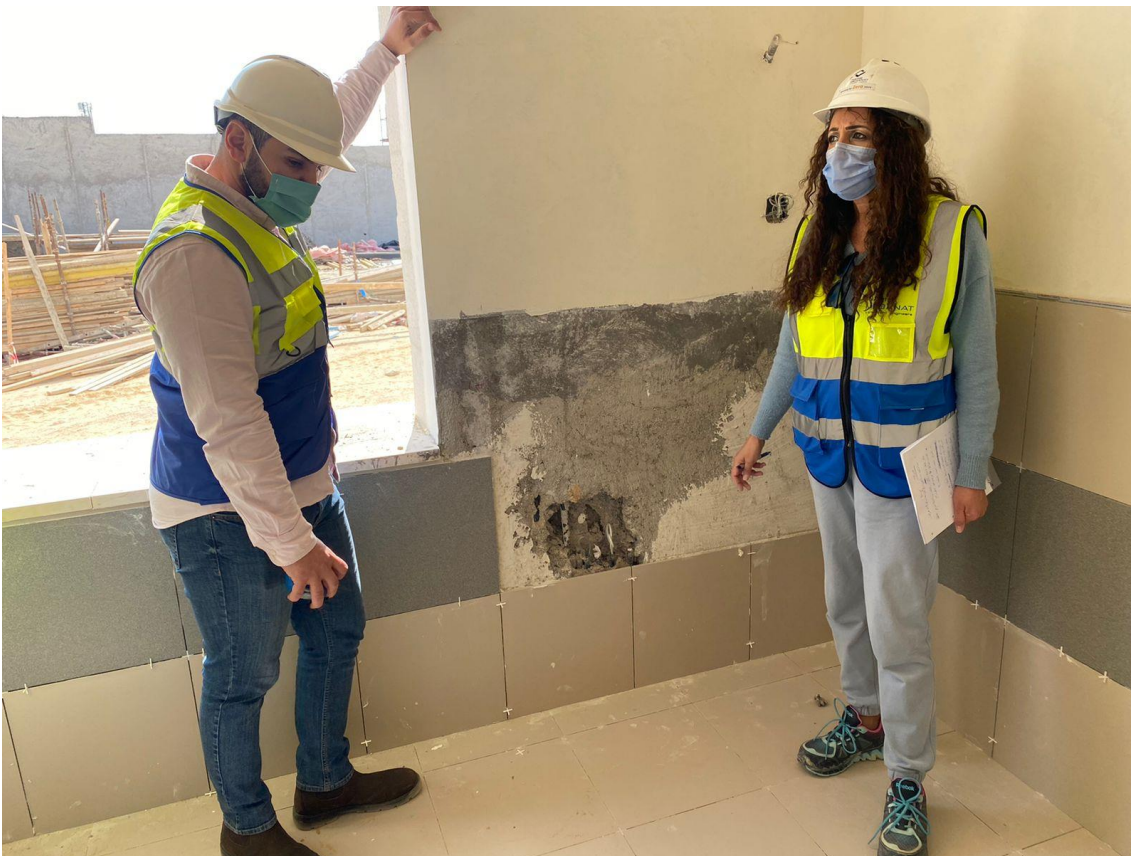
(Figure: 18)

The team requested the Contractor to finalize his work in the electrical outlets at walls

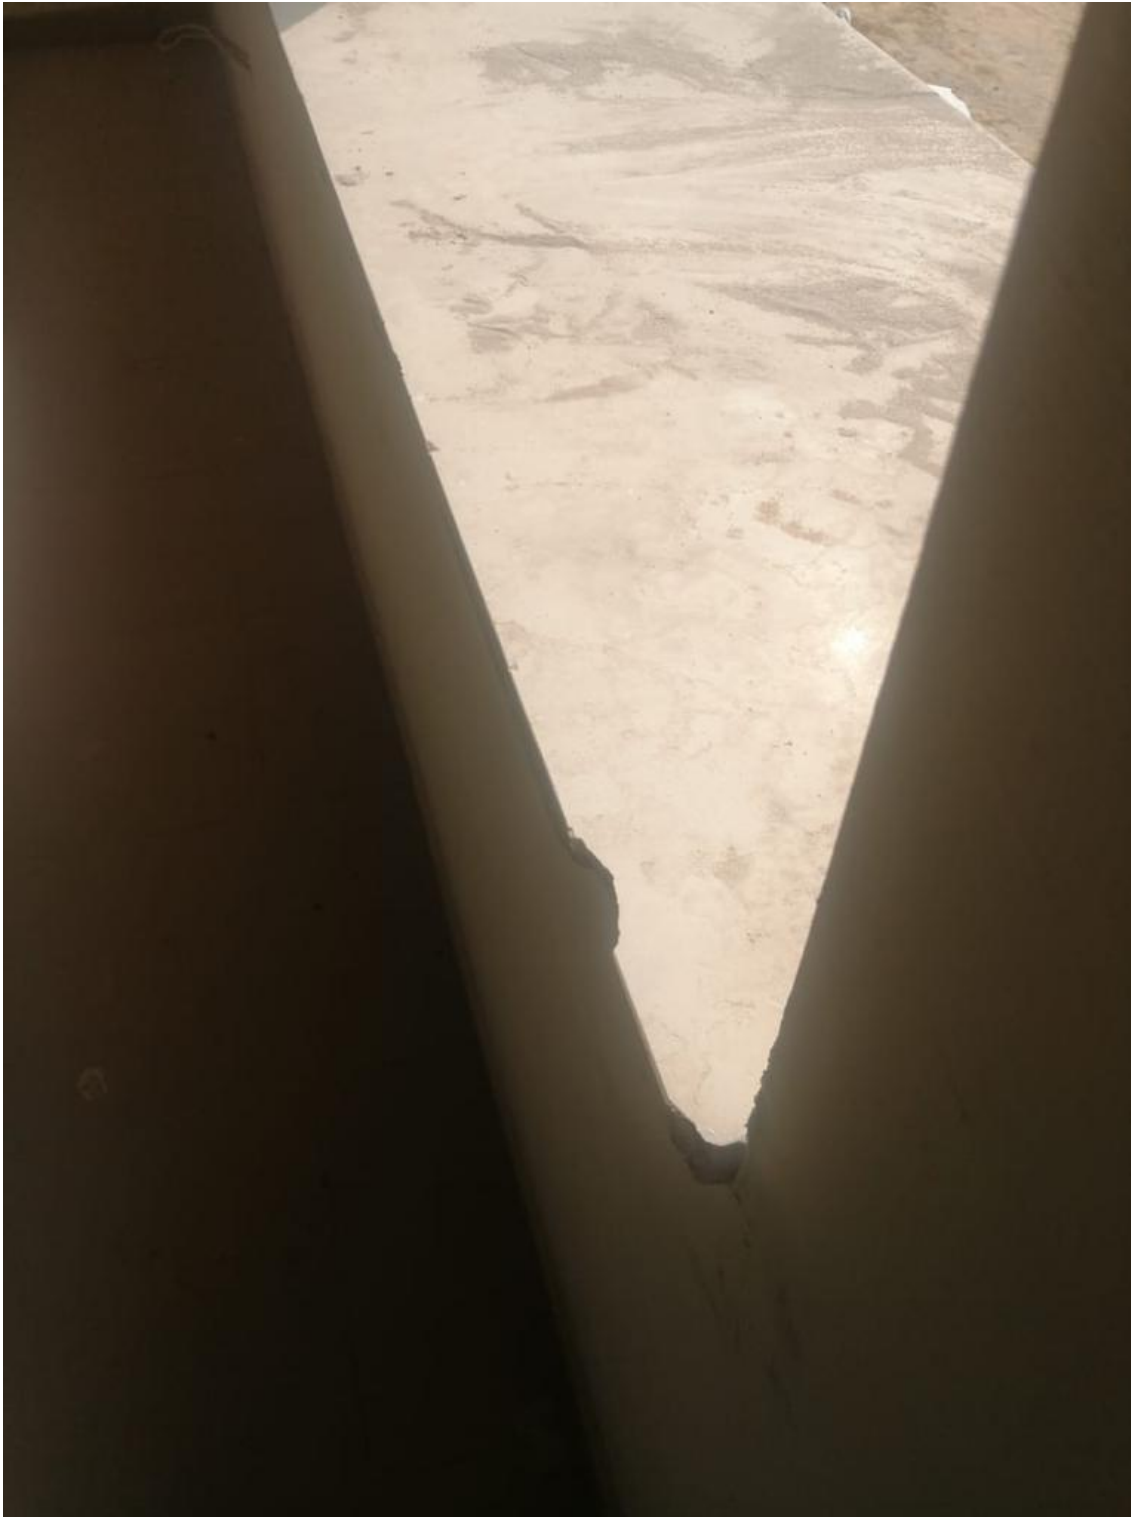
(Figure: 19)

The Contractor was requested to replace the broken window sill
