School for Knowledge Economy Project (SKEP) Phase III – Package 1

Monthly Progress Report

No. 16

March, 2022

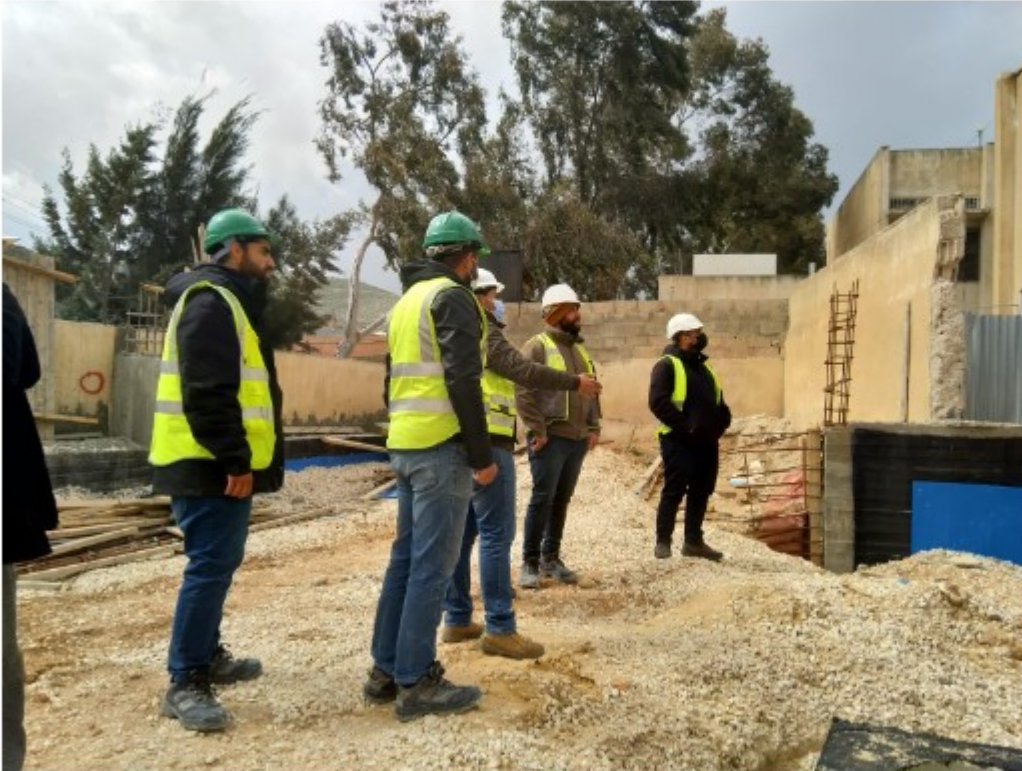
Eng. Odai commenting on the damaged part of the temporary gate and recommending immediate safety measures (such as installing protection boards) to protect labours from falling and other related injuries

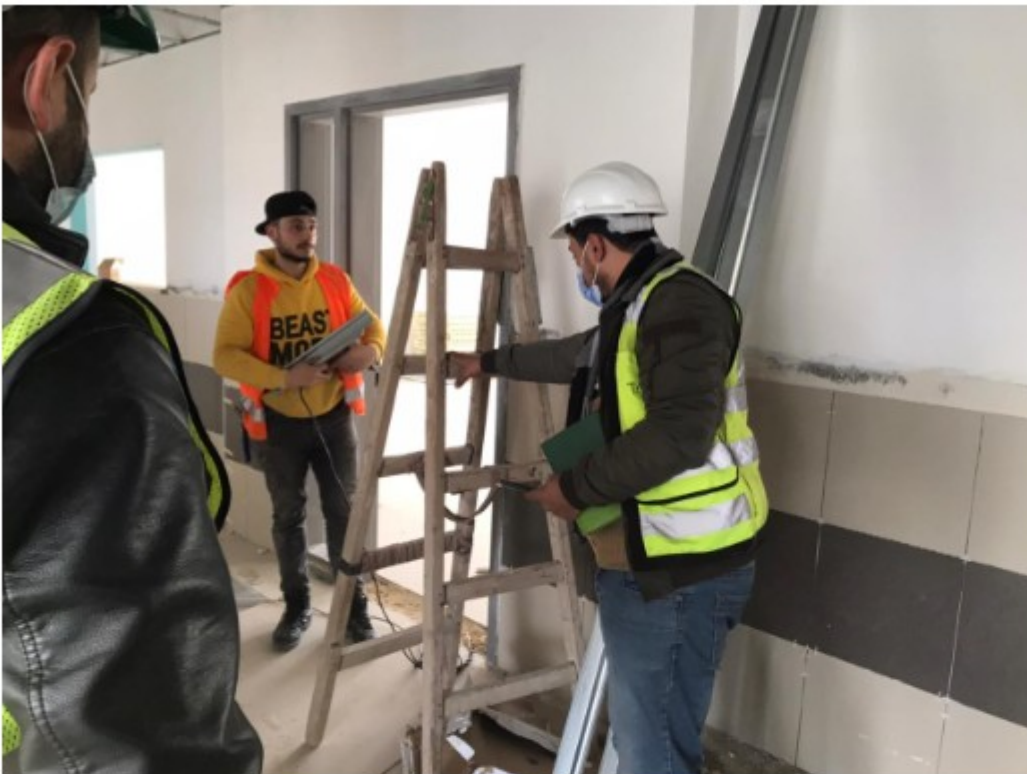
Eng. Odai inspecting ladders used by the Contractor and requesting substituting them with other ones that comply with safety rules and specifications

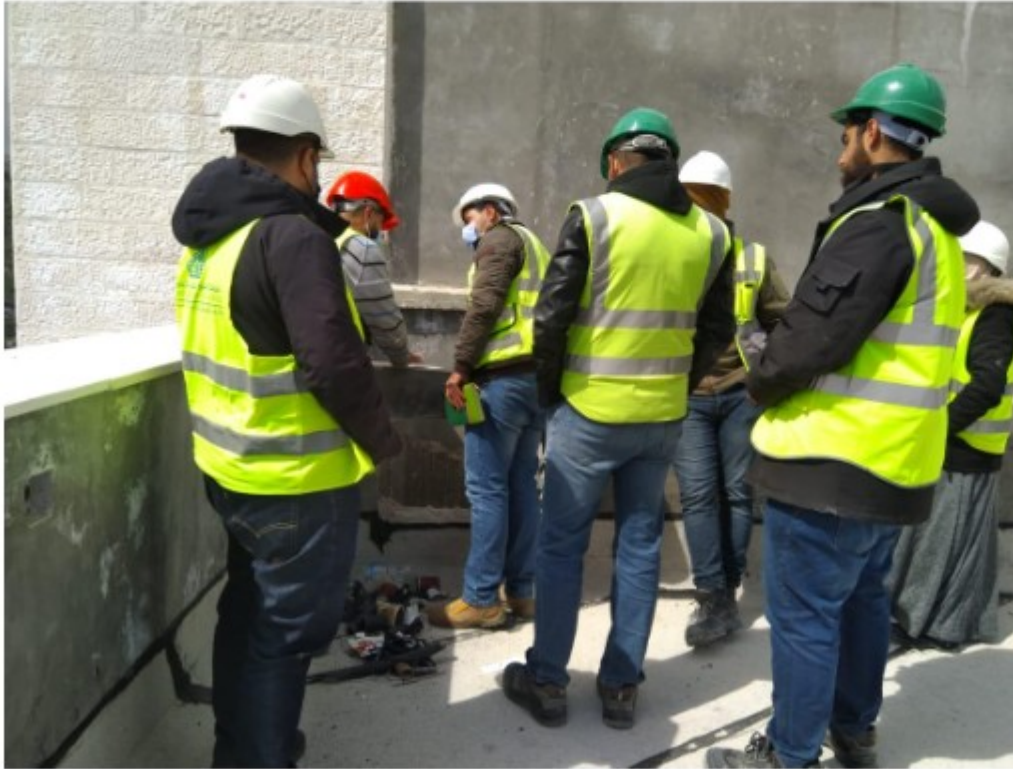
Eng. Odai recommending closing the open shaft and to use scaffoldings that abide to the safety requirements

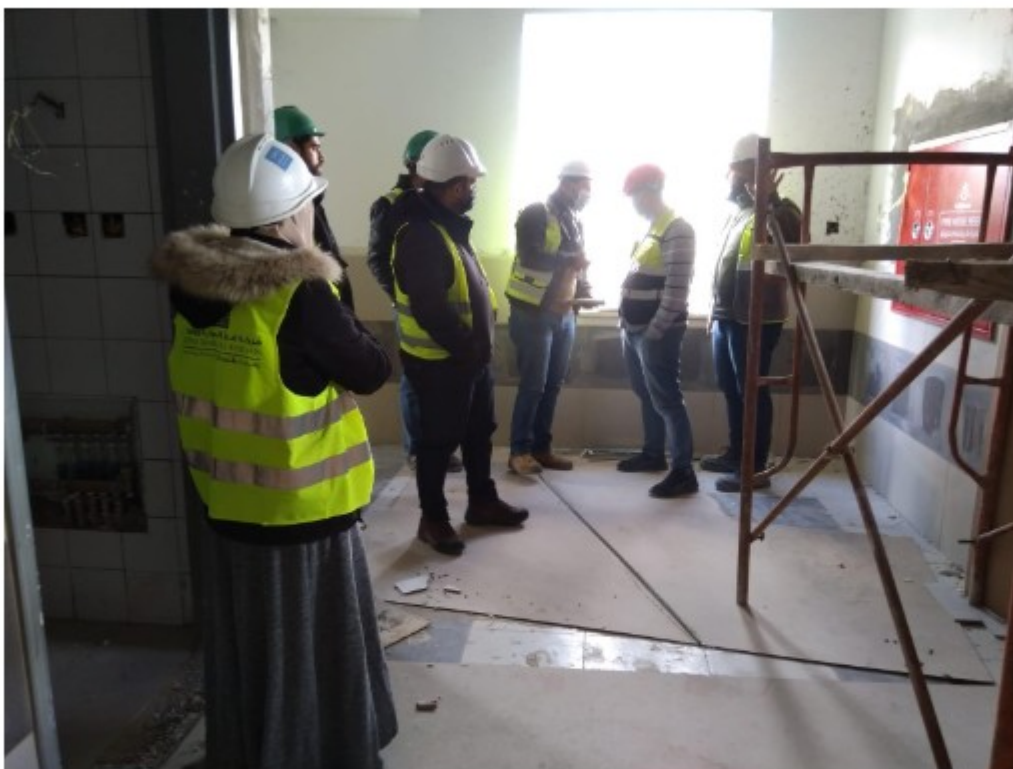
Eng. Odai preserving the fence from the window, commenting that some parts of the fence are clearly damaged and need fixing

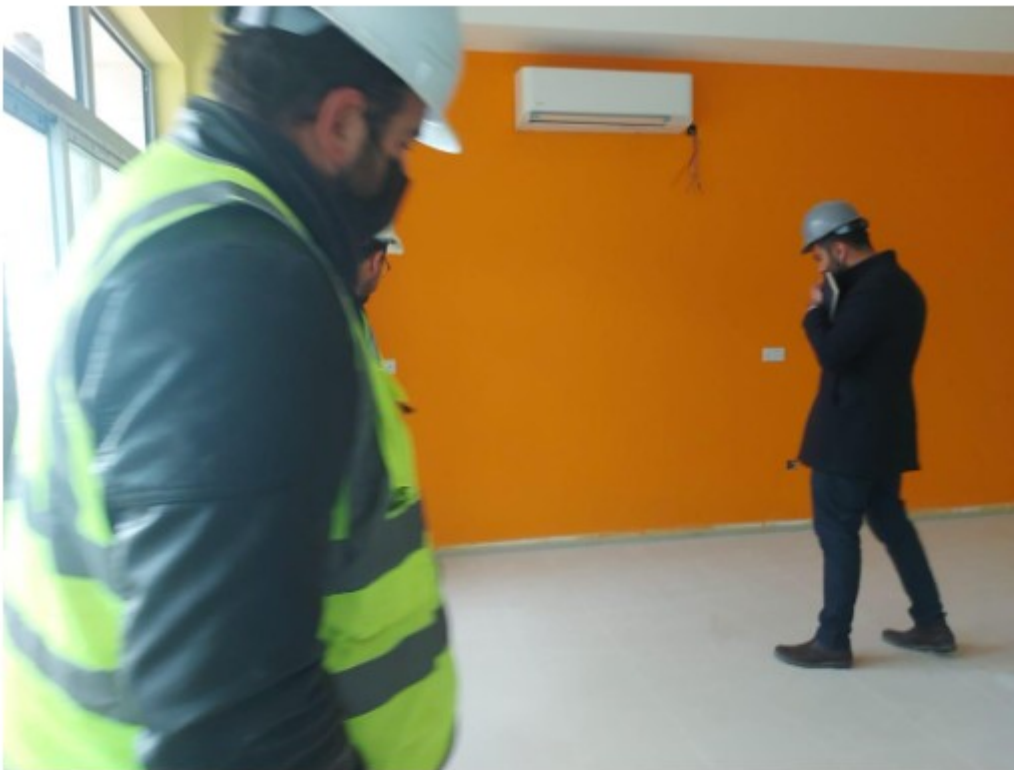
Inspecting painting work and works done on the false ceiling

Minor humidity was notice on paint

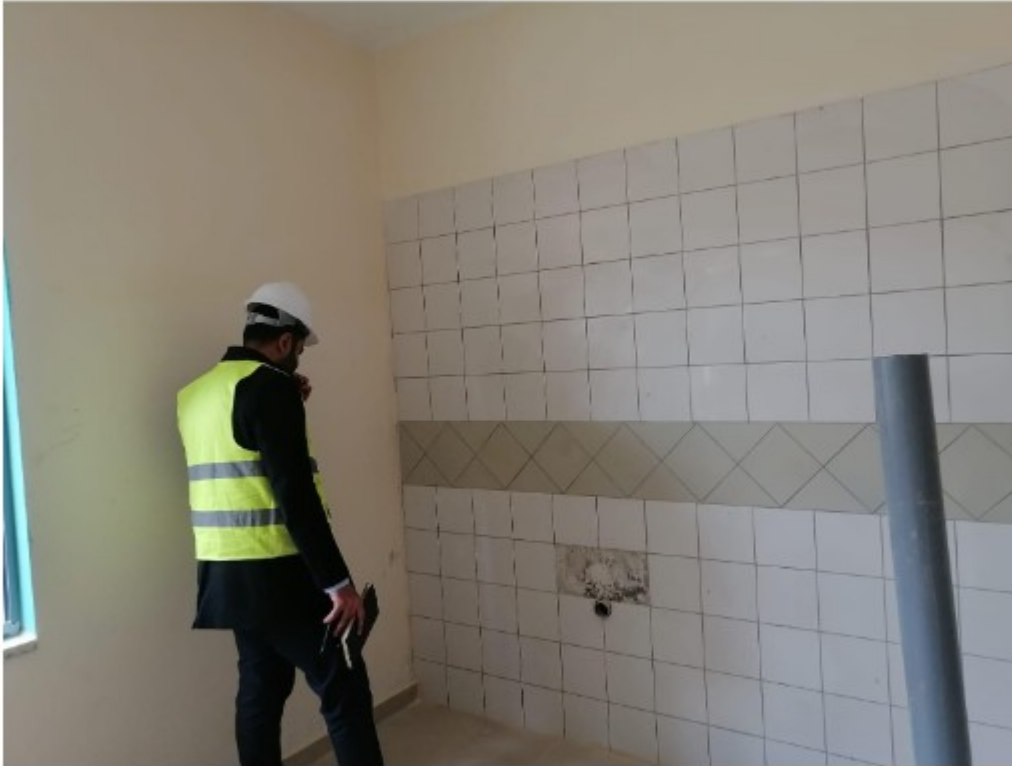
Eng. Odai recommending protecting tiles with covers used for this purpose

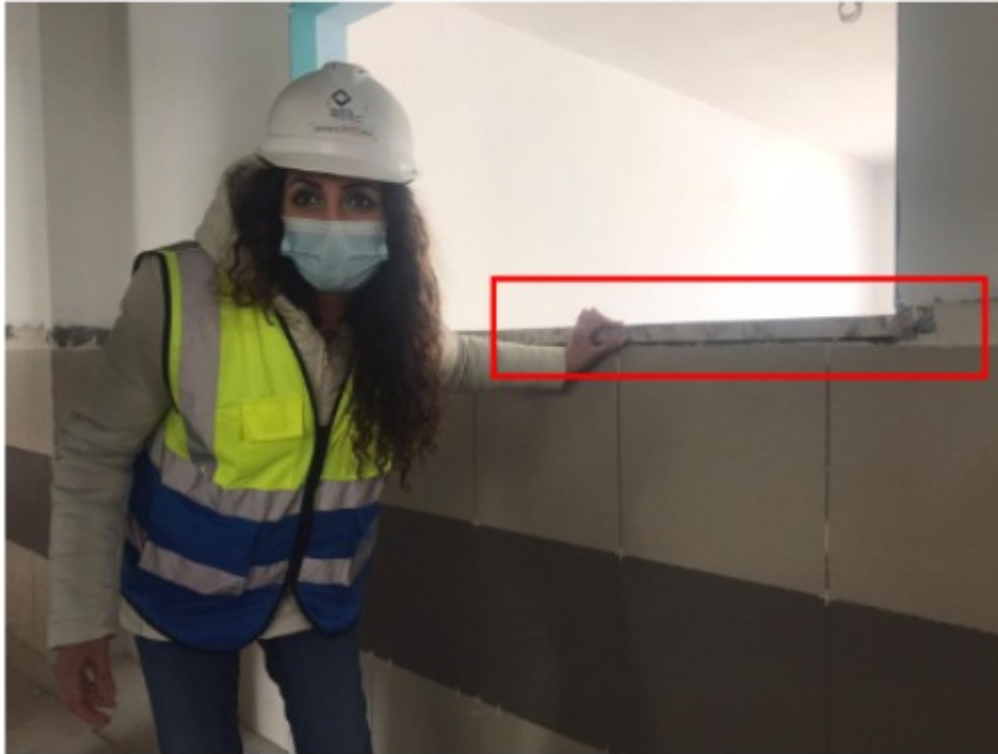
(figure:05)

The supervision team inspected the window sills at the corridors and observed variation in the leveling of those sills and requested the Contractor to rectify

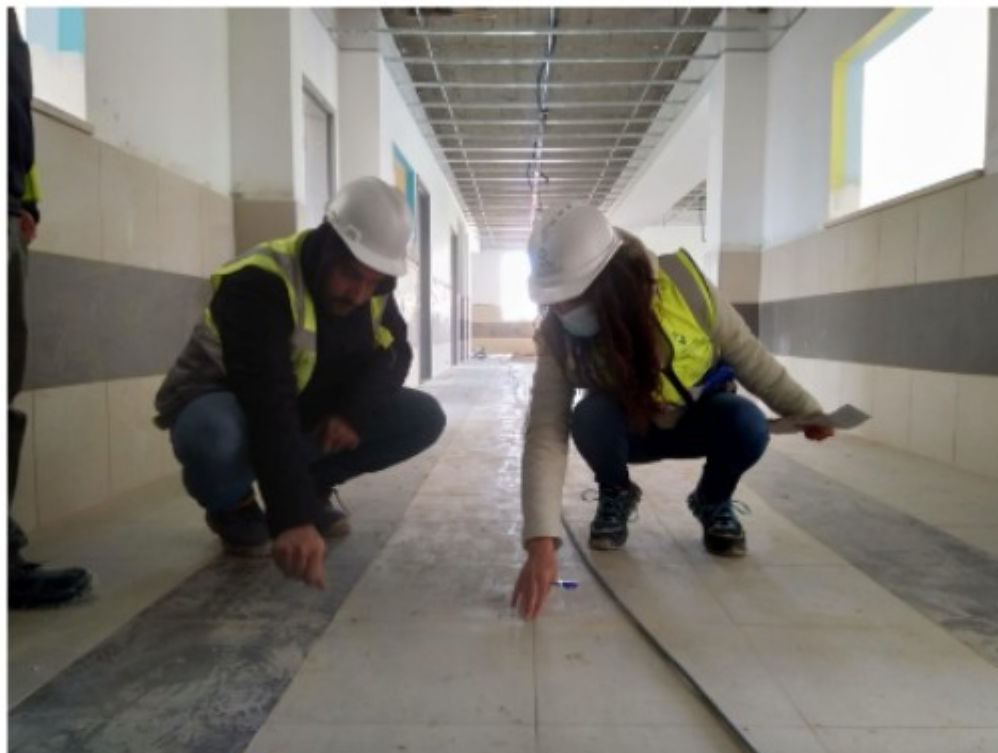
(figure:06)

The team observed minor teething in some parts in the porcelain floor tiles and requested the Contractor to rectify

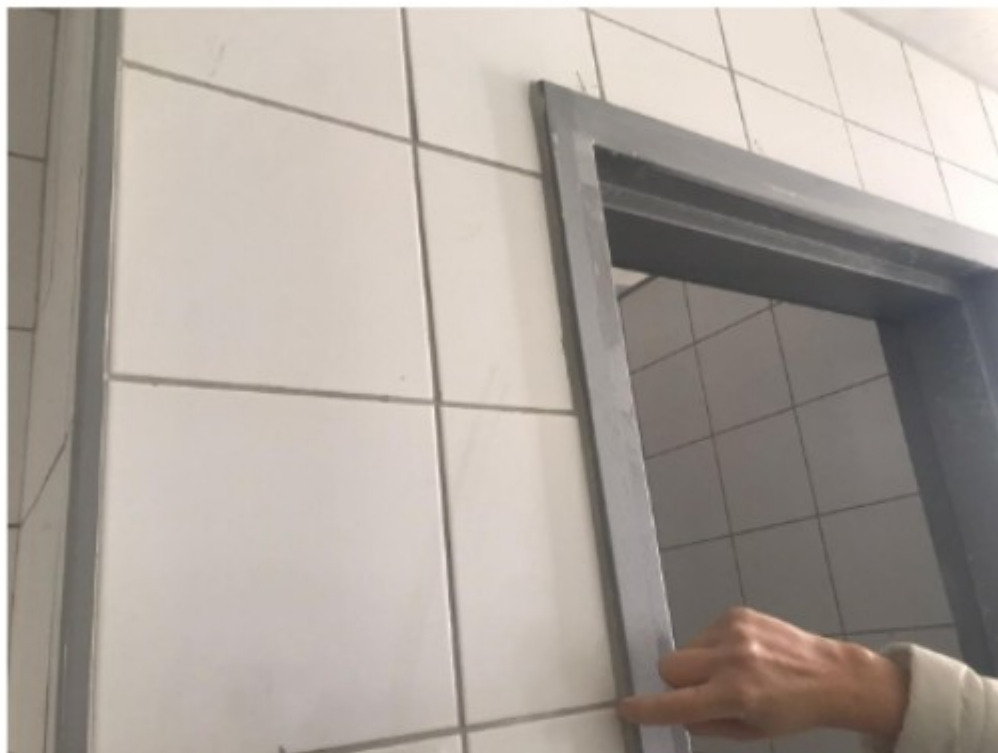
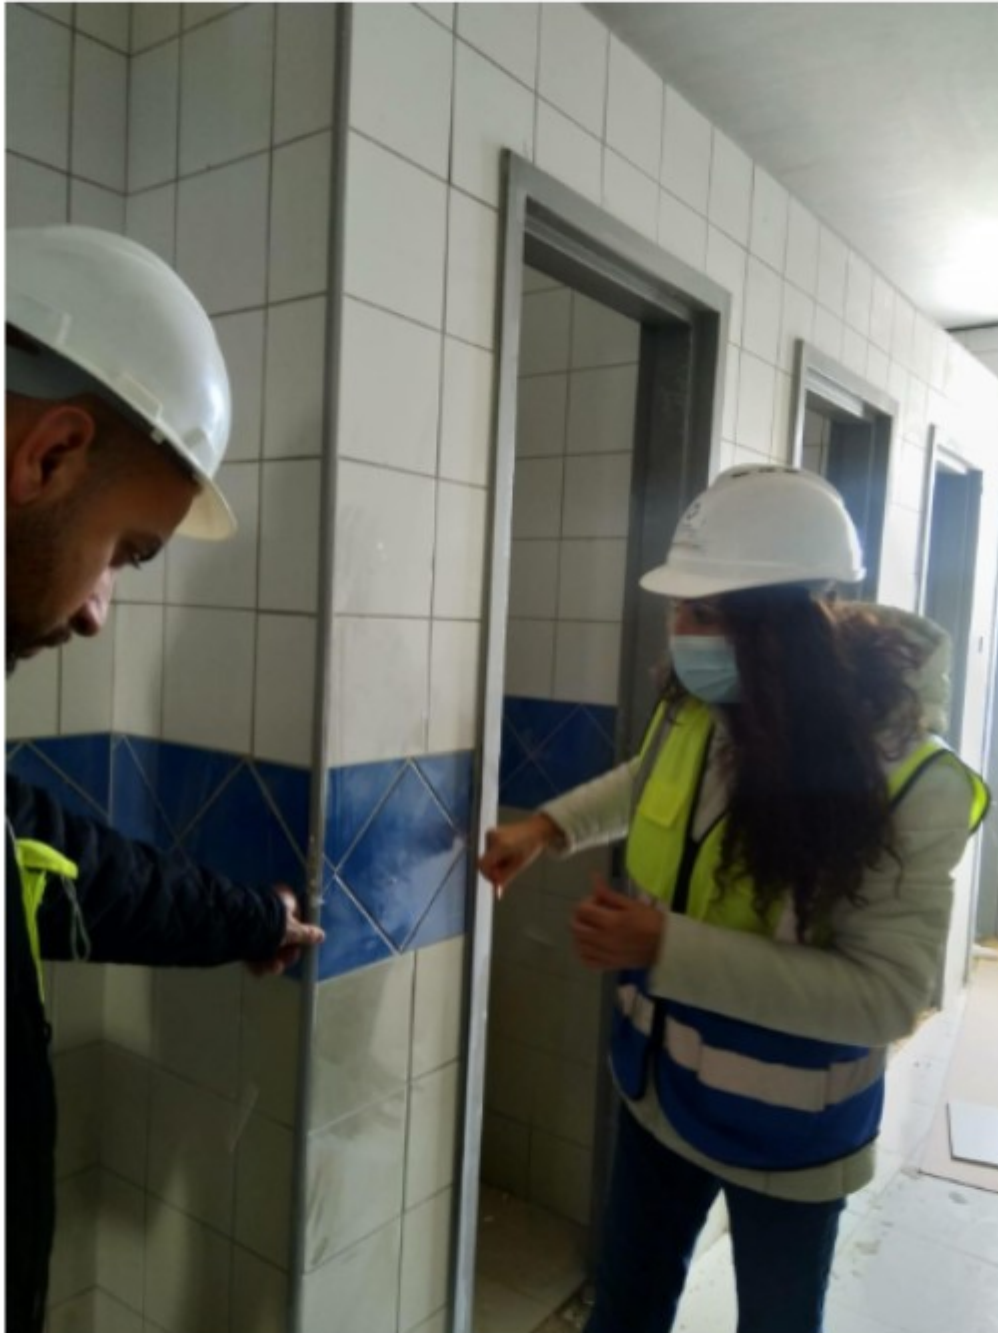
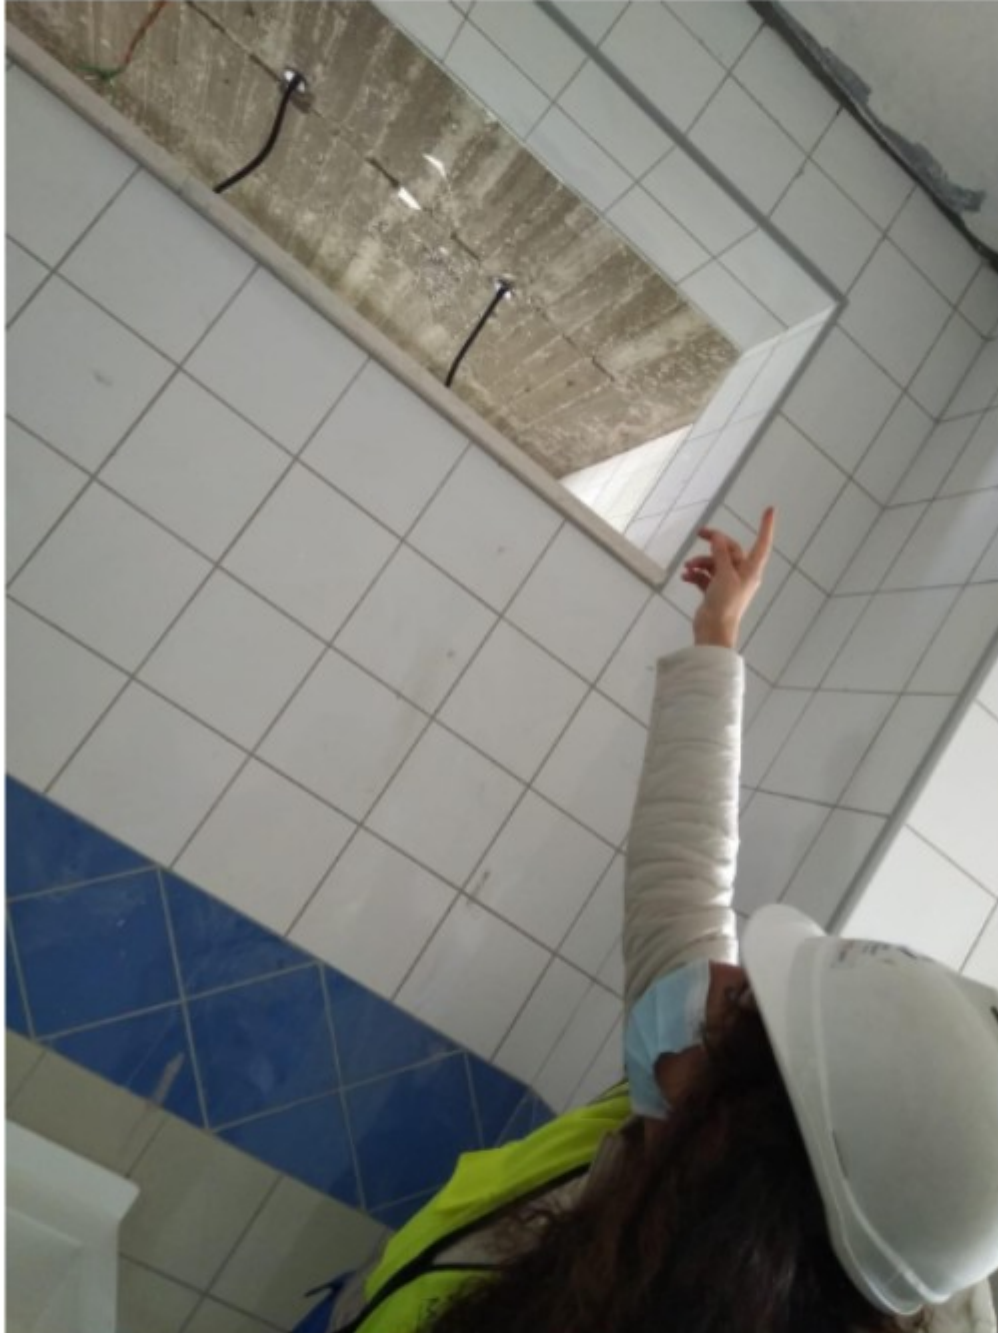
(figure:11, 12 & 13)

The team inspected the ceramic wall tiles at the wet areas and observed defects in some parts, defects in the grouting, beads and broken tiles

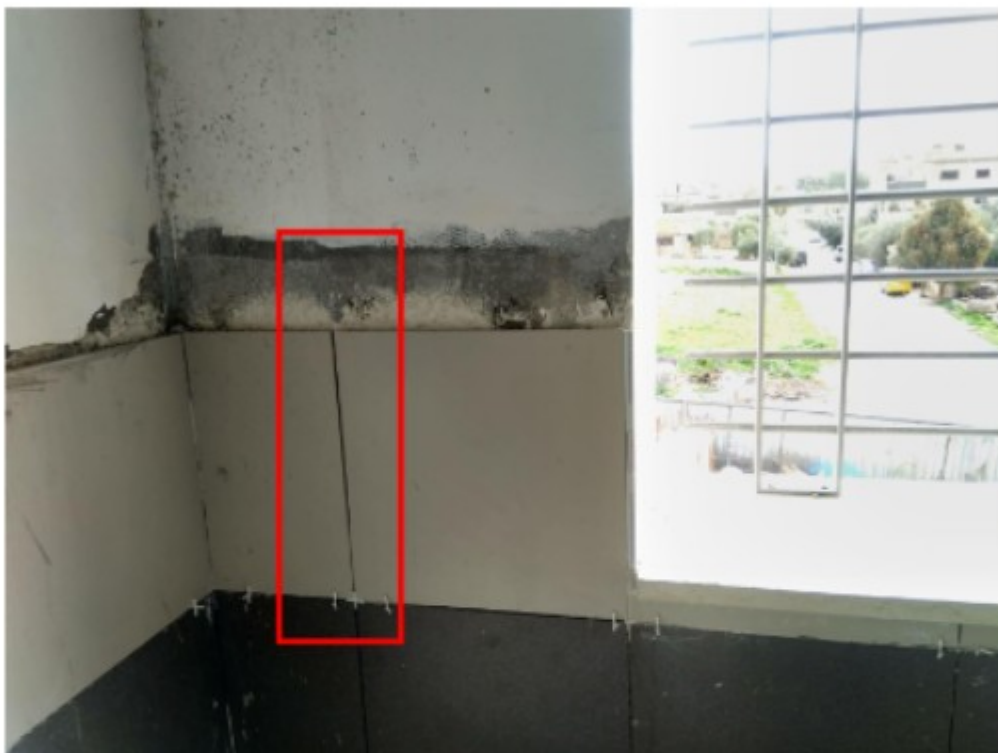
(figure:16)

The team noticed defect in wall tiles installation (spacing between tiles). The Contractor was requested to rectify before installing the granite coping

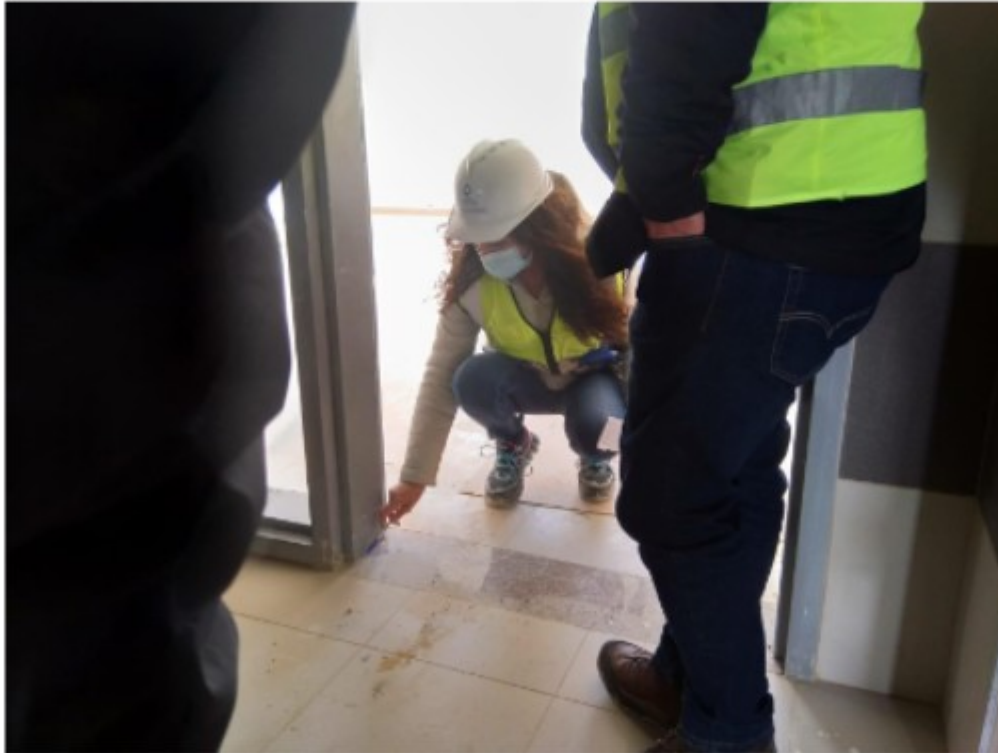
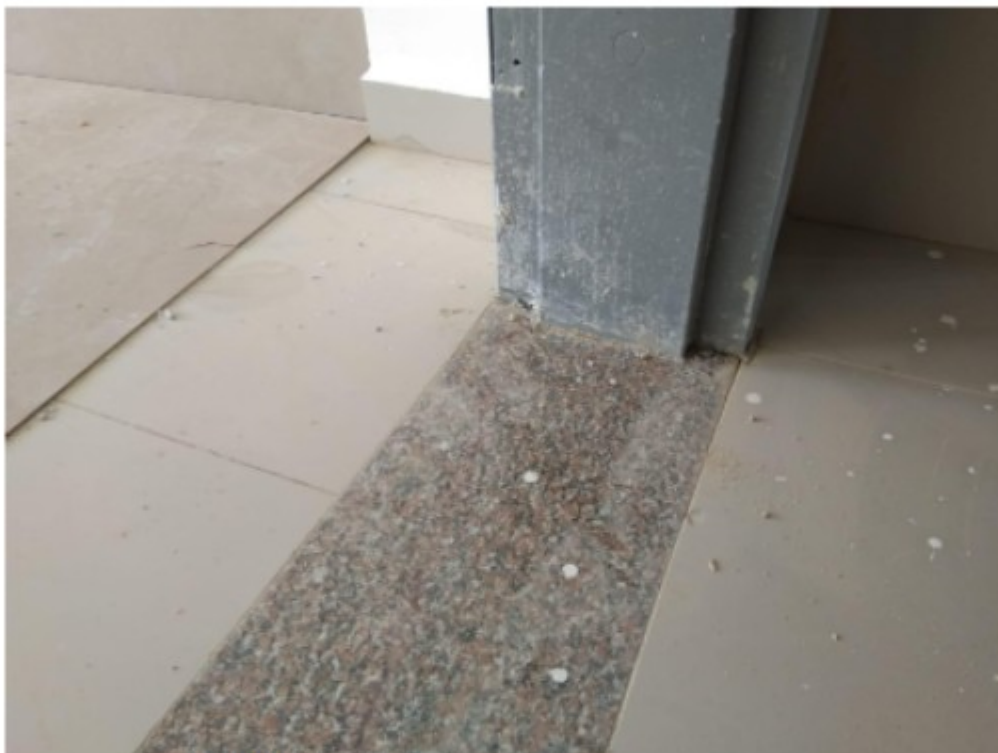
(figure:20 & 21)

The team inspected the executed door thresholds and observed defects in the cutting of those threshold

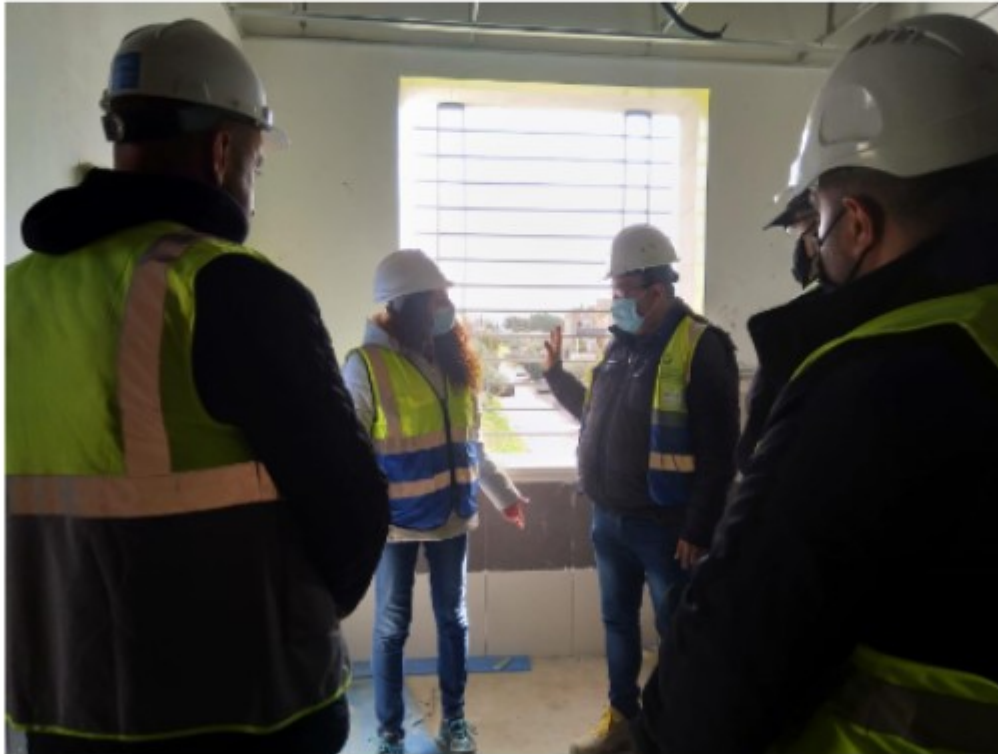
(figure:30)

The team observed that the Contractor is conducting a rectification to the installed steel protection screen

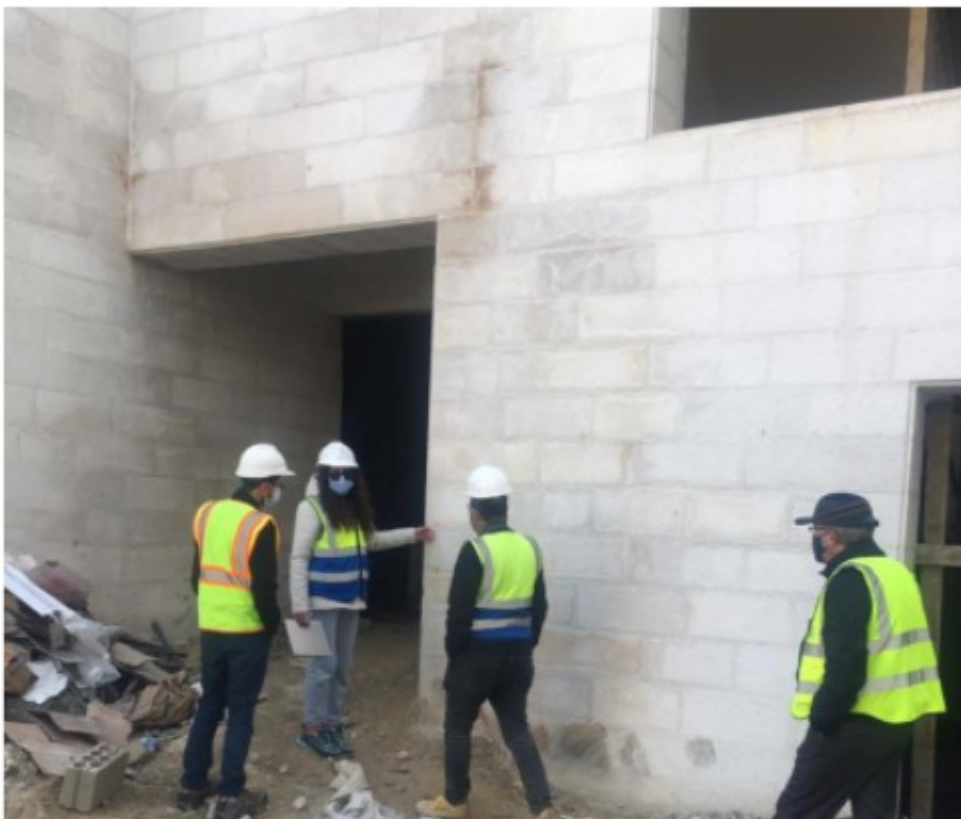
(Figure: 10)

The defective stones of the facades were still not rectified

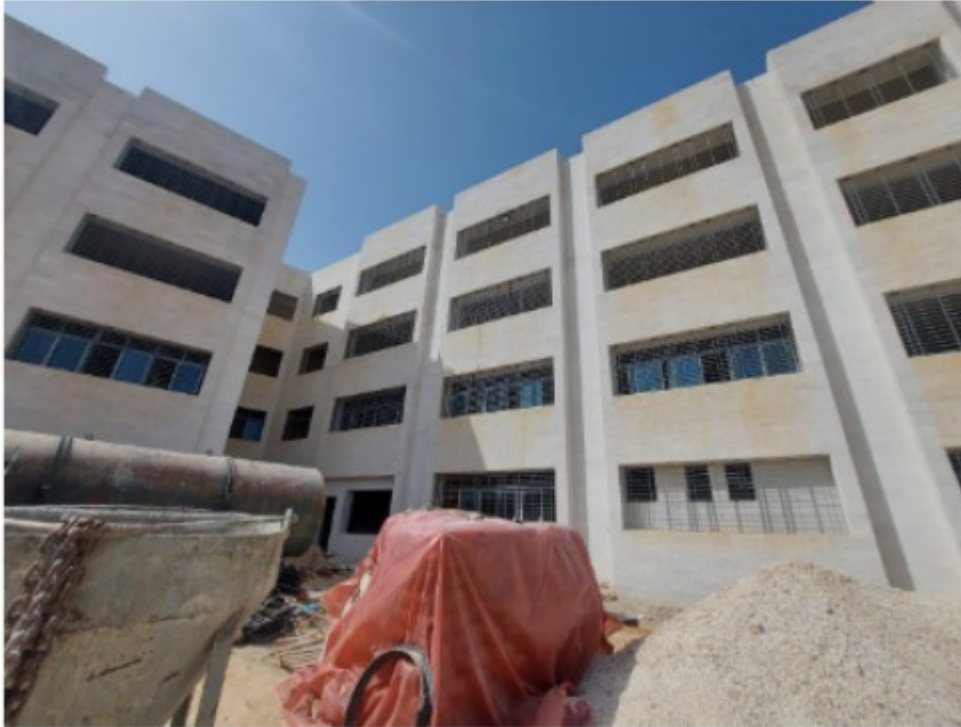
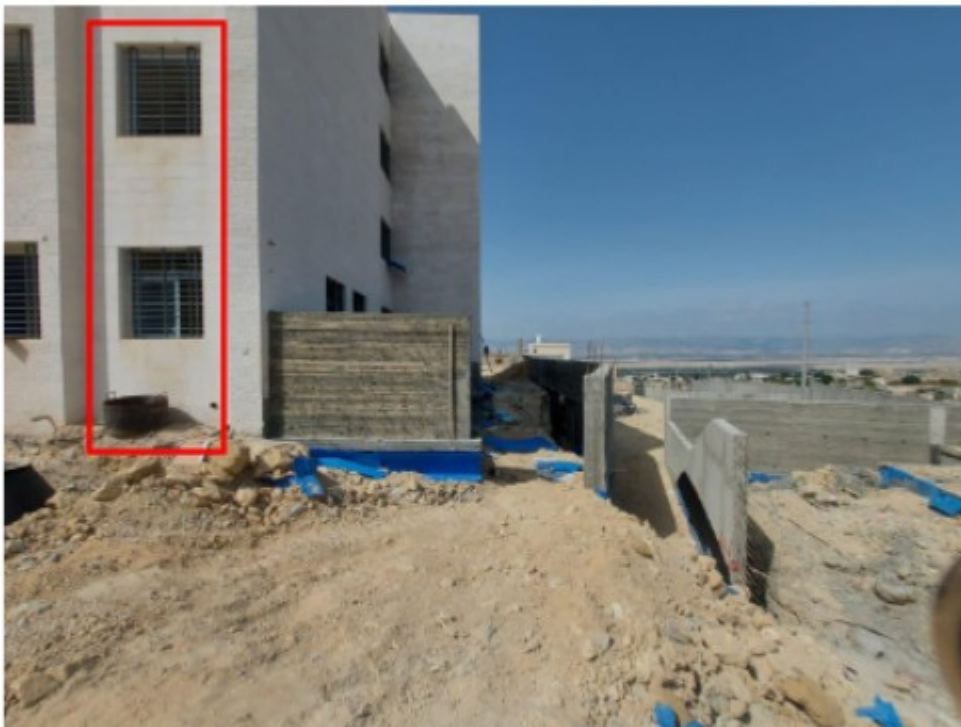
(Figure: 11 & 12)

The team observed that due to other activities the stone facades require cleaning

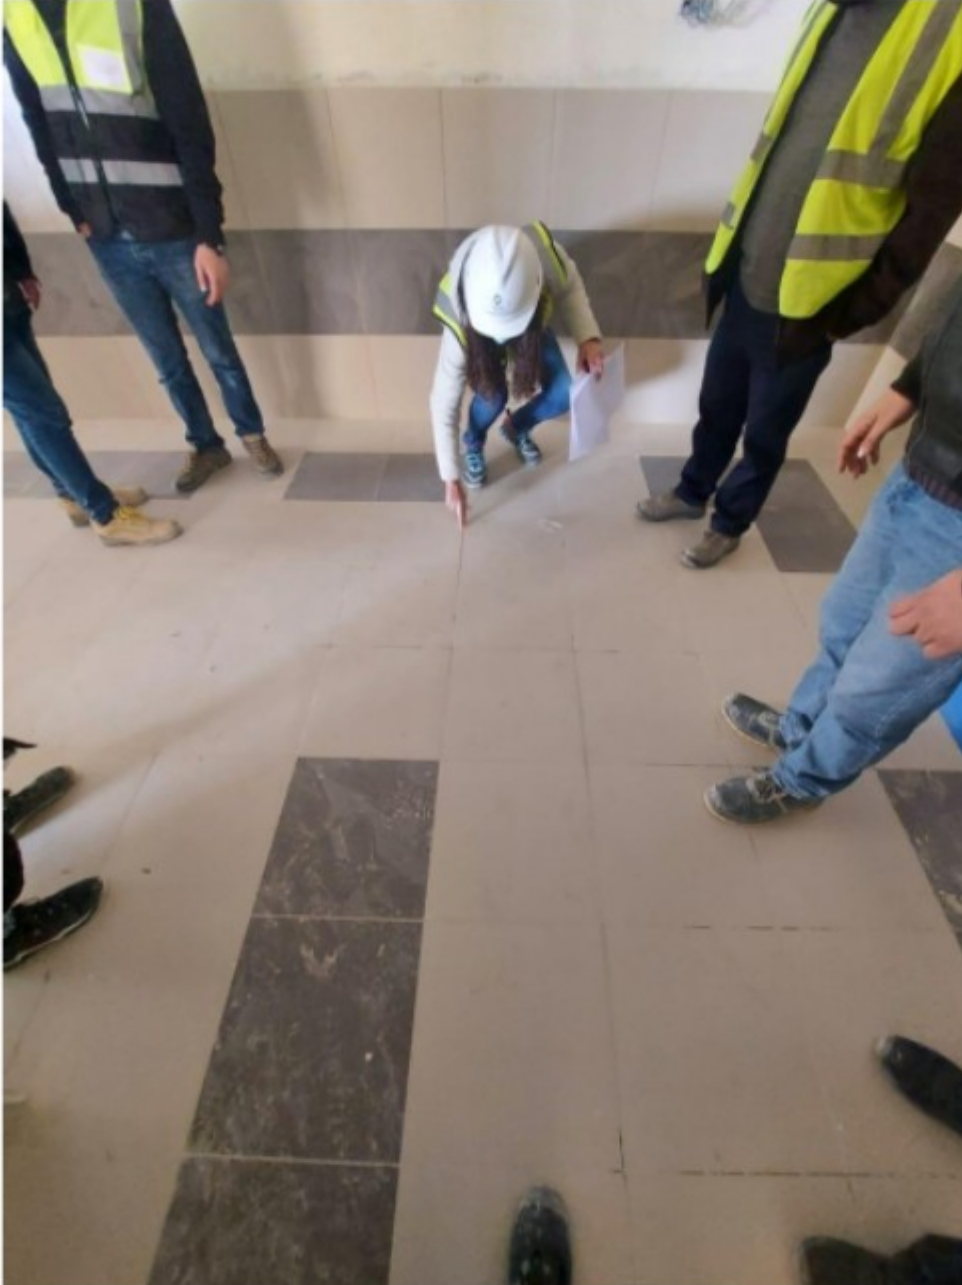
(Figure: 15)

The team observed teething of executed porcelain floor tiles in some parts and request the Contractor to rectify

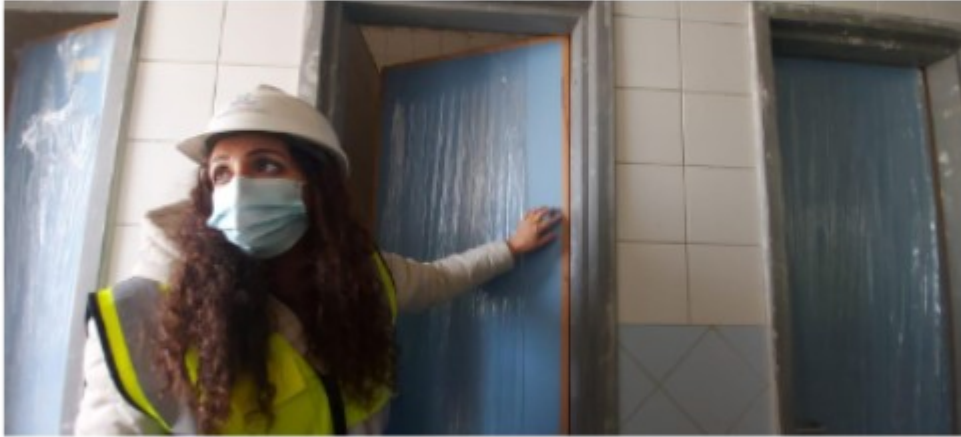
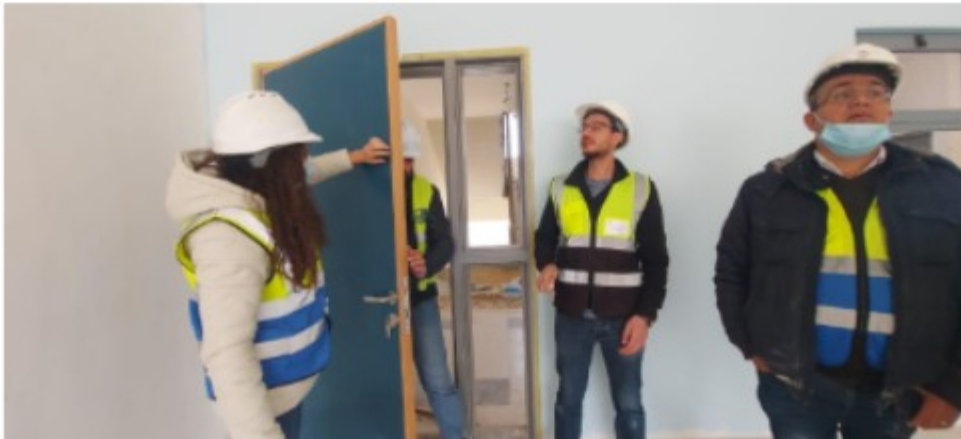
(Figure: 16 & 17)

The team inspected the installed wooden doors and observed that a number of doors have defective beech frames which need to be replaced

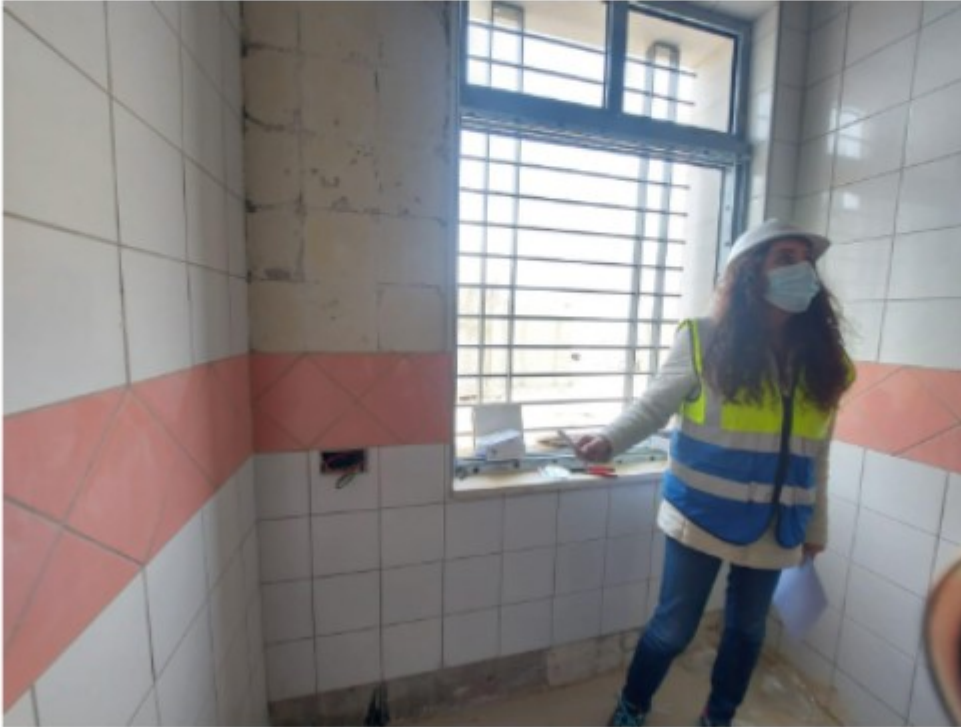
(Figure: 22)

The team observed that the Contractor has removed part of defected wall tiles at the wet area as first step to replace the defected tiles

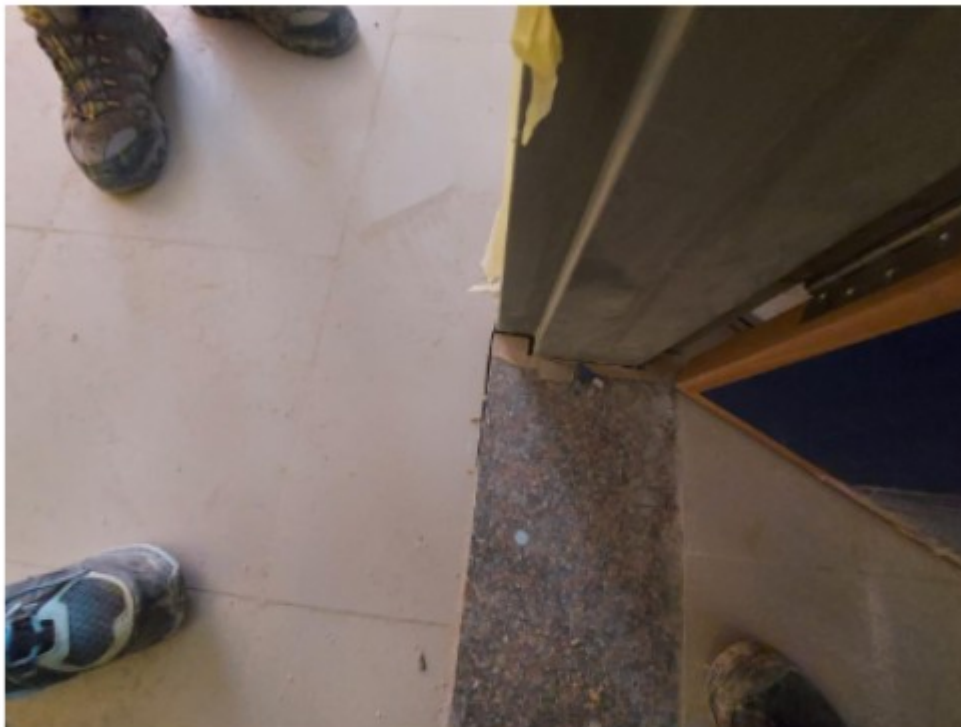
(Figure: 23)

The team inspected the granite thresholds at the wooden doors and requested the Contractor to rectify a number of those thresholds not well installed

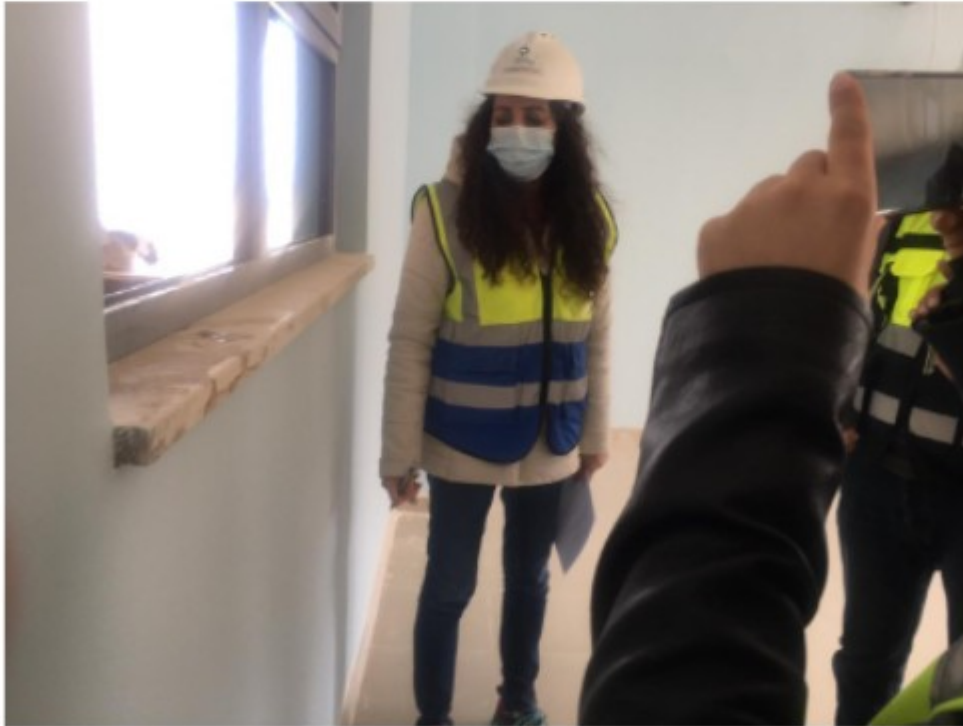
(Figure: 26)

The team inspected the installed window sills and requested the Contractor to rectify the defects and to replace the broken pieces before paint finish at the related areas

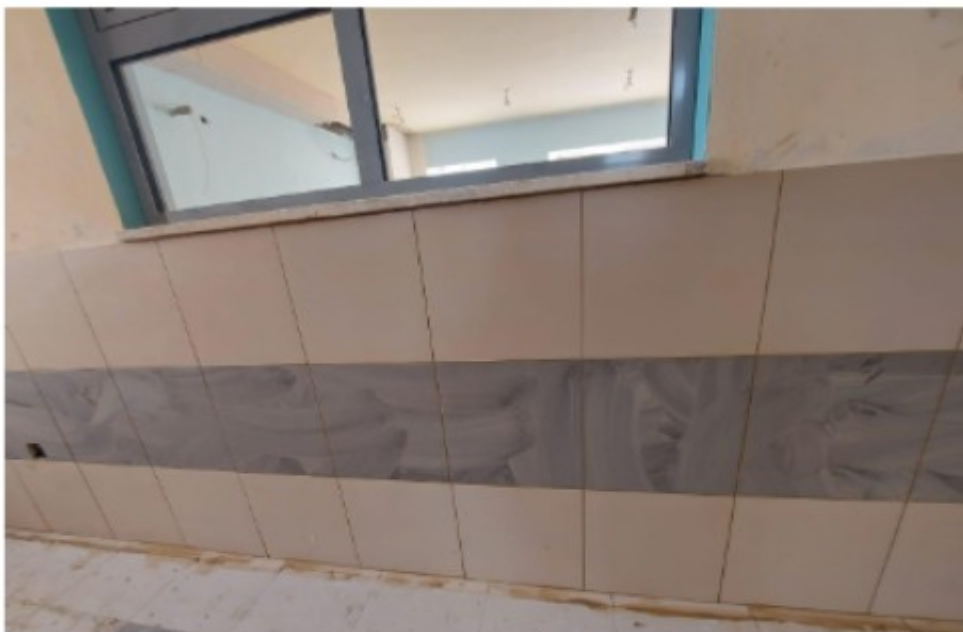
(Figure: 27)

The team observed that the levels of window sills in the corridor are not compatible and need to be checked and rectified

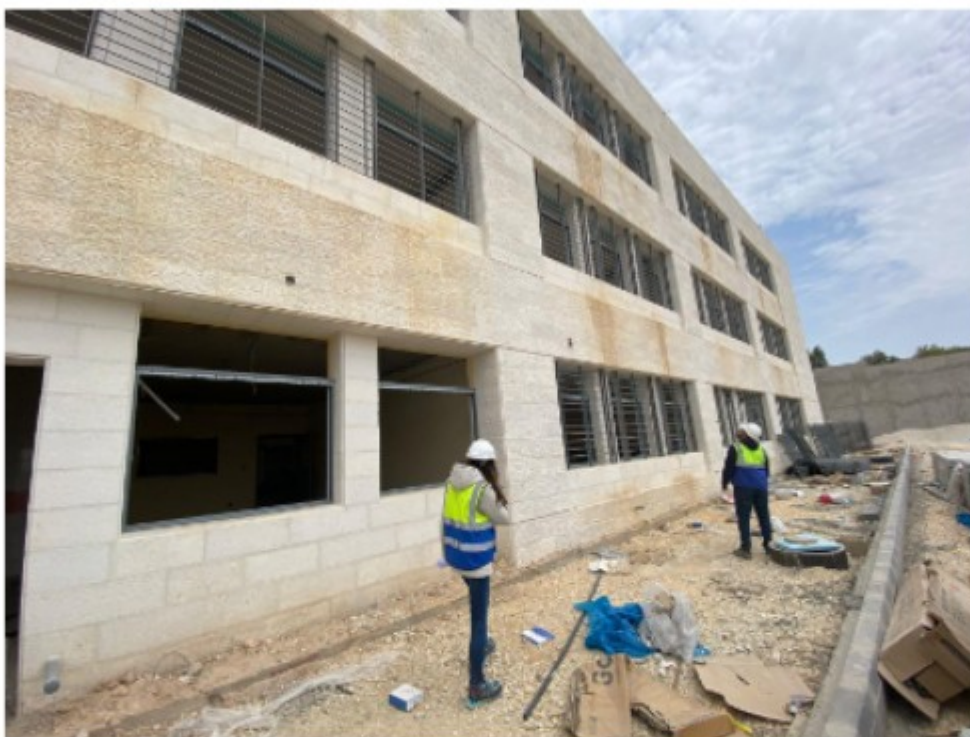
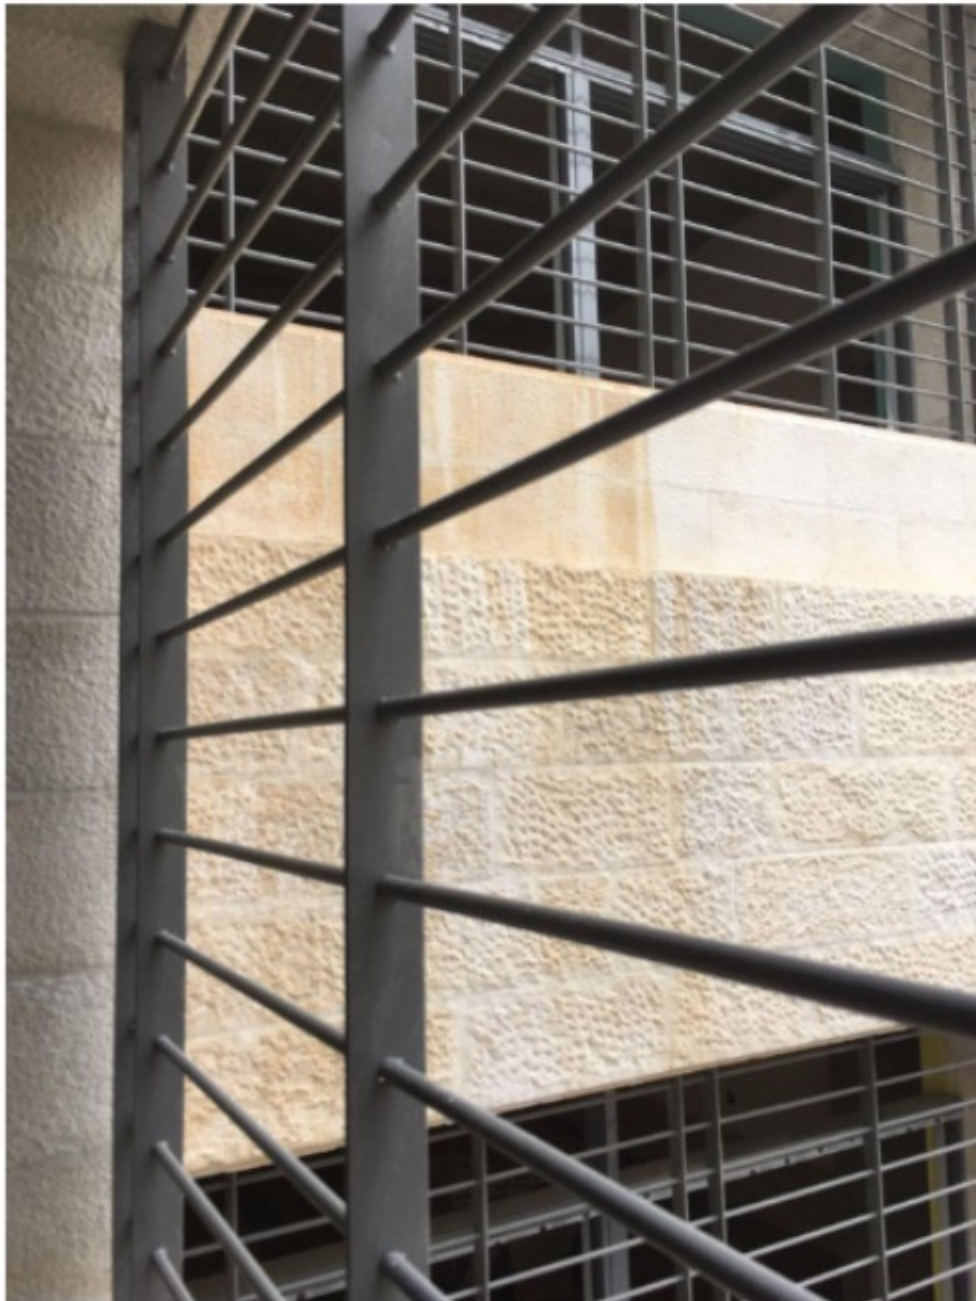
(Figure: 05 & 06)

The team observed that due to other activities the stone facades require cleaning

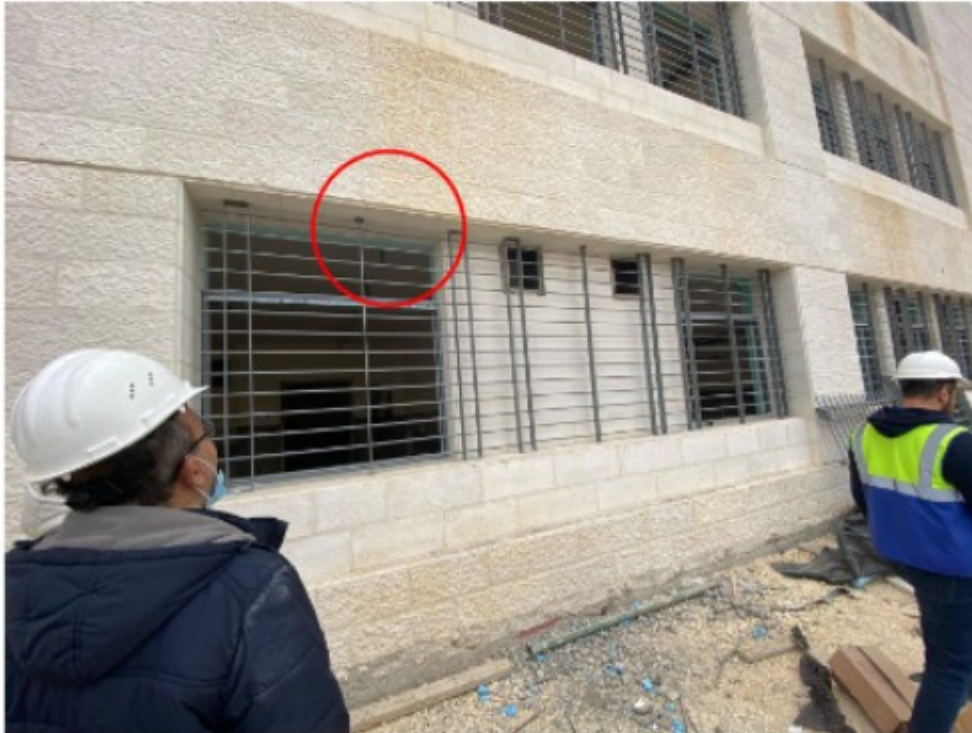
(Figure: 07)

The team observed that parts of the steel protection screens are defective in regards to the paint and to the straightness of bars which constitute the screens. The team stressed on the Contractor to replace those screens
