School for Knowledge Economy Project (SKEP) Phase III – Package 1

Monthly Progress Report

No. 16

March, 2022

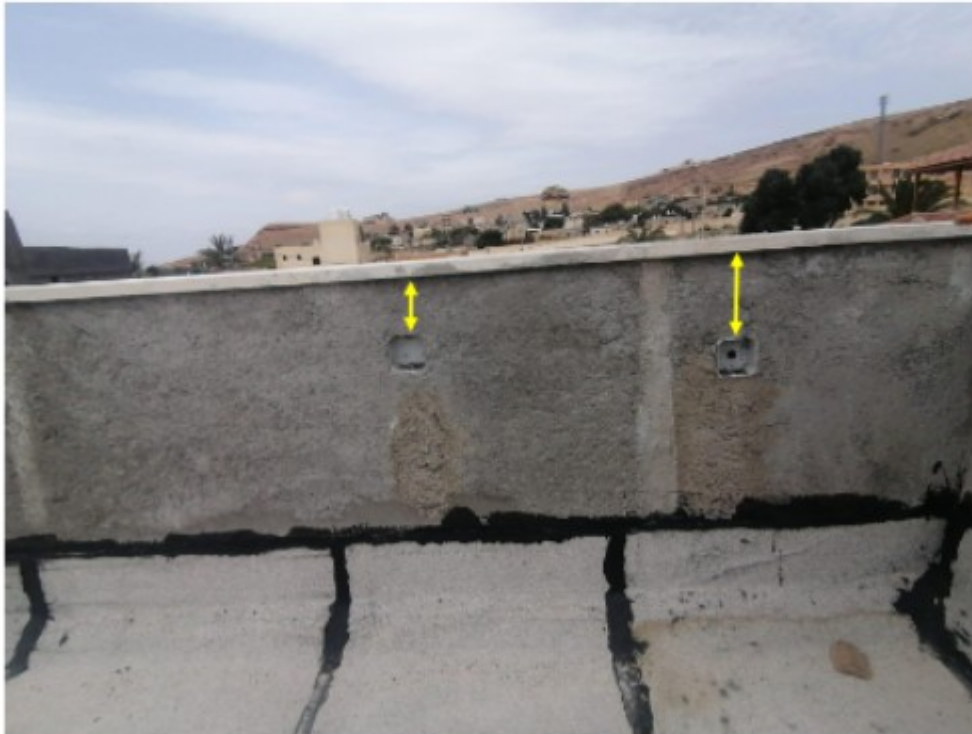
(Figure: 09)

The team observed that the electrical outlets at the parapet are not in line

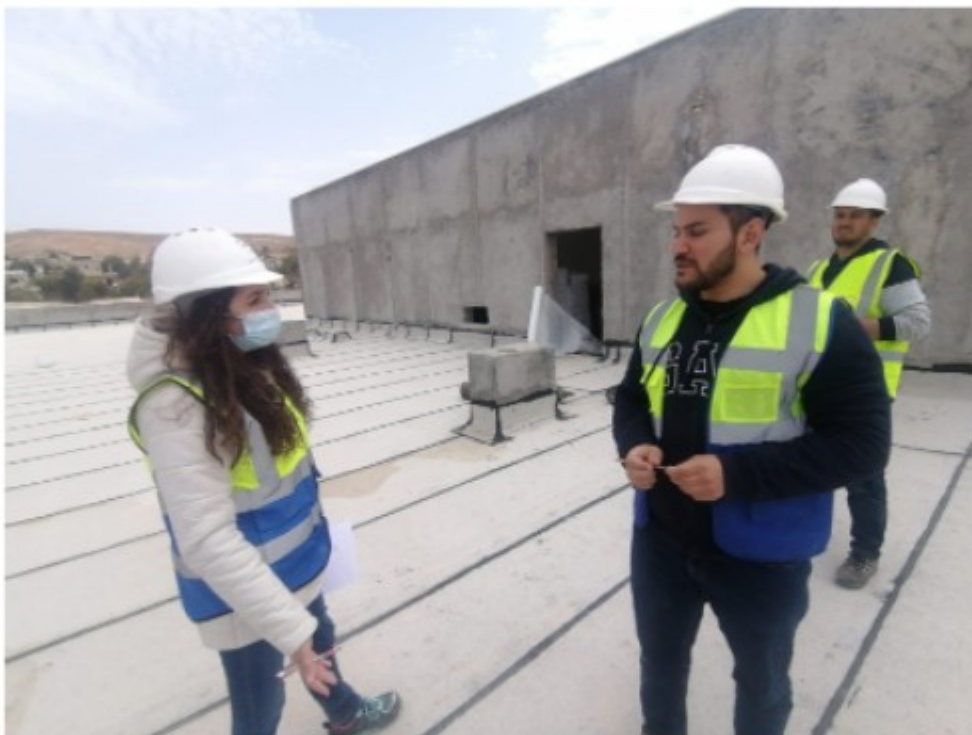
(Figure: 10)

The team inspected the sheet waterproofing executed at the roof and observed defects related to air voids under the sheets which is considered as poor execution that should be rectified

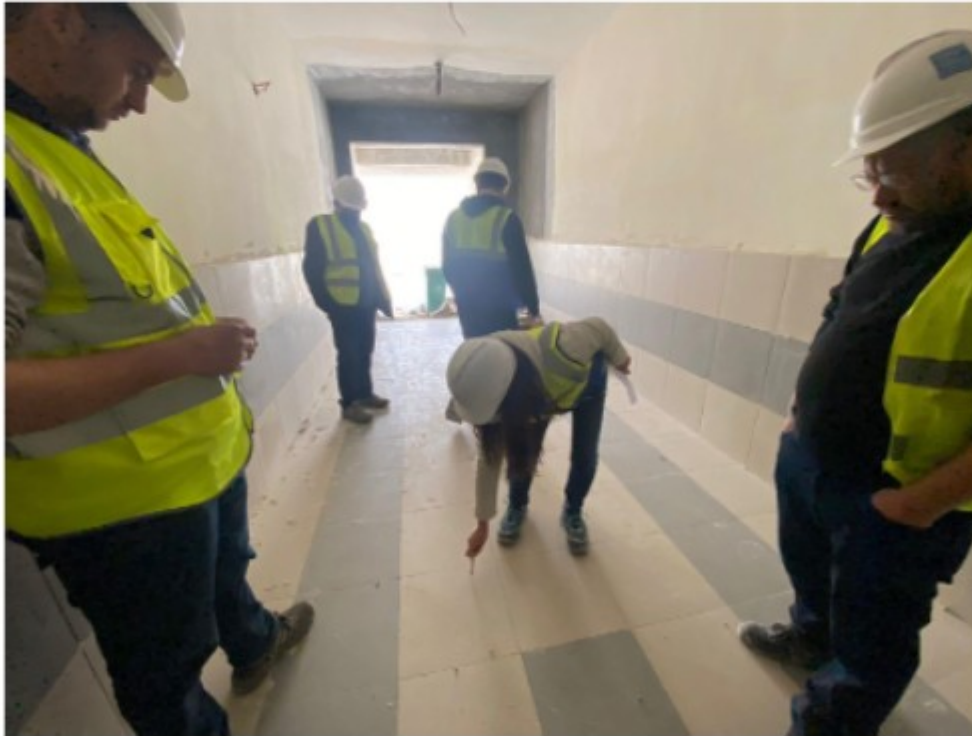
(Figure: 11)

The team observed teething of executed porcelain floor tiles in some parts and requested the Contractor to rectify

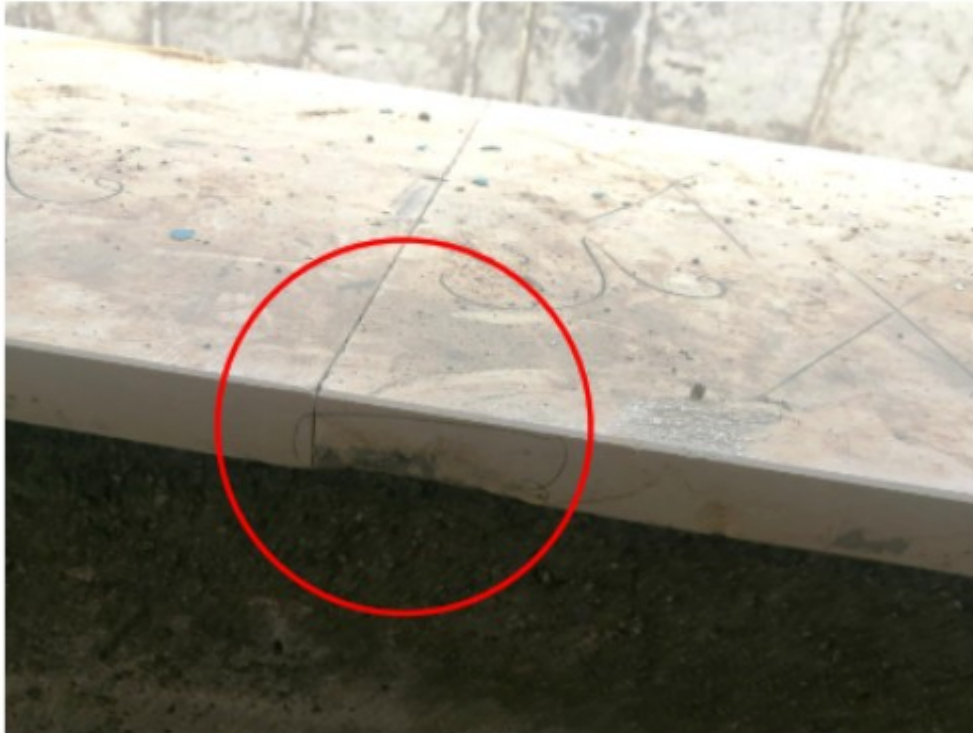
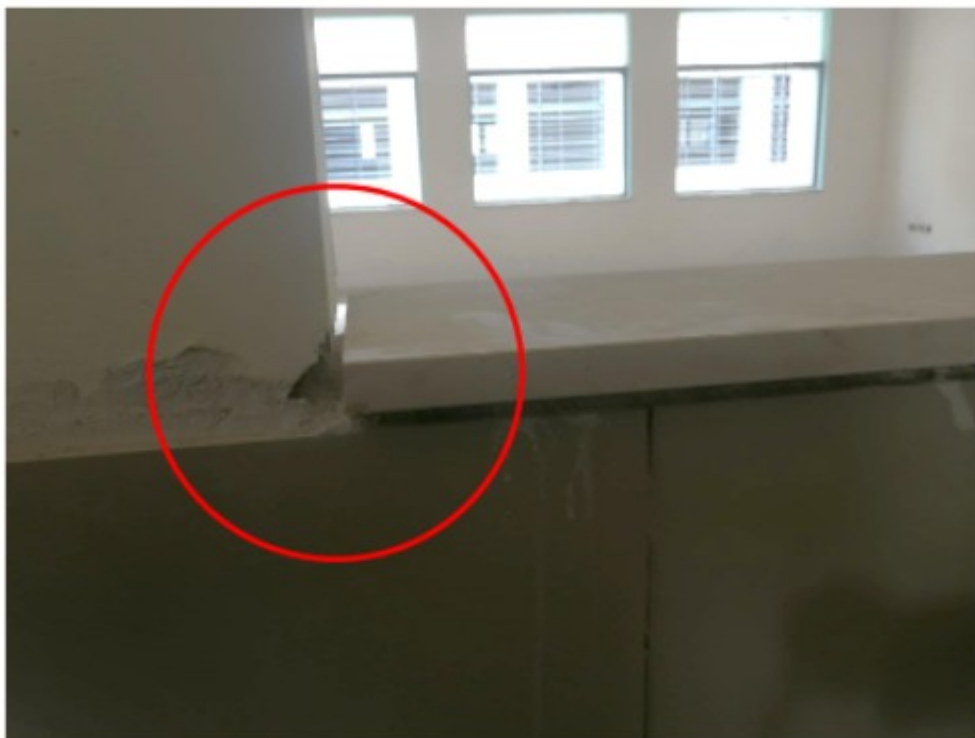
The team observed a number of broken window sills and shortage in length. The Contractor was requested to replace (Figure: 13 & 14)

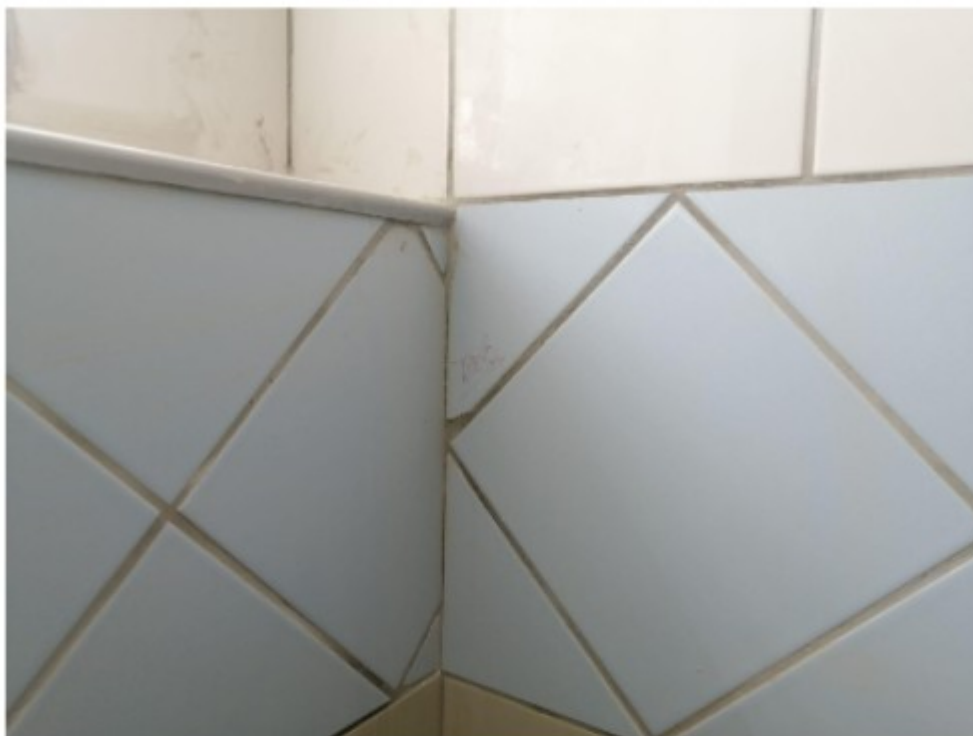
The team inspected the tile work at the wet areas and observed the following remarks:

- Broken tiles
- Repairs in the grouting are needed

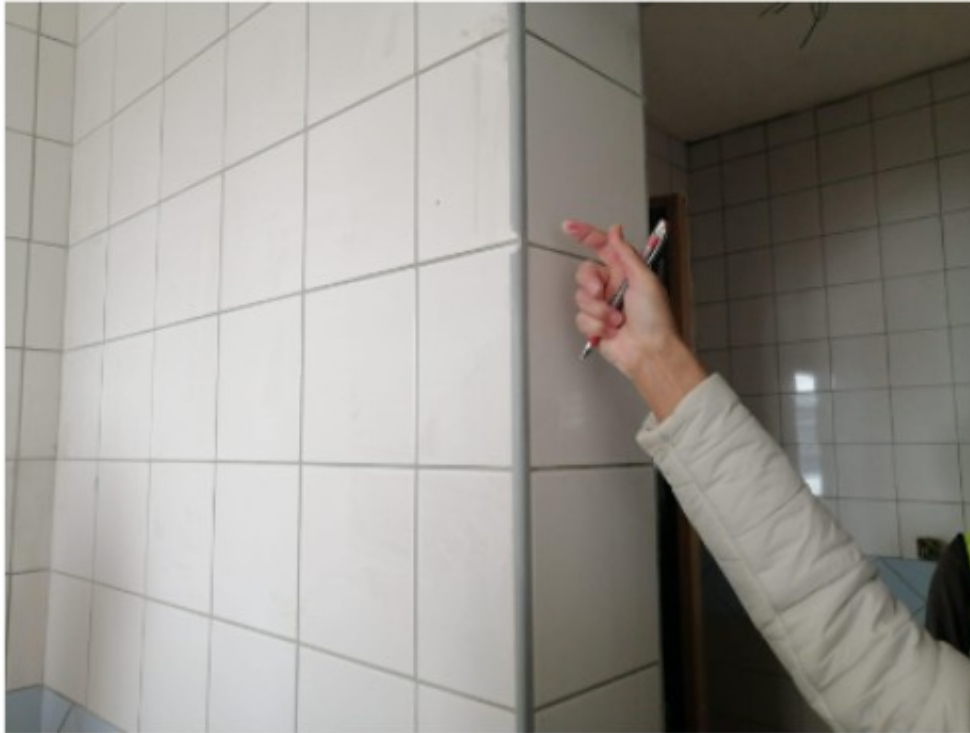
(Figure: 17)

- Broken beads

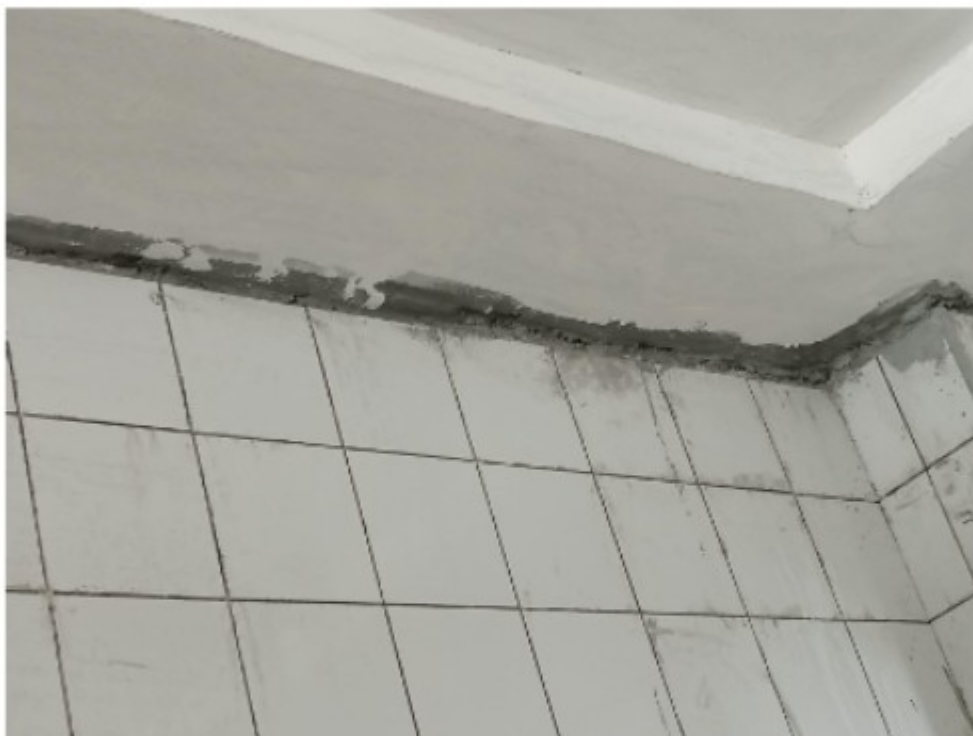
(Figure: 18)

- The plastering for ceiling to be checked to ensure compatibility with the top layer of wall tiles. Gypsum board might be used to remove the defect

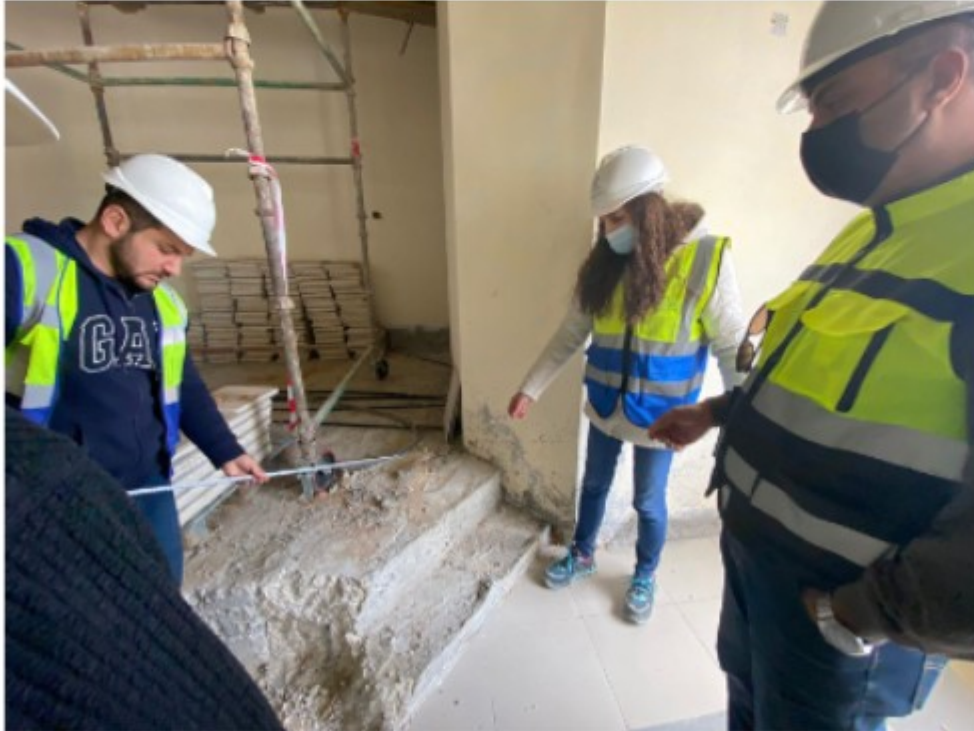
(Figure: 19)

The team observed that the Contractor conducted the necessary repairs regarding the concrete work of the stage and stairs at the multi-purpose hall to comply with the drawings

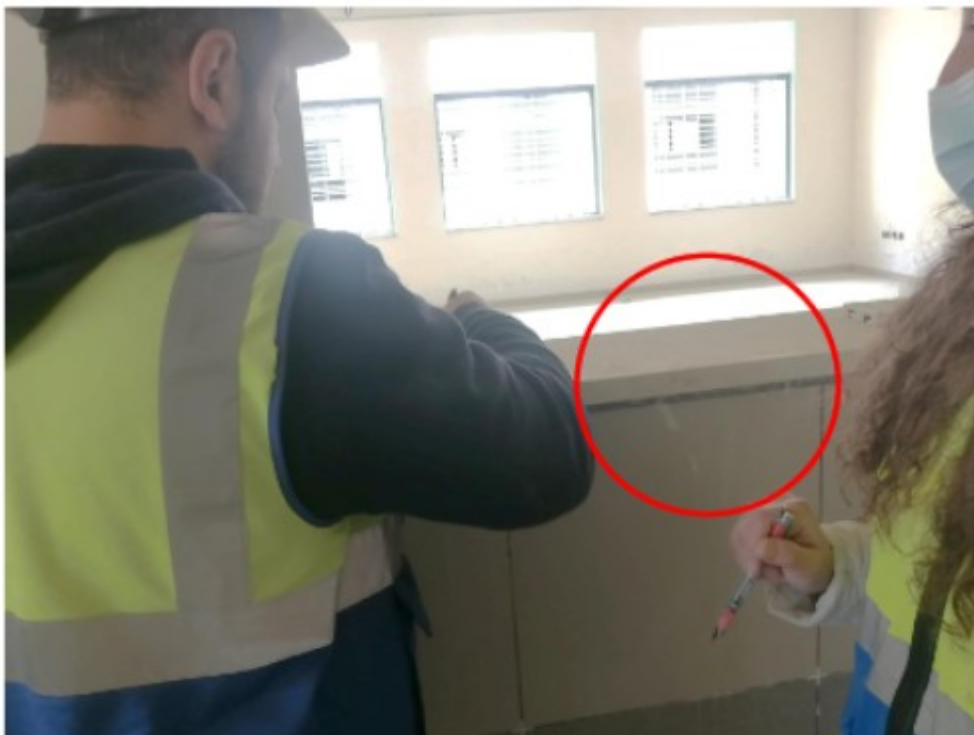
(Figure: 20)

The team observed that the levels of window sills in the corridor are not compatible and need to be checked and rectified

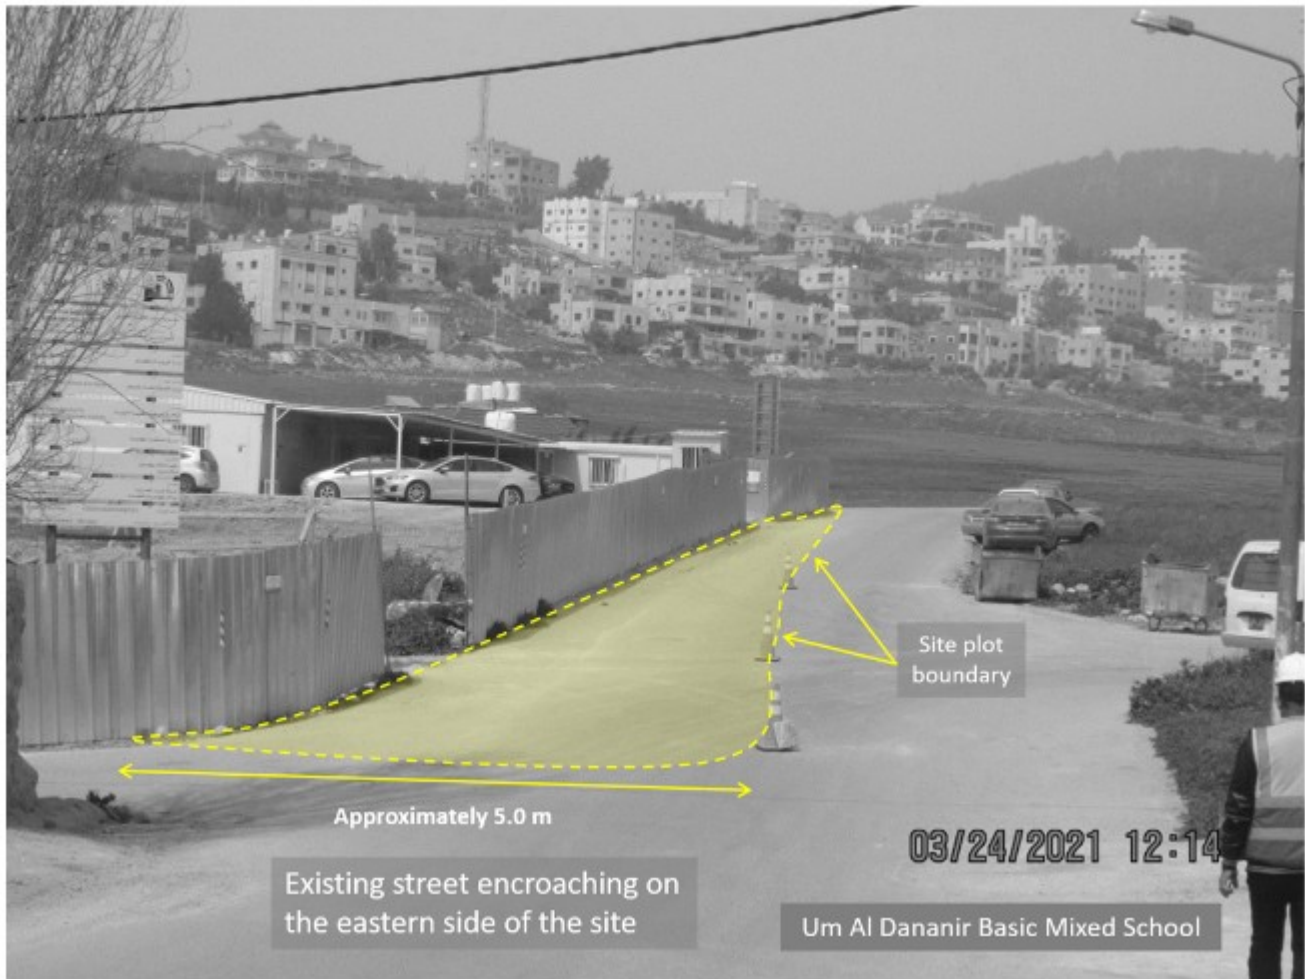
Figure 2. There is an encroachment of the existing street toward the site and this will affect the construction of the eastern boundary wall
