Consultant	Wahib Medanat Consultant Engineer	Rep No.	21-06032022
Contractor	Dijlah Establishment Constr. Contracting	Tender No.	(11/2019/USAID/SKEP/3/S) Schools for a Knowledge Economy Project (SKEP) - Phase (3) Package (1, 2)
Site Name	Hay Al Iskan Basic Mixed School- Jerash	Day/ Date	Sun. 06/03/2022
Duration of Project	450 Calendar Days	Total Project Budget	8,314,983.735 JD

Visit Notes

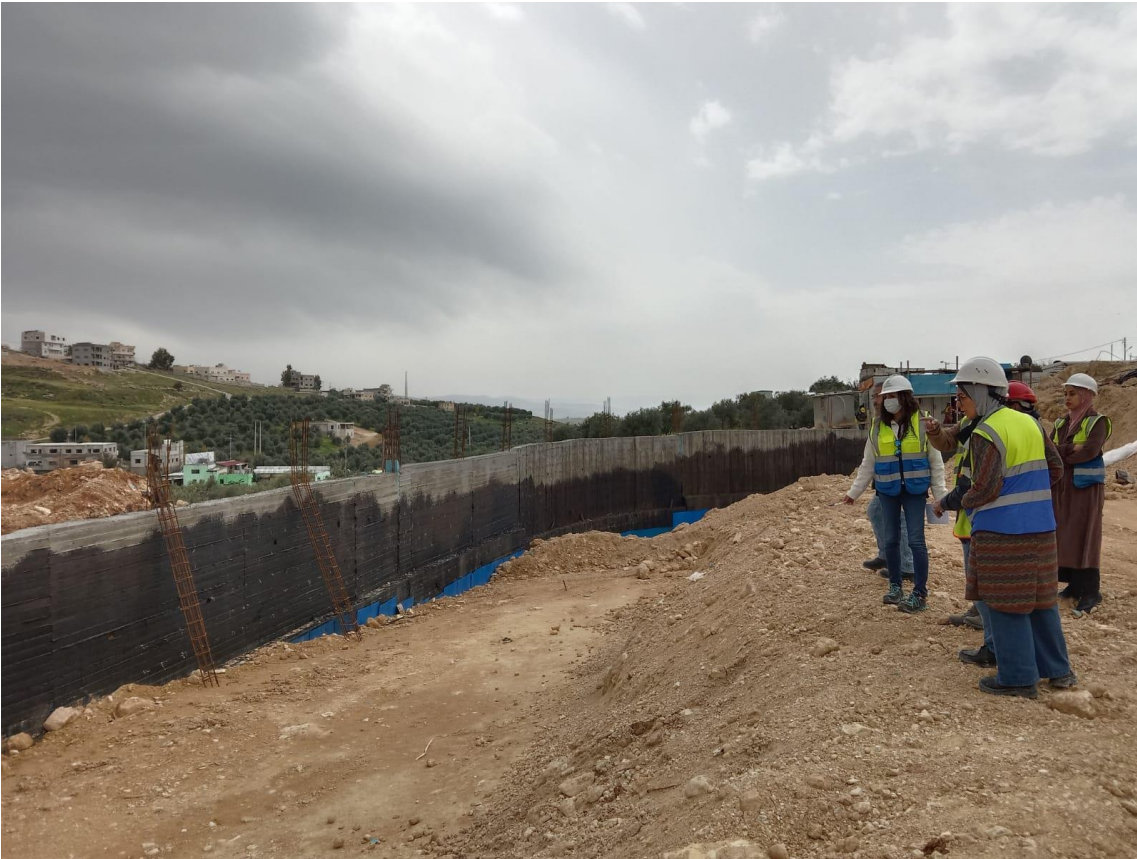
(Figure: 05)

The team inspected the work in the external walls, the waterproofing for the walls and the backfilling. The team stressed on the Contractor to replace the defected cartonal boards and install them well before the backfilling work

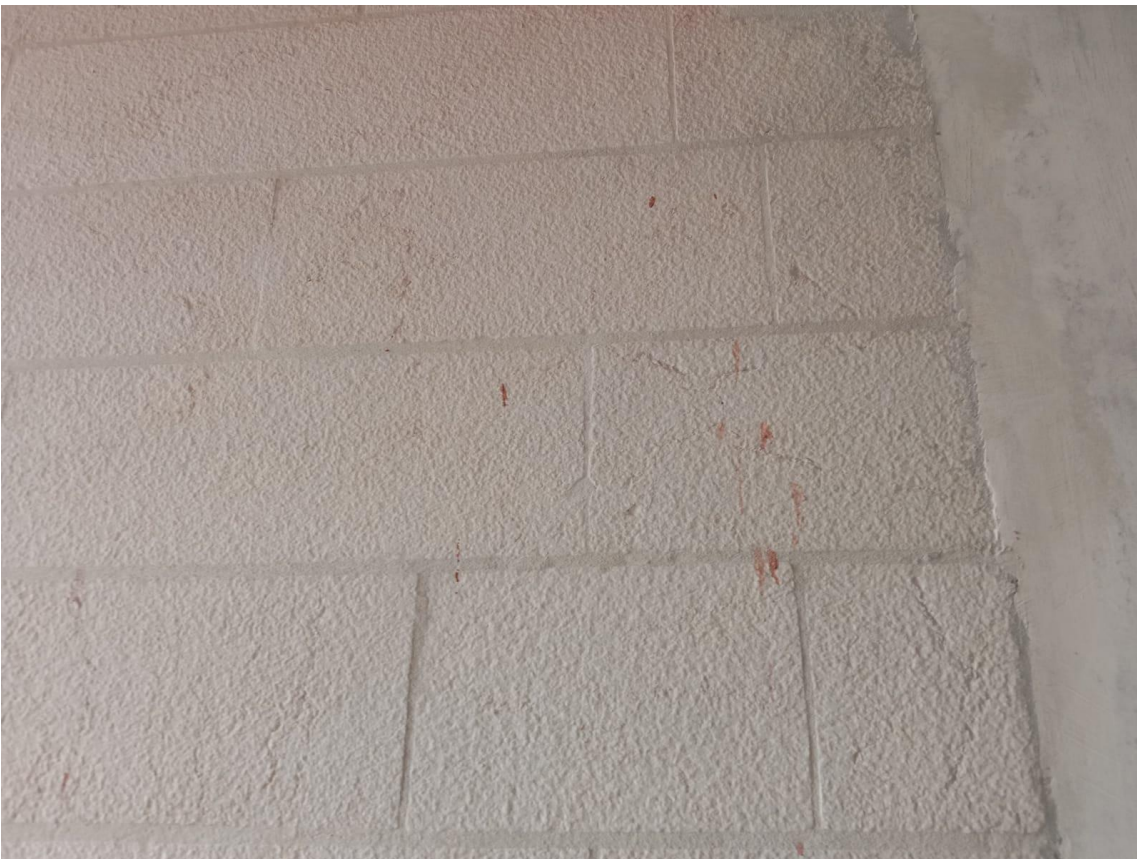
(Figure: 06)

The team observed defects in the built stones at the entrance of the building and stressed on the Contractor to rectify

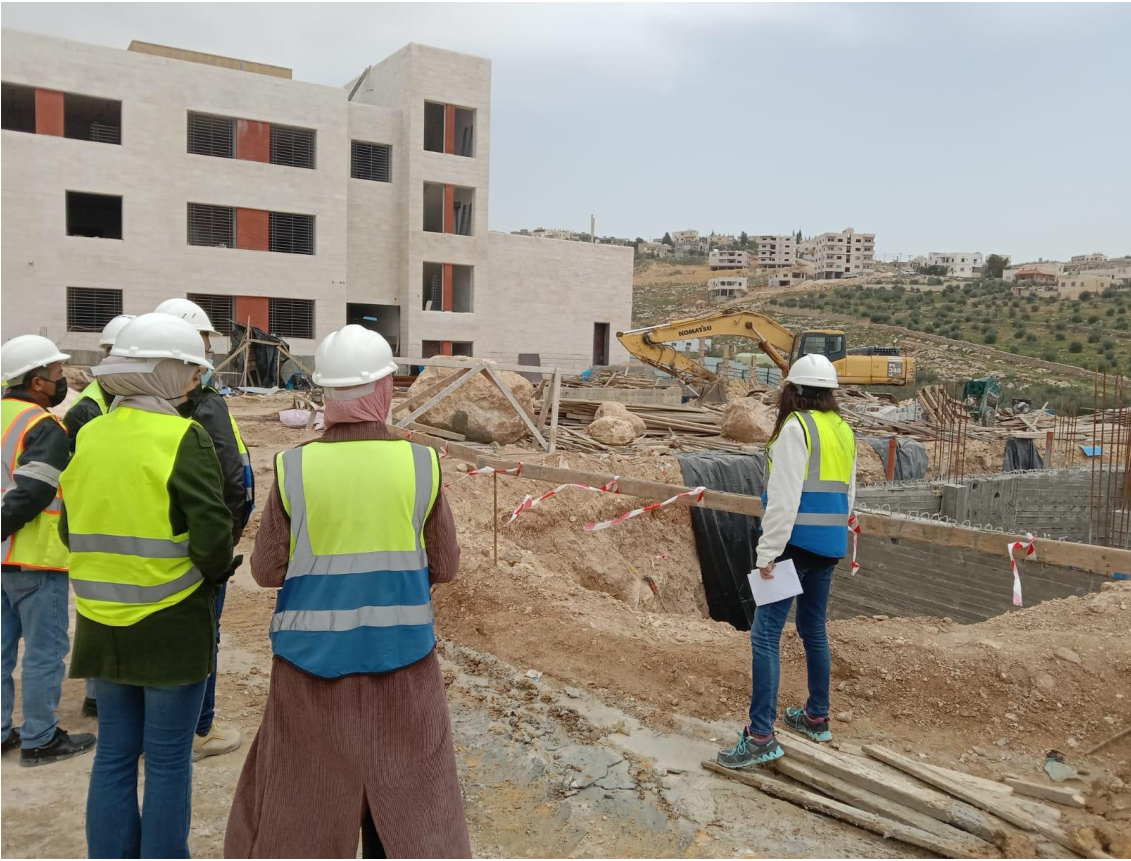
(Figure: 09)

Inspecting the structural work ongoing for the guard room and main gate

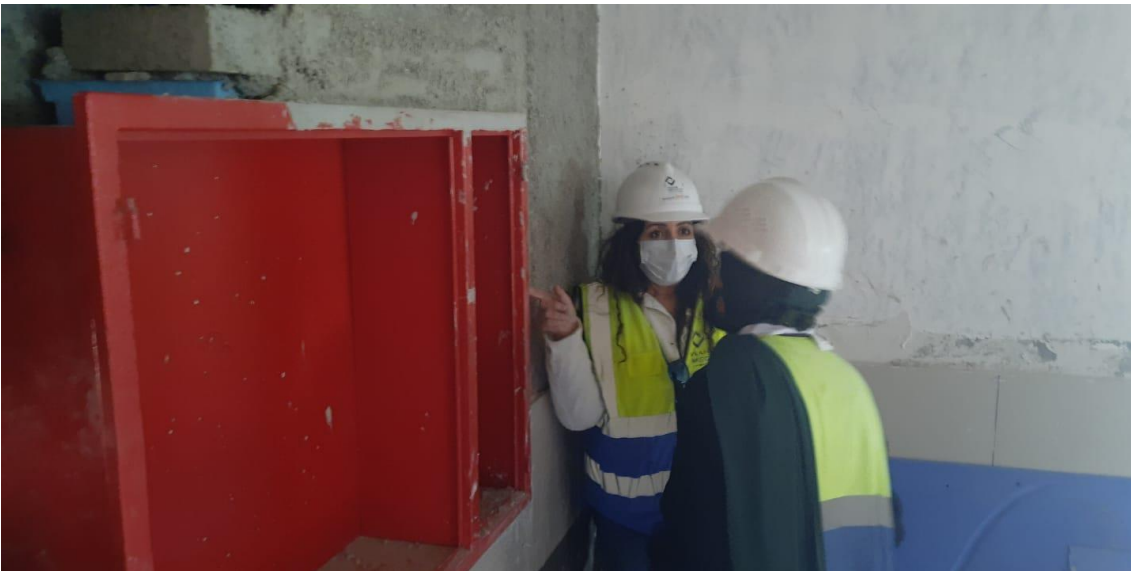
(Figure: 10)

The Supervision team observed defects in the installation of the fire hose cabinets:

- Leveling.

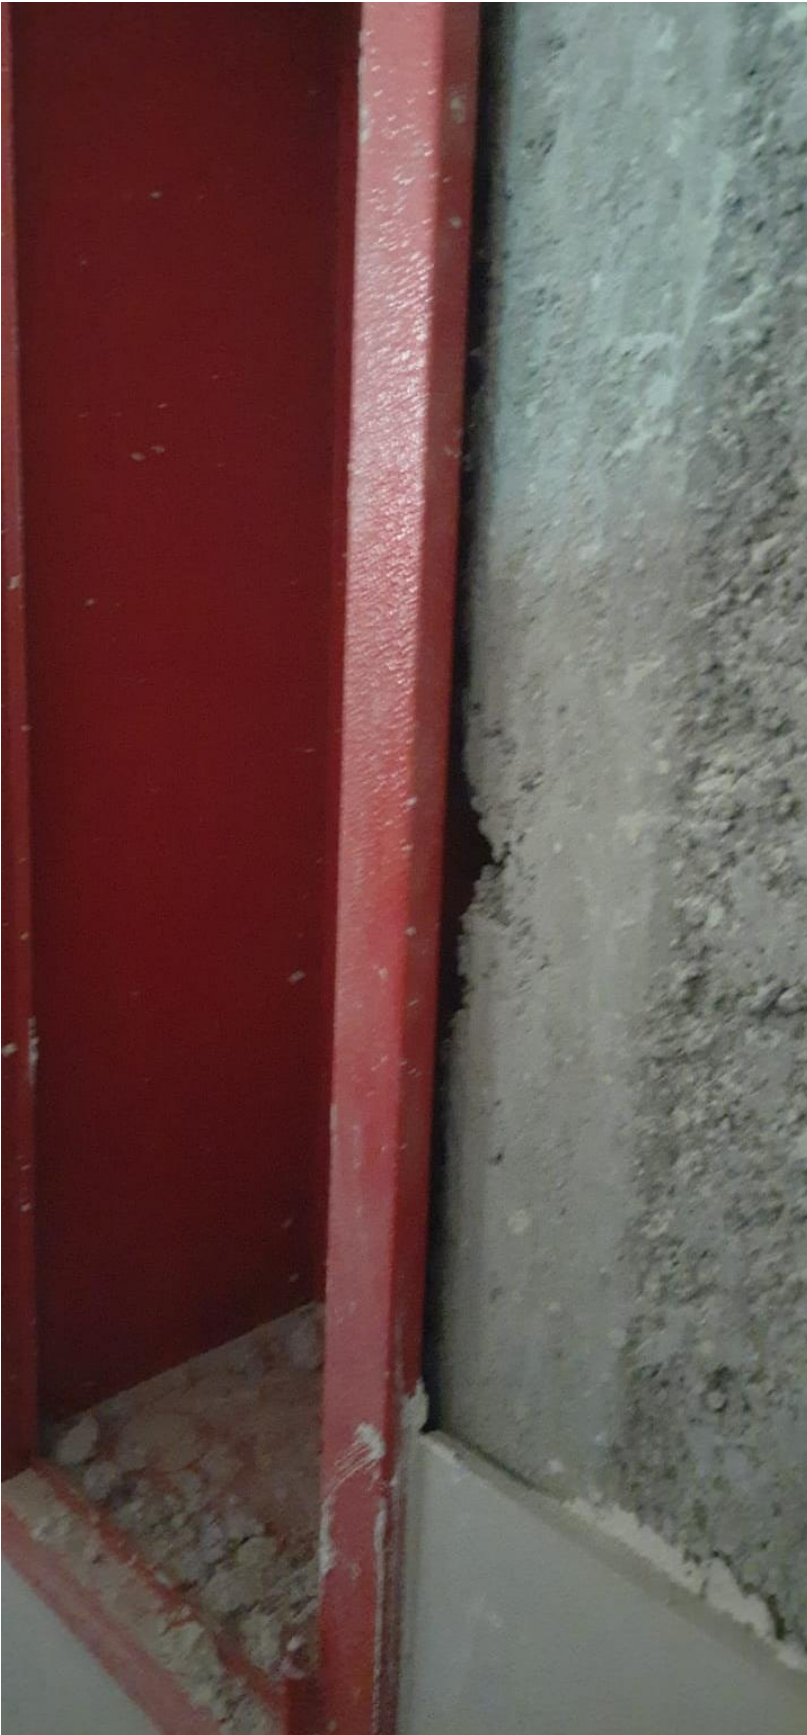
(Figure: 11)

- Large gap between the cabinet frame and the wall

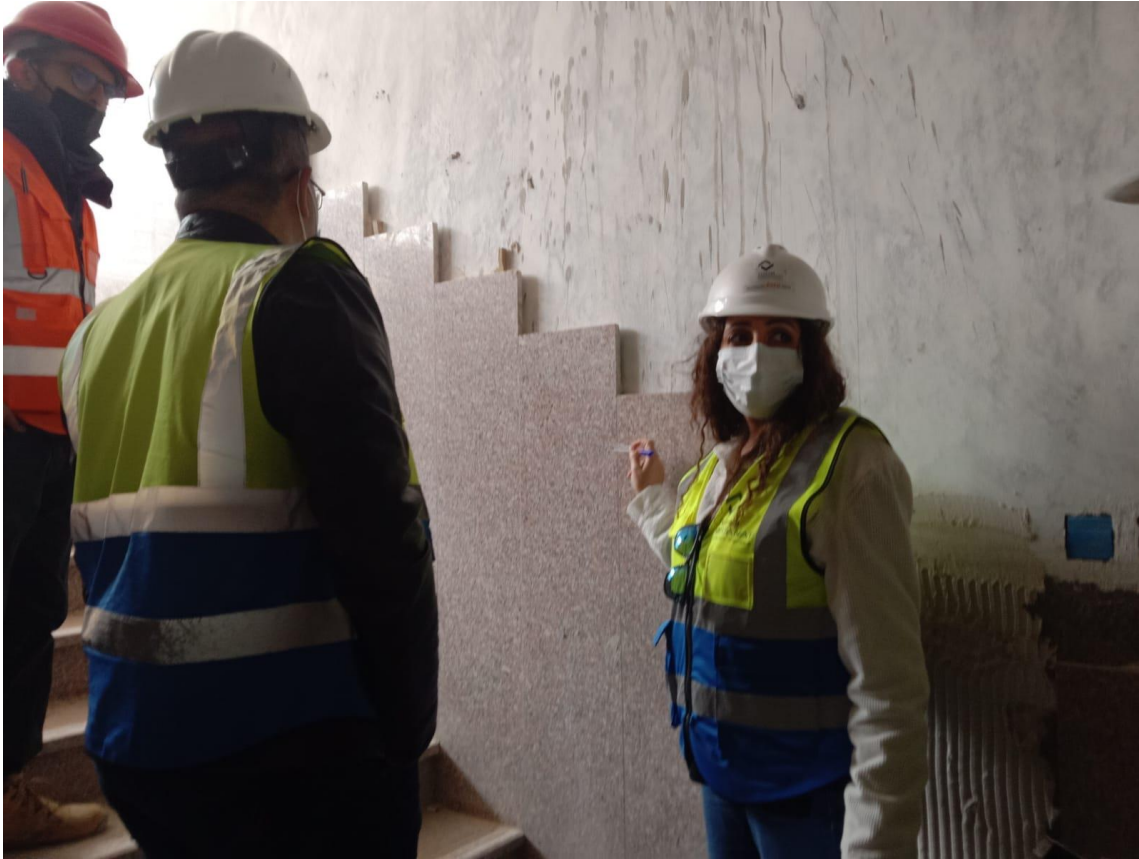
(Figure: 12)

The team observed unacceptable granite cladding and skirting for staircases and stressed on the Contactor to rectify all defects due to wrong cutting of granite pieces

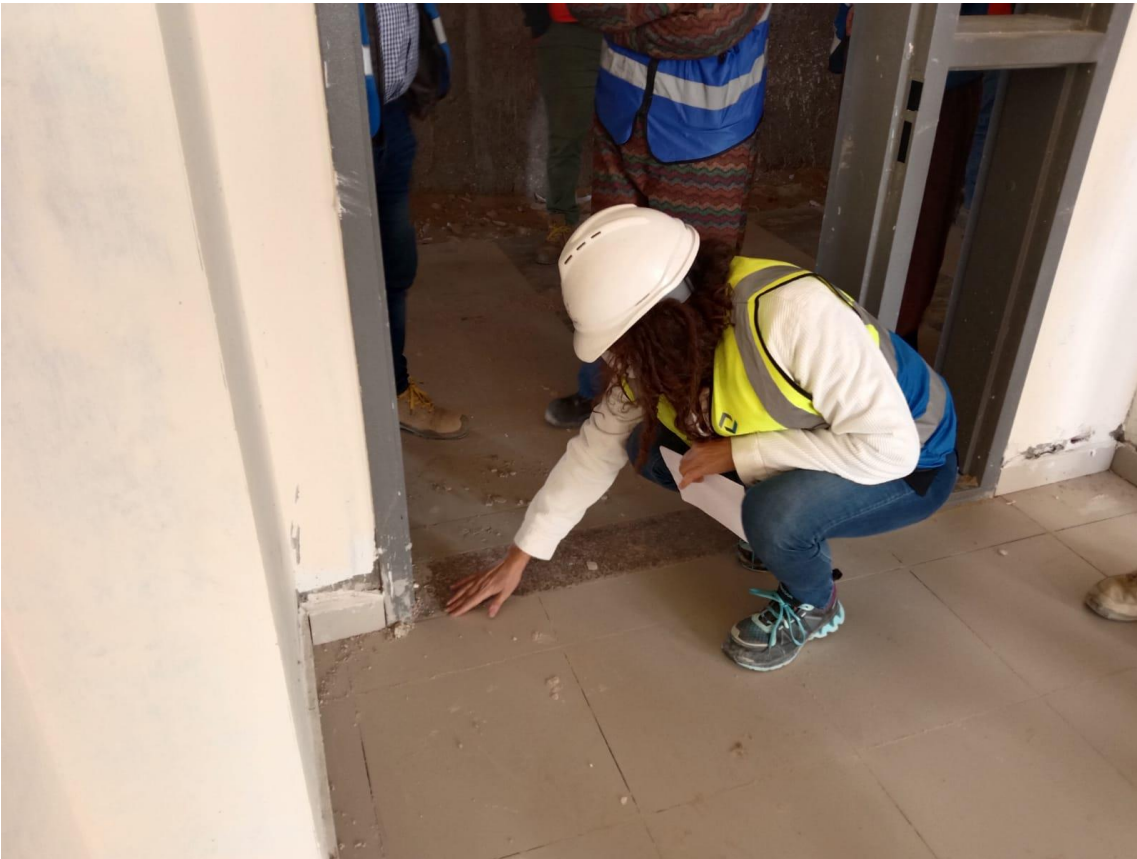
(Figure: 15)

The team observed a number of broken and unlevelled thresholds and stressed on the Contractor to rectify

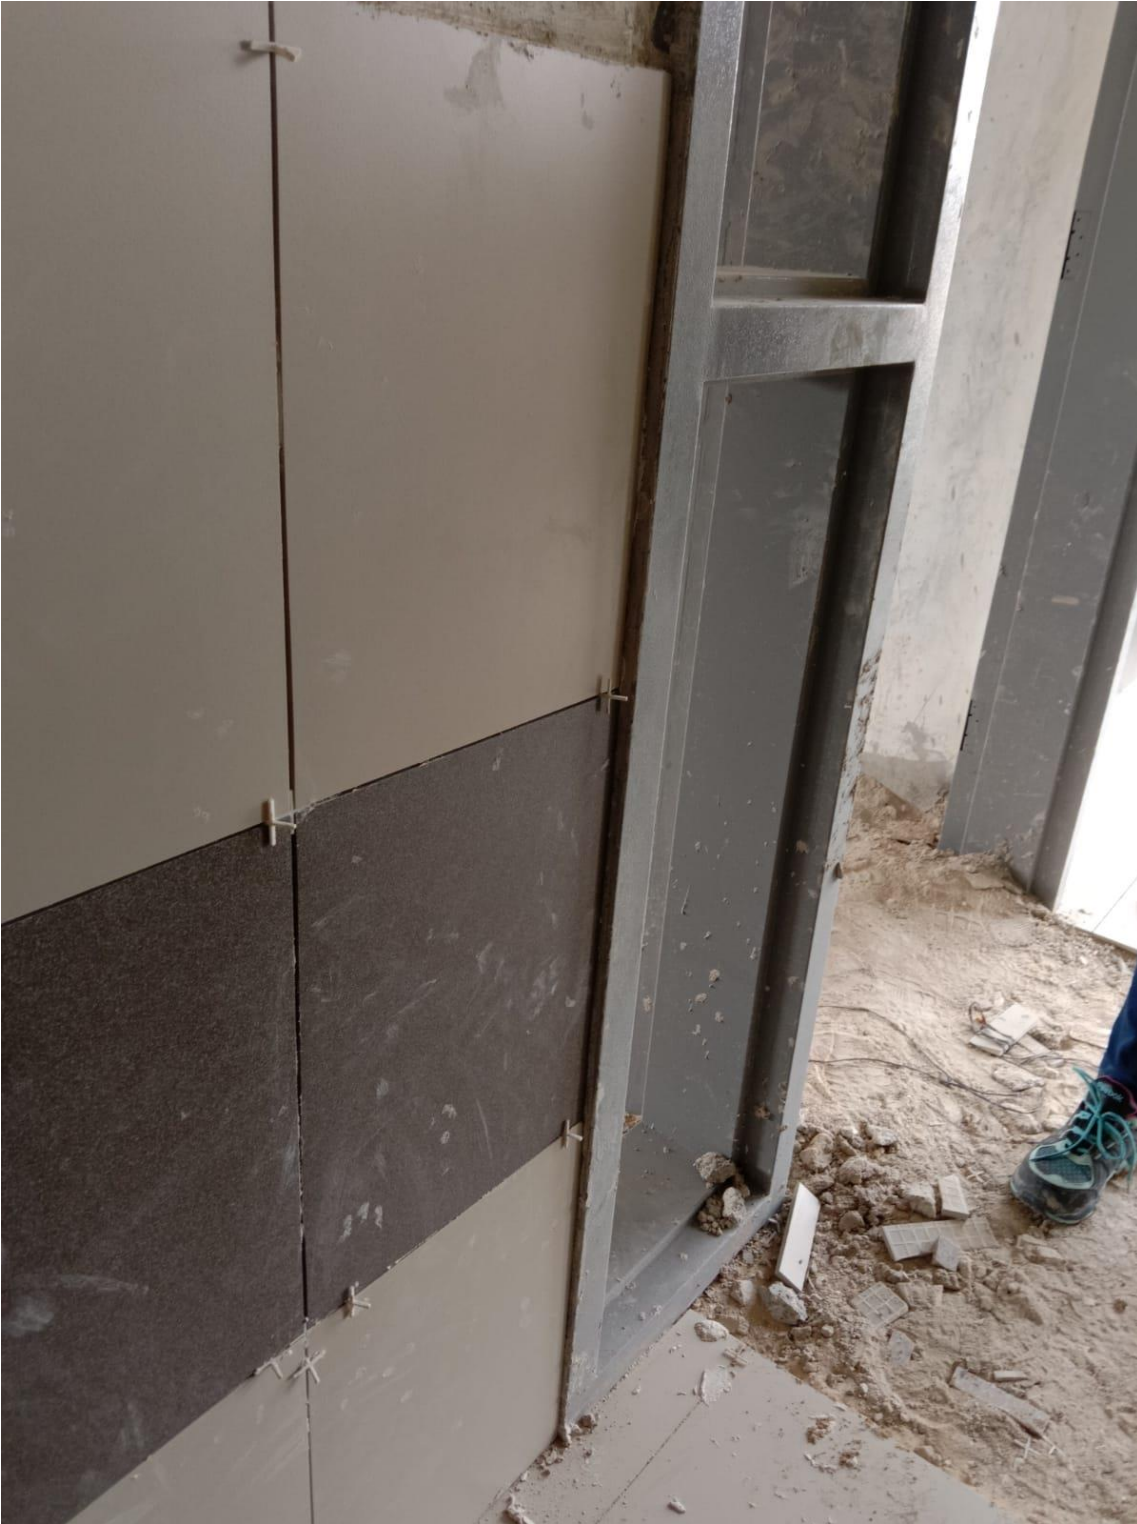
(Figure: 16)

The team observed variation in the verticality of porcelain tiles at the corridor walls. The verticality is not matching with the verticality of door frames

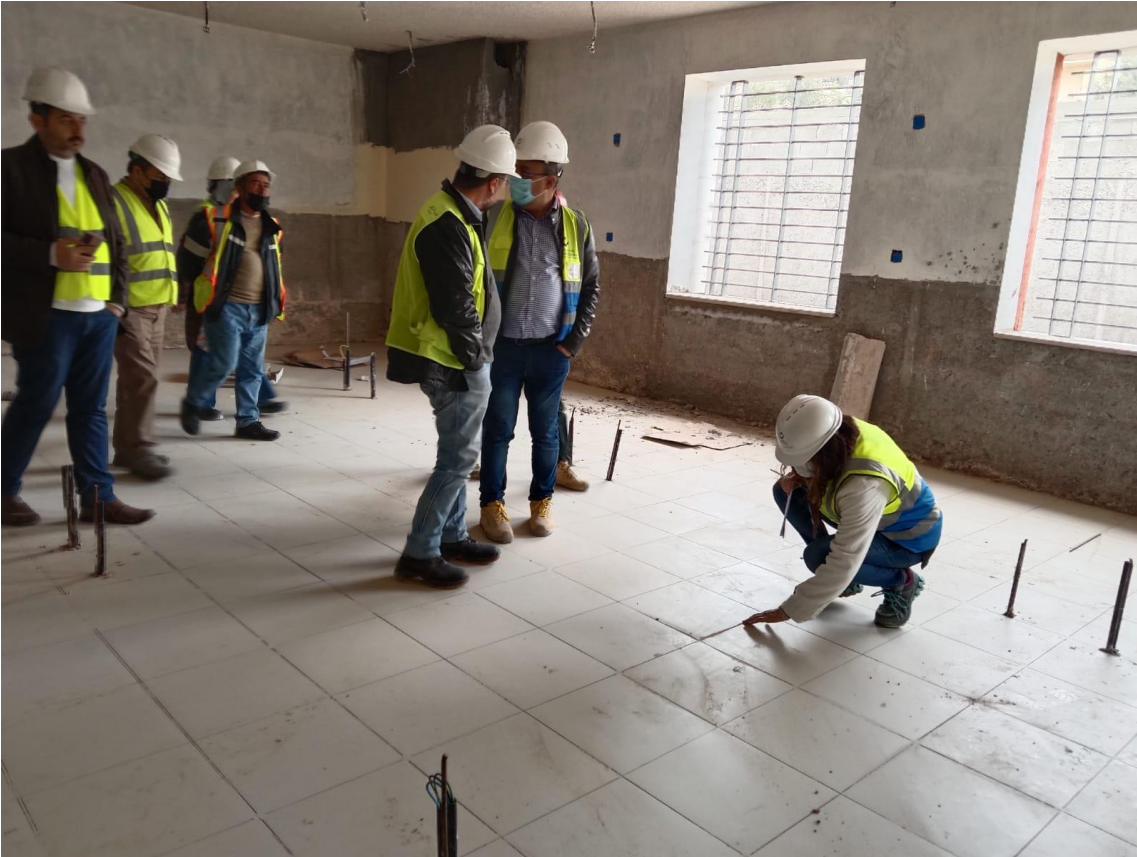
(Figure: 17)

The team observed minor teething in some parts in the porcelain floor tiles and requested the Contractor to rectify

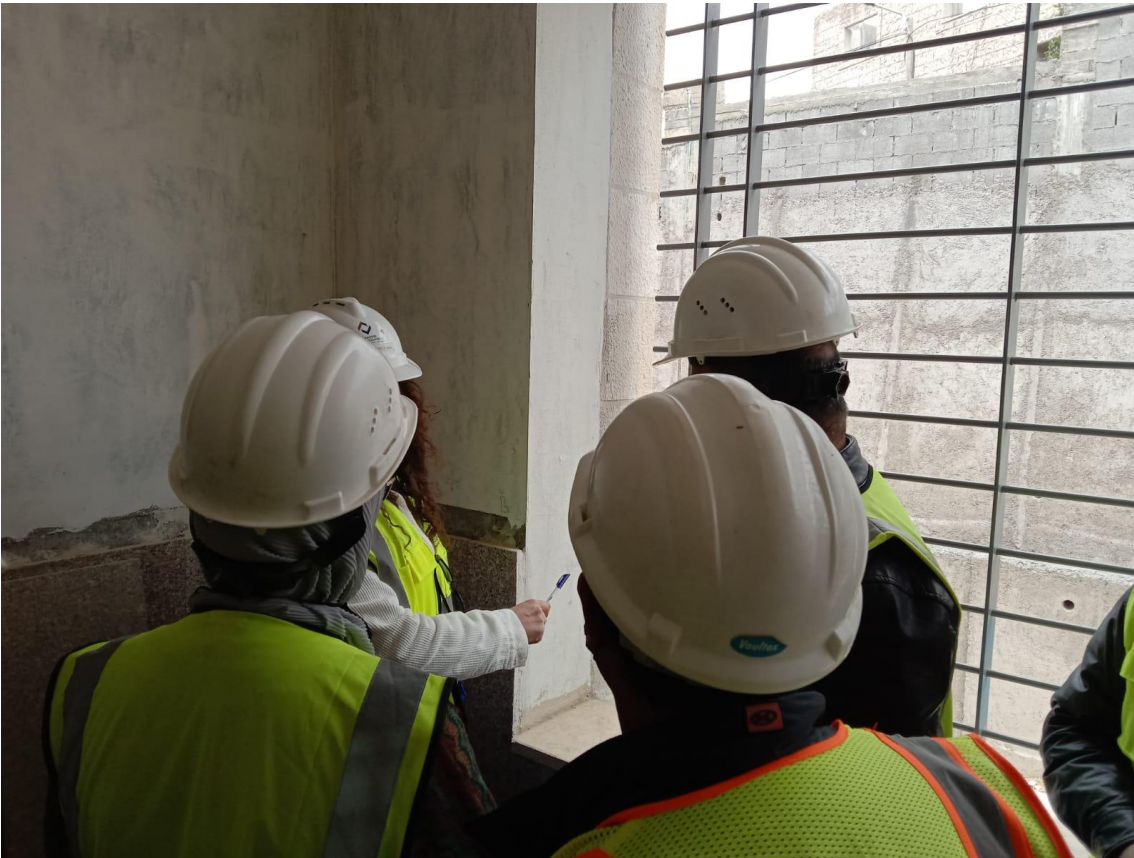
(Figure: 19)

The team discussed with the Contractor the continuation of granite to the window jambs up to the aluminum frame

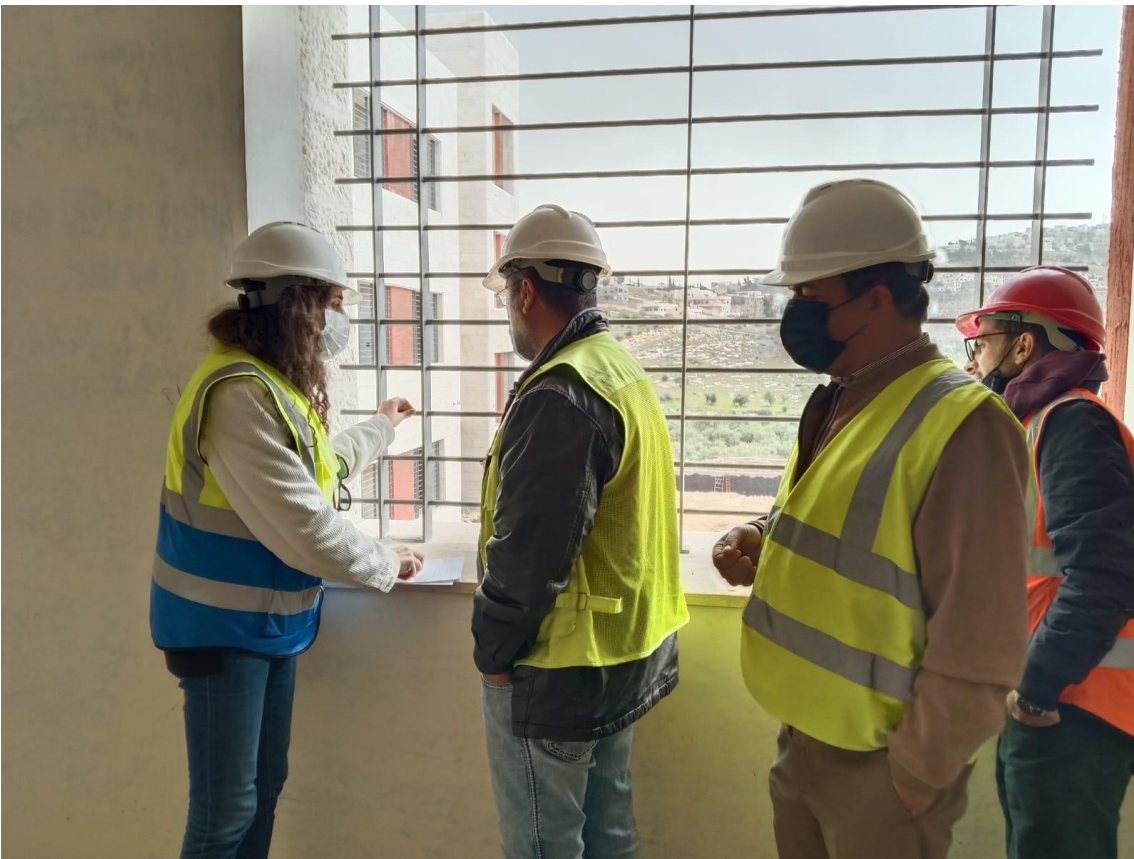
(Figure: 20)

The team inspected the fixation of the steel protection screen and observed corrosion in some parts

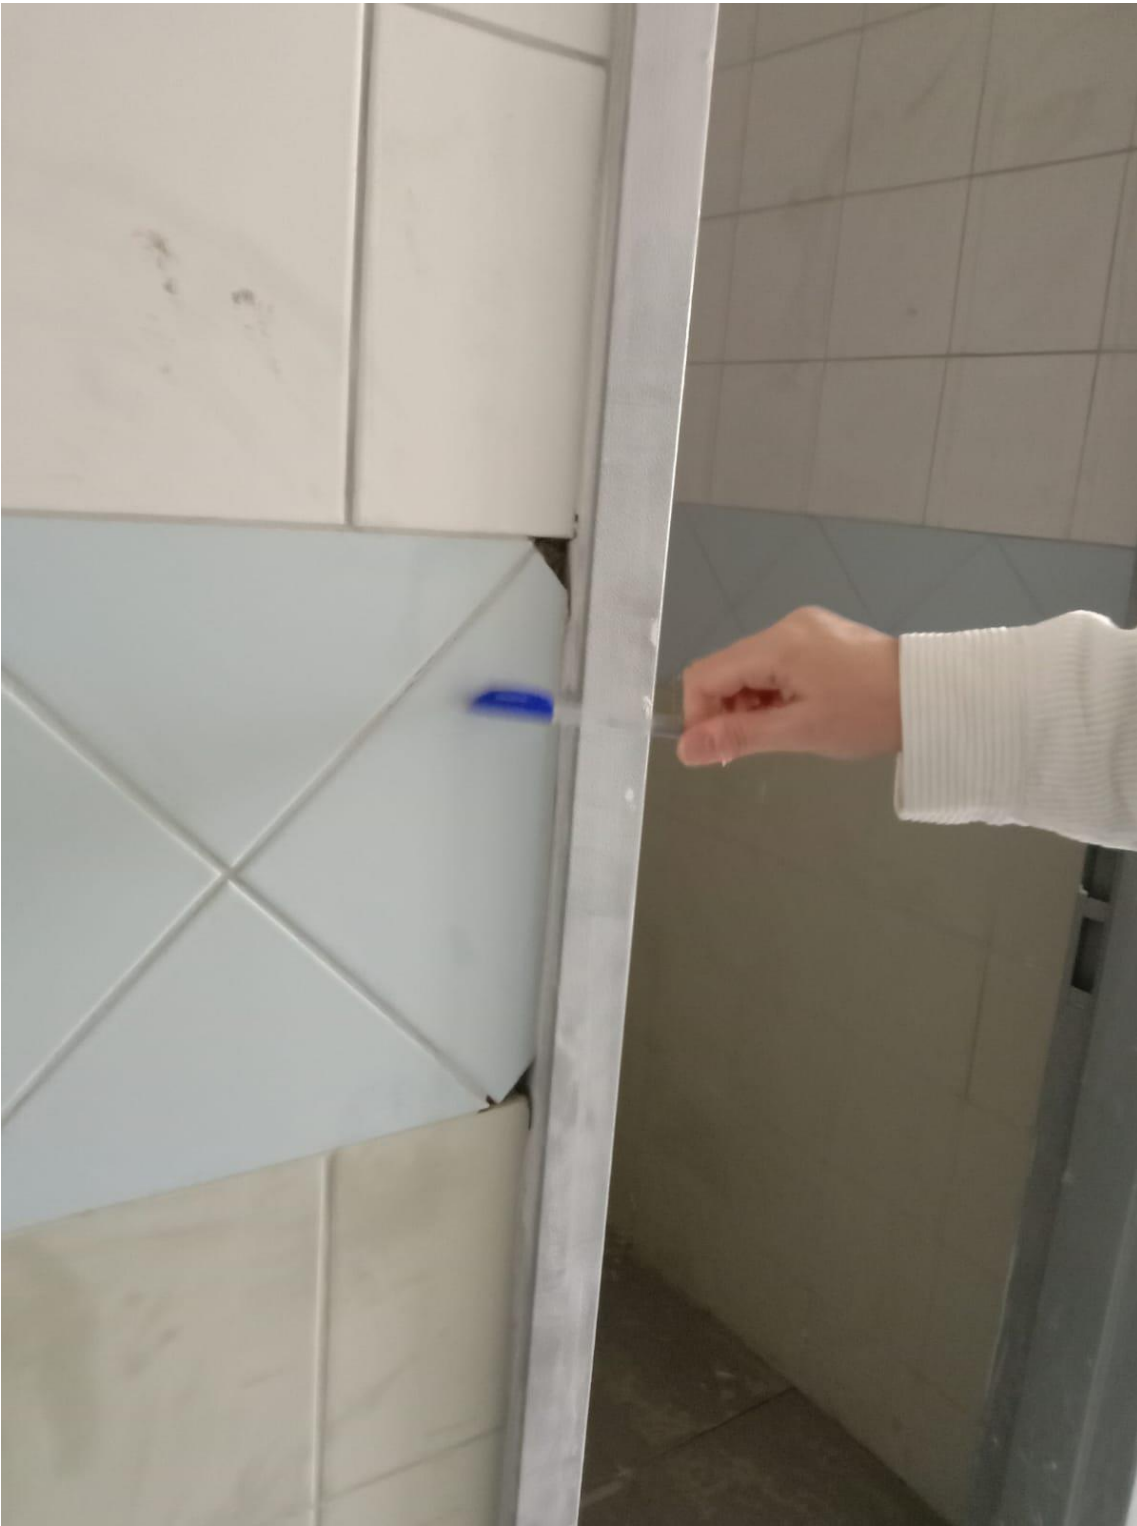
(Figure: 21)

The team inspected the wall tiling at the wet areas and observed broken tiles adjacent to the door frames

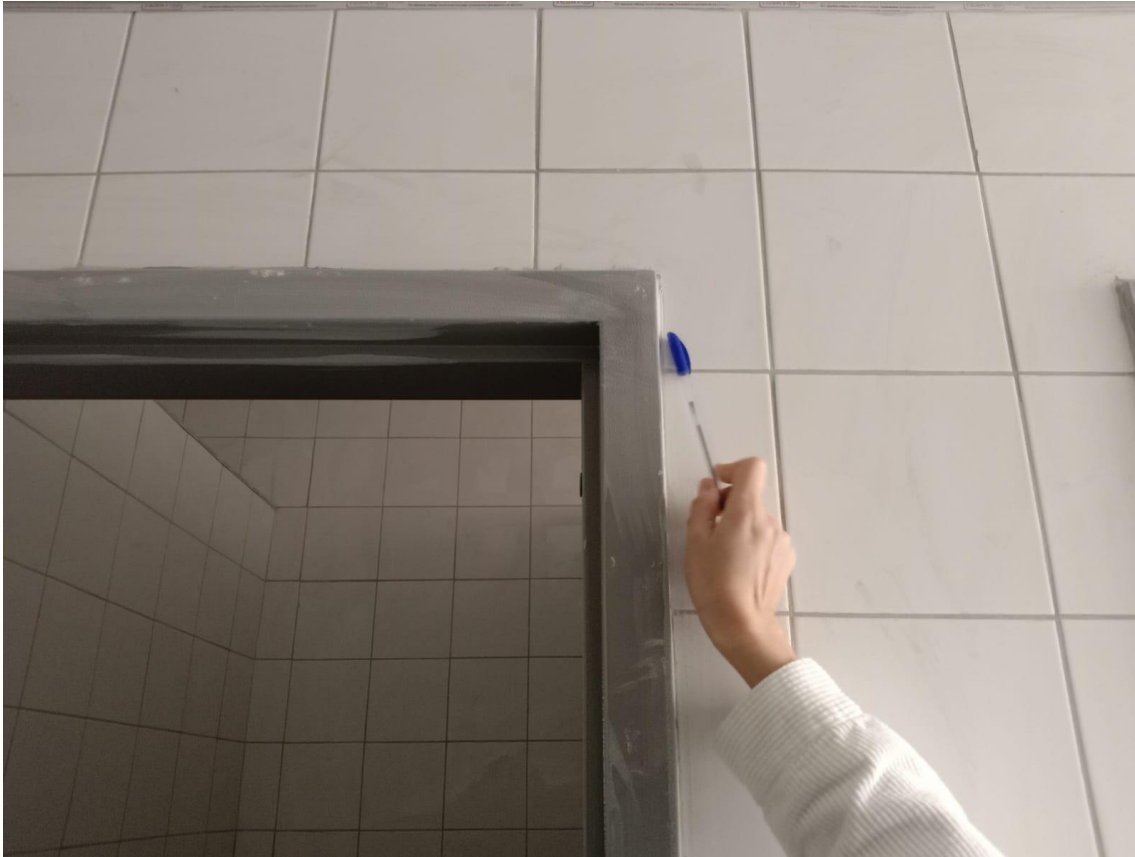
(Figure: 22)

The team observed unaccepted cutting and grouting tiles adjacent to the door frames

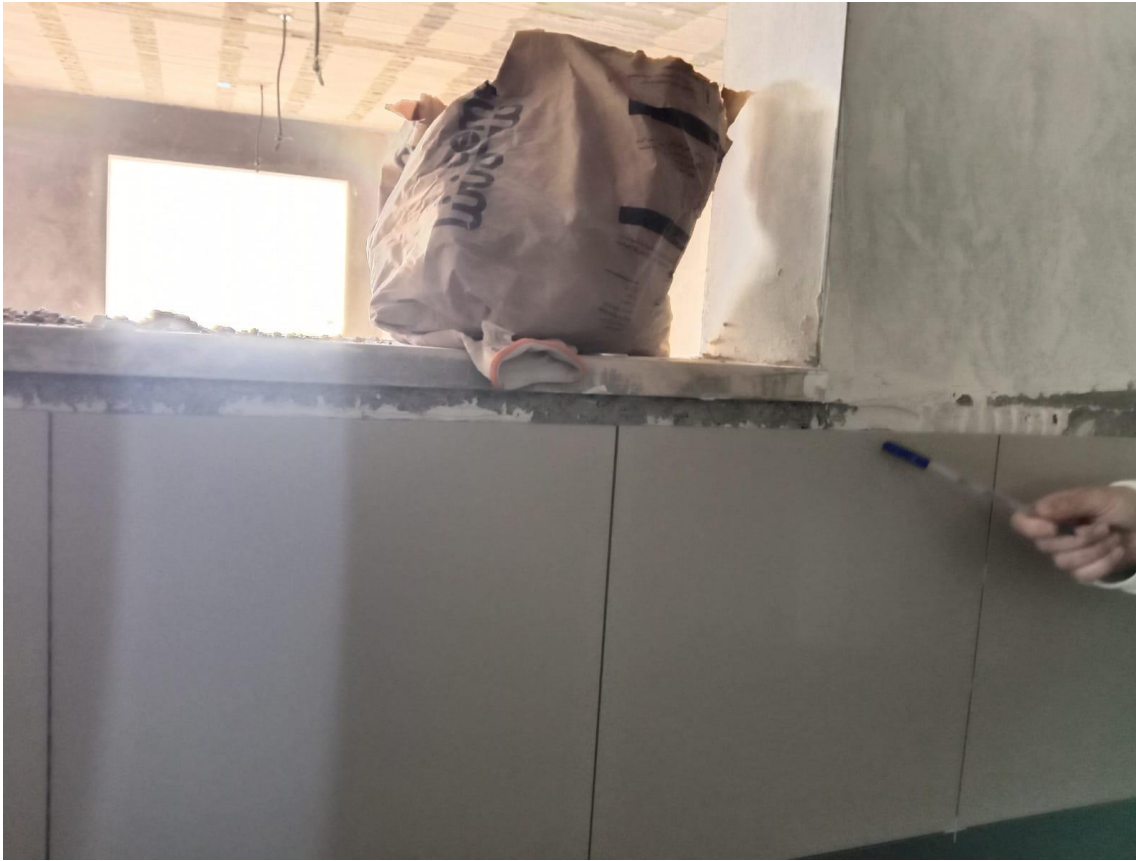
(Figure: 24)

The status of levelling of the internal window sills still not rectified by the Contractor. The team observed that the Contractor tried without success to rectify a number of them
