Quality Control Report

Consultant **Wahib Medanat** Consultant Engineers
Site Name **Um Al Dananir Basic Mixed - Balqa**
Package **Package 1**
Contractor **Derar Saraireh & Sons for Engineering & Contracting**
Tender No. **1/2020/USAID/SKEP/3/1**

Rep No. **QC-11 15**
Date **24 / 01 / 2022**

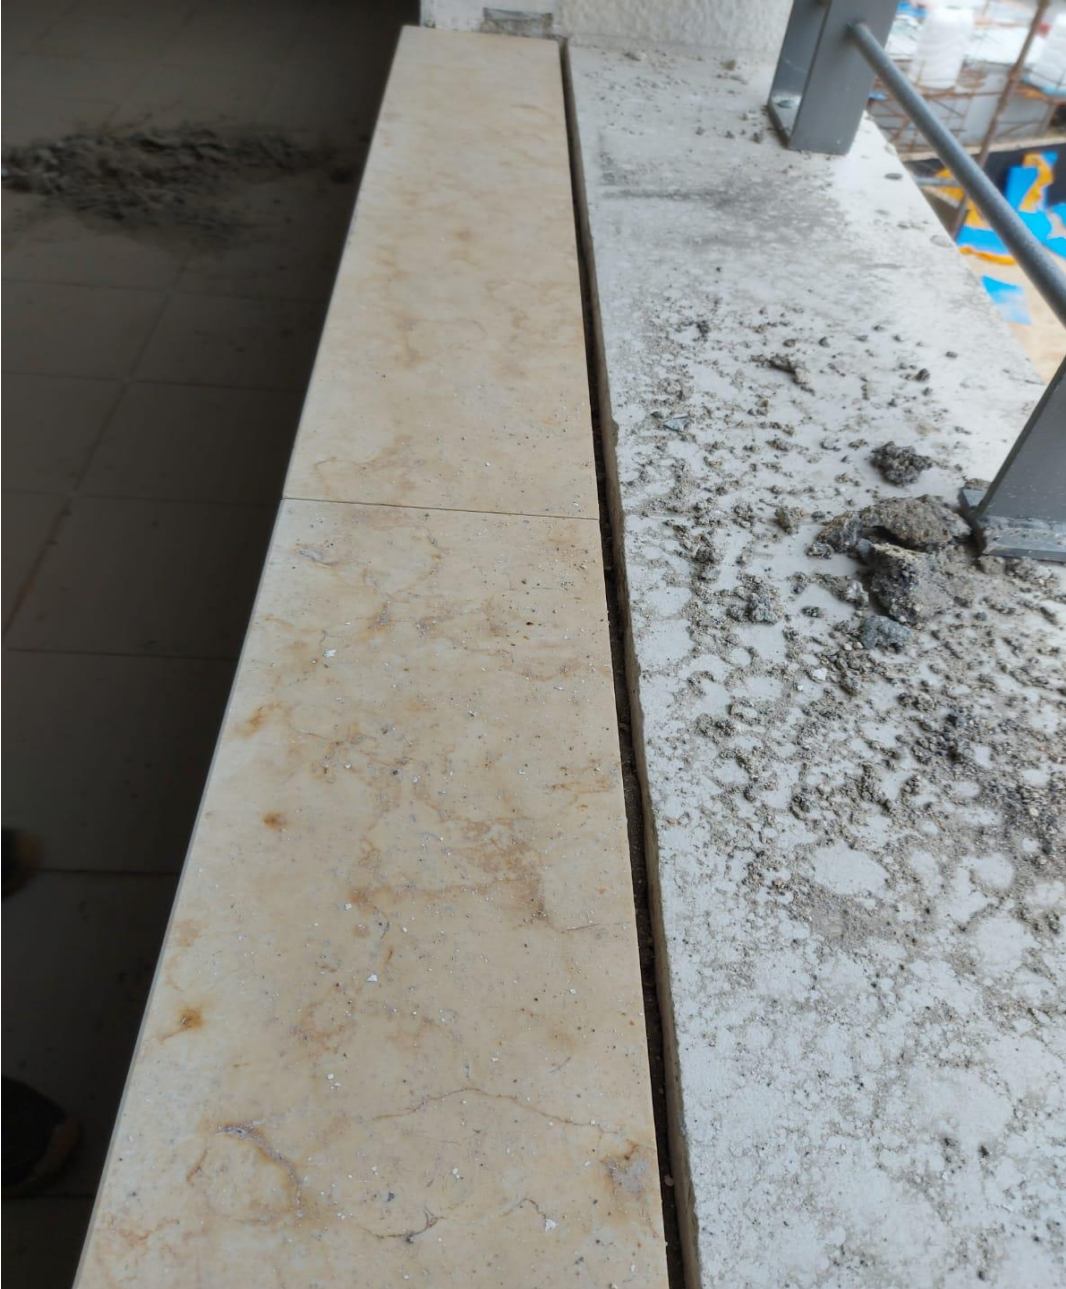
Description of Non Conformance	Corrective Action	Required by / When
<p>1. The joints between the inner window sill part and the outer window sill part are wider than required.</p>	<p>1. Window sills inside to be replaced with wider pieces to cover the difference.</p>	<p>The Contractor/Immediately</p>
<p>Report Prepared by</p>	<p>Hassan Shaqbua, Supervision Quality Control Manager</p>	
<p>Contractor's Response</p>		
<p>No Response yet</p>		
<p>Notes</p>

The gap between the two sills
