Quality Control Report

Consultant **Wahib Medanat** Consultant Engineers
Site Name **Hay Al Iskan Basic mixed - Jerash**
Package **Package 2**
Contractor **Dijlah Est. Construction Co.**
Tender No. **10/2019/USAID/SKEP/3/2**

Rep No. **QC-21 20**
Date **23 / 05 / 2022**

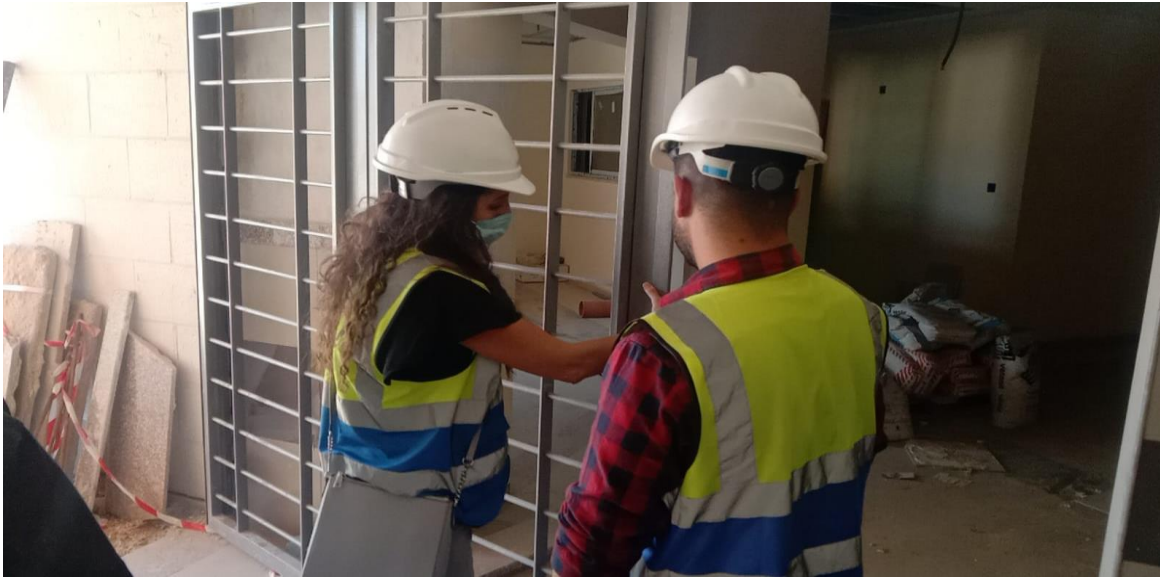
Defects in the main steel doors

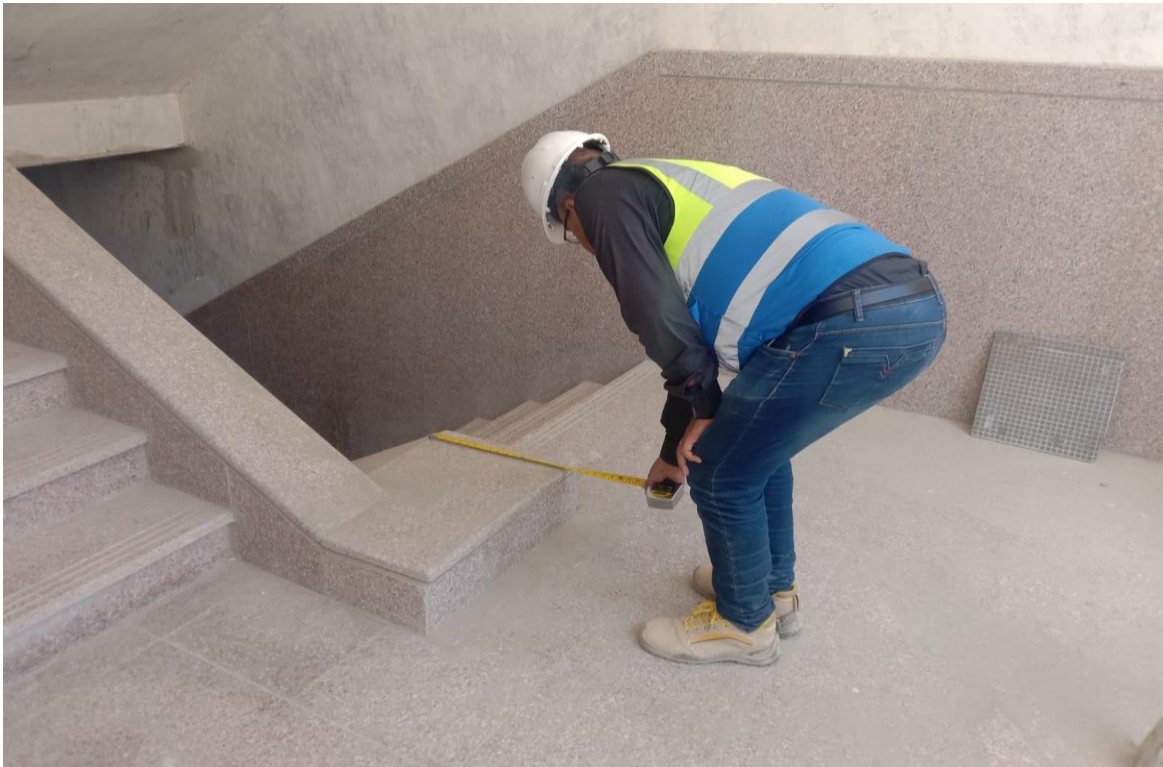
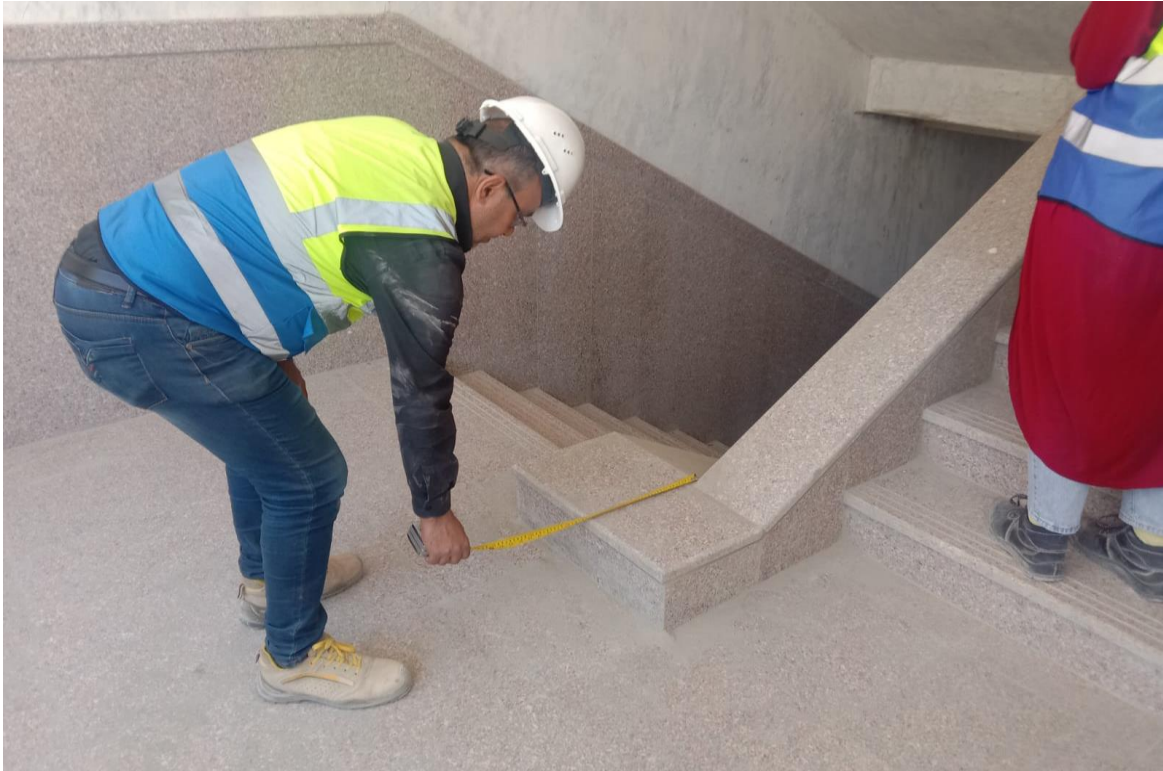
Dissimilarity at the main staircase

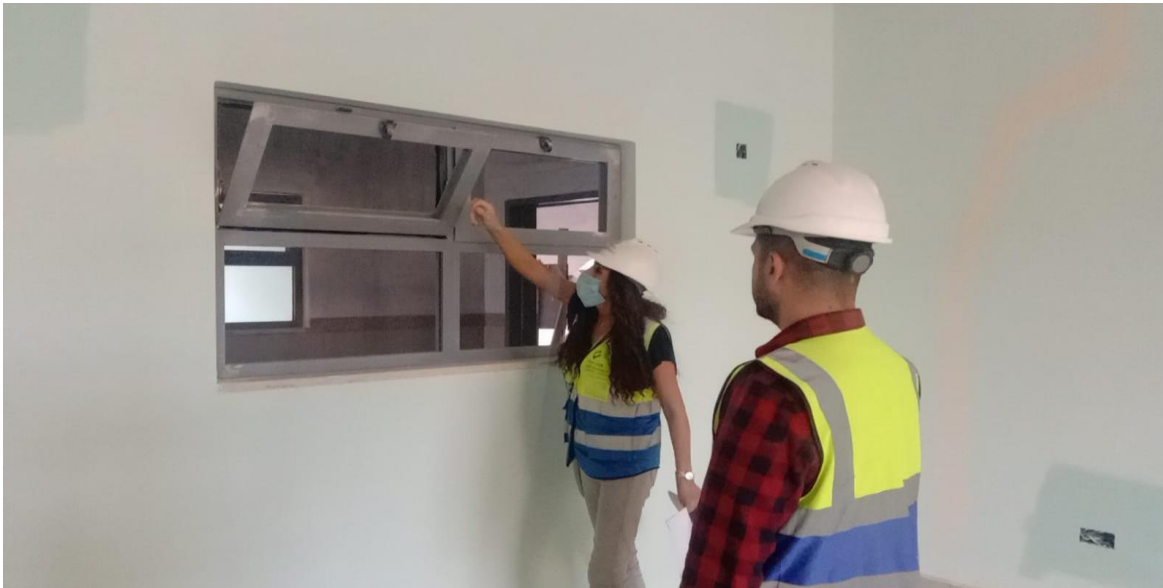
Using plastic accessories for aluminum windows

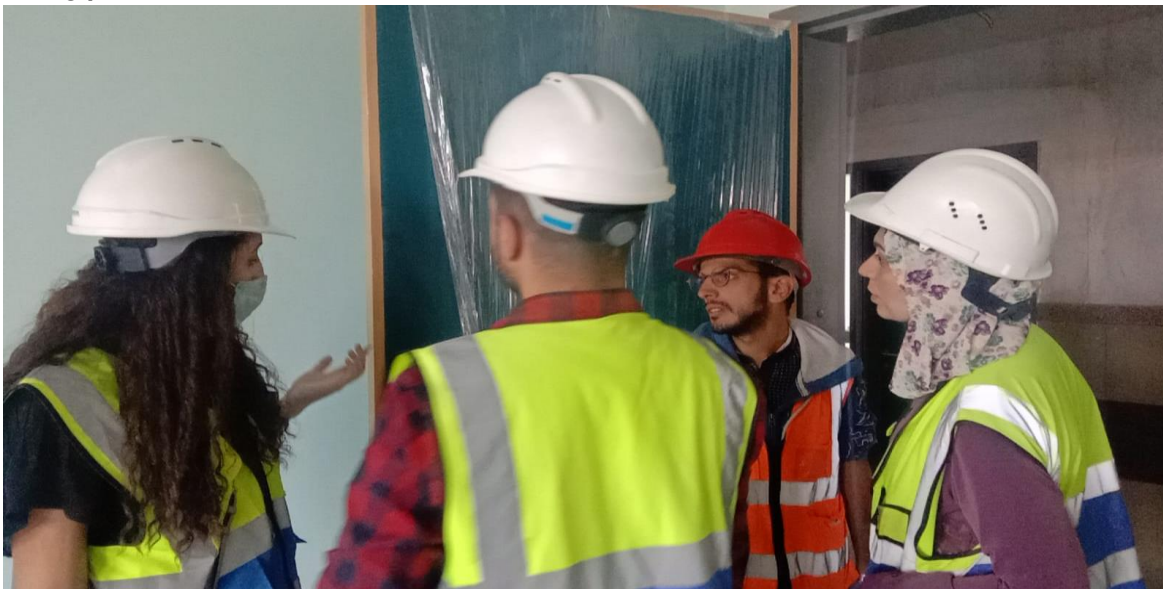
Unprotected wooden doors

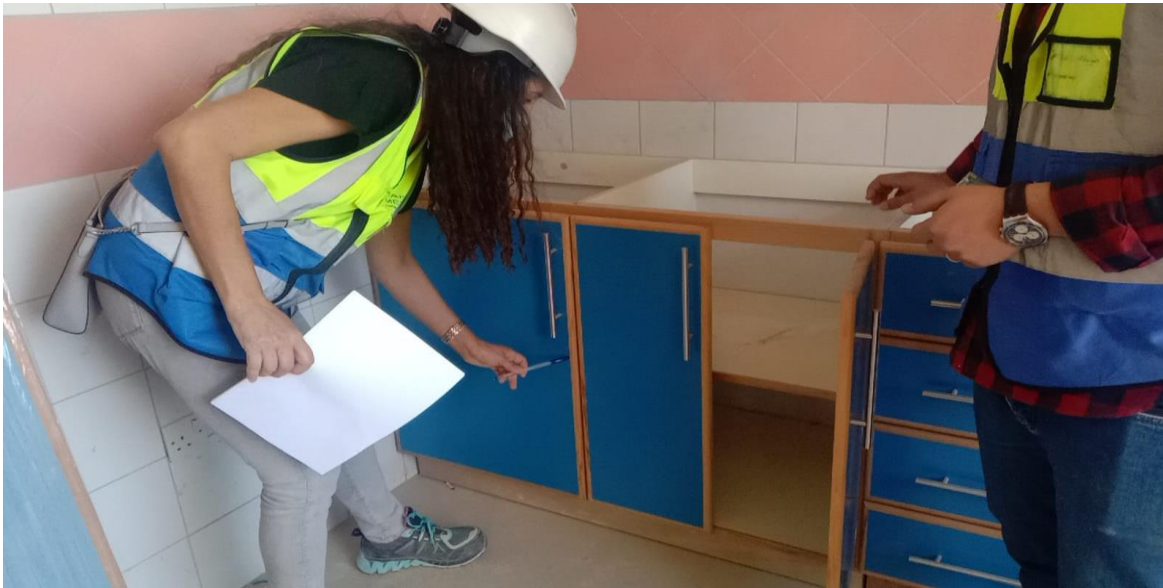
Defects in wooden cabinets

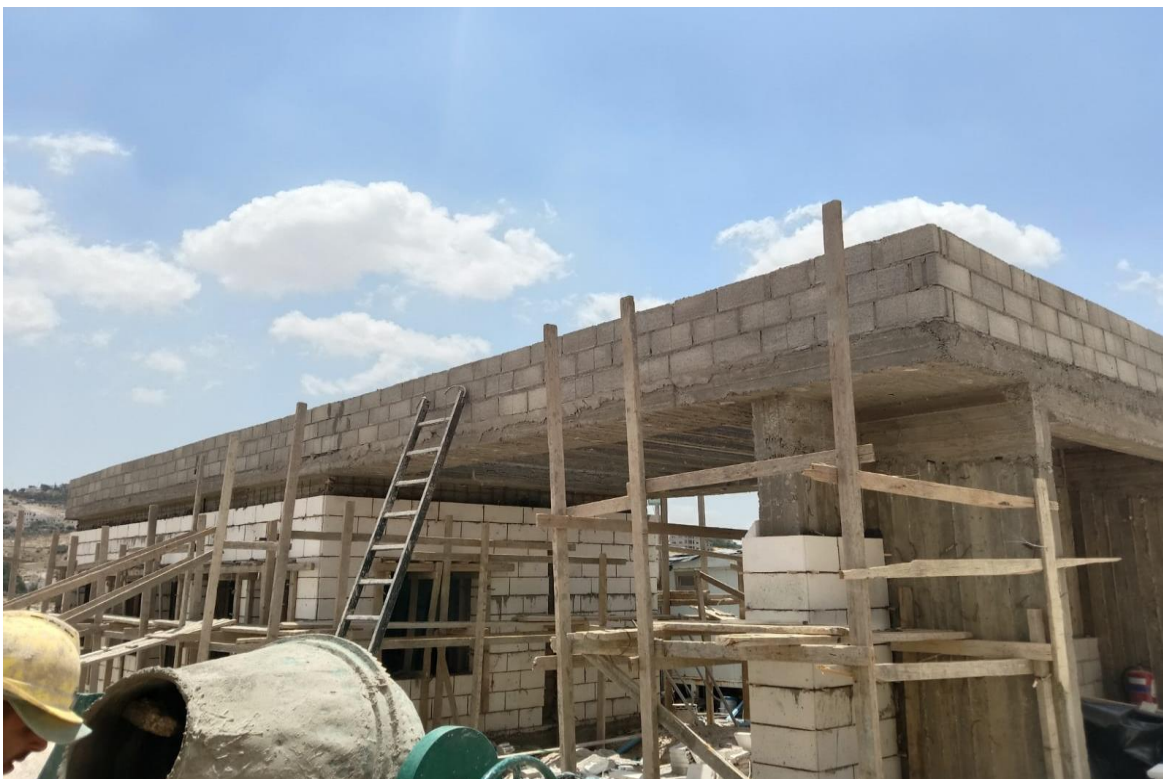
No stiffener columns in the parapet

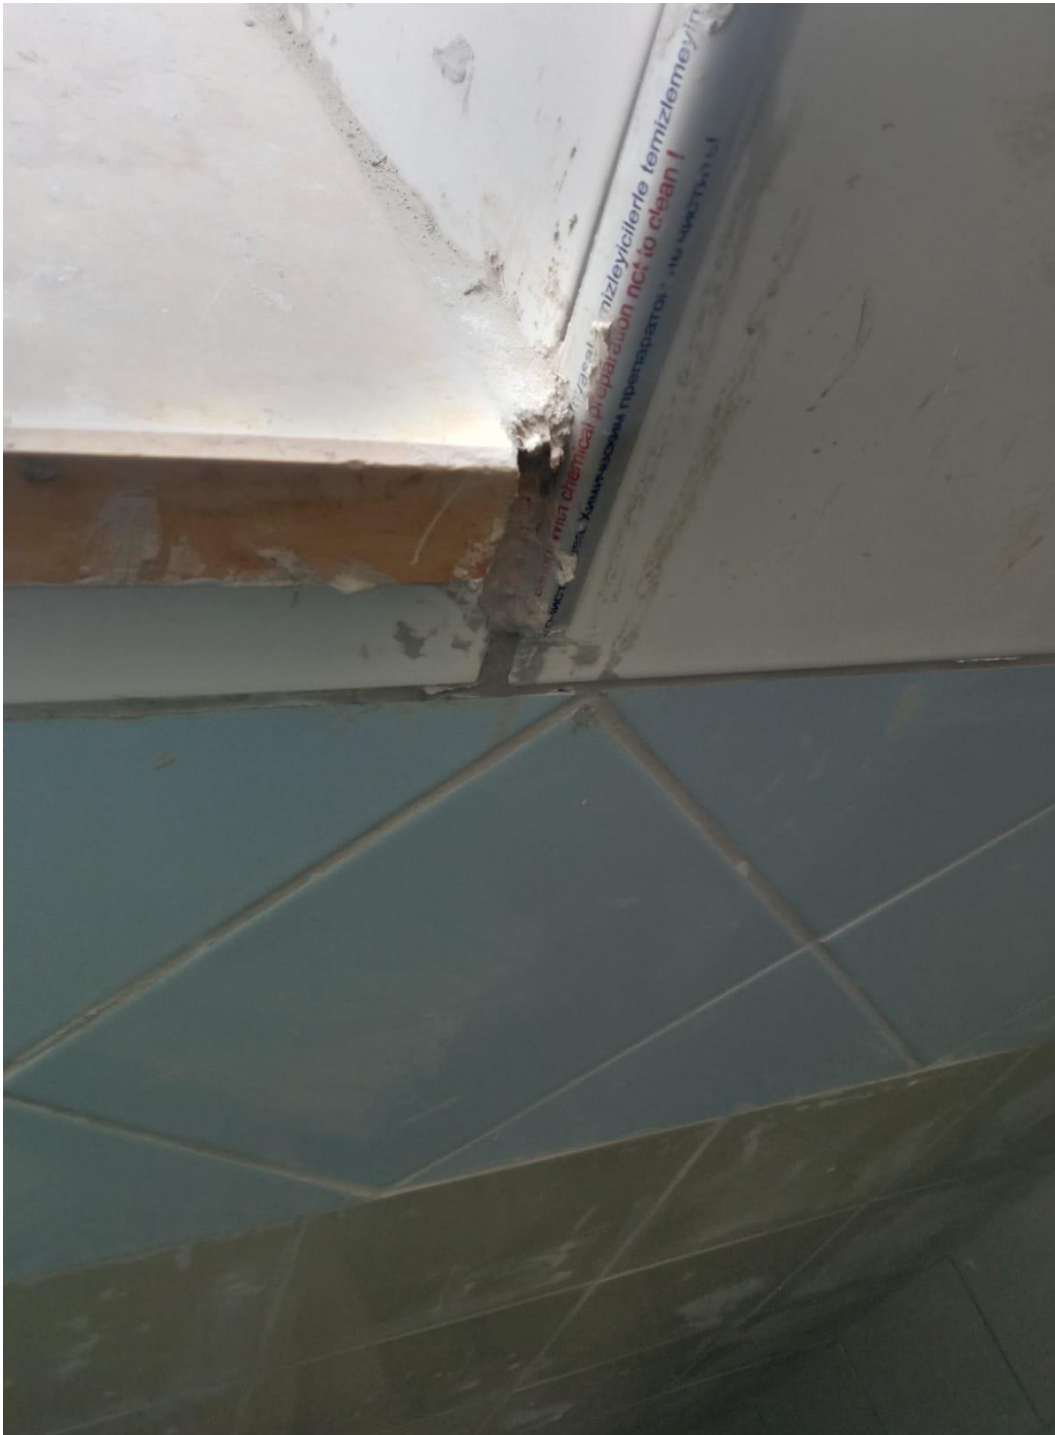
Wrong dimension for window sill
