# Quality Control Report

**Consultant** **Wahib Medanat** Consultant Engineers  
**Site Name** **Hay Al Iskan Basic mixed - Jerash**  
**Package** **Package 2**  
**Contractor** **Dijlah Est. Construction Co.**  
**Tender No.** **10/2019/USAID/SKEP/3/2**

**Rep No.** **QC-21 04**  
**Date** **11 / 03 / 2021**

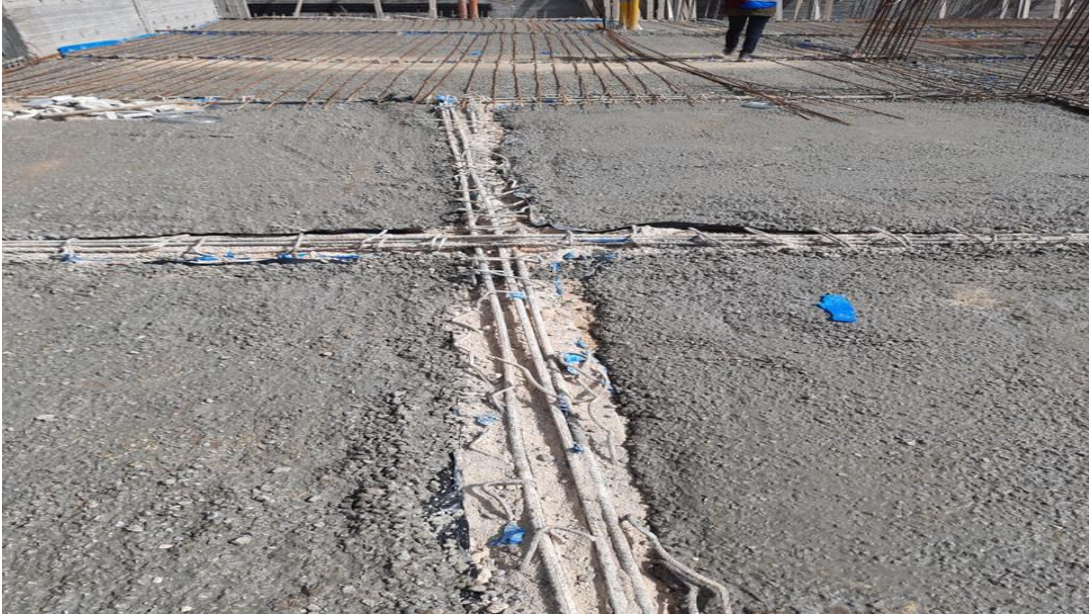
Description of Non Conformance	Corrective Action	Required by / When
<p>The contractor started installing steel reinforcement bars for the slab on grade before finishing the preparation work and the removal of back-filling material around the top steel reinforcement of the ground beams which will be casted along with the slab on grade. Number of steel bars of the grade beams were defected due to back-filling work and became unarranged which need to tidy up and while some need changes (Photos Attached).</p>	<p>The steel bars laid for slab on grde should be removd and all the backfill should be removed from the top of the beams and the defected steel bars should be replaced. All steel bars to be arranged well as per drawings and to the approval of the supervision engineer.</p>	<p>The contractor was requested to take action immediately.</p>
<p><b>Report Prepared by</b></p>	<p>Hassan Shaqbua, Supervision Quality Control Manager</p>

Defected Works- QC Report 2104

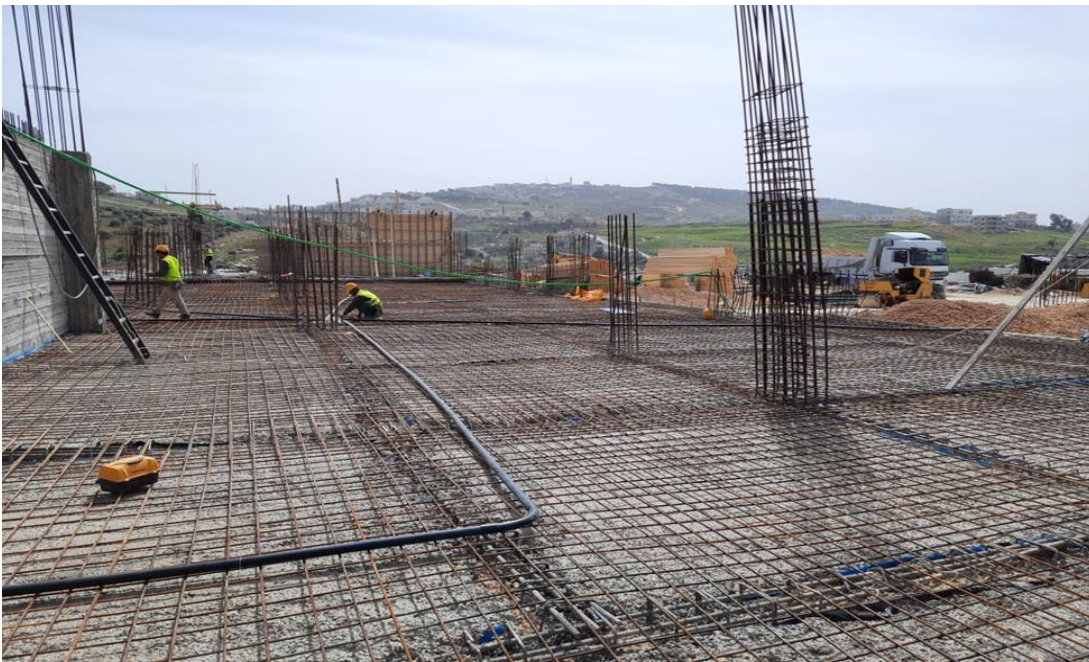
Corrective Action- QC Report 2104

The contractor responded immediately and started with remedy work. The work will be inspected by supervision.
