# Quality Control Report

**Consultant** **Wahib Medanat** Consultant Engineers  
**Site Name** Hay Al Iskan Basic mixed - Jerash  
**Package** Package 2  
**Contractor** Dijlah Est. Construction Co.  
**Tender No.** 10/2019/USAID/SKEP/3/2

**Rep No.** QC-21 22  
**Date** 17 / 07 / 2022

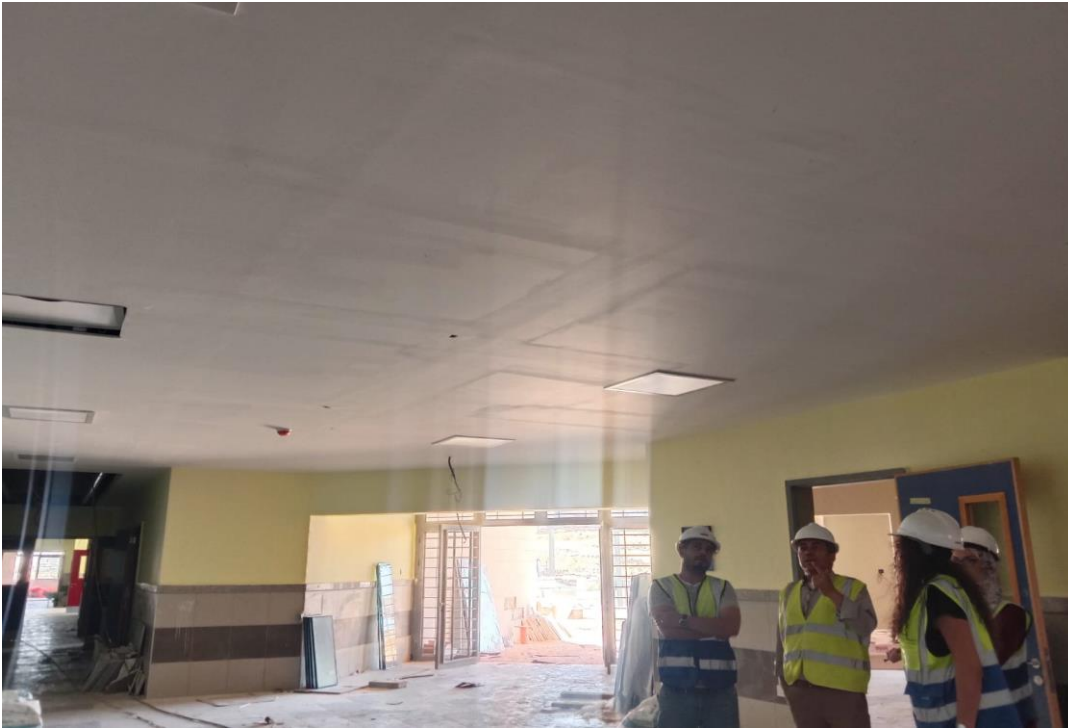
**Waviness in the painting of the suspended ceilings**

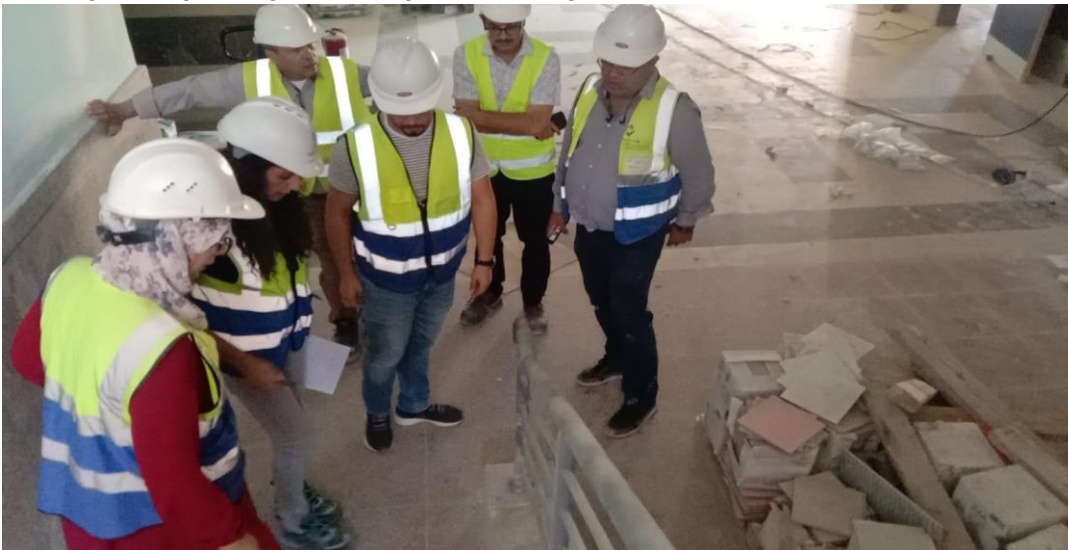
**Fixation of the handrails of the staircase is insufficient**

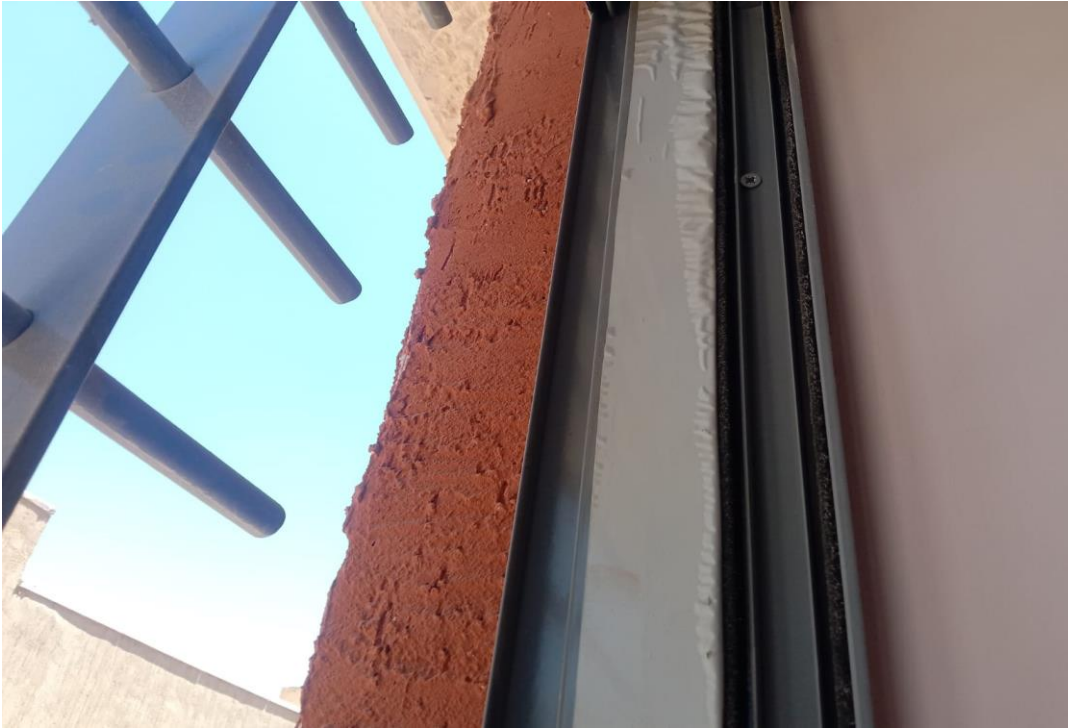
**Defects in the plastering and painting for a number of window jambs**

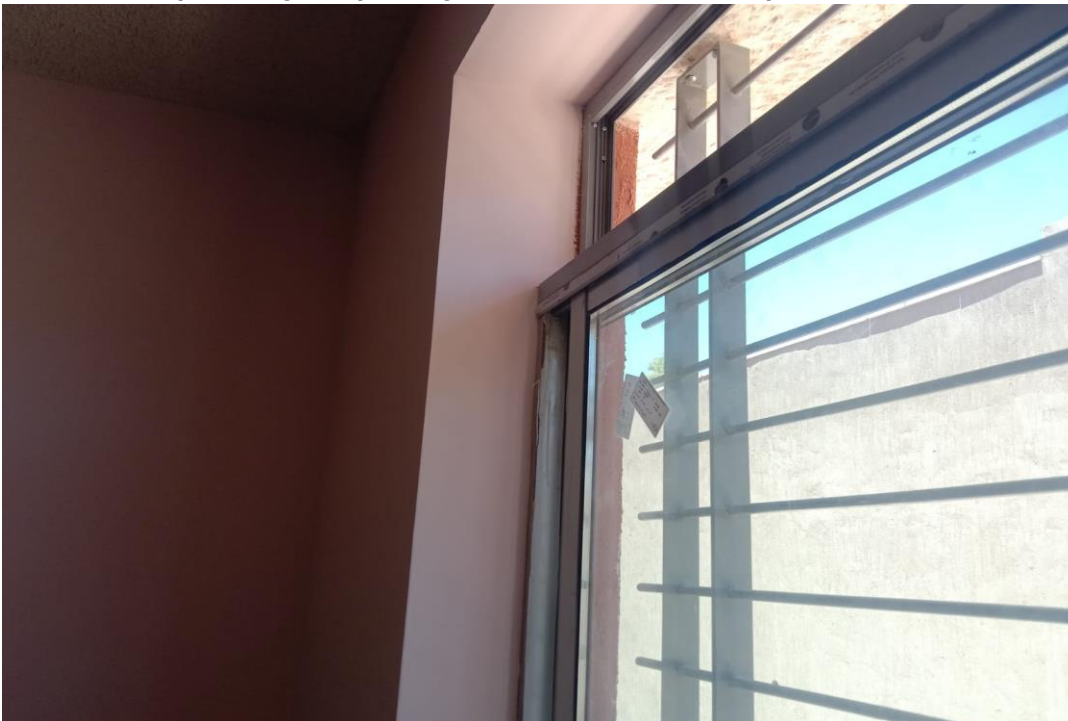
**Defect in the installation of windows related to the external plastering**

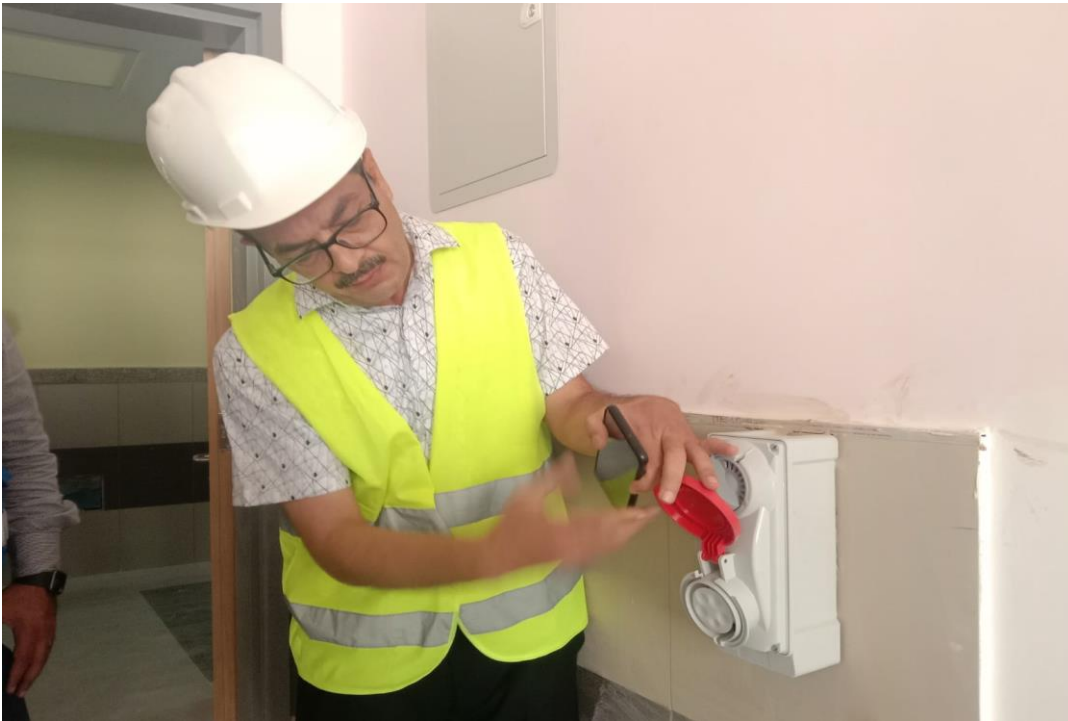
**Incorrect installation of the electrical outlets at the laboratories**

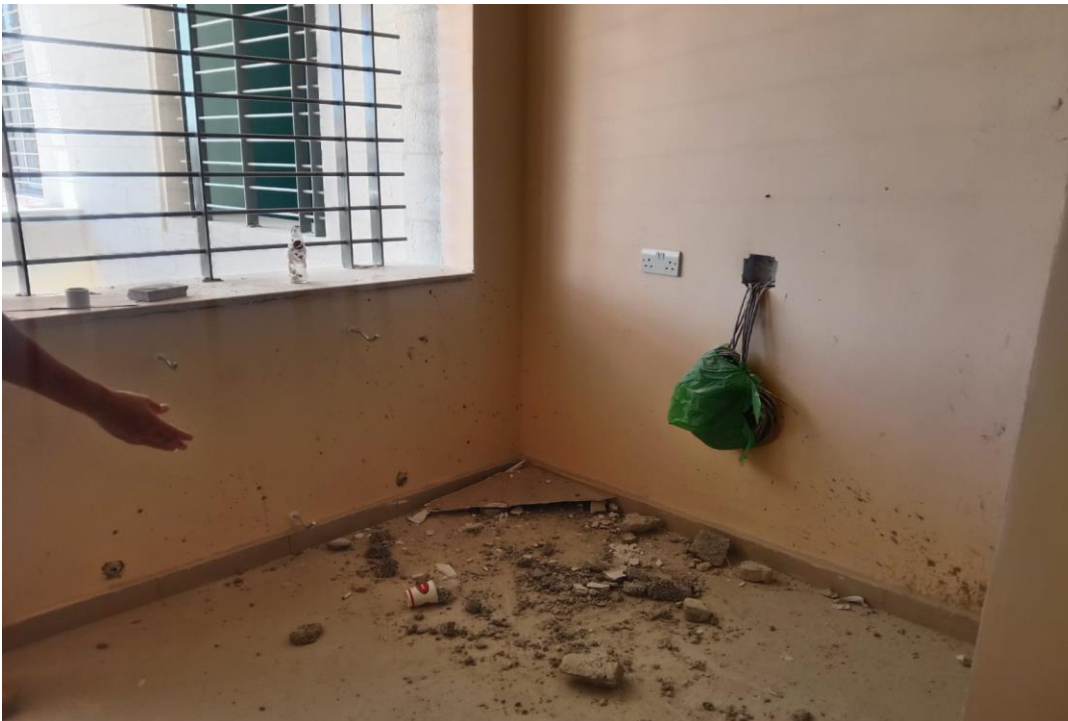
**Accumulation of debris inside the building and defects in tiles as a result of that**

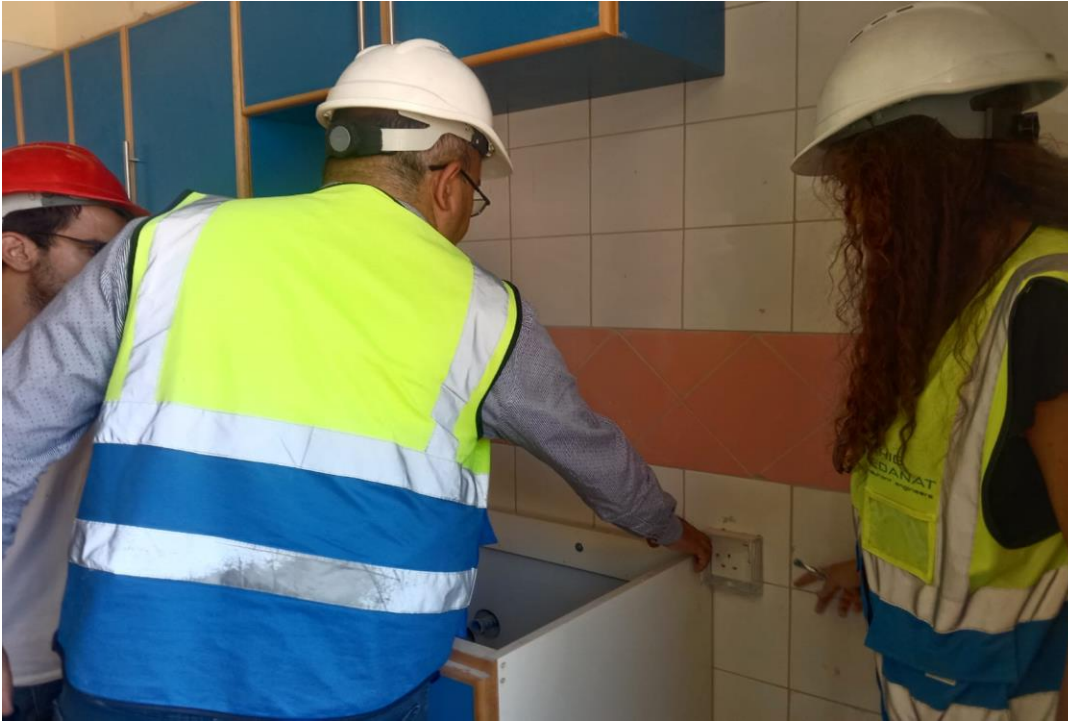
**Contradiction between the granite counter top with the location of electrical outlet**
