SKEP III Home Office Support Site Visit Report

Consultant	Wahib Medanat Consultant Engineer	Rep No.	22-22022022
Contractor	Dijlah Establishment Constr. Contracting	Tender No.	(11/2019/USAID/SKEP/3/S) Schools for a Knowledge Economy Project (SKEP) - Phase (3) Package (1, 2)
Site Name	Thahr Al Sarow Basic School for Boys- Jerash	Day/ Date	Tue. 22/02/2022
Duration of Project	450 Calendar Days	Total Project Budget	8,314,983.735 JD

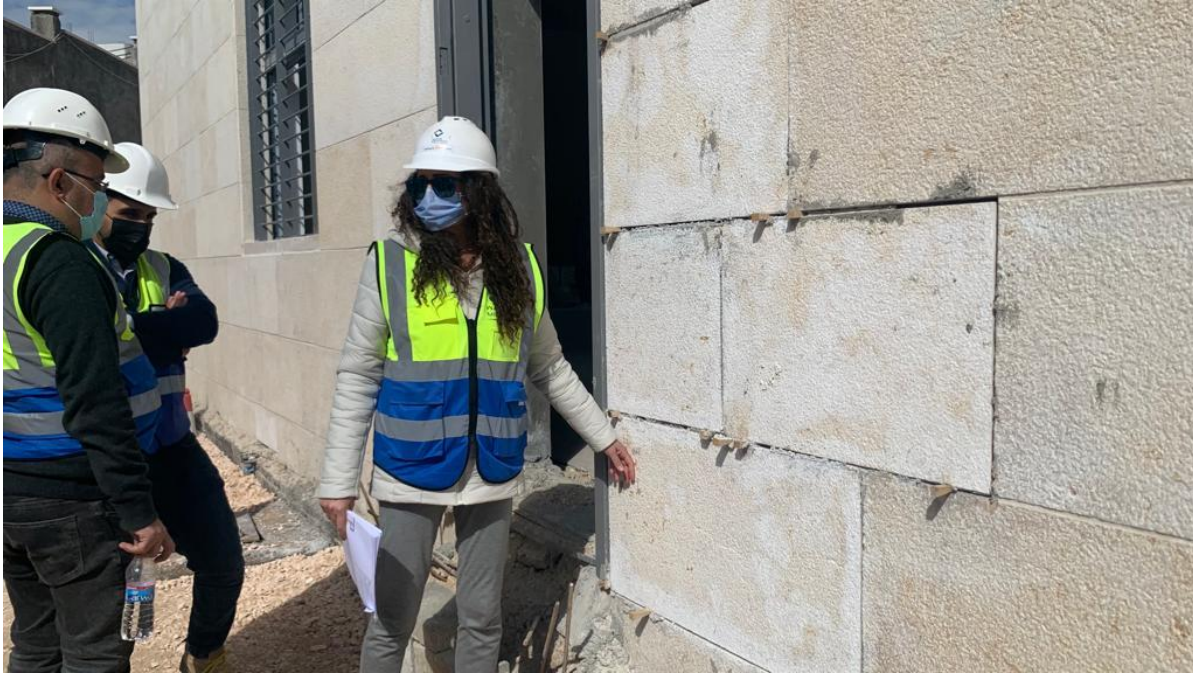
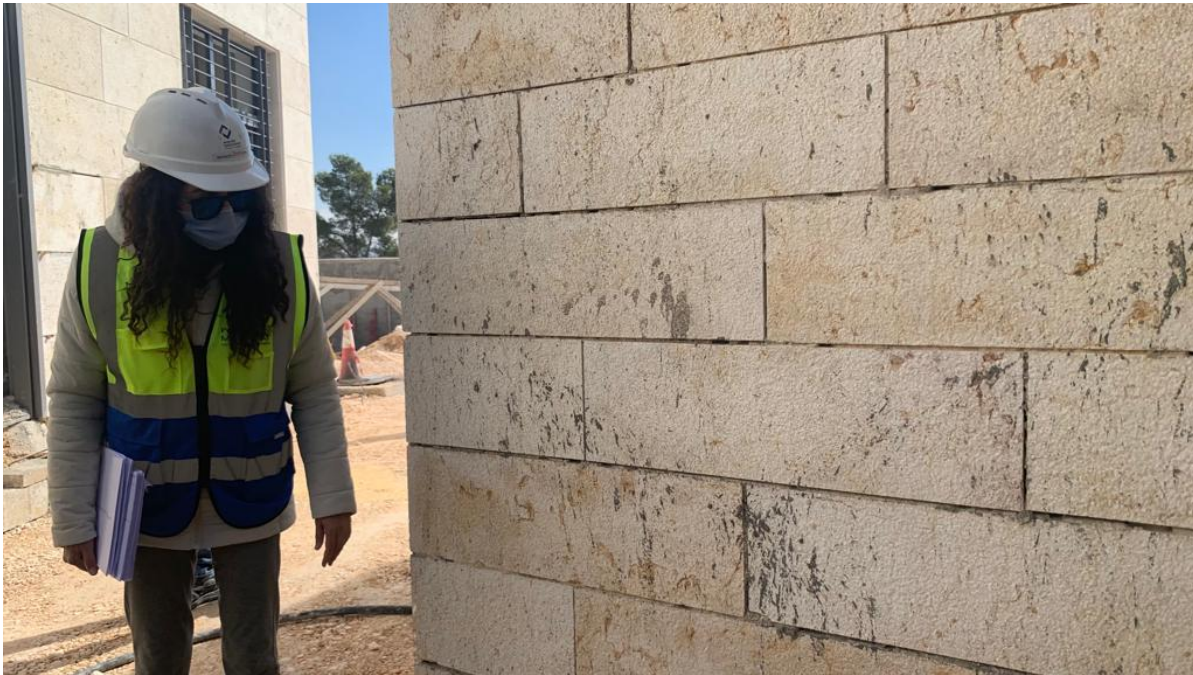
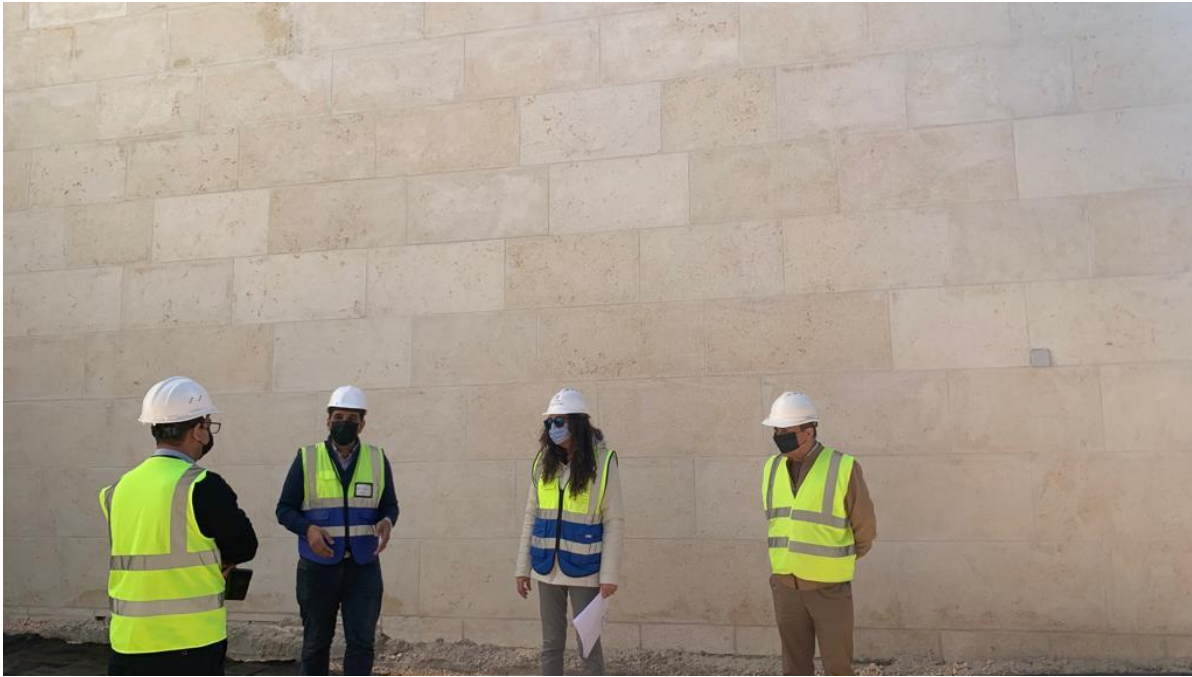
(Figure: 04, 05 & 06)

The supervision team inspected the built stones for facades and observed that the status of stones still the same and defects appear at the stone face

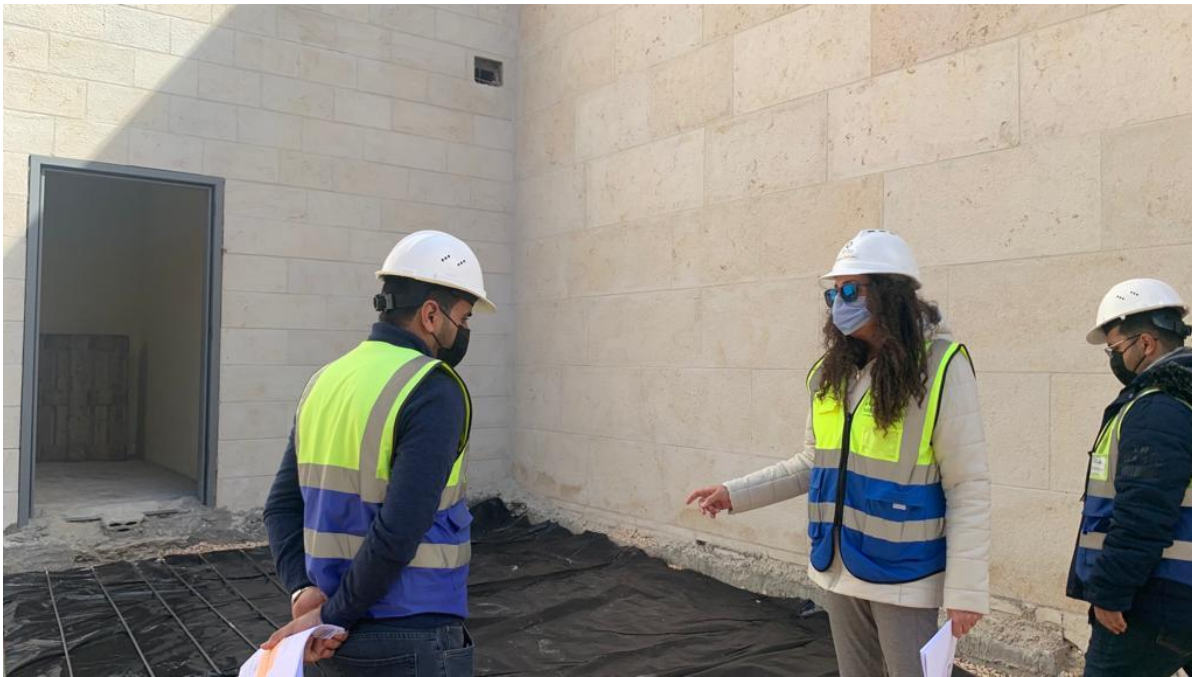
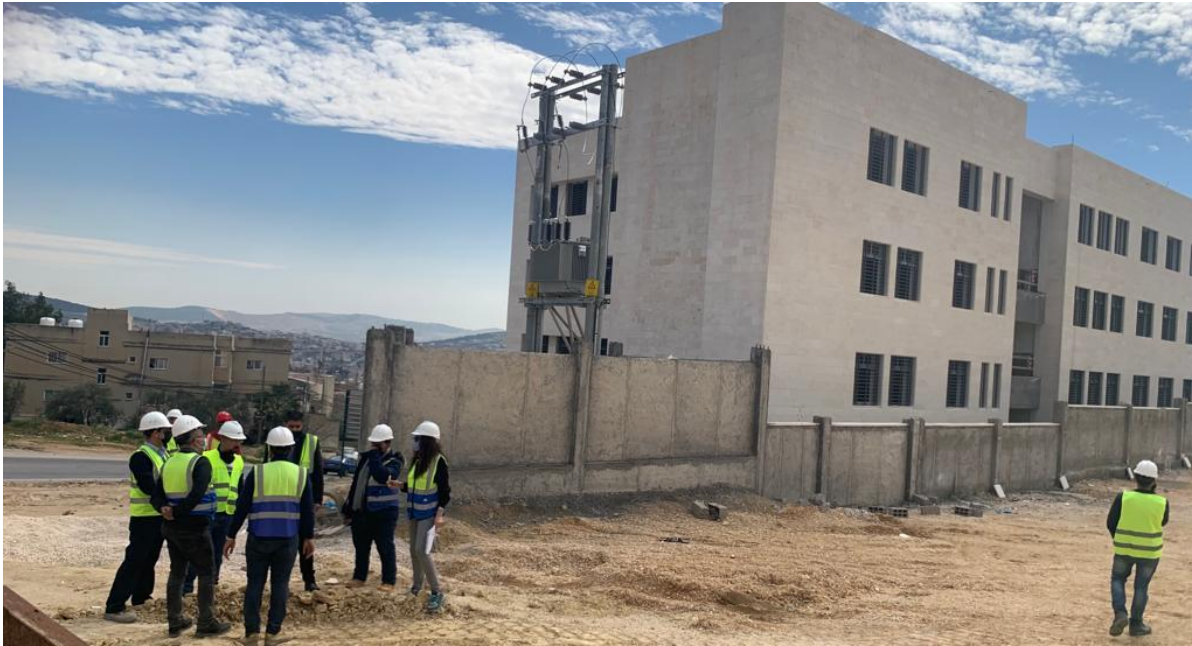
The team inspected the ongoing work at the walkways around the building

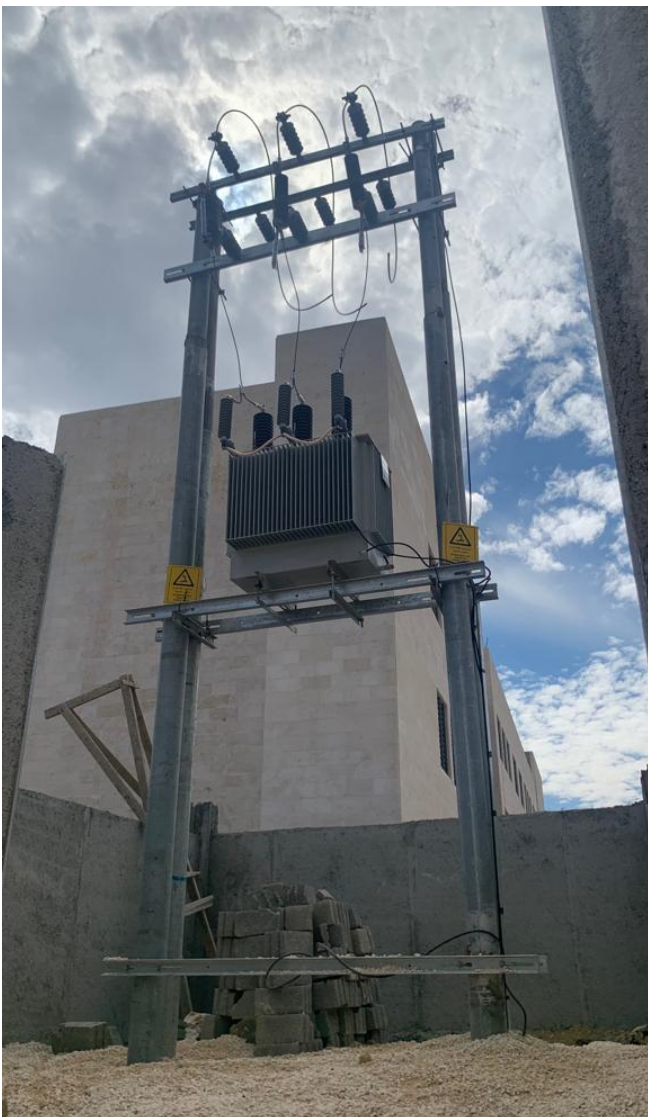
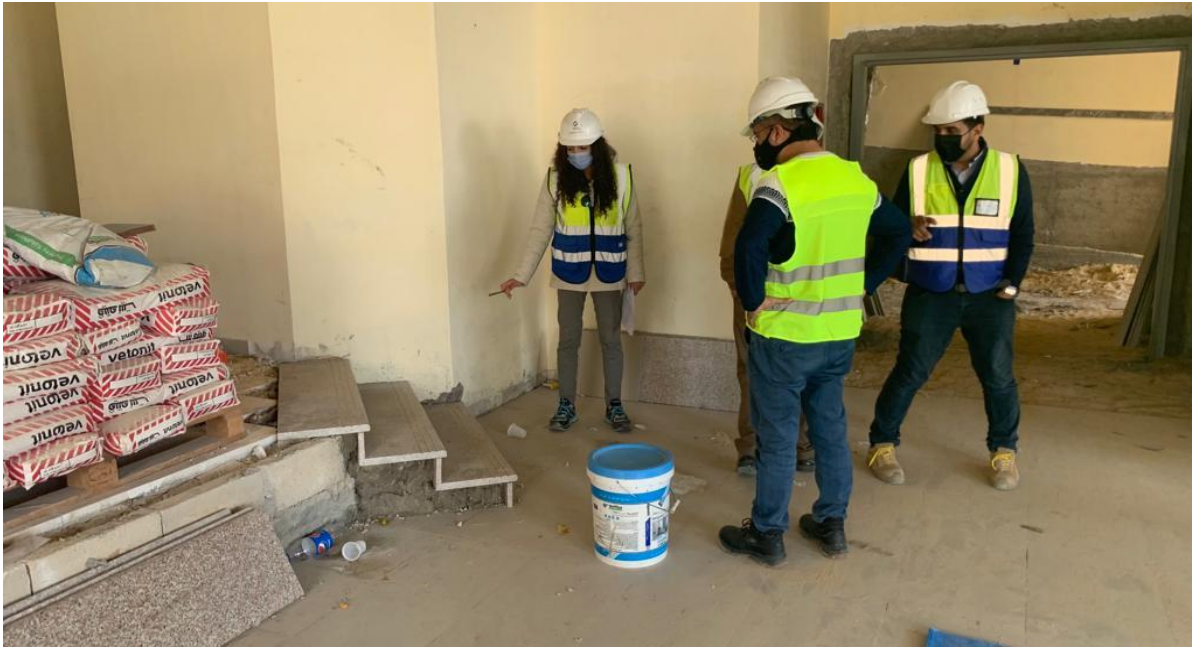
(Figure: 08 & 09)

The team observed that the electrical transformer of the school is already installed by Irbid Electrical Company, and is ready to be connected with the school network at a later stage. A discussion was conducted with the Contractor

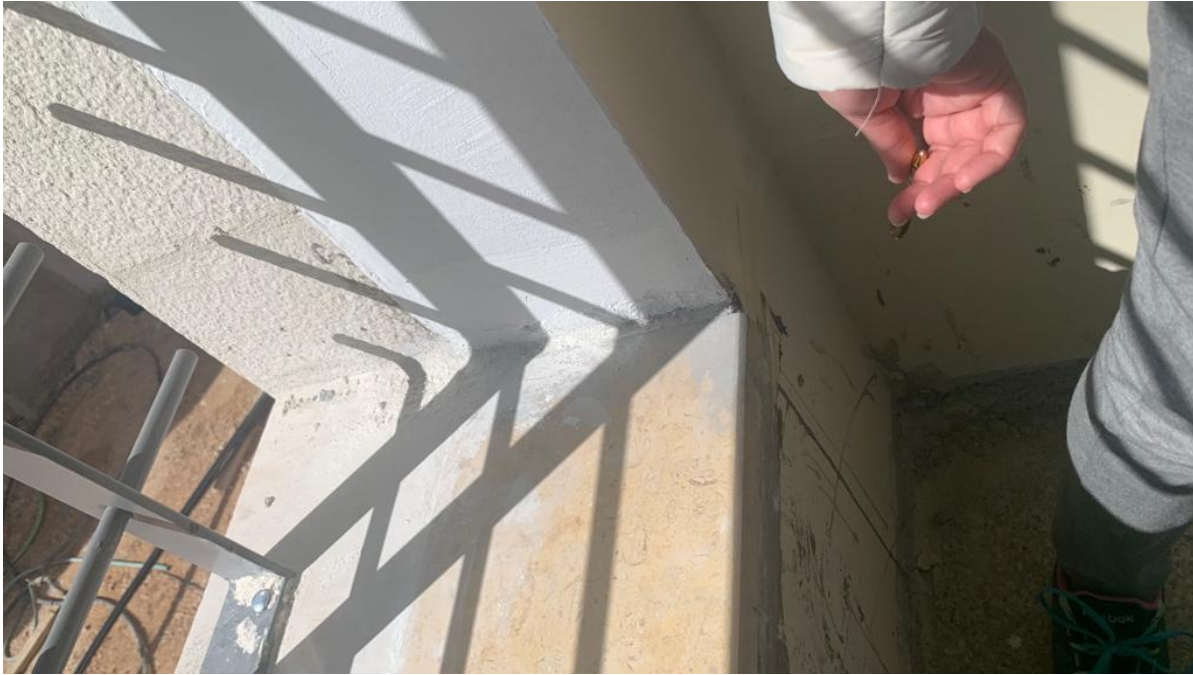
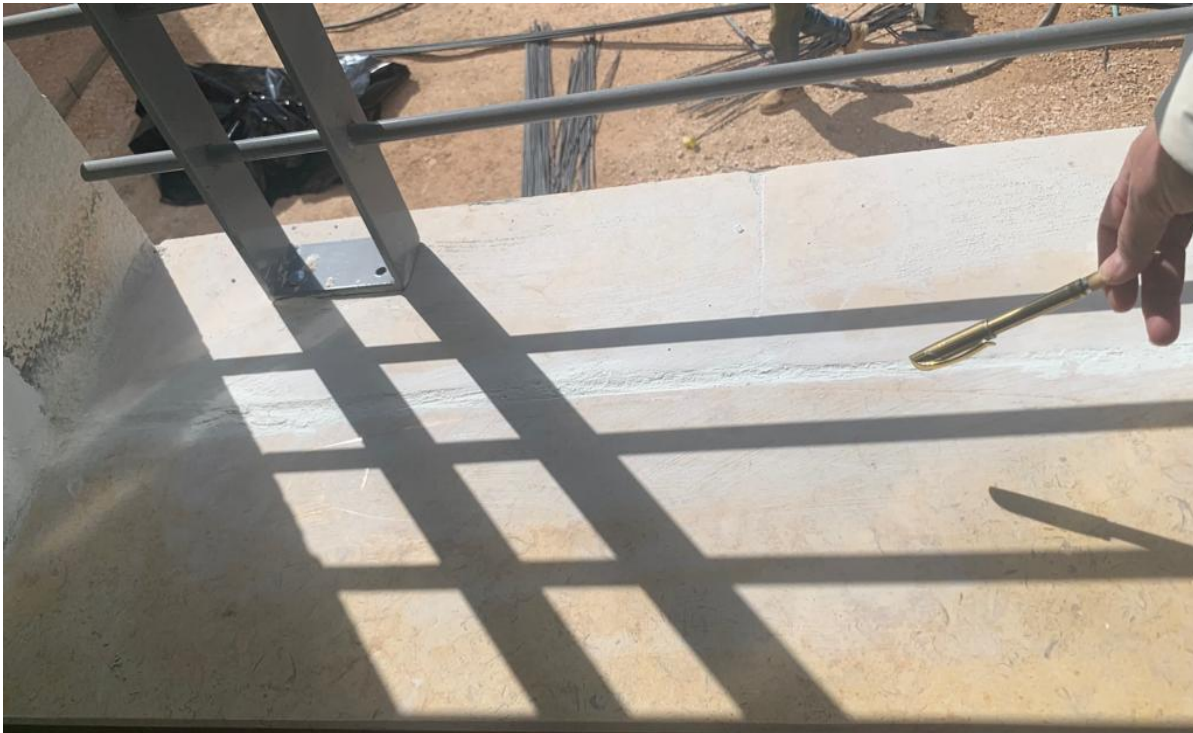
(Figure: 13 & 14)

The team observed bad quality and wrong dimension in installing the marble sill at some of staircase windows

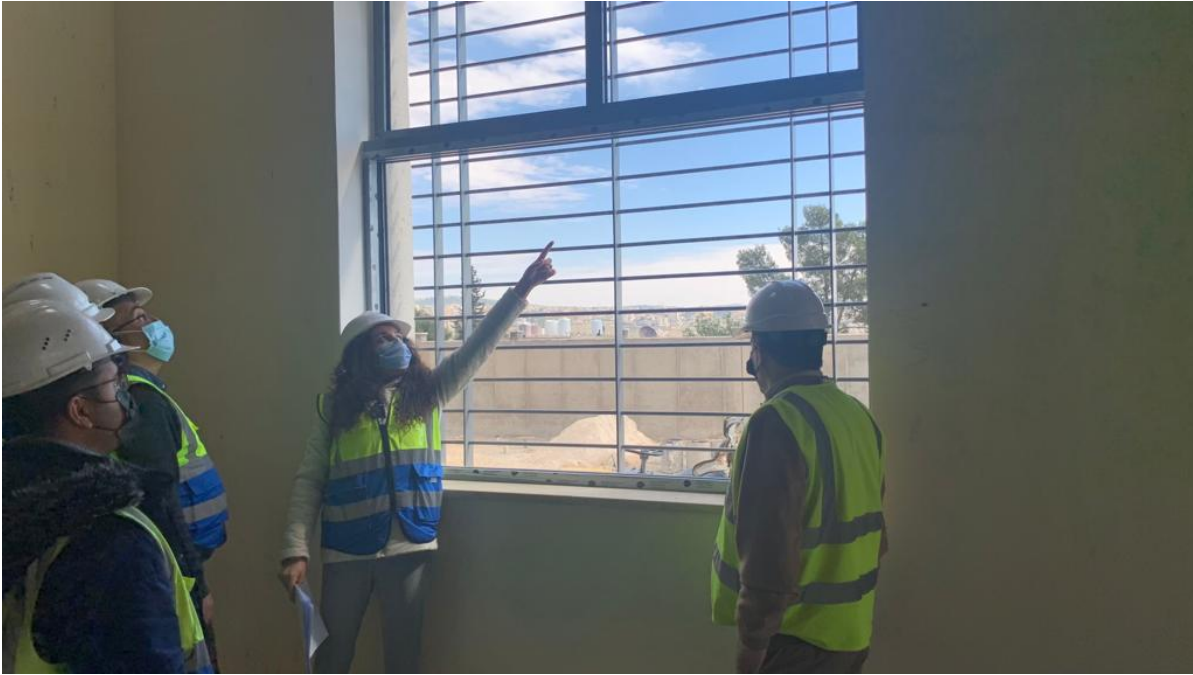
(Figure: 15)

The team observed defects in the steel protection screen

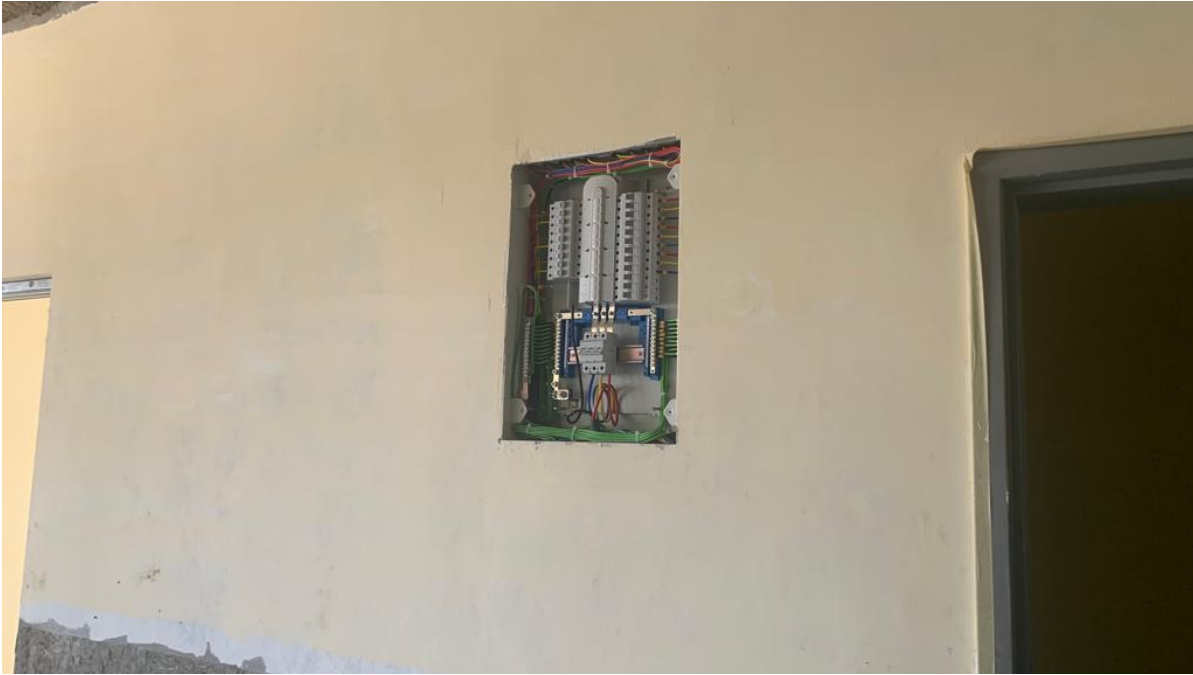
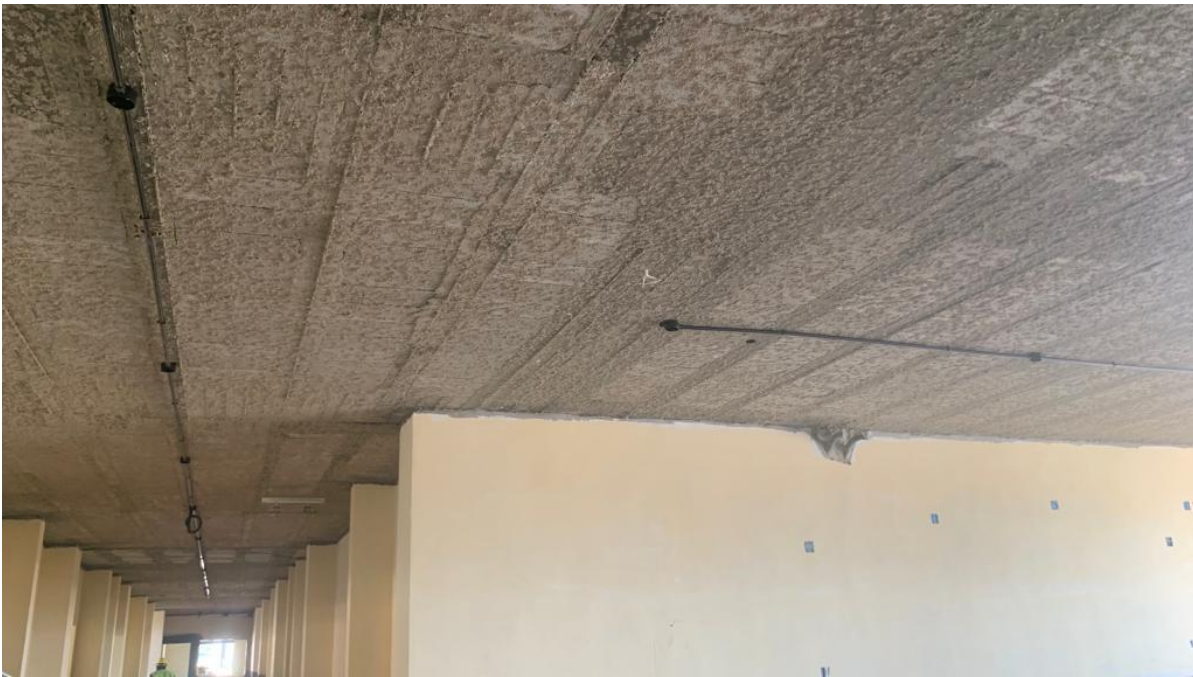
(Figure: 17 & 18)

The team observed that the electrical second fix inside the building is almost finished

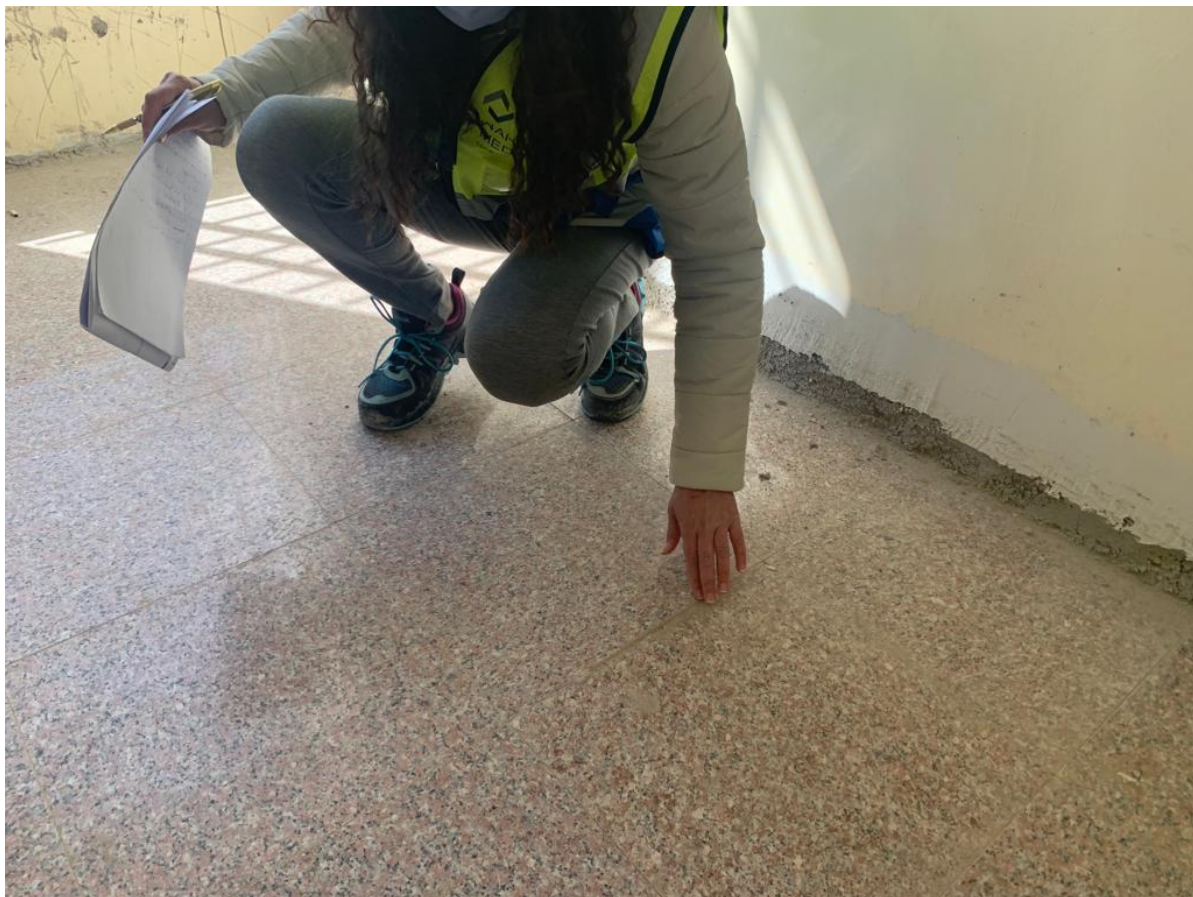
(Figure: 20)

The team observed that the granite tiling for stair landing is not rectified by the Contractor and the teething is still visible

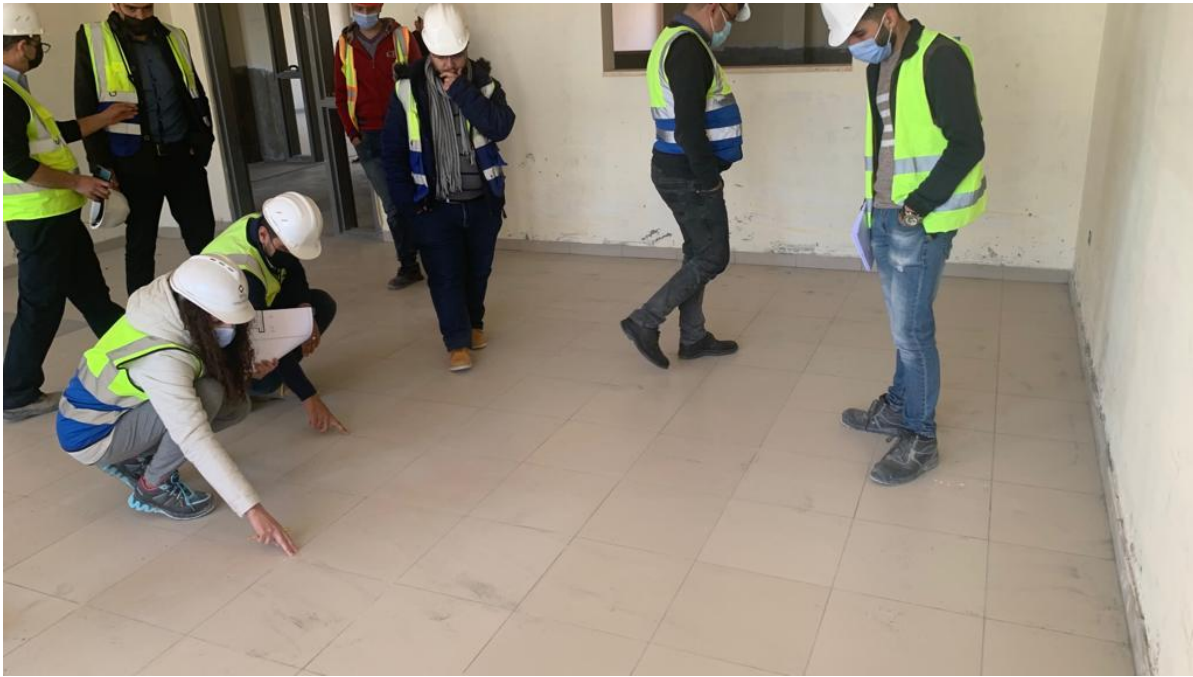
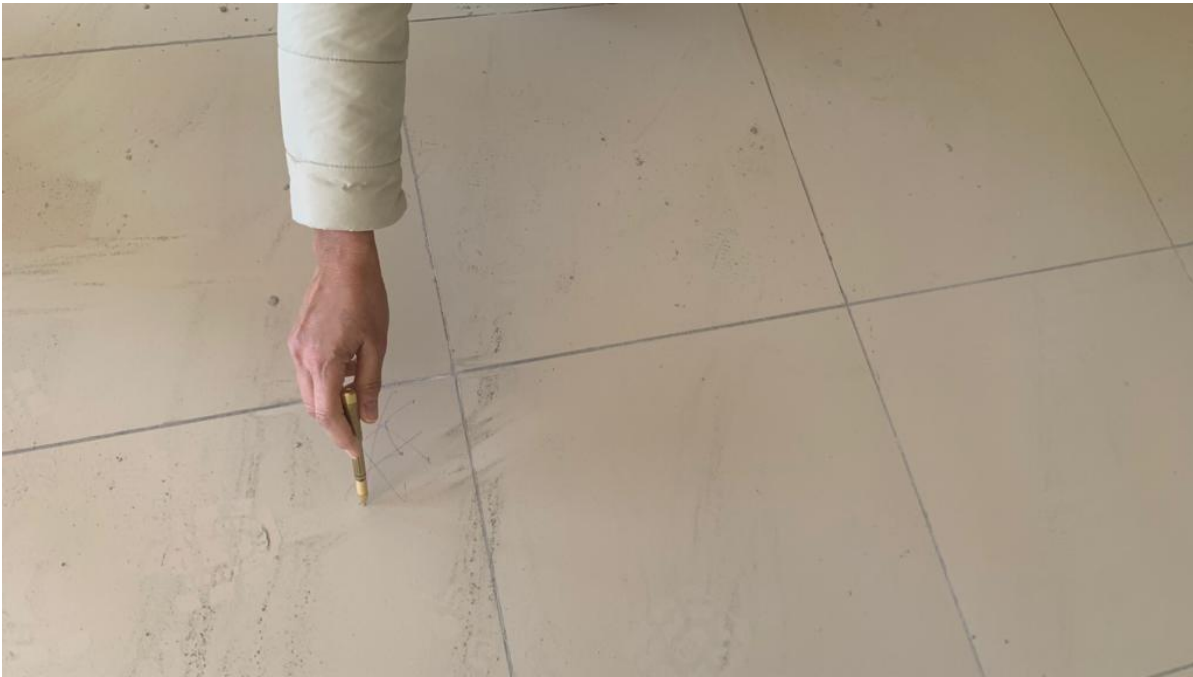
(Figure: 21 & 22)

The team inspected the installed porcelain floor tiles and observed teething at some areas and requested the Contractor to rectify

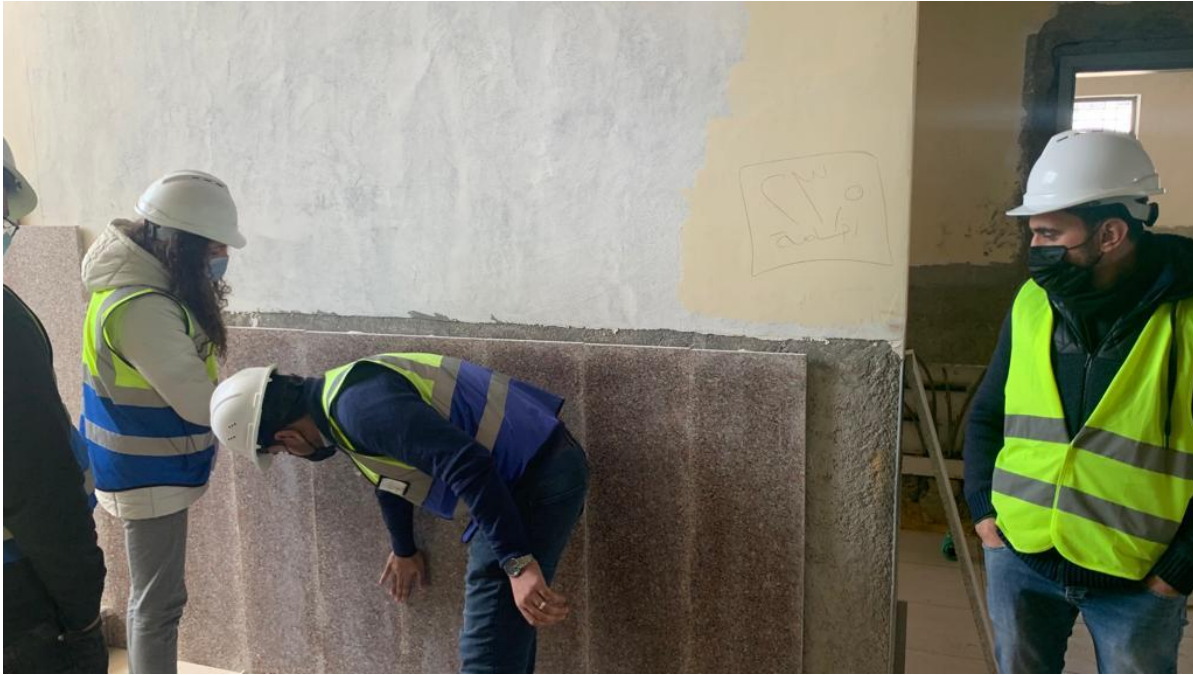
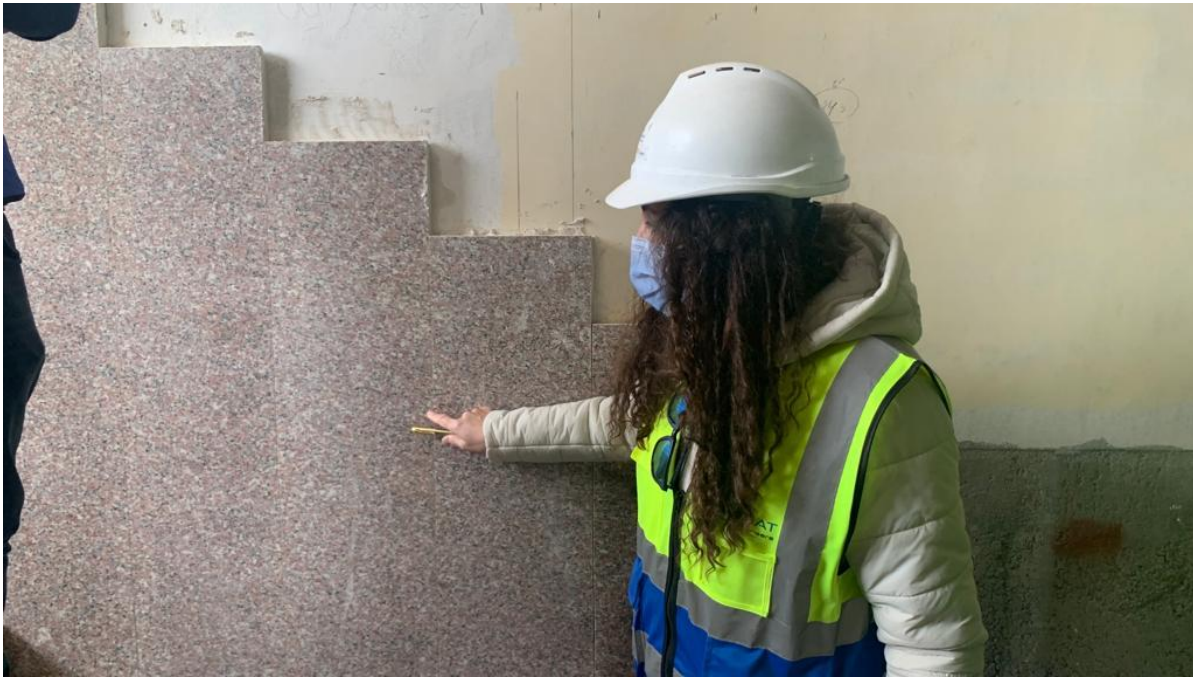
(Figure: 25 & 26)

The team observed that the Contractor has not rectified the granite cladding for staircases and the status has not changed regarding the cutting of the pieces

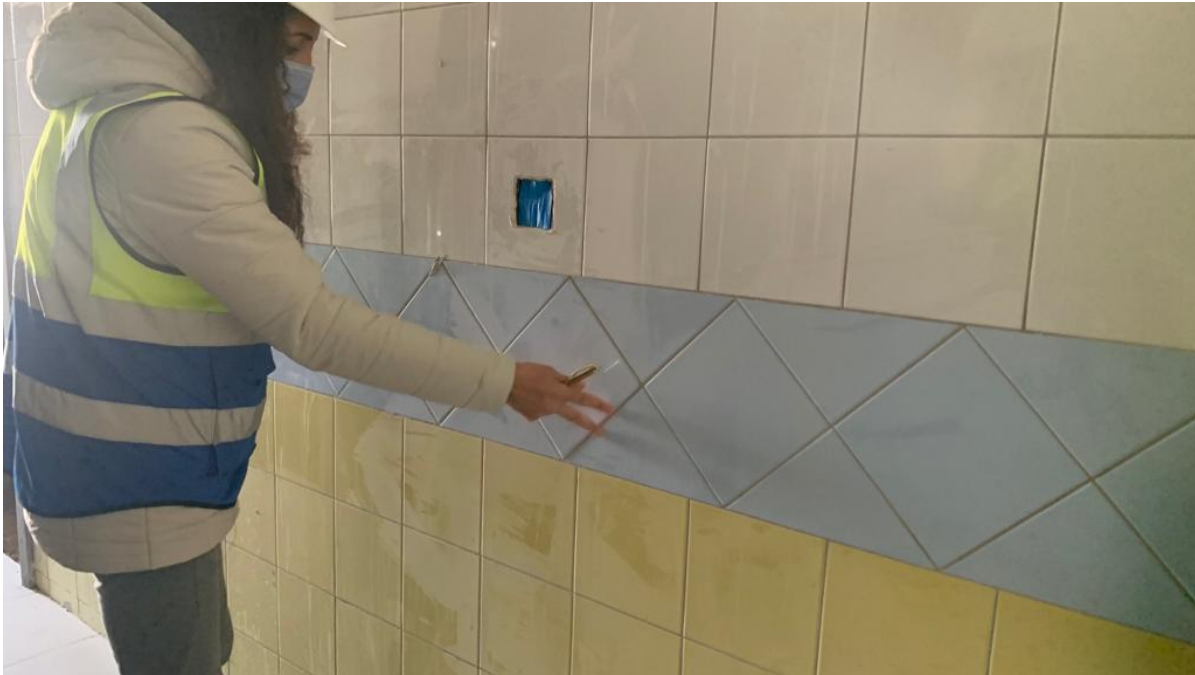
(Figure: 29)

The team observed teething at some areas in the ceramic wall tiling at wet areas

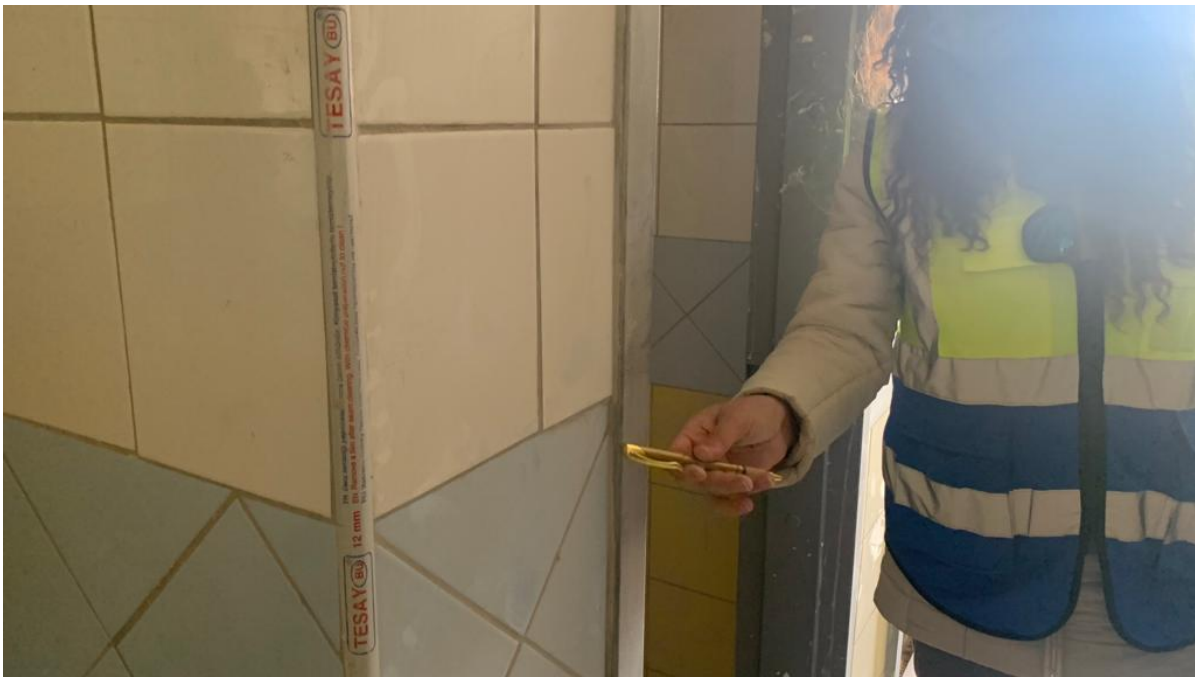
(Figure: 30)

The team inspected the wall tiling at the wet areas and observed unaccepted cutting of tiles adjacent to the door frames
