# SKEP III Home Office Support Site Visit Report

Consultant	Wahib Medanat Consultant Engineer	Rep No.	13-27072022
Contractor	Derar Saraireh & Sons for Engineering & Contracting	Tender No.	(11/2019/USAID/SKEP/3/S) Schools for a Knowledge Economy Project (SKEP) - Phase (3) Package (1, 2)
Site Name	Khadija Bint Khwailed Basic Mixed School- Shouna Janoubia	Day/ Date	Wed. 27/07/2022
Duration of Project	450 Calendar Days	Total Project Budget	9,789,417.840 JD

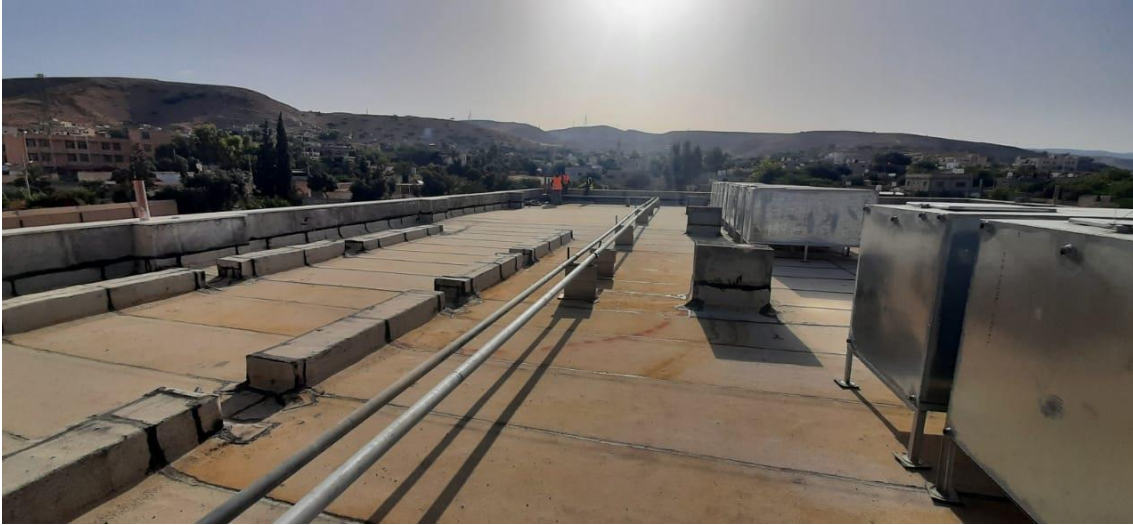
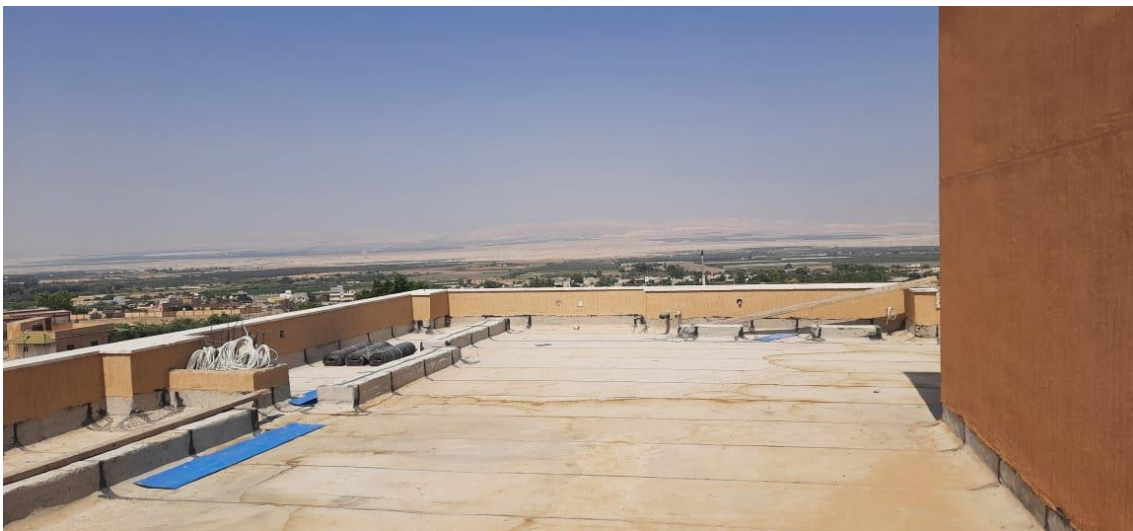
(Figure: 06 & 07)

The team inspected the mechanical and electrical works executed at the roof

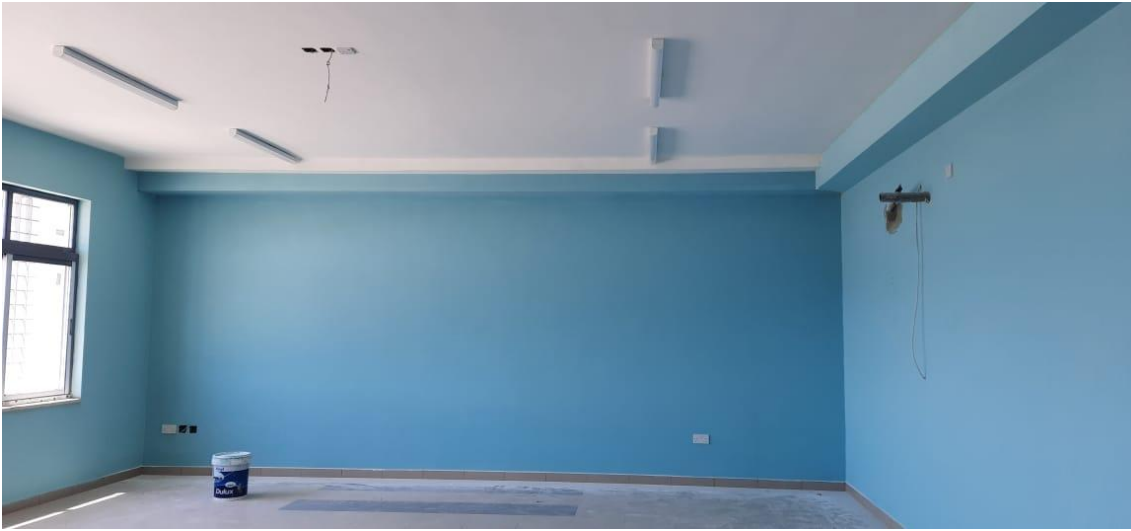
(Figure: 08)

3	The team observed in one of the rooms that the Contractor had installed the gypsum board bulkhead over the drop beam incorrectly, which can be viewed as if there are two boxes at the corner of the ceiling. The Contractor was requested to reinstall so that the bulk head covers the drop beam completely.
4	The team observed that the Contractor has rectified the waving in plastering and painting in the walls at the corridors.
5	The team Inspected the relation between granite coping and the window sill at the corridors.
6	The team remarked that the Contractor started rectifying the teething in granite and replacing granite pieces that have black spots with new standard acceptable ones.
7	The Team observed that the base plate for the wall fans and the wall on which it was installed on is damaged and will not be suitable for the installation of the fans. The Contractor was requested to fix the damages in both the wall base plate and the wall before installing the fans.

The team noticed that the Contractor had installed the gypsum board bulkhead over the drop beam incorrectly

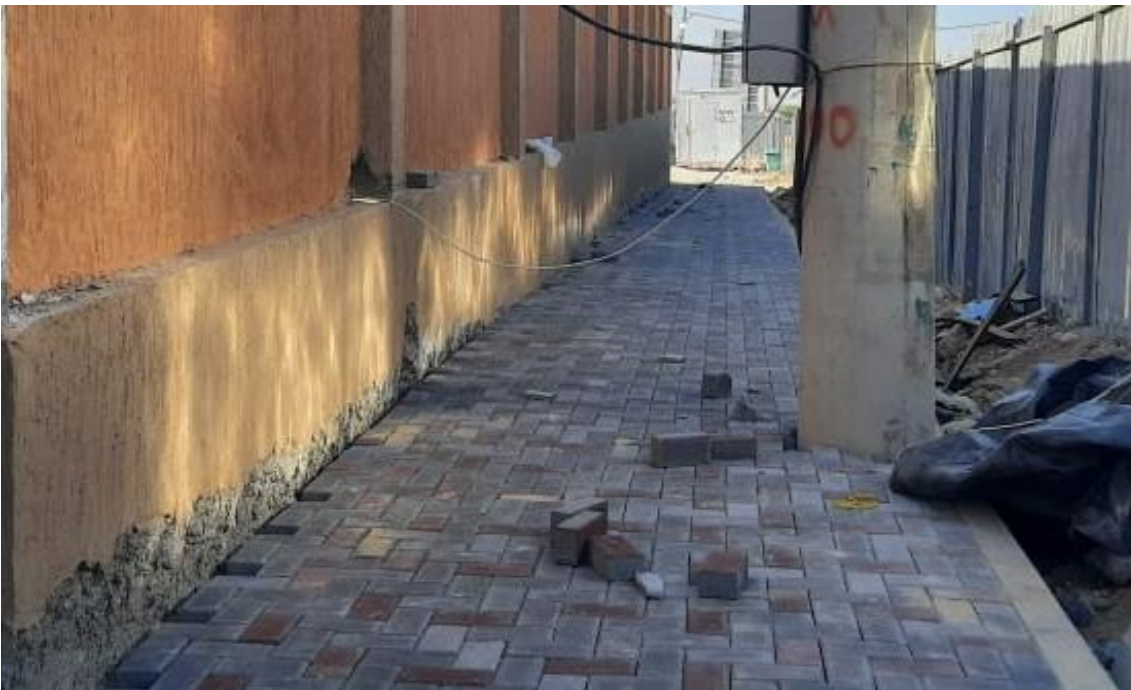
(Figure: 09)

The team previously observed that the Contractor has installed interlock tiles in an unacceptable way with regard to the architectural details and approved shop drawings

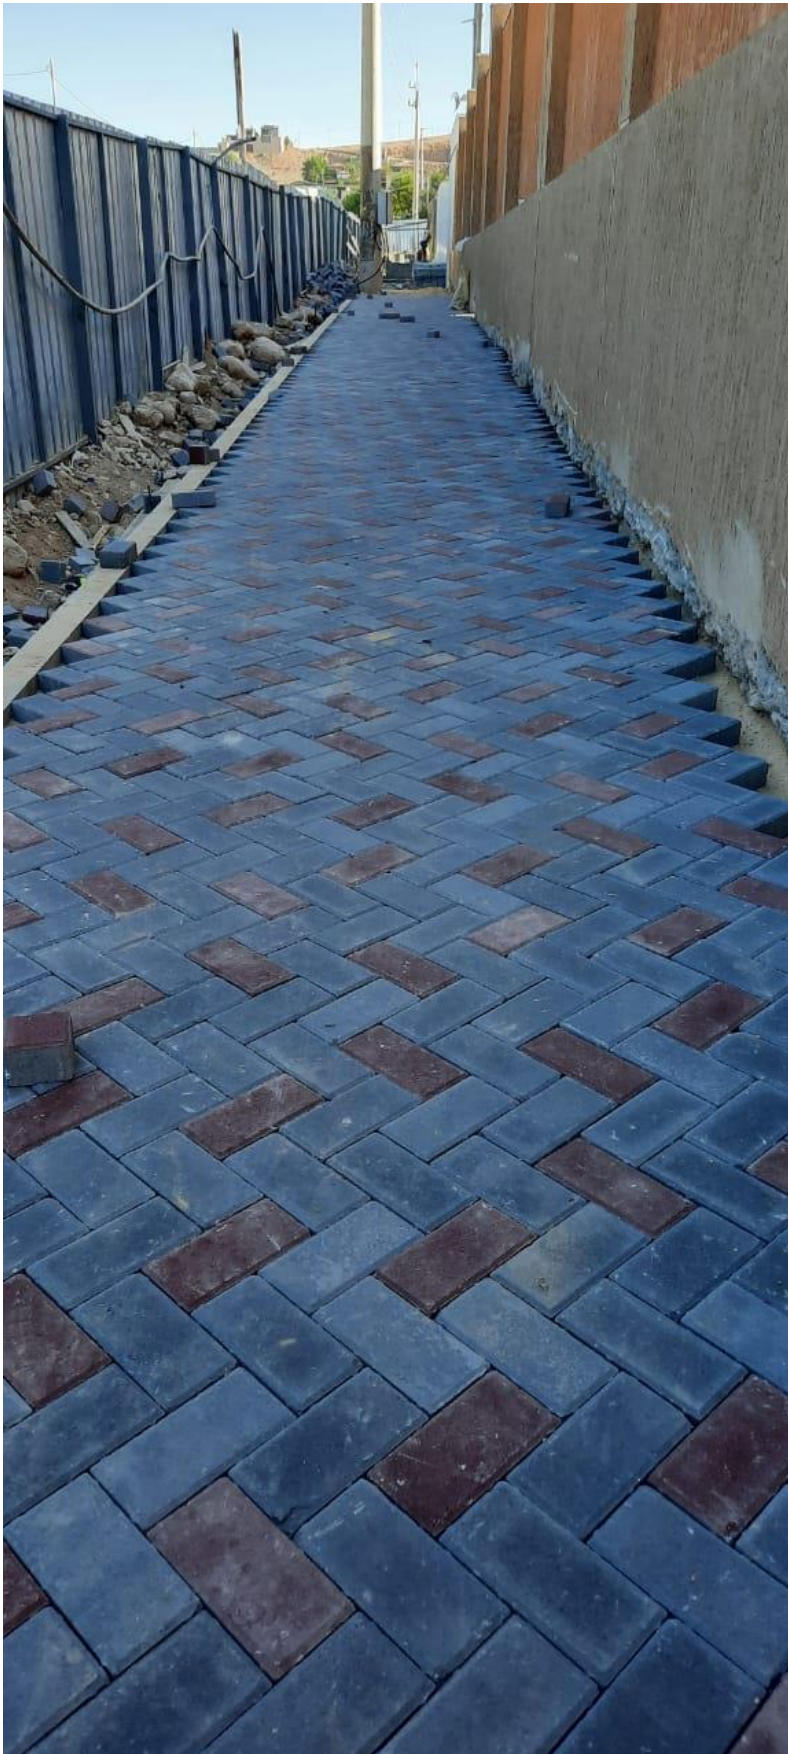
(Figure: 10)

The Contractor has retiled the interlock tiles according to the architectural details and approved shop drawings

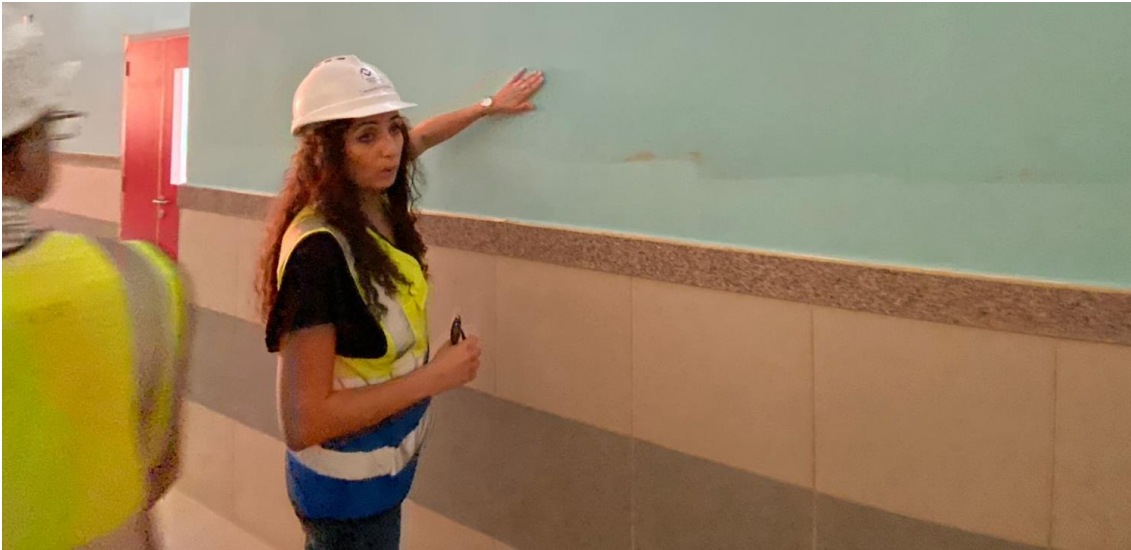
(Figure: 11)

The team previously observed that there is some waving in the plastering and painting at the corridors

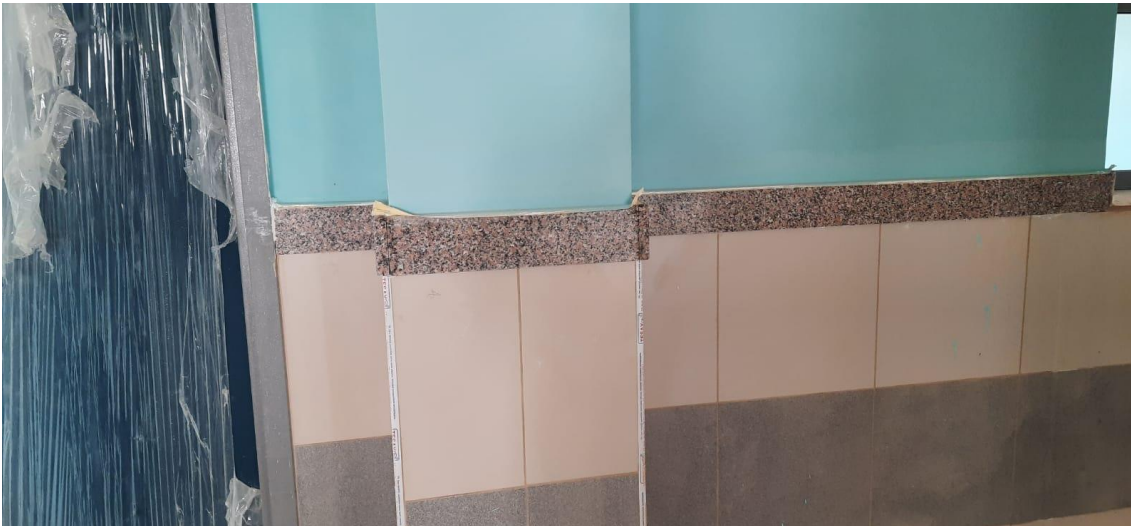
(Figure: 12)

The team noticed that the Contractor rectified the waving in the plastering

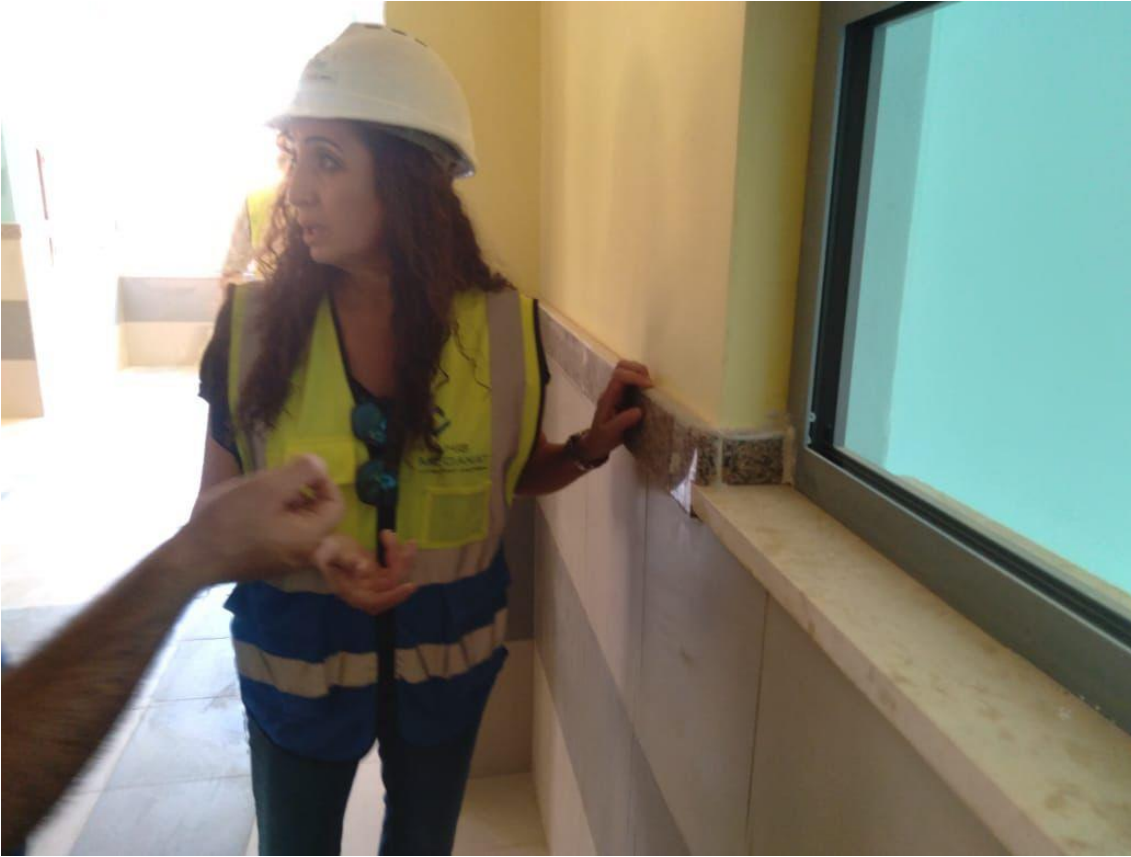
(Figure: 13)

The team Inspected the relation between granite coping and the window sill at the corridor

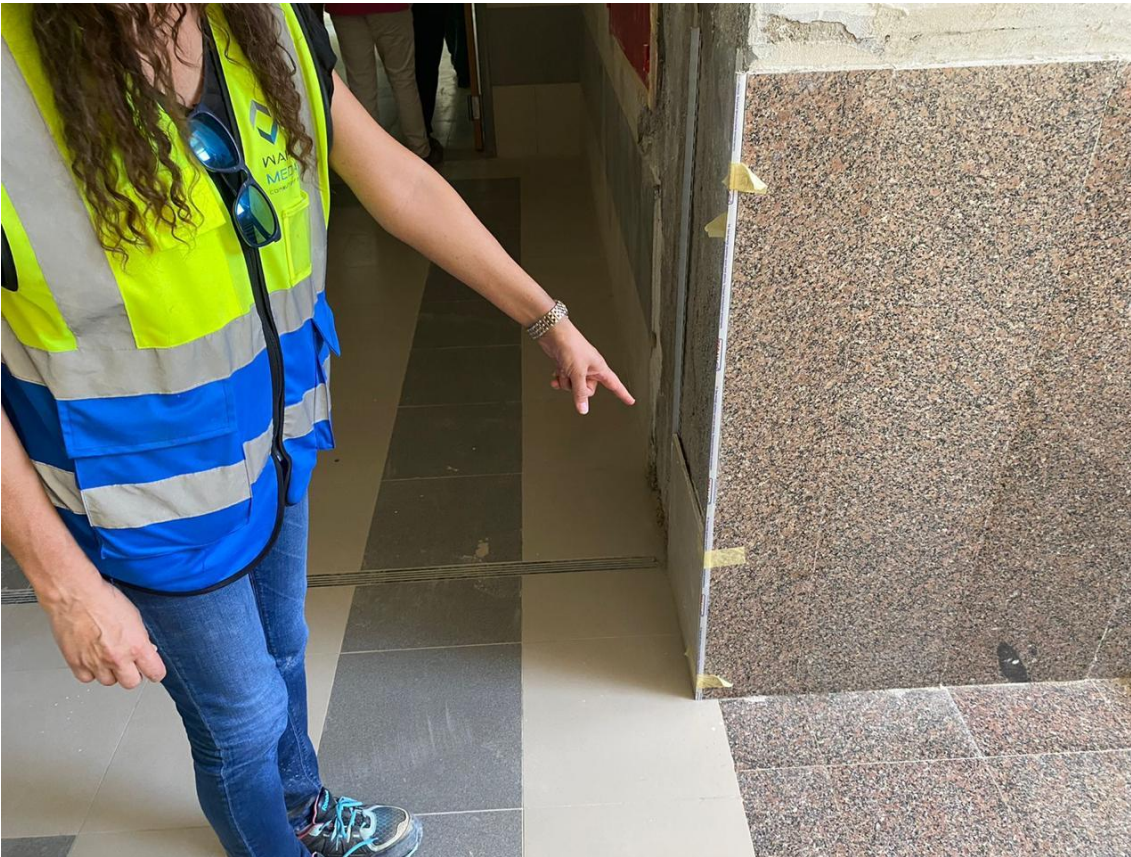
(Figure: 14)

The team observed black spots on the granite cladding of the staircases and requested the Contractor to replace

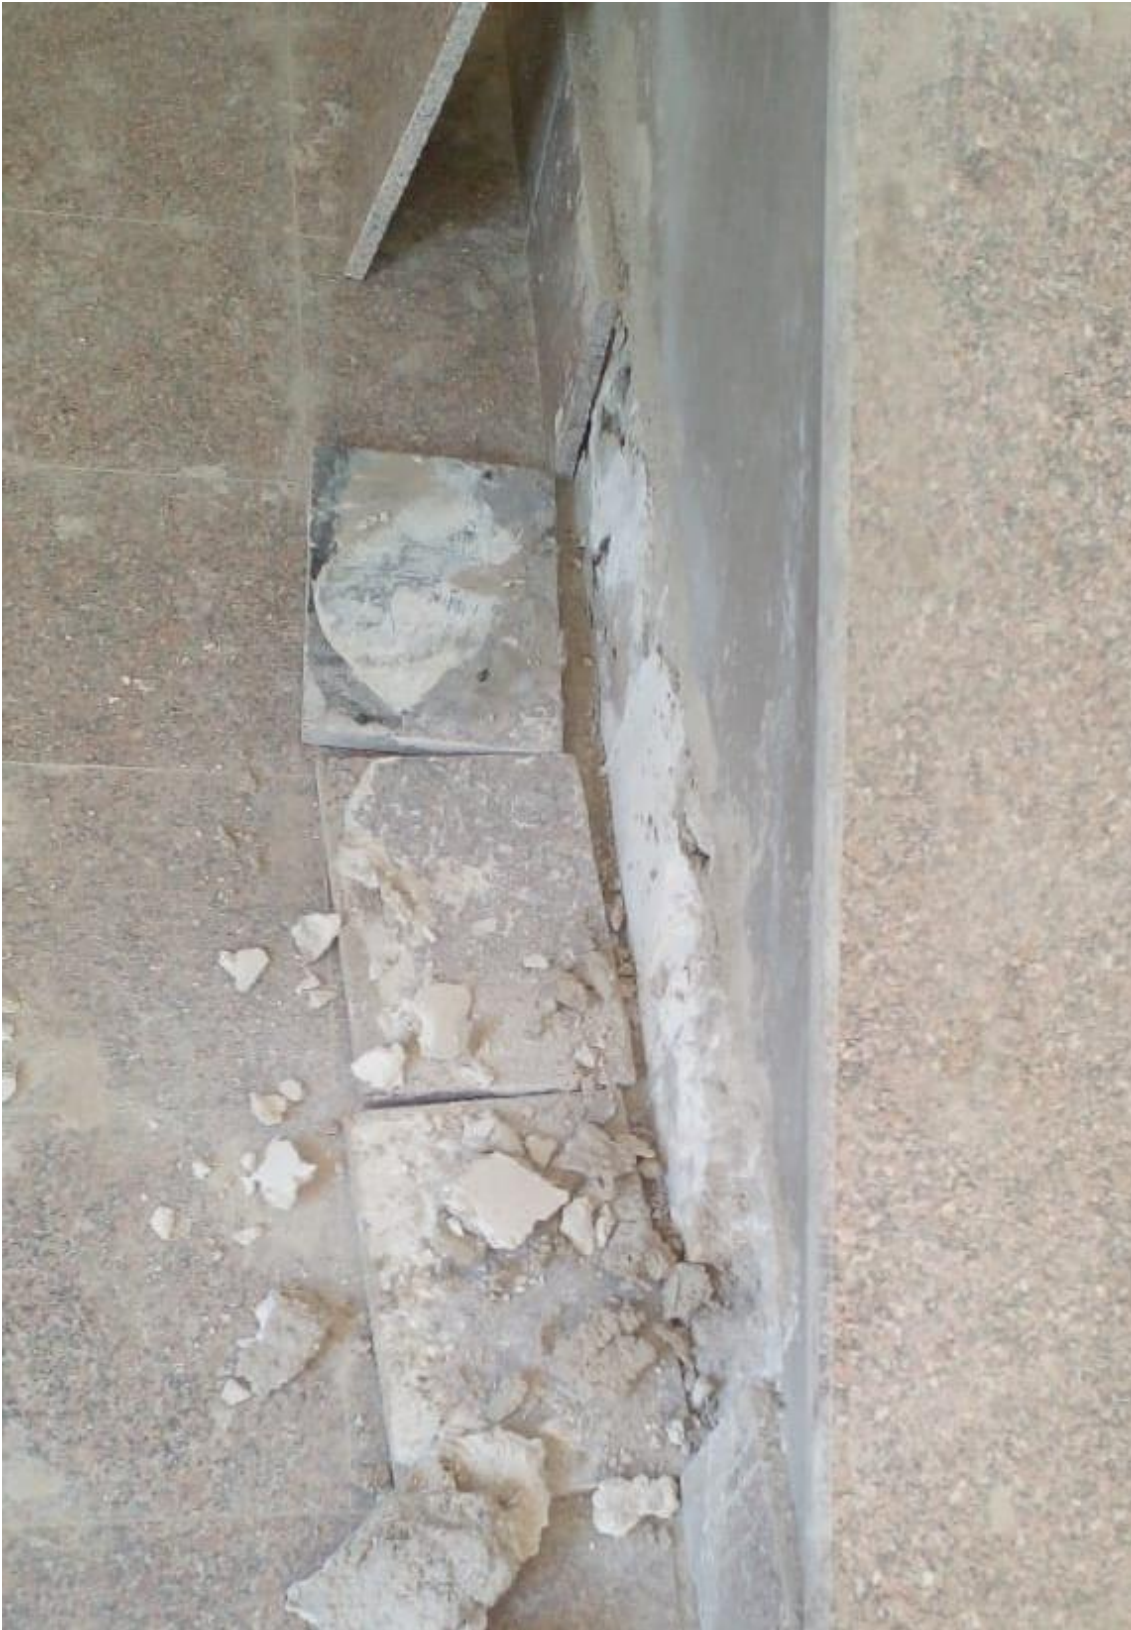
(Figure: 15)

the Contractor started with rectification of the teething in granite and replacing granite pieces that have black spots with new standard acceptable ones

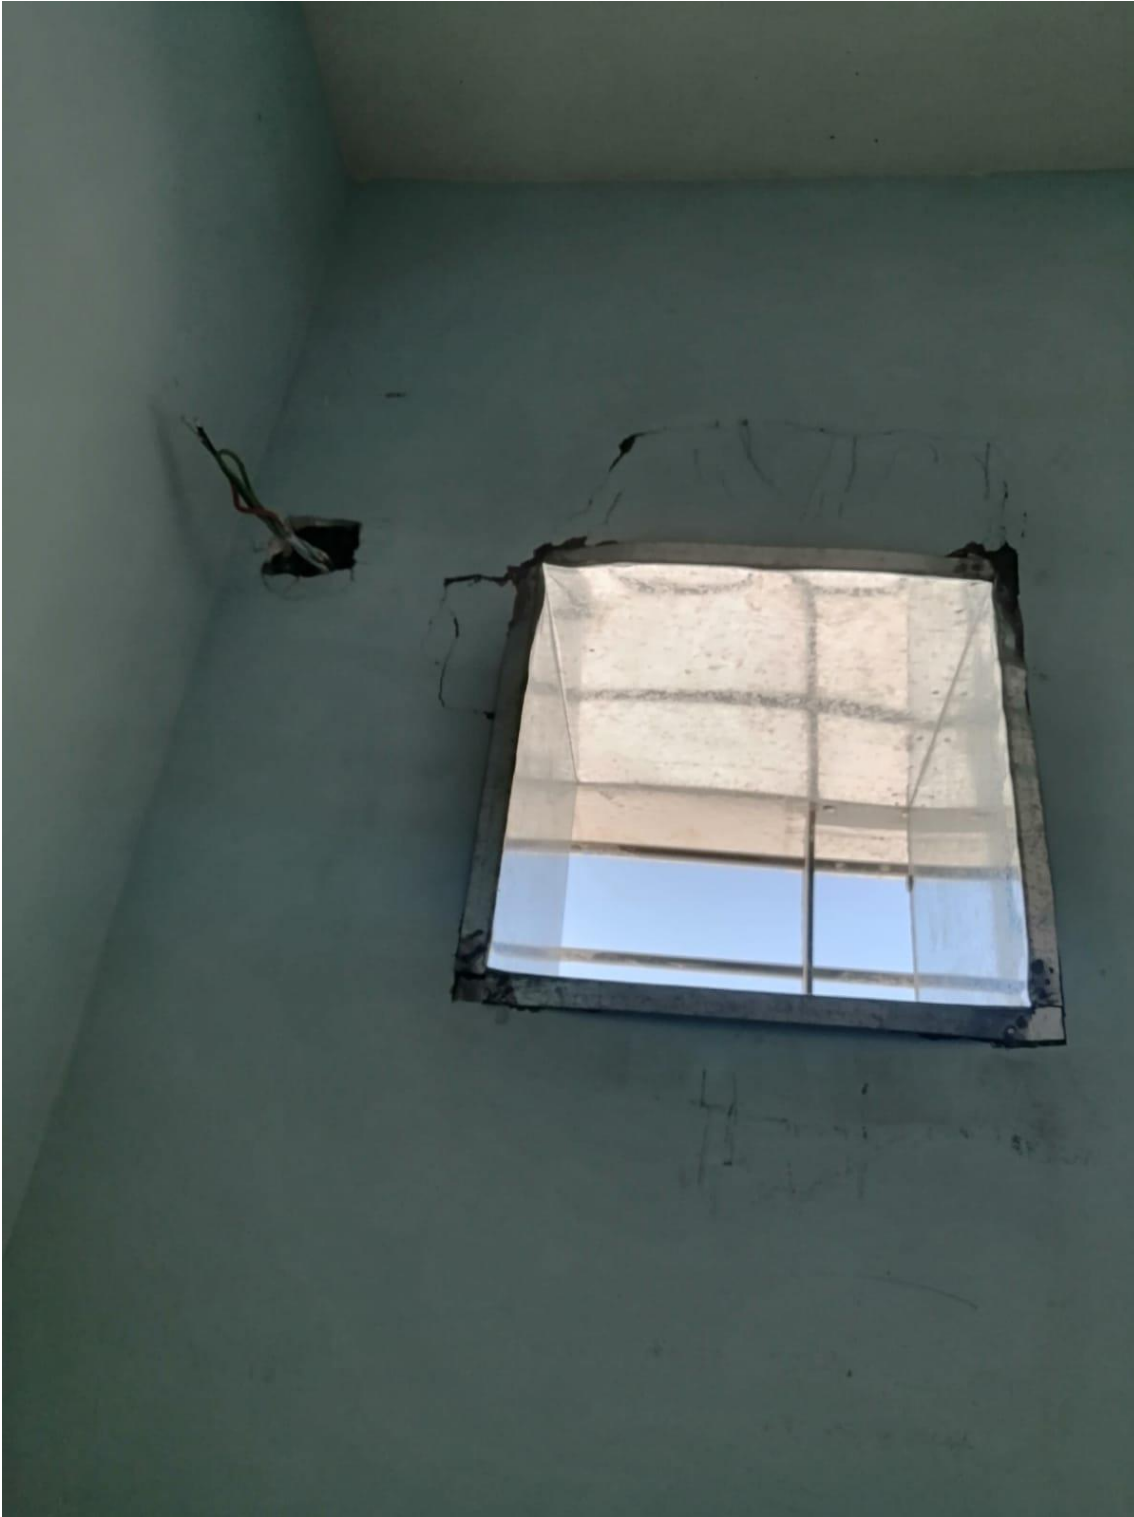
(Figure: 16)

The Team observed that the base plate for the wall fans and the wall on which it was installed is damaged and will not be suitable for the installation of the fans. The Contractor was requested to fix the damages in both the base plate and the wall before installing the fans
