Quality Control Report

Consultant **Wahib Medanat** Consultant Engineers
Site Name **Al Khansa'a Basic Mixed - Balqa**
Package **Package 1**
Contractor **Derar Saraireh & Sons for Engineering & Contracting**
Tender No. **1/2020/USAID/SKEP/3/1**

Rep No. **QC-12 12**
Date **16 / 02 / 2022**

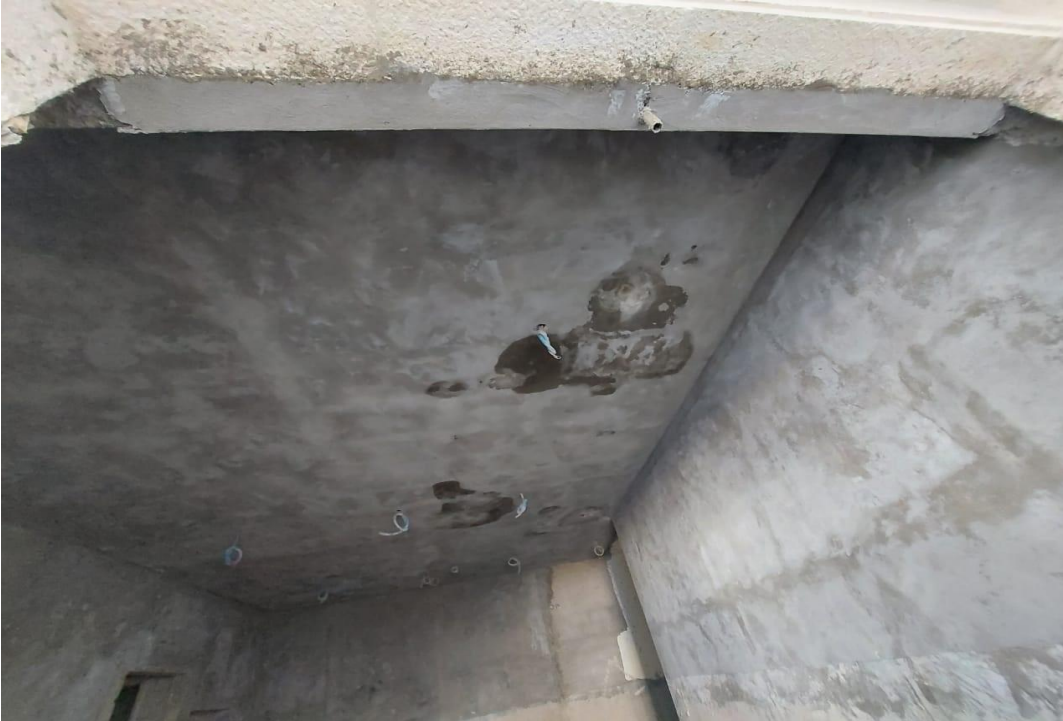
Leakage at the ceiling of the multi-purpose hall

Waterproofing for the roof of multi-purpose hall

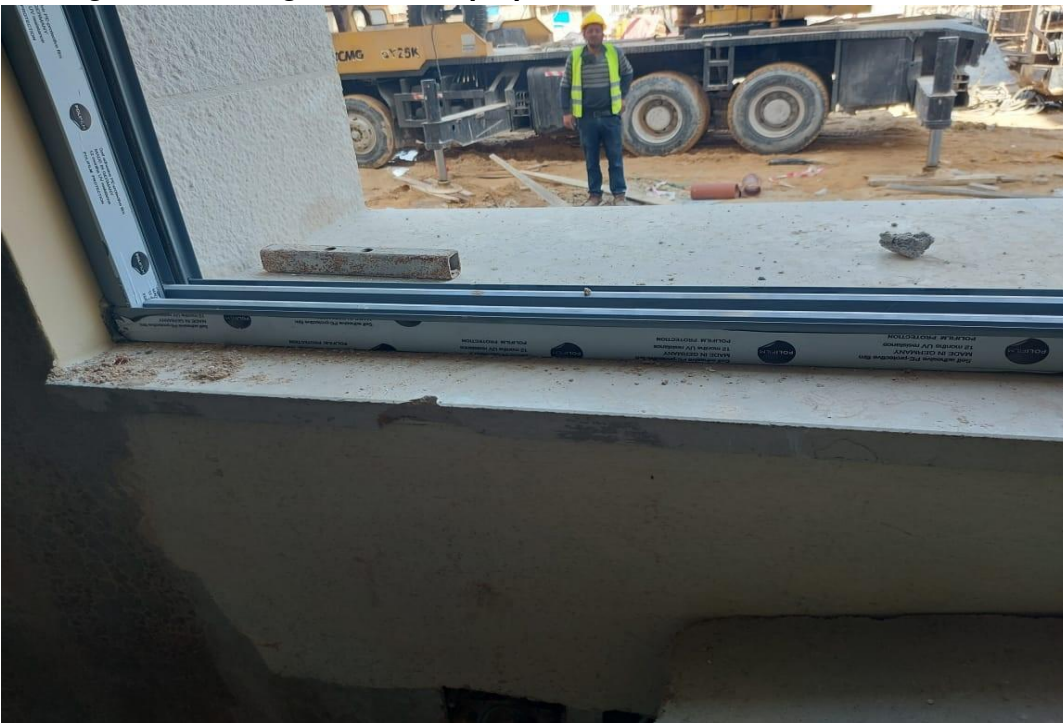
Broken window sill

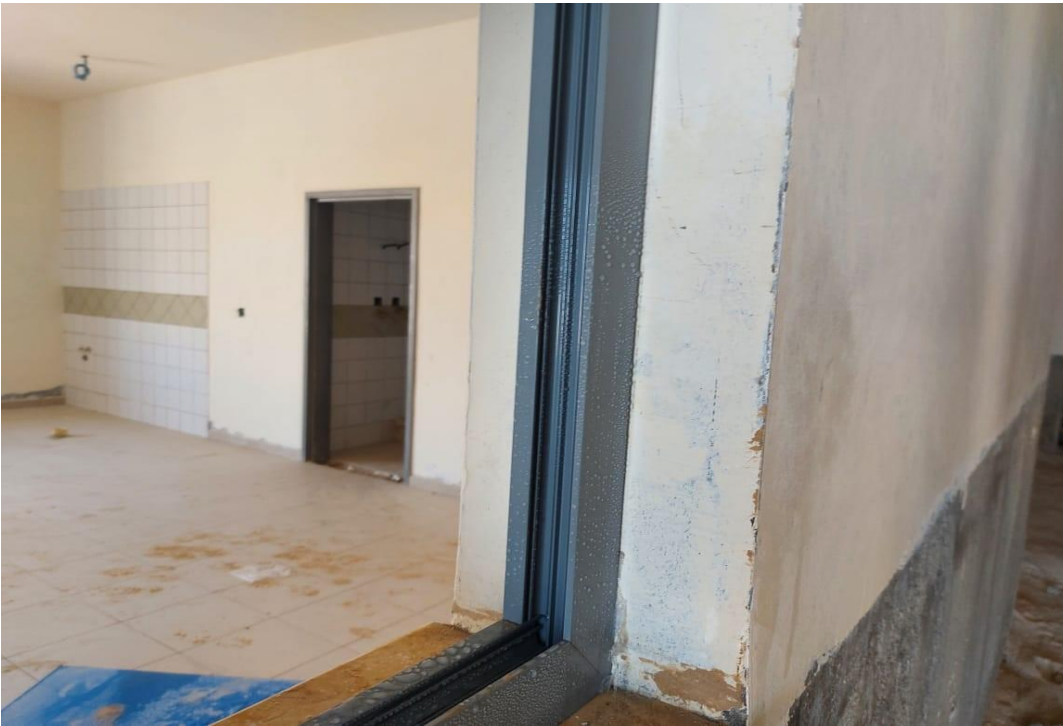
Unfinished window jambs

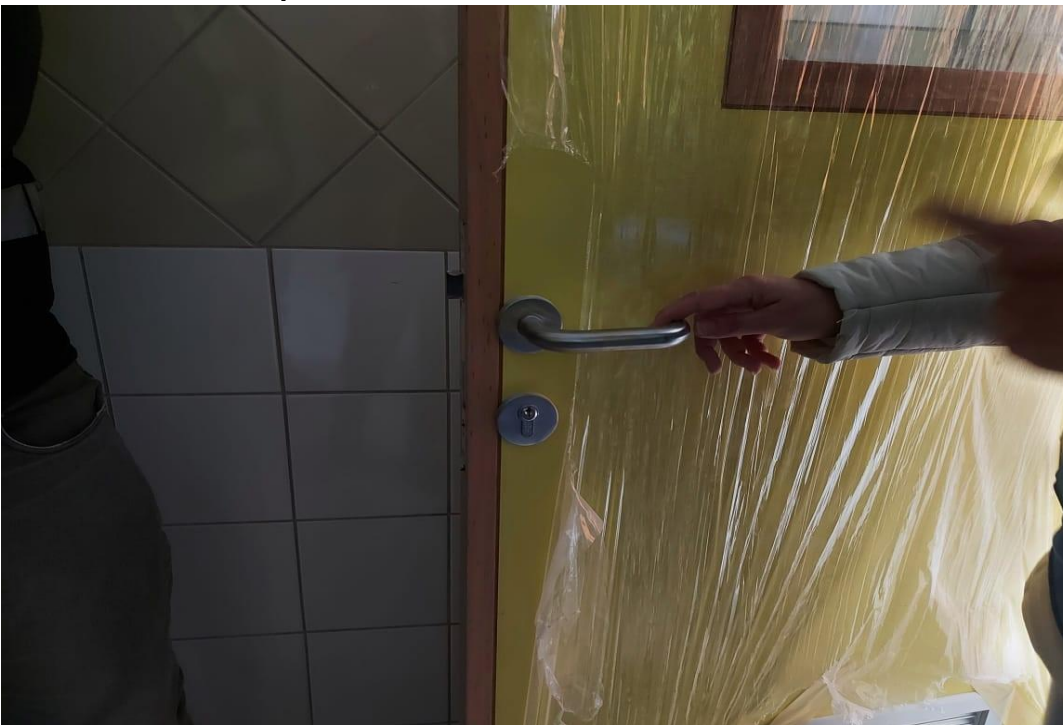
Door locker merging into door frame

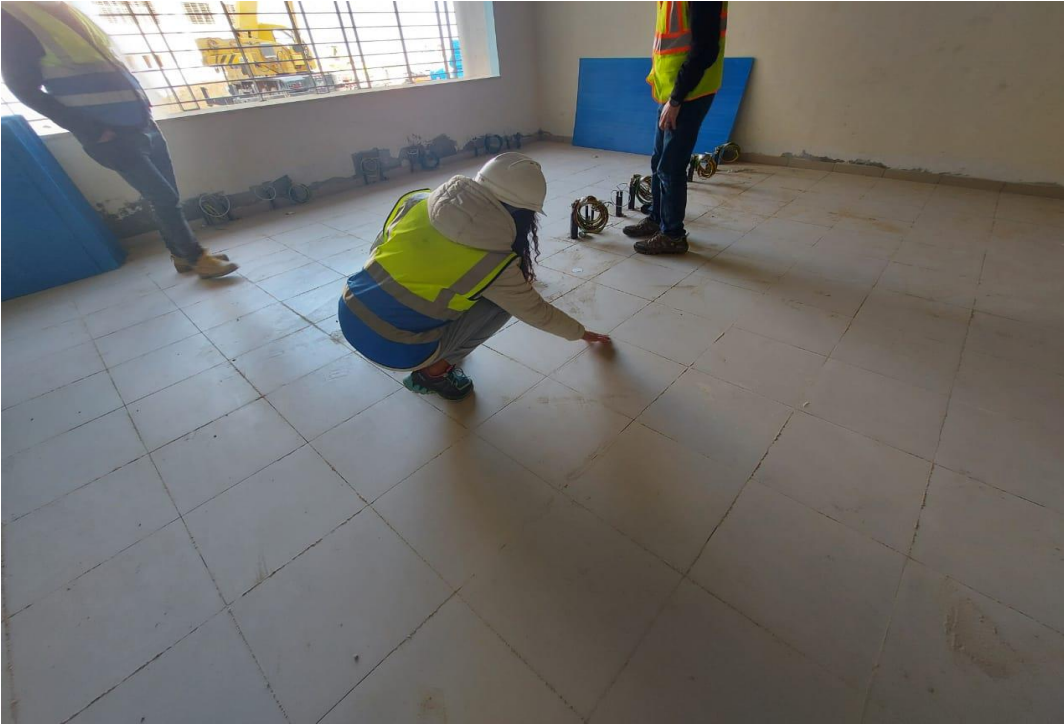
Teething of porcelain floor tiles

Porcelian floor tiles without teething
