Quality Control Report

Consultant	Wahib Medanat Consultant Engineers
Site Name	Um Al Dananir Basic Mixed - Balqa
Package	Package 1
Contractor	Derar Saraireh & Sons for Engineering & Contracting
Tender No.	1/2020/USAID/SKEP/3/1

Rep No.	QC-11	17	
Date	9	/ 03 /	2022

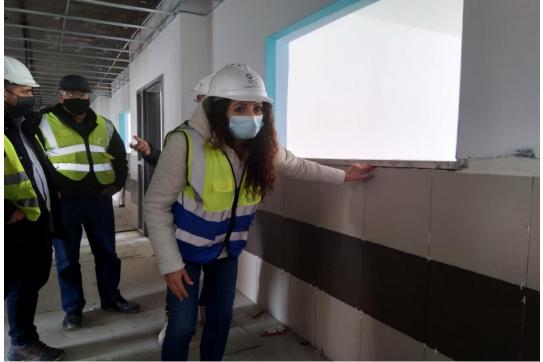
Variations in the levels of window sills

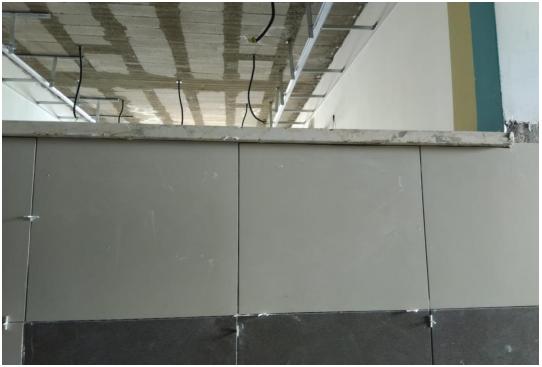
Variations in the levels of window sills

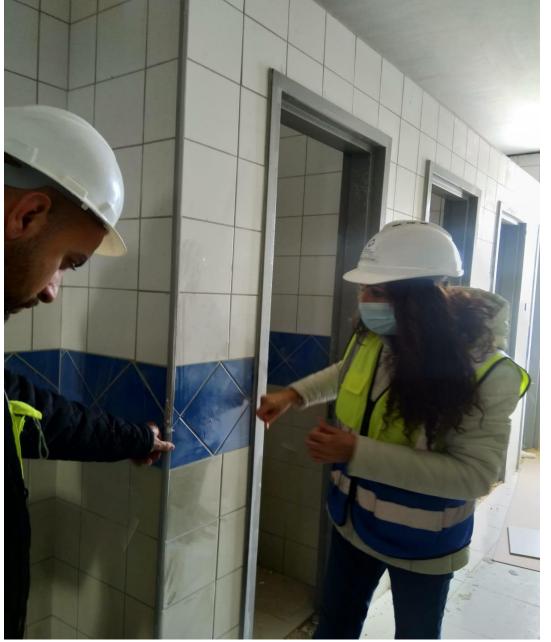
Defects in wall ceramic tiles

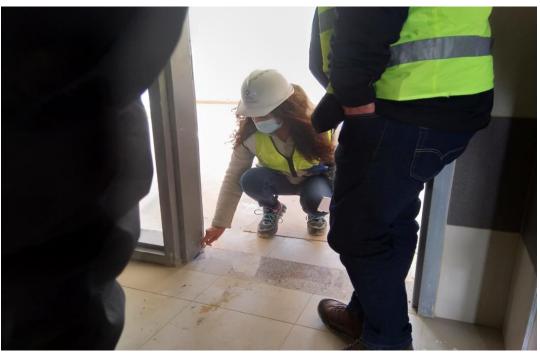
Defects in the threshold

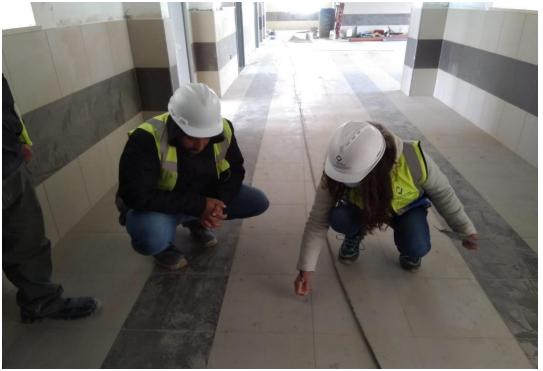
Teething in floor tiles
