SKEP III Home Office Support Site Visit Report

Consultant	Wahib Medanat Consultant Engineer	Rep No.	22-19042022
Contractor	Dijlah Establishment Constr. Contracting	Tender No.	(11/2019/USAID/SKEP/3/S) Schools for a Knowledge Economy Project (SKEP) - Phase (3) Package (1, 2)
Site Name	Thahr Al Sarow Basic School for Boys- Jerash	Day/ Date	Tue. 19/04/2022
Duration of Project	450 Calendar Days	Total Project Budget	8,314,983.735 JD

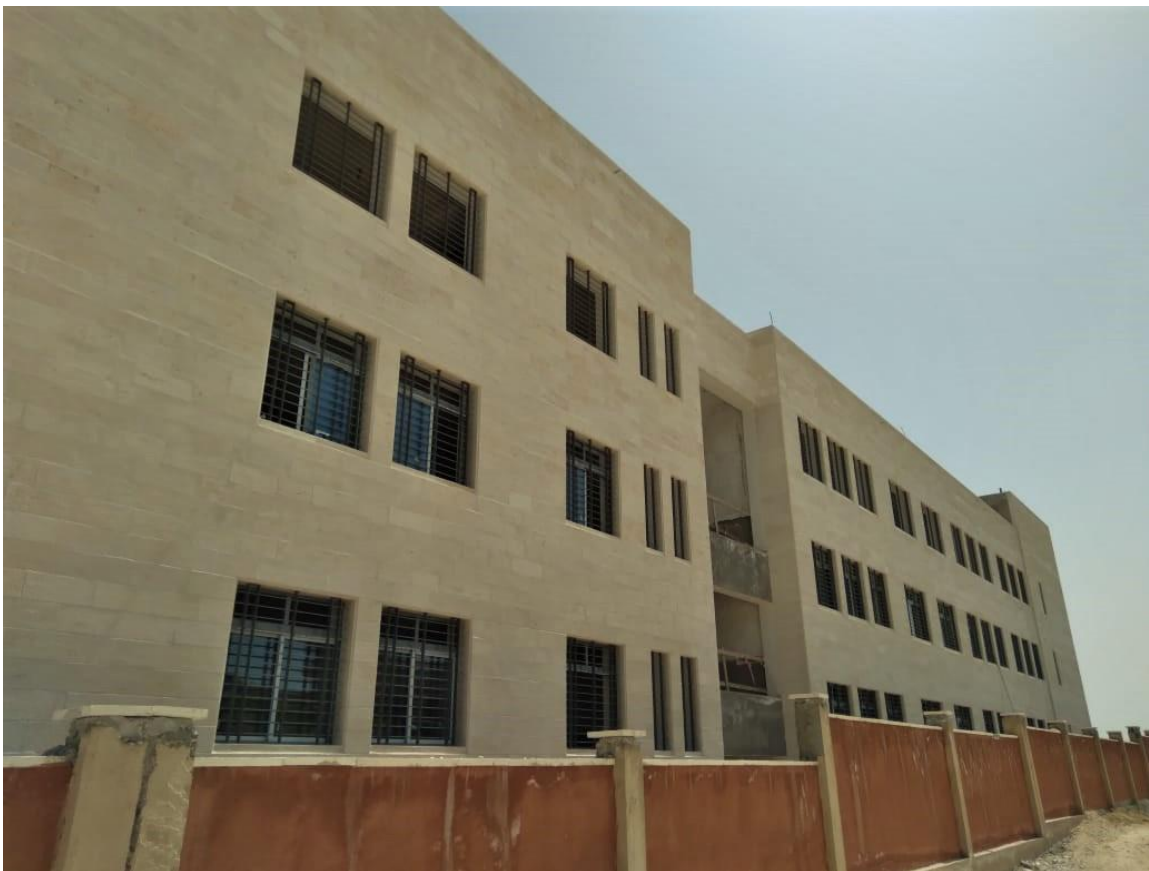
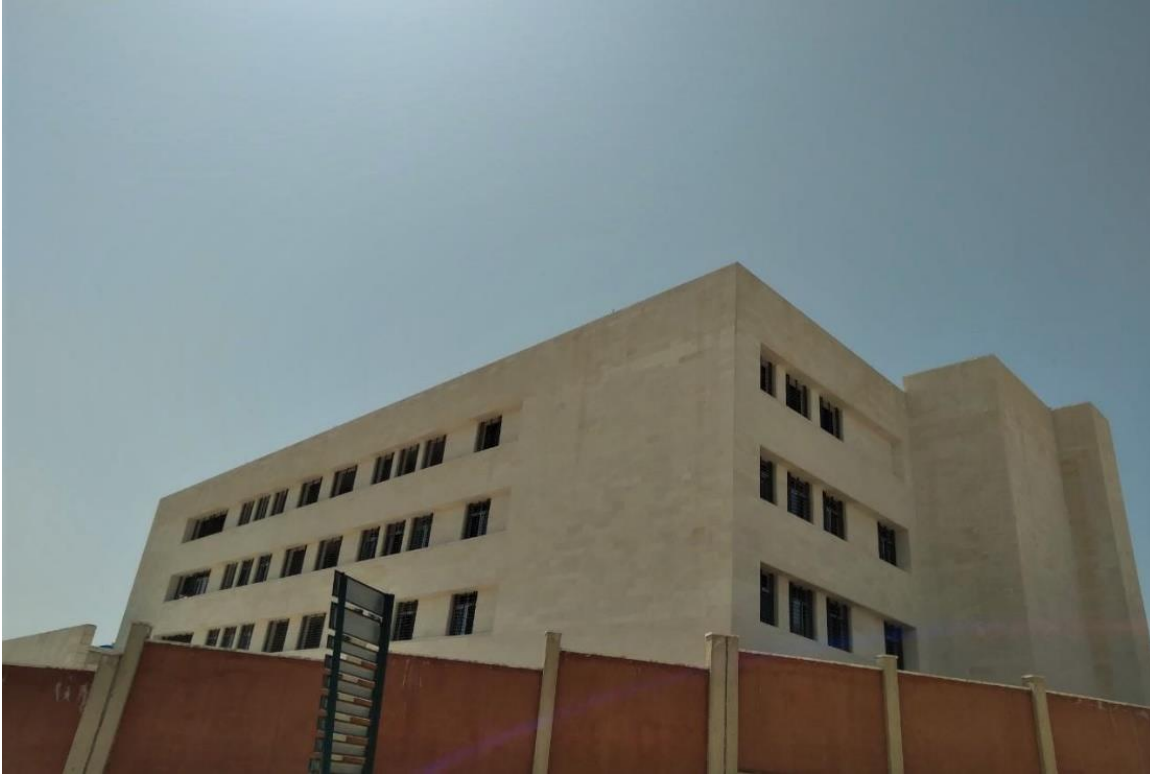
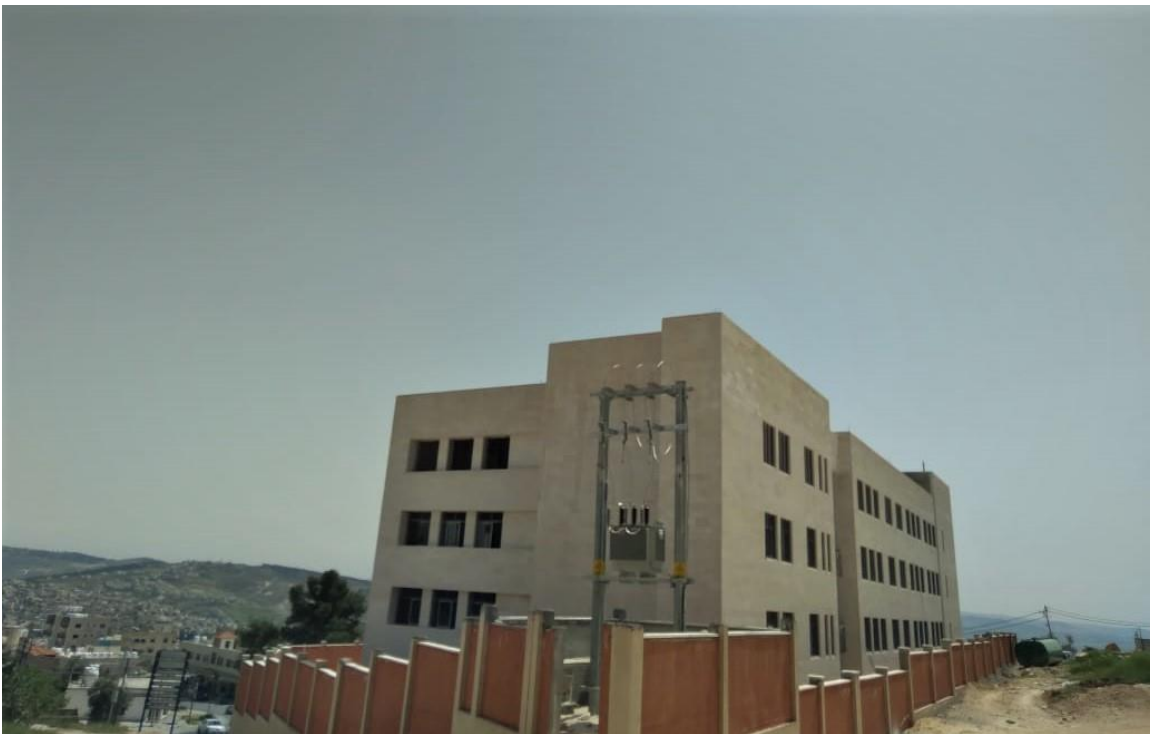
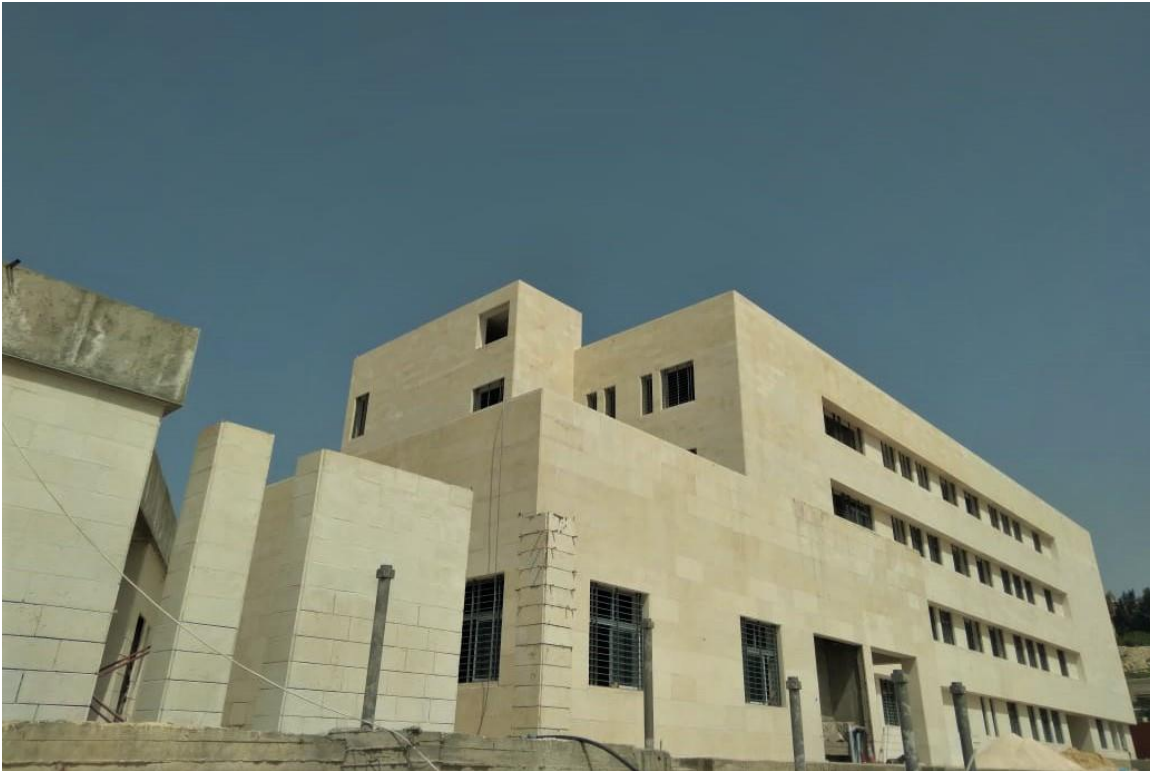
General view of the project

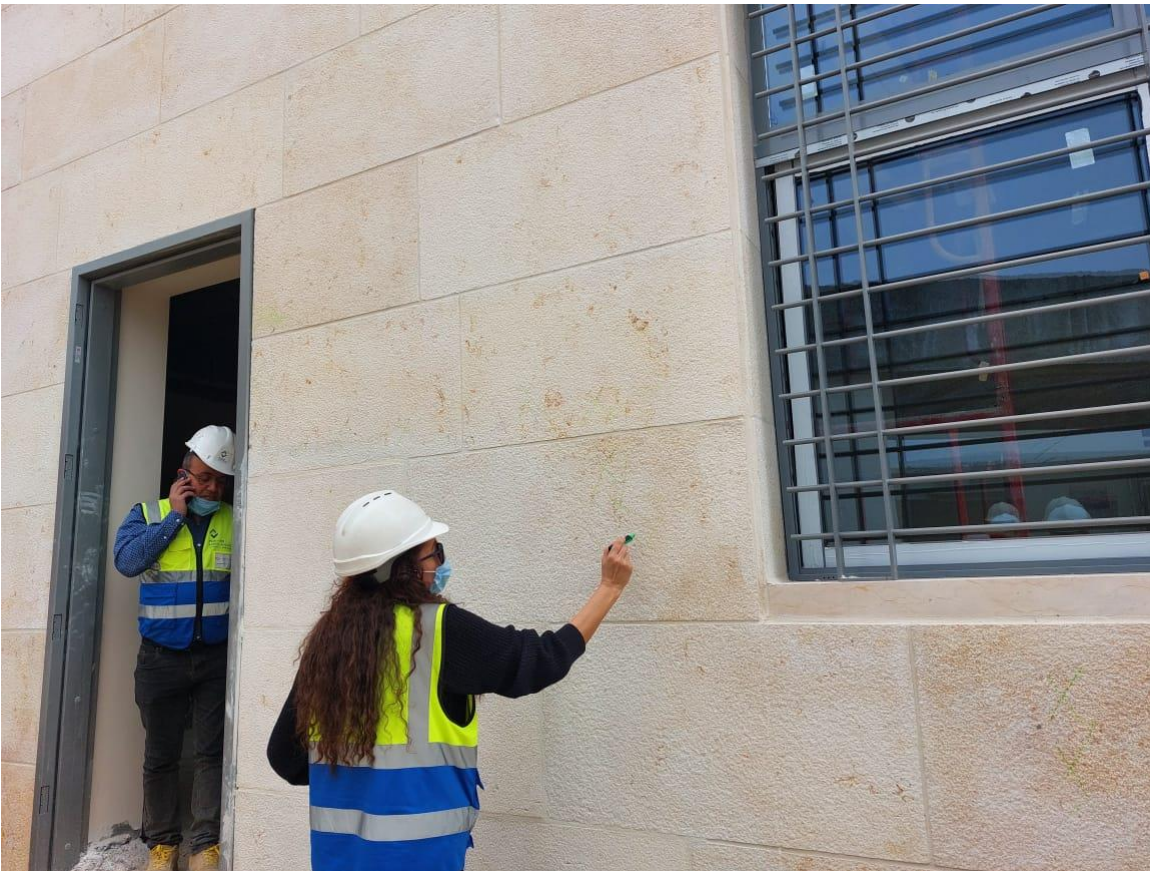
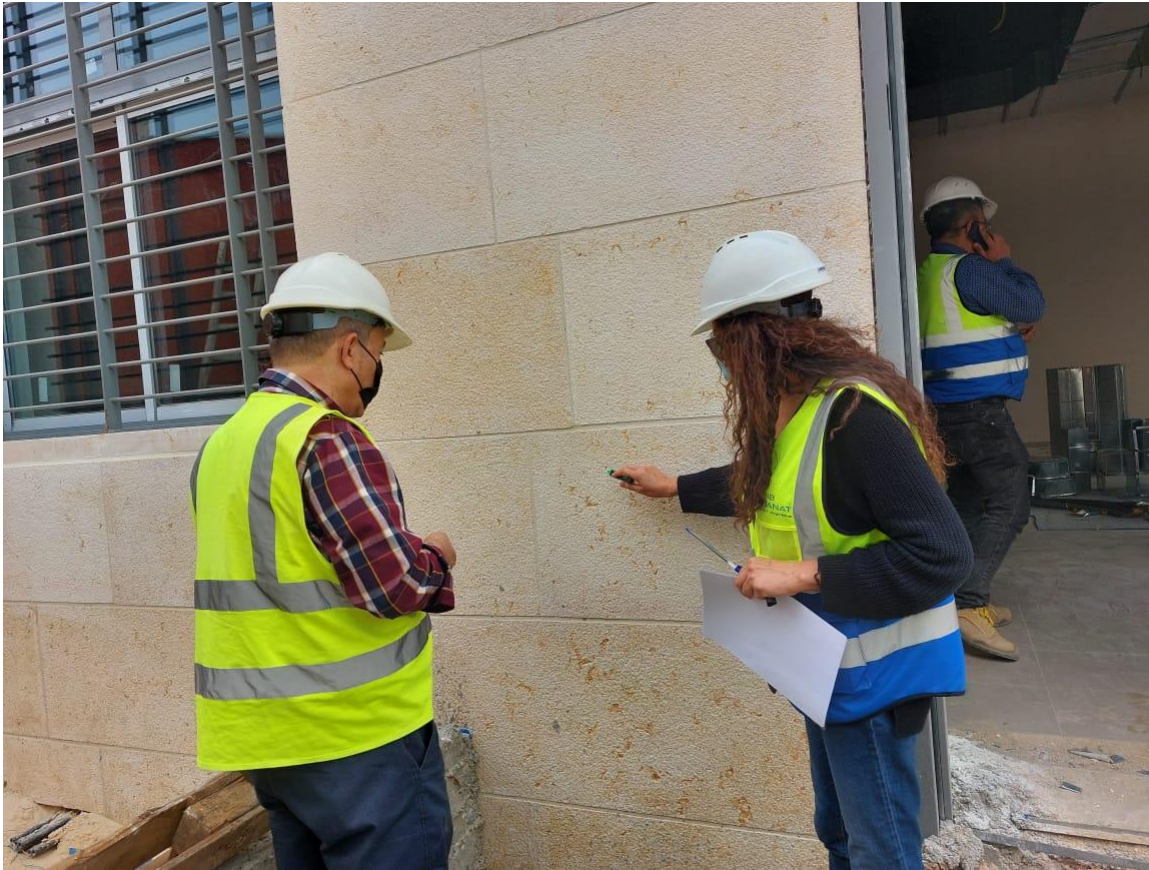
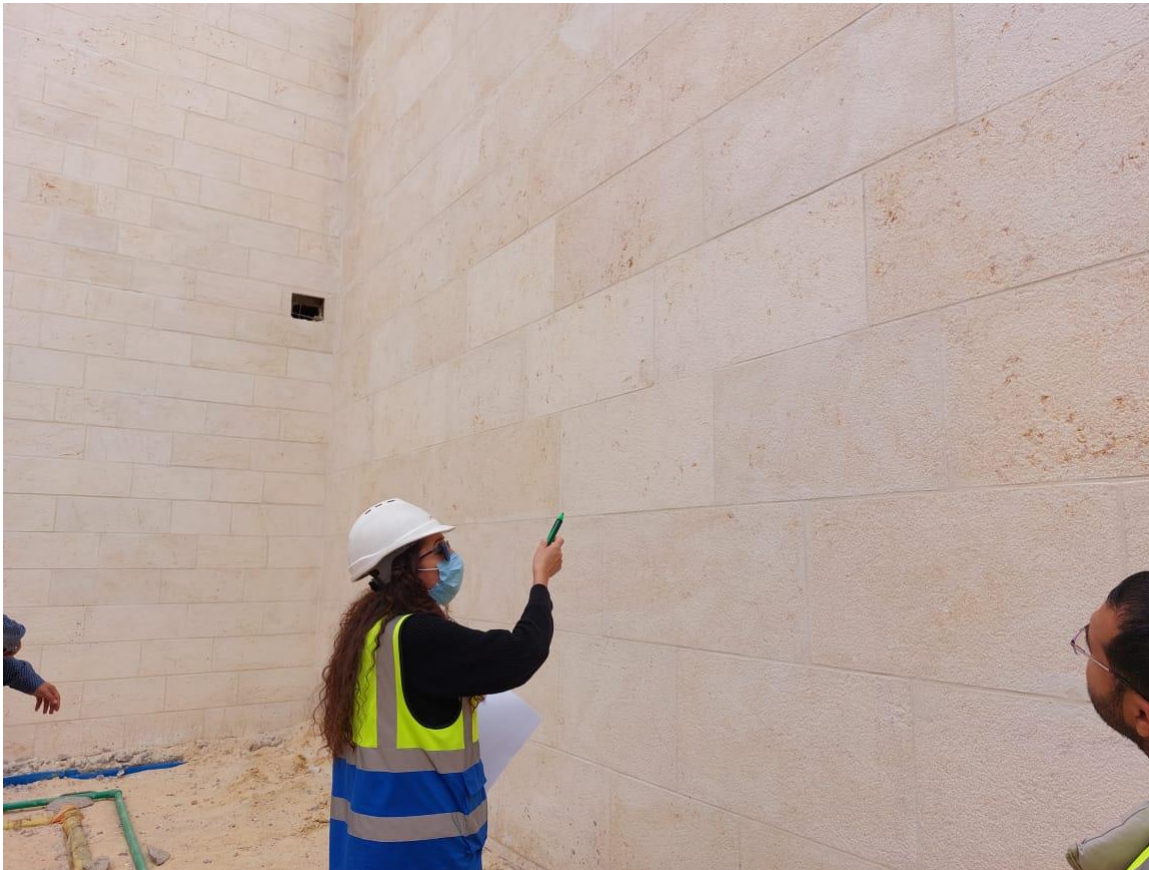
The team observed that parts of built stones at facades are still defective and not replaced

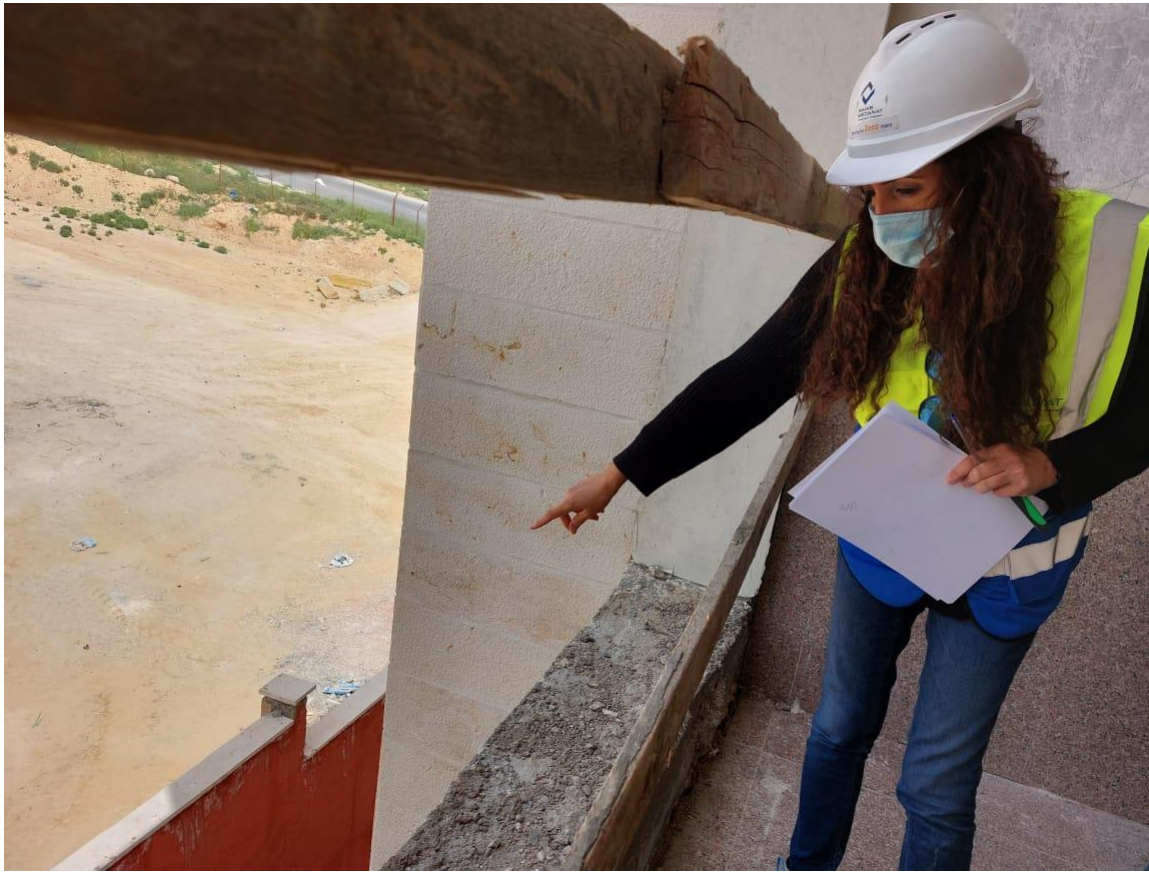
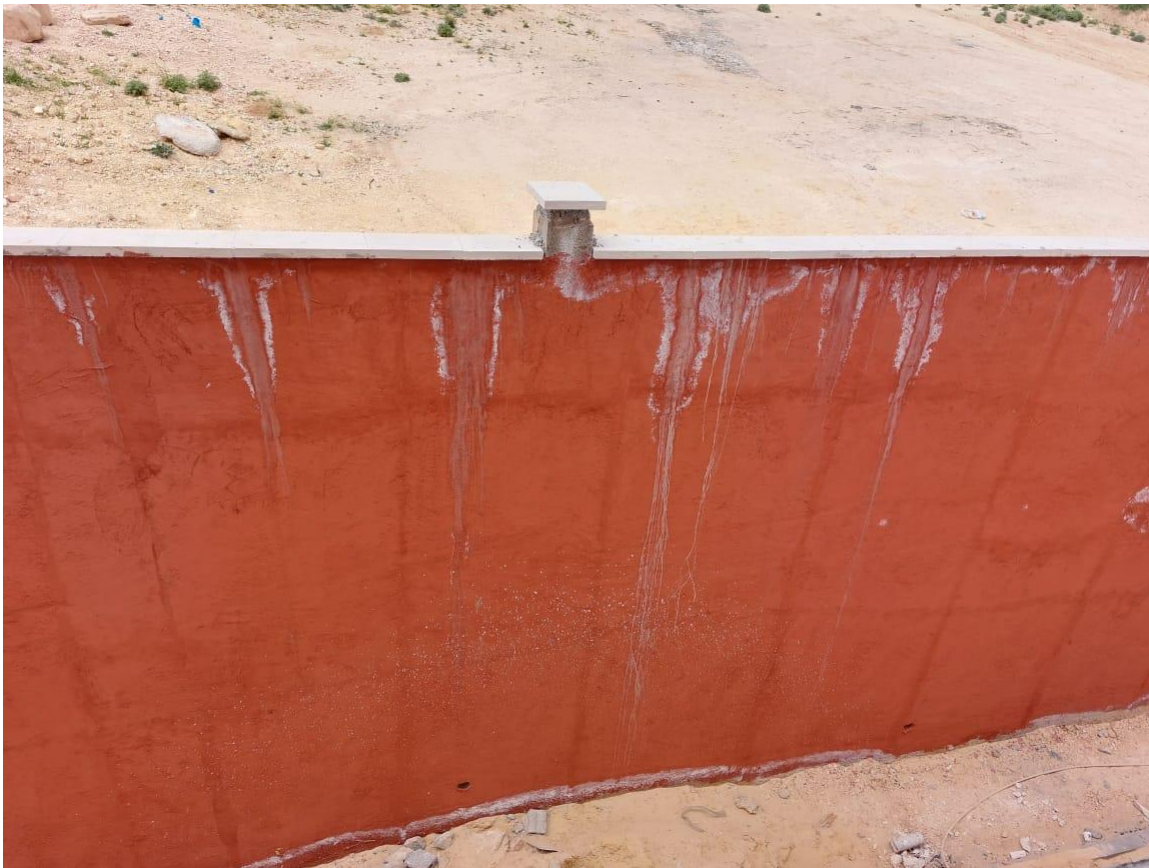
The team inspected the external colored plastering at the building and the boundaries and requested the Contractor to clean all the white dirt at those walls due to the work in the stone coping or defects in the plastering material. Also, the Contractor was reminded with one of the requirements of the specifications, which is to apply protective coating at the top of plastering

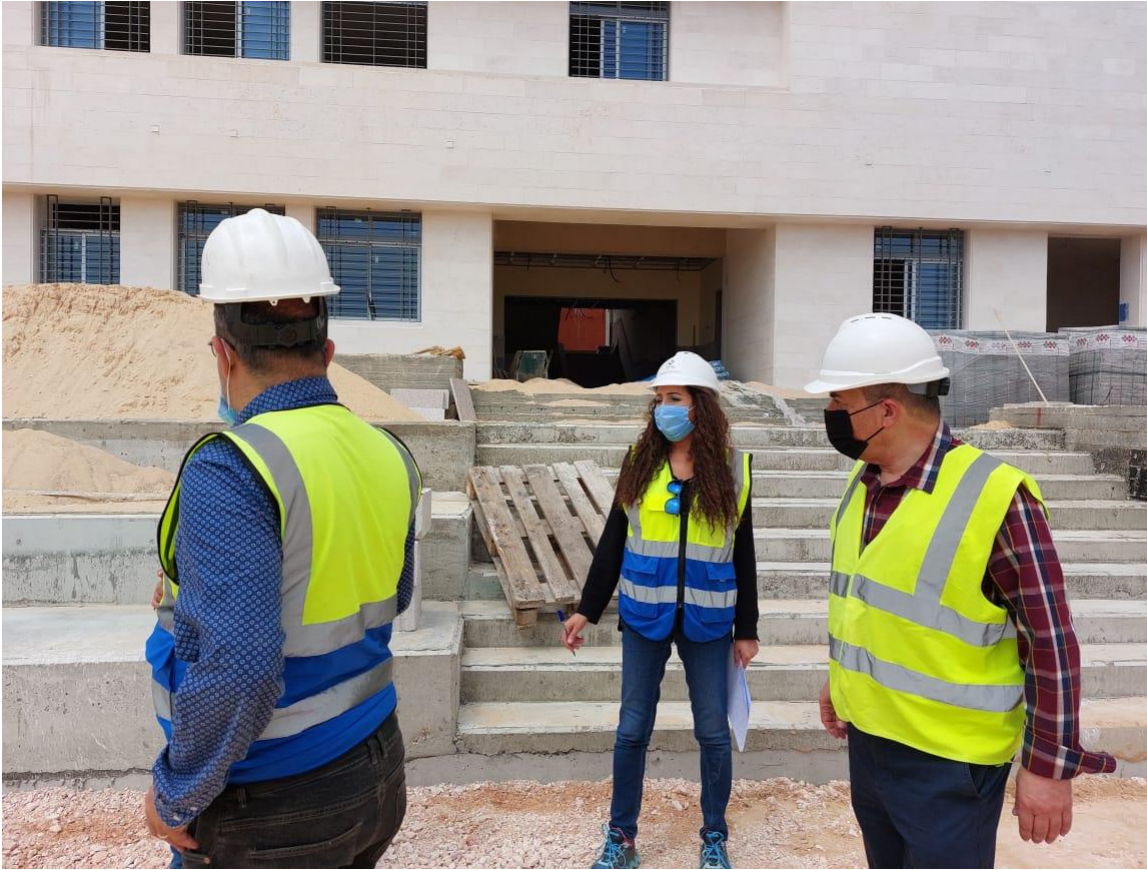
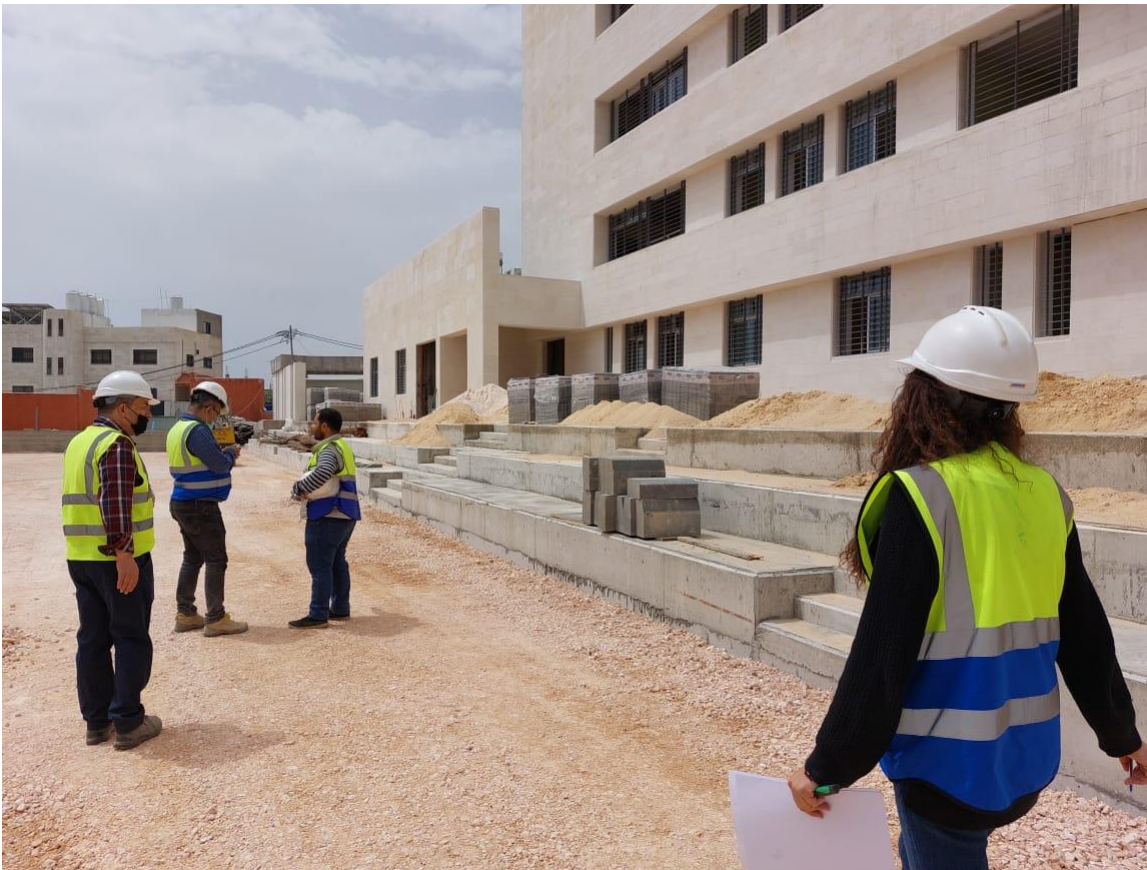
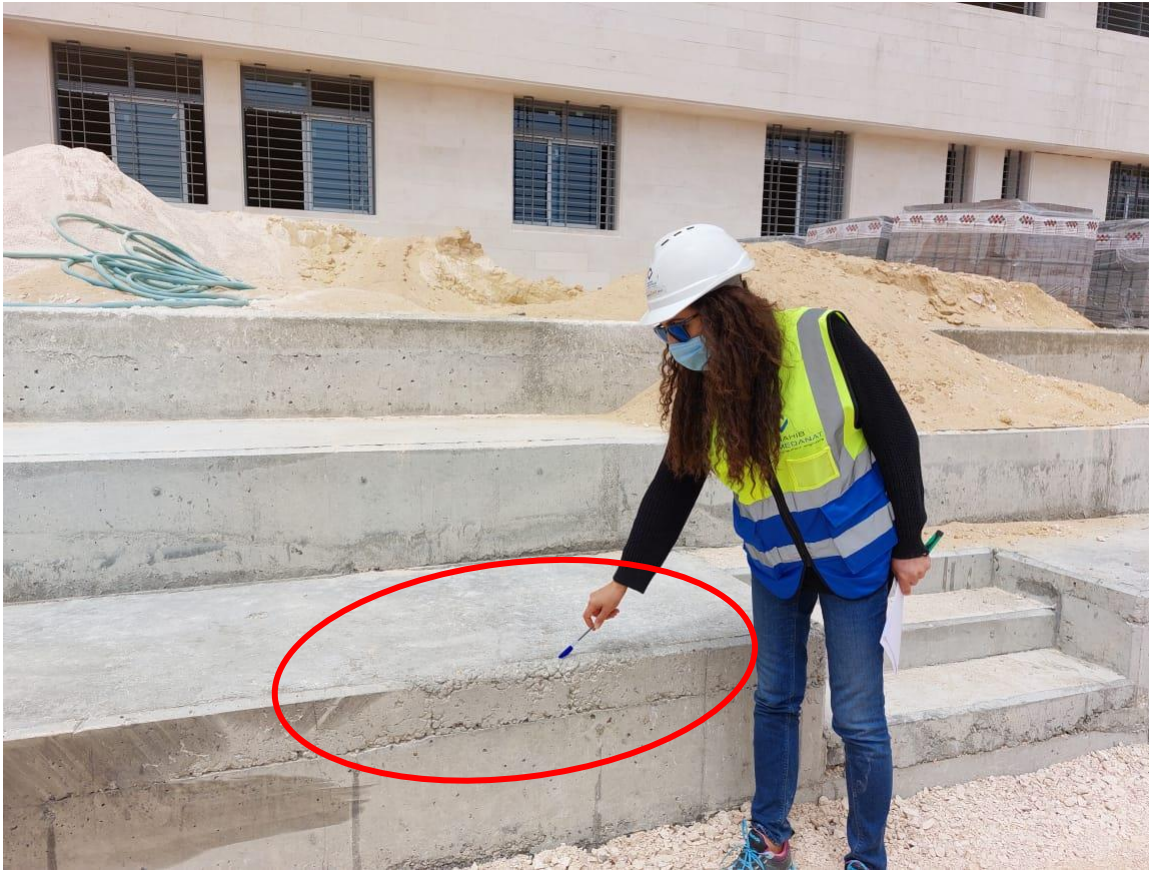
The team observed the executed works at the external yards and requested the Contractor to apply repairs for the spectator's seats

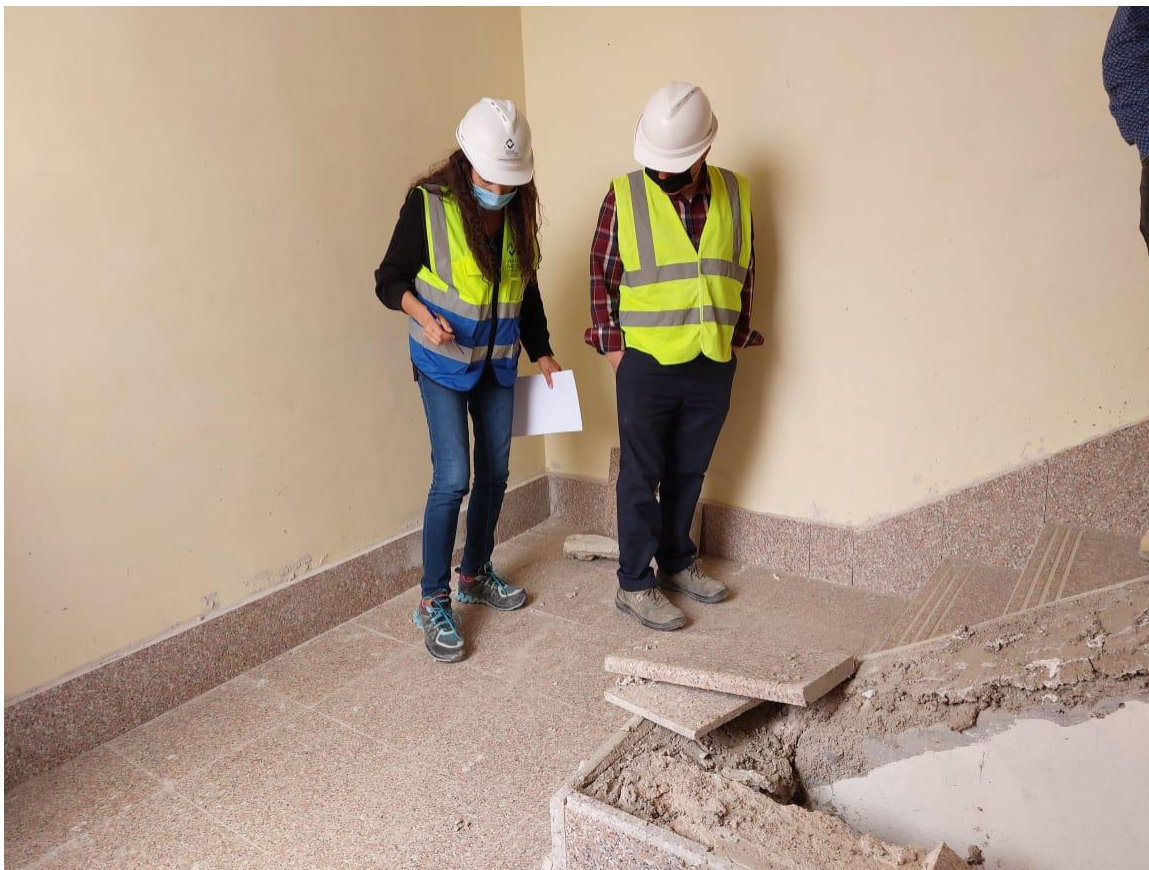
The team inspected the granite tiling for the landing of the staircases and observed teething in some parts and requested the Contractor to rectify

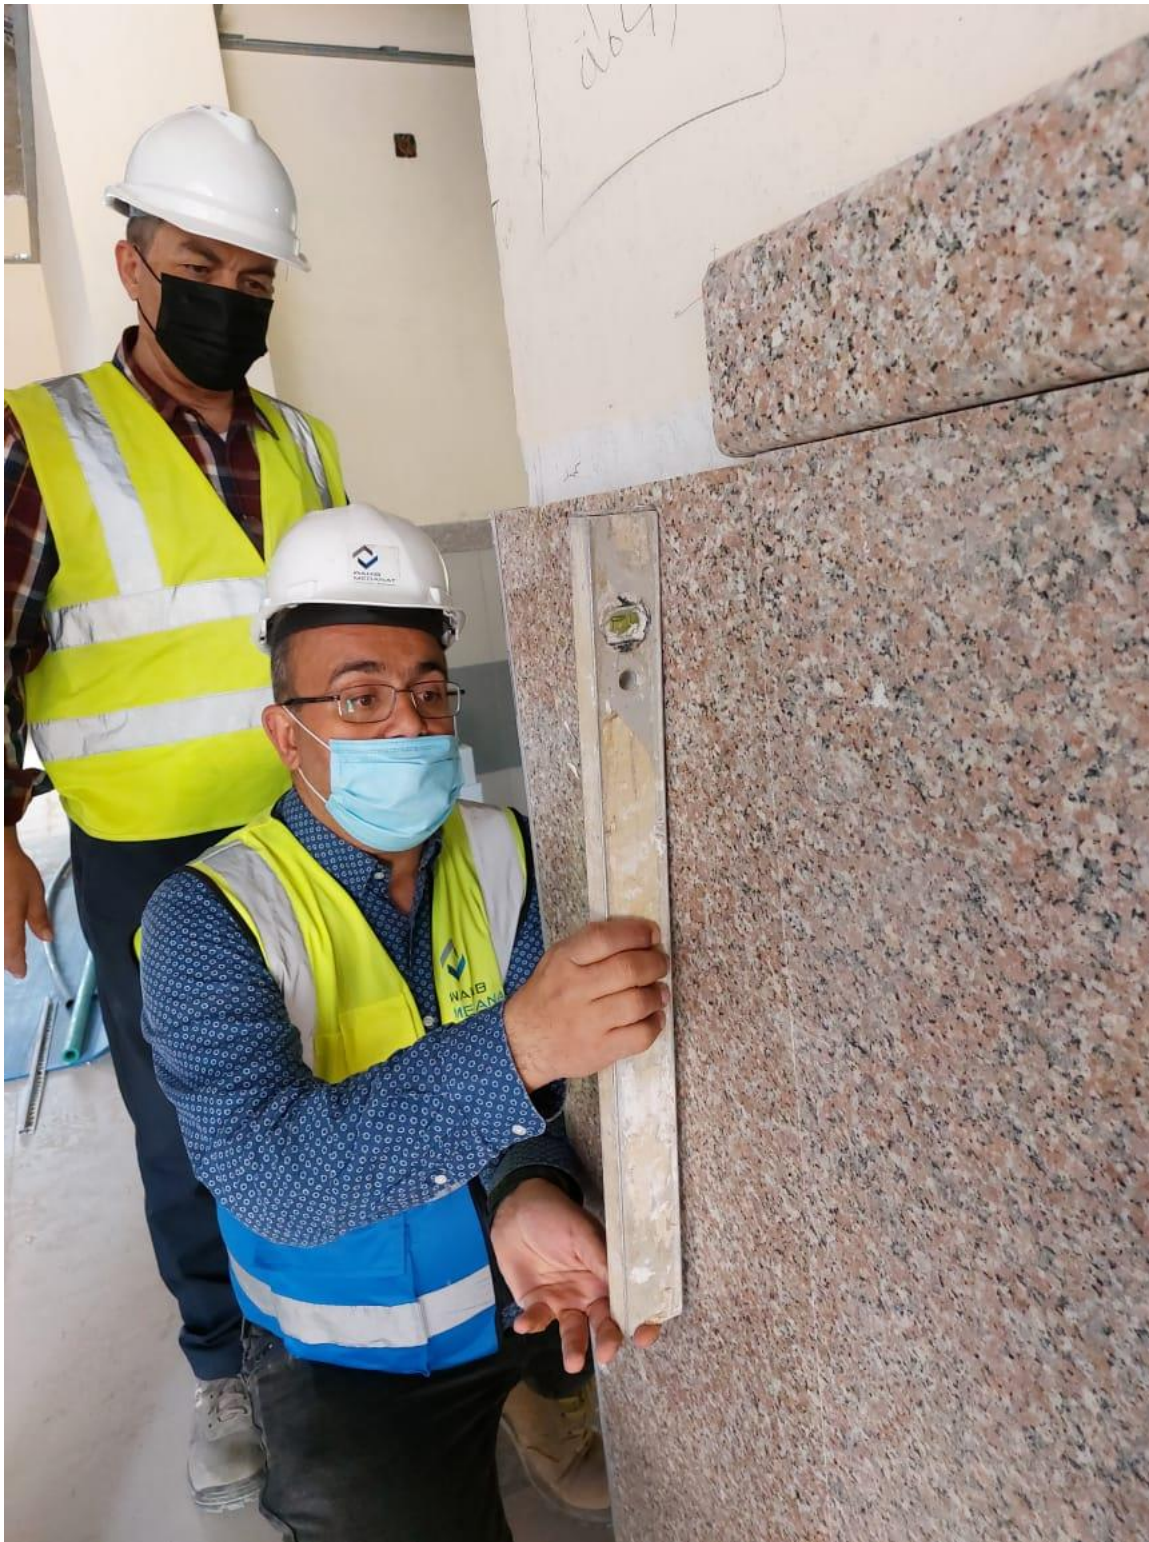
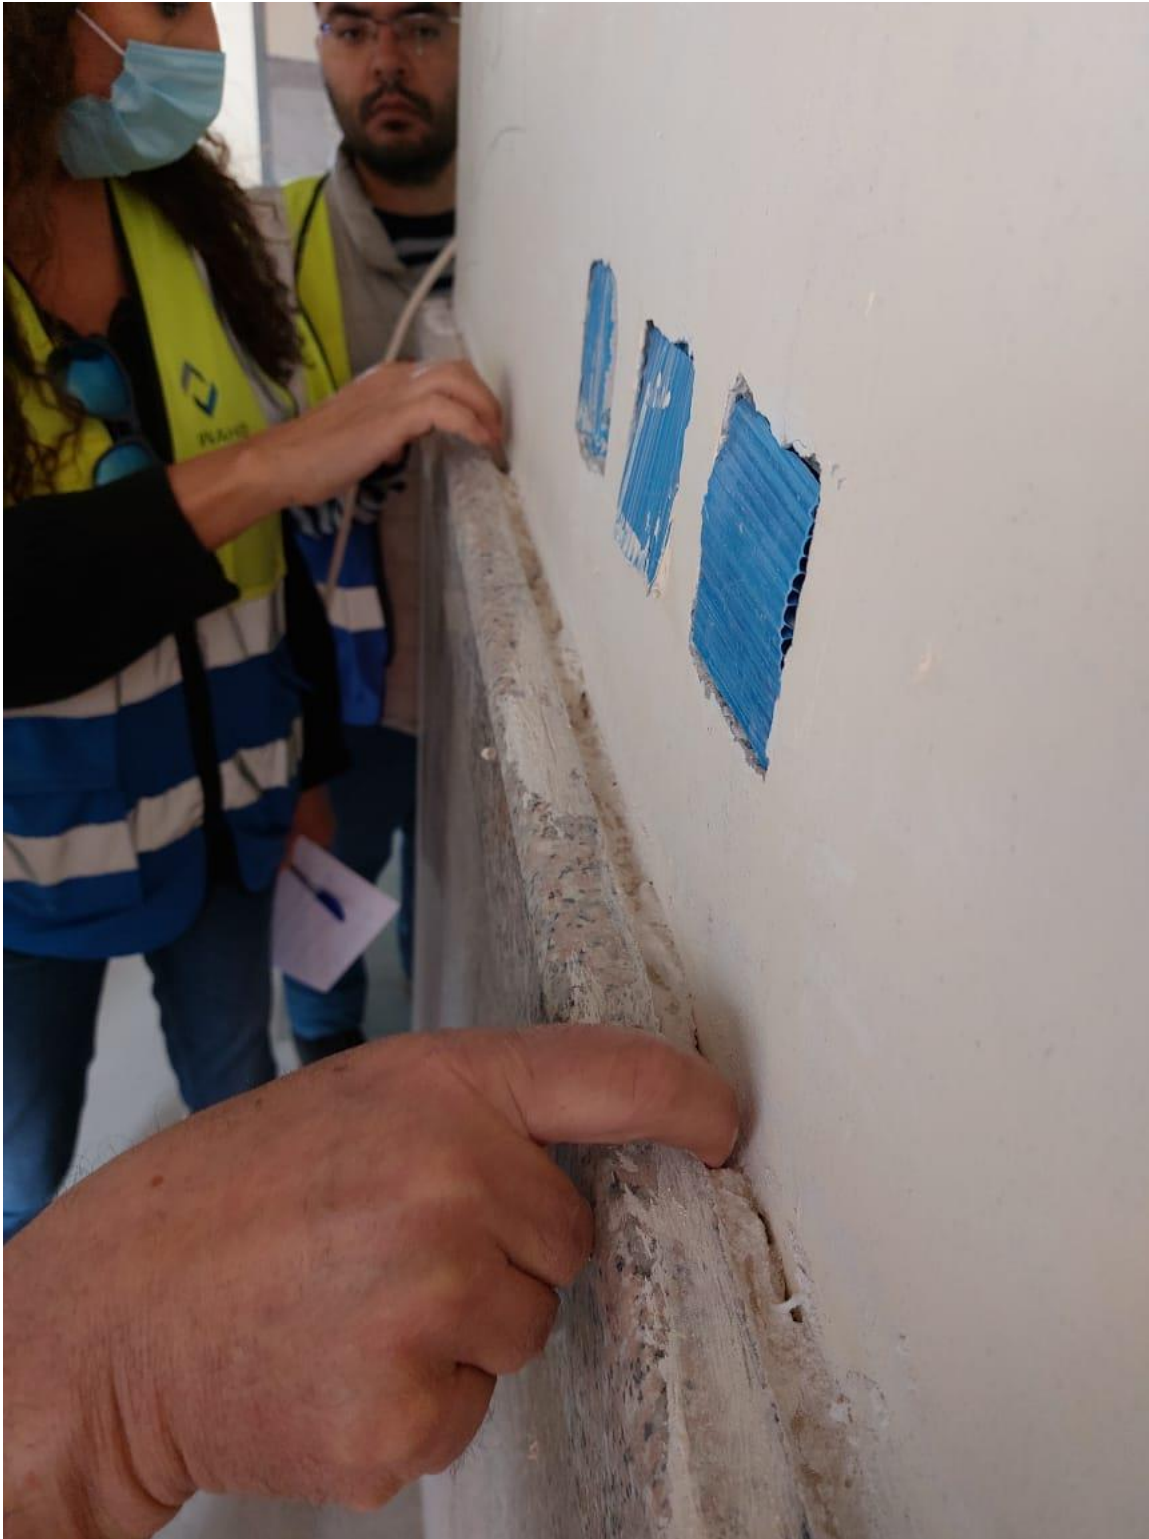
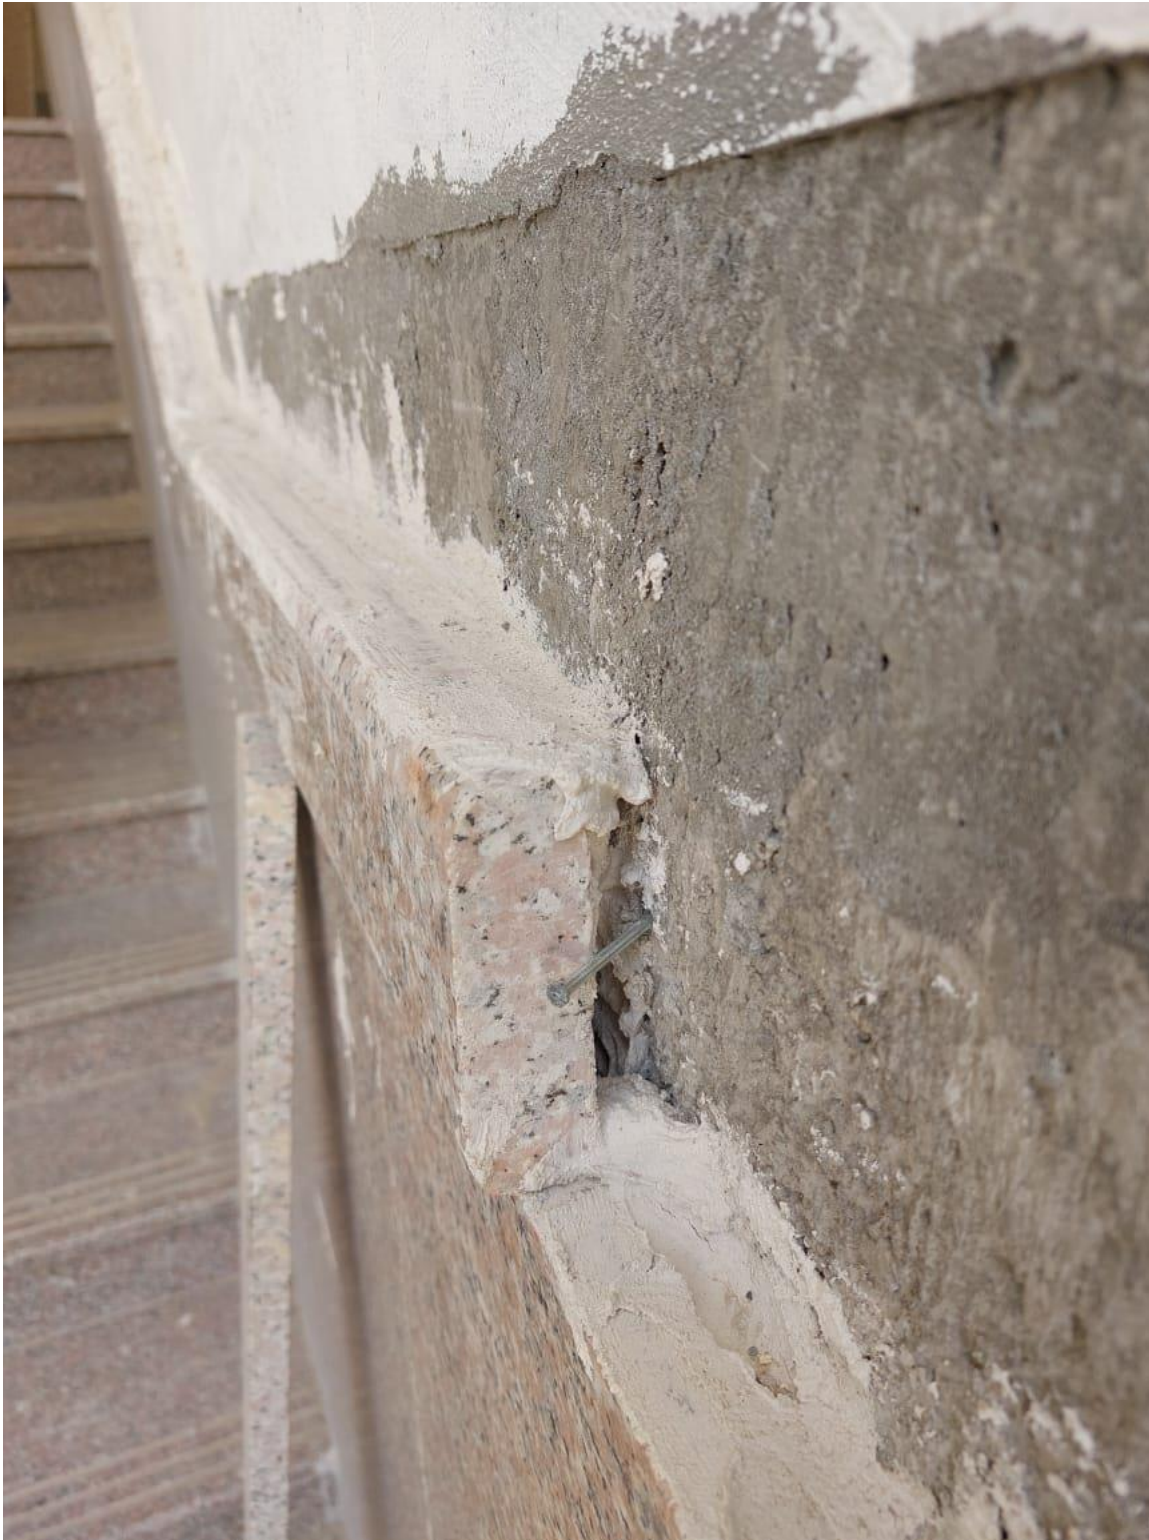
11	The team observed in several locations the gap between the granite coping and the plastered walls at corridors. The Contractor was requested to rectify.
12	The team inspected the installed ceramic tiles at the walls of the wet areas and observed that the quality of work is acceptable.
13	The team inspected the granite tiling for the landing of the staircases and observed teething in some parts and requested the Contractor to rectify.
14	The team inspected the external colored plastering at the building and the boundaries and requested the Contractor to clean all the white dirt at those walls due to the work in the stone coping or defects in the plastering material. Also, the Contractor was reminded of one of the requirements of the specifications, which is to apply protective coating at the top of plastering.
15	The team requested the Contractor to replace the defective stones at the entrance of the building.

The team inspected cladding and the installation of granite coping at the staircases and observed defects in the verticality of cladding and coping which made a large gap between the coping and the plastered wall. The team observed that the installed granite does not comply with the drawing details since the granite coping should be installed within the plastering layer not over. The Contractor was requested to rectify accordingly

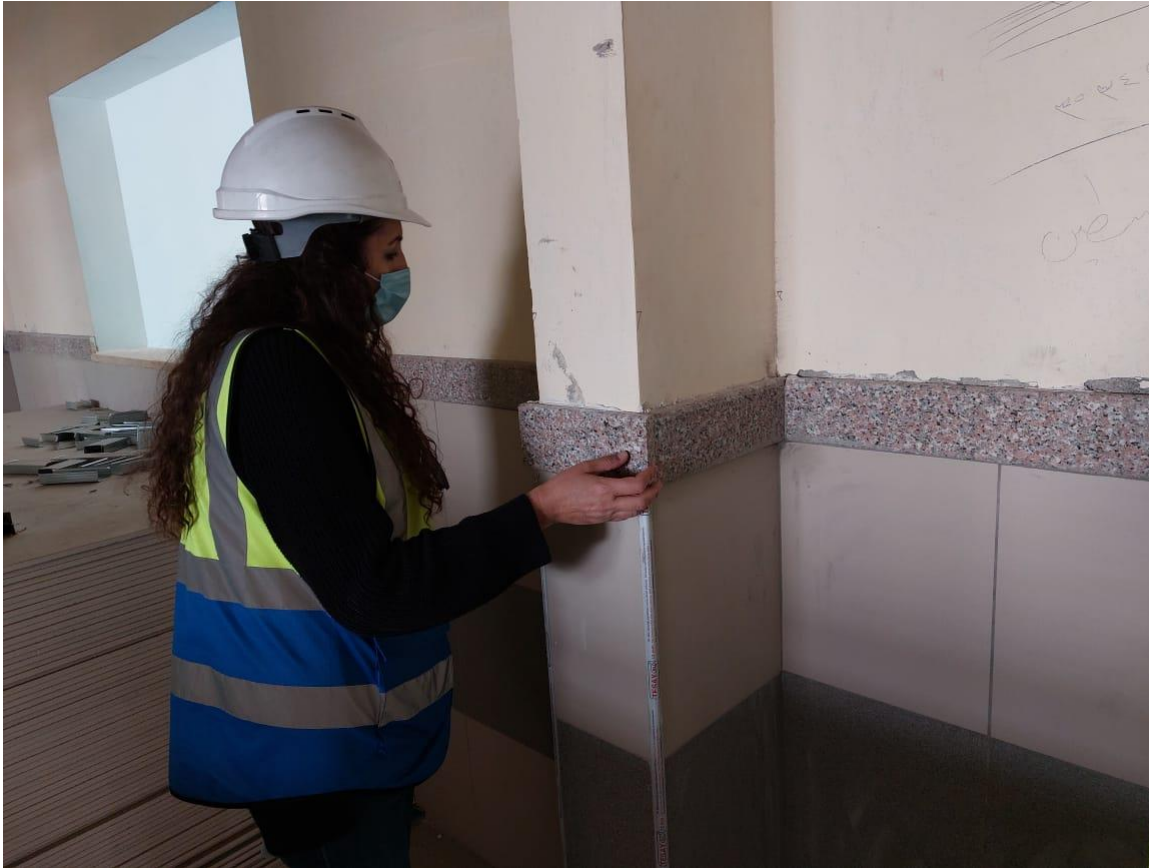
The team inspected the granite coping at the corridors in general and informed the Contractor to ensure the grinding of edges

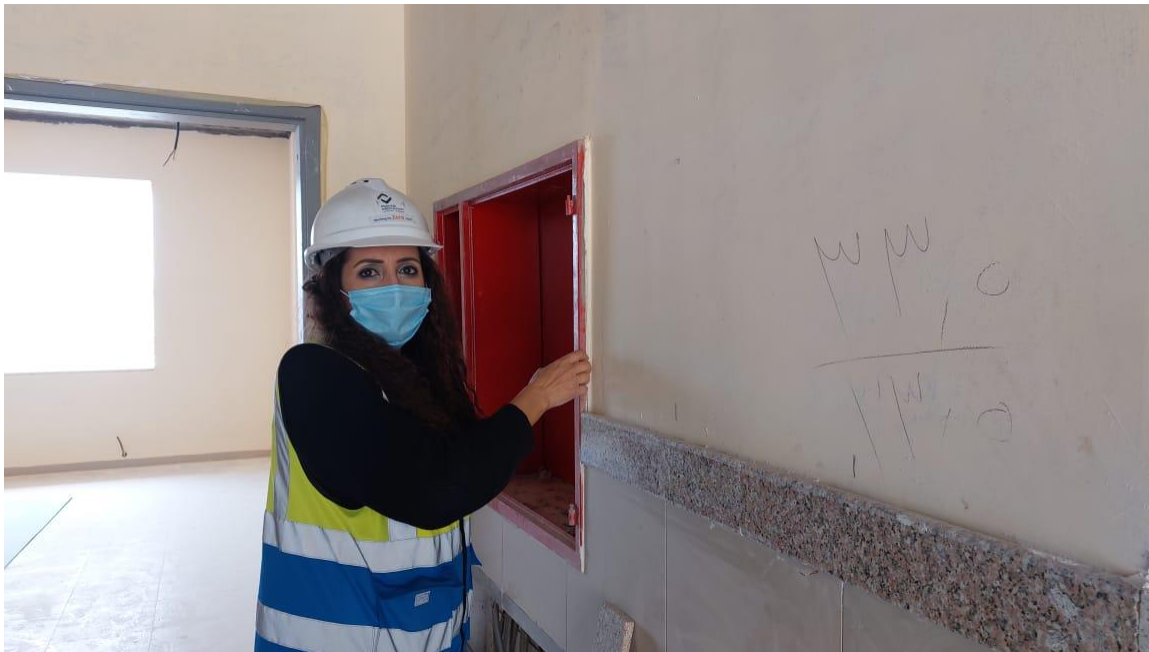
The team observed that the Contractor filled the gaps between the fire hose cabinets and the wall in unacceptable way

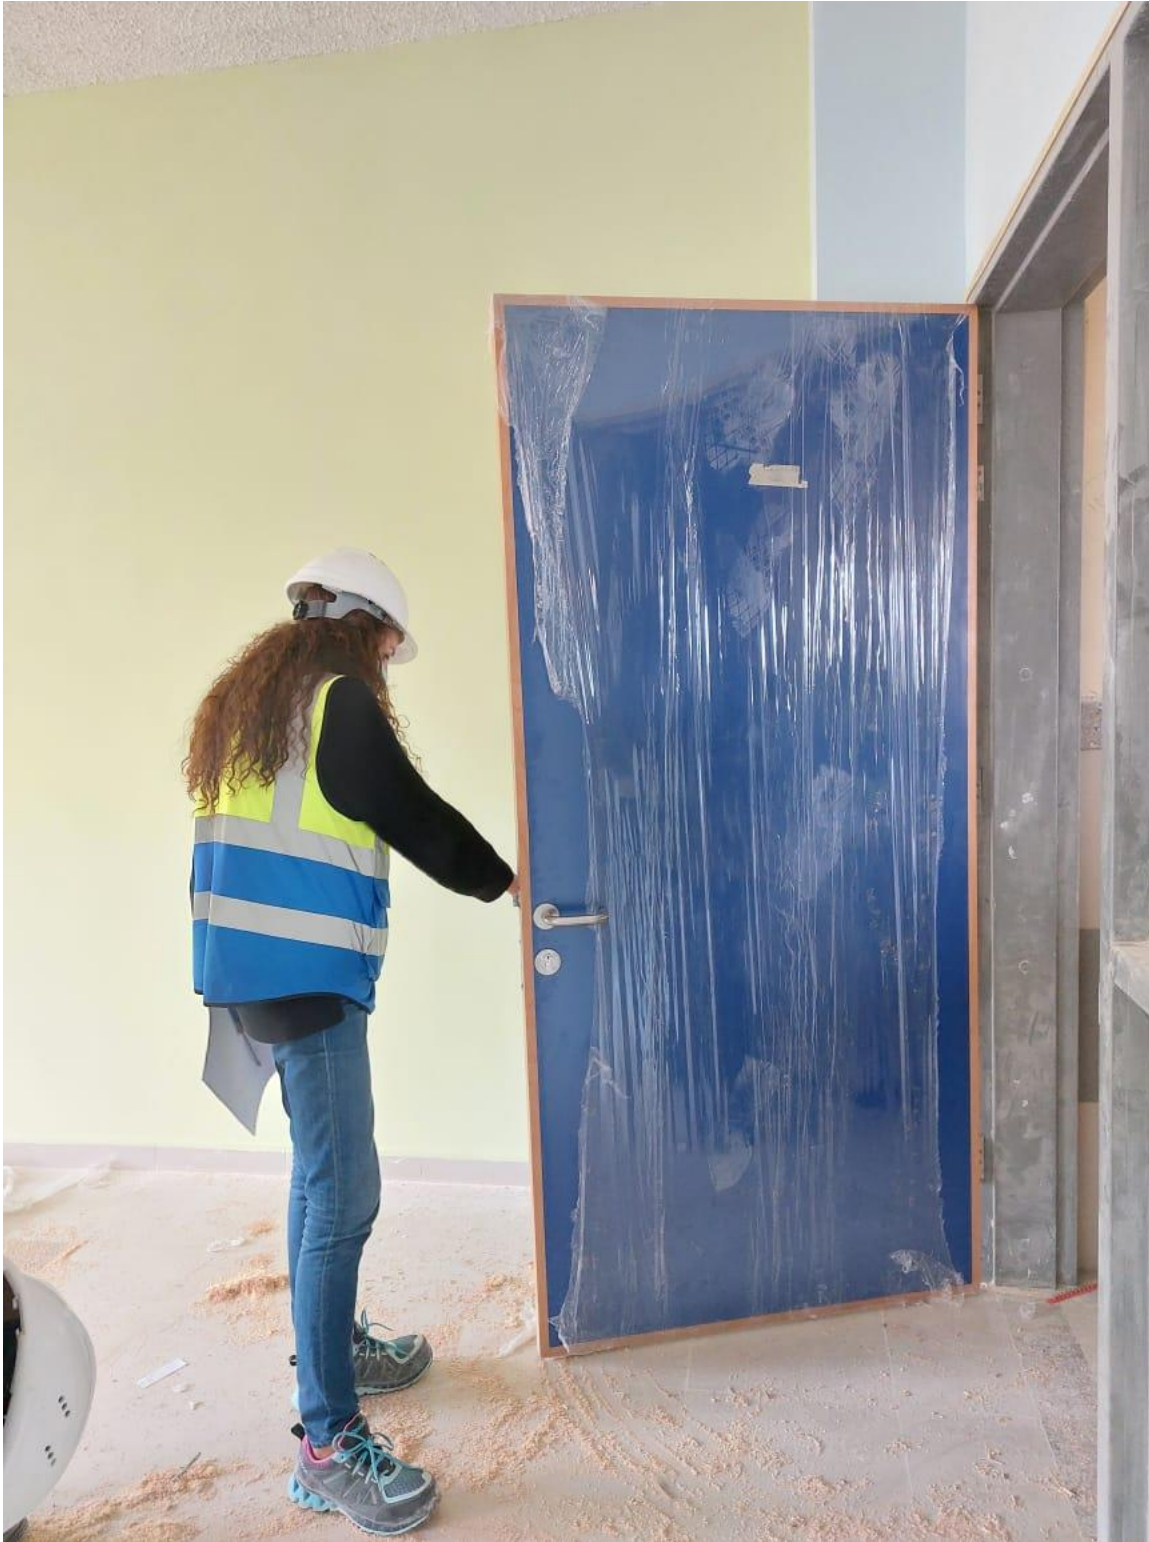
The team inspected the delivered door leafs to the site and observed some defects. the Contractor was requested to rectify before installation

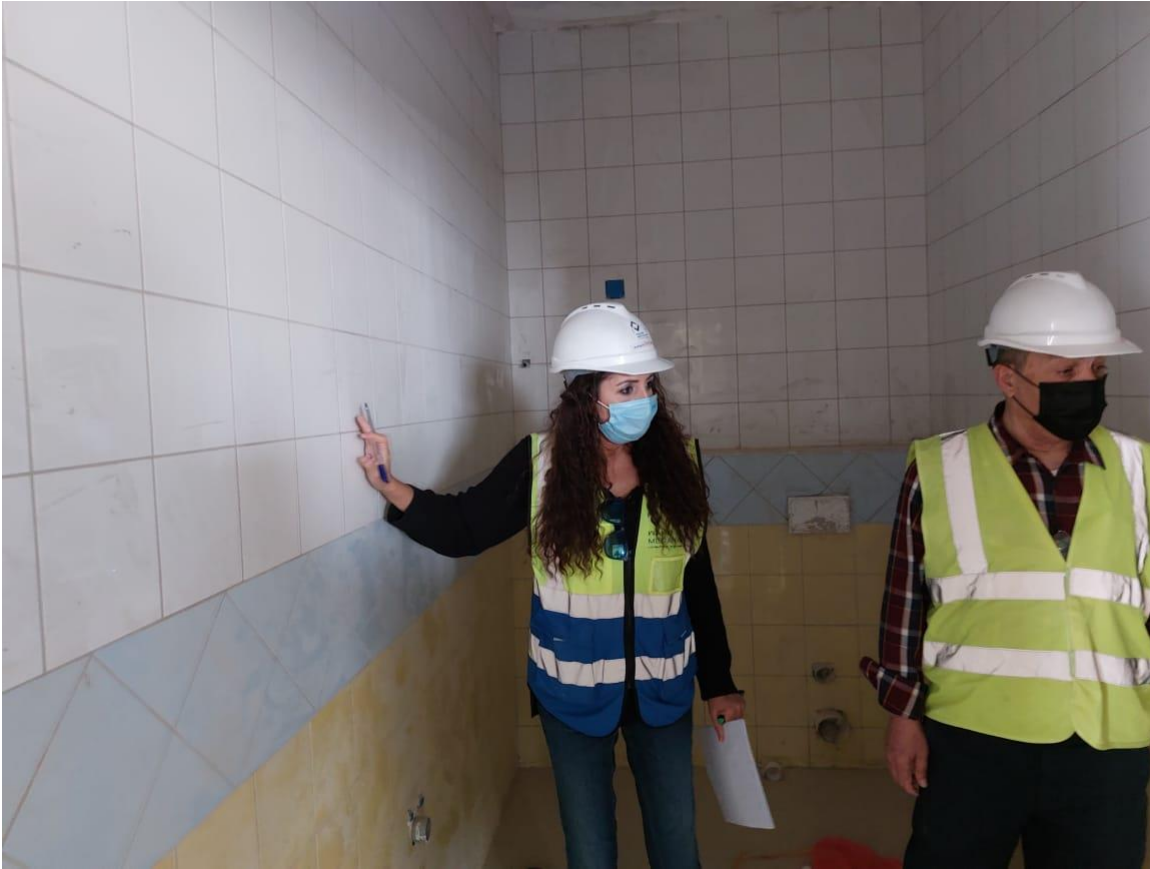
The team inspected the installed ceramic tiles at the walls of the wet areas and observed that the quality of work is acceptable
