SKEP III Home Office Support Site Visit Report

Consultant	Wahib Medanat Consultant Engineer	Rep No.	22-19042022
Contractor	Dijlah Establishment Constr. Contracting	Tender No.	(11/2019/USAID/SKEP/3/S) Schools for a Knowledge Economy Project (SKEP) - Phase (3) Package (1, 2)
Site Name	Thahr Al Sarow Basic School for Boys- Jerash	Day/ Date	Tue. 19/04/2022
Duration of Project	450 Calendar Days	Total Project Budget	8,314,983.735 JD

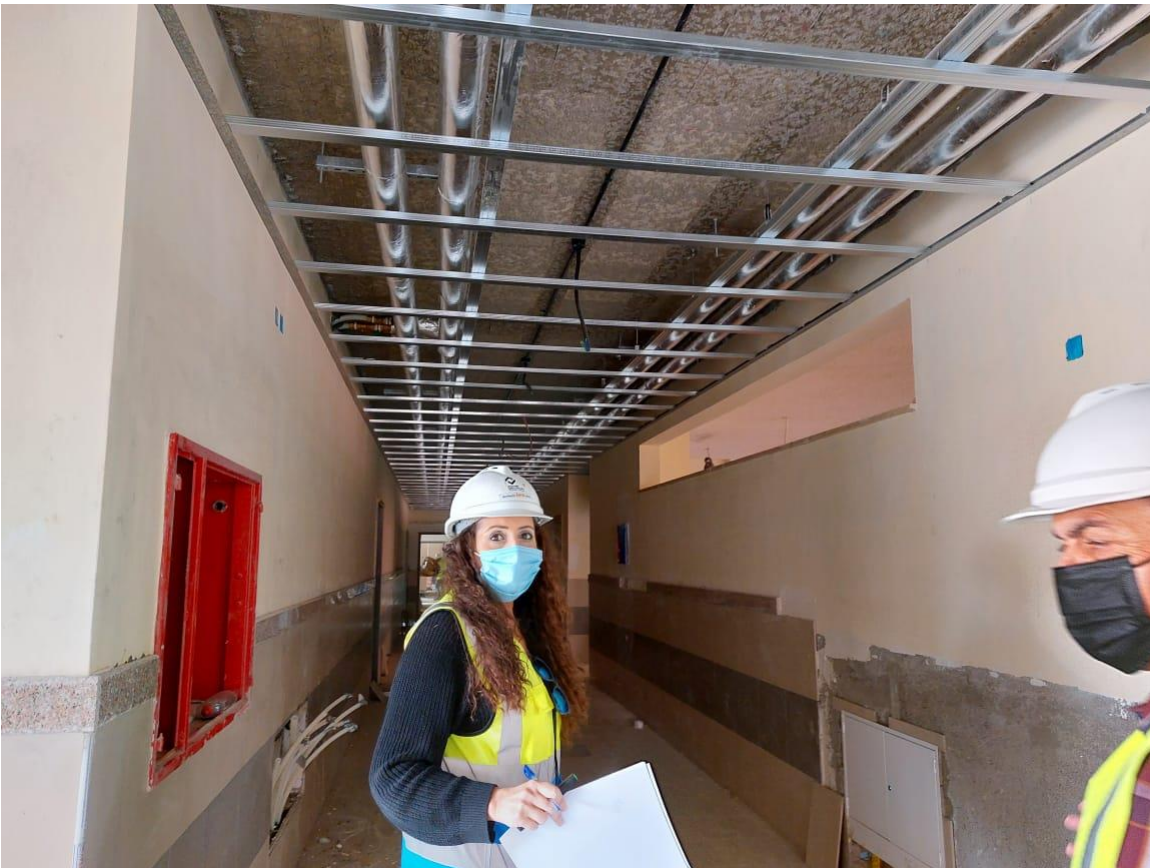
The team inspected the heating pipes network under the suspended ceiling and the installation of the mechanical cabinets at the corridors

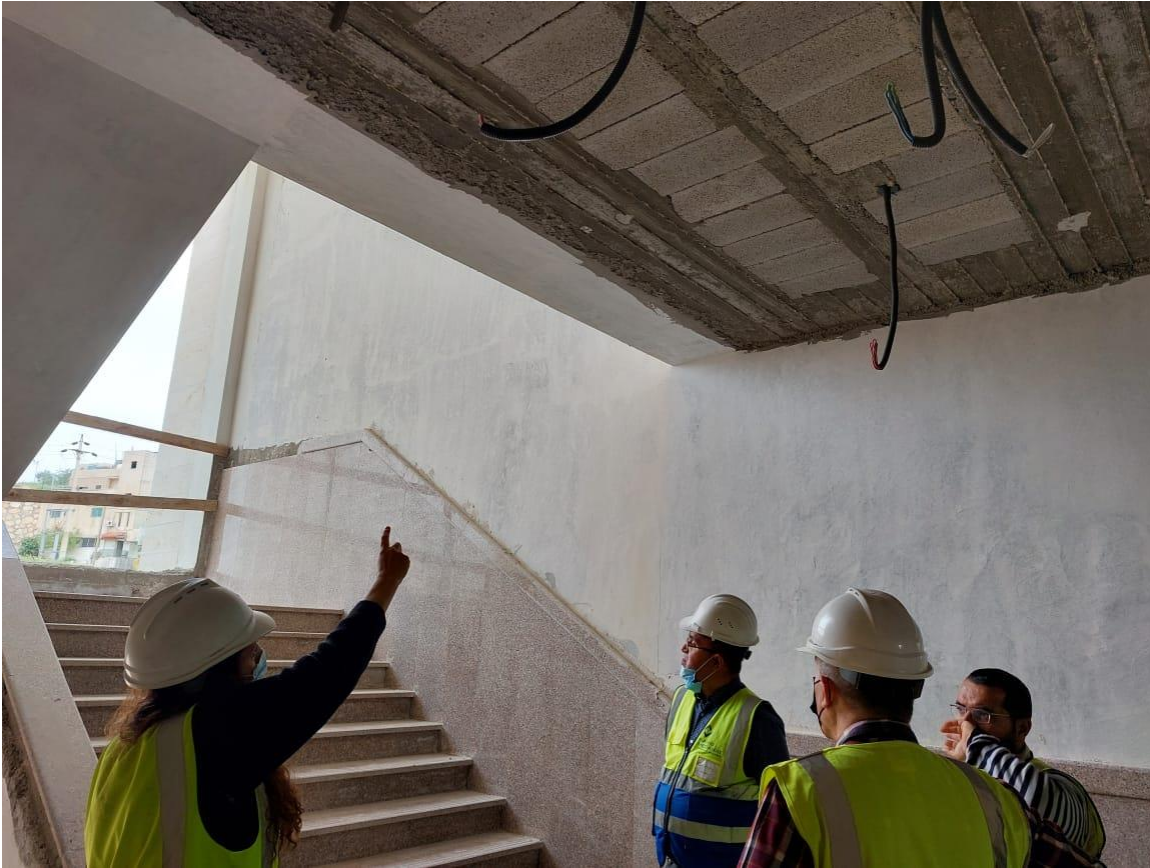
The team discussed with the Contractor the limits of the suspended ceiling at the corridors and at the staircases areas
