Consultant	Wahib Medanat Consultant Engineer	Rep No.	11-09032022
Contractor	Derar Saraireh & Sons for Engineering & Contracting	Tender No.	(11/2019/USAID/SKEP/3/S) Schools for a Knowledge Economy Project (SKEP) - Phase (3) Package (1, 2)
Site Name	Um Al Dananir Basic Mixed School- Al Balqa	Day/ Date	Wed. 09/03/2022
Duration of Project	450 Calendar Days	Total Project Budget	9,789,417.840 JD

Visit Notes

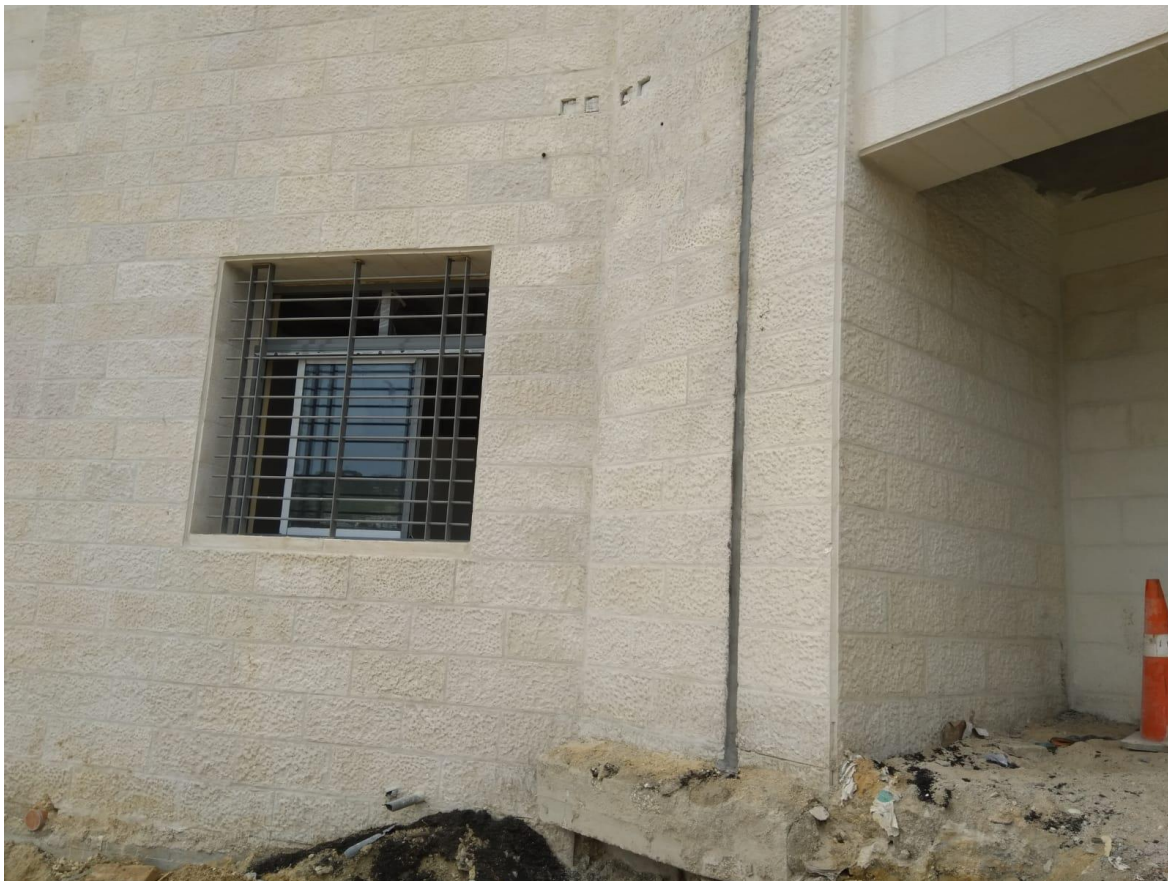
(figure:04)

The team discussed with the Contractor the issue of the executed external expansion joint

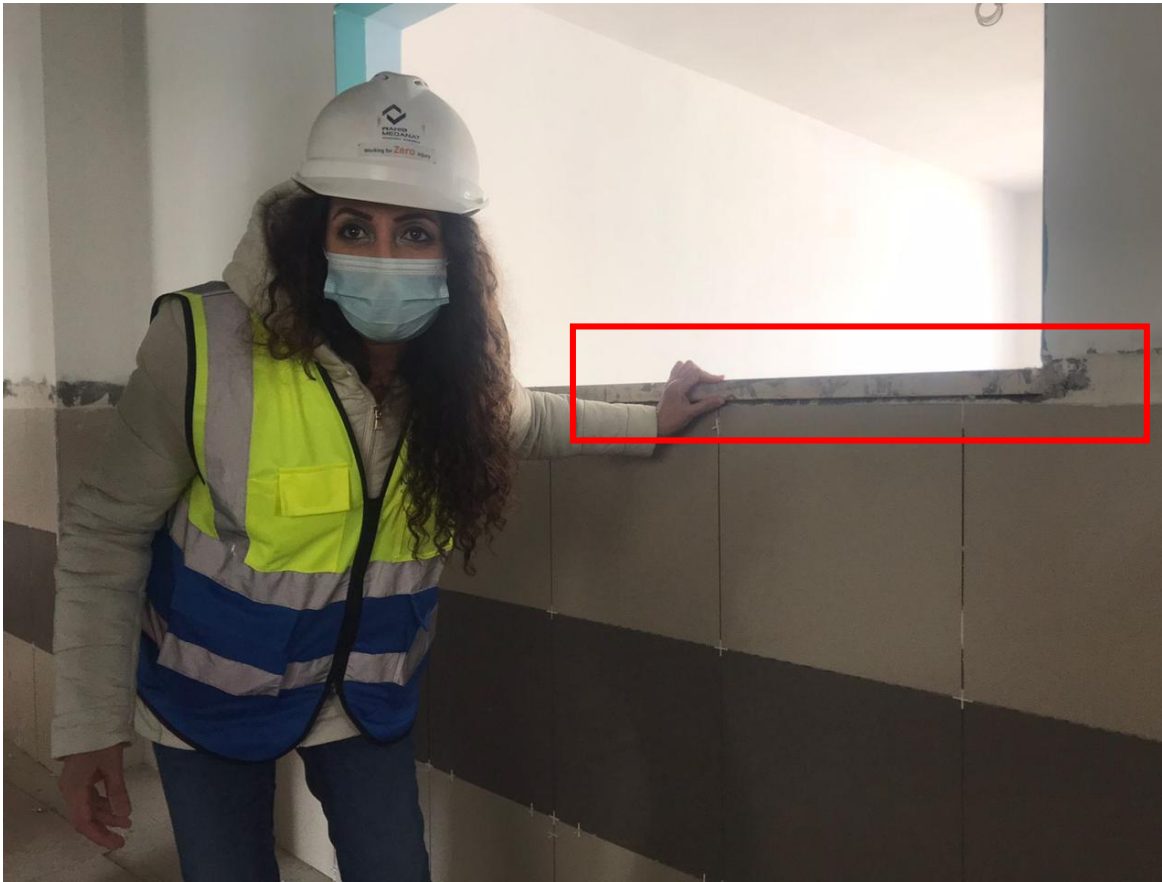
(figure:05)

The supervision team inspected the window sills at the corridors and observed variation in the leveling of those sills and requested the Contractor to rectify

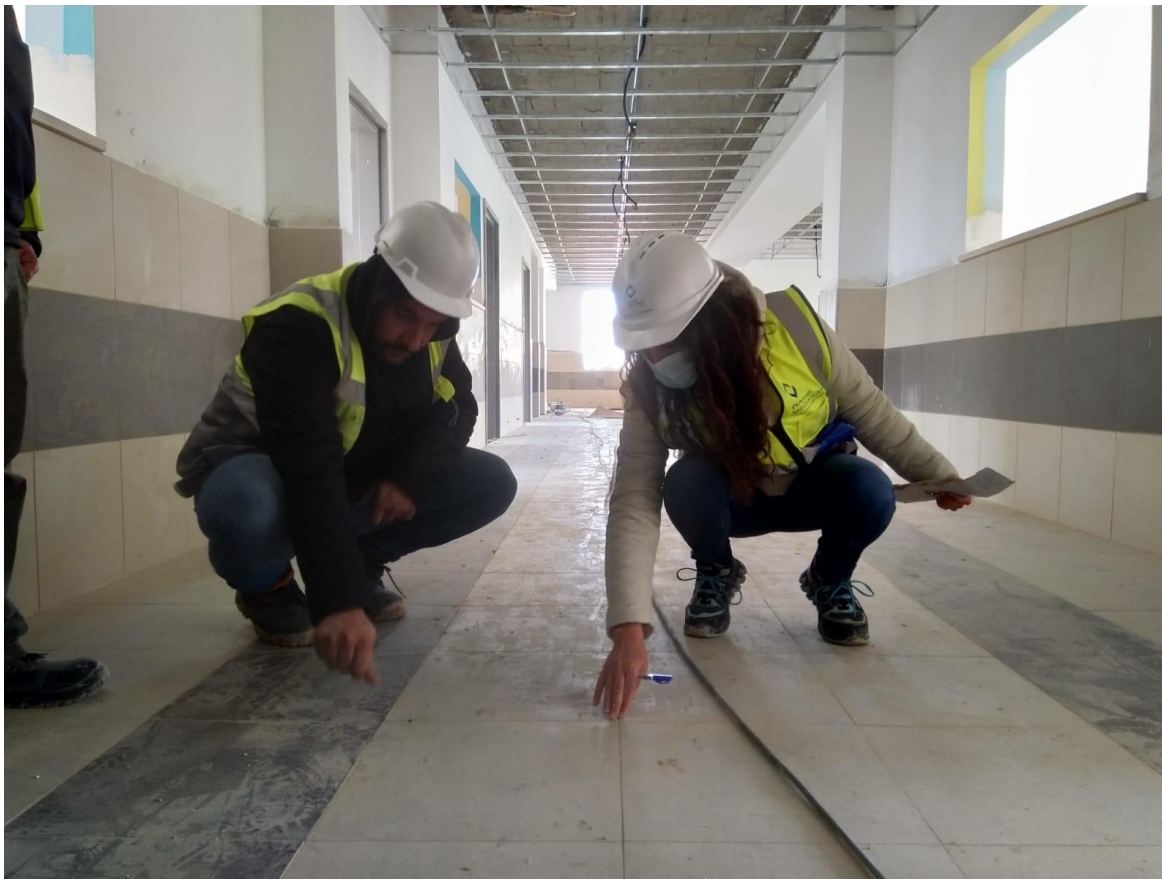
(figure:06)

The team observed minor teething in some parts in the porcelain floor tiles and requested the Contractor to rectify

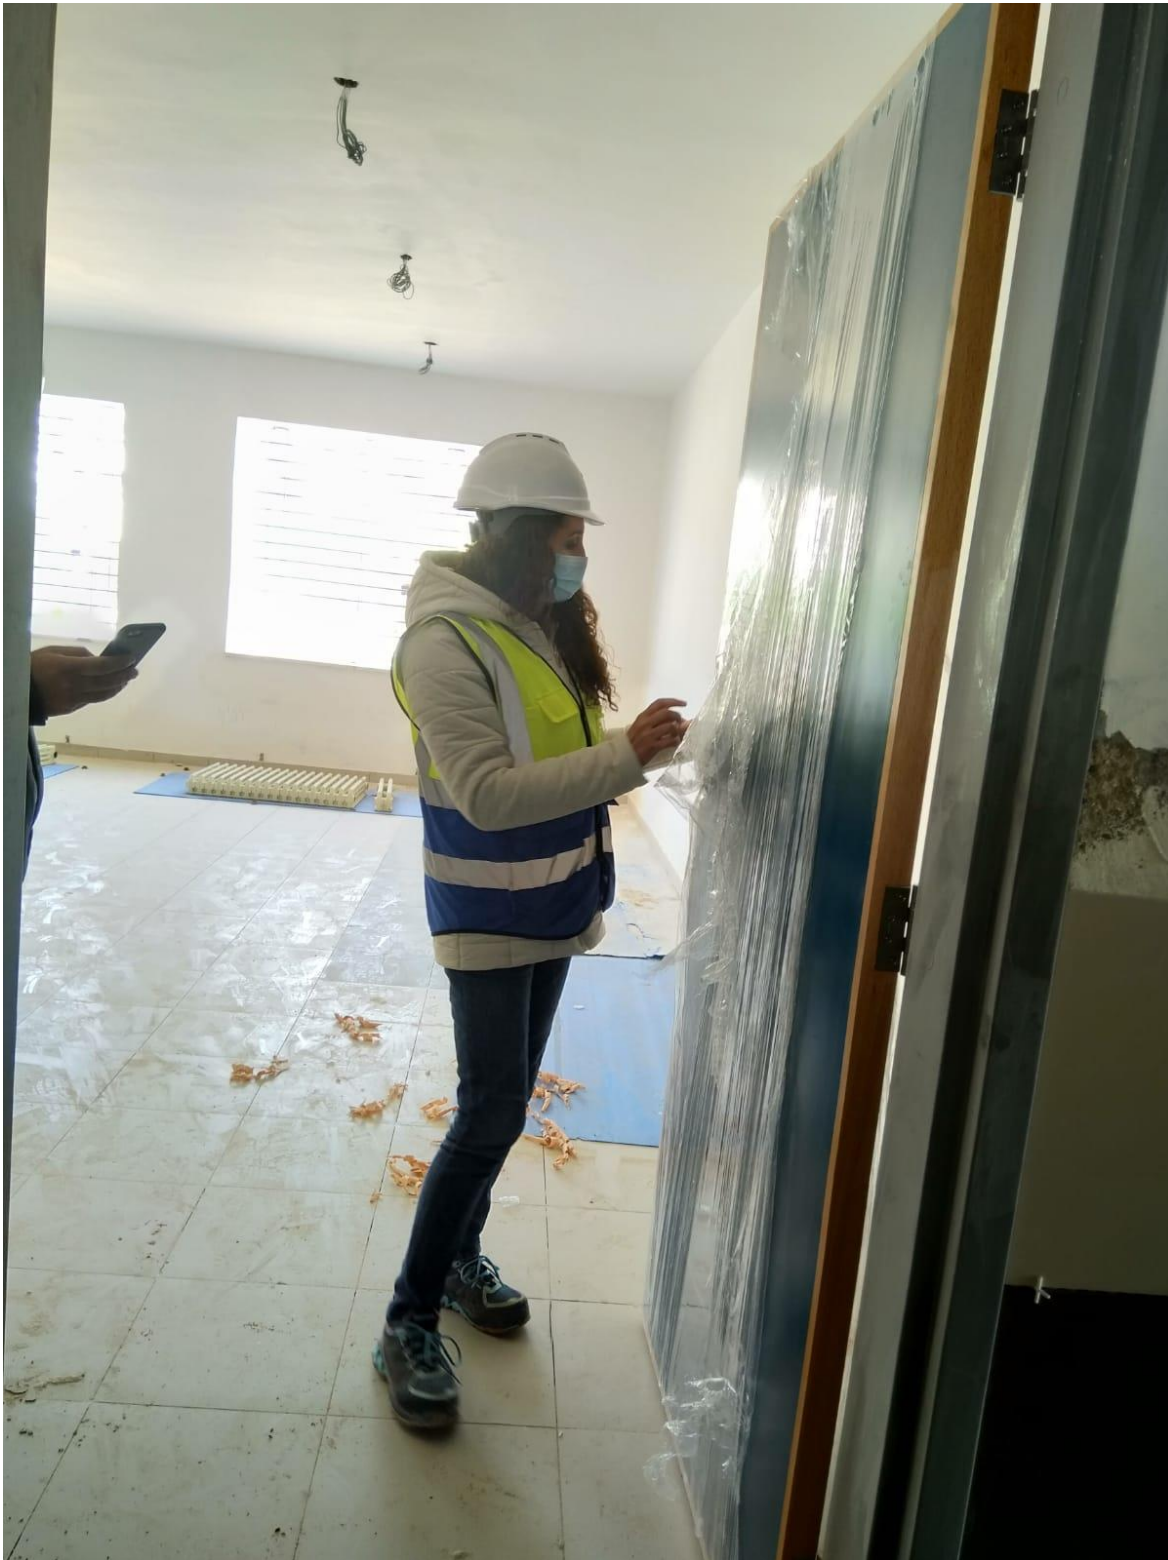
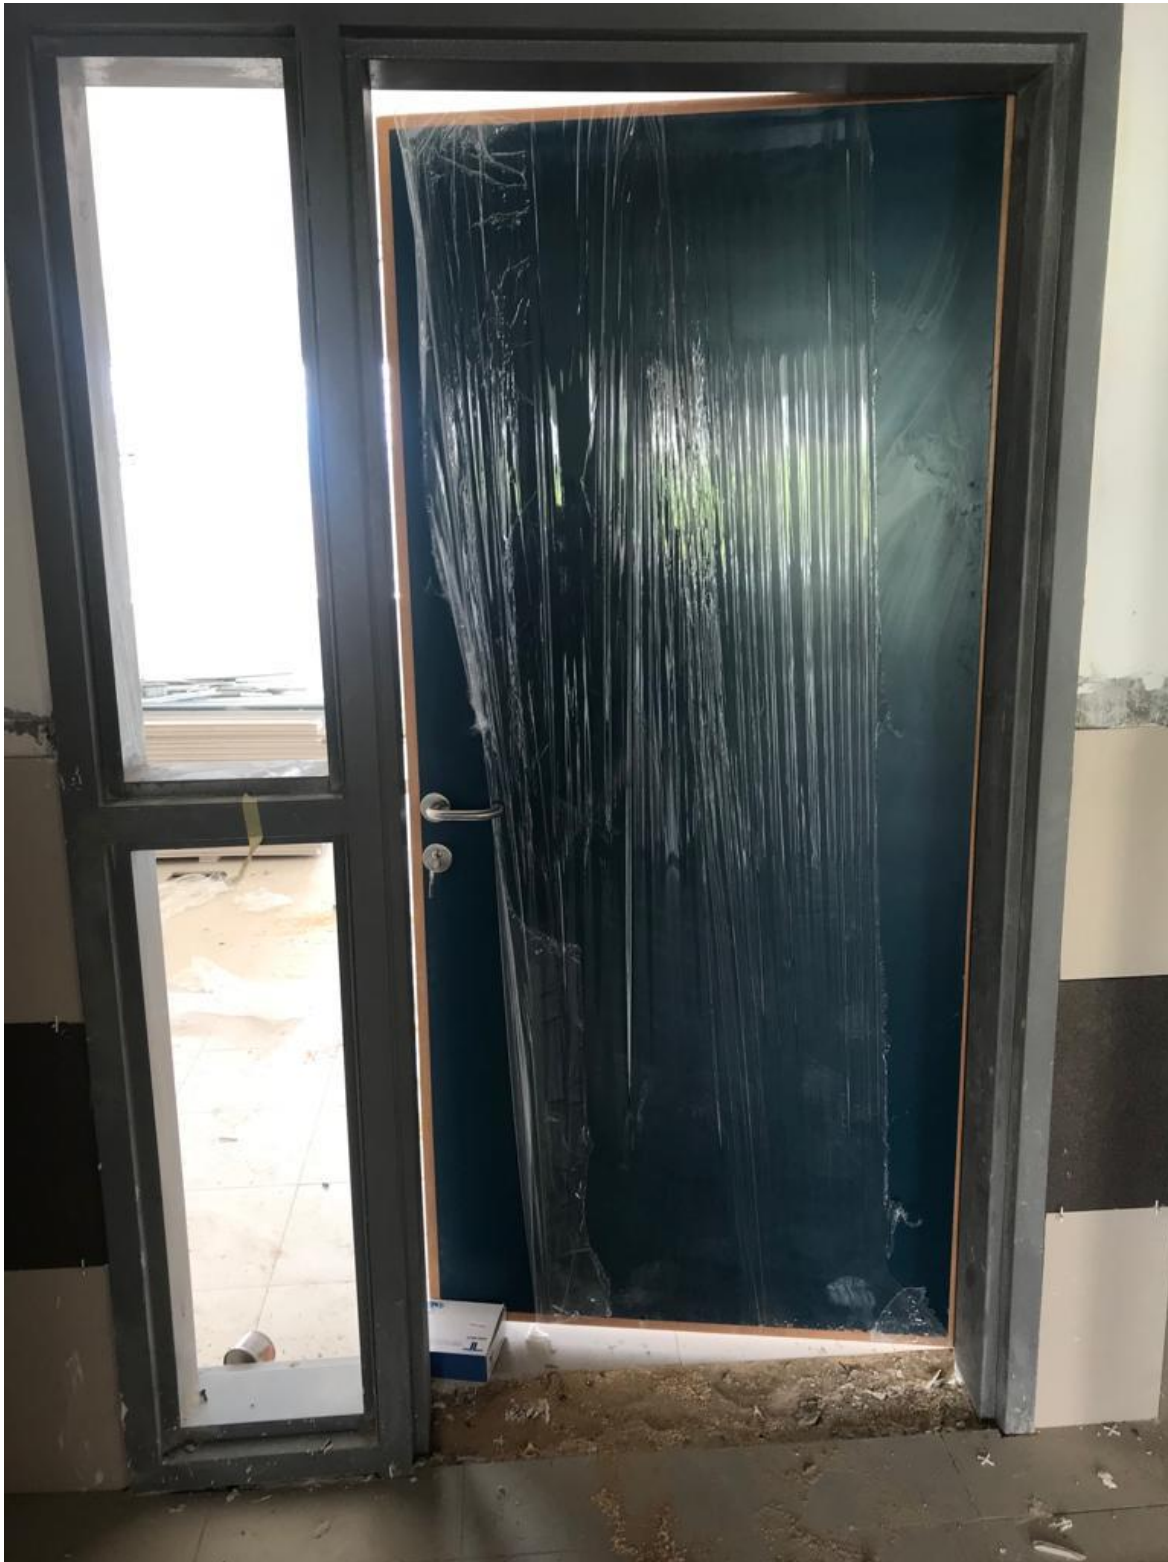
The Supervision team inspected the installed door samples
(figure:07 & 08)

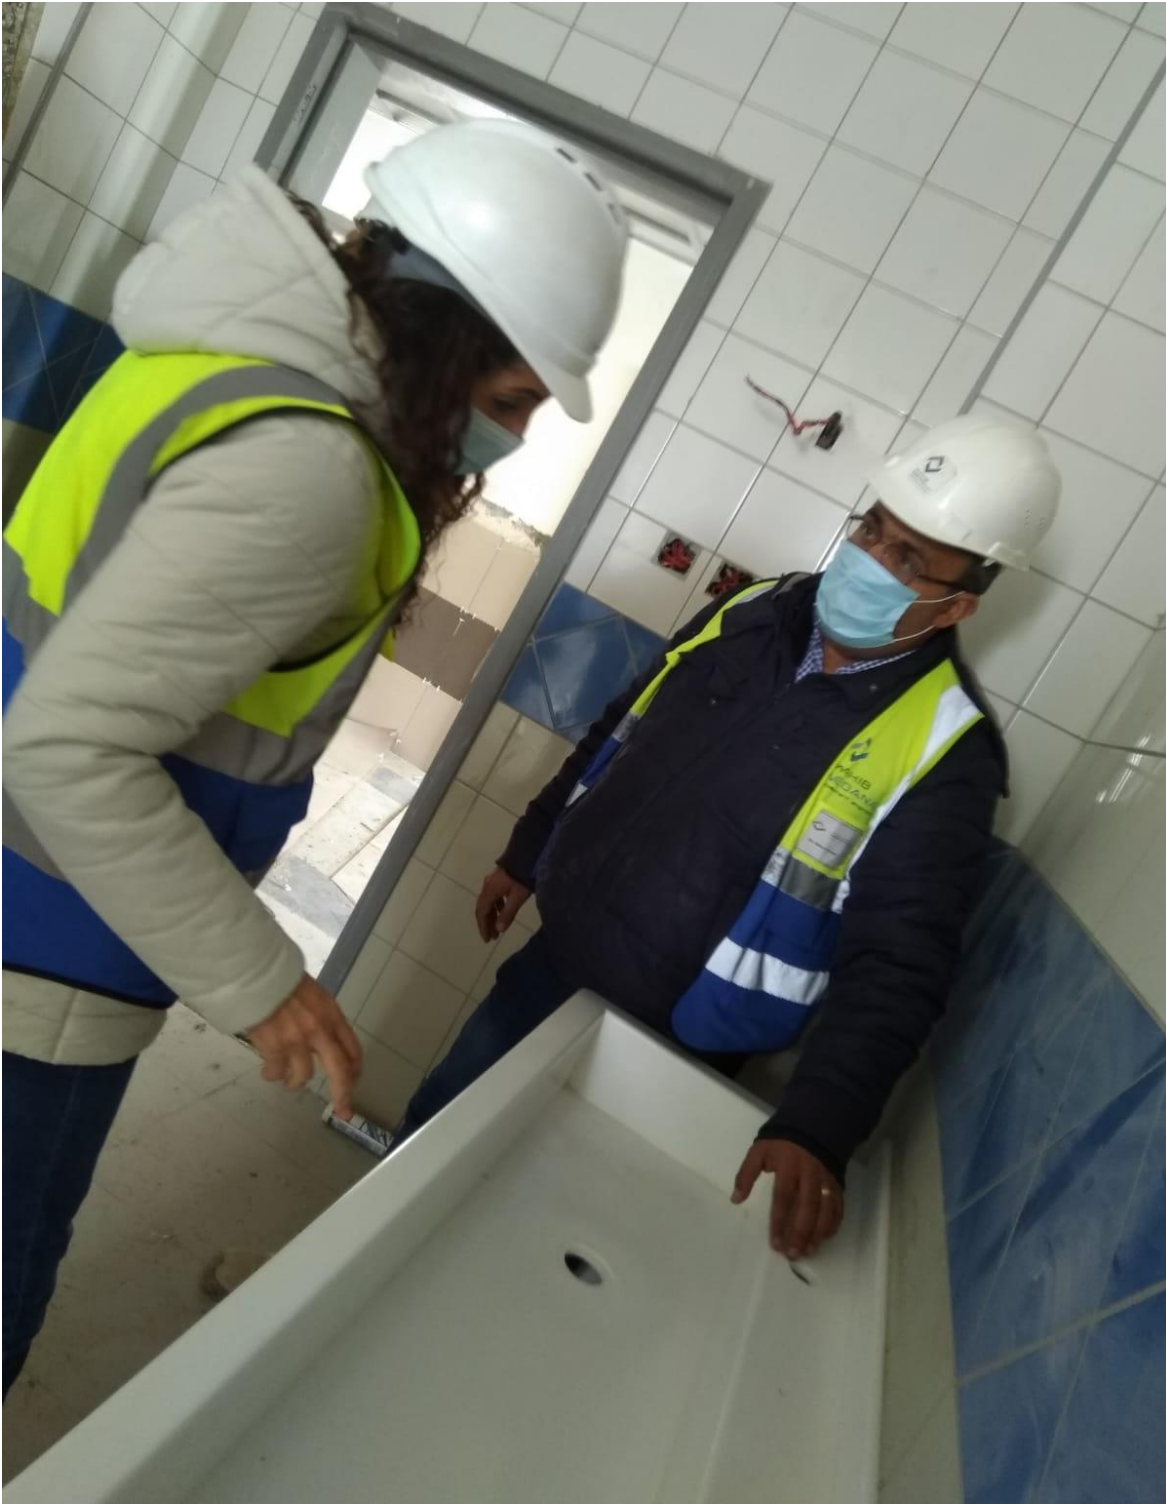
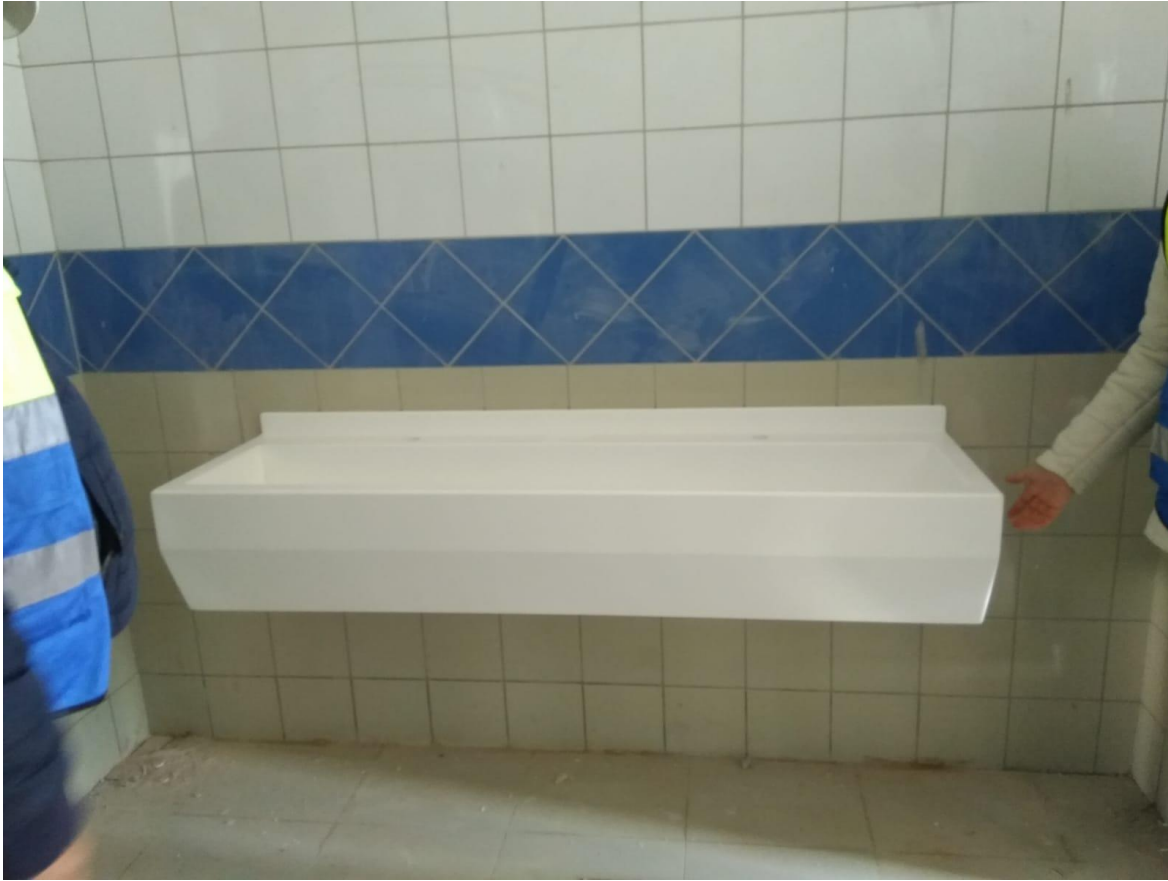
The team inspected the installed wash trough sample and found it acceptable (figure:09 & 10)

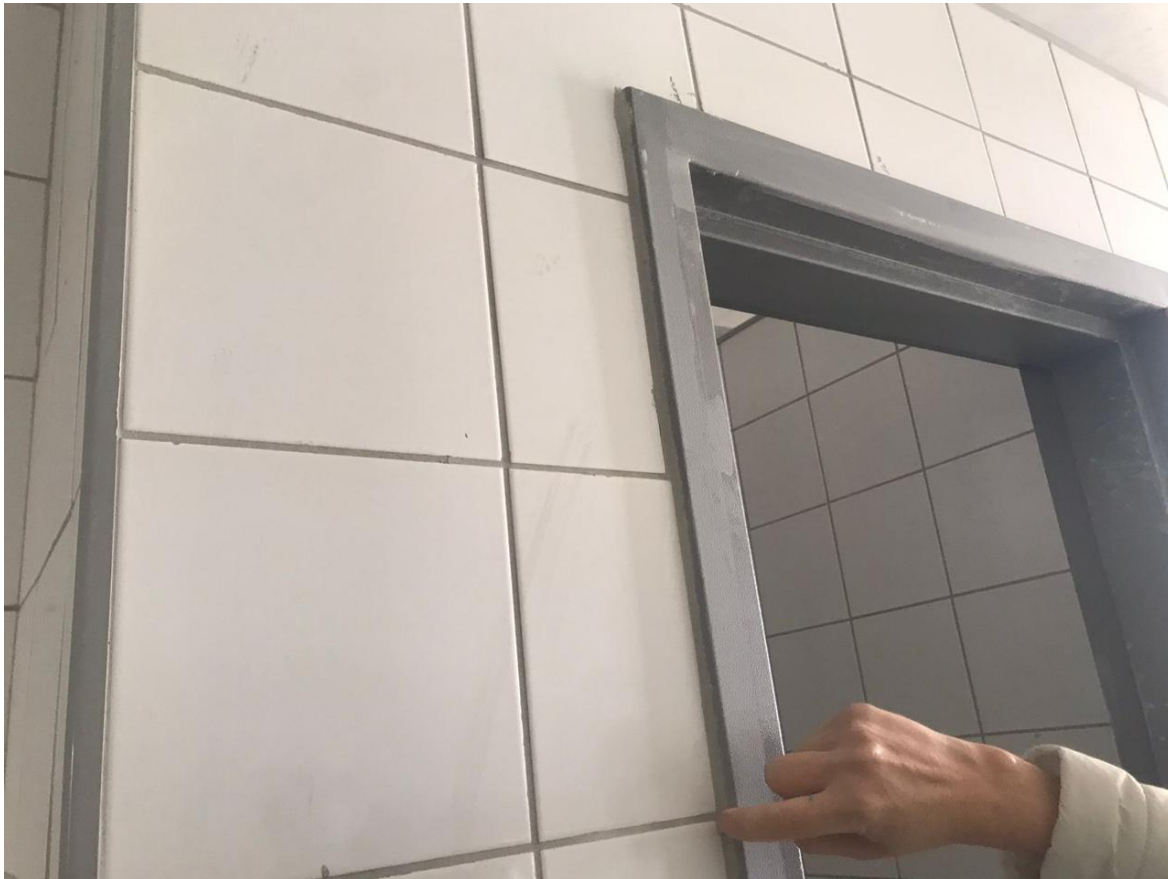
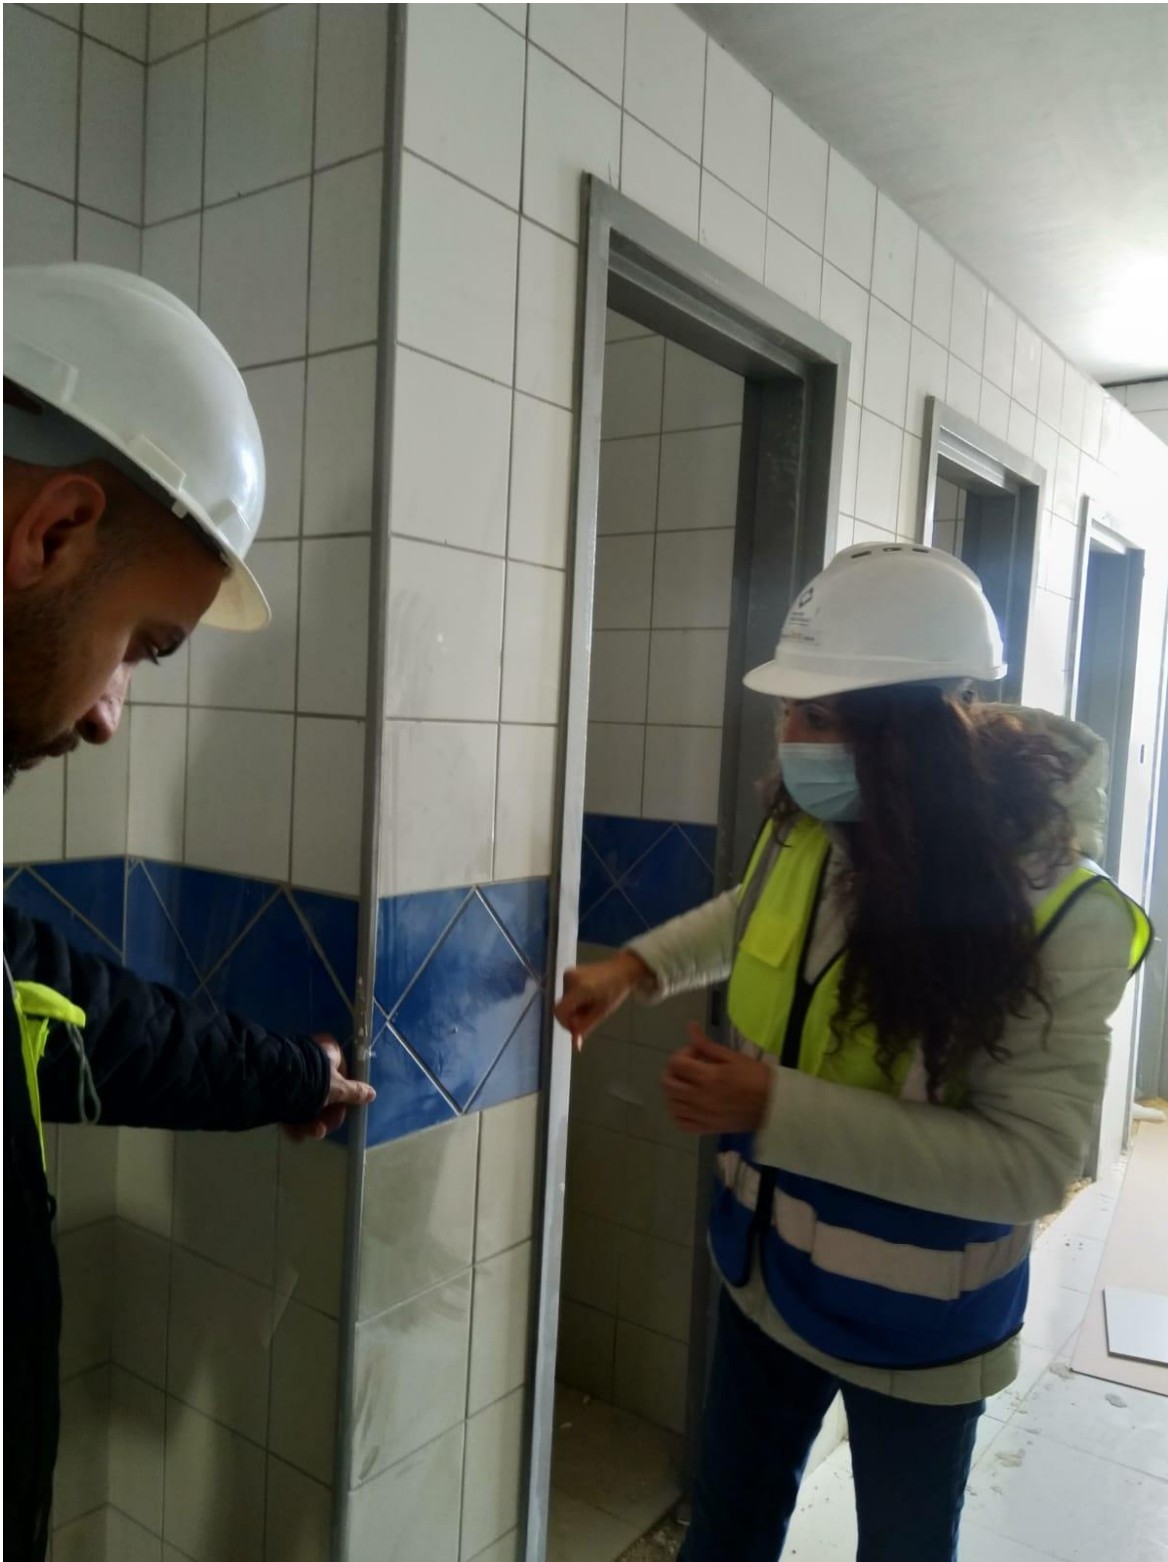
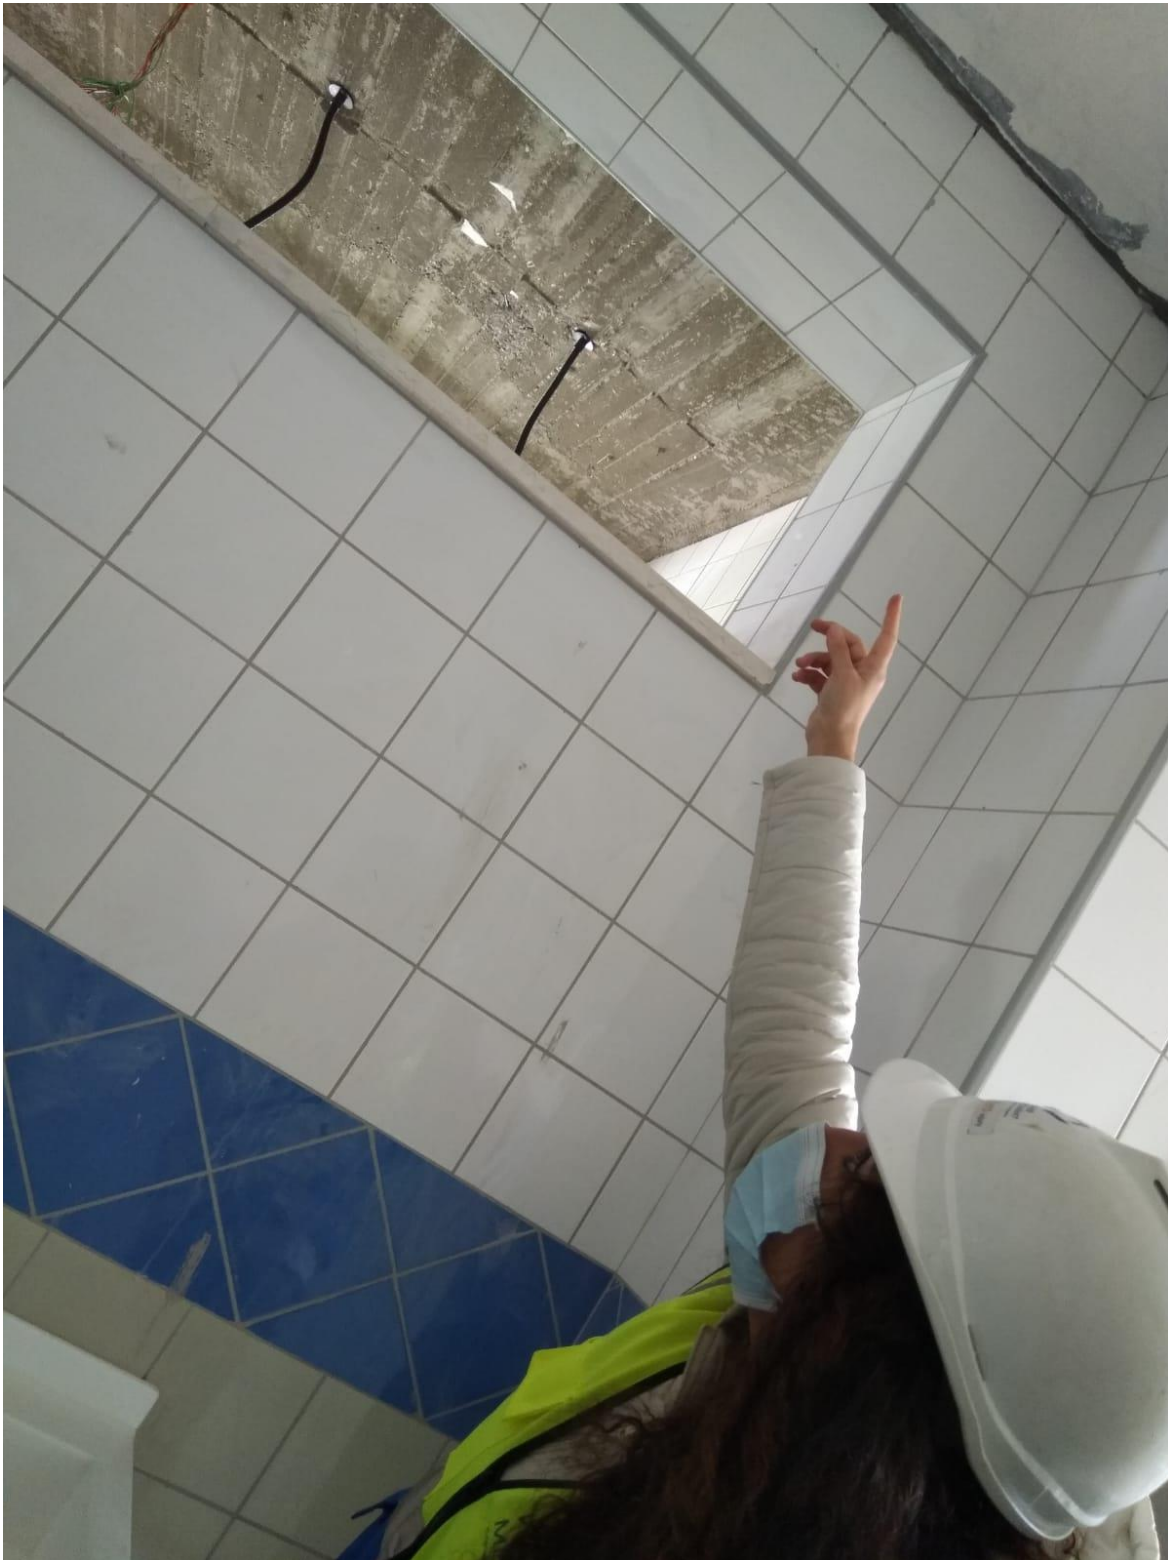
(figure:11, 12 & 13)

The team inspected the ceramic wall tiles at the wet areas and observed defects in some parts, defects in the grouting, beads and broken tiles

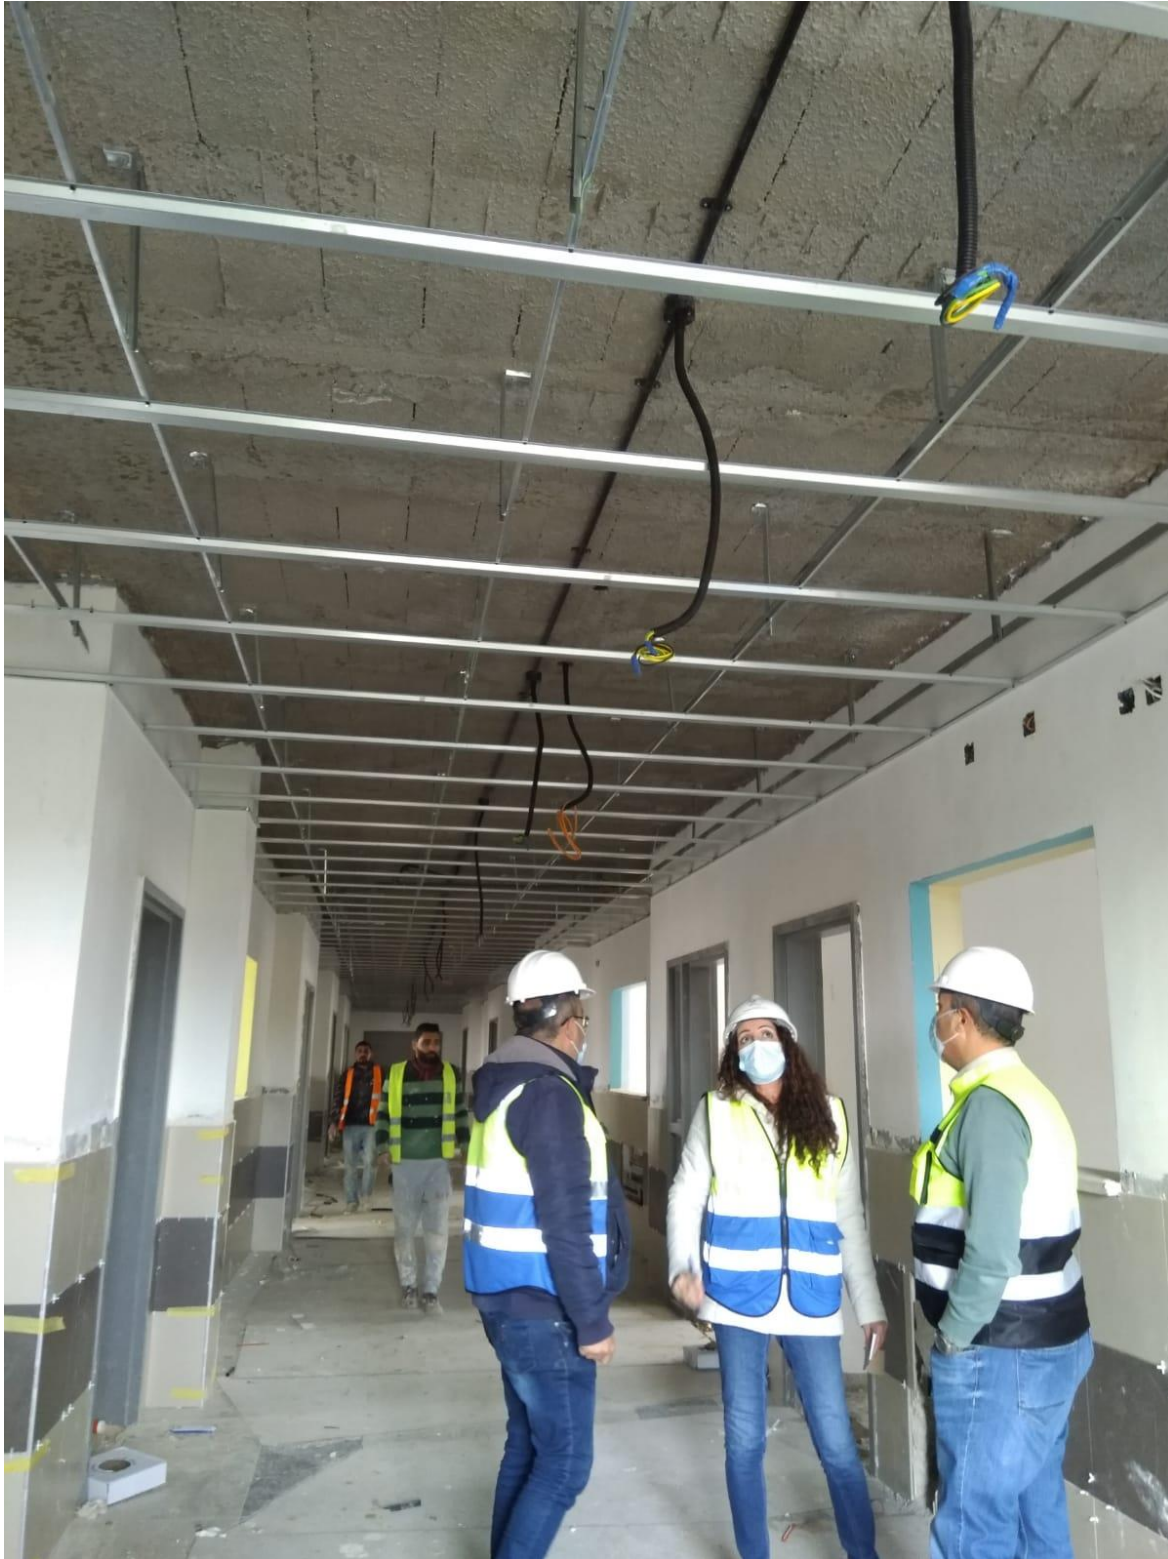
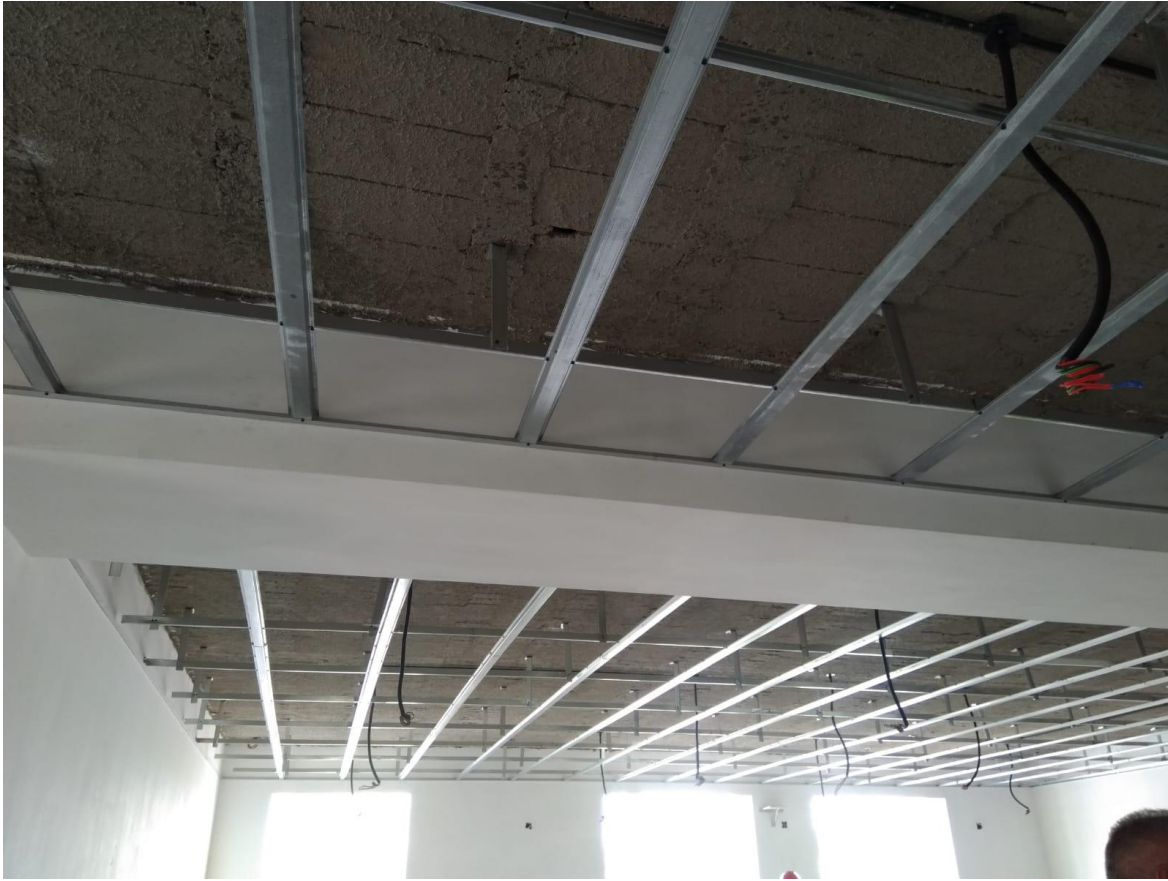
The team observed that the Contractor started with installing the frames for the suspended ceiling at the corridor. The Contractor requested the supervision's instruction whether or not the hangers can be fixed to the rib beams
(figure:14 & 15)

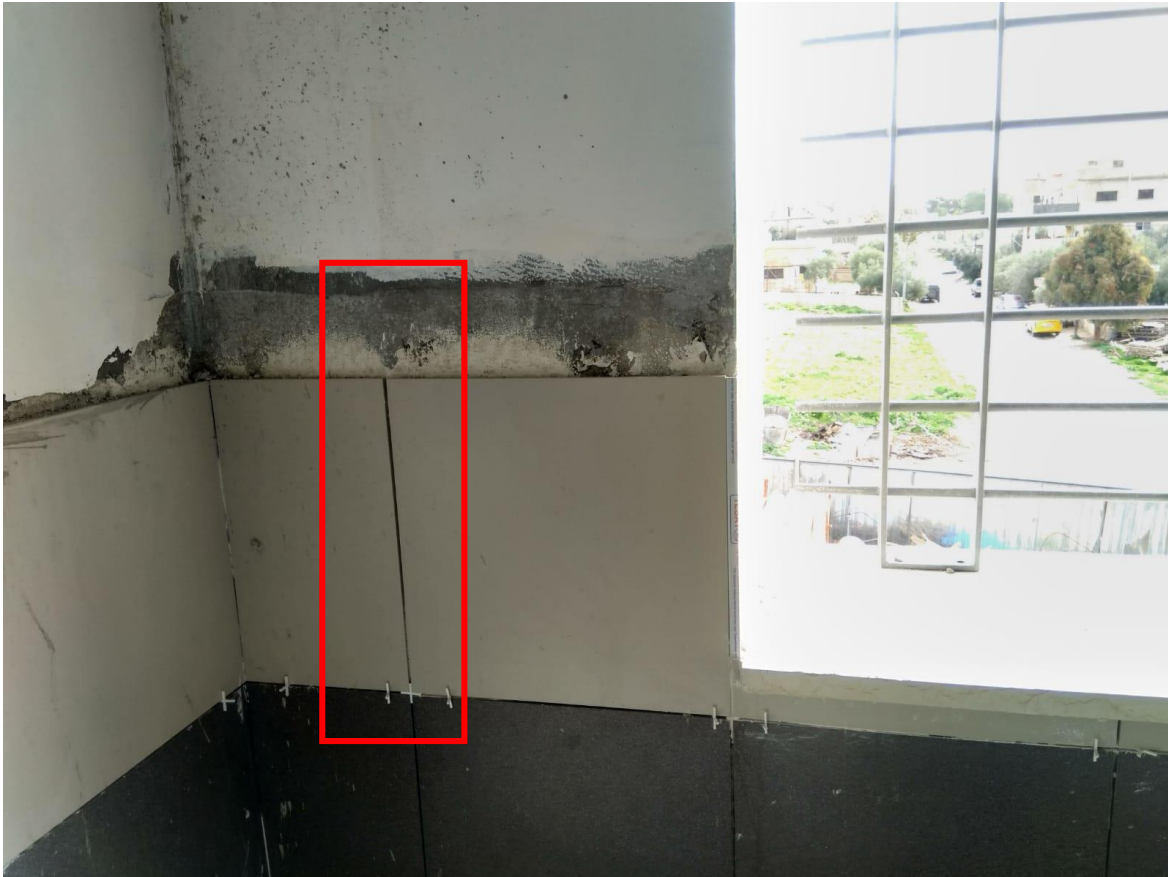
(figure:16)

The team noticed defect in wall tiles installation (spacing between tiles). The Contractor was requested to rectify before installing the granite coping

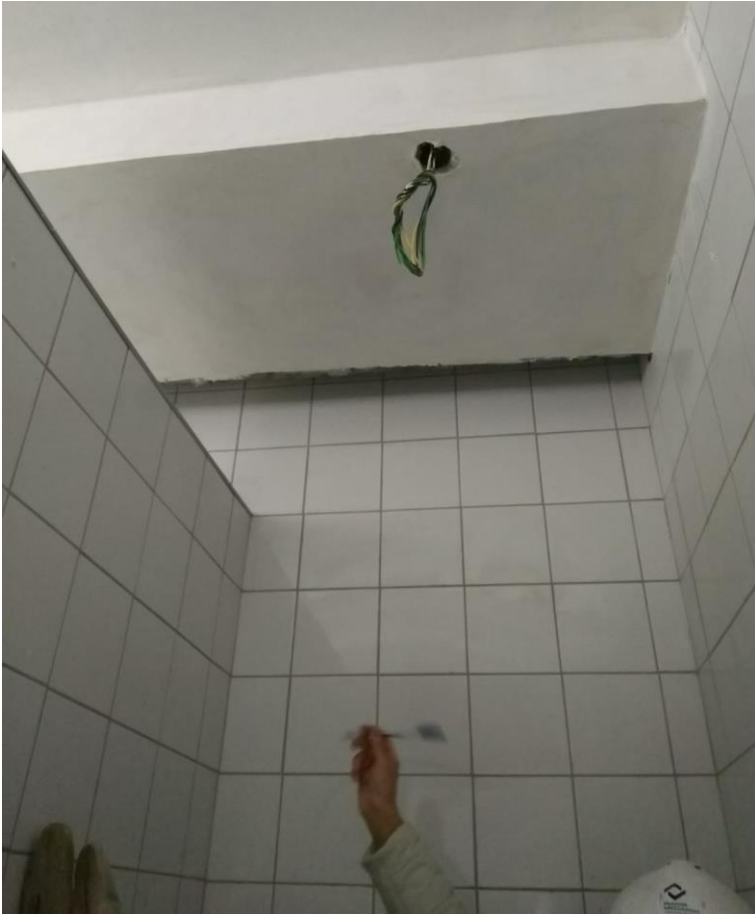
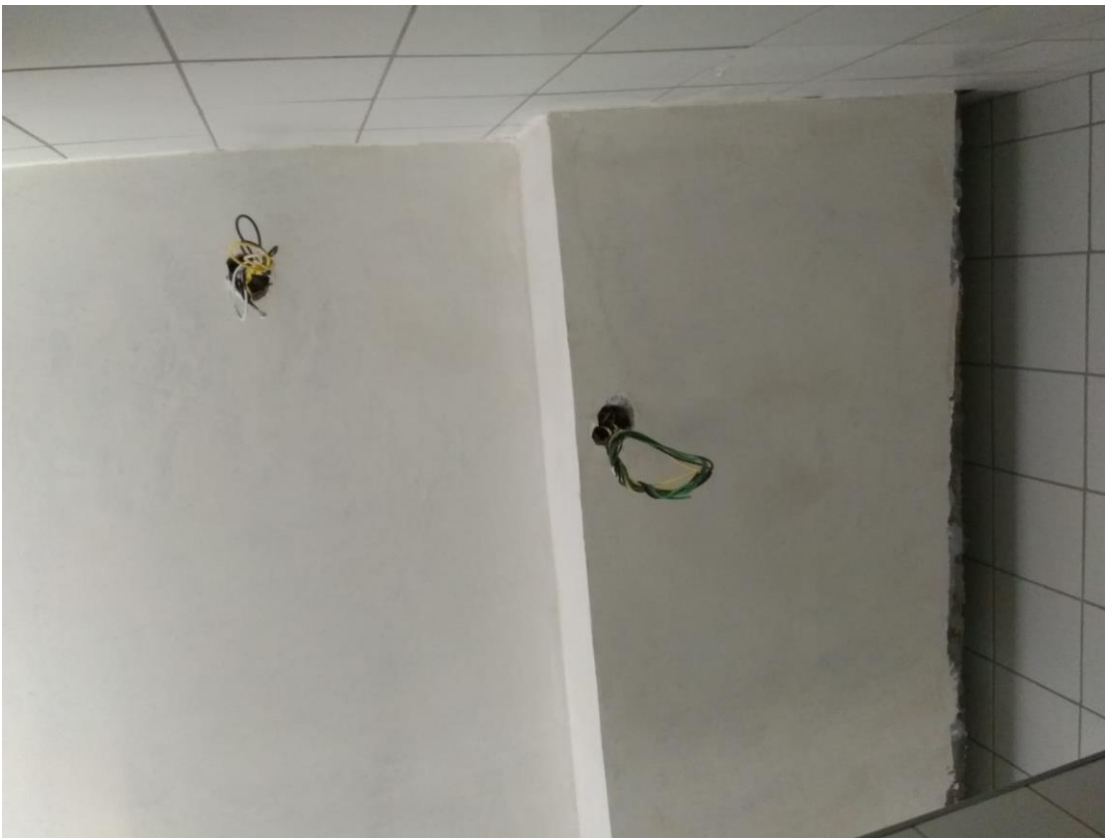
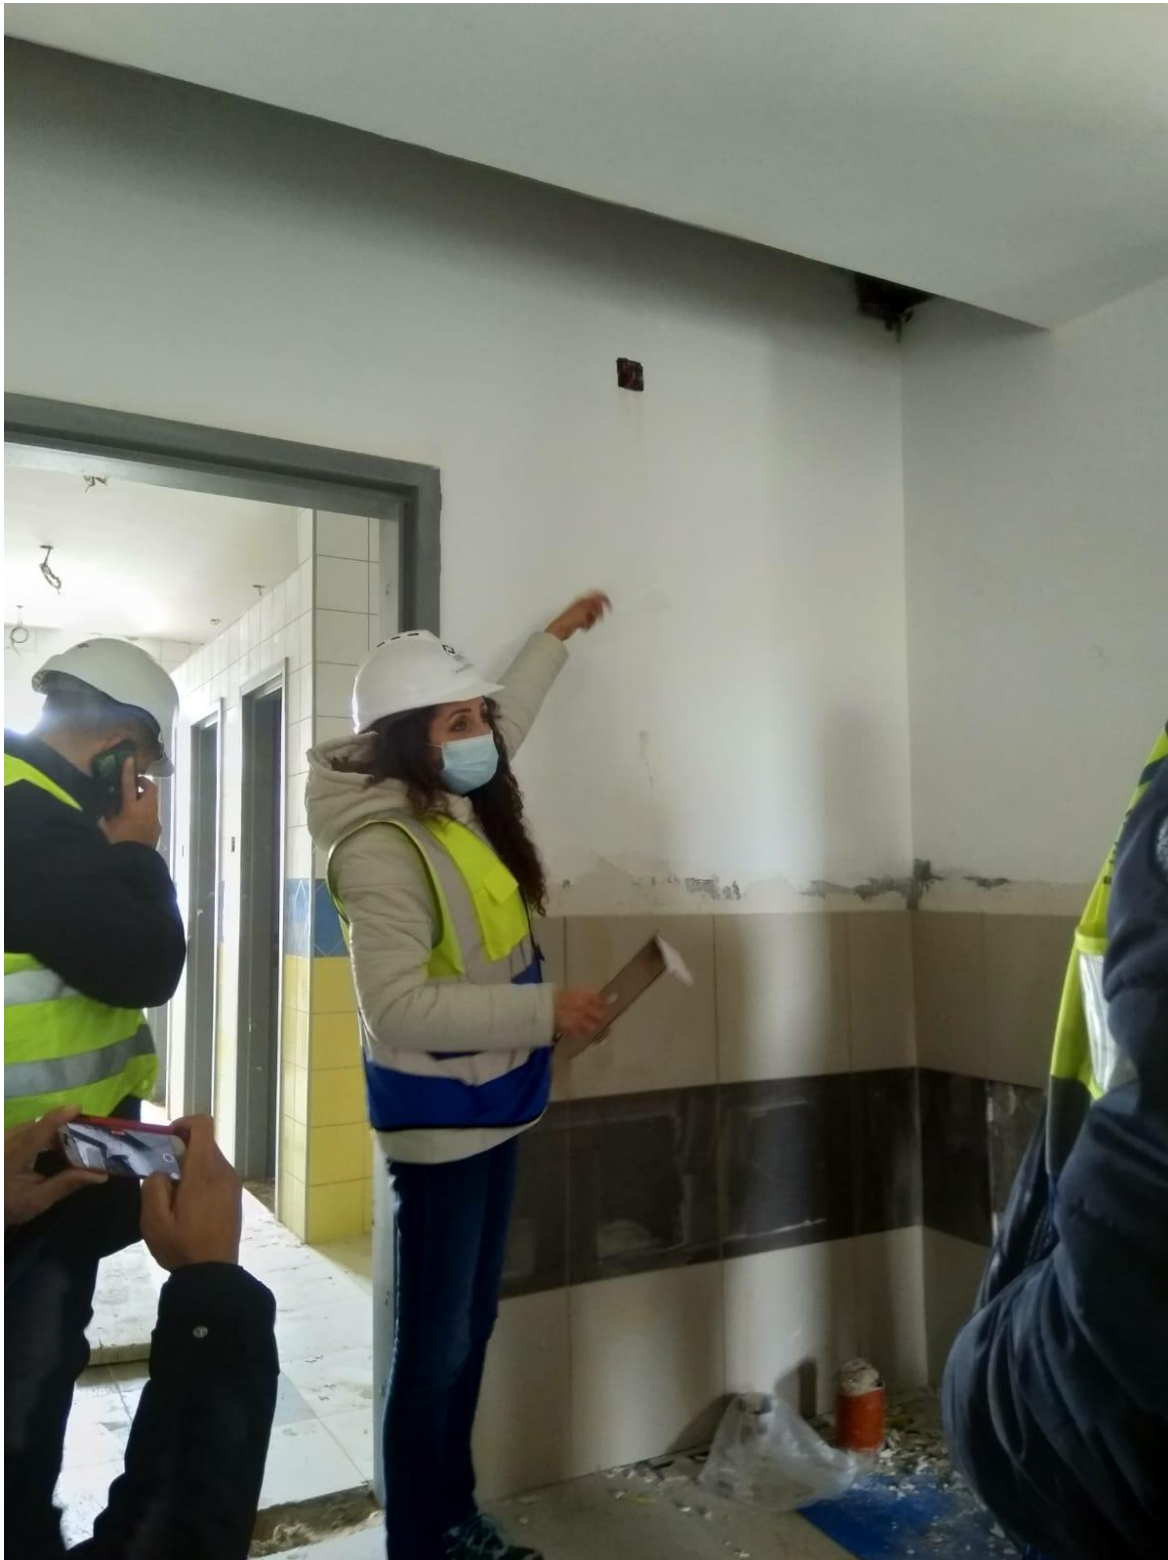
(figure:17, 18 & 19)

The team discussed with the Contractor the gap between some dropped beams and the walls at the wet areas and corridors. The Contractor was instructed to cover the gap with gypsum board installed appropriately and painted

And lower the level of the electrical box to avoid conflict with the level of the suspended ceiling
