Consultant	Wahib Medanat Consultant Engineer	Rep No.	11-09032022
Contractor	Derar Saraireh & Sons for Engineering & Contracting	Tender No.	(11/2019/USAID/SKEP/3/S) Schools for a Knowledge Economy Project (SKEP) - Phase (3) Package (1, 2)
Site Name	Um Al Dananir Basic Mixed School- Al Balqa	Day/ Date	Wed. 09/03/2022
Duration of Project	450 Calendar Days	Total Project Budget	9,789,417.840 JD

Visit Notes

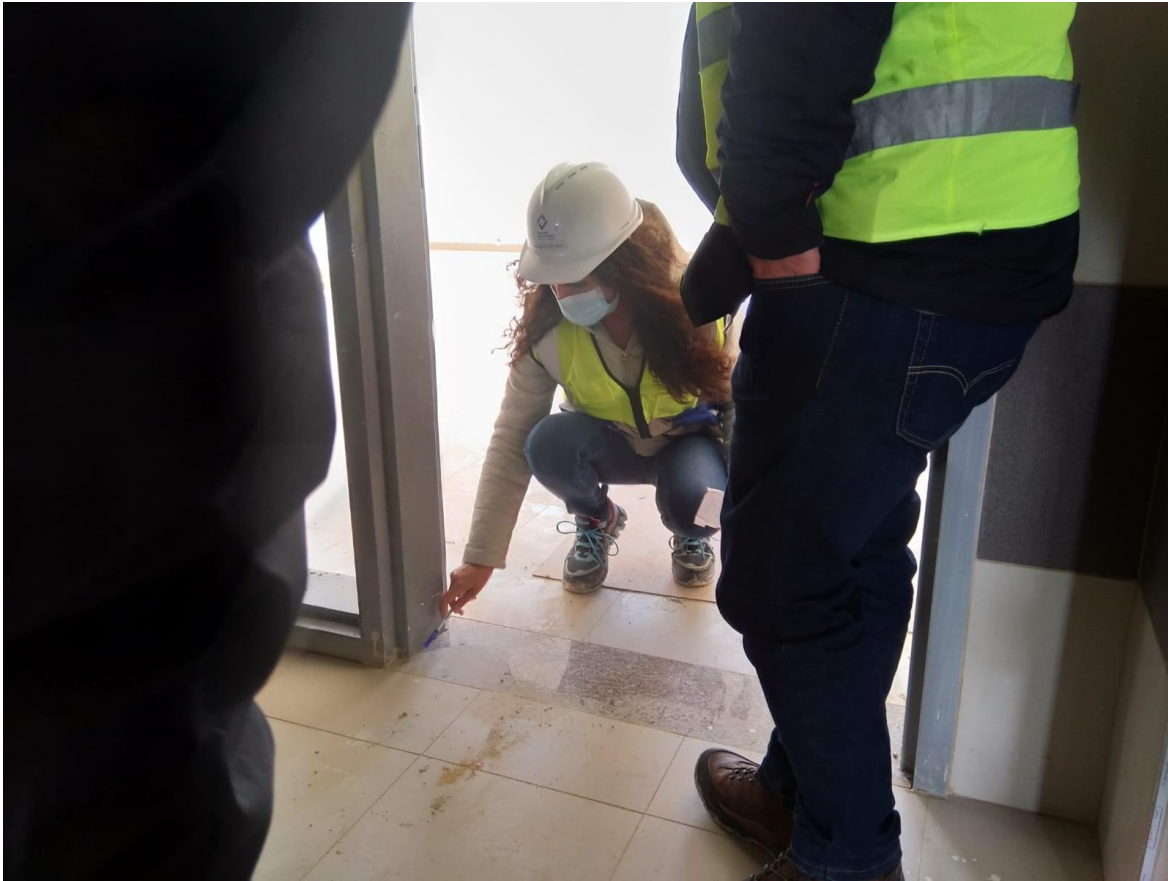
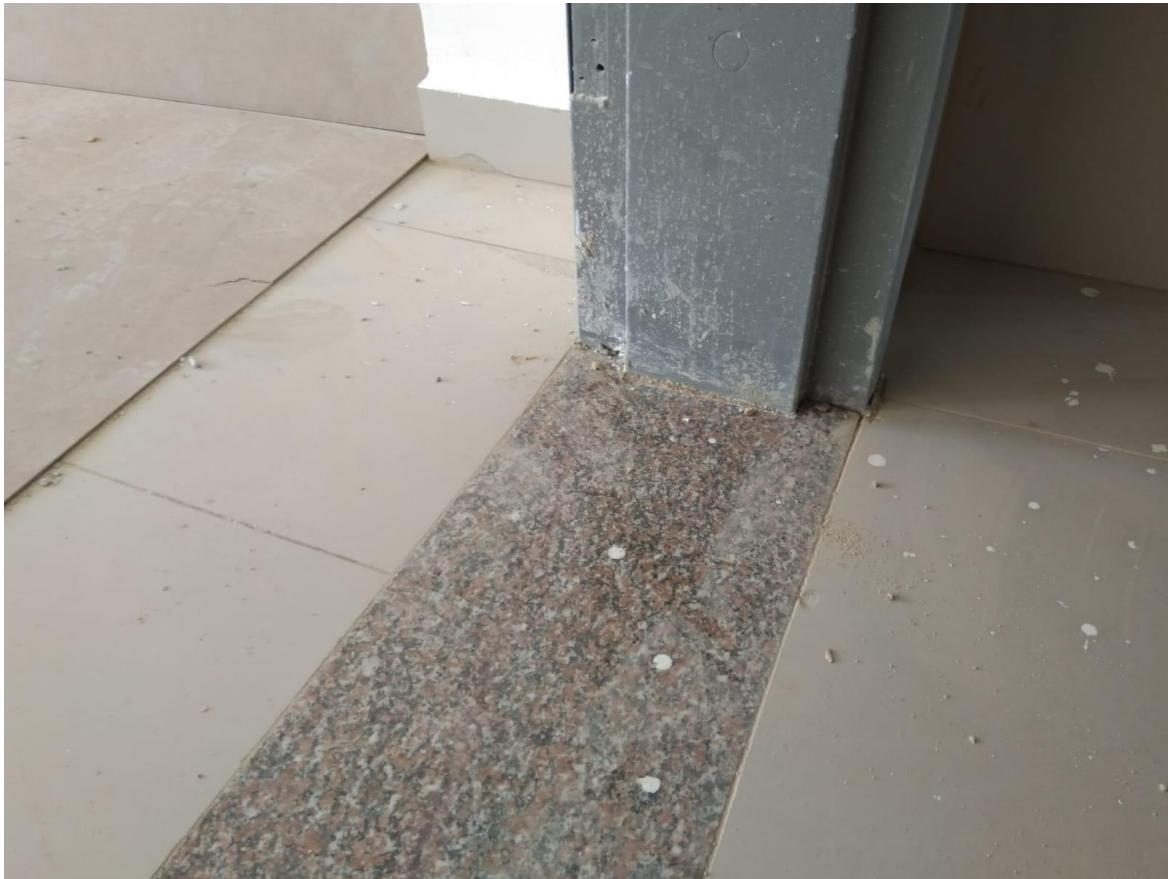
(figure:20 & 21)

The team inspected the executed door thresholds and observed defects in the cutting of those threshold

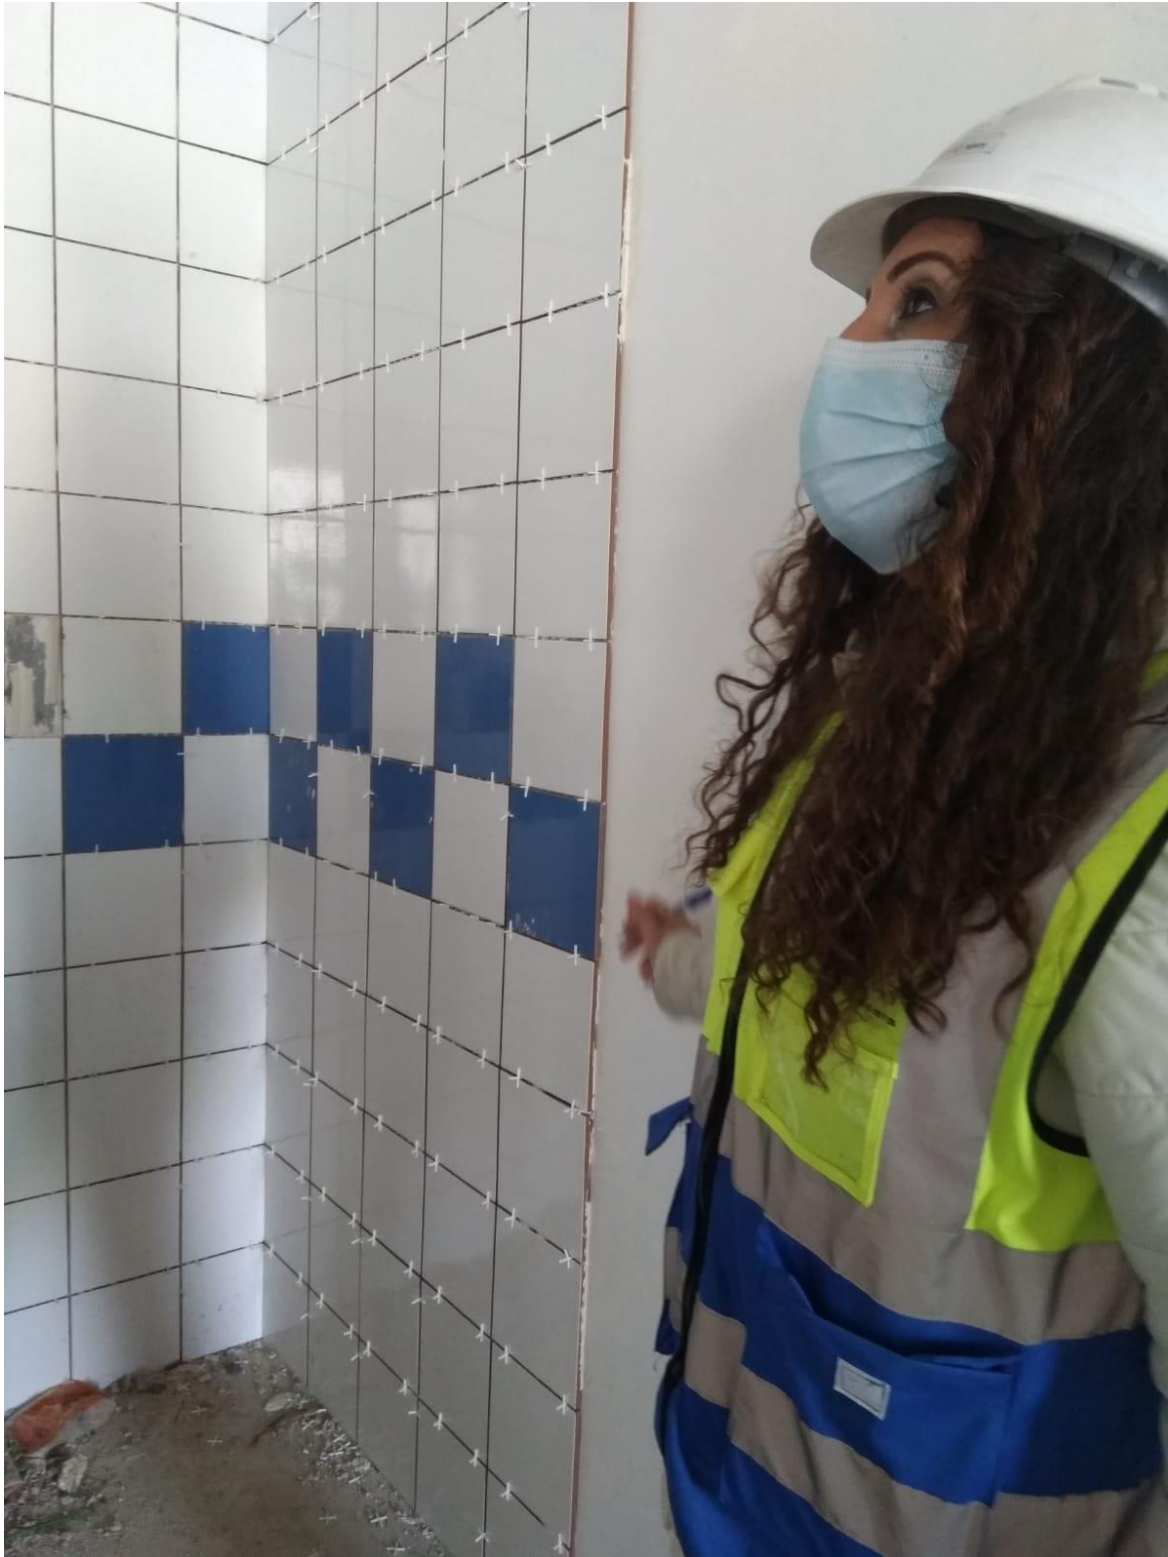
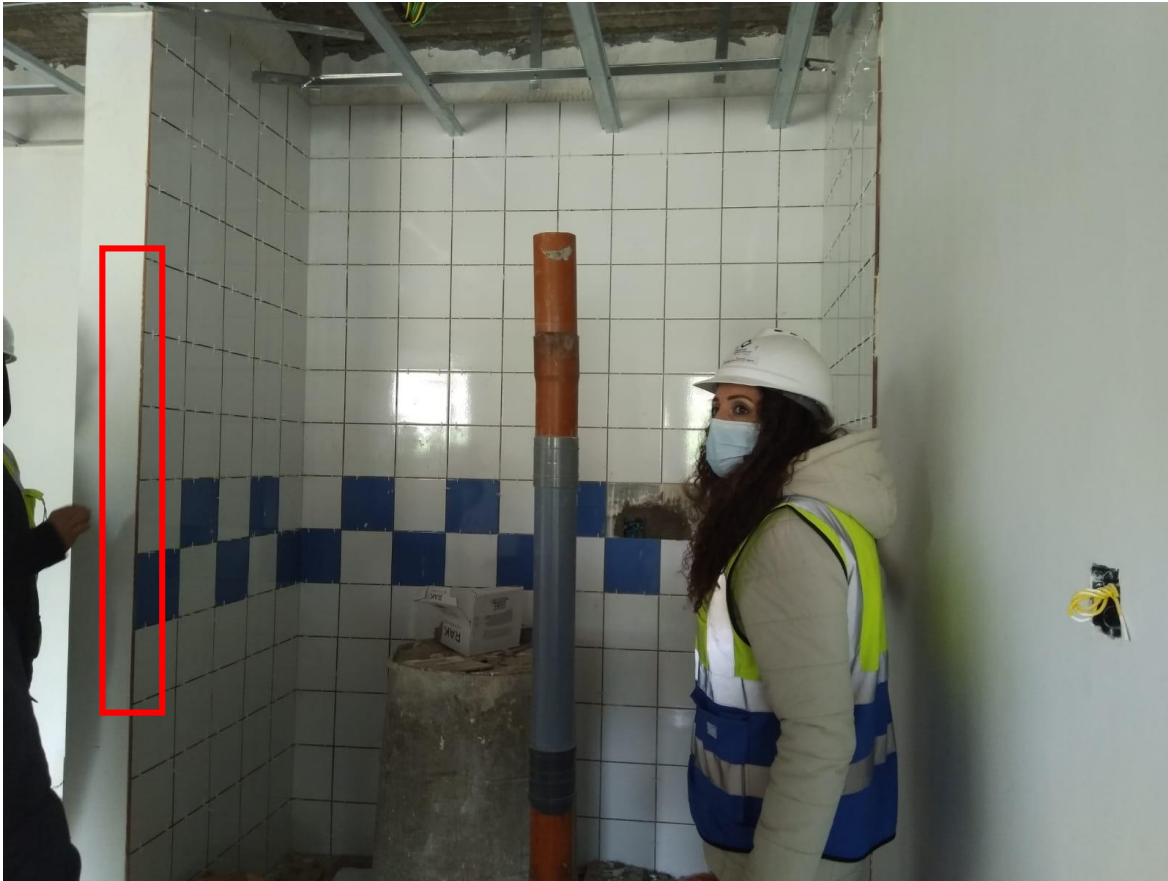
(figure:22 & 23)

The team requested the Contractor to install beads at the end of wall tiles of teacher center to insure the work quality and appropriate view

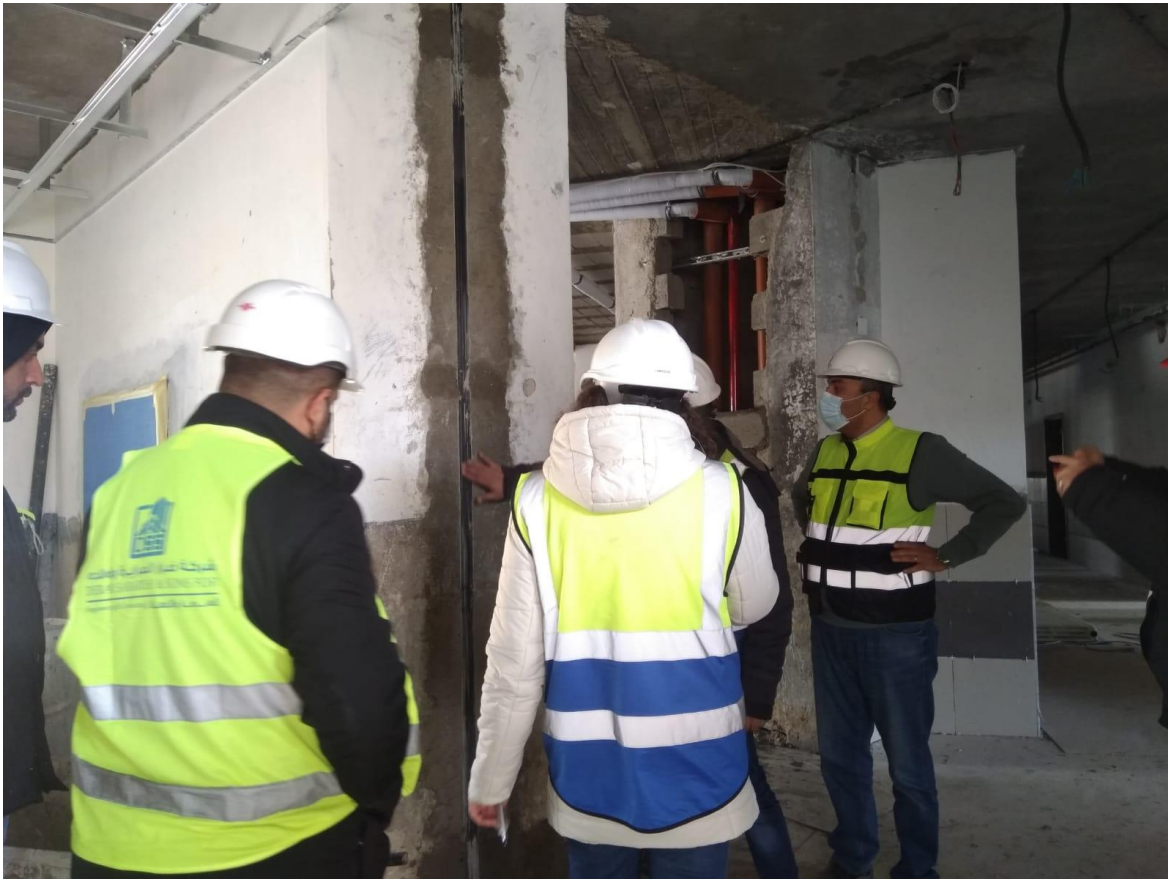
(figure:24)

Inspecting the execution of the internal expansion joint and discussing with the Contractor the architectural detail between the false ceiling and the internal expansion joint

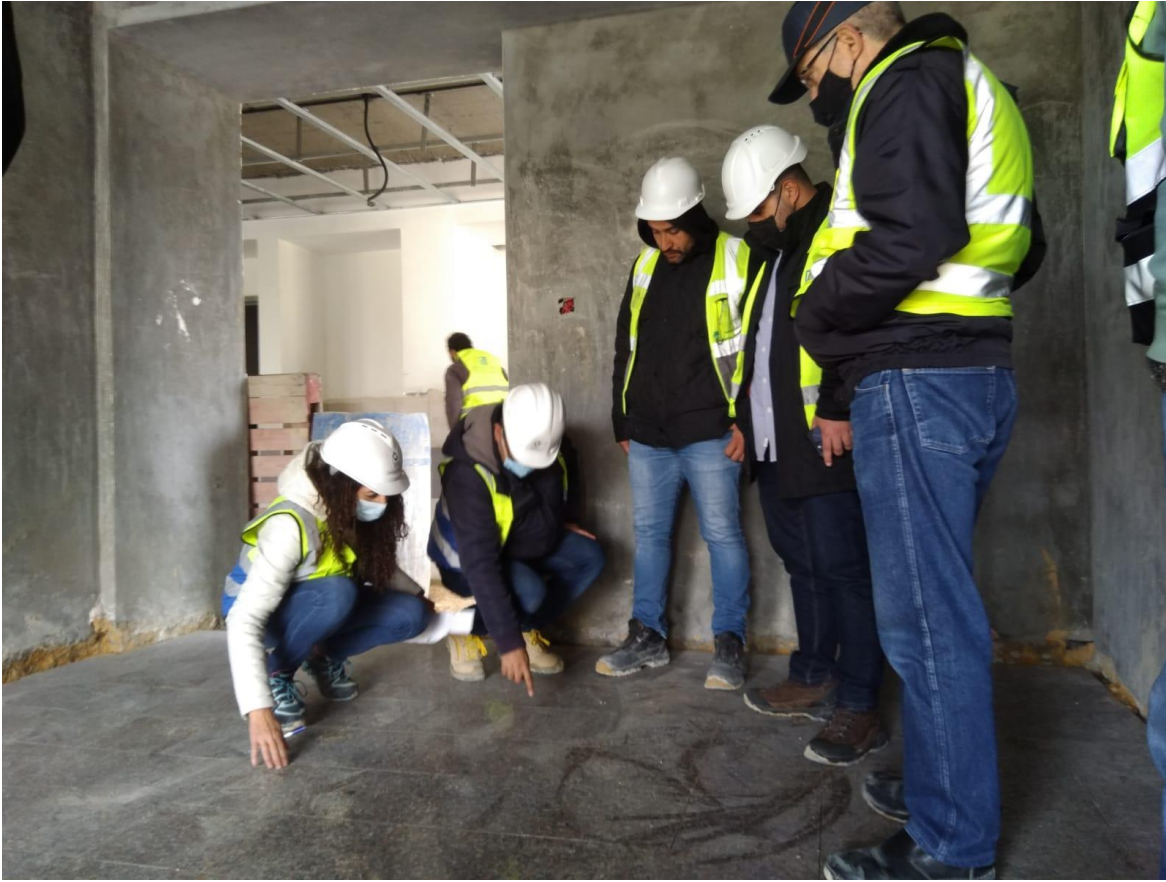
(figure:25)

The team inspected the granite tiling at the staircases landing and observed acceptable quality

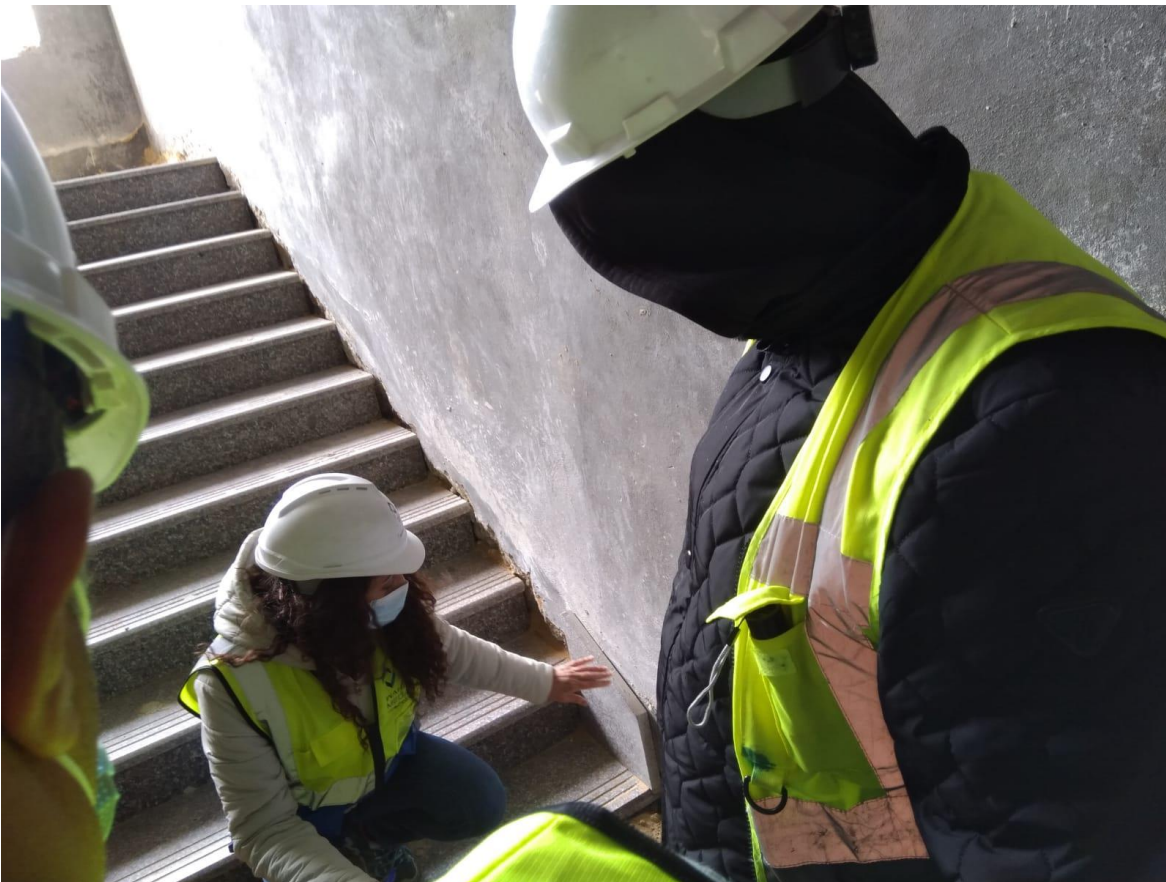
(figure:26)

The team inspected the details of the inclined granite skirting for the staircase and insured that the installation is acceptable

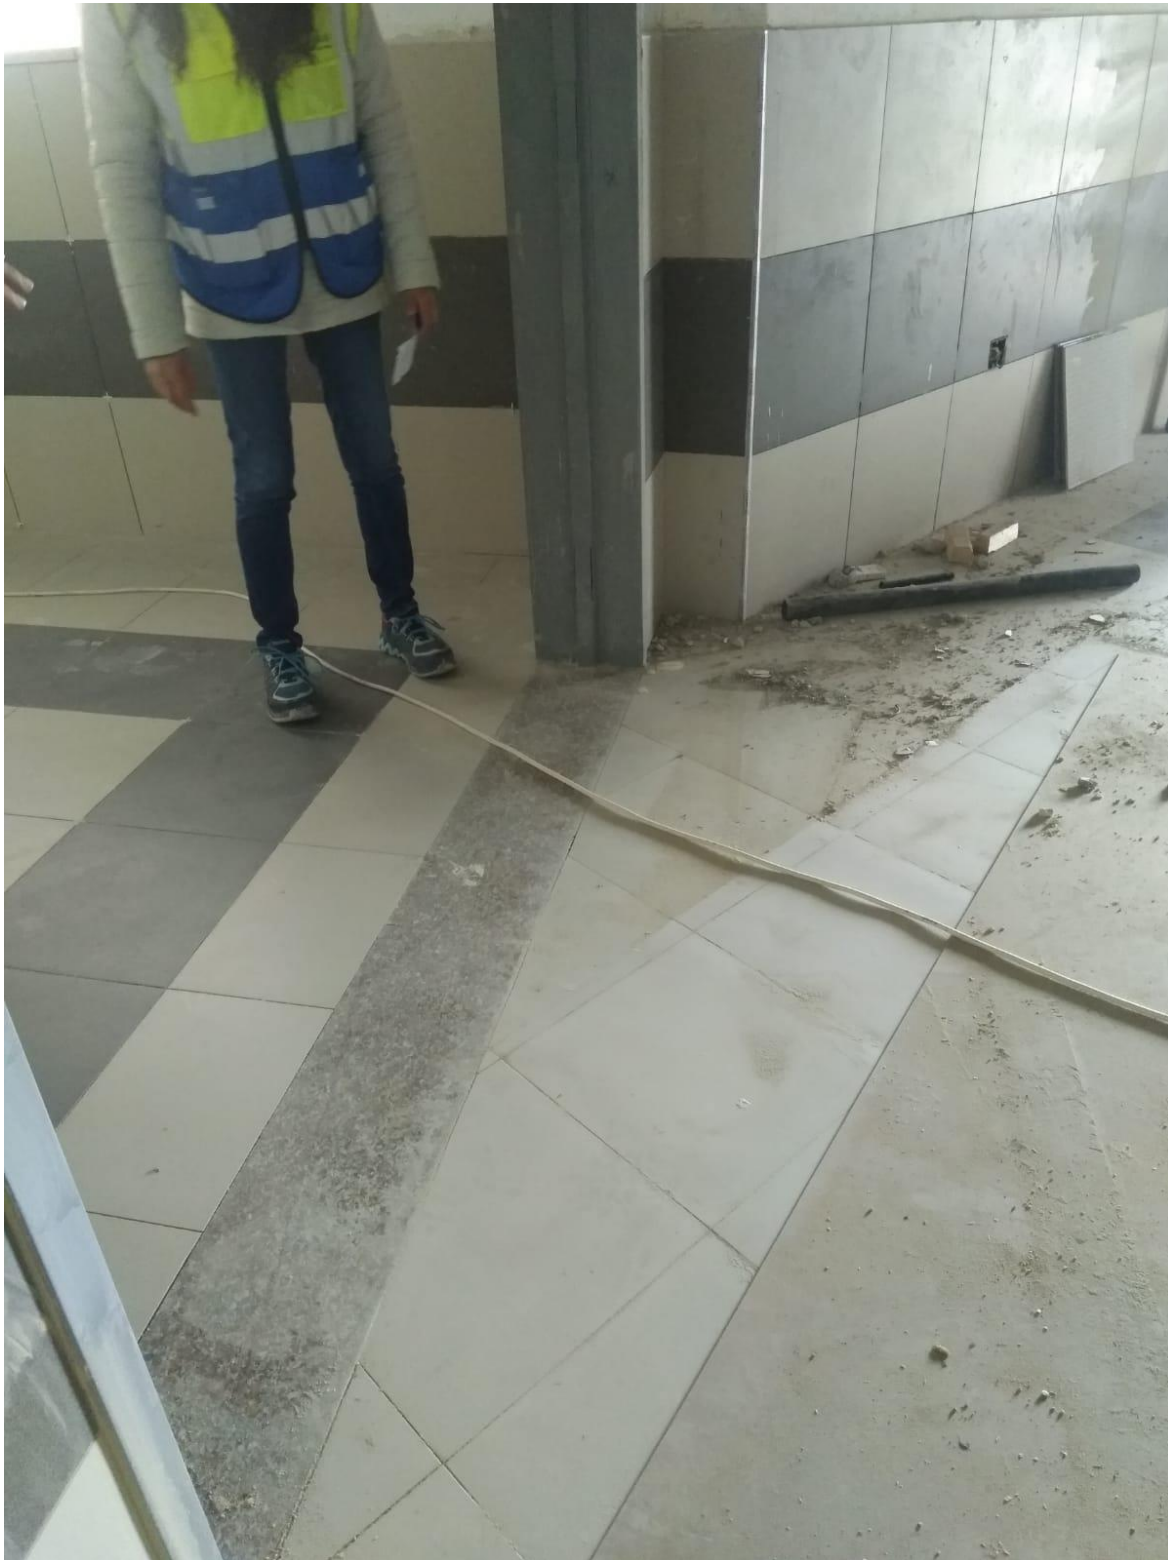
(figure:27)

The team inspected the installation of granite sill between corridors and ensured its appropriate installation

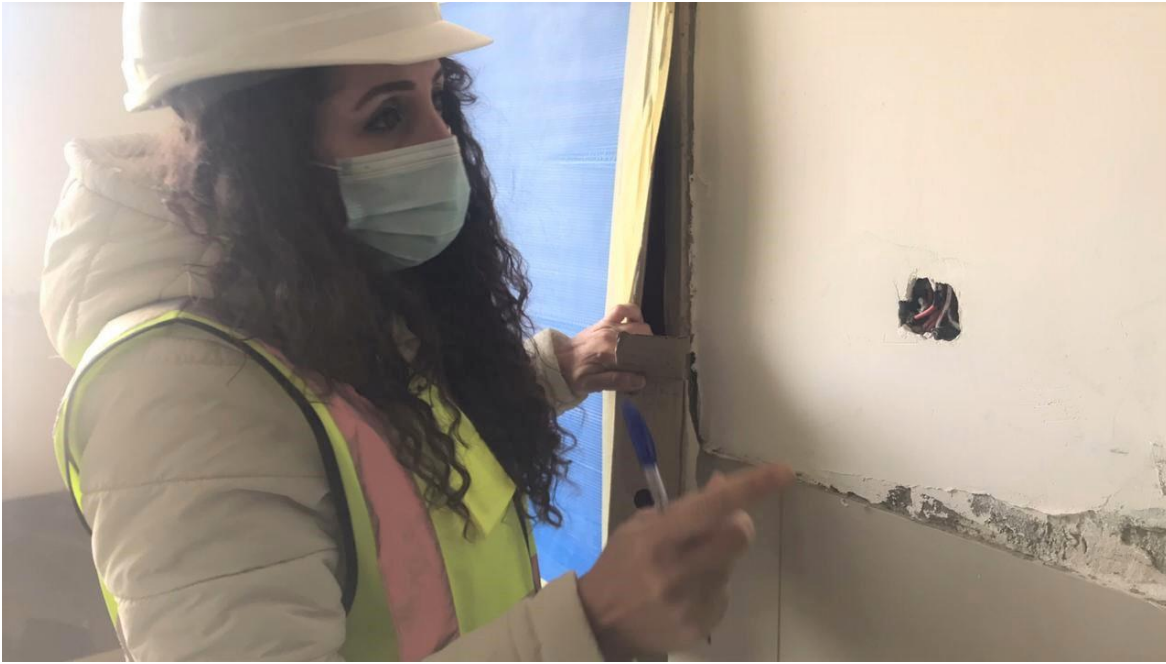
(figure:28)

Discussing the connection between the fire hose cabinets with the wall and to avoid any gaps

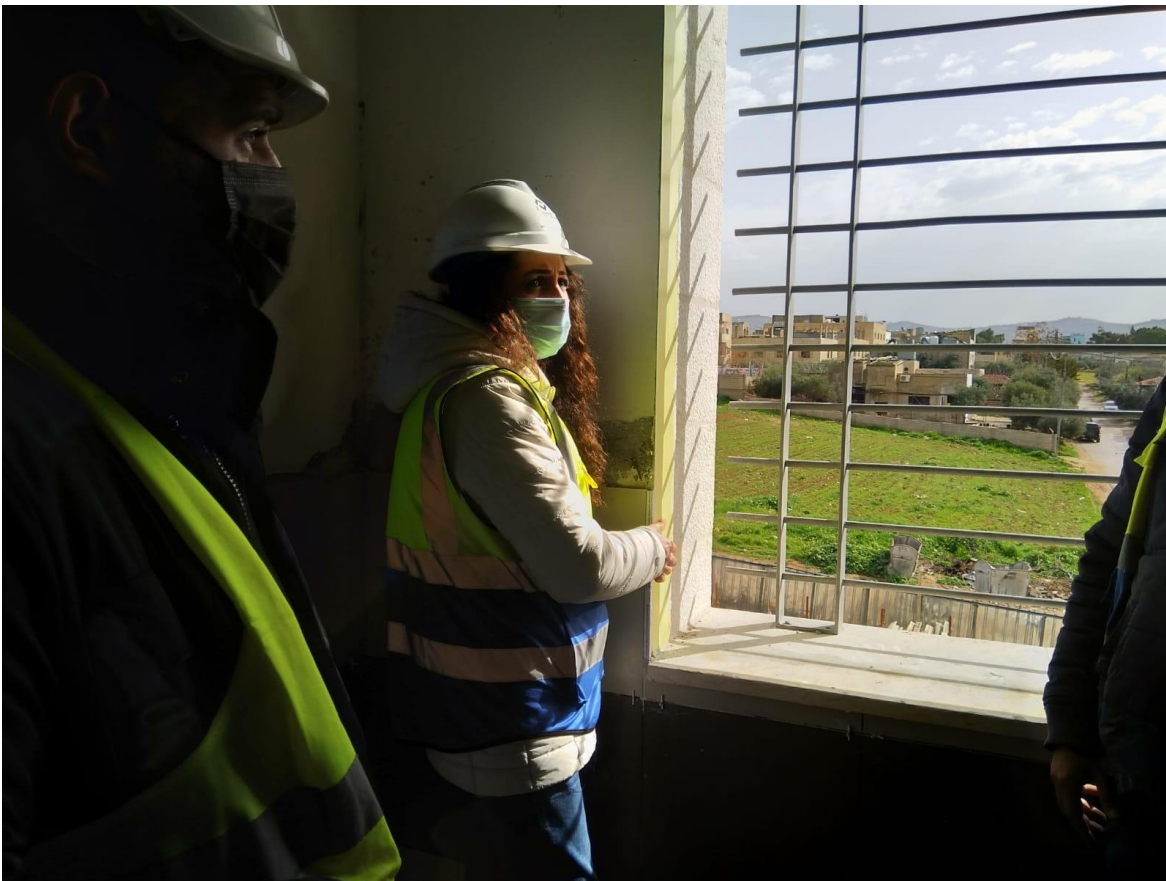
(figure:29)

The team discussed with the Contractor the continuation of granite to the window jambs up to the aluminum frame

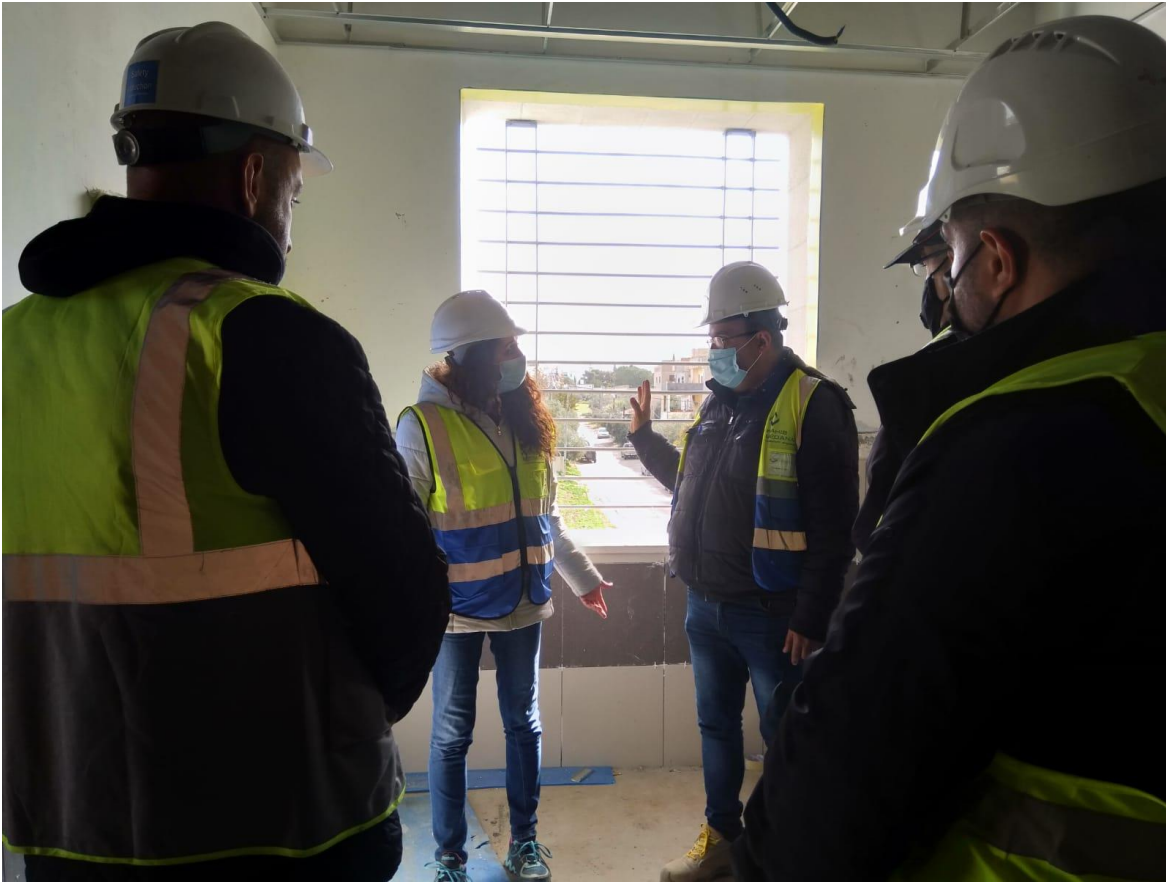
(figure:30)

The team observed that the Contractor is conducting a rectification to the installed steel protection screen
